## EMERGENCY EARTHQUAKE REPAIRS TO THE TALEJU TEMPLE

ANNEX TO THE PROJECT PROPOSAL | NOVEMBER 2011

THE PRINCE CLAUS FUND: CULTURAL EMERGENCY RESPONSE PROGRAM

KATHMANDU VALLEY PRESERVATION TRUST

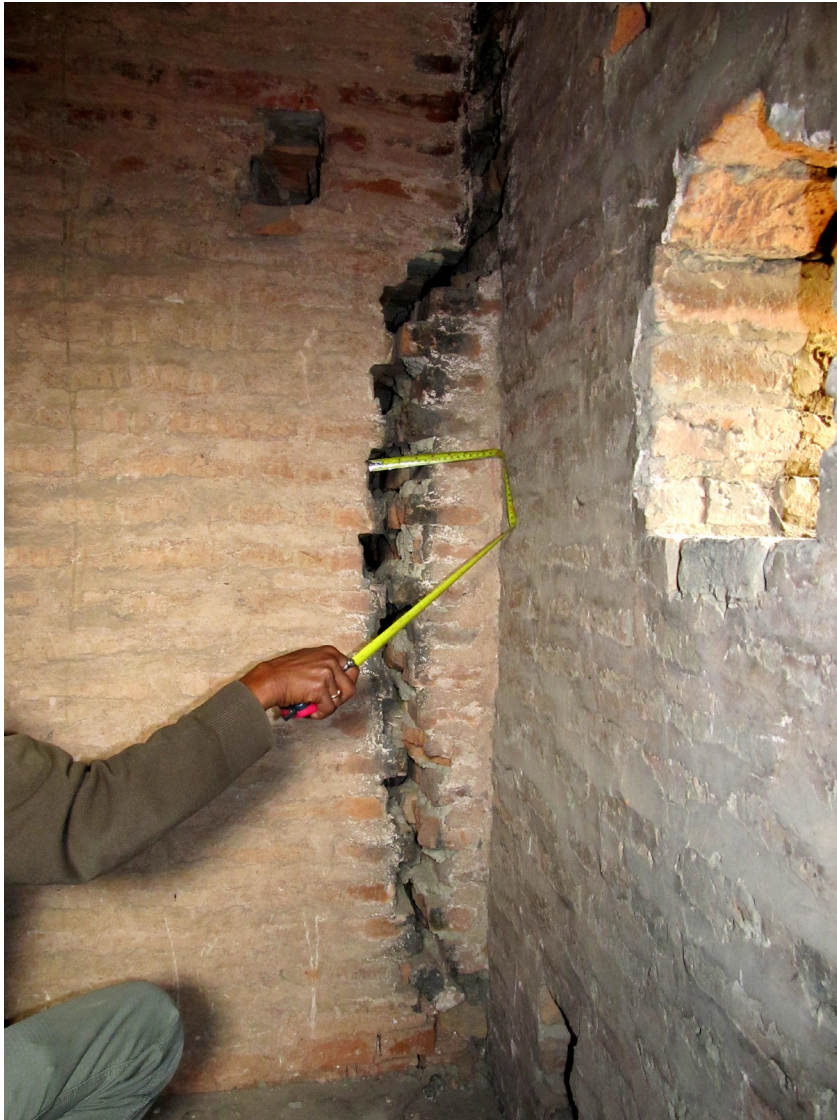
**A: Crack on interior north wall | Nov. 2011**

This large crack on the interior north wall was present before the recent September earthquake, but grew in width as the two walls moved farther apart.

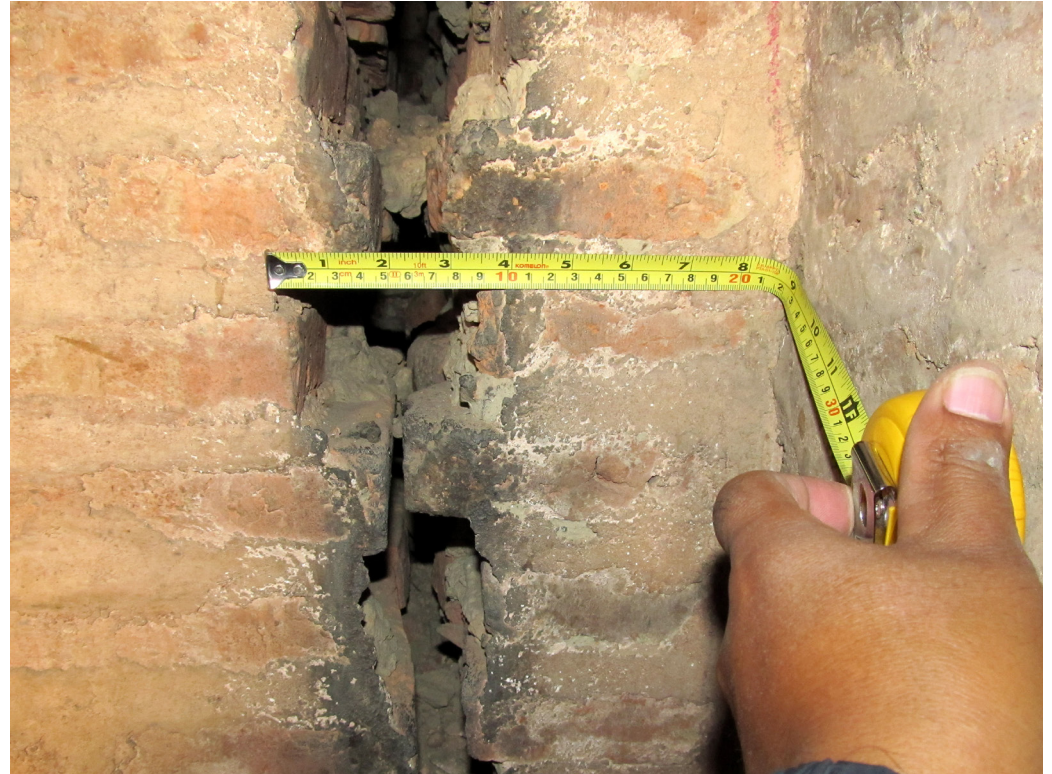
**A: Detail of interior north wall crack | Nov. 2011**

The crack now measures up to 8 centimeters in places, and damages the wall's masonry fabric. A crack such as this, located close to the corner and significant in size, cannot be repaired in-situ and requires partial re-building of the wall.

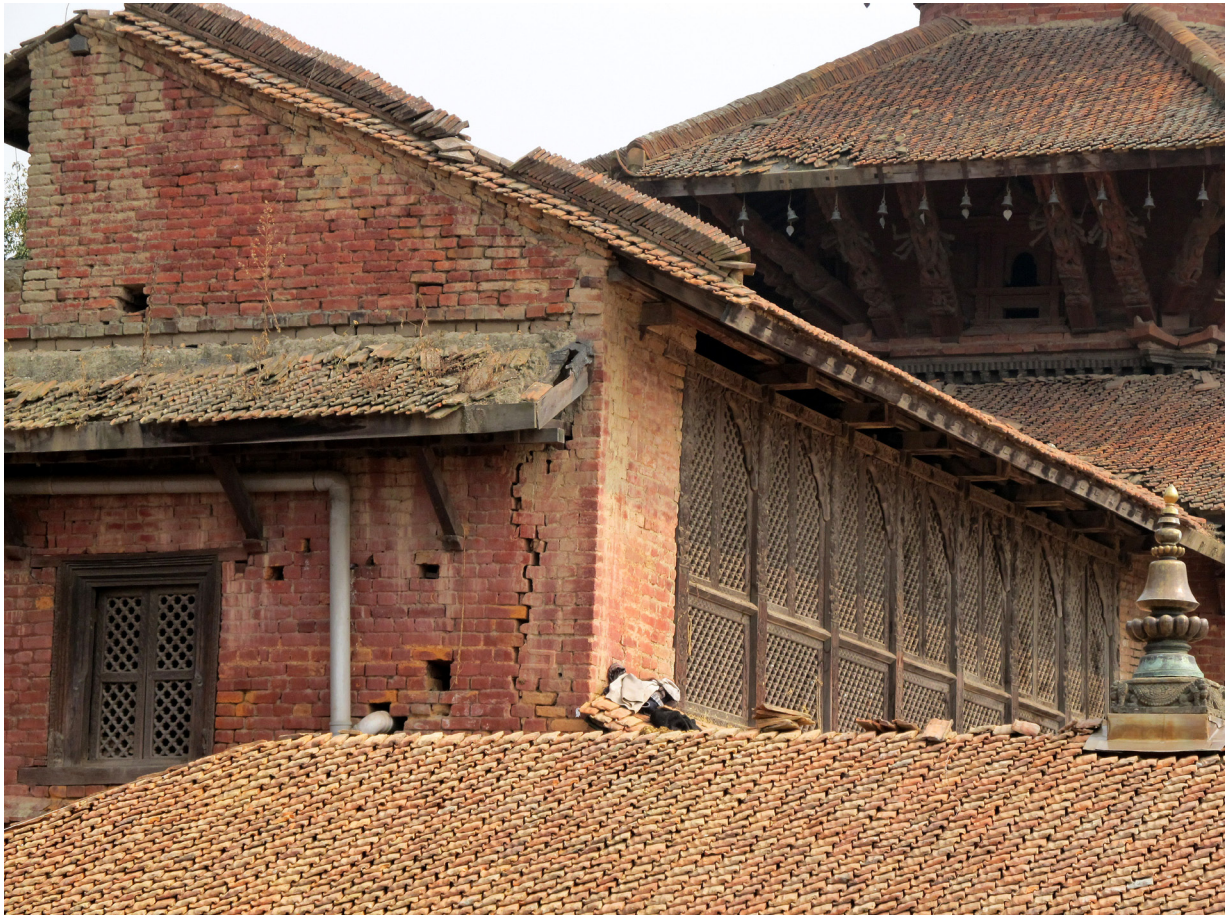
**B: Crack on the west-facing exterior facade of Taleju** | Nov. 2011

This severe crack on the exterior of the building was present prior to the earthquake, and was likely the result of a lack of proper wall joining techniques. The crack grew significantly wider after the recent September earthquake, and now measures up to 10 centimeters in some places.

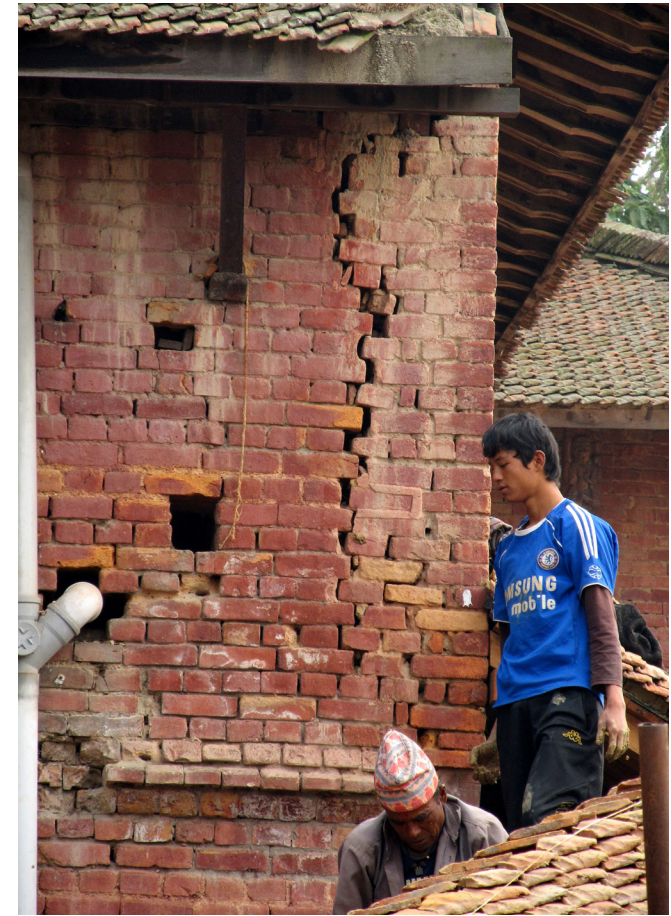
**B: Detail of west-facing exterior facade crack** | Nov. 2011

This detail shows the wide gaps now present between the bricks as they have further separated after the recent earthquake. The crack now takes up the height of the wall, and is in urgent need of repair.

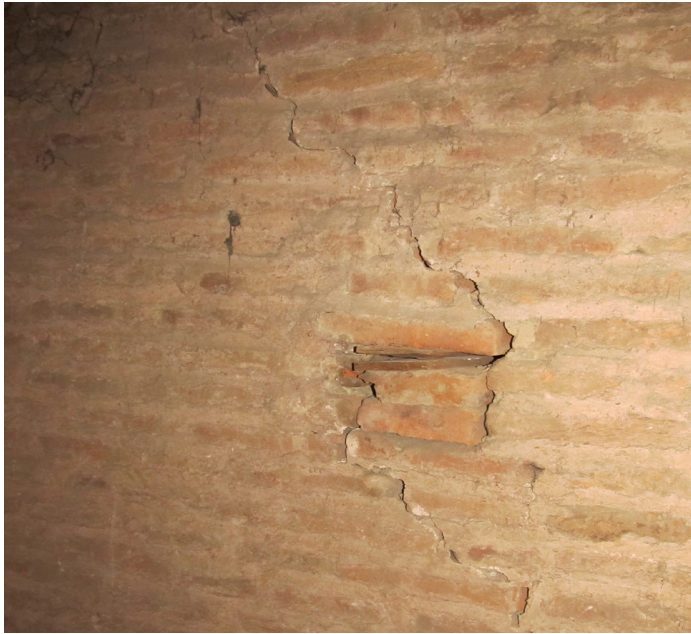
**C: Crack on interior south wall** | Nov. 2011  
 After the recent earthquake several small cracks occurred where the south wall meets the ceiling. The crack shown in the photo at left is the largest, and runs diagonally through the wall.

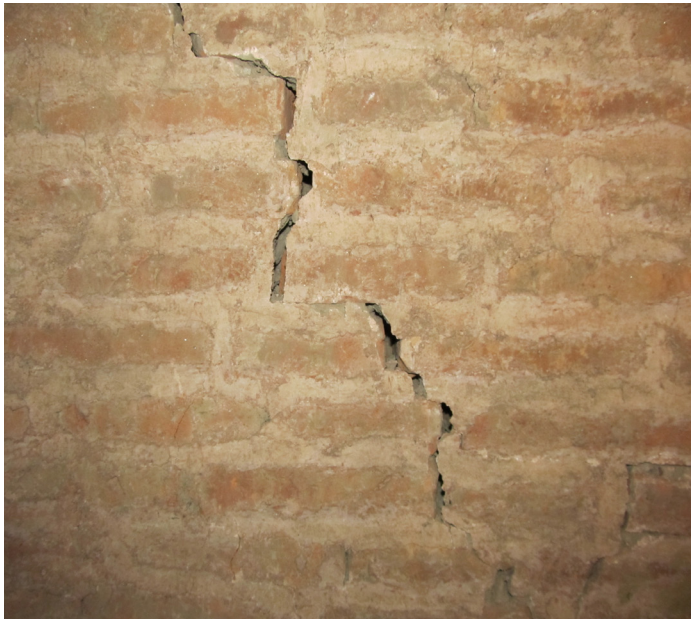
**C: Detail of interior south wall crack** | Nov. 2011  
 This detail shows the freshness and severity of the crack. Such a crack will be repaired by careful extraction of the affected and surrounding bricks, and replacement with traditional, high-fired “ma-apa” brick.

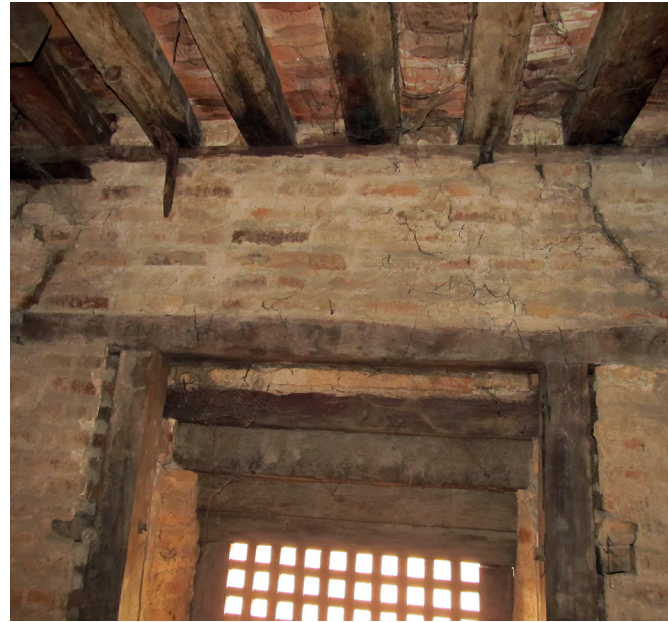
**D: Cracking between wall and timber frame, interior south wall** | Nov. 2011  
 Before the earthquake, there was minor cracking between the timber window frame and surrounding brick wall. After the earthquake, the gap between the frame and the bricks grew considerably wider.

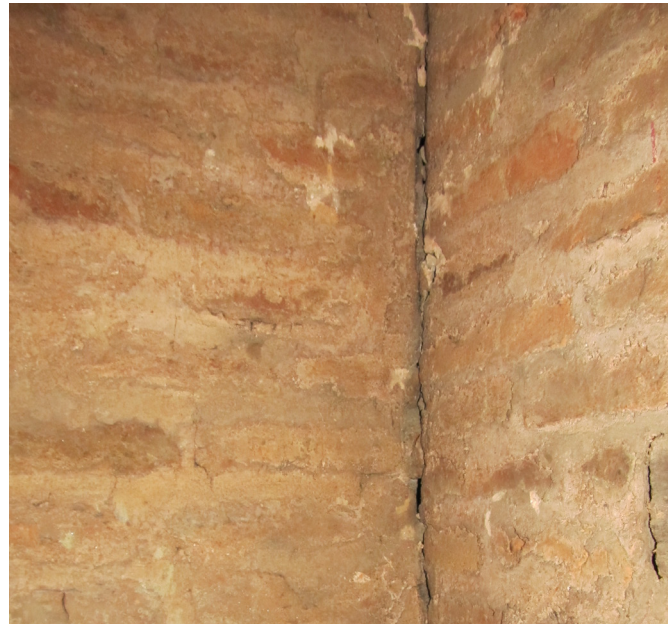
**E: Cracking in southeast corner and fissure between walls** | Nov. 2011  
 The southeast corner suffered some very minor cracks which are seen here. A small fissure occurred between the two walls, which are not properly joined and are therefore prone to break apart in the event of seismic movement.

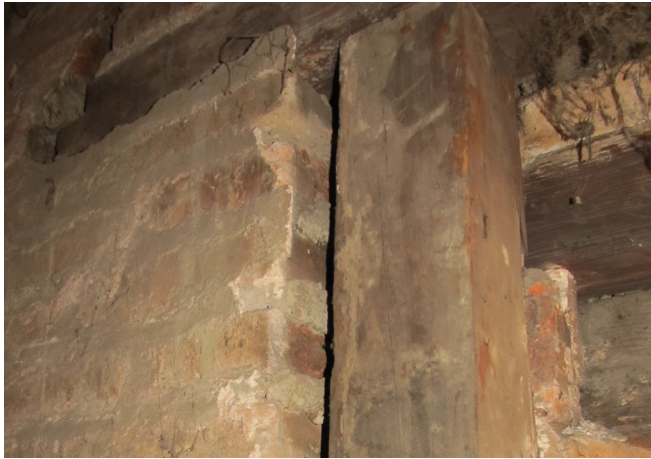
**Door and window frame strengthening** | Nov. 2011

This detail of a timber window pane separated from the surrounding brick wall exhibits the poor condition of the temple's timber elements, which suffer from rot due to water leakage and are therefore structurally weakened.

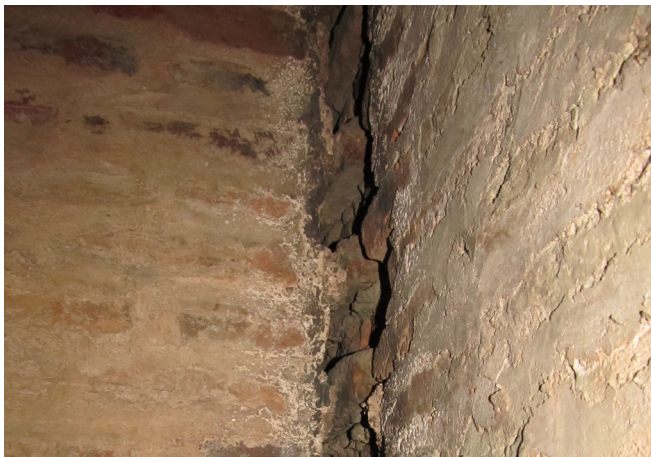
**Stainless steel wall anchoring** | Nov. 2011

These two walls in the southwest corner have pulled apart from one another, creating a massive 14 centimeter gap. The Trust proposes to install new, stainless steel wall anchors for seismic strengthening purposes. These anchors will unit the walls as one unit, allowing the walls to move together in the event of an earthquake, rather than pulling apart.

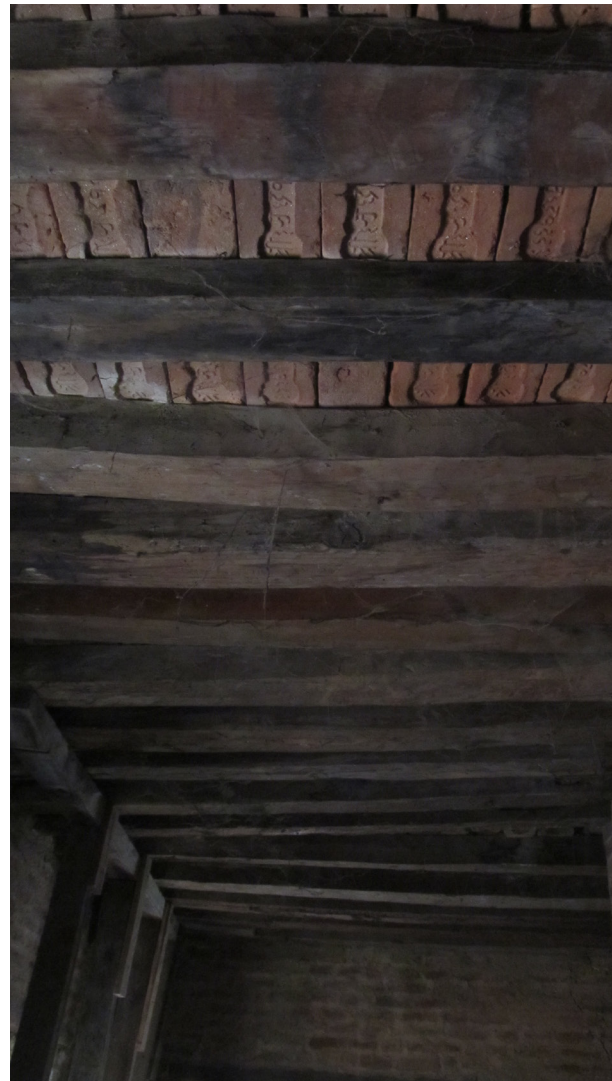
**Weight redistribution** | Nov. 2011

This photo demonstrates the bowing of Taleju's lower level roof beams, as they are inadequately bearing the heavy load of the tower above. The Trust recommends introducing additional support beams to properly and safely transfer the weight to the structure below.

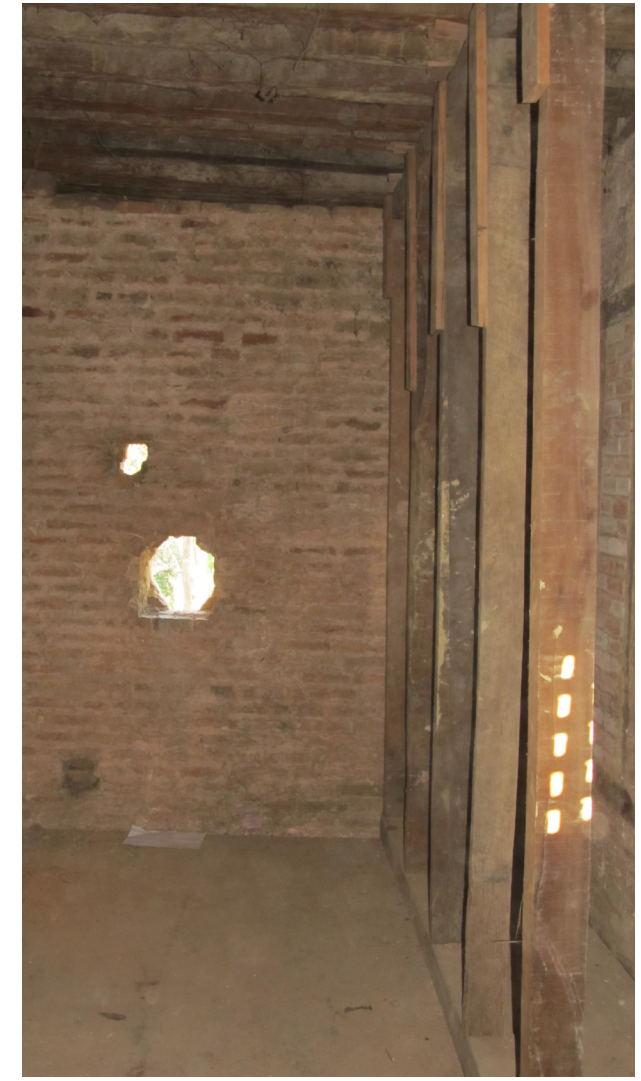
**Emergency vertical support** | Nov. 2011

The Trust has already installed emergency vertical support structures, shown here, to retain the floors of Taleju's shrine room above. The implementation of a sound structural system is imperative and urgent, as the floors will not currently withstand any seismic movement.

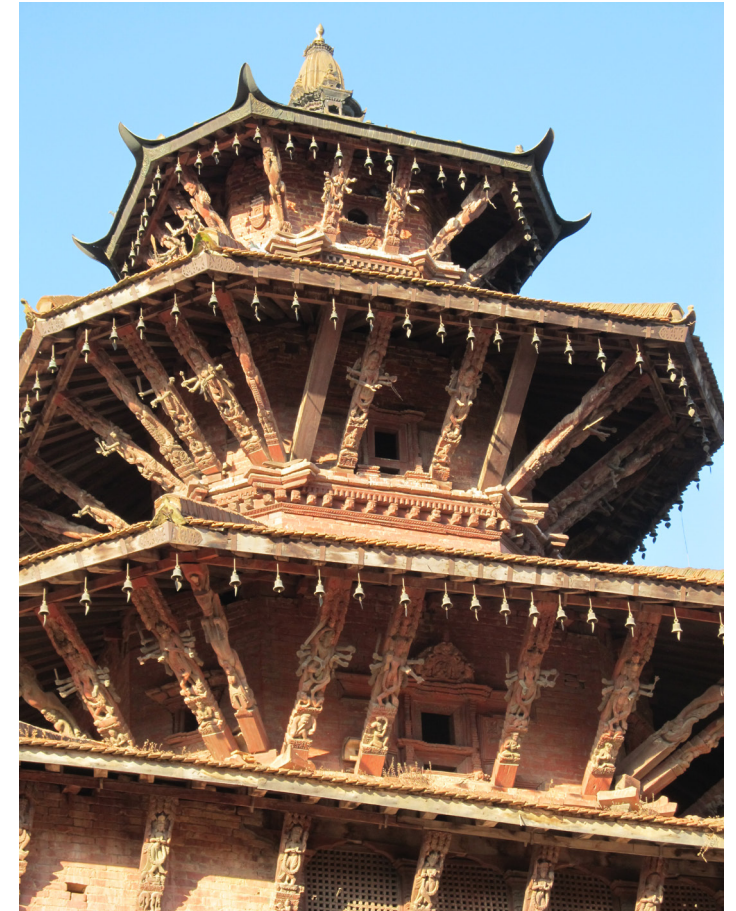
**Carved roof struts** | Nov. 2011

This detail of Taleju's tiered roof shows the intricate craftsmanship of the carved roof struts. Though beautiful, they are loosely and improperly fitted, and barely support the roof above. The Trust proposes to strengthen the struts at the base adjoining the structure, and at the top of the strut adjoining the roof.
