THE RESTORATION OF THE MUL CHOWK STONE STEPS & LIONS ANNEX TO THE PROJECT PROPOSAL | NOVEMBER 2011

SUBMITTED TO

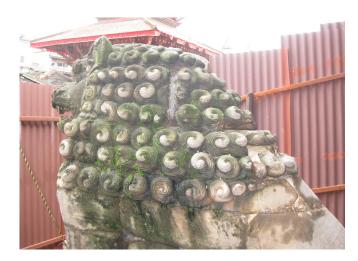
Female lioness' mane before restoration | Aug. 2011 The growth is at its thickest surrounding the lioness' mane and brick, where the brick fill-in was placed.

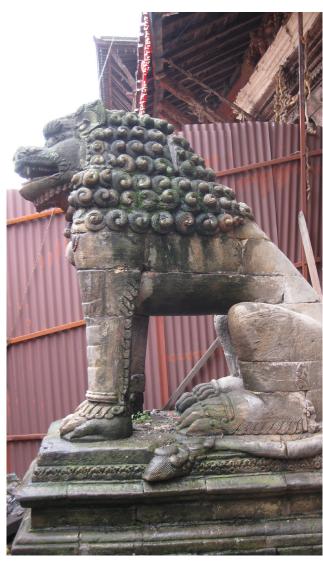
Female lioness before complete restoration | Aug. 2011 The female lioness statue prior to restoration was covered in dark green biological growth. The pointing between joints was also improperly and hastily done with cement, allowing water to seep into the statue. This combined with the statue's porous brick core, promoted this abundant and damaging biological growth.

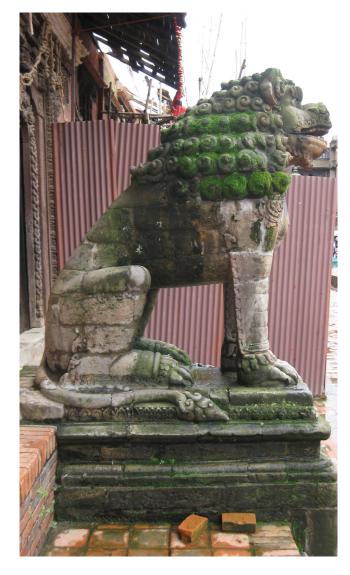
Male lion before cleaning | Aug. 2011 The amount of growth on the surfaces of the stone threatens the lifespans of the two statues. Such growth not only conceals the carvings and craftmanship of the stone, but in extreme cases can cause stones to fracture. The male lion was thoroughly cleaned, but was not disassembled and completely restored like the female lioness.

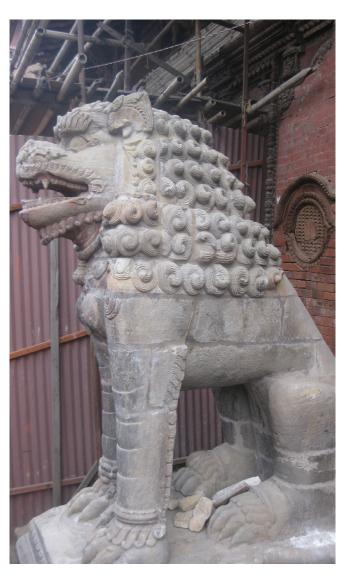
Female lioness after complete restoration | Oct. 2011 The stone lioness is restored to her former glory after being thoroughly cleaned and re-assembled. The stone components fit together smoothly, and the pointing is properly done, thoroughly sealing the joints.

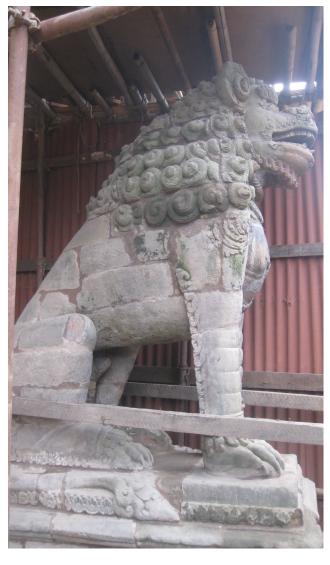
Male lion after cleaning | Nov. 2011 Just six weeks after the adjacent male lion was thoroughly cleaned, biological growth has already re-appeared around the statue's mane and chest. The male lion is in urgent need of complete restoration, as the improper pointing and inner brick core are the sources of this persistent and damaging biological growth.

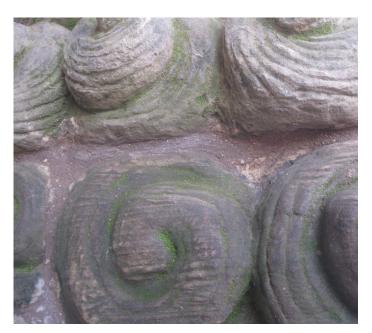
Detail of growth on male lion's mane | Nov 2011 Even after the extensive cleaning it received in late September, the statue has already begun to exhibit a resurgence in surface growth after a mere six weeks. In order to fully restore the lion, its brick fill-in must be removed, its joints properly pointed, and it must be re-assembled with seismic strengthening steel clamps.

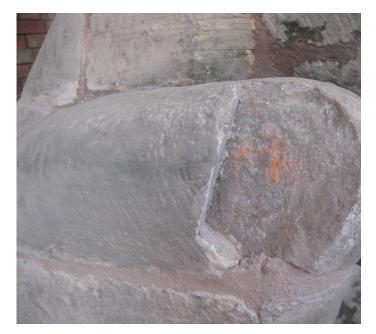
Damaged knee | Nov 2011 This detail shows the lion's right knee, which has been broken off. A replacement will be made by a KVPT stonemason, and will be properly joined to the statue's leg.

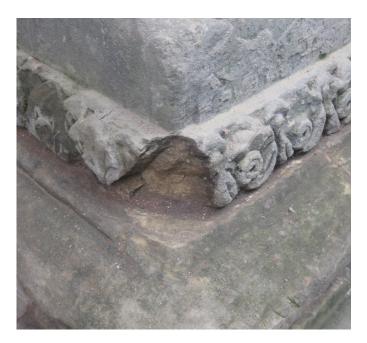
Missing base corner | Nov 2011 The statue suffers from many cracks and missing elements. This front right corner of the lion's base stone has been chipped off.

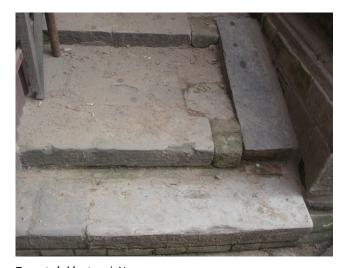
Truncated side stone | Nov. 2011 The long, slender stone at far right, once ran the length of the steps,

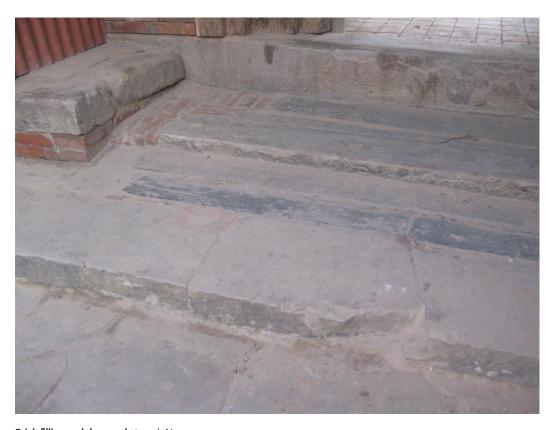
Brick filling and damaged stone | Nov. 2011 Here, improper brick fill-in can be seen in the far left corner of the top step. When re-setting the steps to their current positions, the steps were improperly sized and bricks were used to fill-in the gaps. This photo also documents the poor condition of the steps, they are cracked and in some places are completely broken off.
