THE RESTORATION AND RE-GILDING OF THE YANTAJU SHRINE

PROJECT PROPOSAL | NOVEMBER 2011

KATHMANDU VALLEY PRESERVATION TRUST

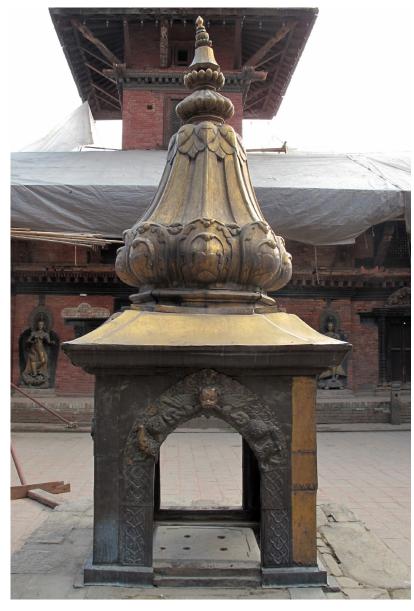
North elevation | Nov 2011

This is the only side retaining the original repoussé arch in its entirety. The gilded corner sheeting on the right is original. All other sheeting and decorative repoussé are later additions of inferior quality.

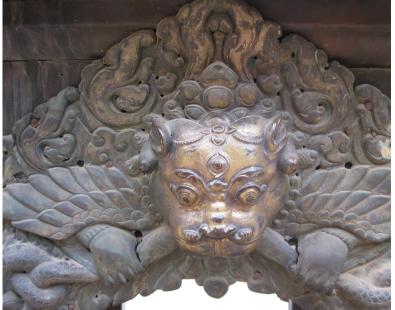
Detail of original arch

Nov 2011 This detail shows the original copper repoussé work, still partly gilded, depicting twisted snakes and a makara, the mythical water creature. Behind the repoussé work there are new copper sheets, of much poorer quality than the original sheeting.

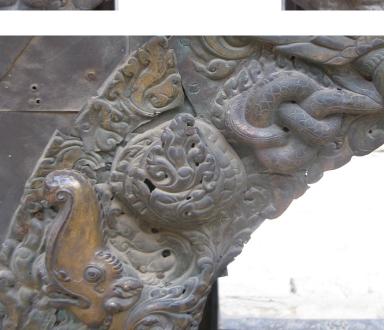
work on the chepa head is outstanding, and the newer replacement arches on the other three sides of the shrine do not compare in craftsmanship to the original.

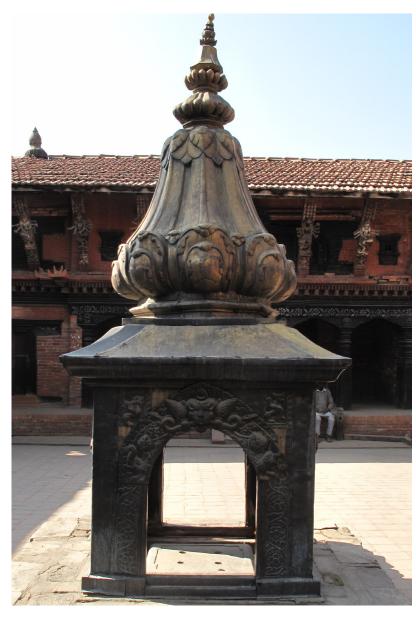
East elevation | Nov 2011
The east-facing elevation of the shrine is almost entirely new and in need of replacement.
Only three small gilded pieces of original sheeting remain.

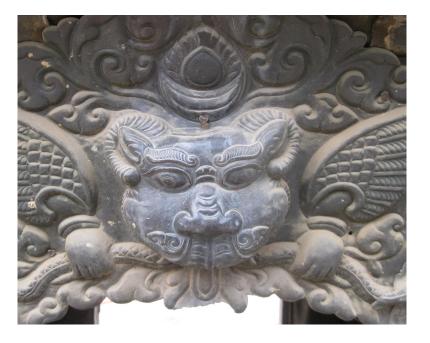
Detail of arch | Nov 2011 When compared to the arch detail on the opposing page, it is immediately obvious that this later replacement does not match the original 17th century craftsmanship.

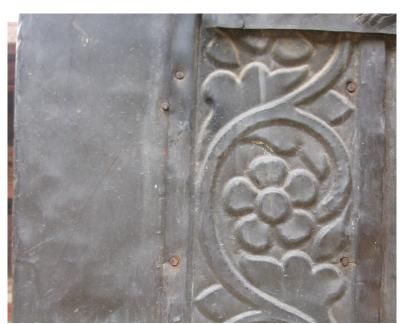
Nov 2011
Here, the shallow relief and simple repoussé work on the decorative frame below the arch lacks the detail and depth of the original.

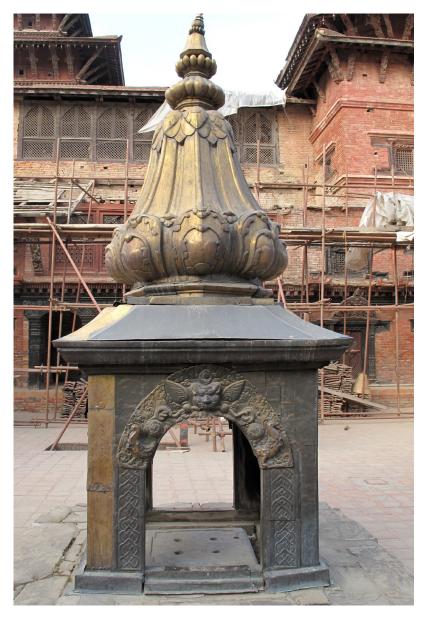
South elevation | Nov 2011

This elevation retains an original gilded corner molding, and parts of the original arch. The face and the decorative framing are later new additions.

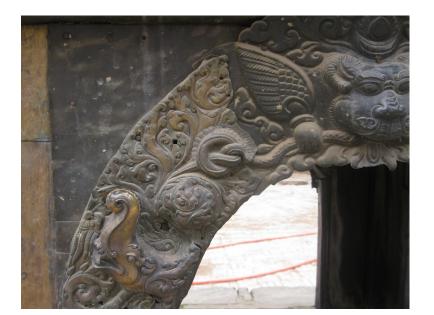
Detail of arch | Nov 2011 When the monument was repaired in the mid 20th century, replacement parts were not only poorly made but also not gilded, as is demonstrated by this detail. Here, the left part of the arch is original, while the center head is a later addition.

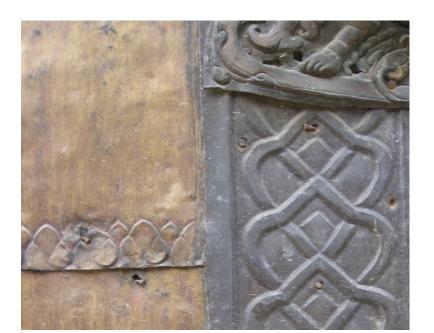
Detail of decorative frame | Nov 2011

The gilded part on the left is original, while the un-gilded part on the right is a later addition. This was affixed to the original using the crude method of fastening with nails.

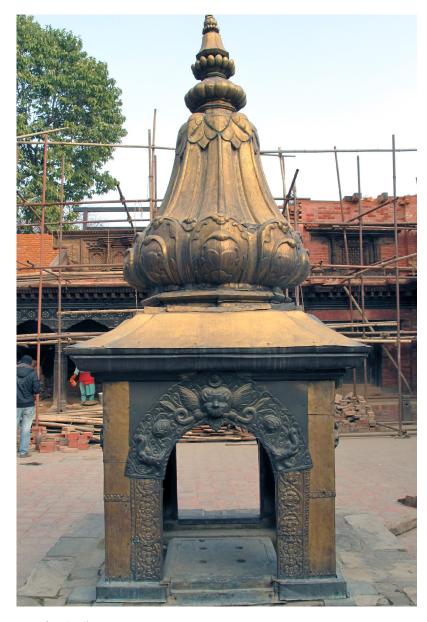
West elevation | Nov 2011 This elevation is the only side retaining the original decorative frame and gilded corner sheeting. The arch, however, is a poor fitting replica.

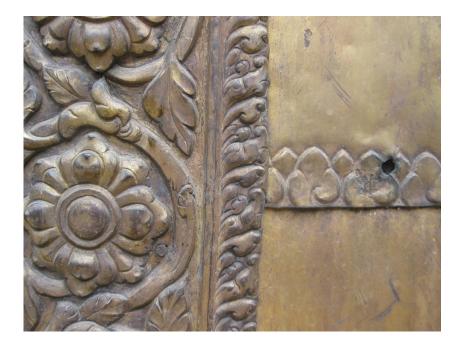
Detail of original decorative frame | Nov 2011 When compared to the replacement decorative repoussé work on the opposing page, the original repoussé work is finely detailed and retains its gilding. In many places there are unsightly holes such as the one depicted here, which is likely the result of a recent attempt to secure the sheeting with nails. Typically sheeting is fastened with hidden rivets, not exposed nails.

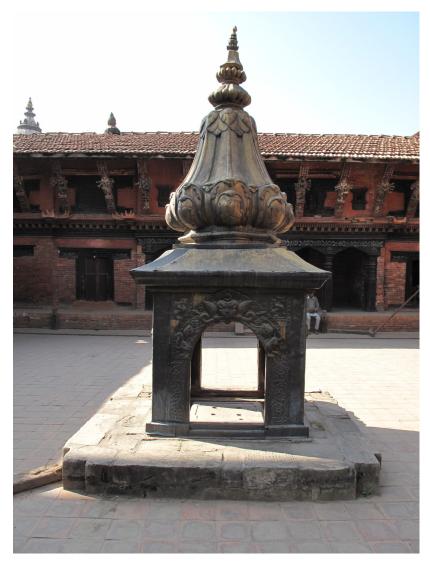
Plinth prior to pavement removal | Sep. 2011

The original quarter-round base stone is covered here by the tile pavement, which was laid in the courtyard in 1975. The tile pavement was recently removed to expose the original flooring, but because hard cement mortar was used to lay the tile, the original stone work of the shrine's plinth has been damaged.

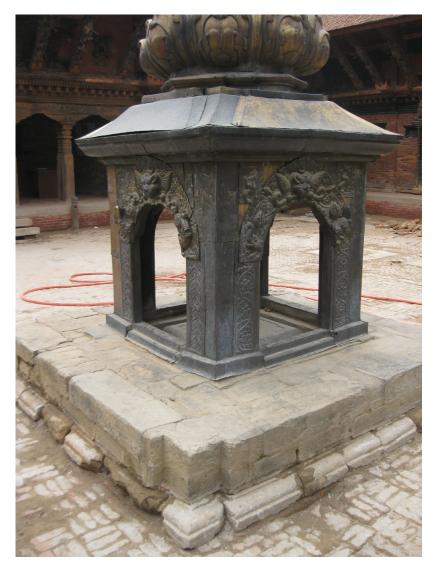
Original base stone | Nov. 2011

After removing the 1975 tile pavement, the original brick flooring and quarter-round base stone of the shrine were revealed. However, approximately 60% of stones are damaged due to the use of hard cement mortar, and are in need of replacement. In some places, the stone work has been poorly repaired with brick fill-ins, which need to be removed and replaced with stone.
