THE RESTORATION OF  
THE EAST WING OF SUNDARI COK  
AT THE PATAN PALACE COMPLEX – A UNESCO WORLD HERITAGE SITE

PROJECT APPLICATION | DECEMBER 2013

SUBMITTED TO

THE EMBASSY OF THE FEDERAL REPUBLIC OF GERMANY, KATHMANDU, NEPAL  
THE MINISTRY OF FOREIGN AFFAIRS, BERLIN, GERMANY

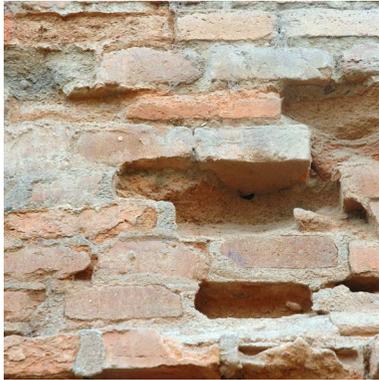
SPALLING

Areas with cement mortar will be re-pointed with traditional yellow mud mortar. Severely damaged and missing bricks will be replaced with salvaged bricks matching the surrounding brick size and coursing.

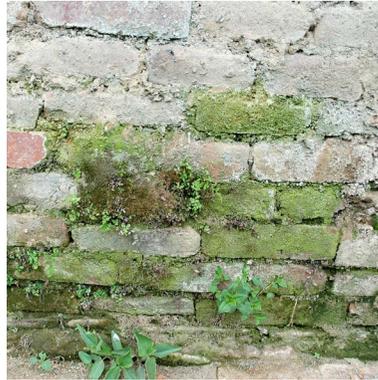
BIOLOGICAL PATINA

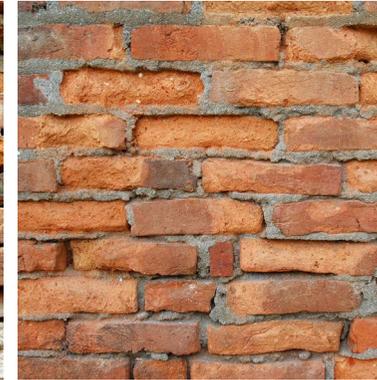
CORROSION

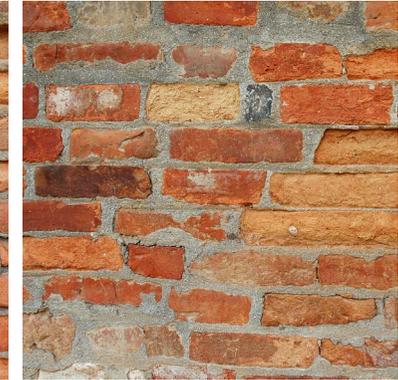
CEMENT POINTING

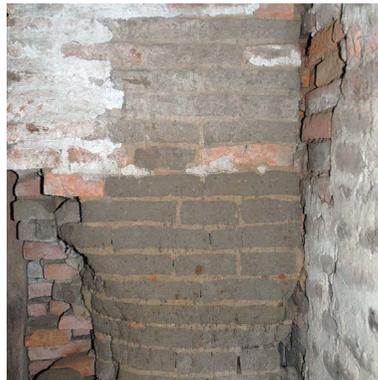
SPALLING

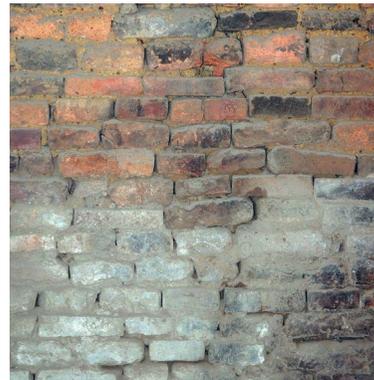
LOST POINTING

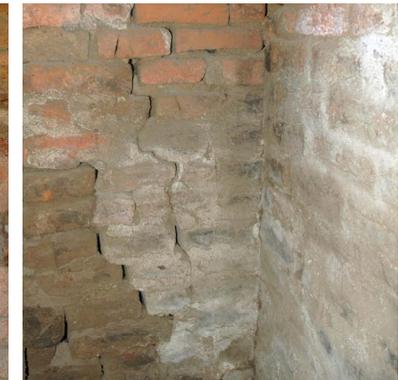
CRACKS

Layers of history are visible in the bricks that make up the ground floor of the east wing façade (top). The *ma apa* in the interior (bottom) are heavily damaged, largely due to the impact rising damp and careless cement pointing. There is considerable variation in the brick bonding throughout the building, with mud, lime (*surkhi*), and cement layers. The cement mortar dates from 1936 onwards.

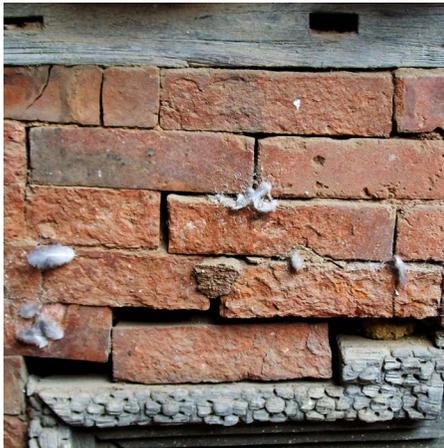
REPLACEMENT BRICK, WIDE JOINTS

The existing *daci apa* bricks are largely intact and will be reused except when severely spalled. Loose and missing joints will be repointed with mud mortar. Historic *daci apa* bricks are constructed with a very thin joint width to minimize exposure to weather, and for aesthetic reasons. Each brick is tapered, which also improves bonding with the inner core of the wall.

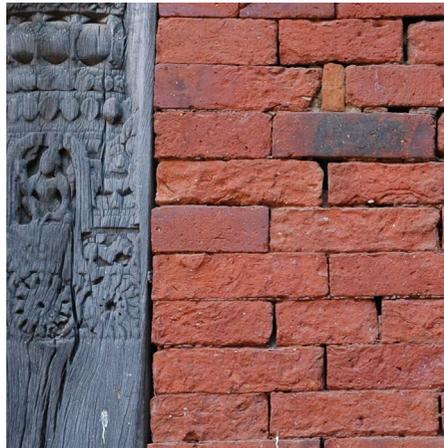
ERODED BRICK, DAMP AREA

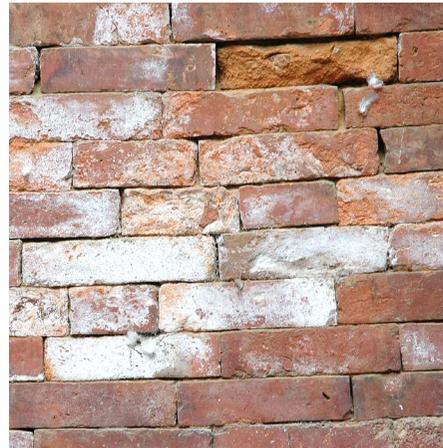
EFFLORESCENCE, SPALLING

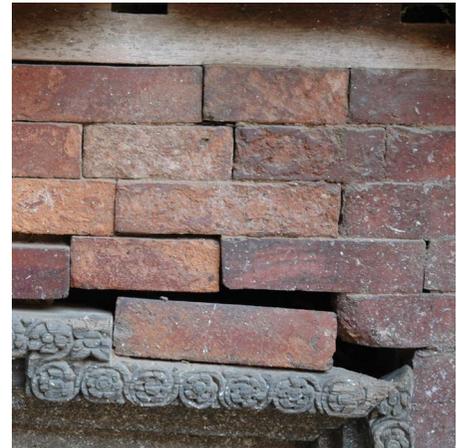
LOOSE BRICK, EFFLORESCENCE

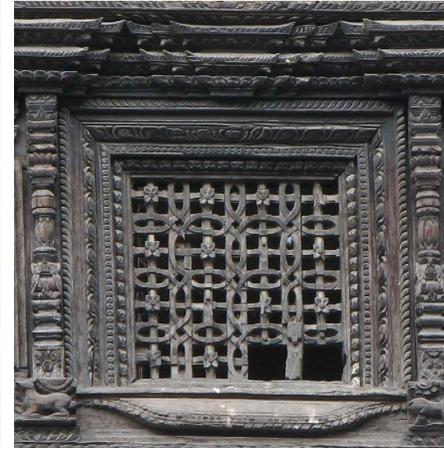
MISSING PIECE - BROKEN

Damaged and missing latticework will be replaced with reference to historical samples. In some cases, carved elements of the door thresholds and wall niches will be refabricated. Copper sheets will be used to protect the timber elements of the door and window openings from rising damp.

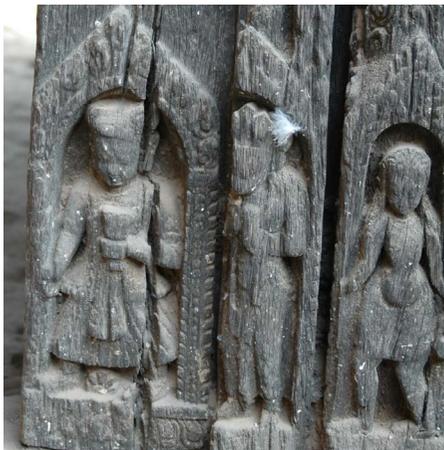
Large splits along the grain of the wood, ranging from 0.5 cm to 2 cm, are evident in the vertical members of door frames and other load-bearing elements such as arcade columns. The extended lintels at some of the doors and windows also exhibit thinner, hairline cracks.

CRACKS

In most cases the vertical cracks do not have structural implications and will be retained without any intervention. Where cracking is structural, reinforcement may be required.

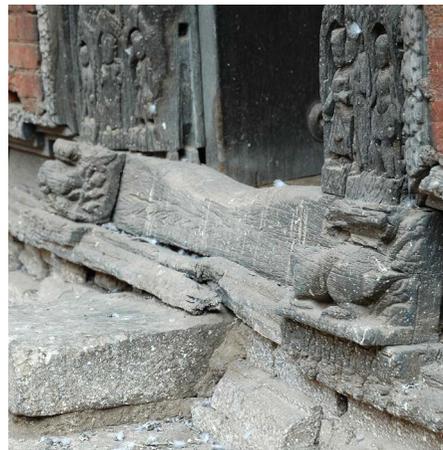
ROT, MISSING PIECE - BROKEN

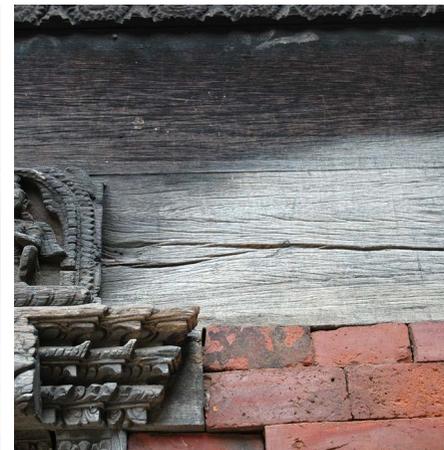
Bleaching of timber elements, caused by the evaporation of rising damp from the ground, is common on door thresholds and niche frames on the ground floor. At the southern end of the courtyard facade, discolored elements can be detected as high as the ground floor cornice level.

BLEACHING

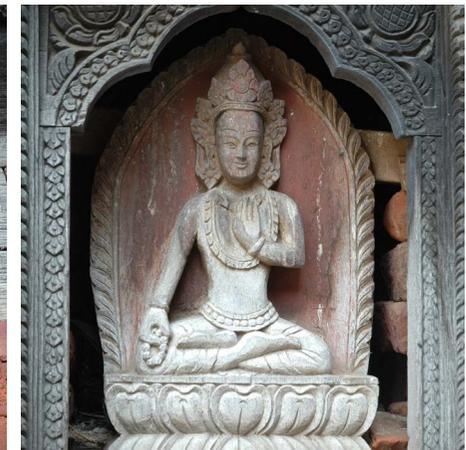
REPLACEMENT (1936)

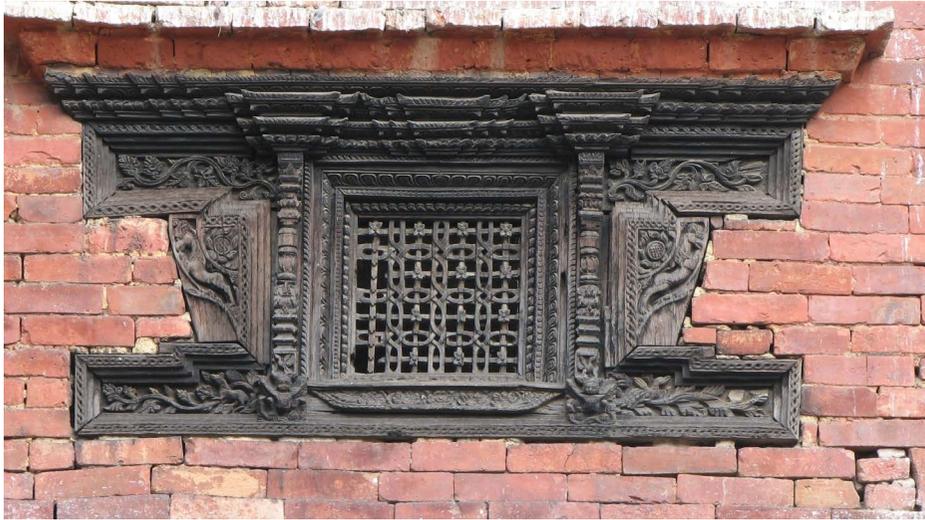
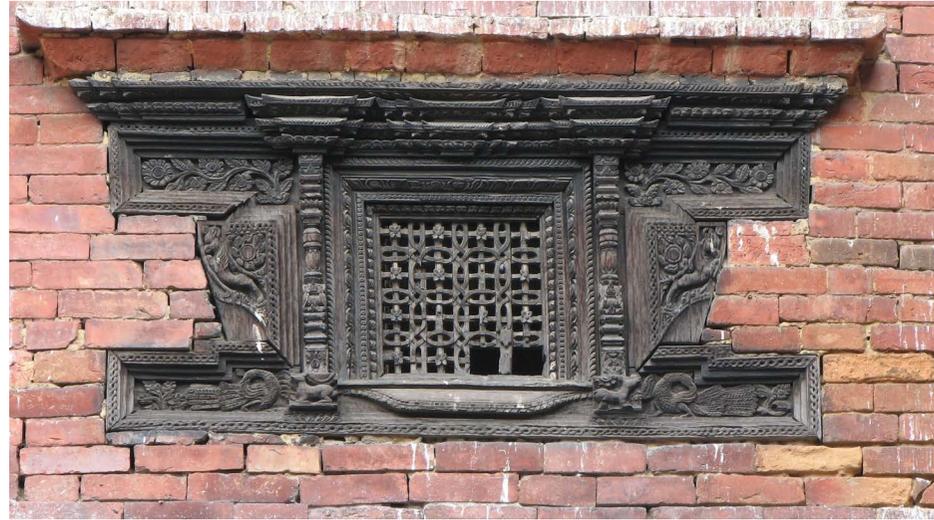
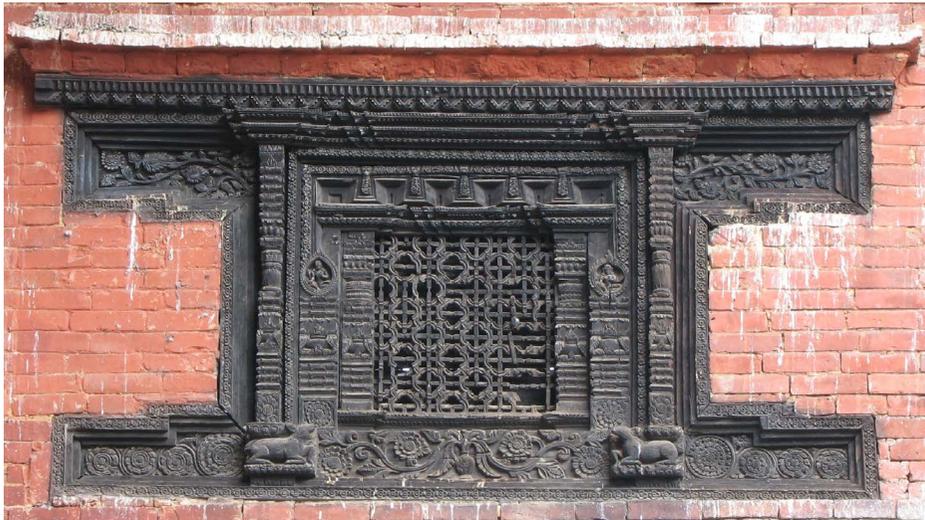
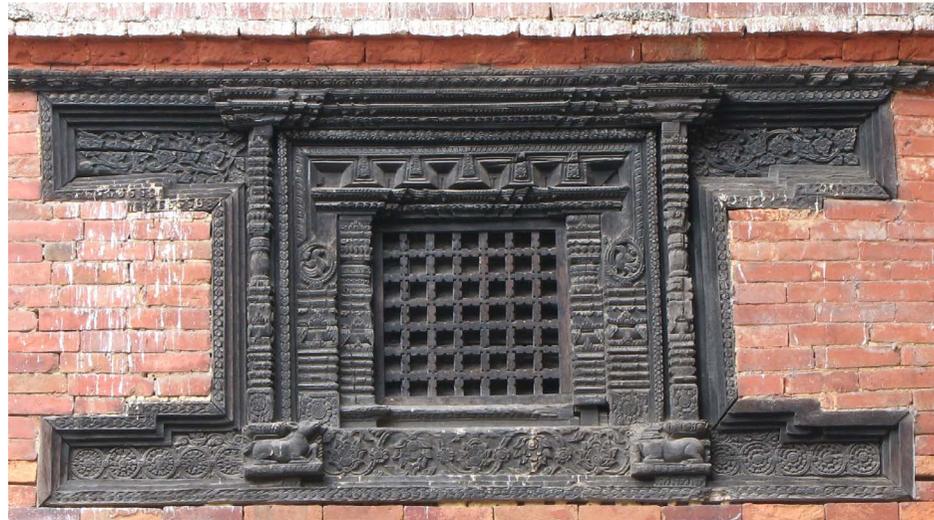
**First floor windows, existing conditions | 2011**

The carved timber windows are intact except for broken lattice pieces that will be replaced. The crude brick cornices dating to 1936 will be replaced by newly moulded eyebrow cornices (*mikhafusi*). The water-soluble black paint will be removed from all windows to reveal the detail of the deep relief carvings.

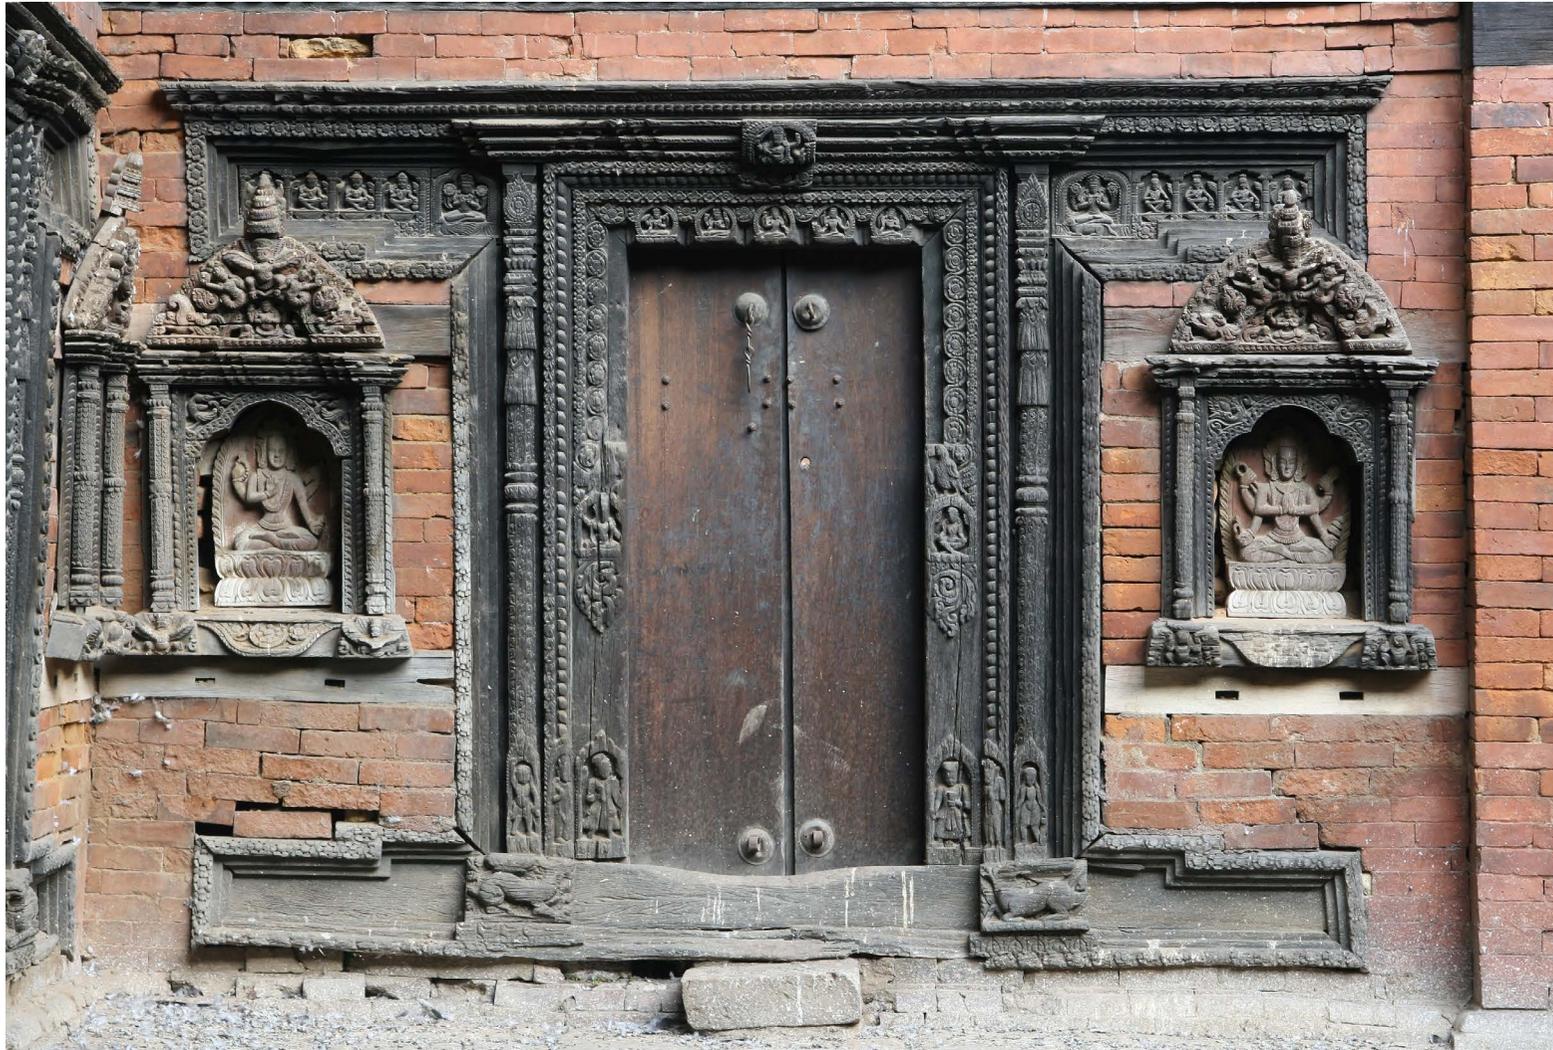
**Ground floor door, existing conditions** | 2011

The base of the door has been heavily eroded and is unstable due to the crumbling of the surrounding masonry. The niches on either side of the door contain carved deities dating to the 1936 restoration. These are noticeably crude compared to the fine carvings found elsewhere, most of which date to the 17th-18th century.

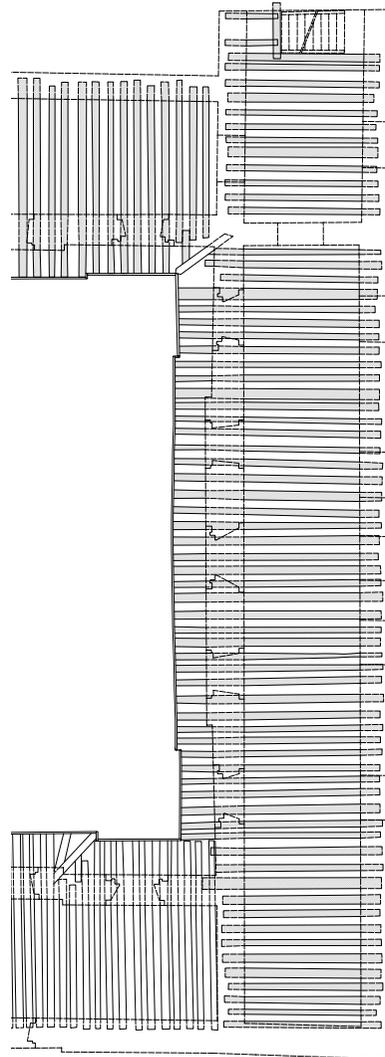
**East wing joist plans, existing conditions | 2008**

The joist plan shows inconsistency in size and spacing. The weak joinery between joists and wall plates weakens the lateral stability of the building.

More than 75% of the floor joists on both first and second floors will be replaced. They will be chemically treated before being re-installed in a traditional configuration.

The floors will be modified from the traditional design with two layers of marine-grade plywood on hardwood planking, fastened with galvanized screws. This will form a strong diaphragm connecting all the joists securely to withstand seismic motion. The traditional Newari construction technique of using timber pegs to connect joists to wall plates will be improved by using stainless steel pins and straps. Two layers of brick soling will be added above the plywood. The traditional mud floor covering will be restored.

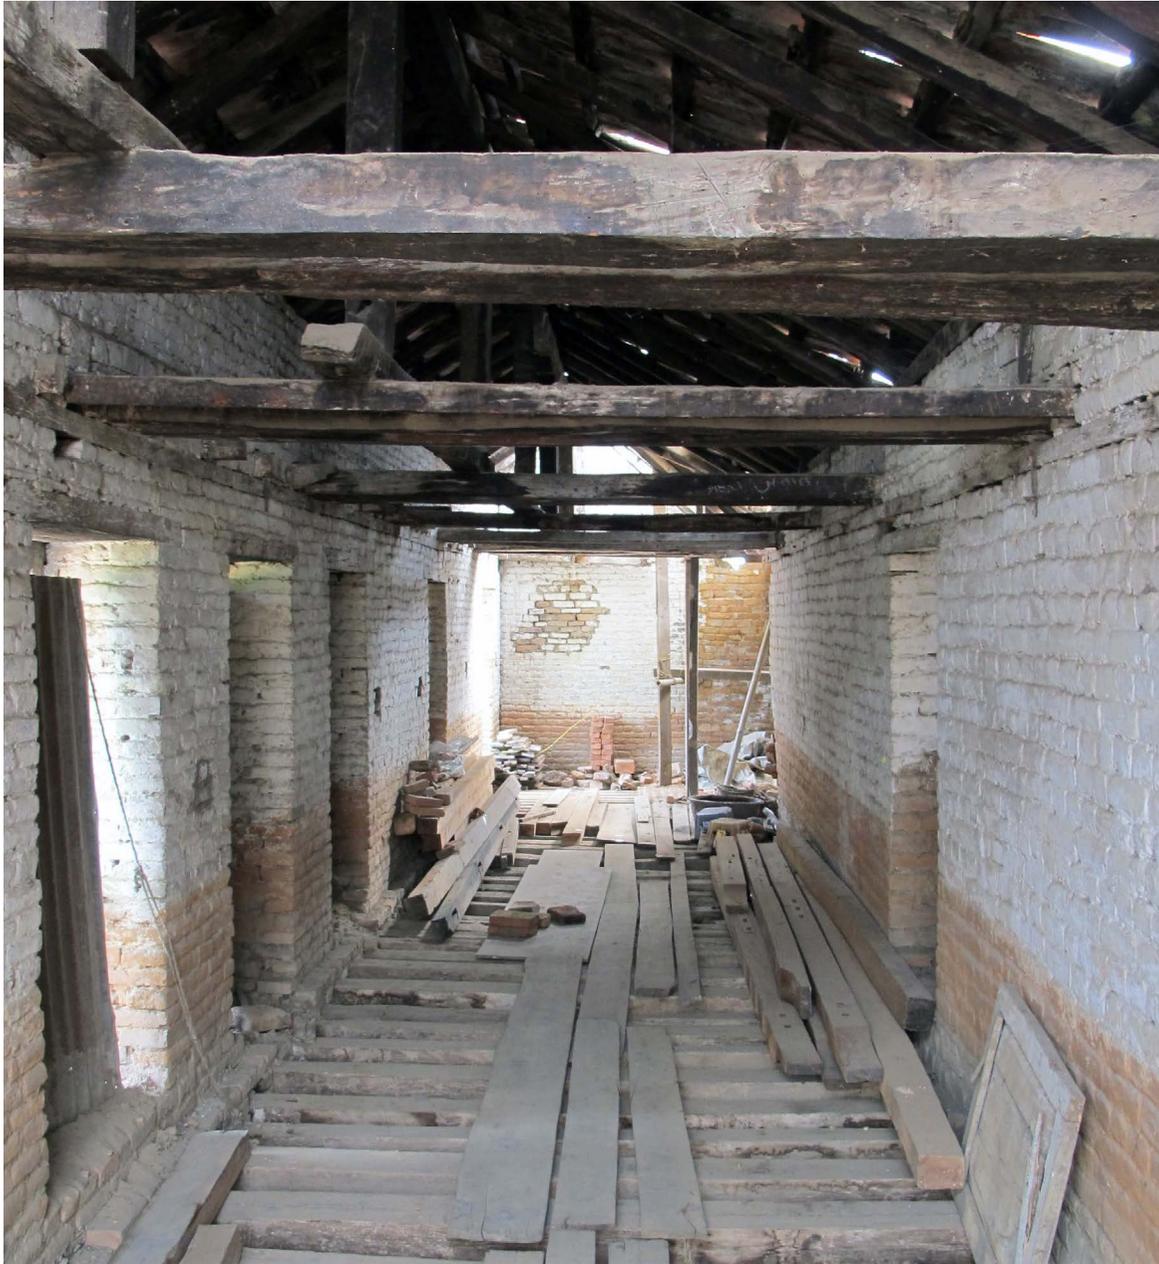
**Second floor, existing conditions** | 2012

When the east wing was rebuilt in 1936, large tiles were placed directly onto timber battens, causing water to leak through the numerous gaps. This caused the timber members supporting the roof to quickly deteriorate. The floor joists have also been affected by the passage of moisture through the entire building.

Rotten timbers will be removed and replaced. If the damp or damaged area is fairly small, it will be cut away and replaced with a new piece of timber. Removing the source of moisture will prevent further instances of rot. This will be achieved through the reconstruction of the roof, preventing leakage of water through the building (see pages 36-37).

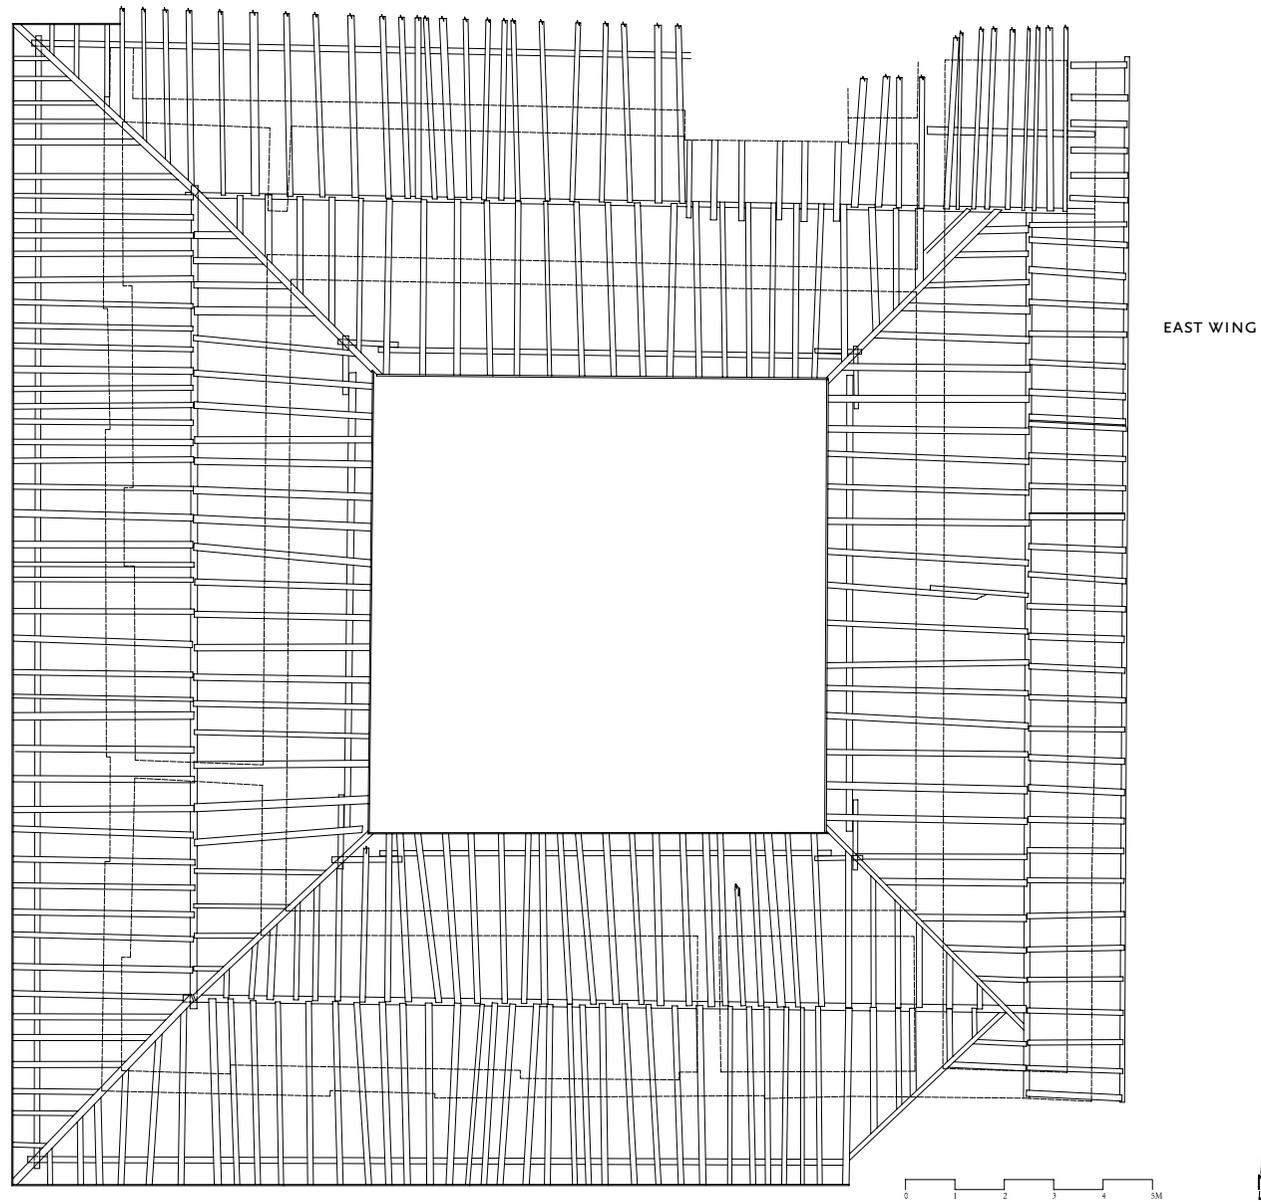
The condition of the roof is very poor due to an improper and hasty reconstruction effort following the 1934 earthquake. Ceiling joists, rafters, planking, wall plates, and ridge beams all exhibit inconsistencies in size, grade, spacing, and species. The large and random spacing between rafters departs from the traditional aesthetic configuration of closely-spaced rafters. Rough carpentry by unskilled carpenters has caused numerous problems including discontinuous wall plates and inadequate seats for rafters on beams. The roof cover was built using large pan tiles laid directly on timber battens, causing significant water leakage into the building. The majority of timber elements of the roof have an excess of moisture well above safety standards.

**Sundari Cok, rafter plan, existing conditions** | 2009  
When the building was reconstructed in 1936, the minimum number of rafters was used. The rafter plan clearly shows inconsistency in size, spacing, and joinery.

The timber structure will be reconstructed in the traditional configuration using both hardwood and pine. Salvageable timber will be reused where possible, along with new timber elements. The connections between rafters, joists, and window frames will be improved using concealed stainless steel pins and braces. Most wall plates will be replaced and fixed in two layers so that they act as ring beams above the wall, stabilizing the structure in the event of seismic movement. 1 inch *sal* hardwood planking and 3/4 inch marine-grade plywood will unite the roof timber members to create a rigid diaphragm and a uniform surface for a waterproof membrane. Finally, a roof cover of hand-made terracotta roof tiles (*jhingati*) will be laid on a mud bed.

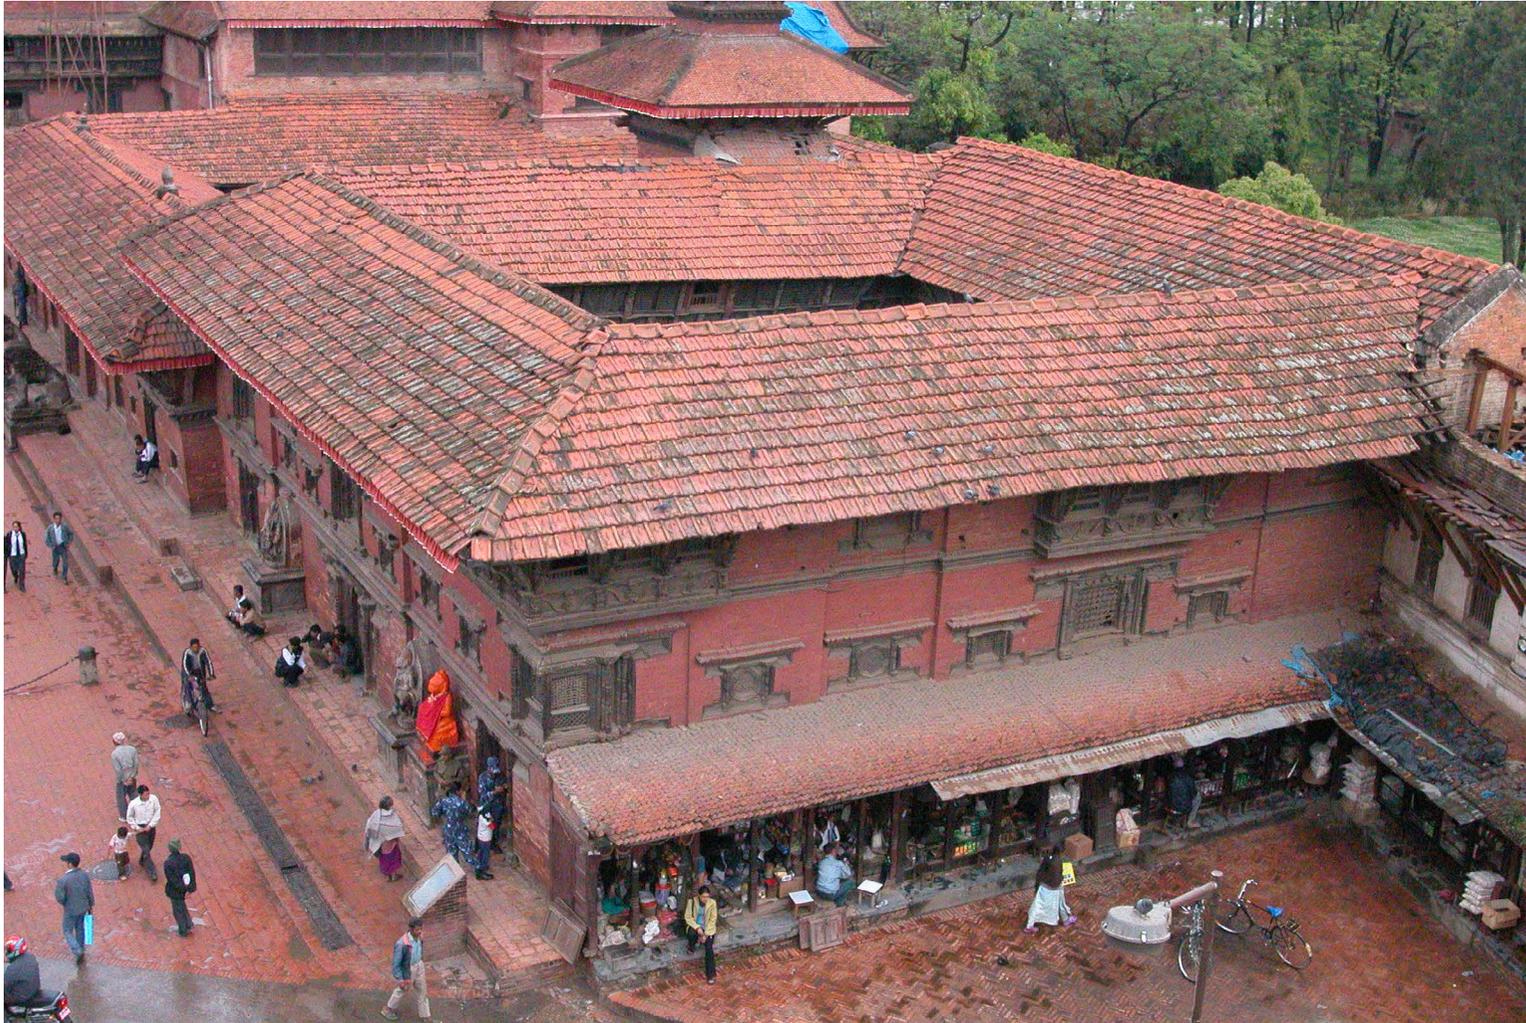
**Sundari Cok from the south** | March 2005

This photograph shows the condition of the building before restoration work began. The poorly constructed roof, covered with machine-made pan tiles in 1936, was responsible for much of the damages endured by the building.

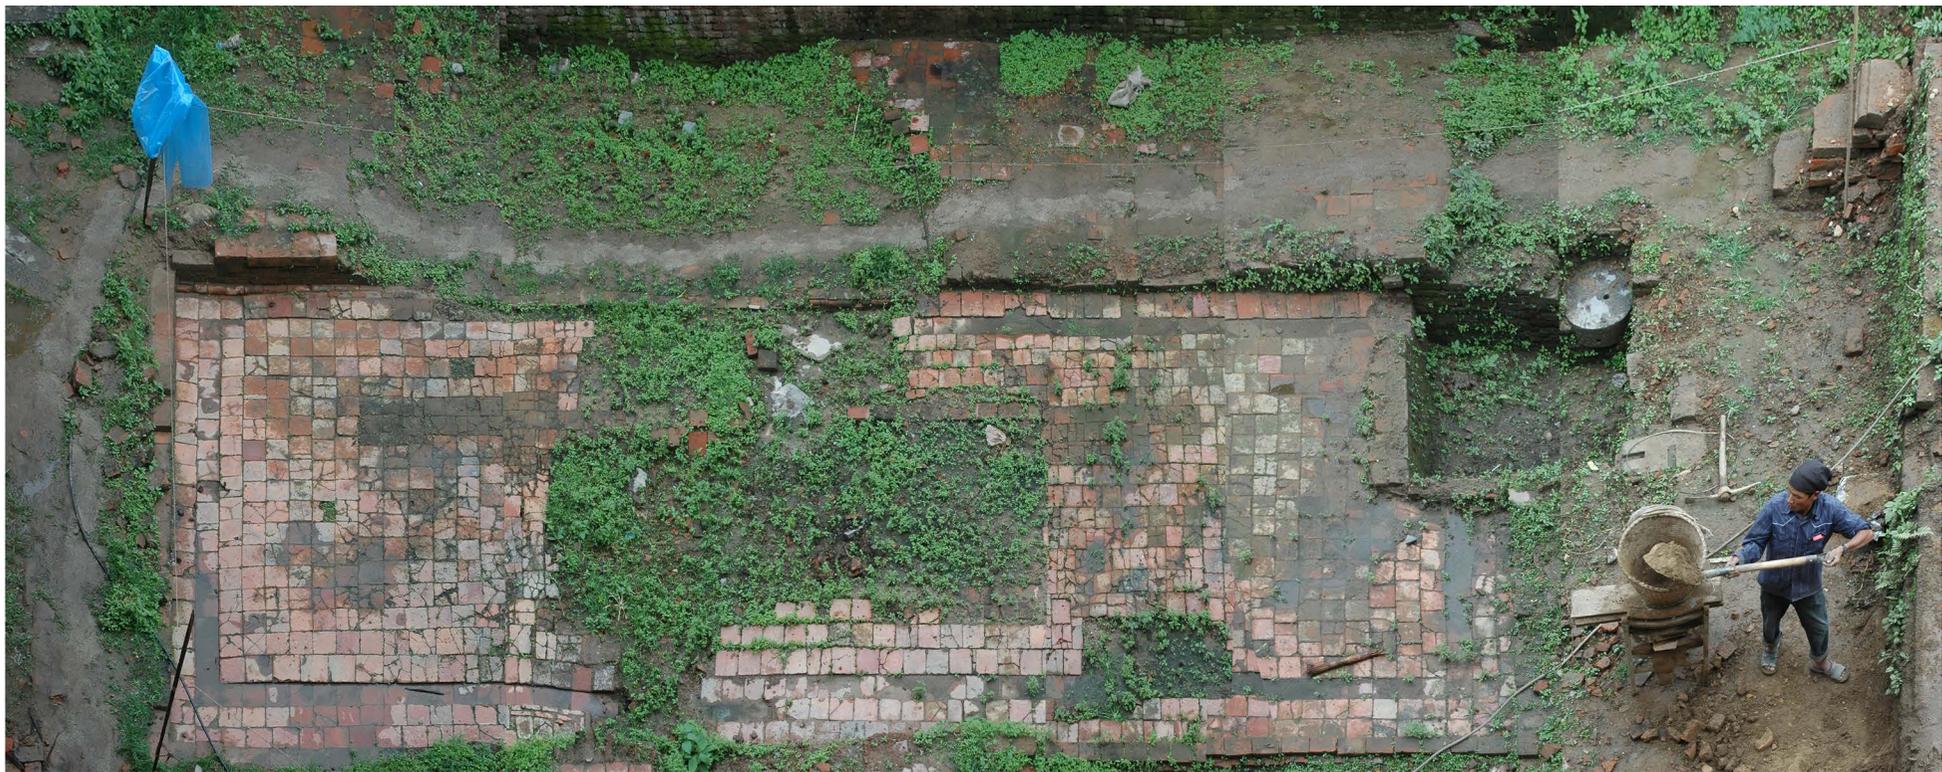
**Historical tile paving | 2008**

Tile paving between the east wing of Sundari Cok and the Bhandarkhal tank was discovered after preliminary digs in 2008. The paving is composed of square *telia* tiles in a rectangular configuration, probably dating to the 18th century.

Although the original paved level is uneven and broken in many places, the configuration of the paving can still be discerned, along with the location of rainwater drainage canals, also made from the same tiles.

The tiles will be laid on top of brick soling to provide a firm base upon which to grade a drainage system.

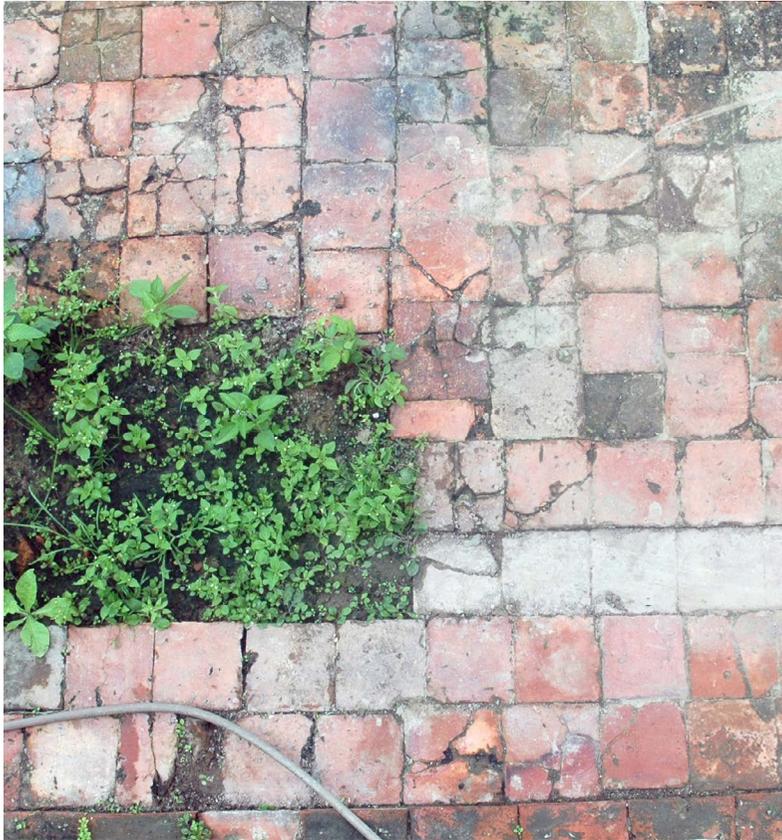
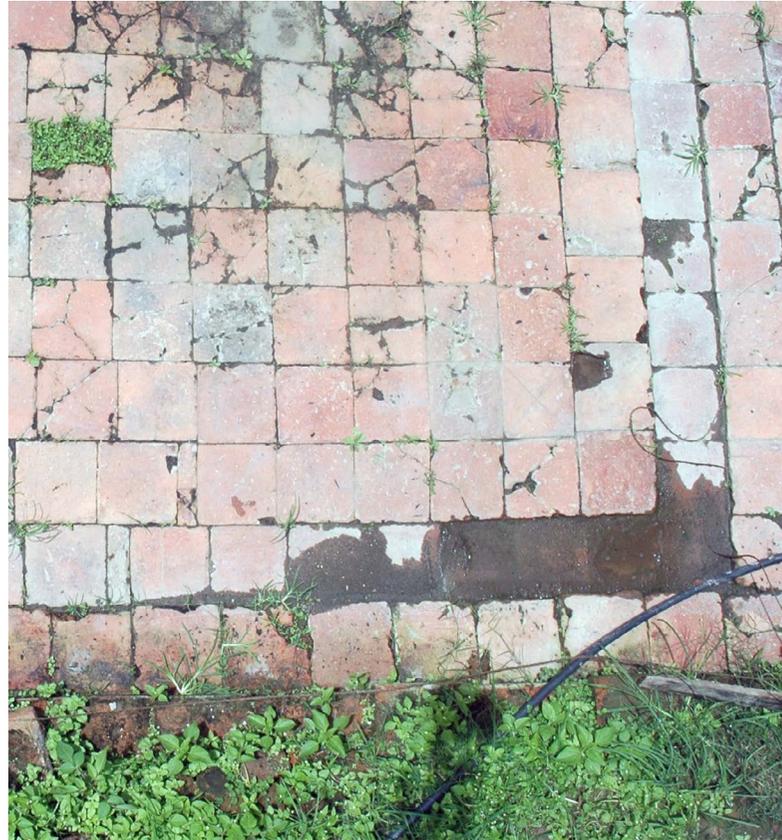
**Tile paving detail | 2008**

The terracotta tiles exhibit worn rose-colored surfaces of various shades, caused by differential pigmentation during manufacture and loss of pigment over time due to weathering. Existing tiles will be reused wherever possible.
