AYUGUTHI SATTAL
PATAN DARBAR SQUARE, WARD 11

HISTORIC STRUCTURE REPORT
JANUARY, 1996

ERICH G. THEOPHILE
ROHIT K. RANJITKAR

KATHMANDU VALLEY PRESERVATION TRUST
IN COOPERATION WITH
HMG DEPARTMENT OF ARCHAEOLOGY

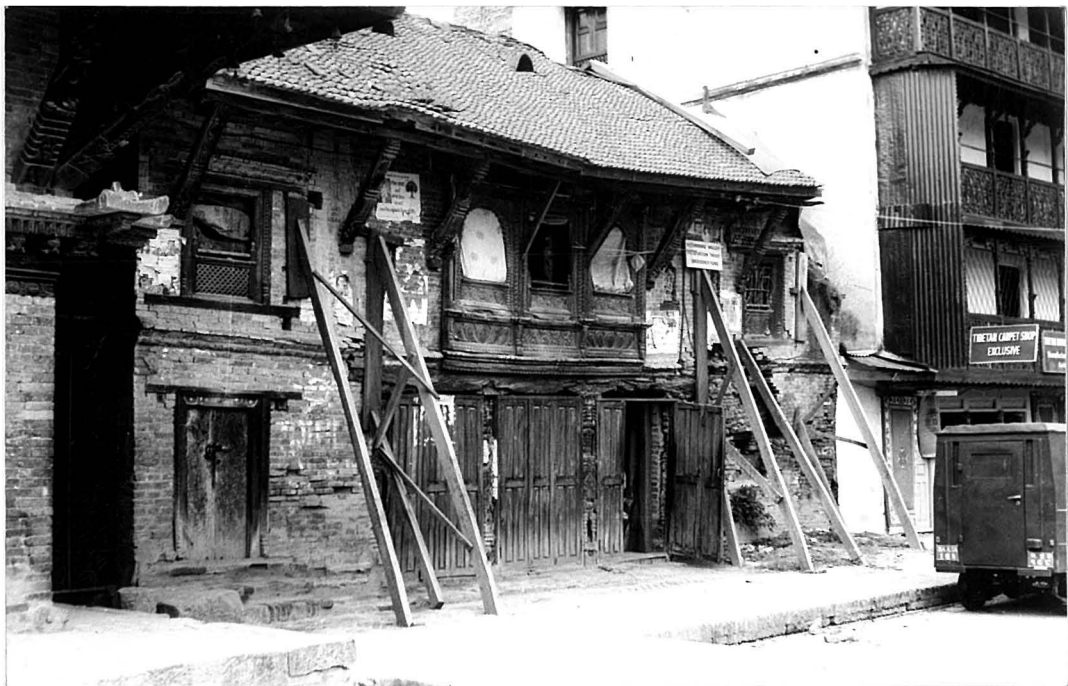
Above: multi-bay window or san jhyah of principal facade, fall, 1993. Below: principal facade spring, 1994. Notice additional wall damage at far right.

The entire facade to the right of ground floor *dalan* has deteriorated over the last seven years, in the last year the veneer brick or *daci apa* has fallen out. Photos of 1988 show a stepping crack travelling 28 courses up, just touching the right end of the *dalan's* lintel beam. The crack appears not to have been larger than one half inch, but water penetration from the damaged roof above caused the individual layers of the wall to separate, the outer veneer splaying out. This is a typical problem in the traditional buildings of the Kathmandu Valley.

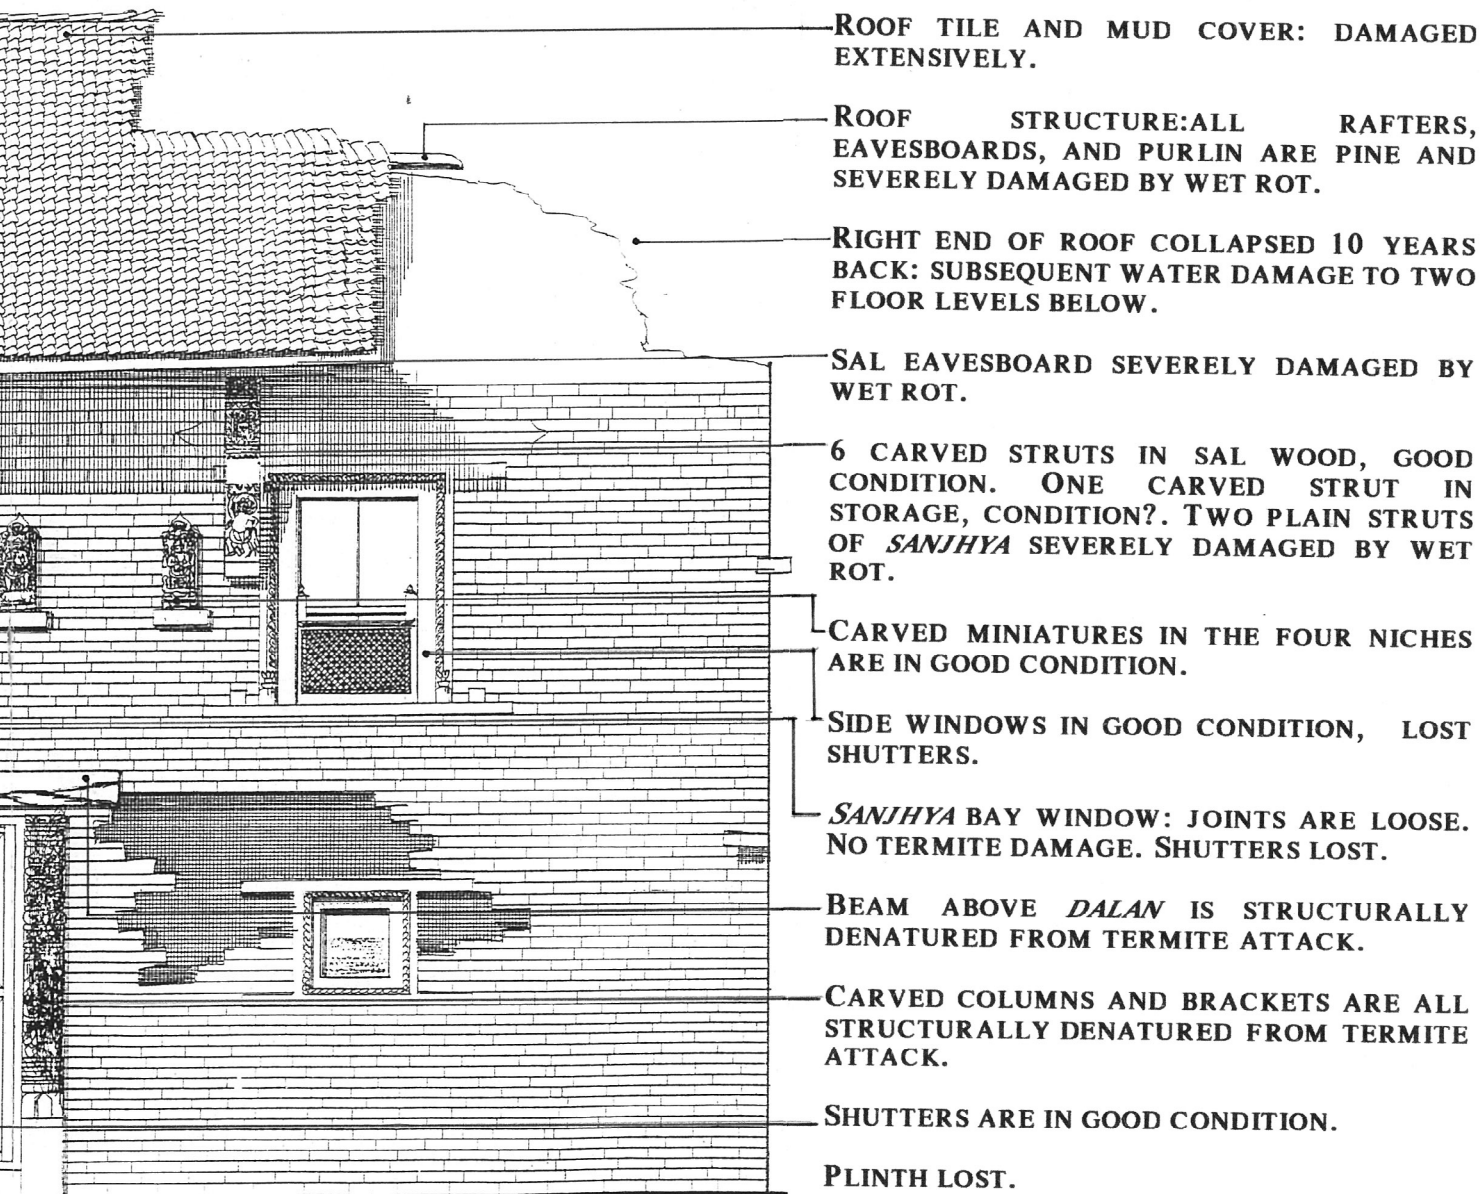
EXISTING CONDITIONS

ROOF TILE AND MUD COVER: DAMAGED EXTENSIVELY.

ROOF STRUCTURE: ALL RAFTERS, EAVESBOARDS, AND PURLIN ARE PINE AND SEVERELY DAMAGED BY WET ROT.

RIGHT END OF ROOF COLLAPSED 10 YEARS BACK: SUBSEQUENT WATER DAMAGE TO TWO FLOOR LEVELS BELOW.

SAL EAVESBOARD SEVERELY DAMAGED BY WET ROT.

6 CARVED STRUTS IN SAL WOOD, GOOD CONDITION. ONE CARVED STRUT IN STORAGE, CONDITION?. TWO PLAIN STRUTS OF *SANJHYA* SEVERELY DAMAGED BY WET ROT.

CARVED MINIATURES IN THE FOUR NICHEs ARE IN GOOD CONDITION.

SIDE WINDOWS IN GOOD CONDITION, LOST SHUTTERS.

SANJHYA BAY WINDOW: JOINTS ARE LOOSE. NO TERMITE DAMAGE. SHUTTERS LOST.

SHUTTERS ARE IN GOOD CONDITION.

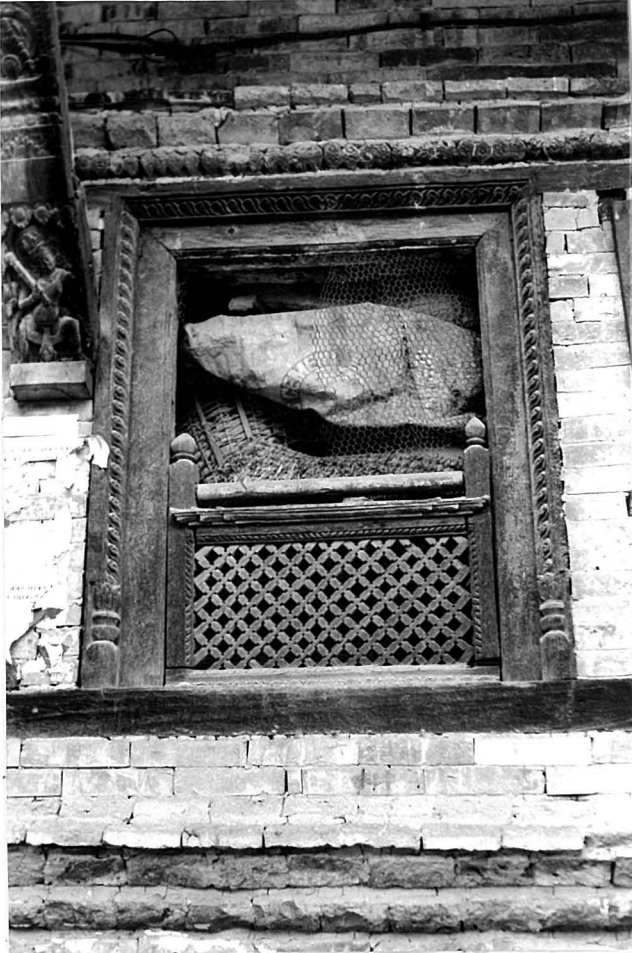
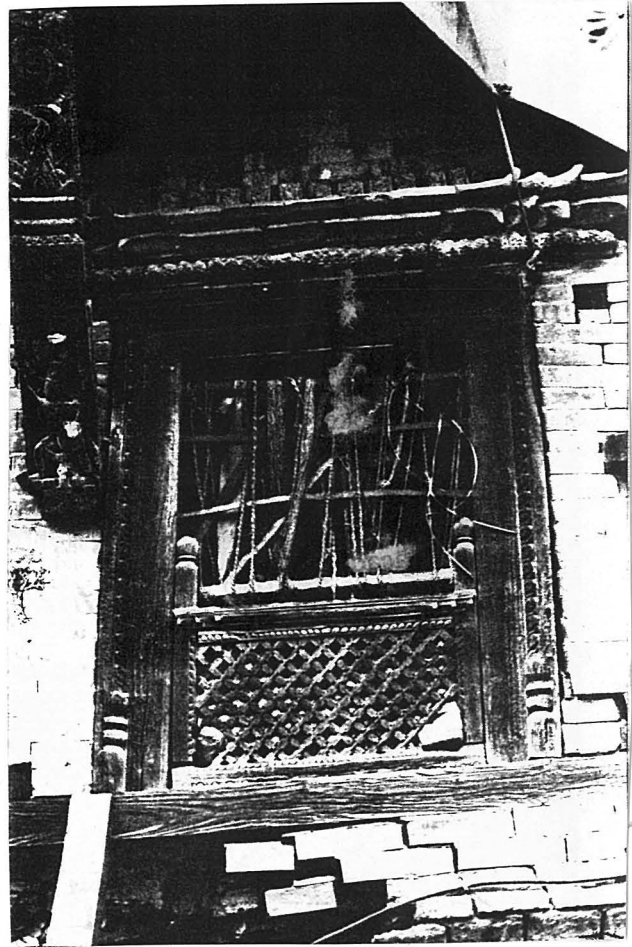
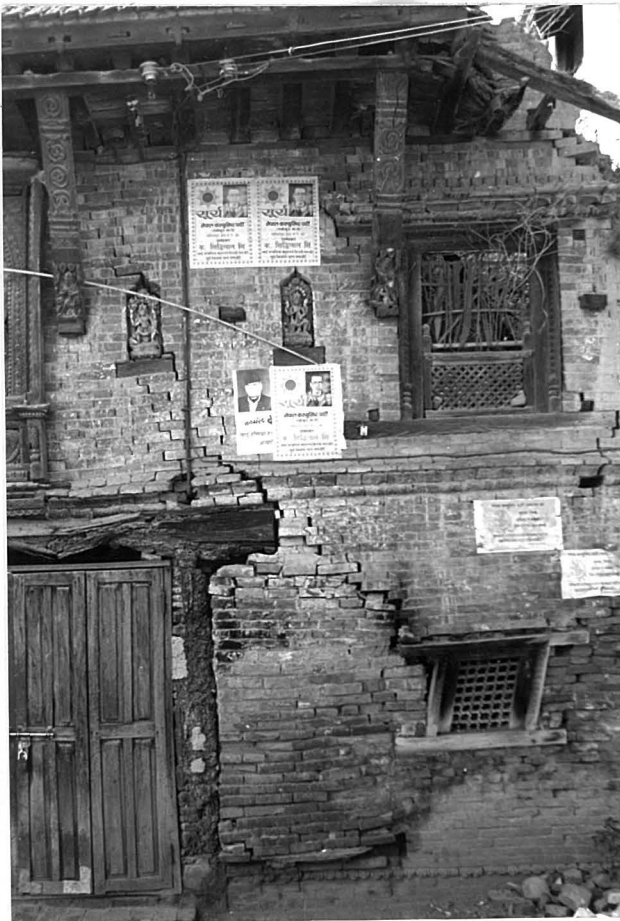
Structural frames of the upper story windows including two flanking and central bay window, *san jhya* are all in fair condition except for some noticeable loosening of the joints in the *san jhya*. There are no signs of termite attack. All openings of the upper floor are missing their shutters (Newari : *kapha*) and are covered with makeshift materials. One interior door survives with shutters in fair condition. The ground floor door alone retains its historical shutters, both frame and shutters in good condition.

The right hand ground floor window has been stored by the occupant after collapse of the veneer wall; condition was fair before storage.

Above, the two upper story windows left and right are in good condition missing only their shutters and small portions of lattice. There are no signs of termite damage. Below the roofless southeast corner of the building with latticed window. This window has since fallen out due to wall damage and is in storage, condition unknown .

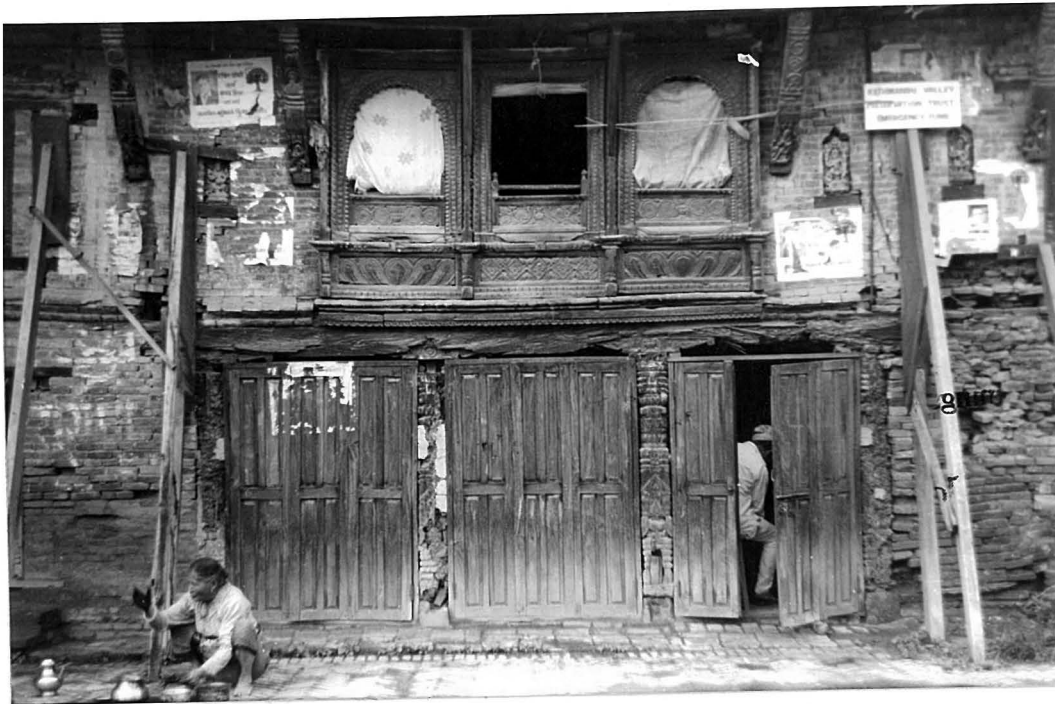
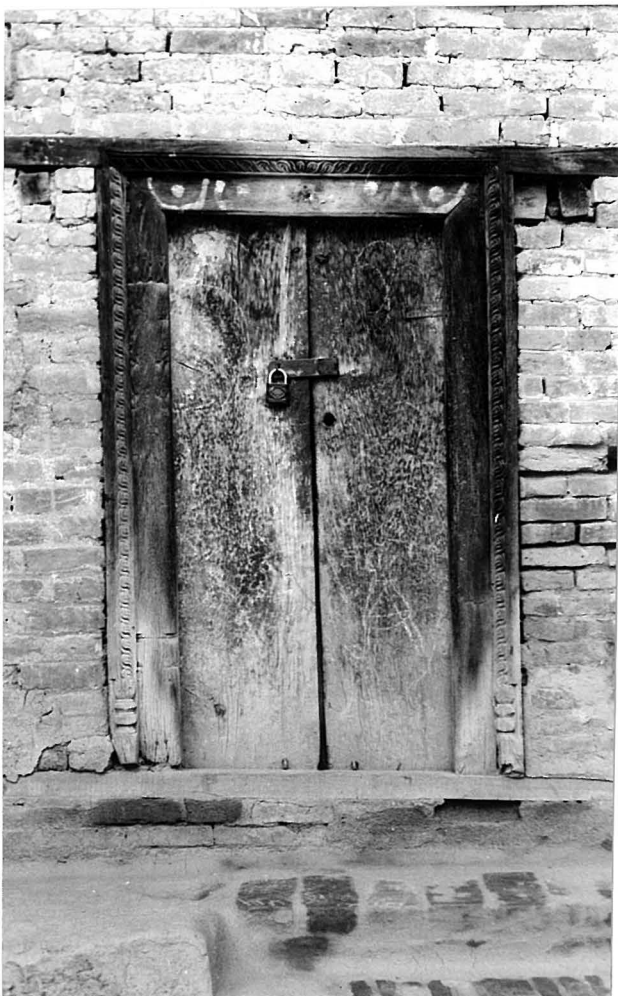
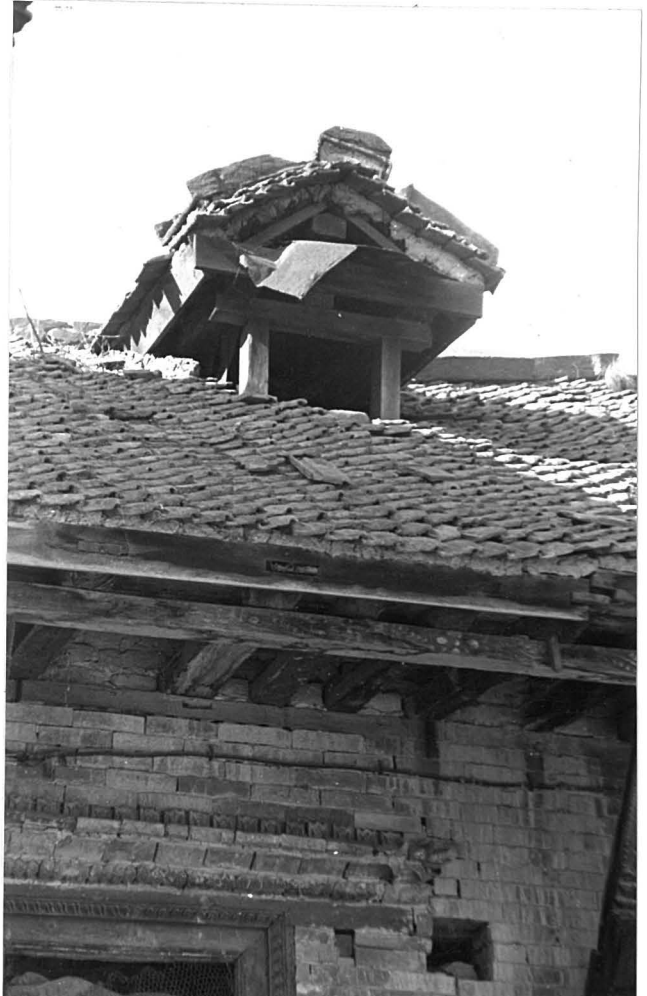
All four historical oversized and carved timber posts in sal wood are completely structurally denatured by drywood termite infestation. This infestation was diagnosed by visiting expert Sir Bernard Feilden (based on the pest's visible mud tracks). The column capitals (Newari: *meth*) are damaged to varying degrees by the termite infestation as well, the outer of four capitals severely denatured, the central two capitals appear to have only superficial damage.

The upper lintel of the *dalan* is a pine member (section 7"x6") which is also structurally denatured by termites, having collapsed into itself from the load of the walls above. This has caused settlement of the central wall ranging from 4-6".

Opposite: the central trabeate opening (Newari: *dala*) is heavily damaged by termites, the outer columns slightly more advanced in their decay than the central pair. Below: the door is in good condition, although interior lintels are termite damaged. Below left: dormered opening in pine is heavily damaged by water.

The pine shutters of this *dalan* are of recent and unobtrusive design approximately ten years old.

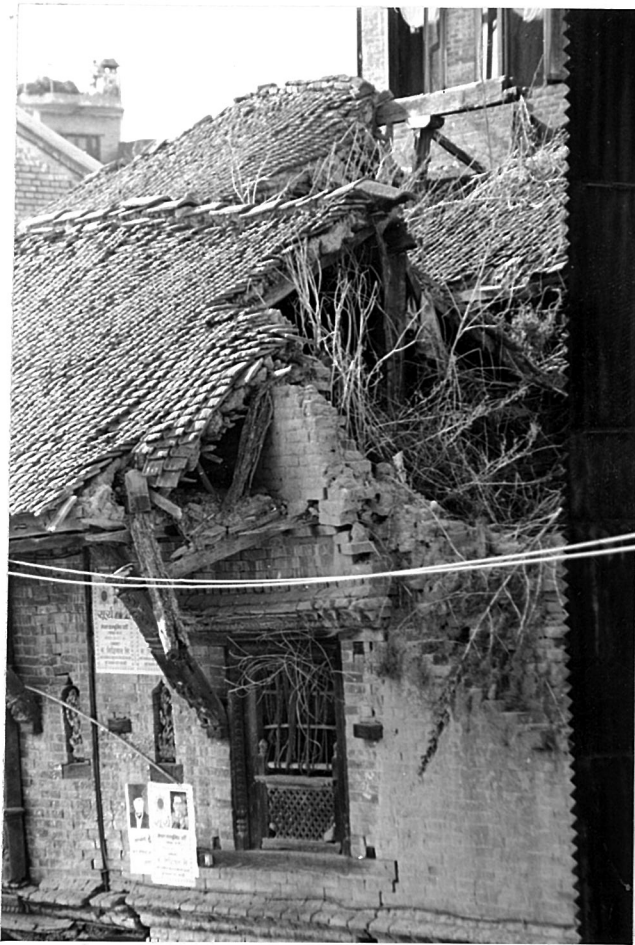
The eastern quarter of the roof collapsed 10-15 years ago. Roof configuration is not original to the building (as discussed in construction history above). All timber rafters are heavily damaged by water, rotten except for very small areas. Two levels of floor joists--like the rafter configuration--are carelessly installed possible from post-1934 earthquake repairs. Both levels of joists are heavily damaged in all but a few locations, the lower level primarily from termites and water, the upper primarily from water.

Collapsed roof structure at southeast corner of the building.

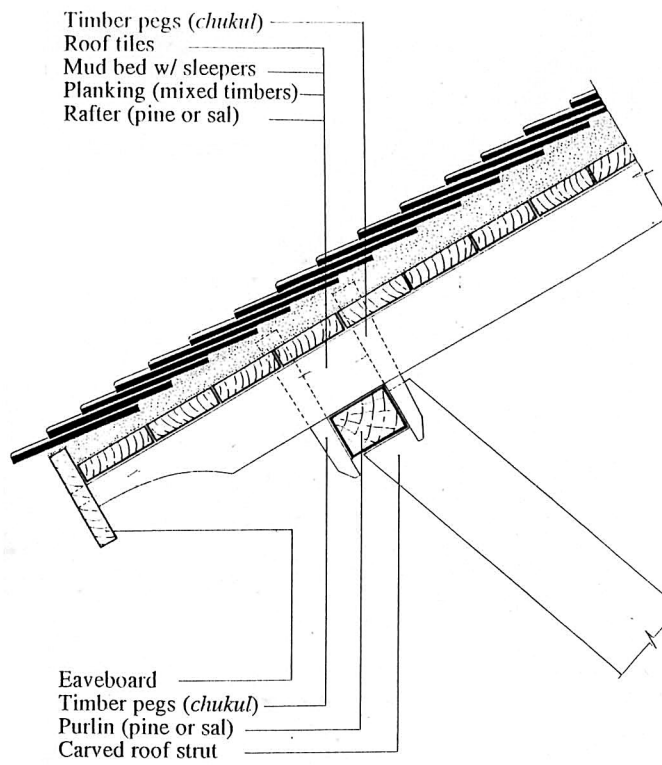
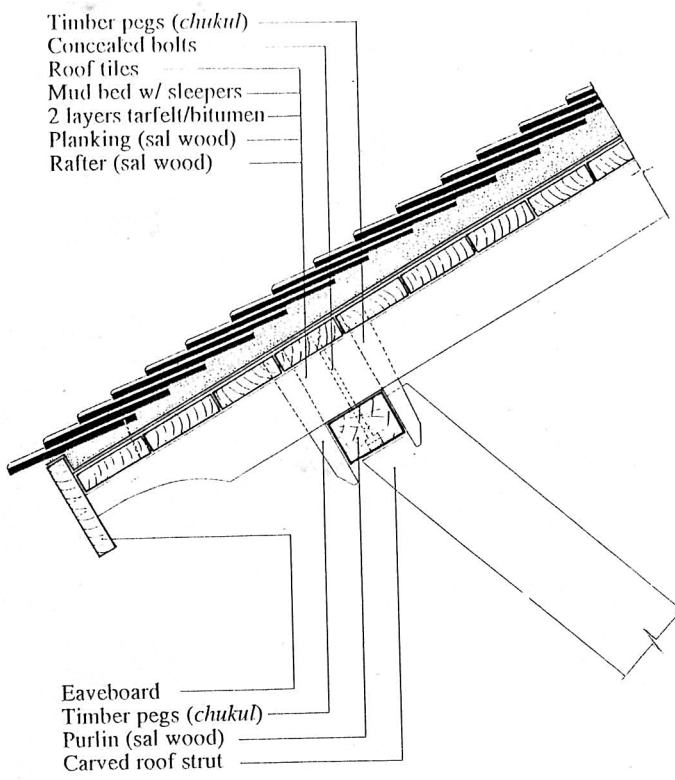
THE "KEY" PROBLEM

Above: Section at roof overhang: as traditionally detailed
Below: Section at roof overhang: Improved detailed
