NARAYANA TEMPLE

KULIMA, PATAN

HISTORIC STRUCTURE REPORT

KATHMANDU VALLEY PRESERVATION TRUST
MARCH, 1998

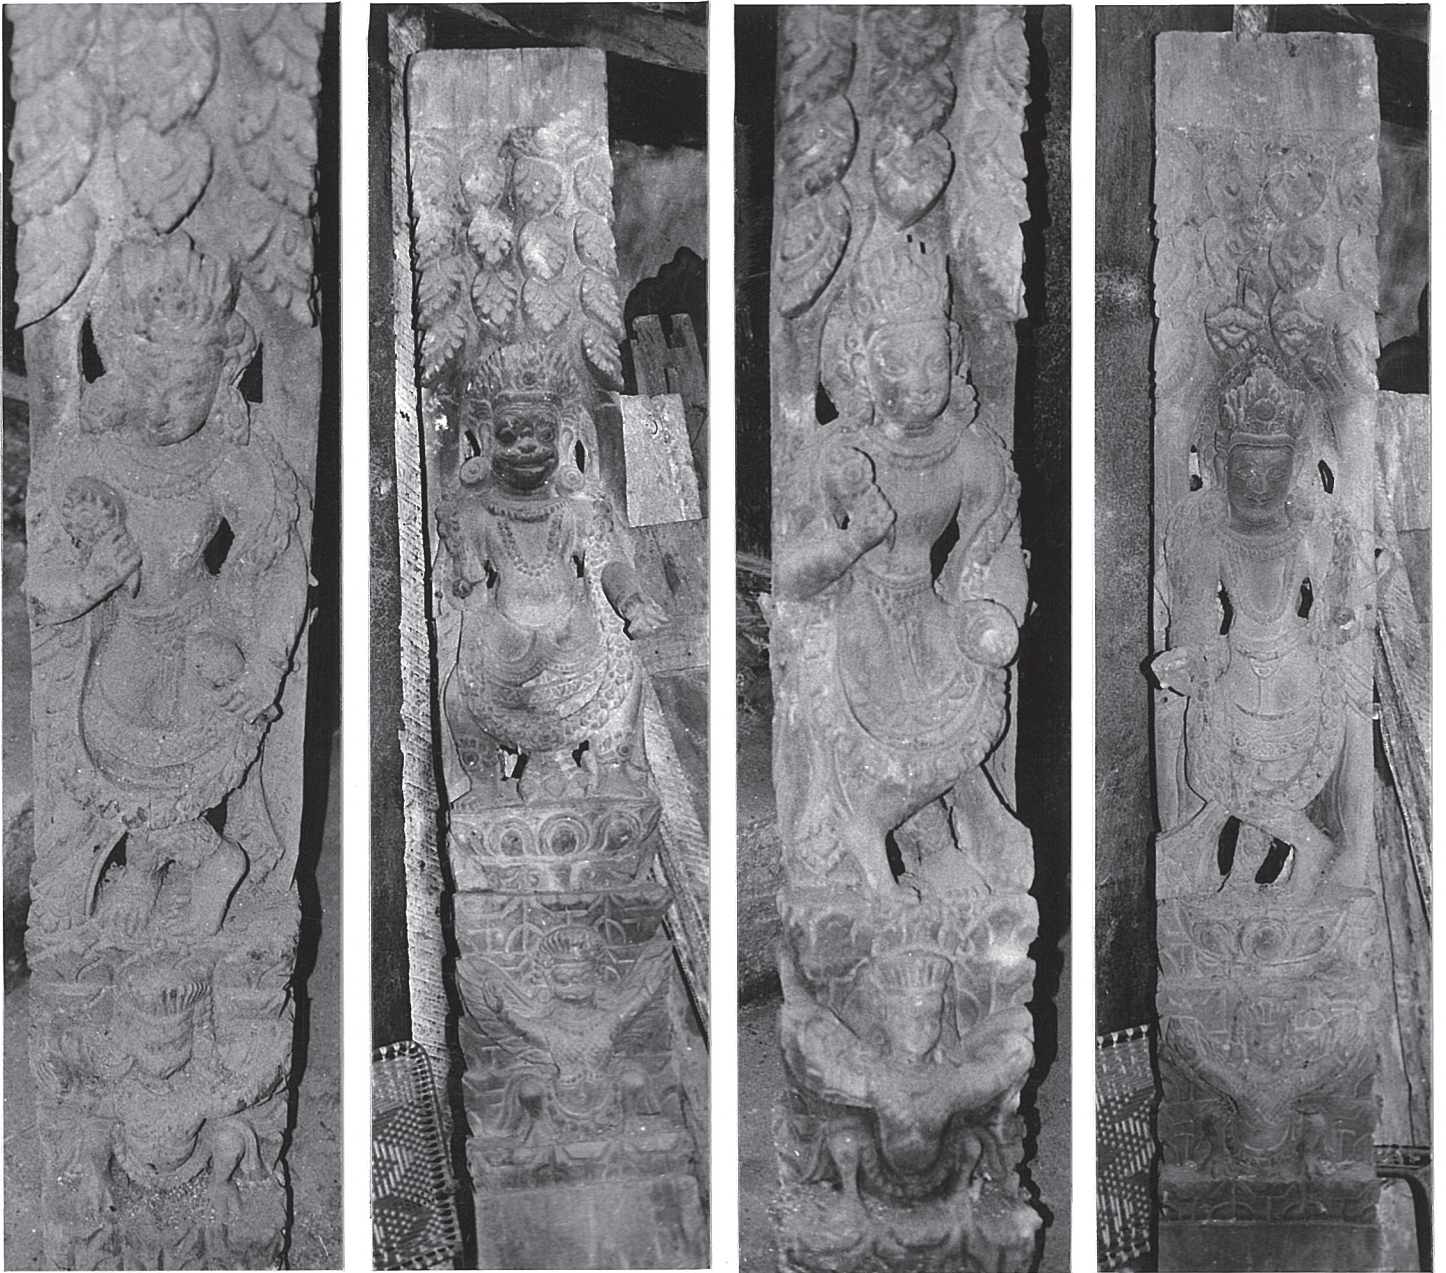
Four of the remaining roof struts.

Documentation of four of the total 13 struts in possession by the local *guthi*. Five struts (Newari: *bilampau*) from the upper roof and four from the lower roof survive in sound condition. Another four are structurally damaged by wet rot. These pictured above are from middle locations, i.e. not at the corners where formulaic animal forms are found (Newari: *kusala* or corner horses). These above belong to a well known iconographic convention, the Dasavata or 10 emanations of Lord Vishnu, a common theme for struts on Vishnu temples. Here he is seen with his characteristic Garuda mount in the lower register and with foliage above, the mount and foliage are typical conventions of roof struts in Nepal 12th-20th centuries.

The four missing corner struts (*kunsuru*) will be replaced as exact copies of those that survive. This process counts on the abilities of carvers like Radhe Shyam Silpakar, master carver. Lost corner horse struts can be easily recarved based on the surviving examples as these members are largely formulaic. One of the upper corner struts is in a critical condition and will require further study to determine the necessity for reinforcement.

The other missing struts (Newari:*bilampau*) will be replaced by plain members as no precise historical evidence survives. These plain members will, however, be sized to allow future votive offering of carving.

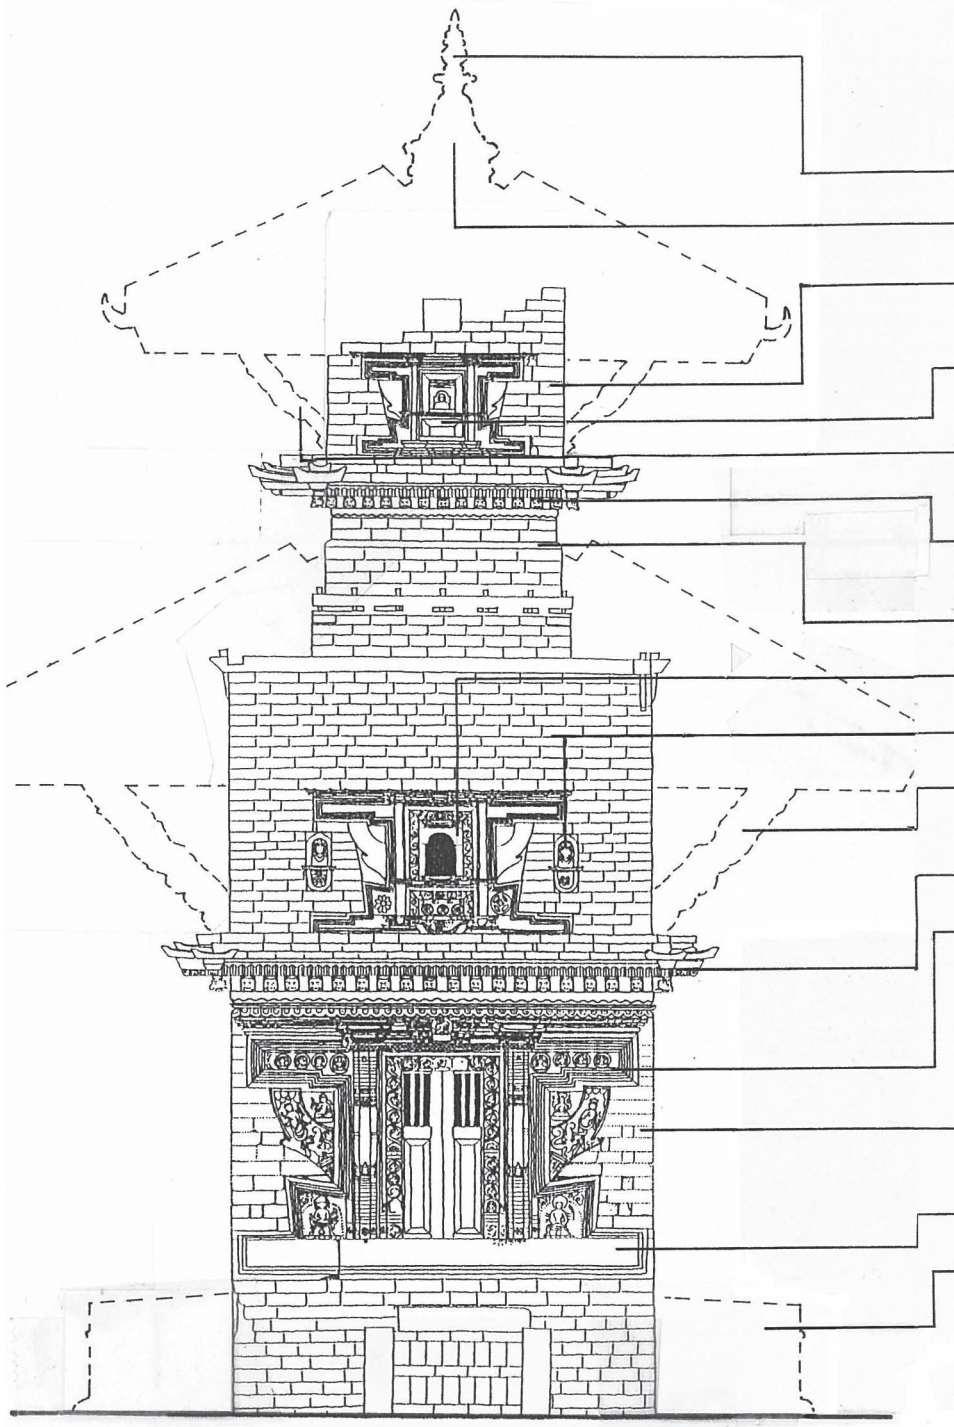
CONSTRUCTION HISTORY: WEST (PRINCIPLE) FACADE
KATHMANDU VALLEY PRESERVATION TRUST - NOVEMBER 1998

- Terra-cotta pinnacle: 1958
- Pinnacle base/ kingpost: original
- Upper wall in *dachi-apa* and *ma-apa* in 1958
- Carved windows: original, north window lost.
- Upper roof struts: 19th cen. (?)
6 surviving, 6 lost.
- Timber cornice original
Wall between cornices. 19th cen.?
- Dachi-apa* veneer brick: original.
- Carved windows: original.
- Carved flanking niches: original.
- Lower roof struts: 19th cen.
8 surviving, 4 lost.
- Timber cornice: original.
- Door frame and brackets: original/
Bhairabhs
- Door shutter: 1958.
- Deity stolen in 1983.
- Wall rebuilt in oversized *ma-apa* brick:
1958.
- Stone threshold original.
- Plinth lost: since 1974
- Foundation original?

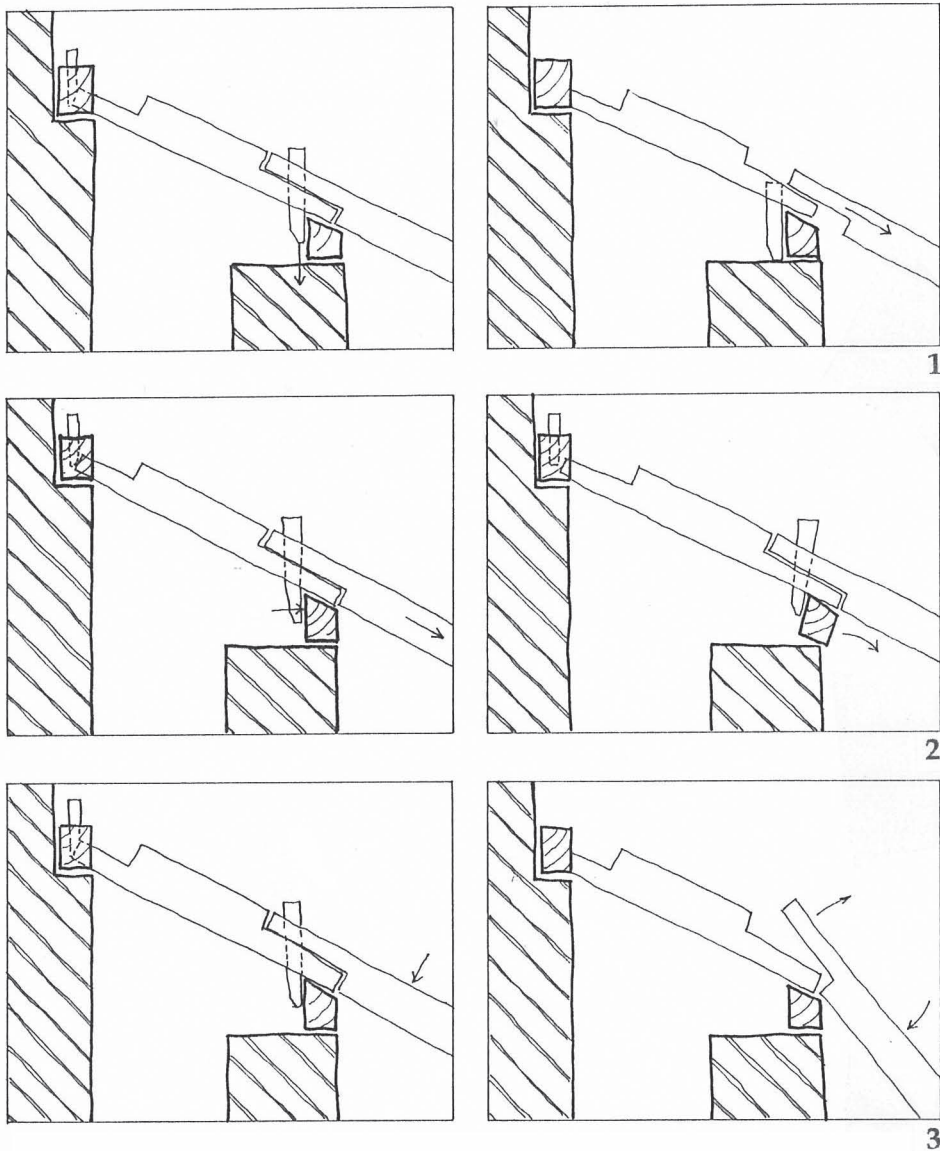
Timber joinery: improper joinery which leads to structural failure

1. Moisture damages the wood around the peg which results in the hole become larger and weaker around the peg. This in turn causes the lower rafter to slip away.
2. If the timber peg which joins the rafter to the wall plate is not secure the rafter will have a tendency to slide. This will ultimately force the outer wall plate from its bearing on top of the outer wall.
3. The lap joint is improperly reversed where the lower rafter is held only by a smaller timber peg. The result is that the upper rafter is not sharing any of the load as it would usually when correctly lapped above the lower.

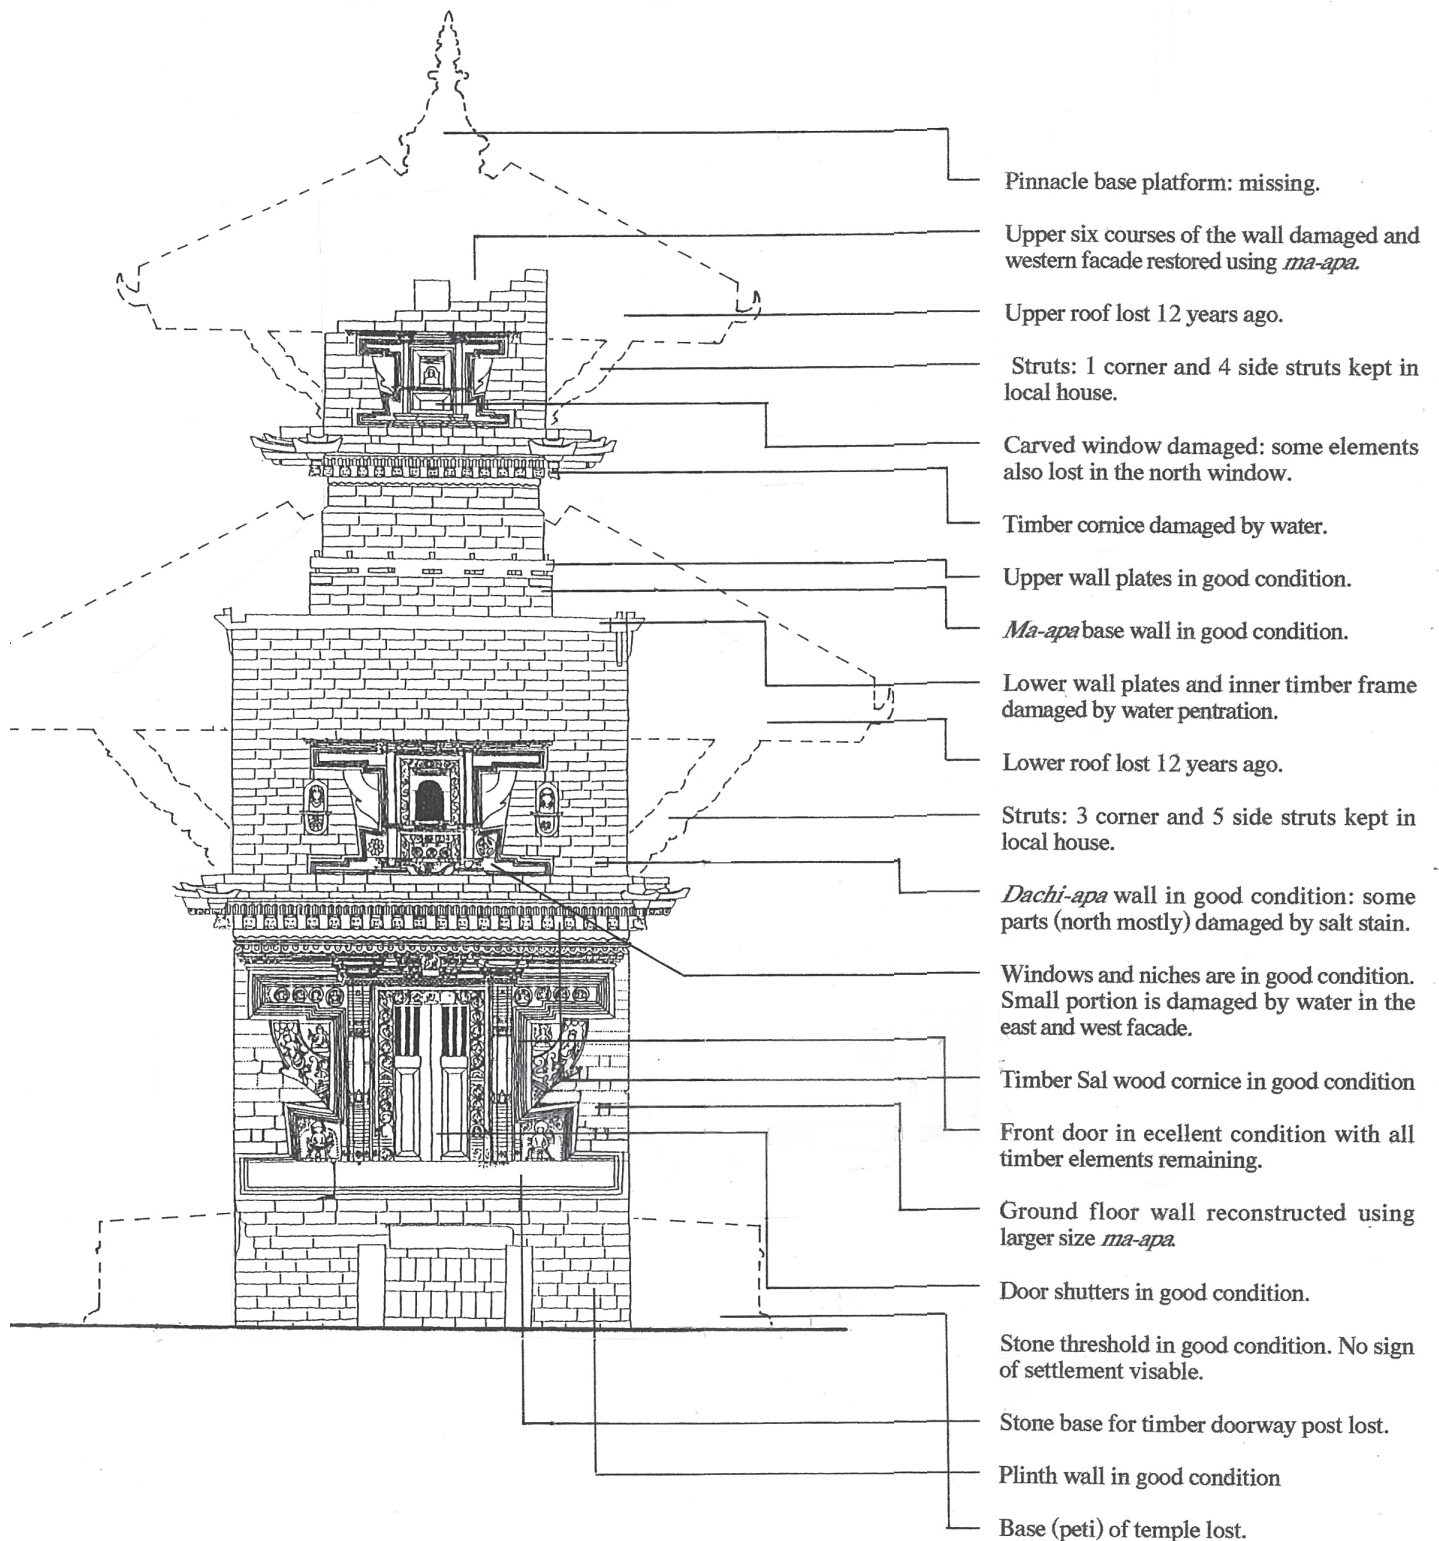
EXISTING CONDITION: WEST (PRINCIPLE) FACADE
KATHMANDU VALLEY PRESERVATION TRUST - NOVEMBER 1998

85% of the historical veneer brick has been replaced with a larger common brick, *ma apa* (3" x 9") laid in cement and lime *surkhi* mortar. Almost all of these replacement bricks have spalled as a result of the bad quality and salts of the cement mortar. This is typical of all repairs since the 1950's in Nepal. In 1958 the ground floor wall fabric was refaced on each side and between this time and 1994 an approximate area of 3' x 3' of wall fabric has been sloppily 'patched' up. Approximately 30% of the wall area is in an advanced state of erosion.

In good condition, the original veneer brick or *dachi apa* wall is intact except at the upper three courses damaged by rain water. Despite the onslaught of vegetation that comes after every monsoon the wall structure has survived. Approximately 20% of the bricks have salt stain from damp.

The inappropriate *ma apa* brick shall be replaced with traditional *dachi apa* using yellow mud mortar matched to that of the upper level. All *dachi -apa* will be custom ordered to make them the same size as in the upper level of the temple.

At first floor level the three upper brick courses will be repaired using *dachi apa*. Bricks displaying salt stain shall be cleaned with water and soft brushes.

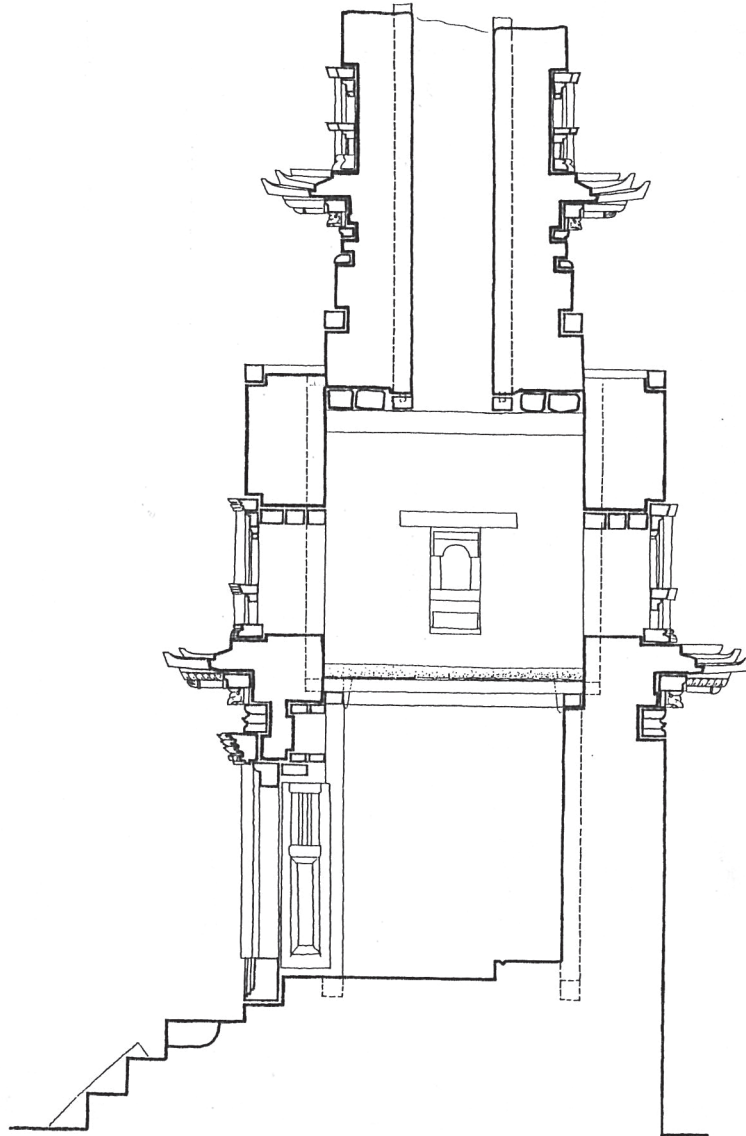
SECTION EAST - WEST : EXISTING CONDITION
KATHMANDU VALLEY PRESERVATION TRUST - NOVEMBER 1998

During renovation in 1958 this level was reconstructed using mixed *dachi apa* (vener brick) and *ma apa* (common brick). The top level has suffered considerable damage. The top three courses of brick masonry have collapsed as a result of water penetration. The southern face was repaired using *ma apa* in the 1958 restoration. The water has penetrated the mud mortar between the structural and veneer wall layers (inner and outer leaf layers, respectively) and has caused the wall to pull apart brick by brick. Water penetration has also caused the northern and eastern wall to bulge by 3" and the southern and western walls by 2".

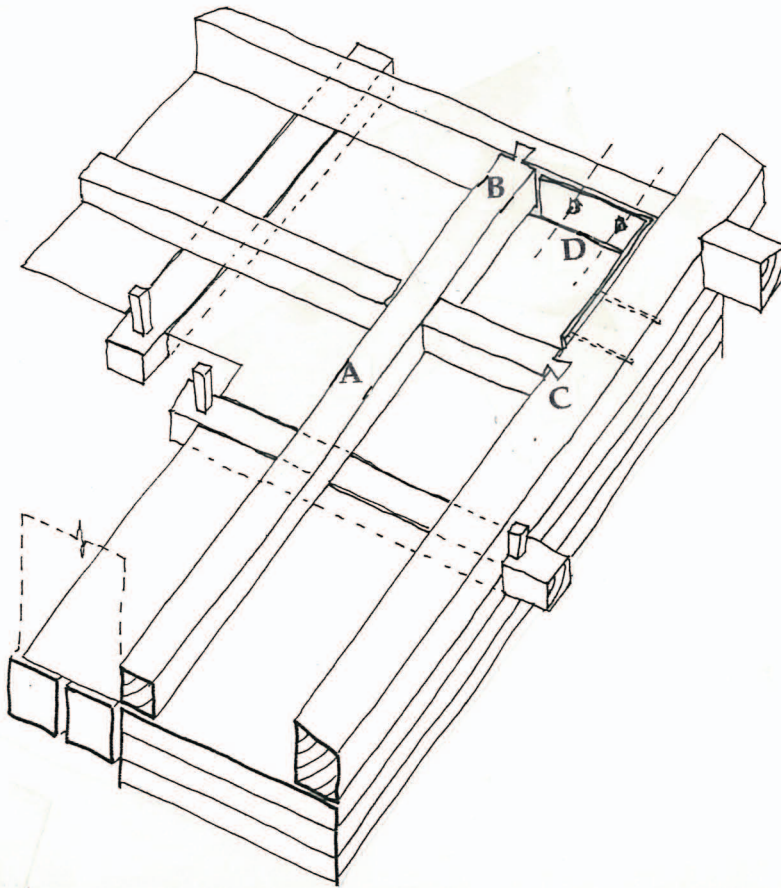
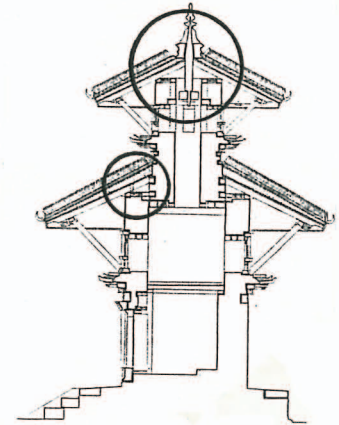
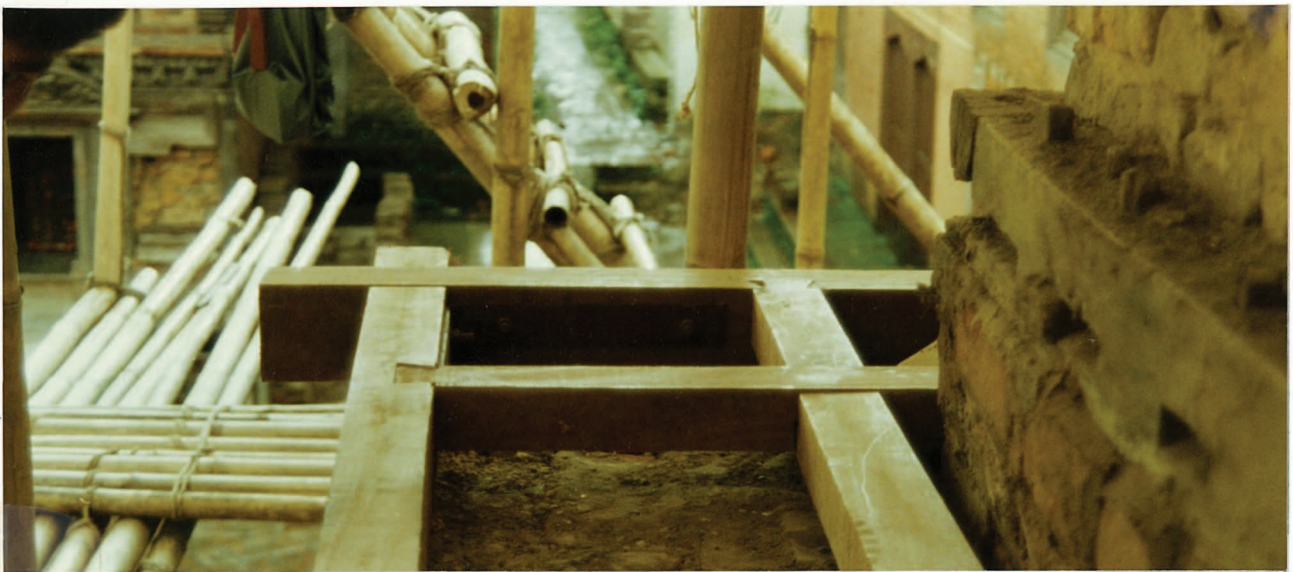
Tie between wall plates.

Connection between innerwall plate and outerwall plate. The traditional configuration of double wall plates makes it easy to develop a timber horizontal ring beam of sorts by careful sizing and joinery at the corners. In this temple there was no connection between the inner and outer wall plates, because these members were already damaged. During replacement, the corner joints will be made with the traditional lap joinery but will also incorporate 3/8" thick steel "L" plates to reinforce this corner. These plates will be made of iron painted with three coats of anti-corrosive paint. The additional joints between inner and outer wall plates use dovetailed joinery.

1. The diagram shows the location of the wall plates.
2. At present the inner and outer wall plates are not connected with each other. The proposed arrangement will act as one horizontal unit. With (a) the introduction of the inner wall plate, the subsequent linking with the outer wall plate (b) using dovetailed joints (c) and steel collars (d) at the corner.
3. Photo august 1997: This technique increases the seismic strength of the temple by acting as a ring beam which ties the walls together.

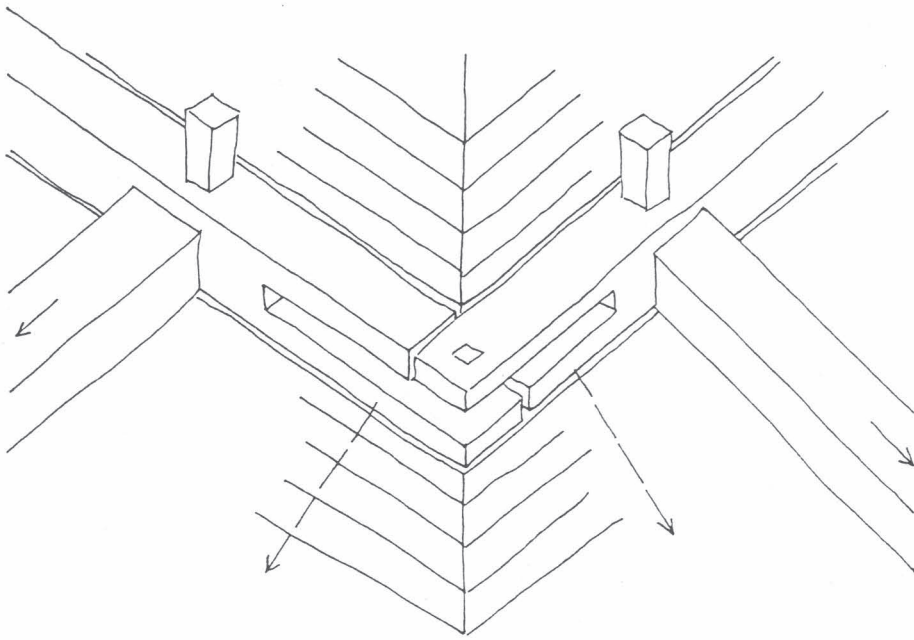
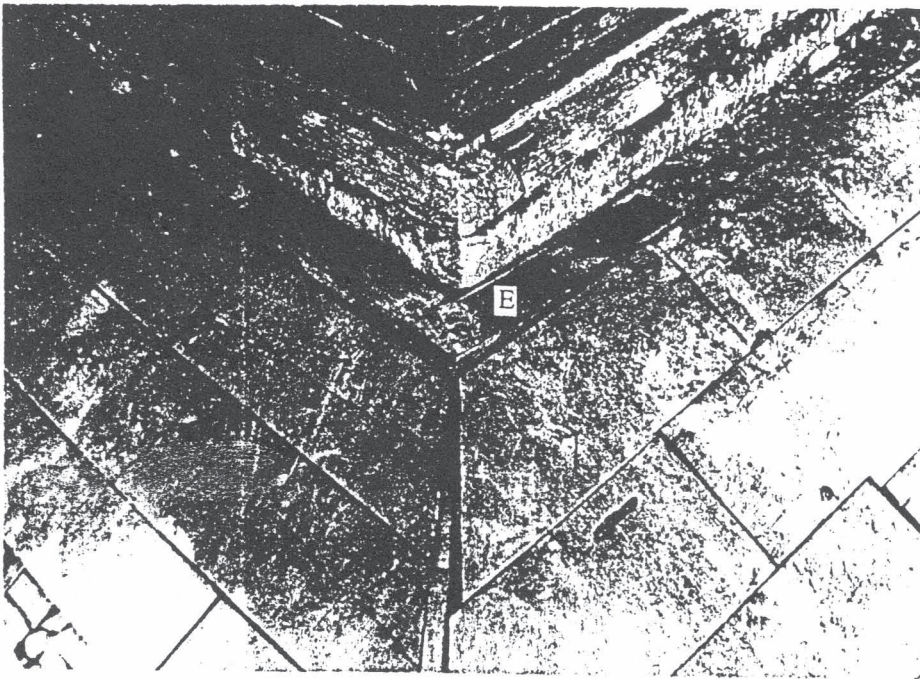
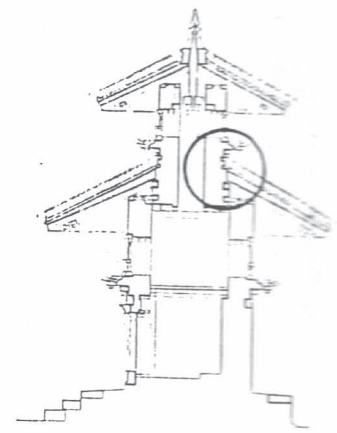
Reinforcement of the corner lap joint

1. The corner lap joint timber section is not sufficient to bear the load of the corner strut. If the corner strut is off center it is highly probable that the protruding timber end will break off easily.
2. To prevent this kind of failure a metal cross piece is attached to the joint. This improves the strength and allows the even distribution of local forces.
