**UMA MAHESWAR TEMPLE
KWALKHU TOL, PATAN**

HISTORIC STRUCTURES REPORT
MARCH, 1992

**ERICH G. THEOPHILE
ROHIT K. RANJITKAR
KATHMANDU VALLEY PRESERVATION TRUST
IN COLLABORATION WITH
HIS MAJESTY'S GOVERNMENT
DEPARTMENT OF ARCHAEOLOGY**

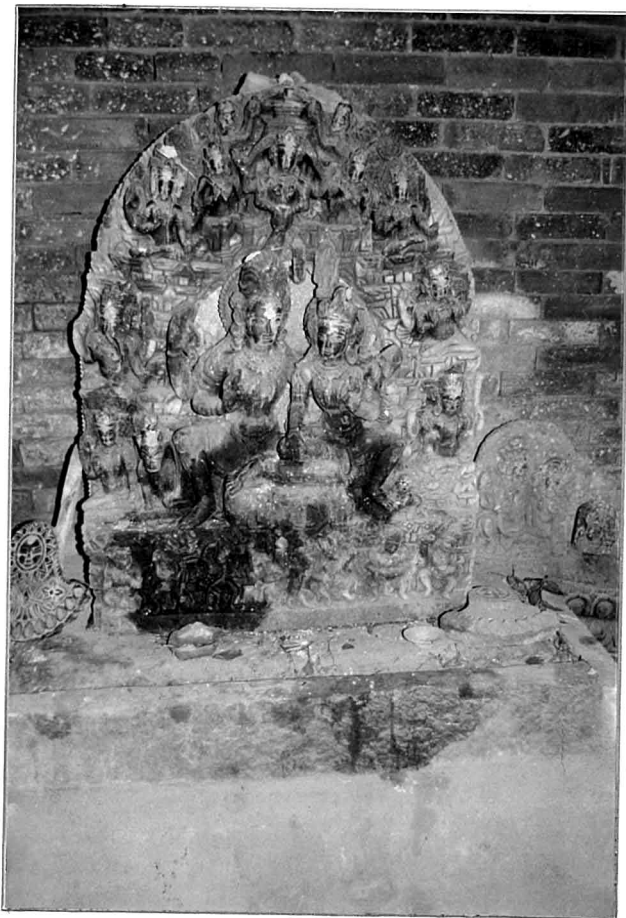
THE ICON OF UMA MAHESWAR. SALT STAINS RESULT FROM THE 1979 INTRODUCTION OF CEMENT PLASTER ON THE STONE PEDESTAL AND ANTI-THEFT MASONRY FILL BEHIND THE SCULPTURE.

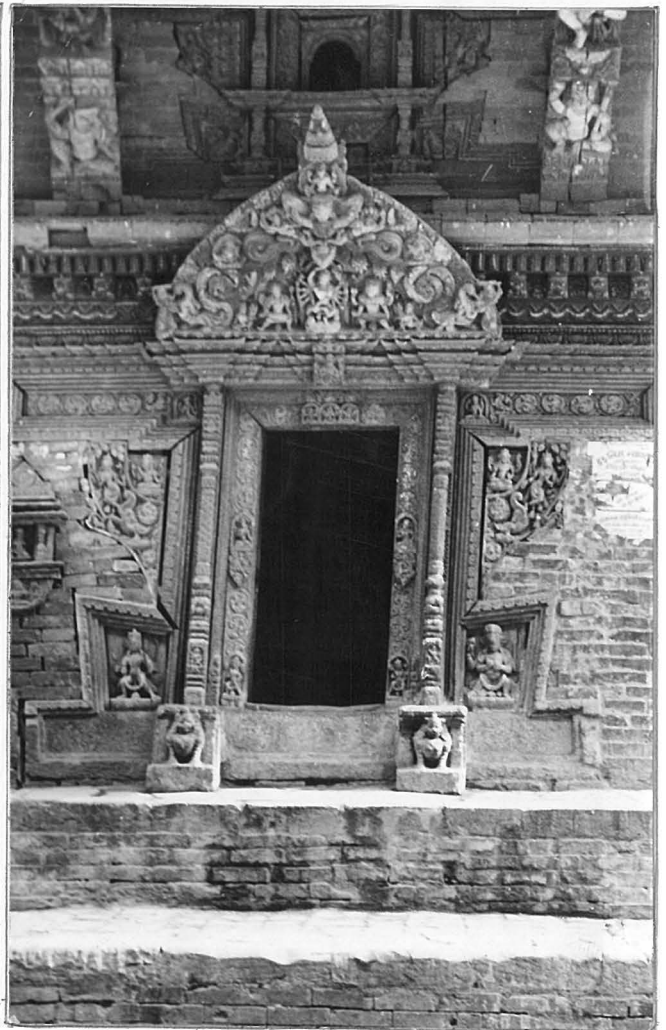
LEFT: PORTION OF BASE STORY CORNICE AFTER TEST CLEANING, MARCH 1992.
RIGHT: ENTRANCE ENSEMBLE WITH RIGHT NICHE MISSING, JANUARY, 1992.

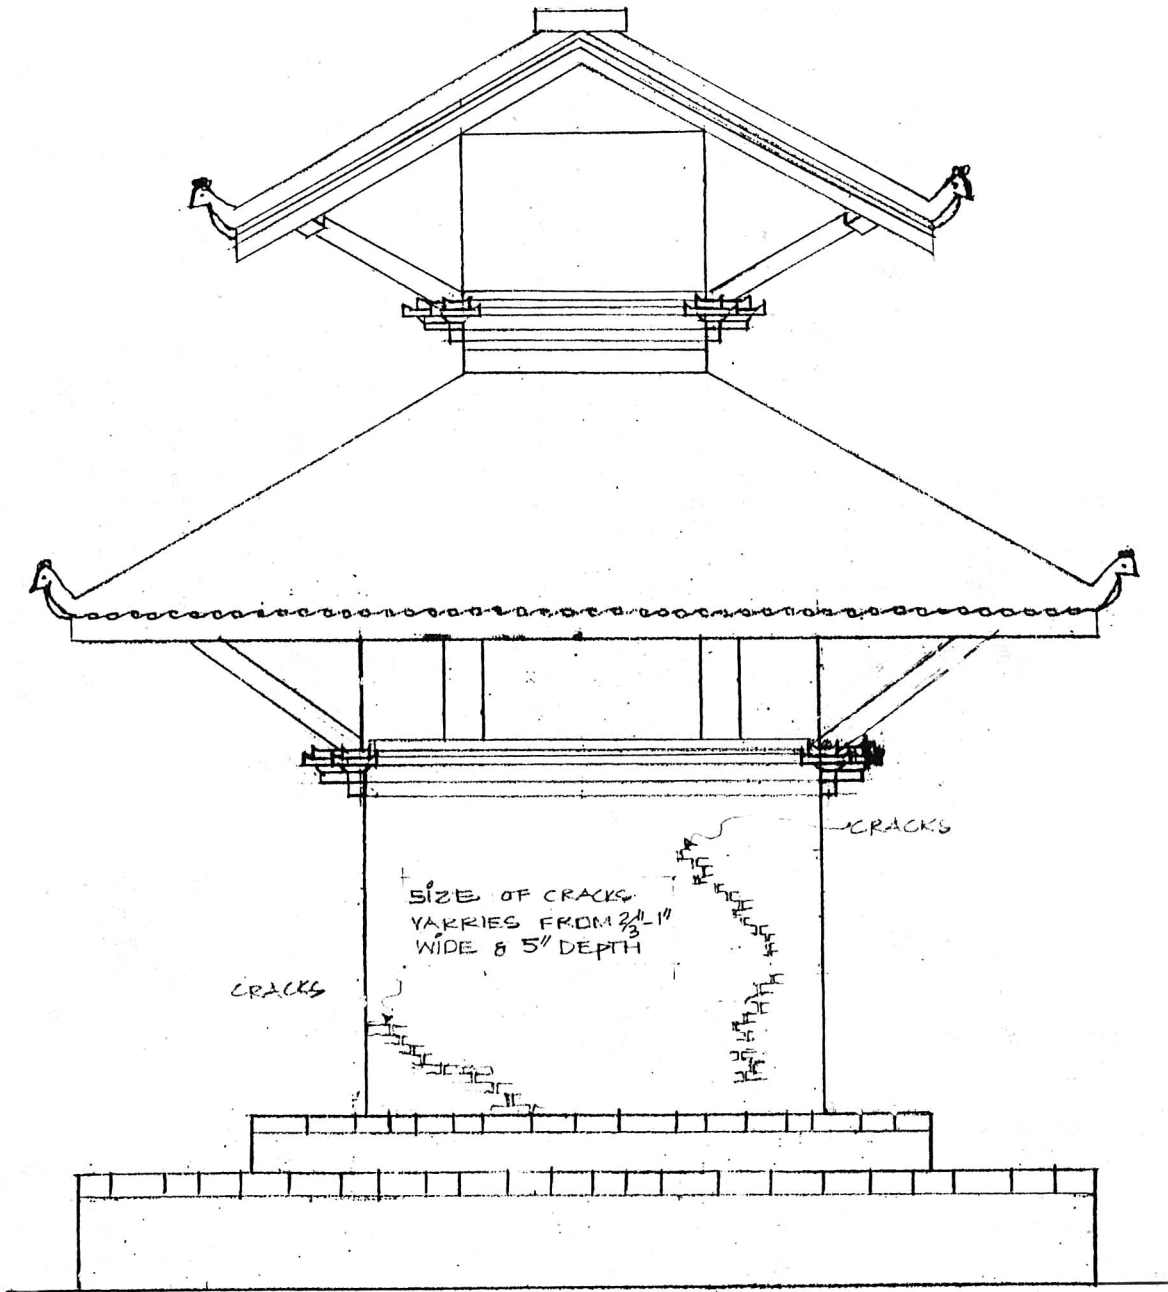
The only structural damage to the masonry wall consists of a tilt to the building's base story wall at the northwest corner. The displacement has been measured on the exterior as 5" out of plumb towards the south, 1" to the west. Maximum displacement is at the top of this 5'8" high lower story wall (measured to bottom of cornice) and tapers to the intersection of wall and plinth below. All other wall corners are within 1" of plumb. The displacement at the same northeast corner on the inside is 2-1/2", that is, less than that of the exterior corner, suggesting that the three-layered wall--especially the middle rubble fill--has taken up the difference. Extensive cracking in the north facade veneer layer appears to have resulted from this displacement. Additionally, the corner joints of the west elevation's door frame have been spread by this displacement, leaving less than one inch of structural interlock at the upper corners.

ABOVE: NORTH ELEVATION: DOCUMENTATION OF CRACKS, MAXIMUM 1" WIDE AND ONE BRICK DEEP. FEBRUARY, 1992.

On the north elevation, the extensive separations of the veneer brick layer can only be corrected through rebuilding as piecing in of small pieces would be visually distracting and structurally insufficient. This rebuilding will incorporate all historical bricks, while eliminating later patches of common brick. The historical bricks, nevertheless, are very difficult to remove without breaking where cement mortar or pointing is present. Similarly, the spalling of the east elevation merits rebuilding as 80% of the historical bricks are damaged up to the cornice level.

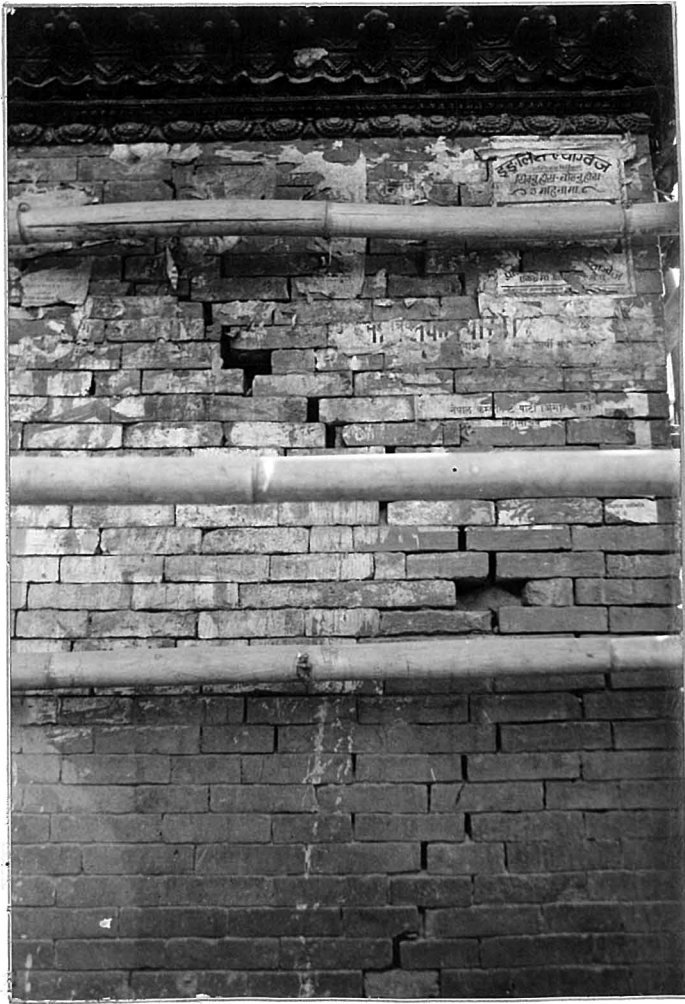
LEFT: THE RIGHT CRACK OF THE NORTH ELEVATION, BASE STORY. (REFER DRAWING OPPOSITE PAGE. RIGHT: SECTION THROUGH WALL AT UPPER BASE STORY WINDOW. THE TYPICAL CONSTRUCTION EMPLOYS INNER AND OUTER LAYERS WITH FEW HEADERS AND A RUBBLE FILL IN THE MIDDLE

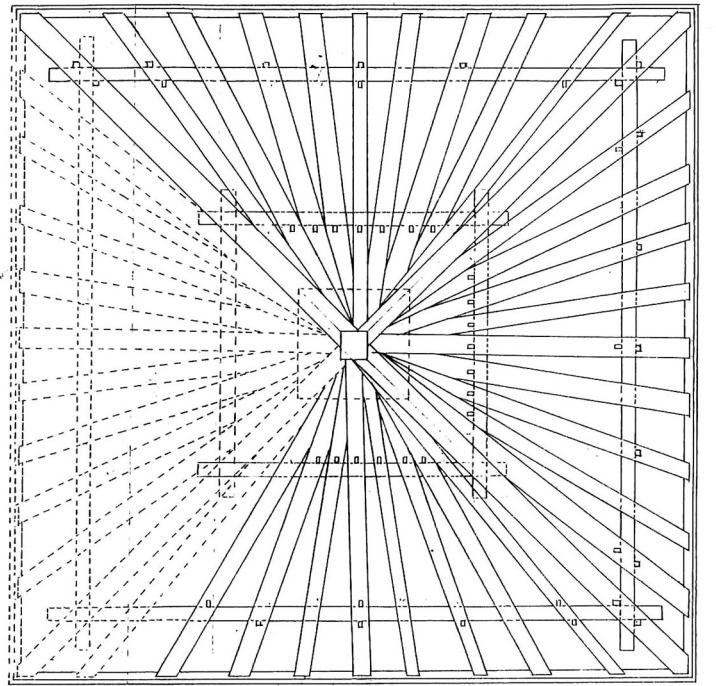
UPPER ROOF PLAN: EXISTING CONDITIONS
KATHMANDU VALLEY PRESERVATION TRUST, MARCH 1992

The much smaller upper roof structure has collapsed on the north side. This damage was brought on by water penetration at *chukul* locations which allowed the rafters to slide off.

On the other three extant roofs, sal eavesboards and pine purlins are severely water damaged. Rafters are damaged at *chukul* locations. A careful survey is being made to identify all rafters able to be conserved. The three sides of surviving pine wall plates are severely damaged by water penetration brought on by the missing north roof.

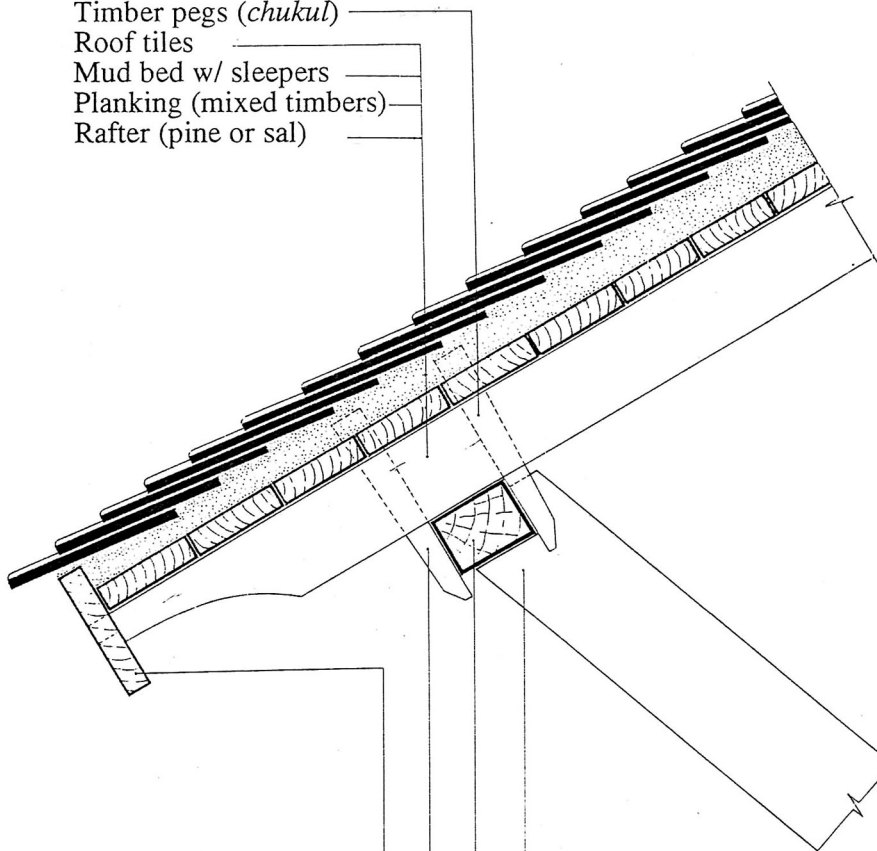
THE "KEY" PROBLEM

The traditional connection between rafter and wall plate and between rafter and purlin consists of two timber pegs inserted to brace the rafter against the horizontal member. At approximately 80% of these peg locations, water penetration had caused deterioration of the peg, enlargement of the peg hole, and deterioration of the surrounding area on the rafter of 3" square on average.

The most important conclusion of the detailed study of the roof structure is that the traditional wooden peg (Nepali-*cuku* , Newari-*chukul*) inserted as a key at the wall plate and purlin is the principal entry point for water into the structural timbers. The traditional detail uses the peg as a key in the mud layer above the planking, especially at more exposed locations above the purlins. Thus any damage to or movement of the rather loose roof tile (*jhingati*) allows water to reach the mud and then penetrate to the cross grain of the rafter through this wooden peg. Moreover, when the small timber peg deteriorates, there is nothing to prevent the heavy rafters from sliding off the masonry core structure. This scenario describes the majority of roof failures in Newar buildings.

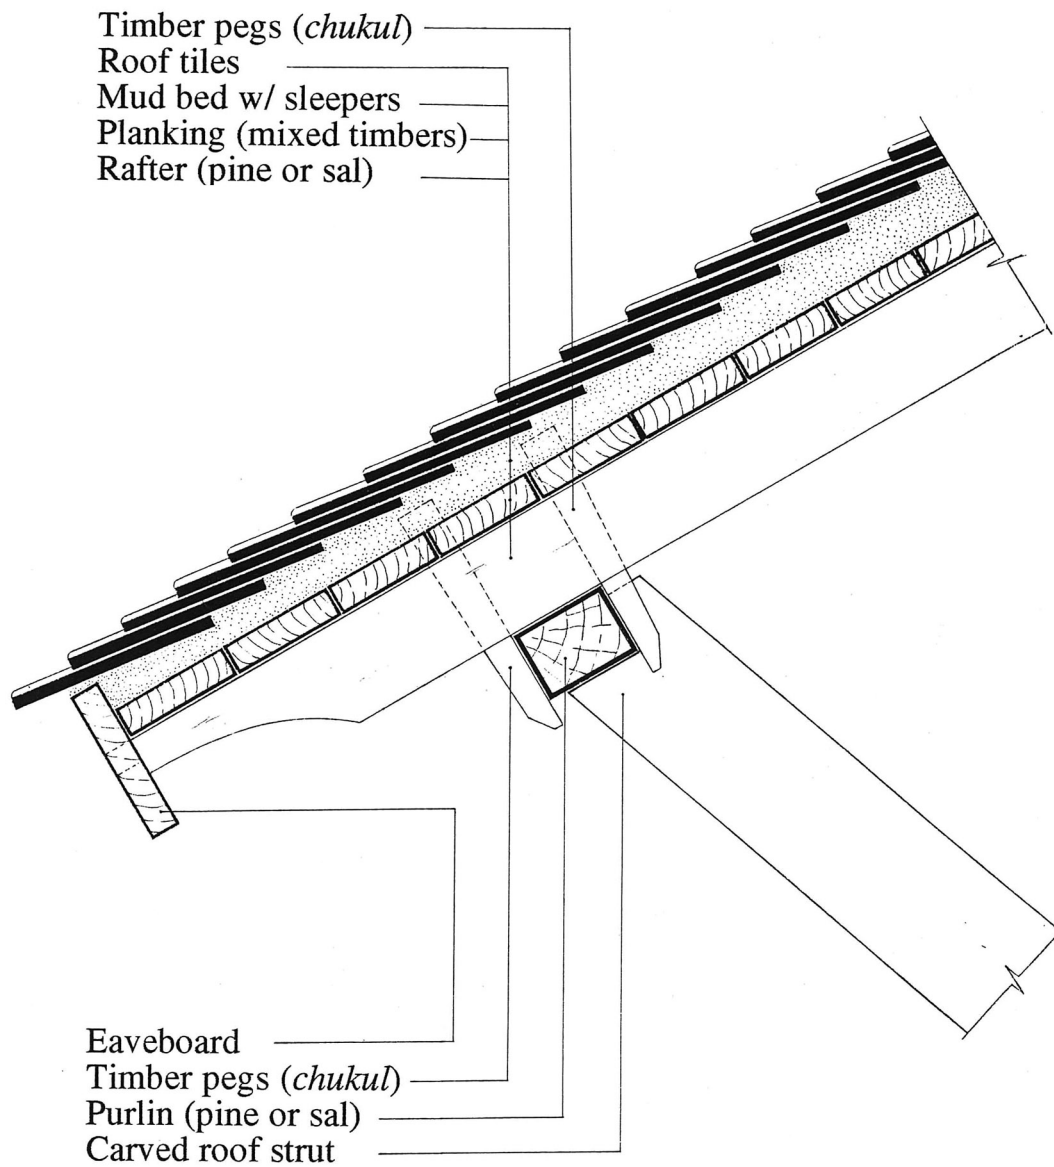
THE "KEY" PROBLEM

*Section at roof overhang:
as traditionally detailed*
