**Structural Report
Itum Baha, Kathmandu**

November 2002
Dipl. Ing. Matthias Beckh

Structural Report

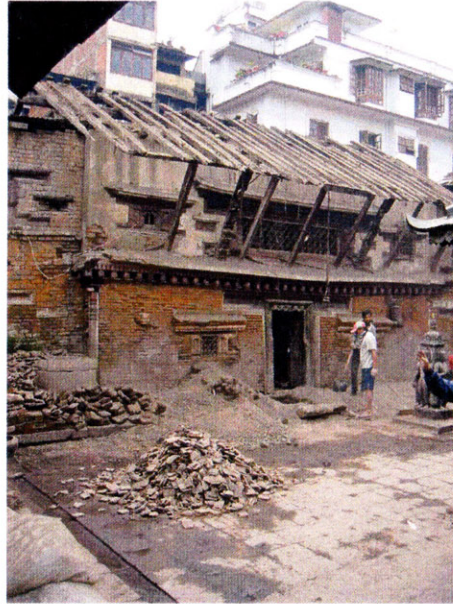
1

After the removal of the roof tiles and planking, the roof structure was inspected on 25th November. What became visible was a timber structure in its ultimate state of decay. The purlins were completely rotten and had

partially collapsed, most of the timber pegs broken off or in a state of distress. All of the top connections of the rafters had been rotten away. The lower ends of the rafters and the eave boards had been rotten and partially broken off. Similarly, the joists at the third floor were in a progressed state of decomposition, with some of them having already collapsed. Altogether, the existing roof is beyond repair and has to be completely rebuilt, using entirely new timber elements.

- 1) View without roof tiles and planking.
- 2) Western door of the south wing, seen from courtyard.
- 3) Excavated foundations inside.
- 4) Excavated foundations outside.
- 5) South wall of south wing.
- 6) Decayed joists at second floor level.
- 7) Rotten connection of rafters at the top purlin.

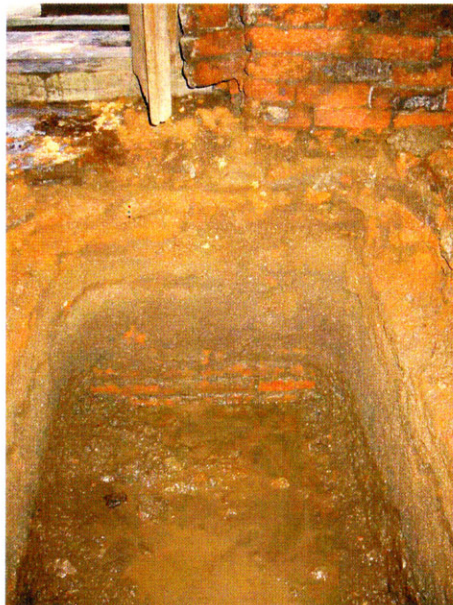
3

Excavations at the existing foundation walls that were carried out by mid November, unveiled a surprisingly high water table. Water was found only 50 cm below courtyard level. Due to that fact, the base condition of the existing foundations could not be inspected. Based on observations of similar structures, it can be assumed that the brick foundation wall reaches a base of large rubble stones about 1m below the courtyard level.

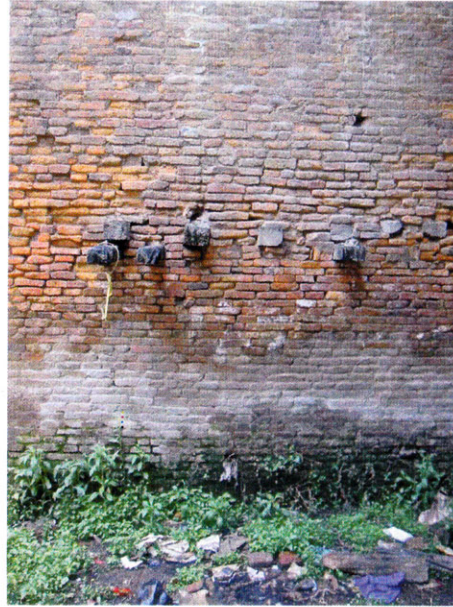
5

The load bearing walls of Itum Baha are made of locally produced fired brick - maapa - laid in mud mortar. Most parts of the brickwork are in poor or even extremely poor condition. Heavily decayed brickwork can be seen along the entire northern and southern wall of the south wing. Here, rising damp has caused spalling of the bricks and washed out the mud mortar in the evaporation zone of the wall, between 50 -180 cm above ground level. Below this zone, heavy efflorescence and moss can be seen along the walls. The extreme leaching of salts also indicates an advanced denutrition of the mortar. The rising water, exacerbated by an unusually high water table, has led to a substantial weakening and decomposition of the structure.

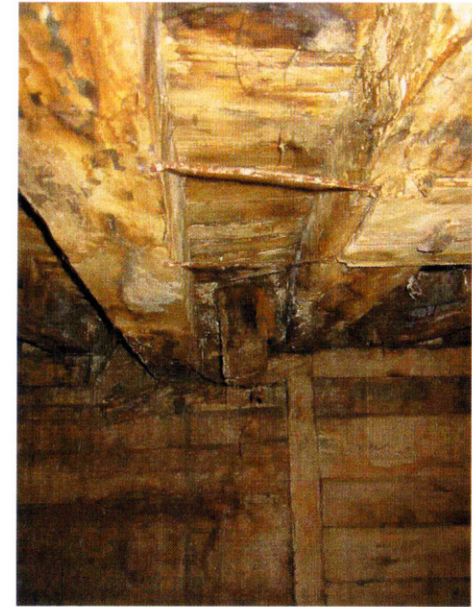
6

At the second floor, many of the joists are rotten and severely affected by wet rot, fungus and insect infestation. However, some of the joists appear to be still in usable condition and will be reused in the renovated structure. Many of the timber windows on the second floor level show boreholes caused by insects that have led to a partial decomposition of the wood.
