KAGESWAR MAHADEV TEMPLE

KATHMANDU DARBAR INITIATIVE

FINAL REPORT

DECEMBER 2005

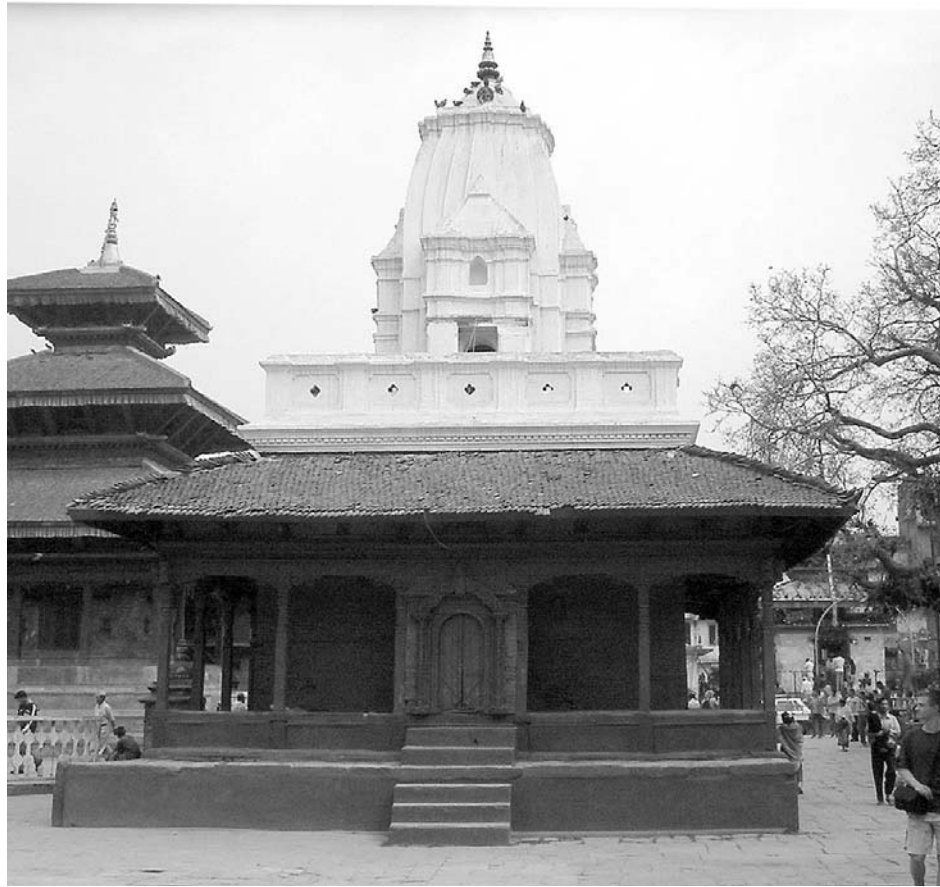
above: The temple stood in a dilapidated state with much of its roof structure disintegrating. The moisture penetration through poorly done joinery in the roof had completely deteriorating its members. Seepage of annual monsoon rains had resulted in corrosion of brick work in the ground level. Kageswar Mahadev Temple as it stood in 2003. *Photo by: Raju Roka, KVPT, March 2003.*

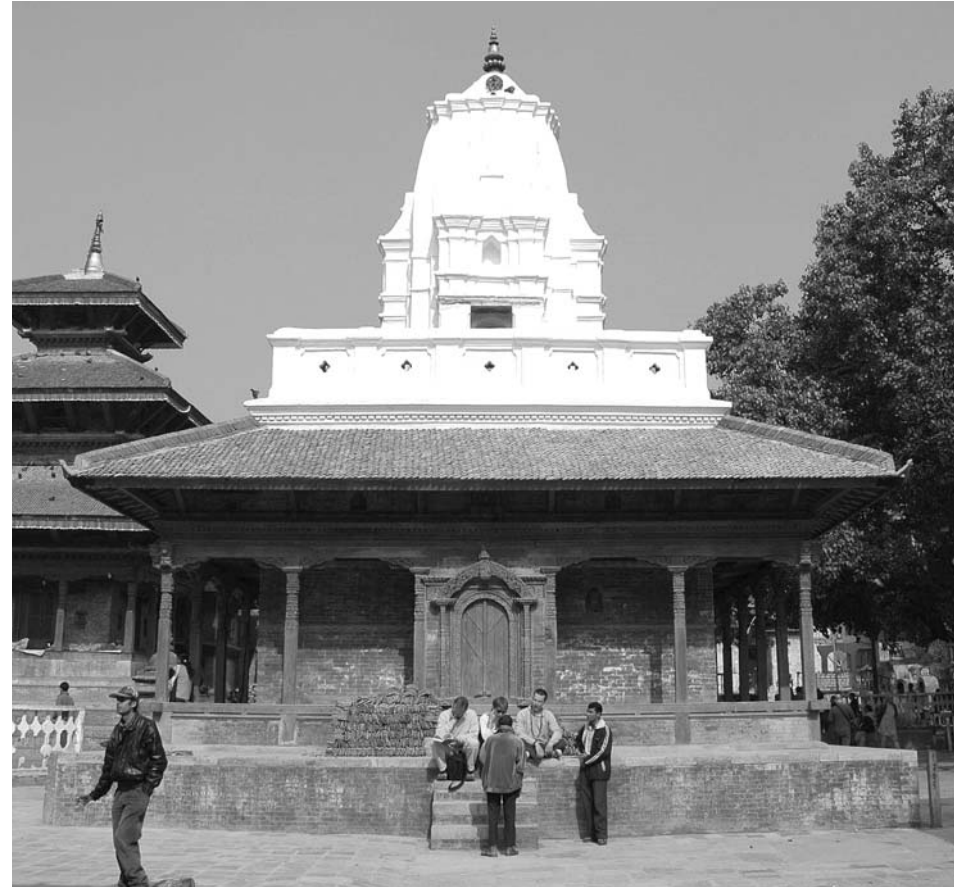
above right: Kageswar Mahadev Temple on completion, November 2005. The roof structure was completely refurbished, the masonry work at the ground floor level was replaced, new damp proofing material introduced to check the undesired seepage of rainwater from the terrace level and steel members incorporated to further strengthen the structure. *Photo by: Raju Roka, KVPT, November 2005.*

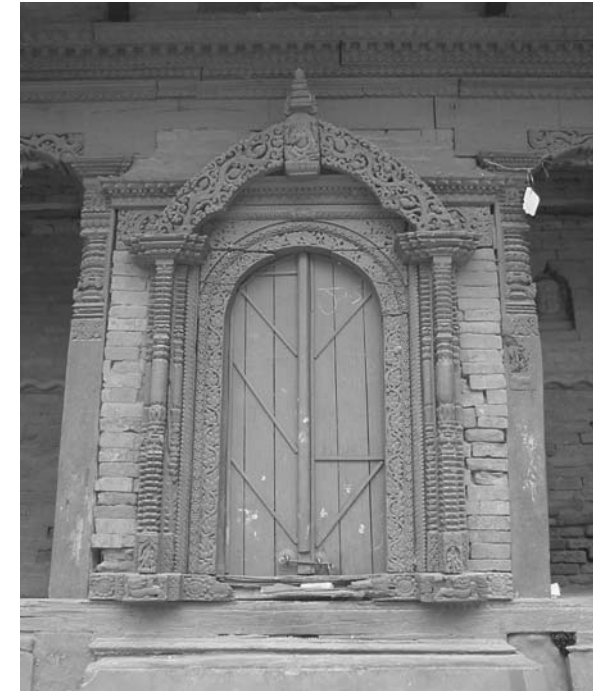
above: Some of the significant features of the main door had either damaged or were lost. These were replicated and incorporated with the existing during restoration.
Photo by: Lumanti Joshi, KVPT, April 2003.

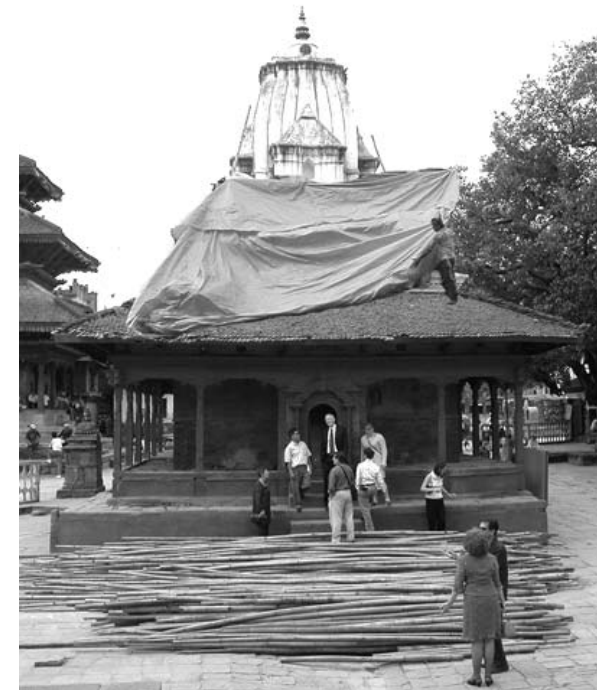
above: Tarpaulin was installed over the structure as an emergency measure to protect it from the coming monsoon rains. Photo by: Raju Roka, KVPT, June 2004.

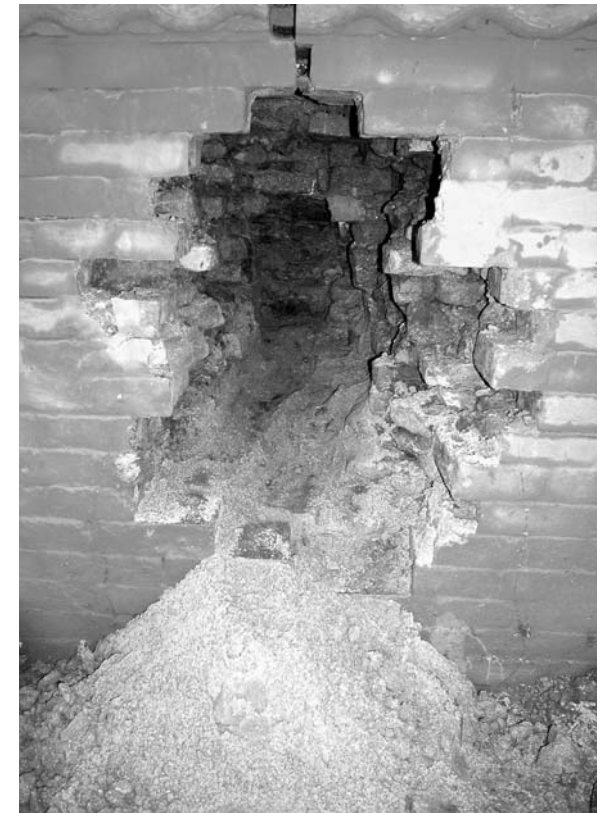
above: A section of wall in the ground floor level was probed into to assess its condition. The investigation revealed that the interior had been completely compacted with brick masonry, not hollow as we had anticipated. Since it was in fair condition, we decided not to intervene in the core structure. *Photo by: Lumanti Joshi, KVPT, May 2005*

During the site investigation, we probed into a section of the east wall of the structure in the ground floor level to assess its condition. In preliminary inspection, we had expected the interior to be hollow, only opening to be blocked by the staircase, an addition from 1823. The crude construction of the staircase indicates hasty repairs after the earthquake. However, it was discovered that the interior had been compacted with common bricks set in mud mortar. The reason for doing this is unknown, we can only assume that it was prompted by the damage triggered by the earthquake. Any intervention in the ground floor would mean dismantling the whole structure, implying total reconstruction. But the core structure is still in fairly good condition, only the veneer bricks required maintenance.

Rain water seepage into the structure had resulted in total damage of the masonry structure, about 80% of it was damaged. Besides this, the upper level of the walls was protruding outwards, also caused by the water seepage. In the process of restoration, the protrusion was corrected and the lower section of the wall was rebuilt with *dachi appa* set in mud mortar, section by section. The mud mortar construction greatly increases the performance of the structure in an event of seismic movement as it is able to absorb shock waves of the earthquake without fracturing the adjacent bricks. Because of the fairly good condition of the *shikhara* structure, no intervention was required to be administered.

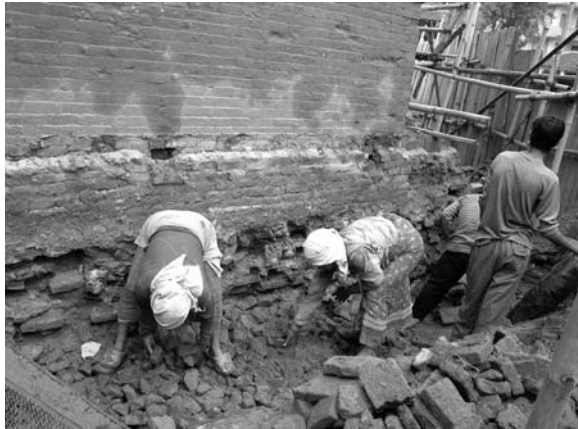
top: The plinth in the south facade being excavated to reconstruct it with traditional *dachi appa* and *ma appa* set in mud mortar. The east section was lost in the 1934 earthquake and was never rebuilt. It was reconstructed to regain its original configuration.

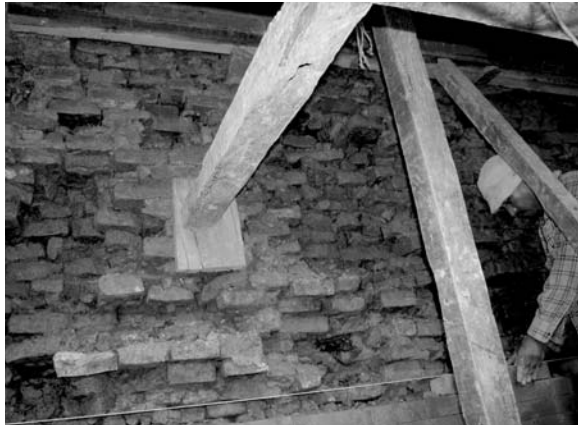
below: The damaged wall was dismantled section by section and was carefully shored to replace the deteriorated veneer brick with new ones. Photo by: Raju Roka, KVPT, August, 2005.

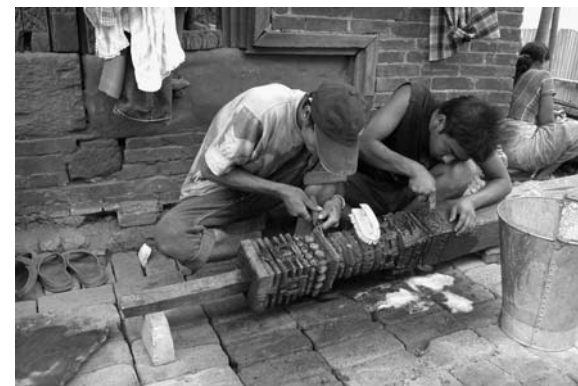
top: Simple and conservative cleaning method using water and mild detergent proved effective for removing the un-historic red paint from the carved elements. *Photo by: Raju Roka, KVPT, June 2005.*

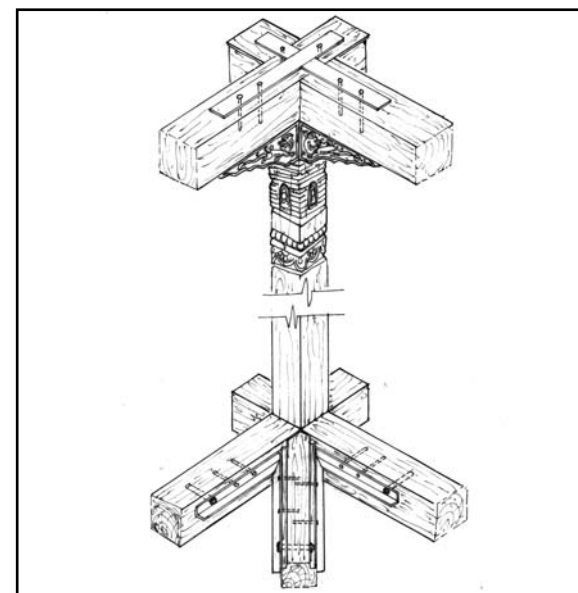
below: Steel members are incorporated in the timber structural members for seismic strengthening. *Drawn by Rajan Shrestha, June 2004.*

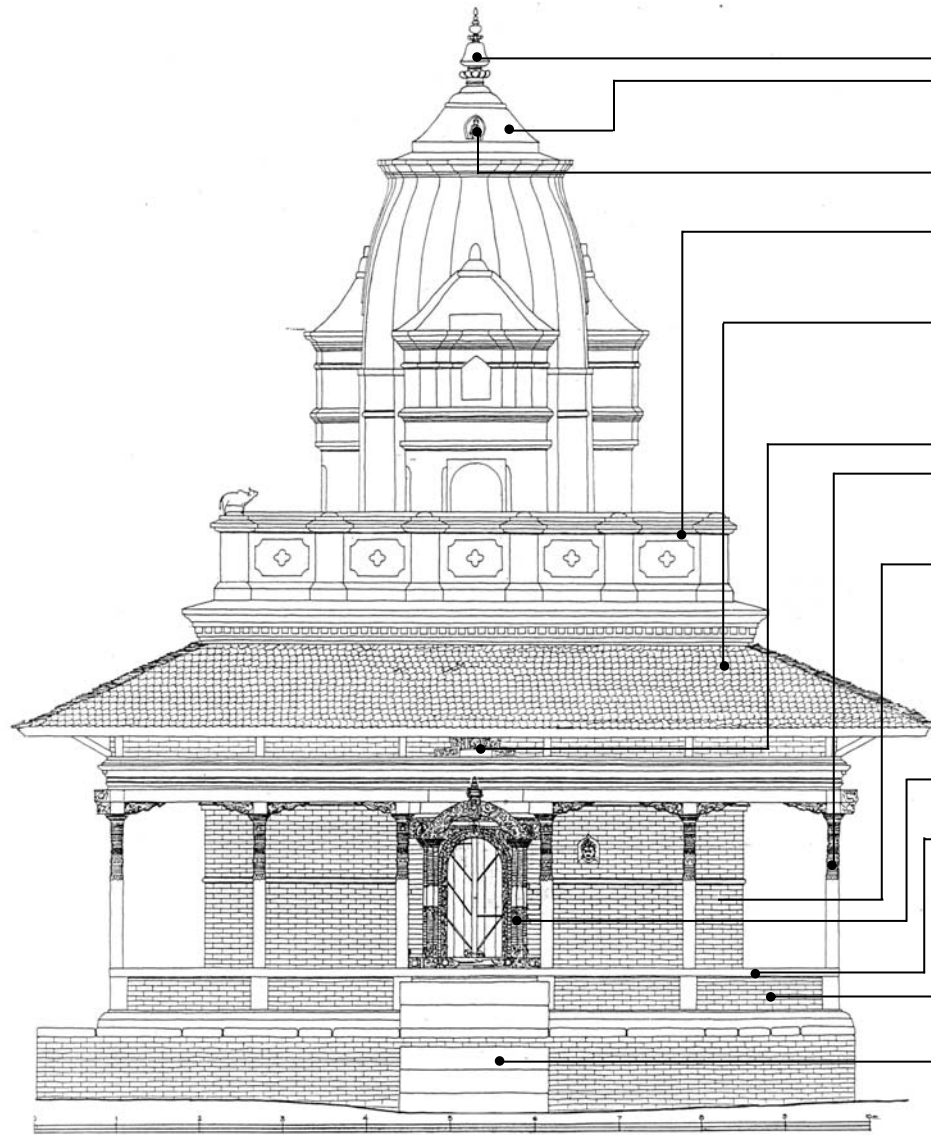
SOUTH ELEVATION : EXISTING CONDITIONS

- **Pinnacle:** Altered after the 1934 earthquake, which can be proved clearly with the help of the historical photograph taken before 1934 earthquake.

- **Shikhara:** Shape of the shikhar or the dome is more slender than the pre-earthquake configuration. The plaster work is white washed and is in good condition. Similarly the details in the plaster work has also been altered.

- **Small figures:** Auxiliary deities on all four sides, which can be seen in the historic photograph, is now missing.
- **Parapet wall:** The design and pattern of the parapet wall on all sides too were altered after the earthquake. There exists a large crack on the parapet wall in the east and south facade. There is no provision of drainage of rain water from the terrace.

- **Roof cover:** Roof tiles have been displaced at some places revealing the mud bed. Ridge tiles on all corners are not properly placed (more tilt than the tradition configuration) and in north east & north west corners, some of these are missing. Corner tiles are missing on n/e, s/w and n/w corners.

- **Windows:** Intact in all sides, red washed which has faded.
- **Timber columns:** All columns are damaged at the lower ends, but intact in all sides. There are insect bore holes in all of them. Dowels, which are used for connecting the columns with *lakhashi* are different from the traditional detail. All columns in the arcade are red washed.

- **Wall fabric:** Wall is constructed with *dachi appa* laid in mud mortar, in poor condition, is red washed. Wall above the beams is in urgent need of restoration. Seepage from roof have damaged upper five layers of bricks on all sides. Large cracks have developed on the east and north facades. At many areas in the wall, as in lower 5 layers of west facade, traditional *dachi appa* has been replaced larger chinese bricks. Lower 6 layers of bricks of the principal wall and bricks around the door frame have worn out. Bricks are sprawling out, where the dampness has effected.

- **Door frames:** Intricately carved, details are covered with red paint. Lower frame has totally worn out. Details of the left frame lost or have worn out.

- **Timber plinth beam:** These have completely worn out on all sides, large cracks have formed. sitting on brick plinth without timber runners in an ahistorical configuration.

- **Plinth:** Constructed of veneer brick on mud mortar, cement plaster has been applied over this on all sides at both levels. The lower plinth in the east side is lost. Apron stones are intact with superficial damage. Both levels have been red washed. Base stones for columns (*Ilohan*) are intact on all sides. *Nagol* encircling the upper plinth is not uniform in size and is undulating.

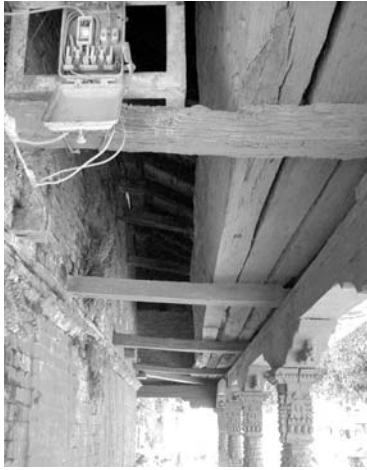
top left: The beams supporting the upper wall were smaller in section and thus had warped because of the load. *Photo by: Lumanti Joshi, KVPT, April 2003.*

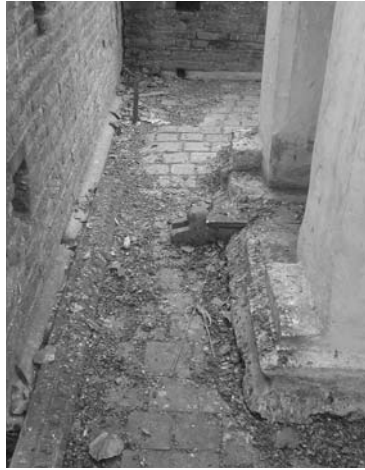
top right: The floor tiles laid on the terrace were coming off at many places and required emergency repair work. *Photo by: Lumanti Joshi, KVPT, April 2003.*

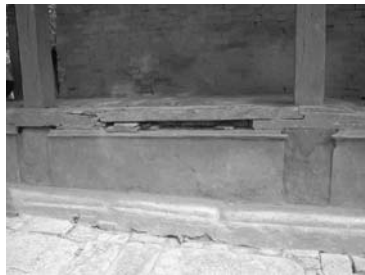
bottom right: The *lhakashi* had deteriorated at many places and were replaced during restoration. *Photo by: Lumanti Joshi, KVPT, April 2003.*

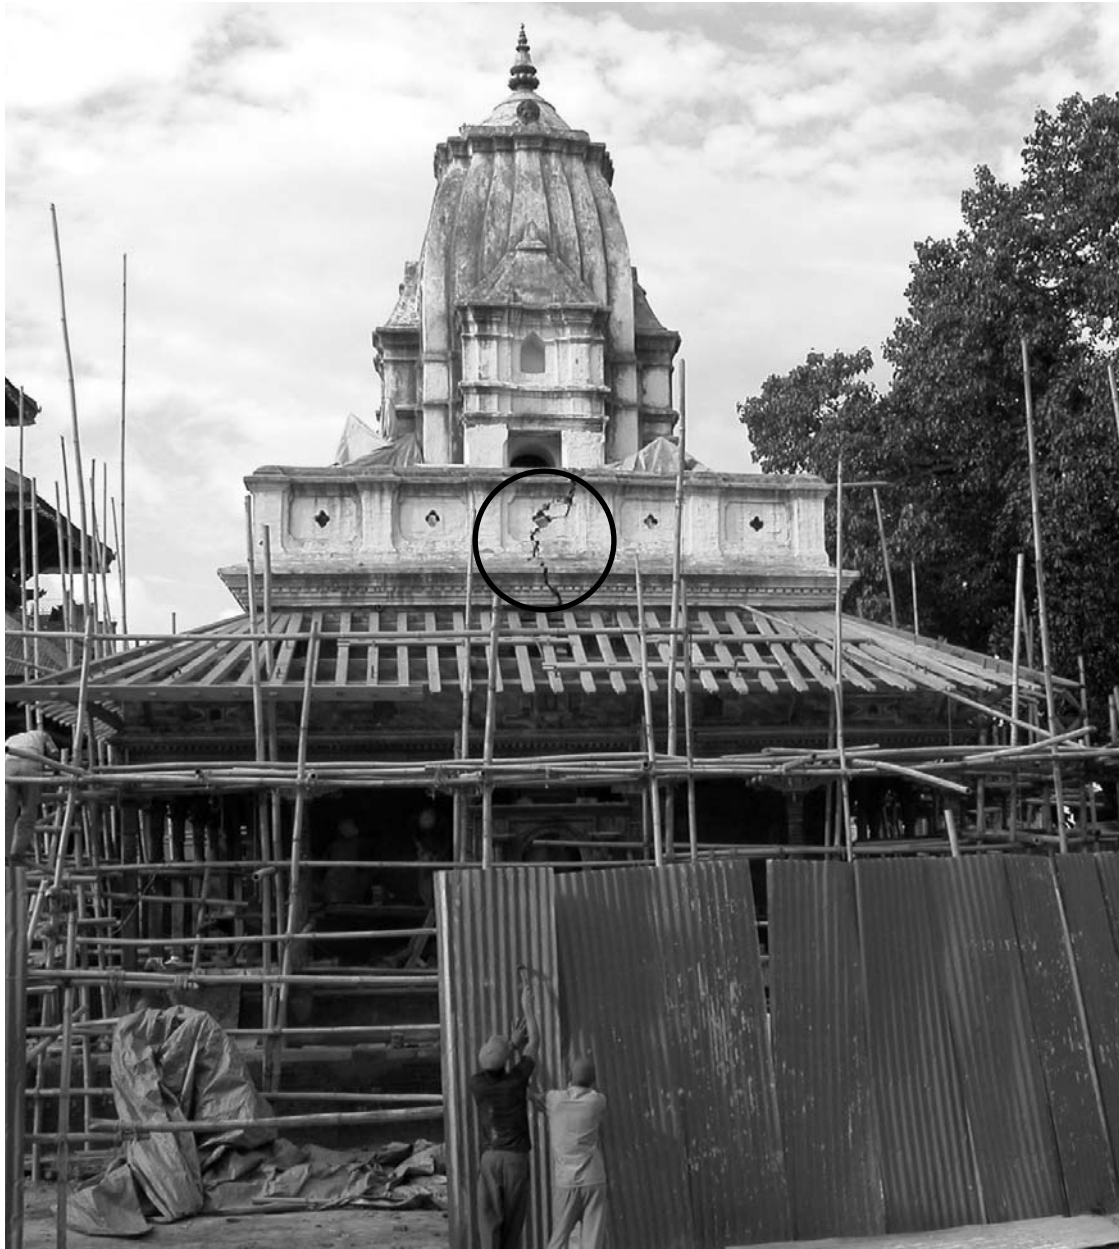
left: Kageswar Mahadev Temple with newly prepared rafters installed. A large crack developed on the parapet walls as we progressed with work, was later repaired. *Photo by: Badri Juwal, KVPT, September 2005.*
top: Masons at work. *Photo by: Badri Juwal, KVPT, May 2005.*
bottom left: Preparation of mud for mortar. Mud mortar construction greatly enhanced seismic performance of the building. *Photo by: Raju Roka, KVPT, September 2005.*
bottom right: Carpenters installing the rafters. Every third rafter was bolted to the wall plate for stability of structure. *Photo by: Badri Juwal, September 2005.*
