MAHADEV TEMPLES

KATHMANDU DARBAR INITIATIVE

FINAL REPORT

ROHIT K. RANJITKAR * LUMANTI JOSHI
KATHMANDU VALLEY PRESERVATION TRUST
AUGUST, 2007

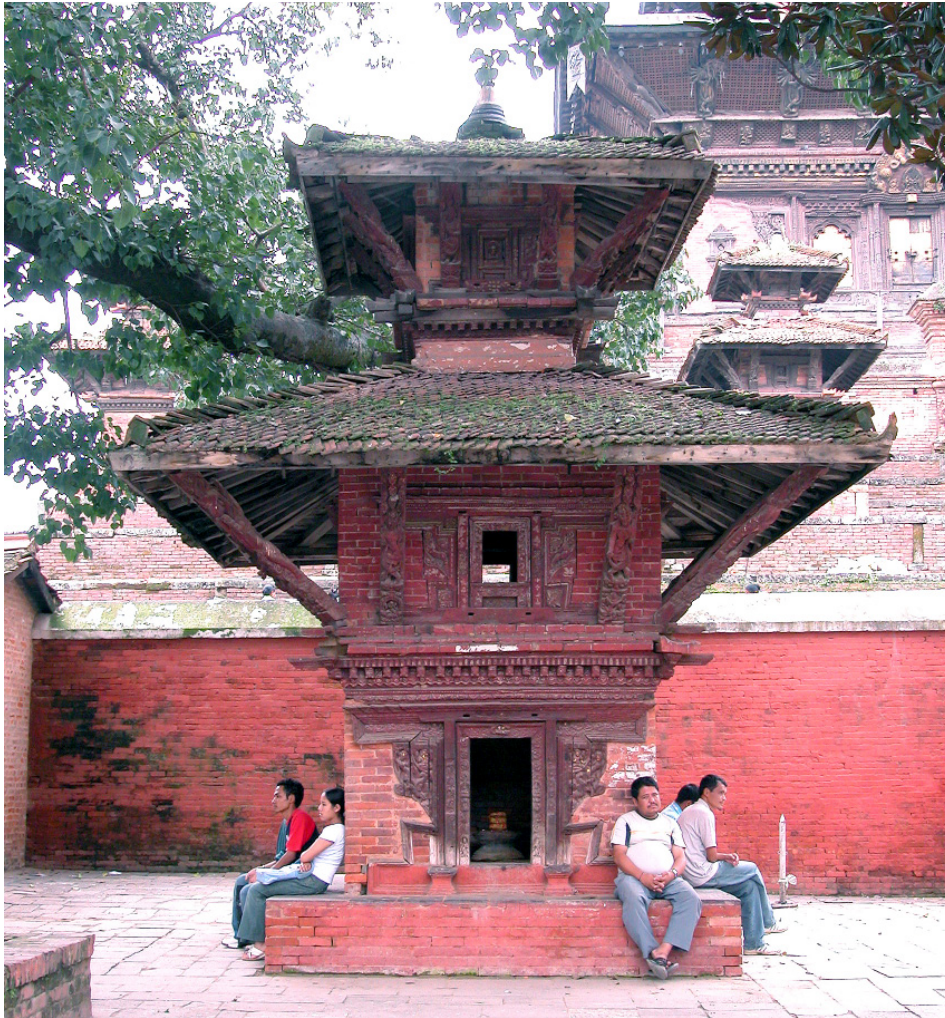
left: The Mahadev Temple I as it stood in December 2006. The roof structures were in poor state and in urgent need of repair. *Photo by :Lumanti Joshi.*

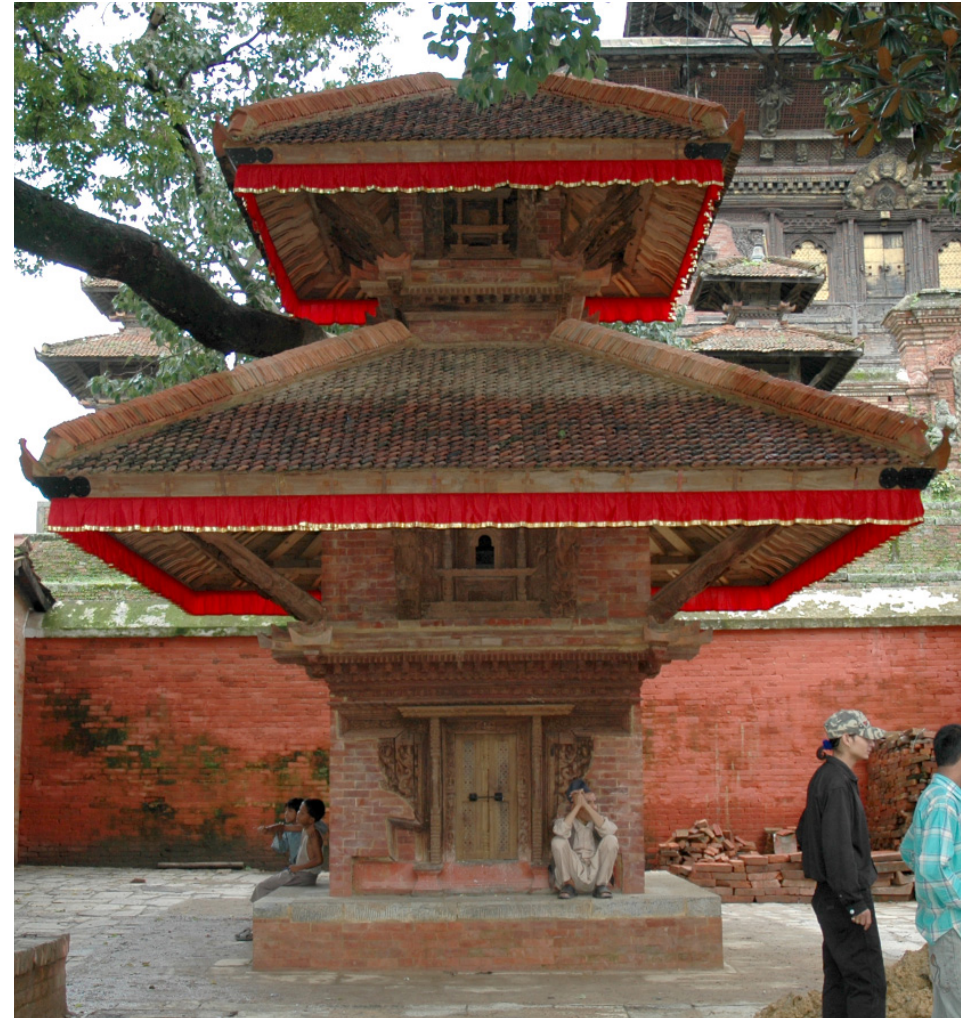
right: The restored Mahadev Temple I. The entire roof structure was refurbished. *Photo by: Lumanti Joshi, July 2007.*

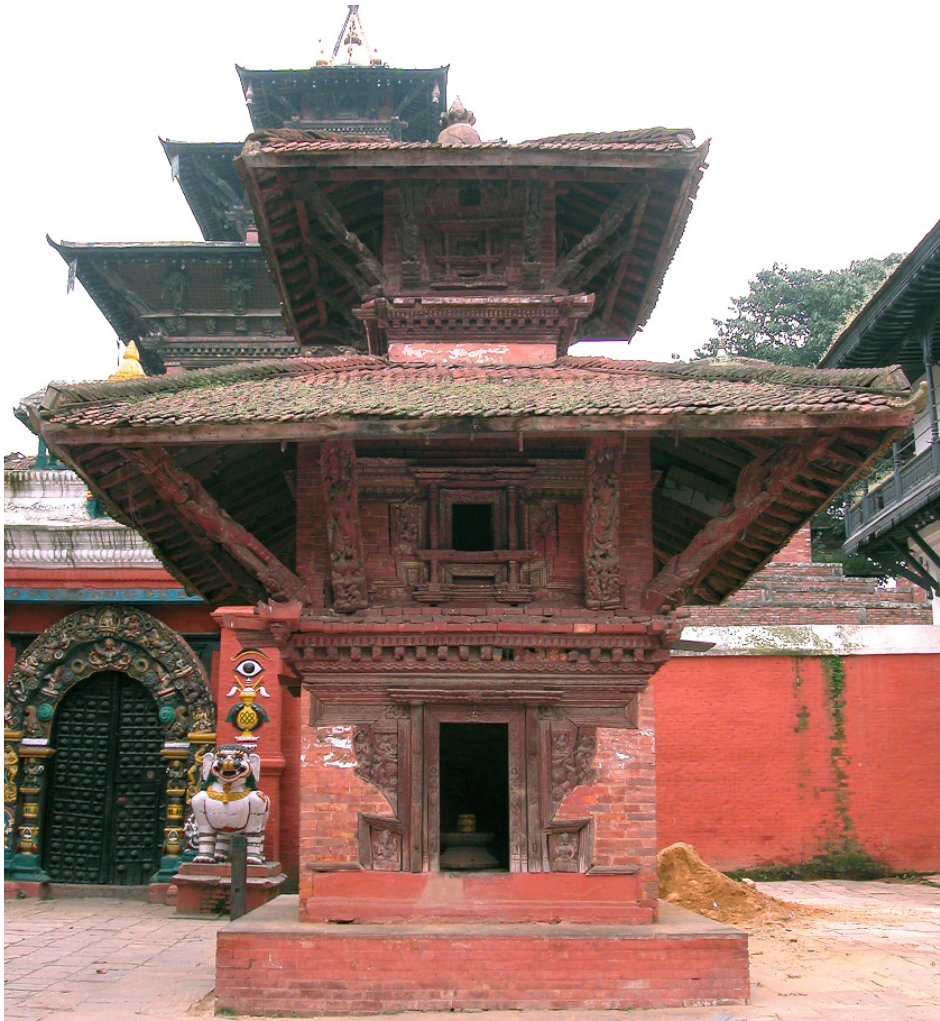
left: The Mahadev Temple II as it stood prior to the restoration. *Photo by: Lumanti Joshi, December 2006*

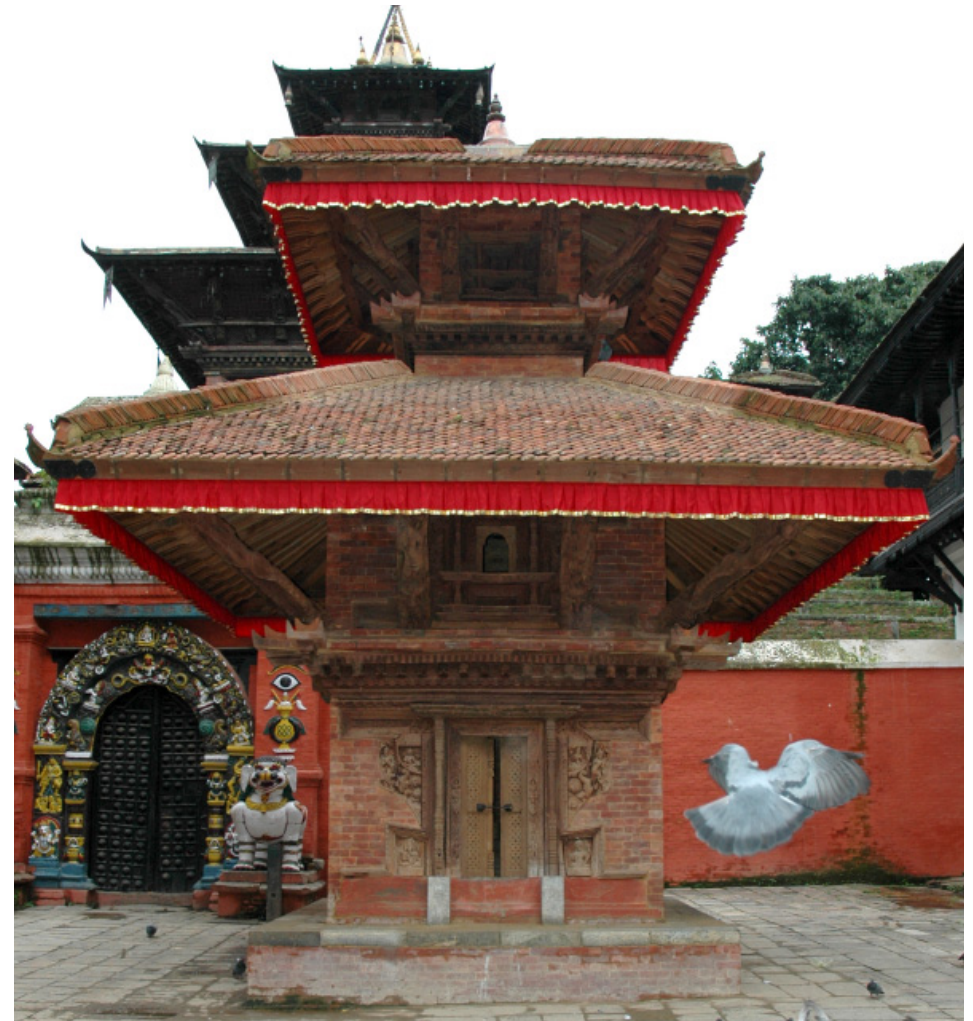
right: Mahadev Temple II after restoration. During restoration the uneven settlement of the east facade was corrected and the roof structures were also reconstructed. *Photo by: Lumanti Joshi, July 2007.*

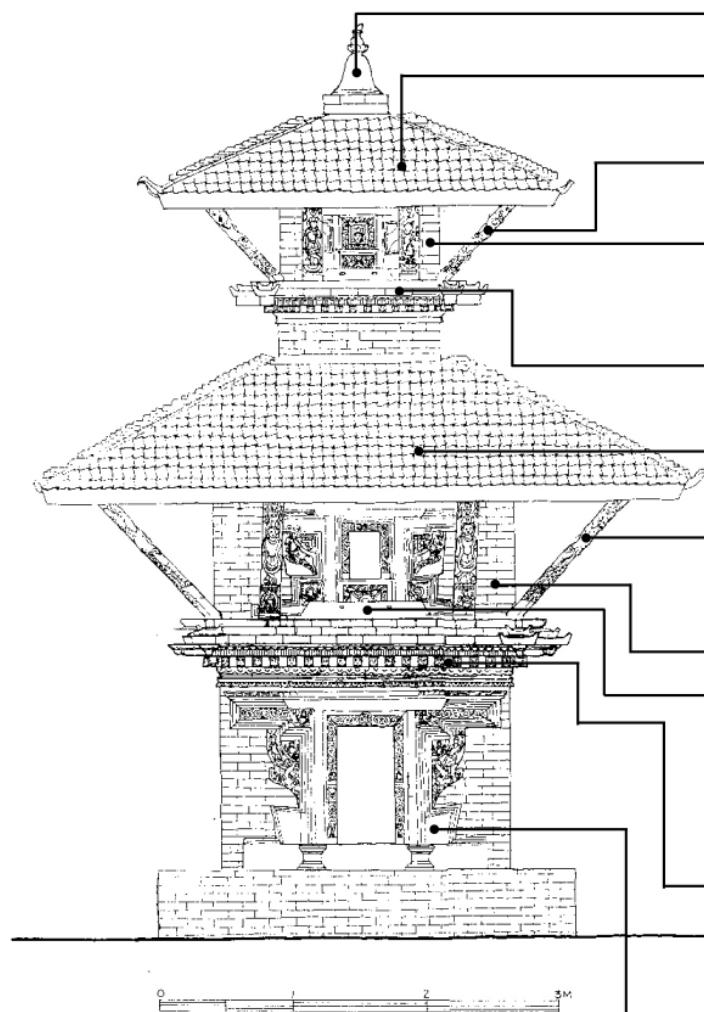
Principal Elevation: Existing Conditions (documentated in July 2005)

- **Pinnacle:** Made with copper and the upper portion of the pinnacle is damaged. Base is constructed with bricks instead of traditional timber base.
- **Roof tiles:** Tiles are not stable and have fallen off at many places, specially at roof ends. All the corner tiles are missing. Mud bed is visible at the edges. There is excessive amount of vegetation growth on the roof. Ridge tiles are loosely stacked and about 50% of them are lost.

- **Wall Structure:** constructed with local chinese bricks in cement mortar. The upper two layers below the wall plates are loose and no mortar remains in between. Area below the cornice is plastered with lime surkhi.
Windows: All four on four sides are probably original to the structure and are redwashed with details highlighted using yellow paint. Details are not clear under the several layers of paint. However the details are not that elaborate. In all windows, *kulan* and *kulan than* are lost.

- **Cornice:** The upper layer of the cornice detail (*khichwa*) is lost and has been replaced with plain timber member. Except for this, all the other layers are painted with red color. Terracotta *lahkha* has been replaced with timber ones. Terracotta cornice details are loose at the joints.

- **Roof tiles:** Tiles are intact on all sides with vegetation growth on all sides. Corner tile at the north west corner is missing. Ridge tiles are loosely stacked and about 70% are lost. Tiles on south east, north west and south east ridges are displaced.

- **Roof struts:** All redwashed except for two plain struts on east sides. Details are highlighted with yellow color and have worn out completely. The struts can be divided into 3 distinct layers, first a layer of foliage, under this a principal figure standing on a lotus pedestal and at the lower portion depicts small figurines on the carving symbolizing mountains. Major cracks have formed at the areas where they are connected to the purlins.

- **Wall structure:** Constructed with *dachi appa* on mud mortar and has been redwashed. Joints are painted with yellow color. Walls on all sides are bulging out, is more prominent on north east corner. Upper 3 layers of bricks below the wall plates are loose. Wall below the cornice was reconstructed in 2001 using *dachi appa* in lime *surkhi* mortar. The joints have been roughly pointed with *surkhi*. Lower 6 layers on the East and South sides are severely damaged.

- **Cornice:** The timber cornice details show signs of termite attack. Details have been redwashed. Large cracks have developed on south side. 15% of the lion heads have been affected by termite attack. On east side, one of the lion heads are replaced with brick. Terracotta details are loose at the joints, some have completely worn out. Terracotta details along with the *lhakha* are all lost. The lowest cornice detail have worn out and settlement has occurred.

- **Door:** Is probably original to the structure. Details have worn out and some of the details such as the *kulan than* are missing. The tympanum is lost. Large cracks have developed on the frames. The door frame has been red-washed. The stone threshold is intact but does not belong to this door.

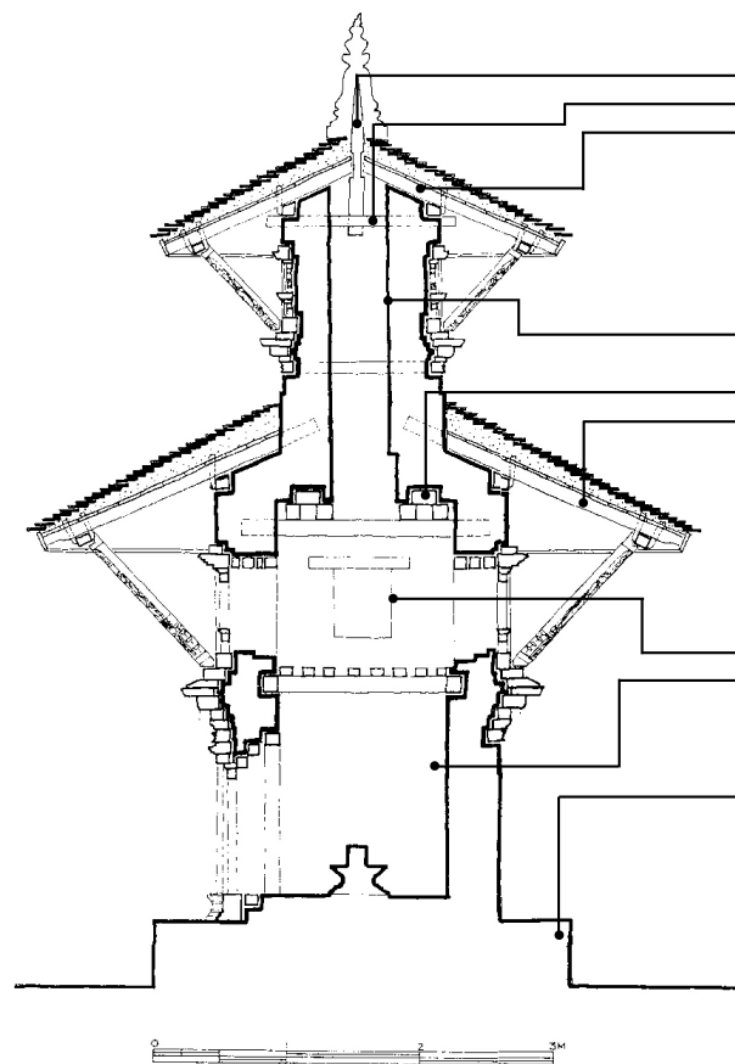
West East Section: Existing Conditions (documentated in July 2005)

- **Pinnacle king post:** It has been damaged due to wet rot.
- **Pinnacle beam:** It has been damaged due to wet rot.
- **Timber roof members:** Roof structure was totally refurbished in 2001. Plankings show major damages caused by wet rot. In the east side, the lower portions of the planking have completely disintegrated exposing the roof tiles from below. Rafters are of 7.5 cm x 10 cm section. They have been affected by wet rot, the damage is more prominent at the south, east and north sides. Eavesboards are not of traditional section and have warped. They have been nailed on the rafters and at some places eavesboards are not in contact with the rafters. Wall plates are intact. Purlins are of small size and have not been properly joined. They are affected by damp.

- **Interior:** The wall fabric at this level is in fair condition and has been constructed with *dachi appa* in mud mortar. There is no opening on all sides for the windows, similar to blind windows.

- **Beams:** The beams are in fair condition but some of them show fine cracks.
- **Timber roof members:** Planking has been hapazardly placed. Almost all of them are damaged by wet rot. Some of them (on the east and north sides) are severely damaged exposing the mud layer from below. Rafters show effects of dampness but are fairly intact. However, some of the rafters are damaged around the eavesbosrd level. The sizes of rafters are not according to the traditional configuration as the roof was reconstructed in 2001. Timber peg are missing. Eavesboards are not of traditional configuration and have deteriorated on all sides. They are nailed on the rafters. Eavesboard are not properly joined at the corners. Purlins are in fair condition but there are no sufficient projection at the joints. Wall plates are worn out with large cracks on them. These are red washed.

- **Windows:** The internal window frames are missing in all windows.
- **Interior:** Is constructed traditional *dachi appa* in mud mortar. The lower portions of the wall in the sanctum are damaged because of the rising damp. Timber joists are intact. These of 10cmx13cm section are in structurally fair condition. Tolia tiles have been used for paving the sactum. These have worn out completely. Stone Shiva Linga, the principal deity is centrally placed in the sanctum.

- **Plinth:** The single level plinth is constructed with *dachi appa* in lime *surkhi* mortar and has been red washed. The bricks on the lower level are damaged from the rising damp. It has been paved with large stone slab, which were added to the structure during repair of the temple in 2001.

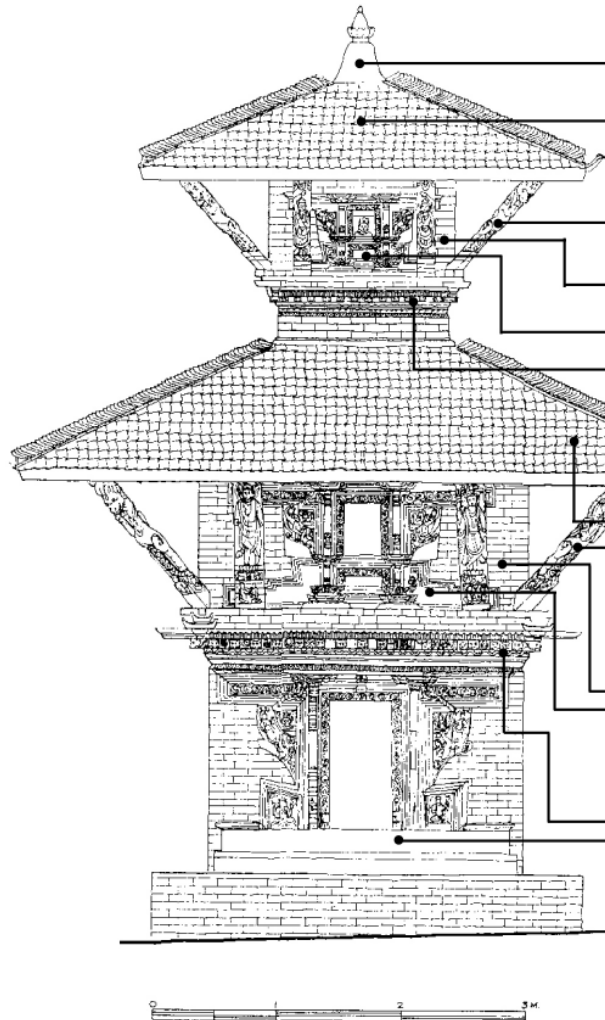
Principal Elevation: Existing Conditions (documentated in July 2005)

Whole structure is off the plumbline and the tilt is more severe in the upper level.

• **Pinnacle:** It is a terracotta pinnacle with a gilded top, probably replaced during 1934 repair. The pinnacle is broken on the west side and does not have a proper base.

• **Roof tiles:** Roof tiles are almost intact however the ones at the edges are loose and mud bed exposed Ridge tiles are loosely stacked and 50% of these are lost. Corner tile missing in NS corner.

• **Doorway:** It is probably original to the structure. It is on the west facade and has lost some of its details like *kulan*, *toran*. Details have worn out. It depicts Ganesh and Kumar on the lower portion. The door shutters are missing.

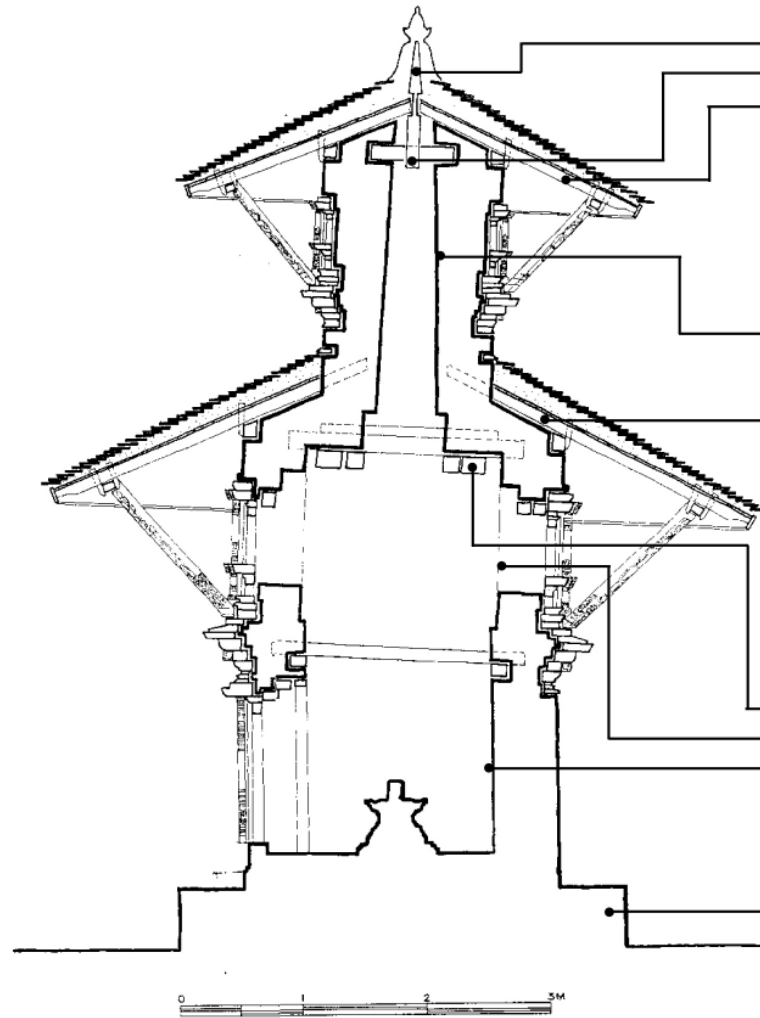
West East Section: Existing Conditions (Documentated in July 2005)

- **Pinnacle king post:** Its condition is not possible to examine before the dismantling the roof structure.
- **Pinnacle beam:** Its condition is not possible to examine before the dismantling the roof structure.

- **Timber roof members:** Water seepage through the places where the tiles have dislodged (like at the edges of roof line, have damaged due to wet rot. All the rafters are redwashed, are intact. But some are affected by damp penetration. Rafters are not in historic configuration and timber pegs (*chukul*) placed in every alternate rafter. About 30 % of them are not reusable. Purlins are in fair condition. They are redwashed and flower details painted with yellow color. It was probably done for coronation of King Birendra in 1975. Eavesboards are not in historical configuration and have been nailed to the rafters. All of them have warped, damaged due to dampness. The joints between two eavesboards are not properly executed. Wall plates where the rafters rest on the wall are of smaller section than traditionally proportioned.

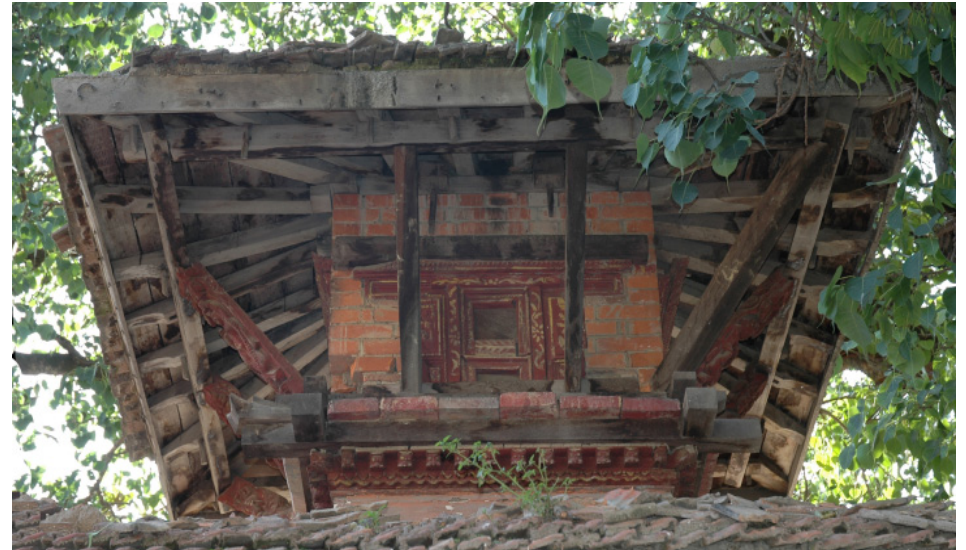
right above: The upper wall was constructed of locally available machine made bricks in cement mortar. Even the rafters were of insufficient length and had deteriorated considerably, thus could not be reused. *Photo by: Lumanti Joshi, December 2006.*

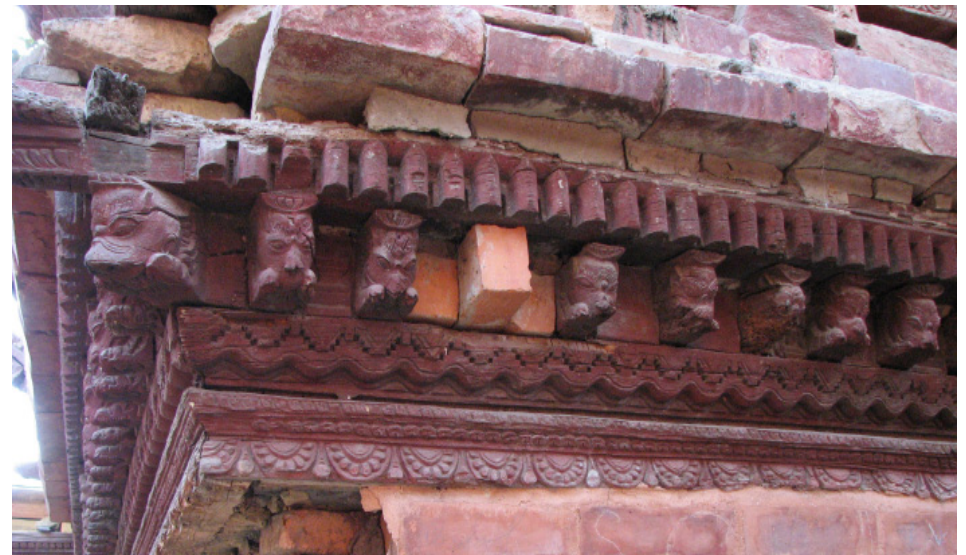
right below: The missing lion heads and the area with the astamangal were replaced with brick bats. *Photo by: Lumanti Joshi, December 2006.*

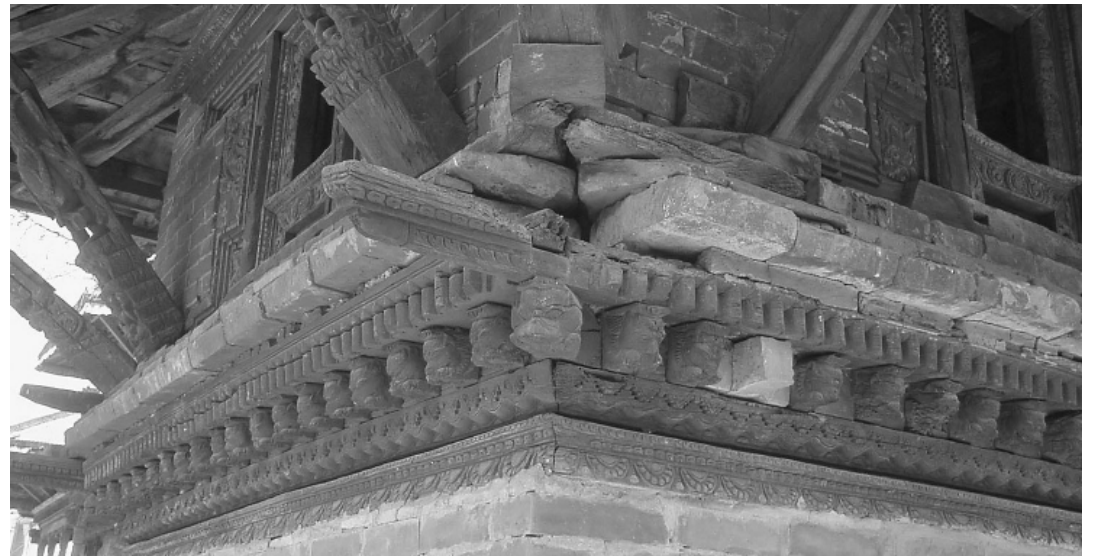
right below: The terracotta corner pieces were lost and the timber details were badly damaged. *Photo by: Lumanti Joshi, December, 2006.*

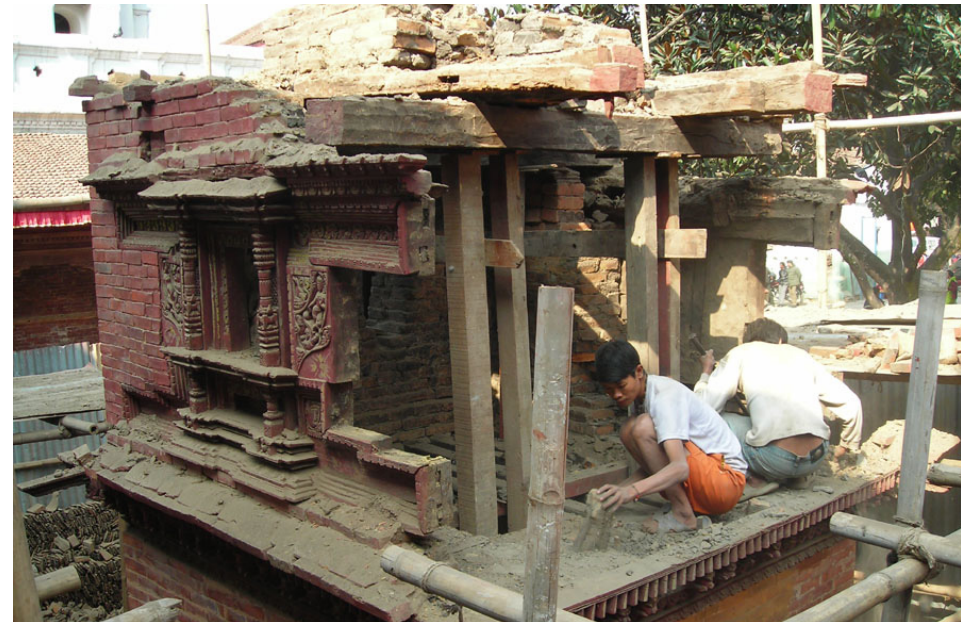
right above: Top correct the tilt in the East facade, it had to be dismantled along with a section of the South and North faces. *Photo by: Lumanti Joshi, February 2007.*

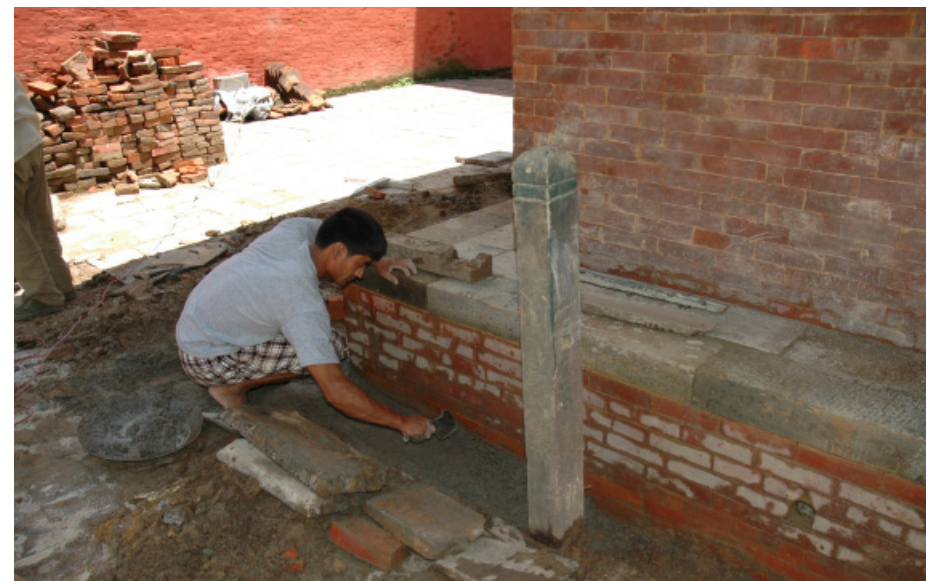
right below: Because of the poor condition of the brick work in plinth, it had to be replaced. *Photo by: Lumanti Joshi, June 2007.*
