NARAYAN TEMPLE

KATHMANDU DARBAR INITIATIVE

FINAL REPORT

ROHIT RANJITKAR * LUMANTI JOSHI
KATHMANDU VALLEY PRESERVATION TRUST
JUNE 2004

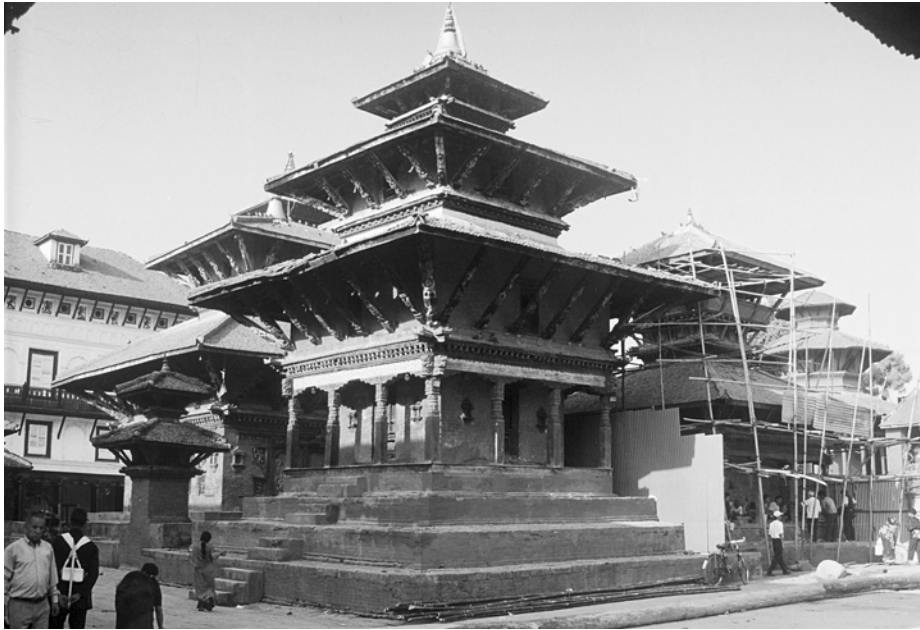
above: Narayan Temple before restoration, as seen from the north east side . The structure is 1936 reconstruction, which was not according to the historic configuration. It was in dilapidated condition since many years and was in urgent need of restoration program. Photo: Raju Roka, September 2002.

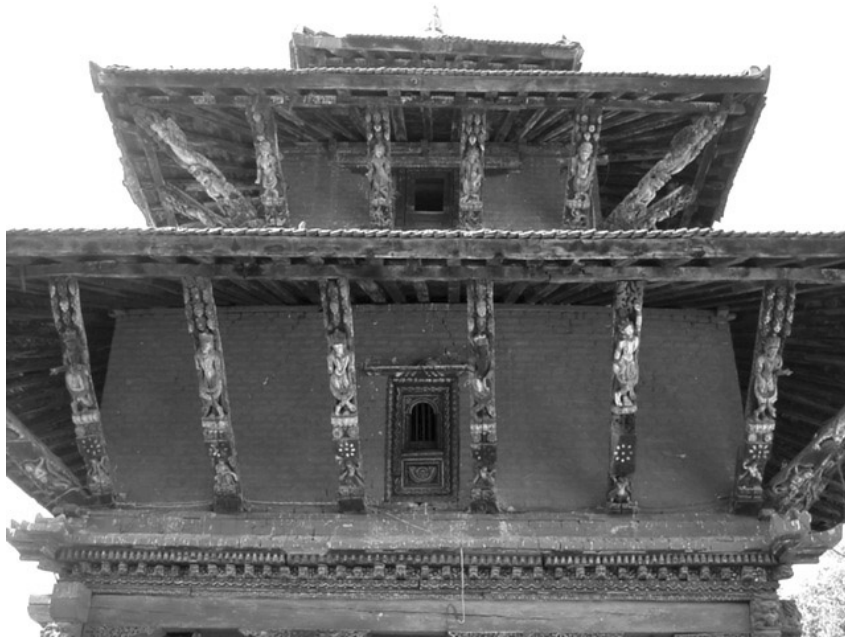
above left: The dilapidated condition of the roof structure on the east facade prior to the restoration. Photo: Rohit Ranjitkar, April 2003.

The lower roof structure was totally dismantled since it was in dilapidated condition with none of the timber members being reusable. The roof was totally reconstructed using new timber members. In order to protect the structure from water penetration, a layer of water proofing membrane (multiplus) was used prior to placing the mud bed on the planking. This measure will increase the life of the roof. In order to stabilize the roof structure, every third rafter was bolted to the wall plate and purlin.

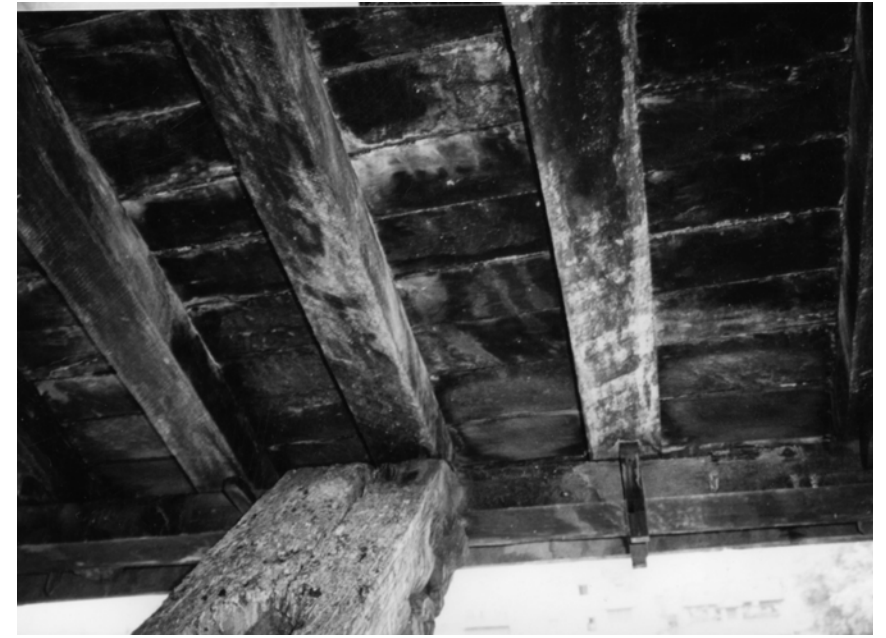
above: All the timber members on the roof structure including the planking, rafters, purlins, eaves boards and struts were in dilapidated condition. This was due to moisture penetration from roof tiles for several years. At few places, one could see through the roof. Photo: Rohit Ranjitkar, April 2003.

The old roof structures were dismantled and new structural roof members were introduced because of the decayed condition of the existing members and to replace the lime surkhi cornice details with timber ones. Waterproofing membrane was introduced under the mud bed to extend the life of the roof. Our experience shows that careful supervision of the various work components such as mud treatment, batten installation, etc is the most critical determinant of the roof life. Above the membrane, battens were laid in diagonal sloping pattern to allow water to run off. Traditional roof tiles were then laid on thick bed of mud.

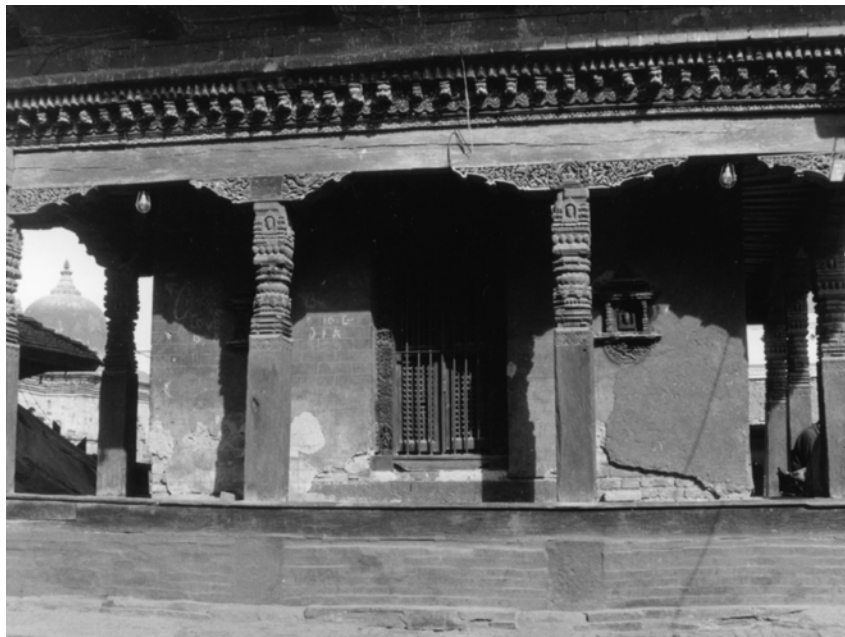
left: The lime surkhi plaster, from the 1936 reconstruction on the ground floor arcade was coming off showing the brick finish underneath it. Photo: Rohit Ranjitkar, April 2003.

In the ground floor arcade, the inappropriate and large size bricks from 1934 reconstruction and cement patches was replaced with traditional *dachi appa* using yellow mud mortar. A layer of bricks from the outer face was carefully removed and the new bricks were laid interlocking in mud from outer face to inner wall face using saw tooth joints, used at every 1m distance. This has been further strengthen by introducing copper rod after every 3 bricks. The timber columns, beams, cornices were cleaned with water.

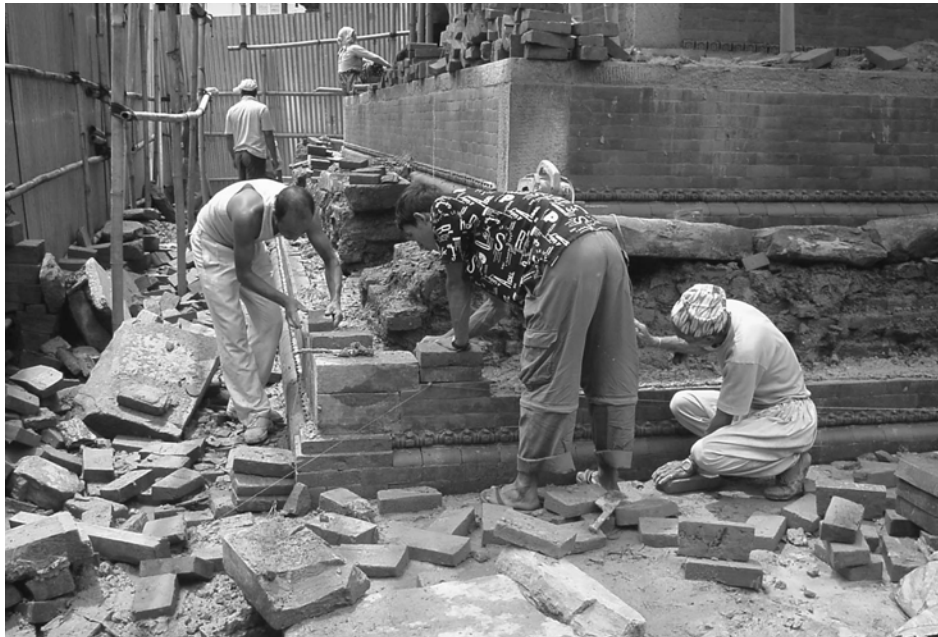
below: Rebuilding of plinth structure to historic configuration with traditional bricks (*dachi appa* and *ma appa*) in mud mortar. Photo: Raju Roka, September 2003

The unhistoric bricks from 1934 reconstruction was replaced with traditional *dachi appa* using mud mortar. The gaps between the plinth were filled with *ma appa* so that whole structure acts as a solid mass in an event of earthquake. The mud mortar construction greatly increases the performance of the structure in an earthquake as it is able to absorb the shock waves of an earthquake without fracturing adjacent bricks.

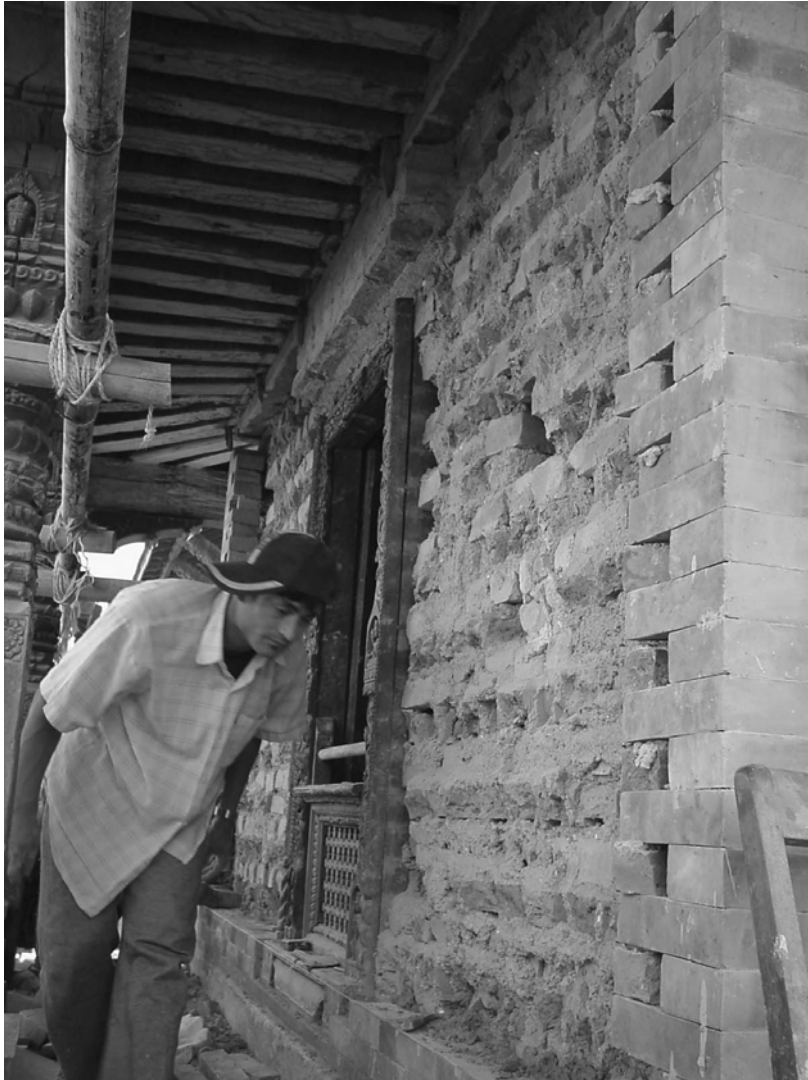
left: A layer of unhistoric bricks from 1934 reconstruction was replaced with traditional *dachi appa* in yellow mud mortar. Photo: Badri Juwal, February 2004.

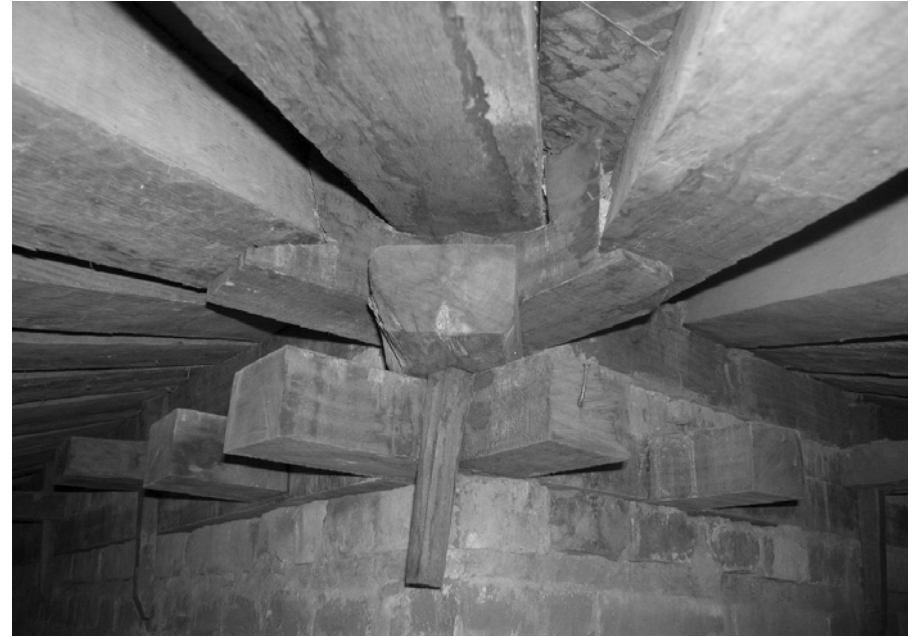
above: The detail of the joinery at the wall plates. Concealed steel plates have been used to strengthen this detail. Photo: Badri Juwal, May 2004.

The walls at both levels were rebuilt using *dachi appa* set in yellow mud mortar. The new timber structural members such as wall plates were incorporated with concealed steel plates, thus, strengthening the structure.

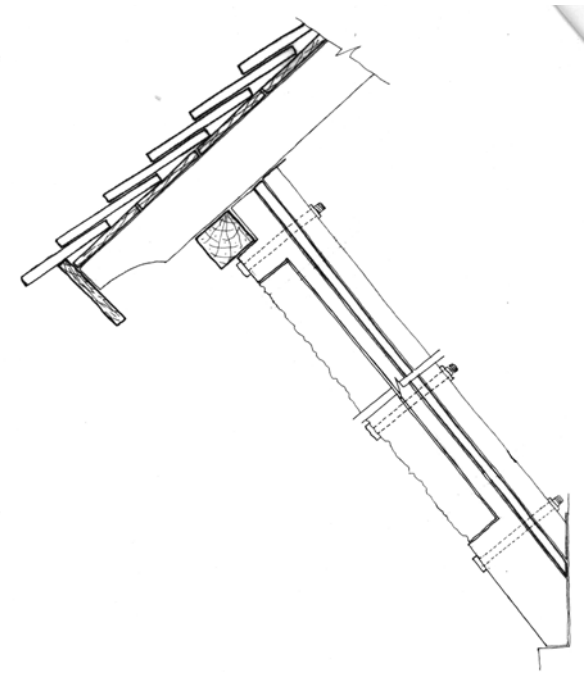
above: The old carved strut is bolted into a new timber member before installation.

The struts, which were used at the upper most roof, were identified as the ones salvaged from a different temple and reused in the temple during the 1934 reconstruction work. We had no documentary evidence of the original detail in order to recarve the new set of struts.

Thus, project architect Ranjitkar developed the technique to install the existing struts into the timber member with sufficient length and section to be used as struts which support the roof structure. A steel member was bolted at the back of all the struts in order to reinforce them.

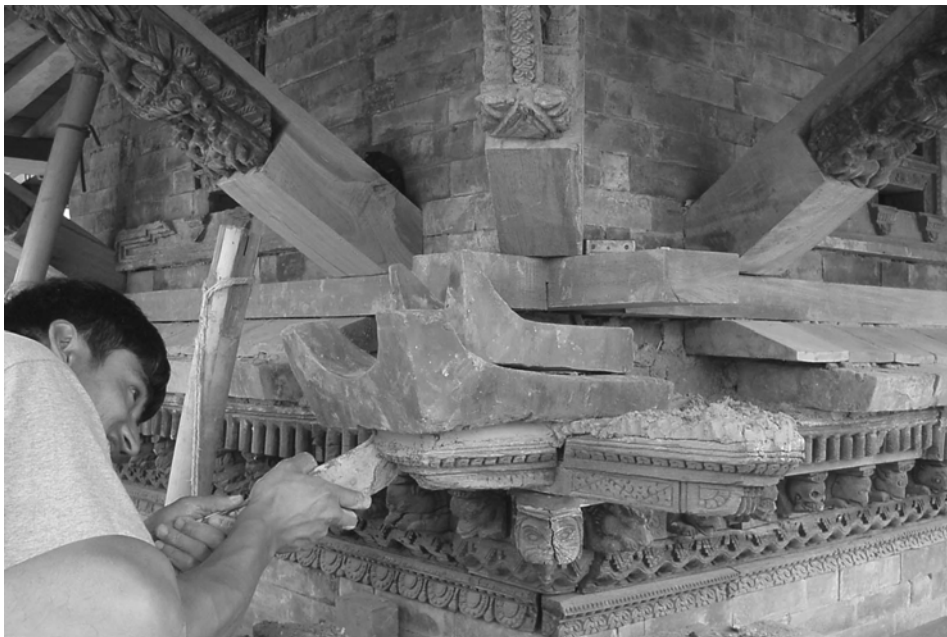
- a) The corners decorative timber cornices (*lah-kah* in Newari) just below the corner struts bear heavy terracotta corner pieces . Because the timber corner pieces are half notched, their section is insufficient to bear the load of these terracotta pieces. This often leads to broken corners creating a weak joint which may fail under the load of the strut. So, to prevent this, a metal cross piece is screwed on top of the *lah kah*. The terracotta pieces rest above thereby concealing its presence.

below: The corner terracotta pieces being installed above the cross metal section. This detail is used at all the corners to prevent the timber *lah kah* from breaking under the heavy load of terracotta *lah kah*. Photo: Raju Roka, August 2003.

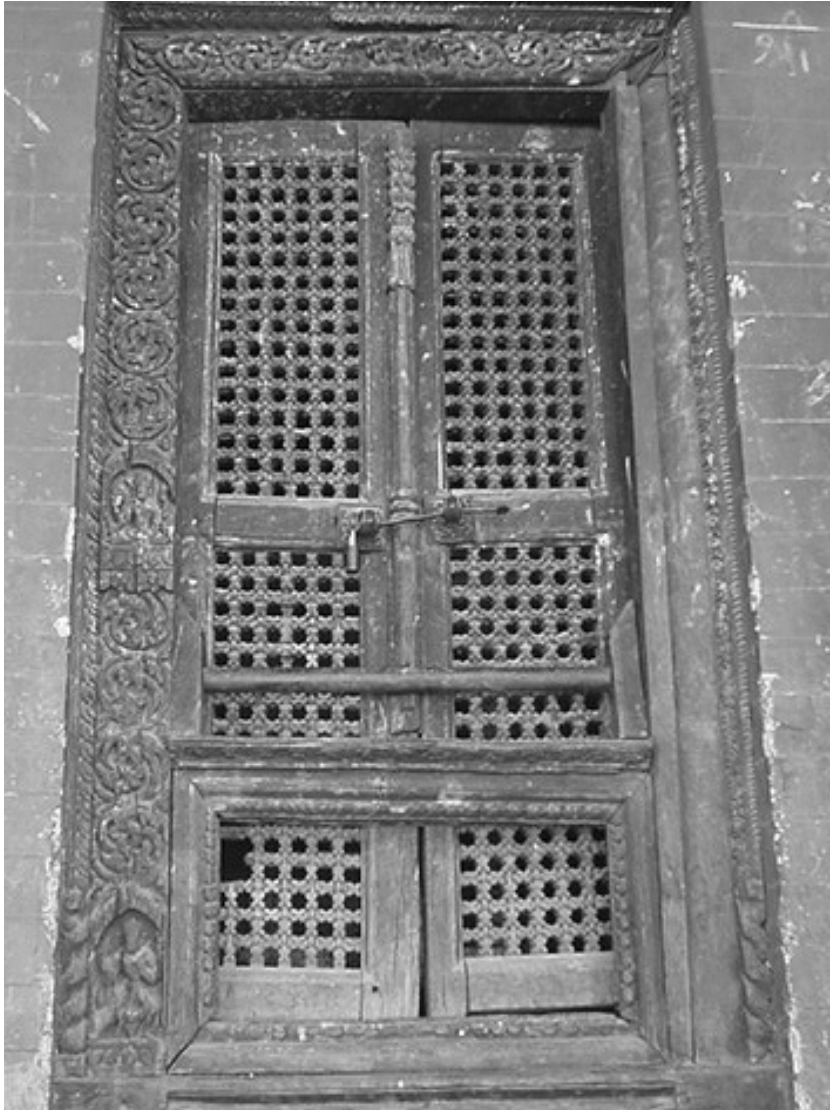
left: Detail of the principal entrance at the east, with missing elements in the door frame. Photo: Rohit Ranjitkar, April 2003.

right: The detail was recarved with reference to the existing one by the German intern Irene Paetzung. The exercise was a part of her training program at KVPT. Photo: Raju Roka, June 2004.

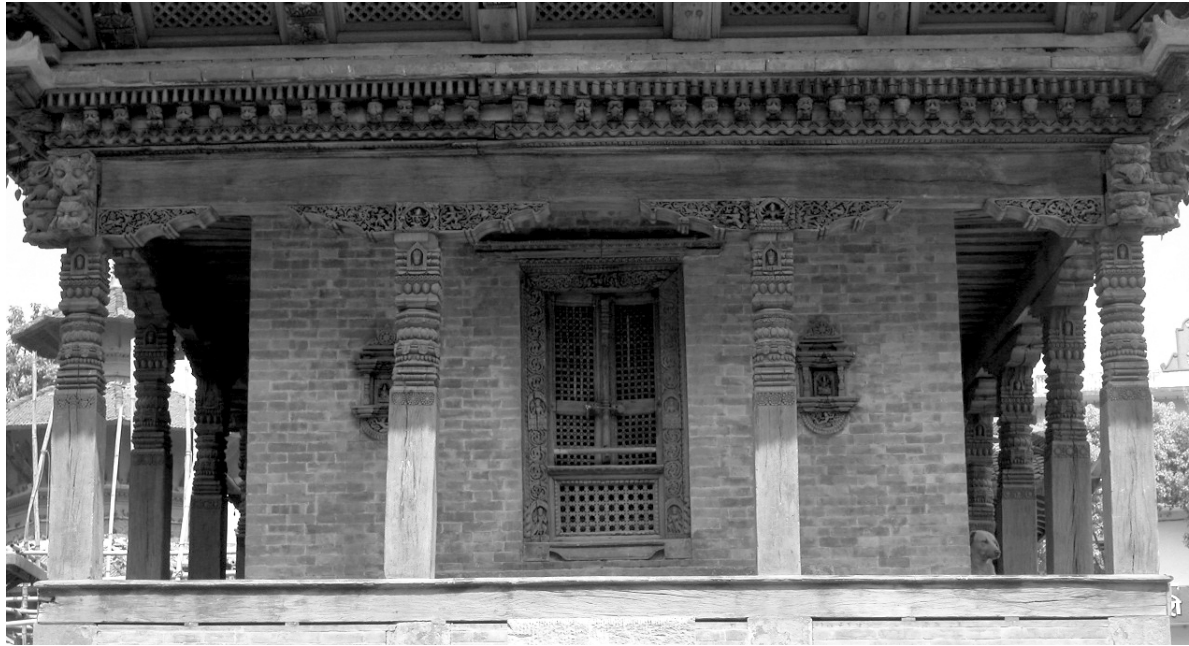
above: Ground floor arcade after restoration. The black and red paint layer from the cornice, beams, columns, doorways and niches was removed. Photo: Raju Roka, June 2004.

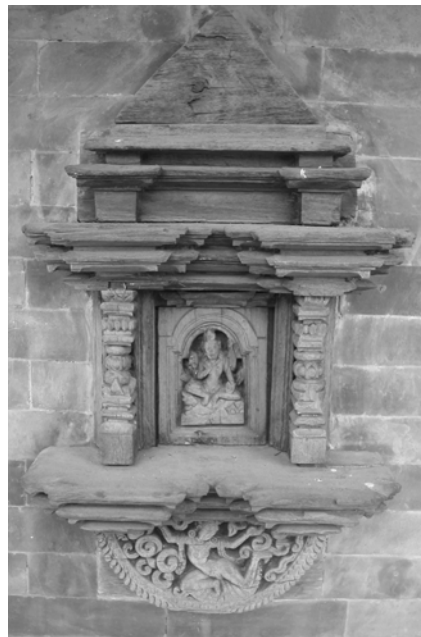
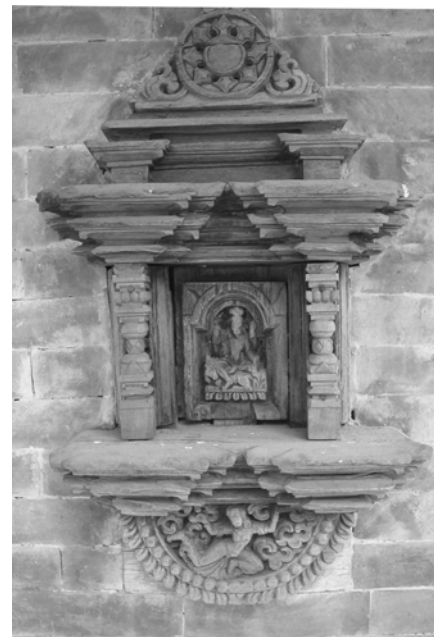
left and right: Blind niches at the east facade after cleaning of the black colour. A missing column (left) from the right hand side niche was recarved. Photo: Raju Roka, June 2004.
