EMERGENCY EARTHQUAKE REPAIRS TO THE TALEJU TEMPLE

FINAL DOCUMENTATION | OCTOBER 2012

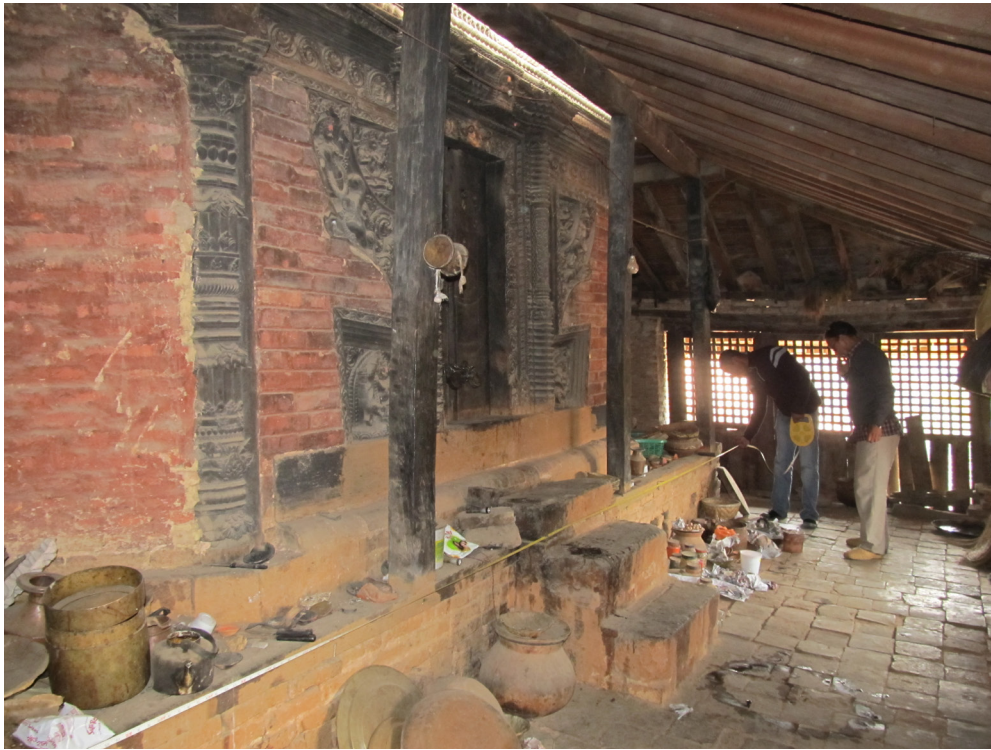
South side of the sanctum before restoration | April 2012
Note the sagging of the rafters and the make-shift columns and beam supporting the roof, part of an inadequate recent intervention.

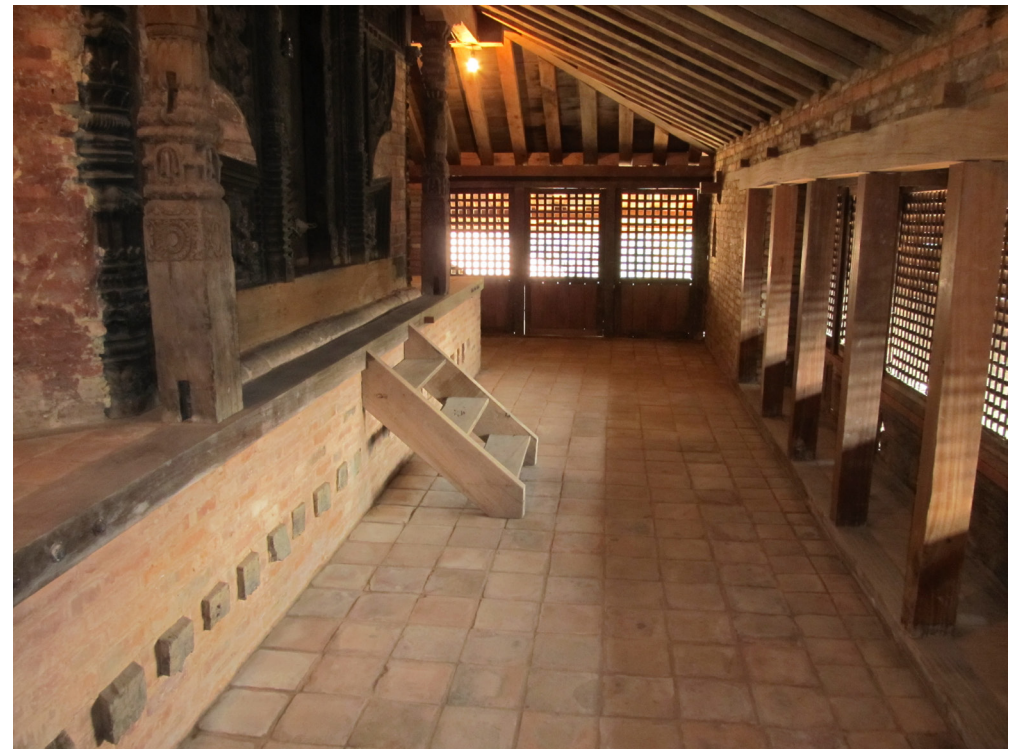
South side of the sanctum after restoration | October 2012
The uncarved columns (seen in the photo at left) were replaced with historic carved columns provided by the Nepal Government's Department of Archaeology. Although not original to this building, these columns date from the same period and are carved with similar motifs used on other timber elements. Also note the newly built roof with all of the bearing timbers replaced.

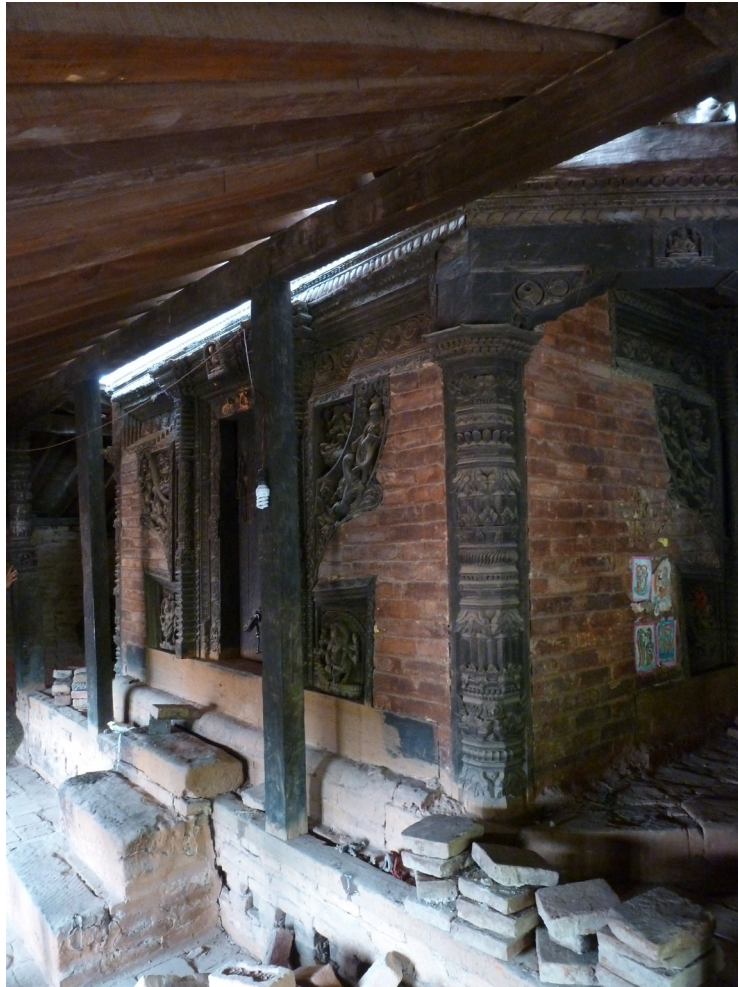
South side of the sanctum before restoration | April 2012
 Note the strip of light along the top of the sanctum's cornice. This light is entering the third level via the large gap between the roof structure and the sanctum's walls. The chief focus of this seismic upgrade was to improve the structural connection between the inner sanctum's masonry structure and the surrounding roof. Also note the poor condition of the plinth.

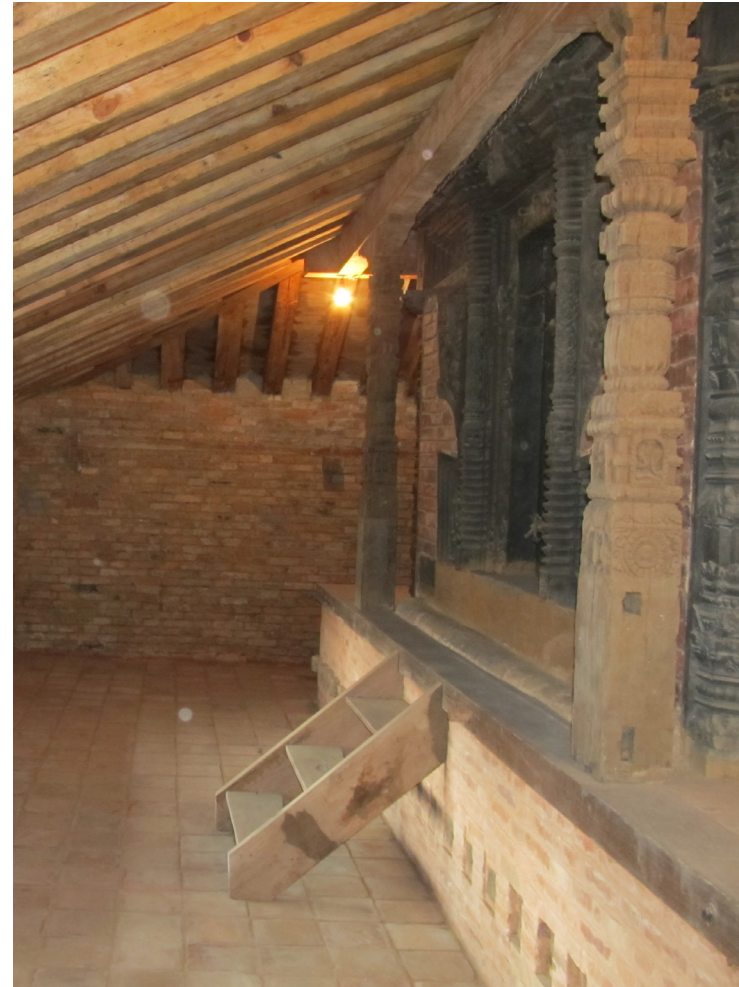
South side of the sanctum after restoration | October 2012
 Note the improved condition of the masonry plinth, which was completely re-built. A new timber frame on the outer edge acts as a brace against seismic movement. The beam supporting the rafters was moved as close to the sanctum's structure as possible, and was connected to the sanctum with steel bolts and straps.

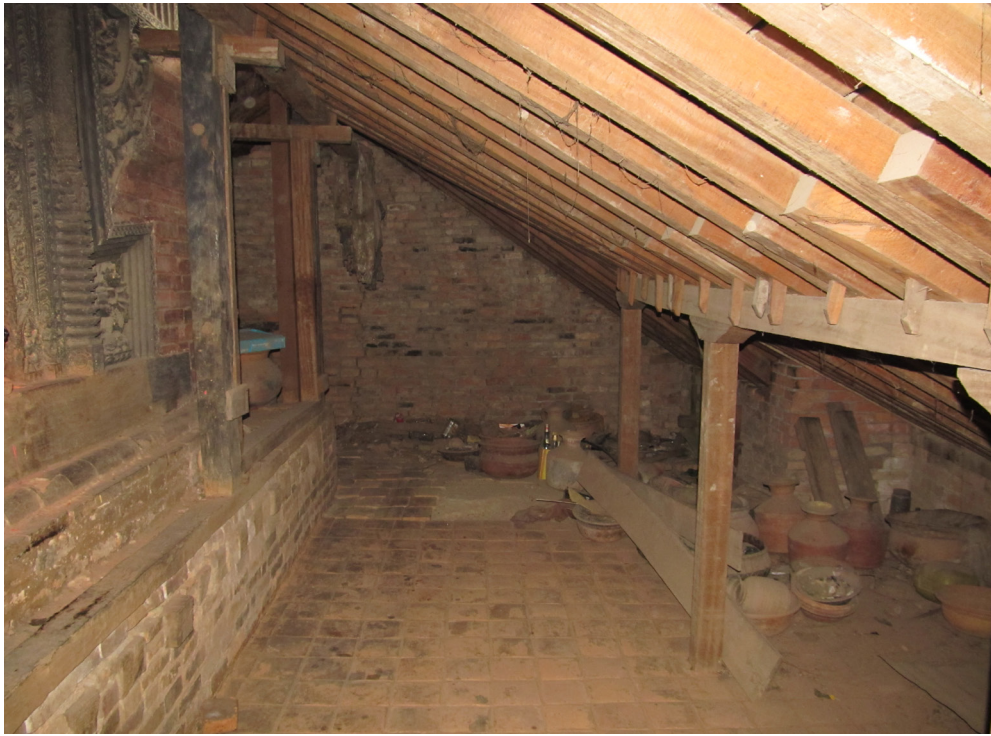
Roof before rebuilding | April 2012

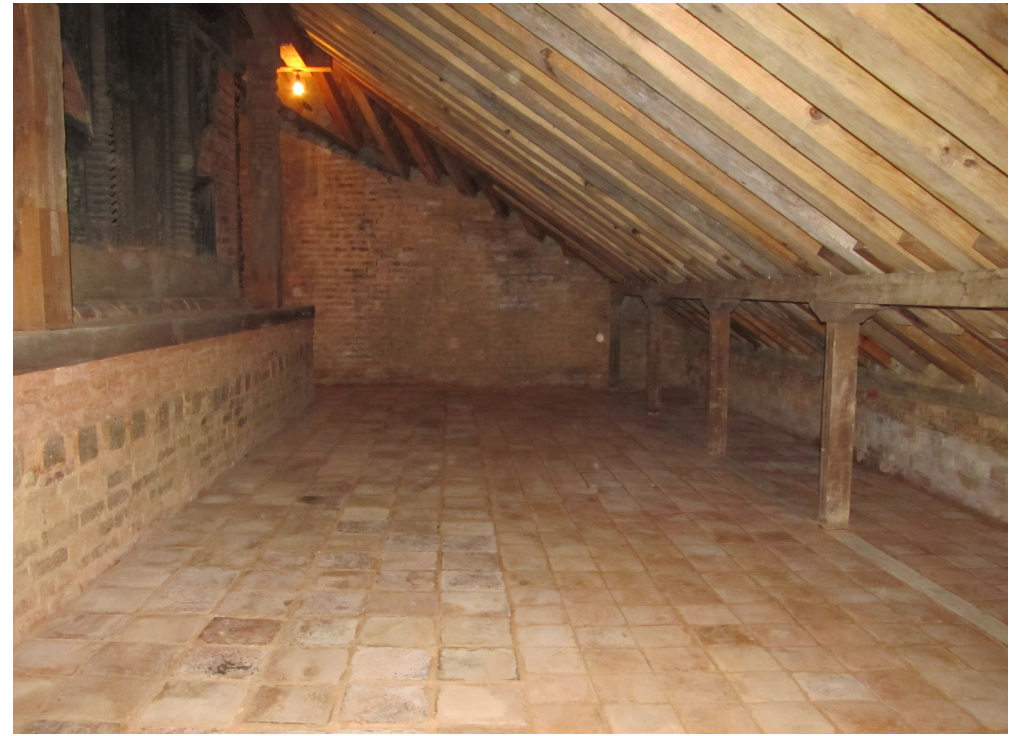
Roof after restoration | October 2012

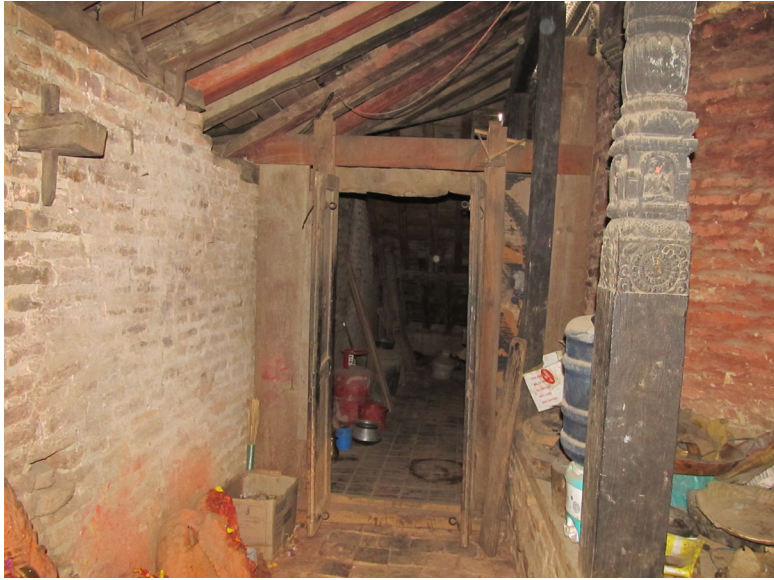
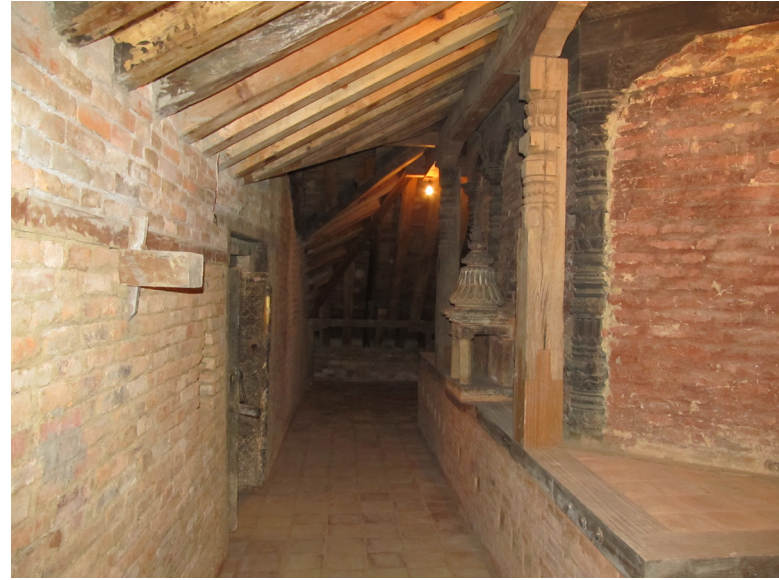
far left (before): The west side of the third level before restoration. Note the presence of a poorly made partition wall which was not original to the building and served no structural purpose.

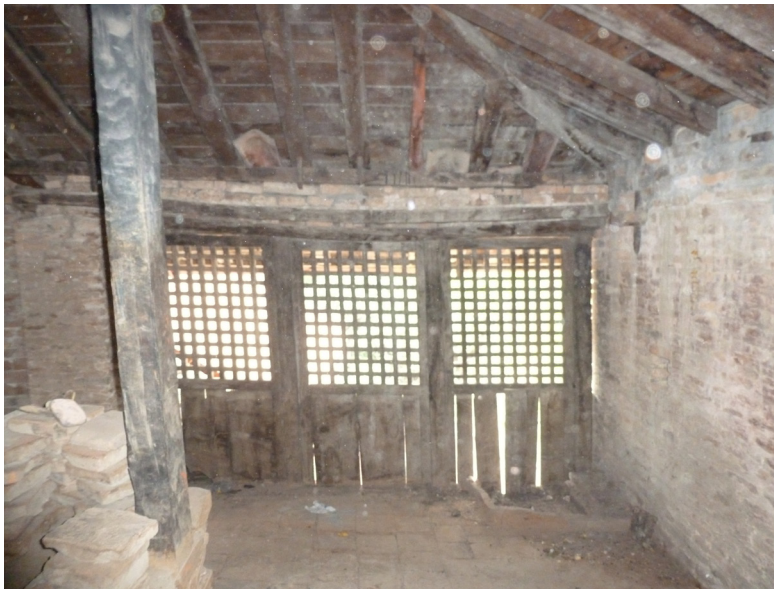
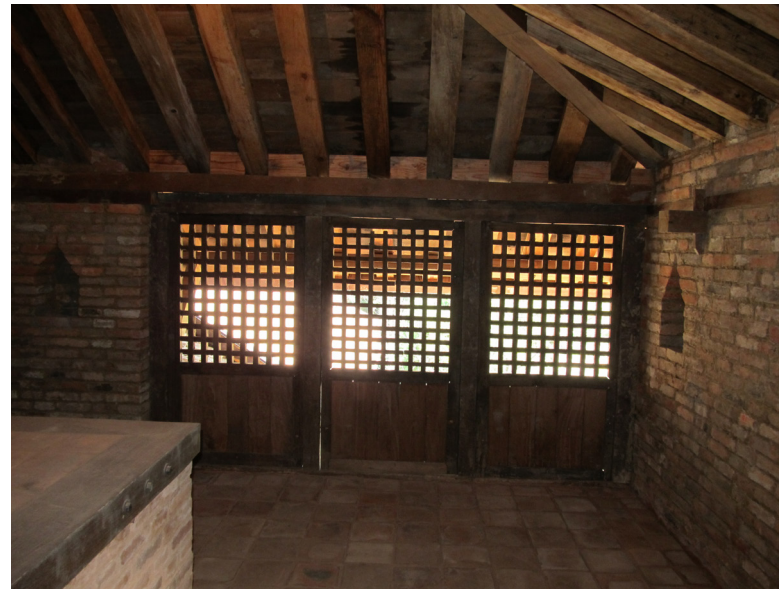
far left (before): The east-facing wall and the three-bay window prior to restoration. Note the extreme bowing of the beam above the window frame, as it could not support the load of the roof.

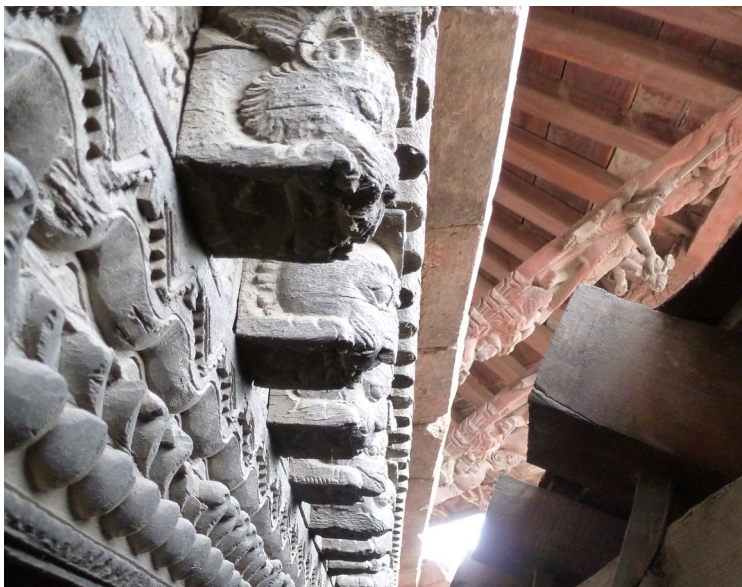
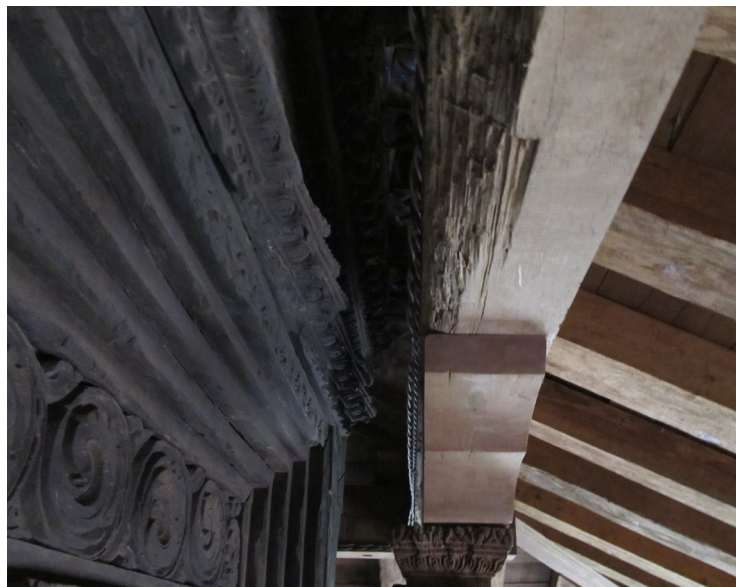
far left (before): A detail of the gap that originally existed between the carved cornice and the roof structure.

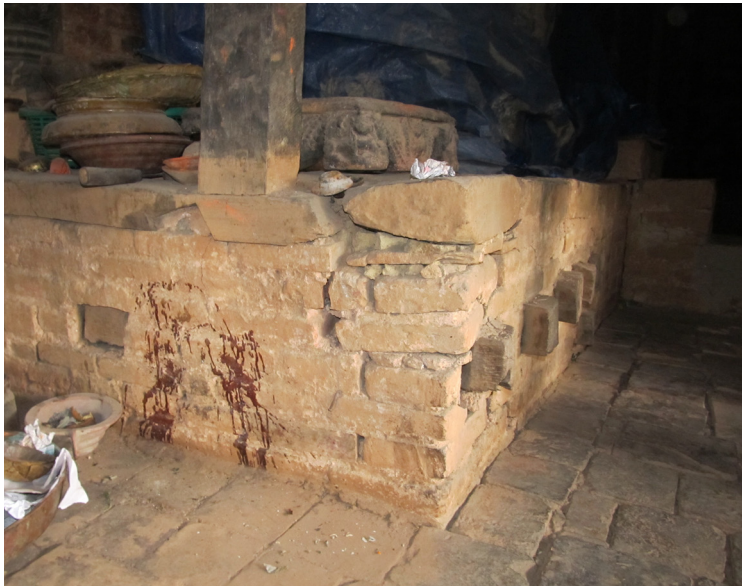
far left: The south east corner of the plinth prior to restoration. Note the broken brick and the timber column's precarious placement.

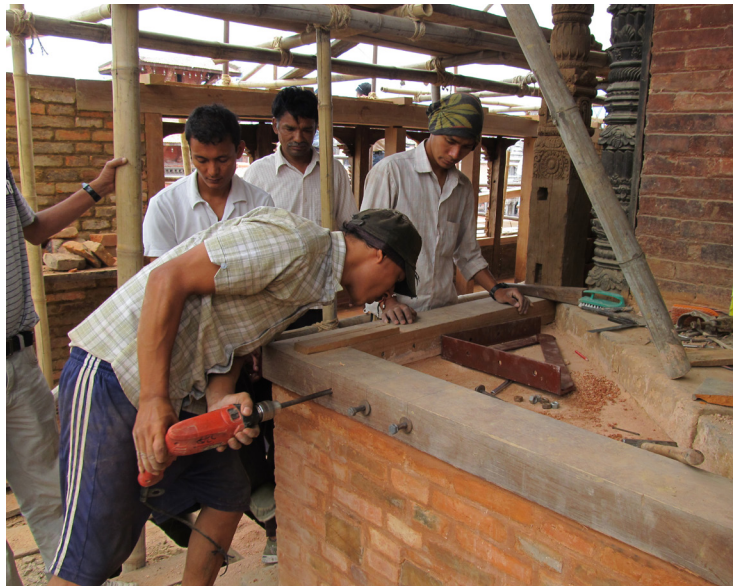
left: The plinth after it has been re-built with new brick and mortar. Here, a carpenter is installing steel corner braces tied with bolts to the timber frame of the plinth. This strong ring beam provides additional strength to the structure and also acts as a solid base for the roof support columns.

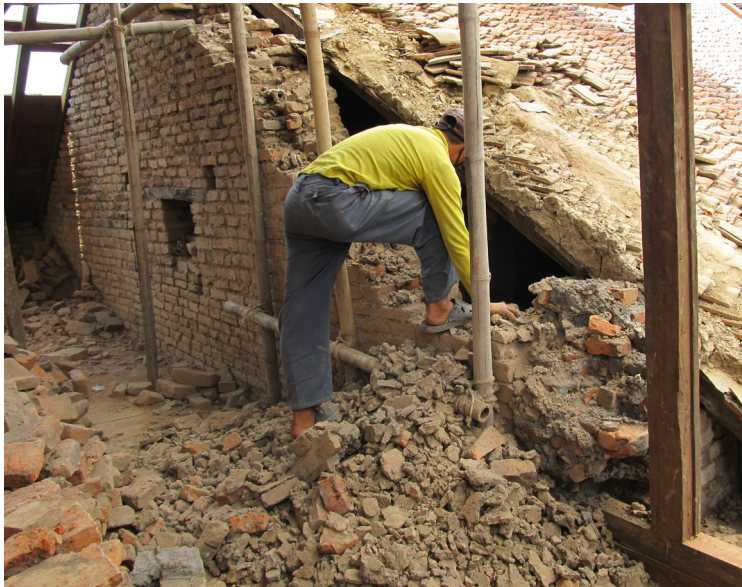
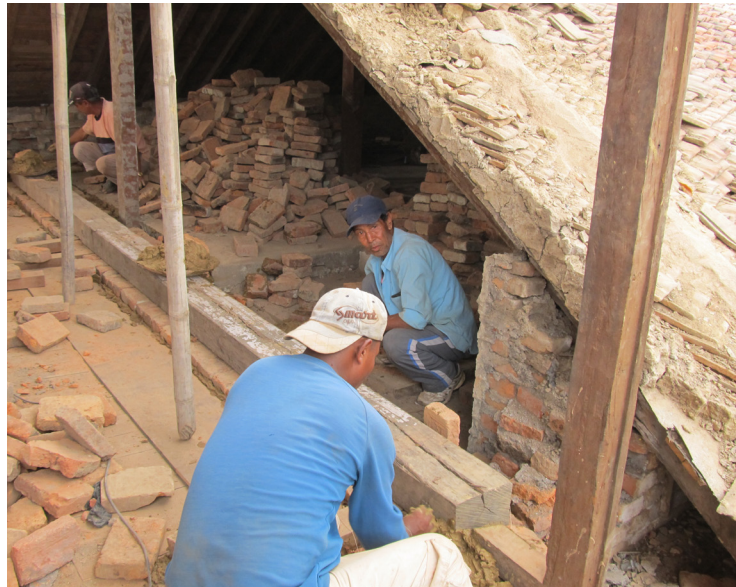
far left: The east-facing wall was beyond in-situ repair after it was badly damaged by the 2011 earthquake. Here the wall is being dismantled.

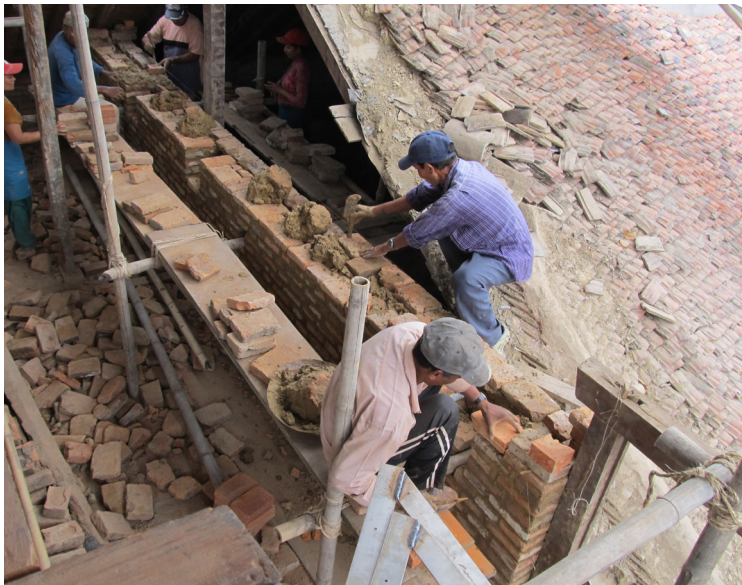
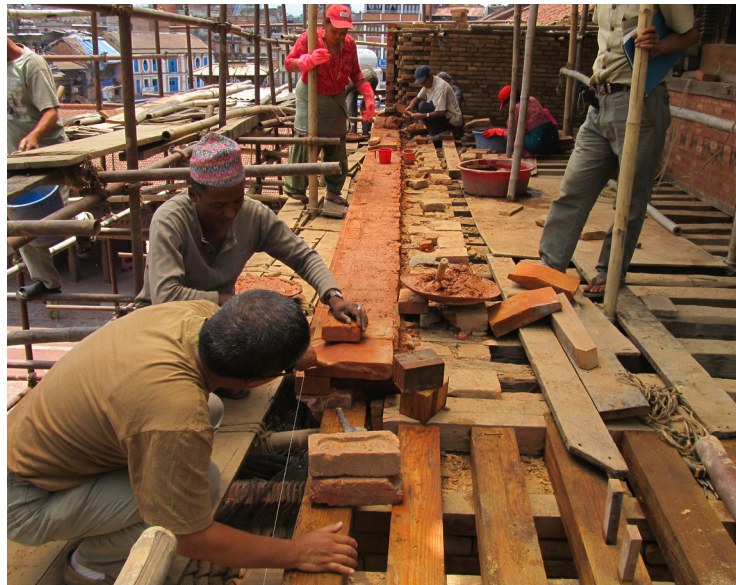
left: Continued re-building of the east-facing wall. Note the proper integration of the timber window frame into the masonry.

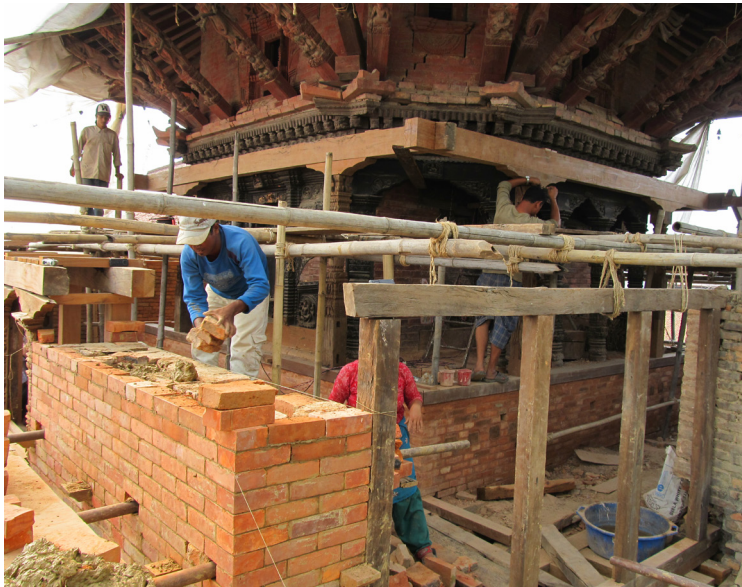
left: The south-facing wall being rebuilt with new brick in an interlocking arrangement to ensure both the south and east walls are sufficiently tied together.

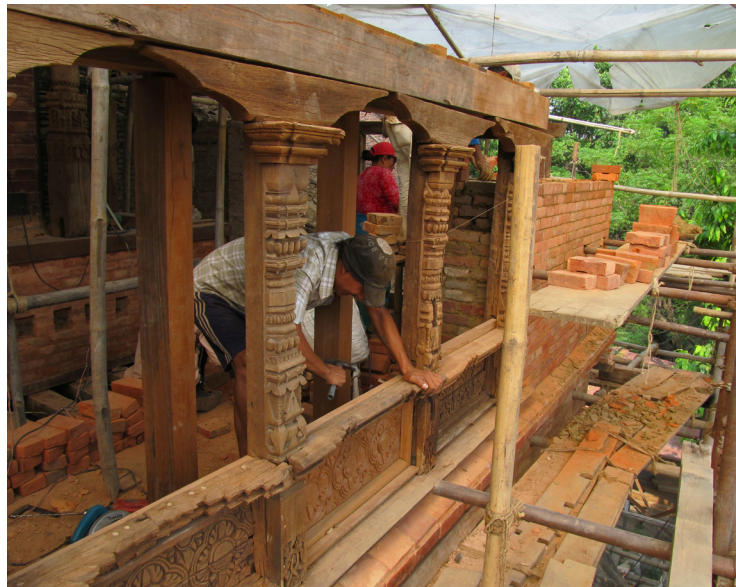
far left: Installation of the repaired and strengthened five-bay window in the south-facing wall.

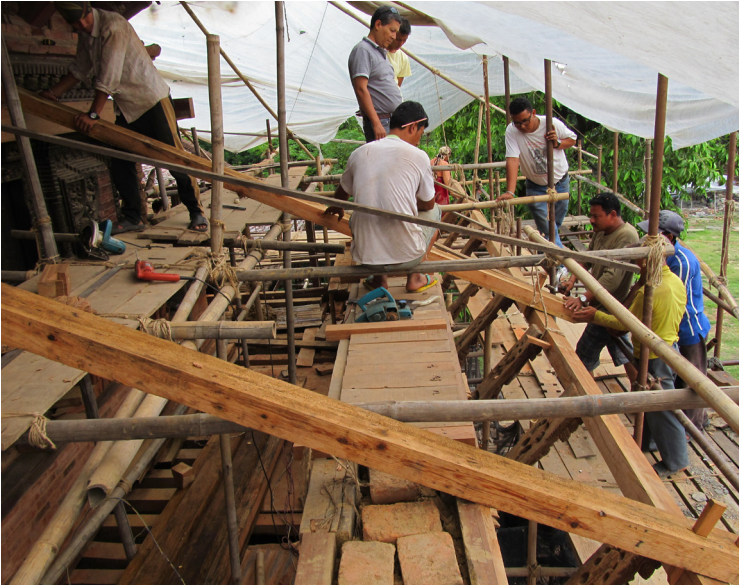
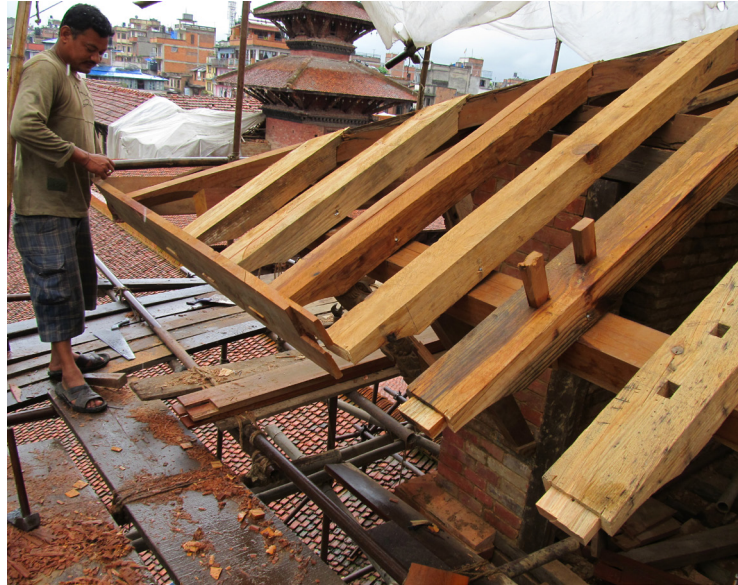
far left: Setting of the first rafters. Note how the rafters are connected to the newly installed inner roof beam, running along the sanctum's cornice.

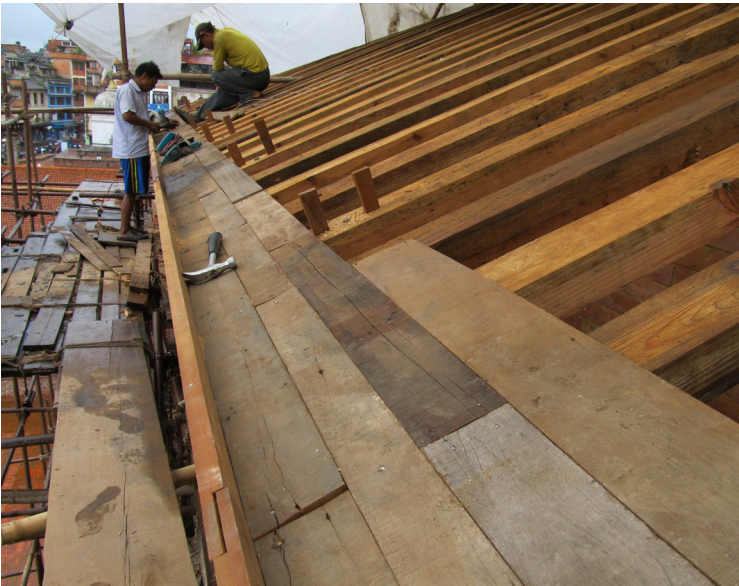
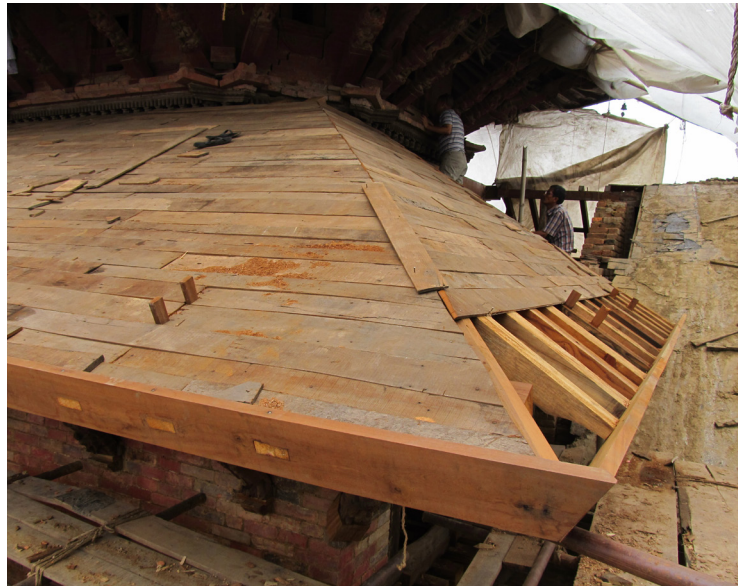
far left: Hardwood planking is being nailed over the rafters. Note the use of stainless steel nails.

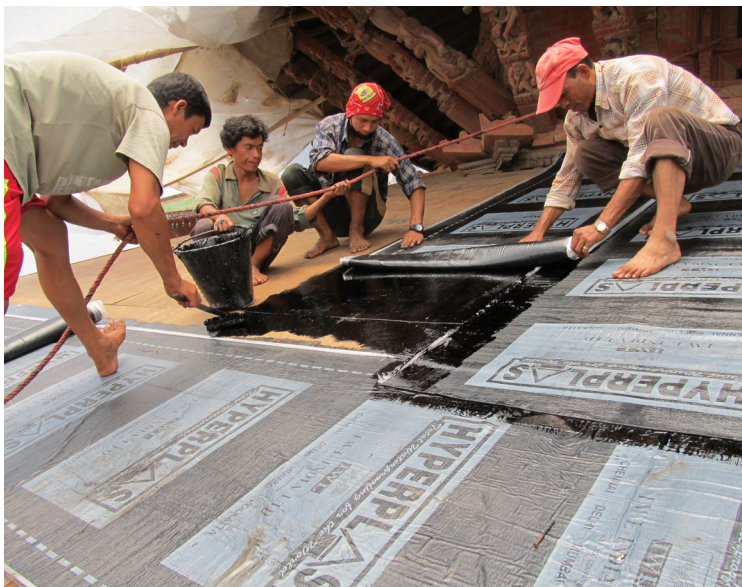
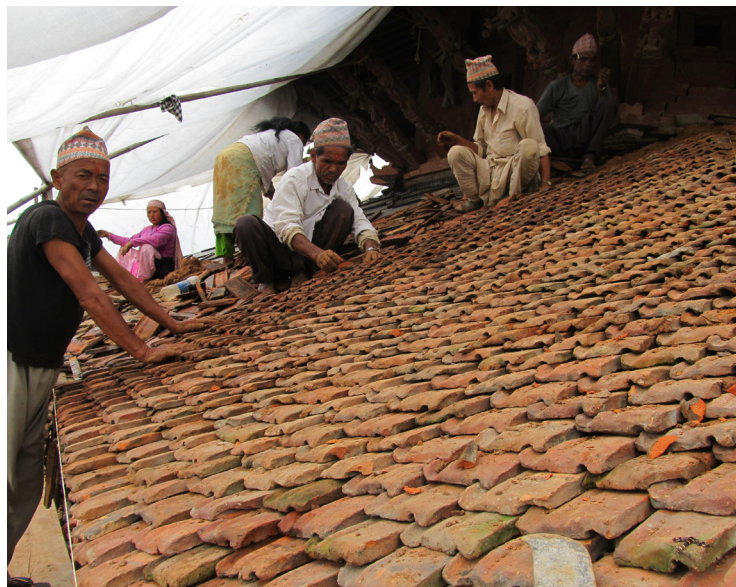
far left: The waterproof membrane is installed over the plyboard. This will protect the timber against any future water infiltration, and acts as a waterproof layer.

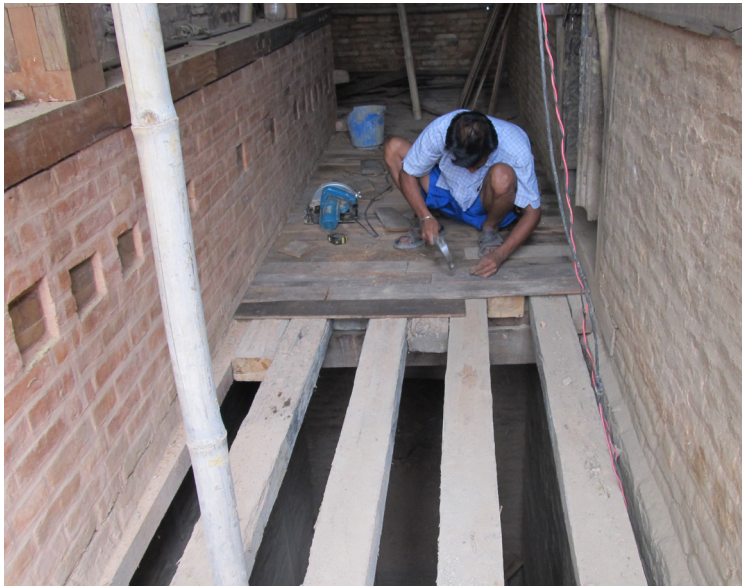
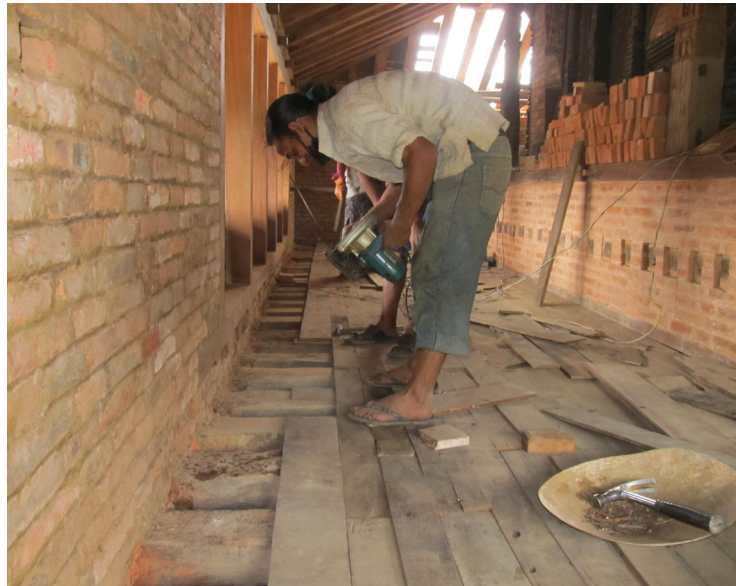
far left: A carpenter nails planking over the newly installed and repaired floor joists.

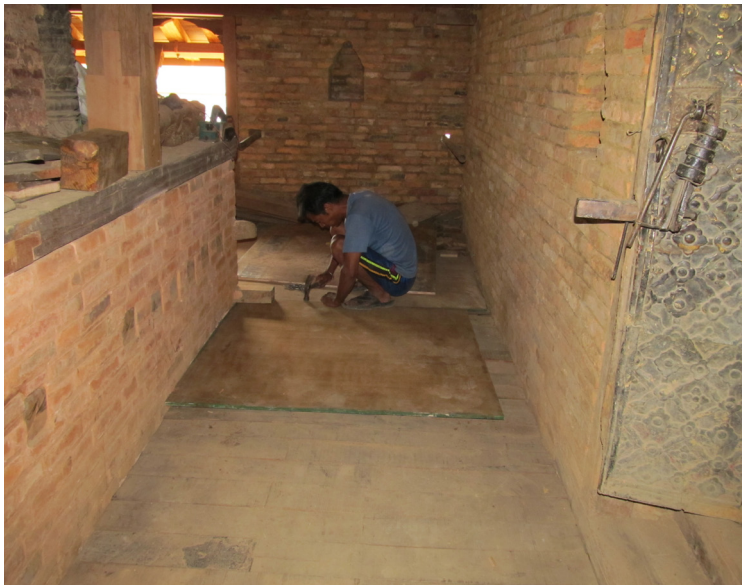
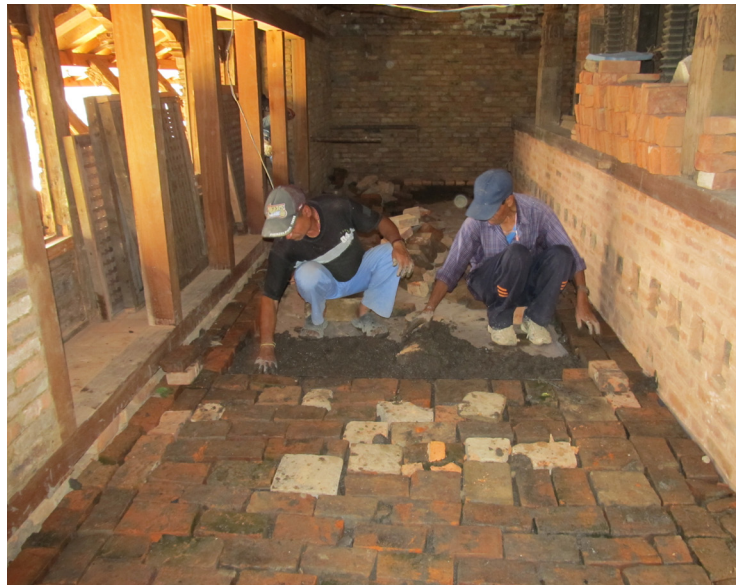
far left: The plywood is installed in a staggered arrangement to create a rigid diaphragm, and is joined to the planking below with the use of stainless steel nails.

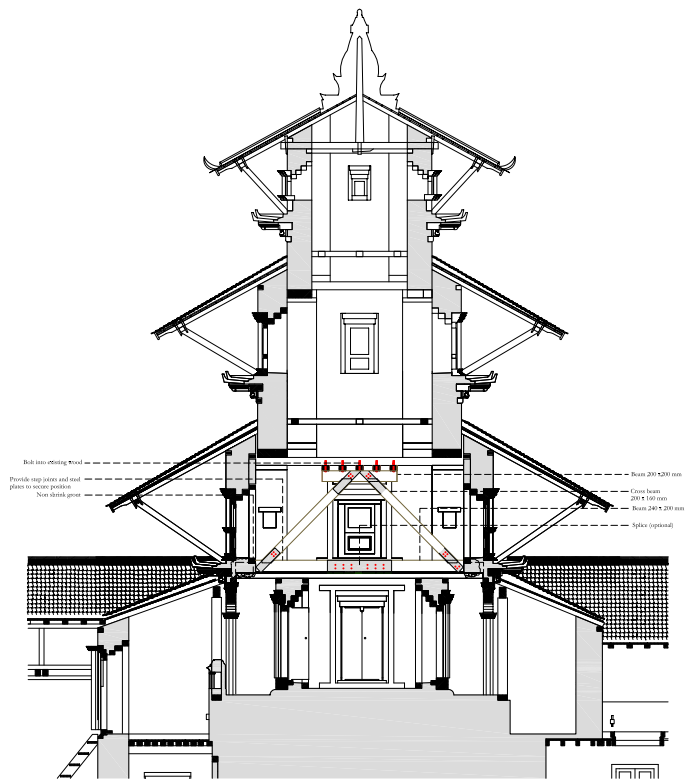
KATHMANDU VALLEY PRESERVATION TRUST
