THE RESTORATION & SEISMIC STRENGTHENING OF
KARUNAMAYA TEMPLE | BUNGAMATI

PROJECT DOCUMENTATION/ANALYSIS
REVISED: JULY 2015

PROJECT DOCUMENTATION PREPARED
BY DAVID ANDOLFATTO AND THOMAS SCHROM
FOR UNESCO KATHMANDU

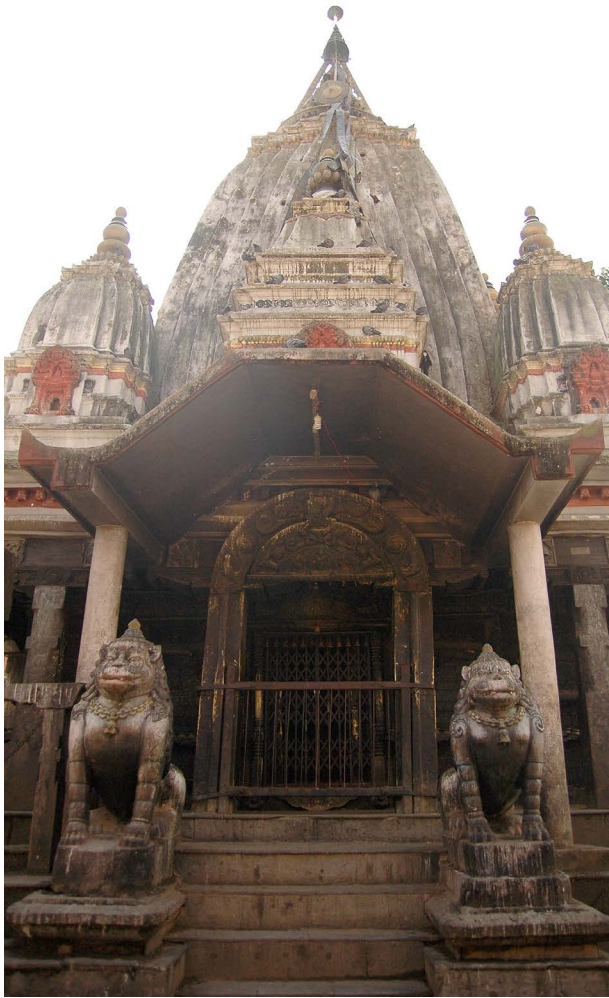
KARUNAMAYA TEMPLE

A crude RCC structure had been grafted on to the northern entrance covering a modern repoussé arch and tympanum.
Photograph David Andolfatto | 2010

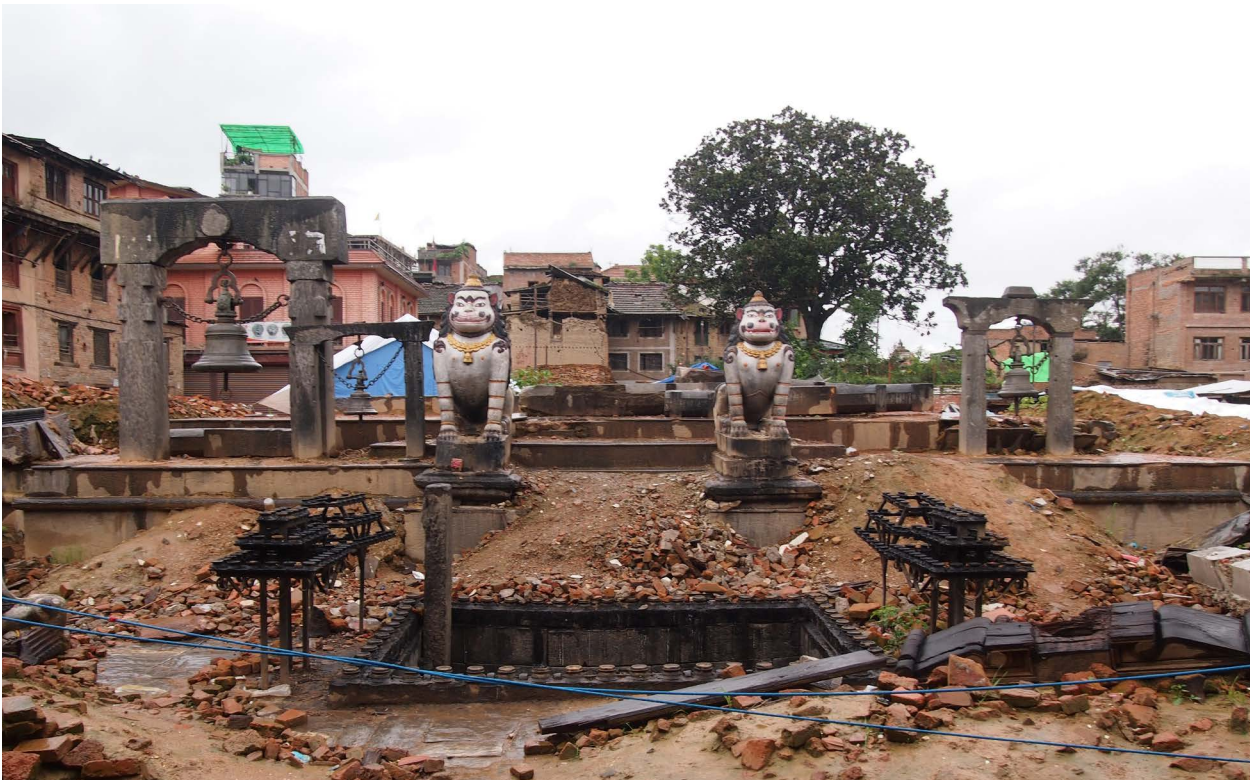
View from the North

Note the thin stone veneer which detached from the plinth in some places.

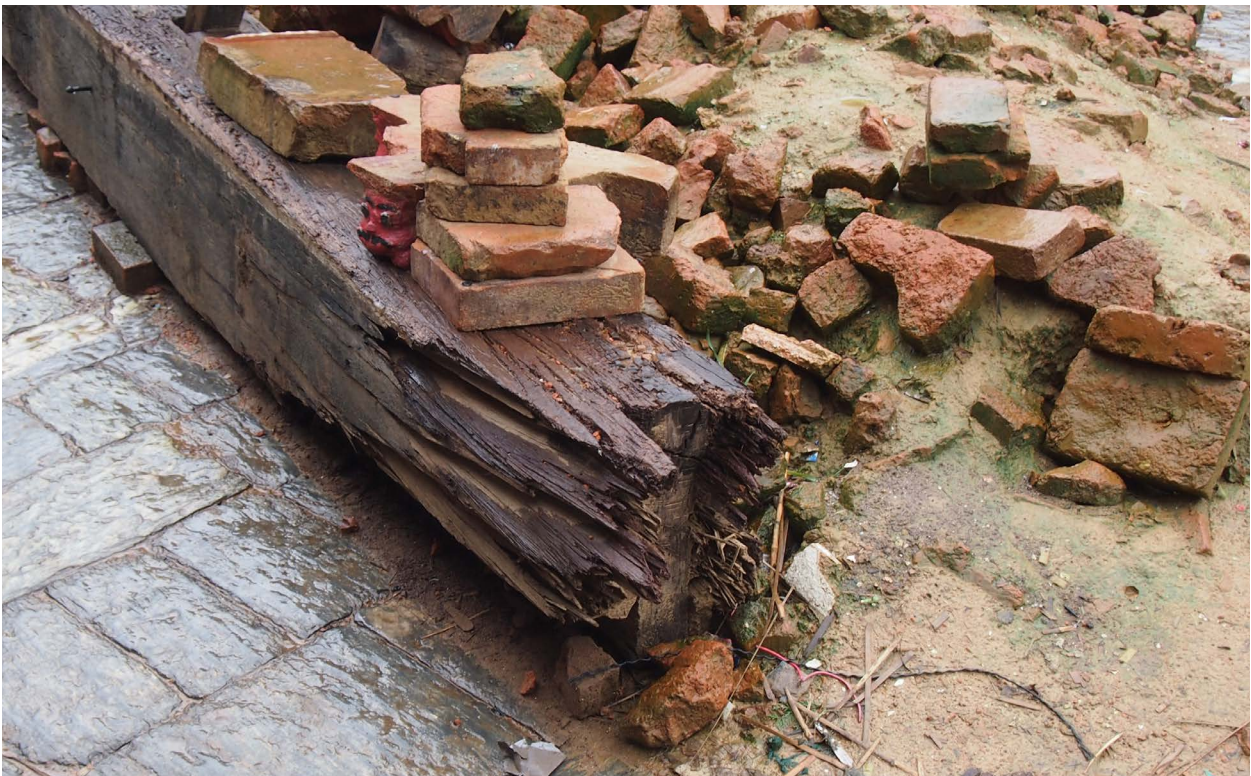
Detail of a cross beam

A typical example of material failure.

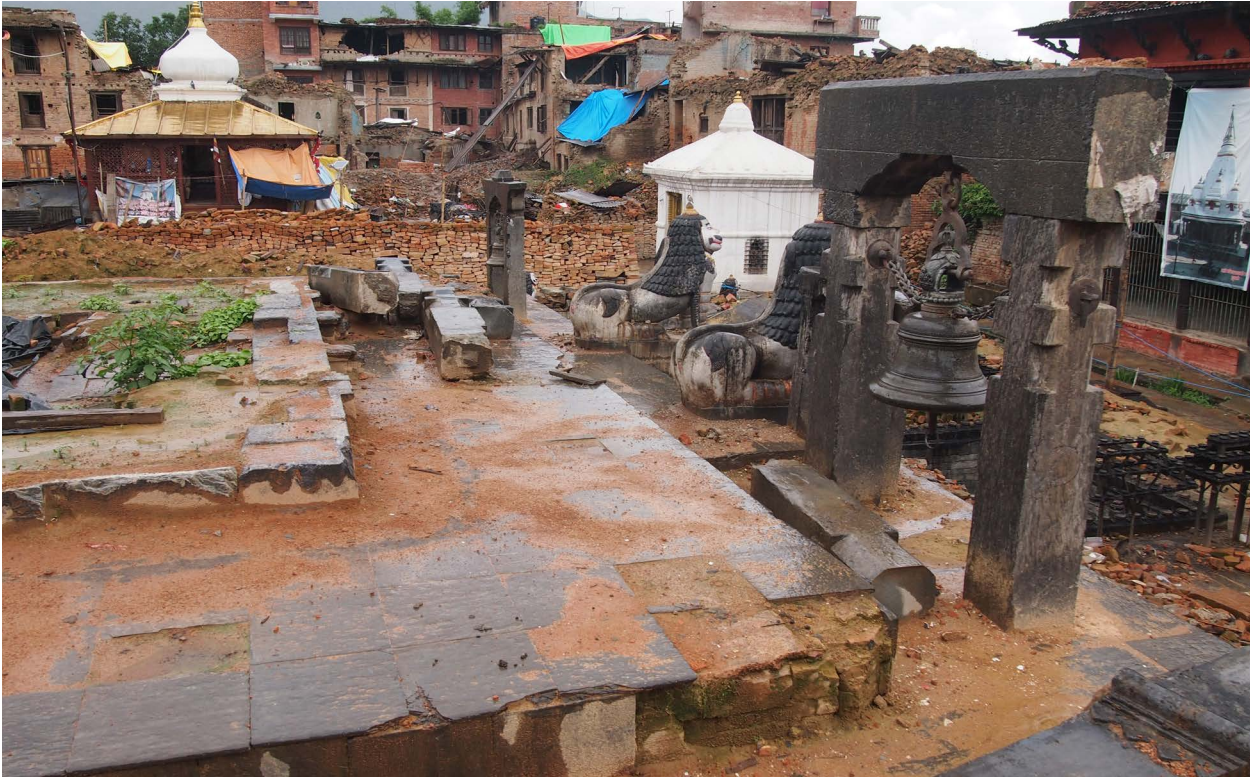
Foundation of the inner cella and surrounding plinth

The use of thin square stone cladding is unusual in traditional temple architecture. Note the damaged corner of the plinth that used to support one of the heavy stone pillars.

The foundations were never meant to support the weight of the massive brick sikhara dome. The poor condition of the mud and brick sub structure was obviously a major cause for the temple’s collapse. For future reconstruction it is highly recommended to consider the complete redesign and rebuilding of adequate foundations with seismic strengthening features and also the complete reconstruction of the plinth.

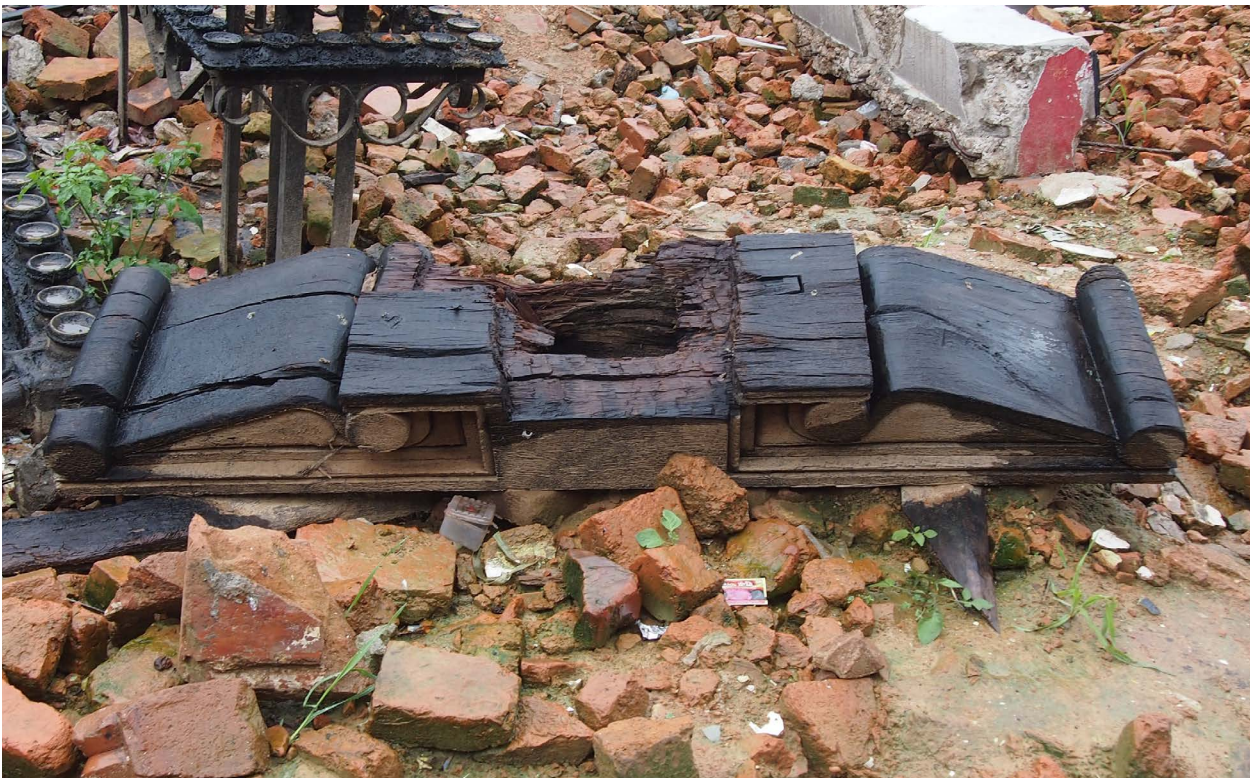
Corbel

This decayed corbel has completely lost its bearing capacity.

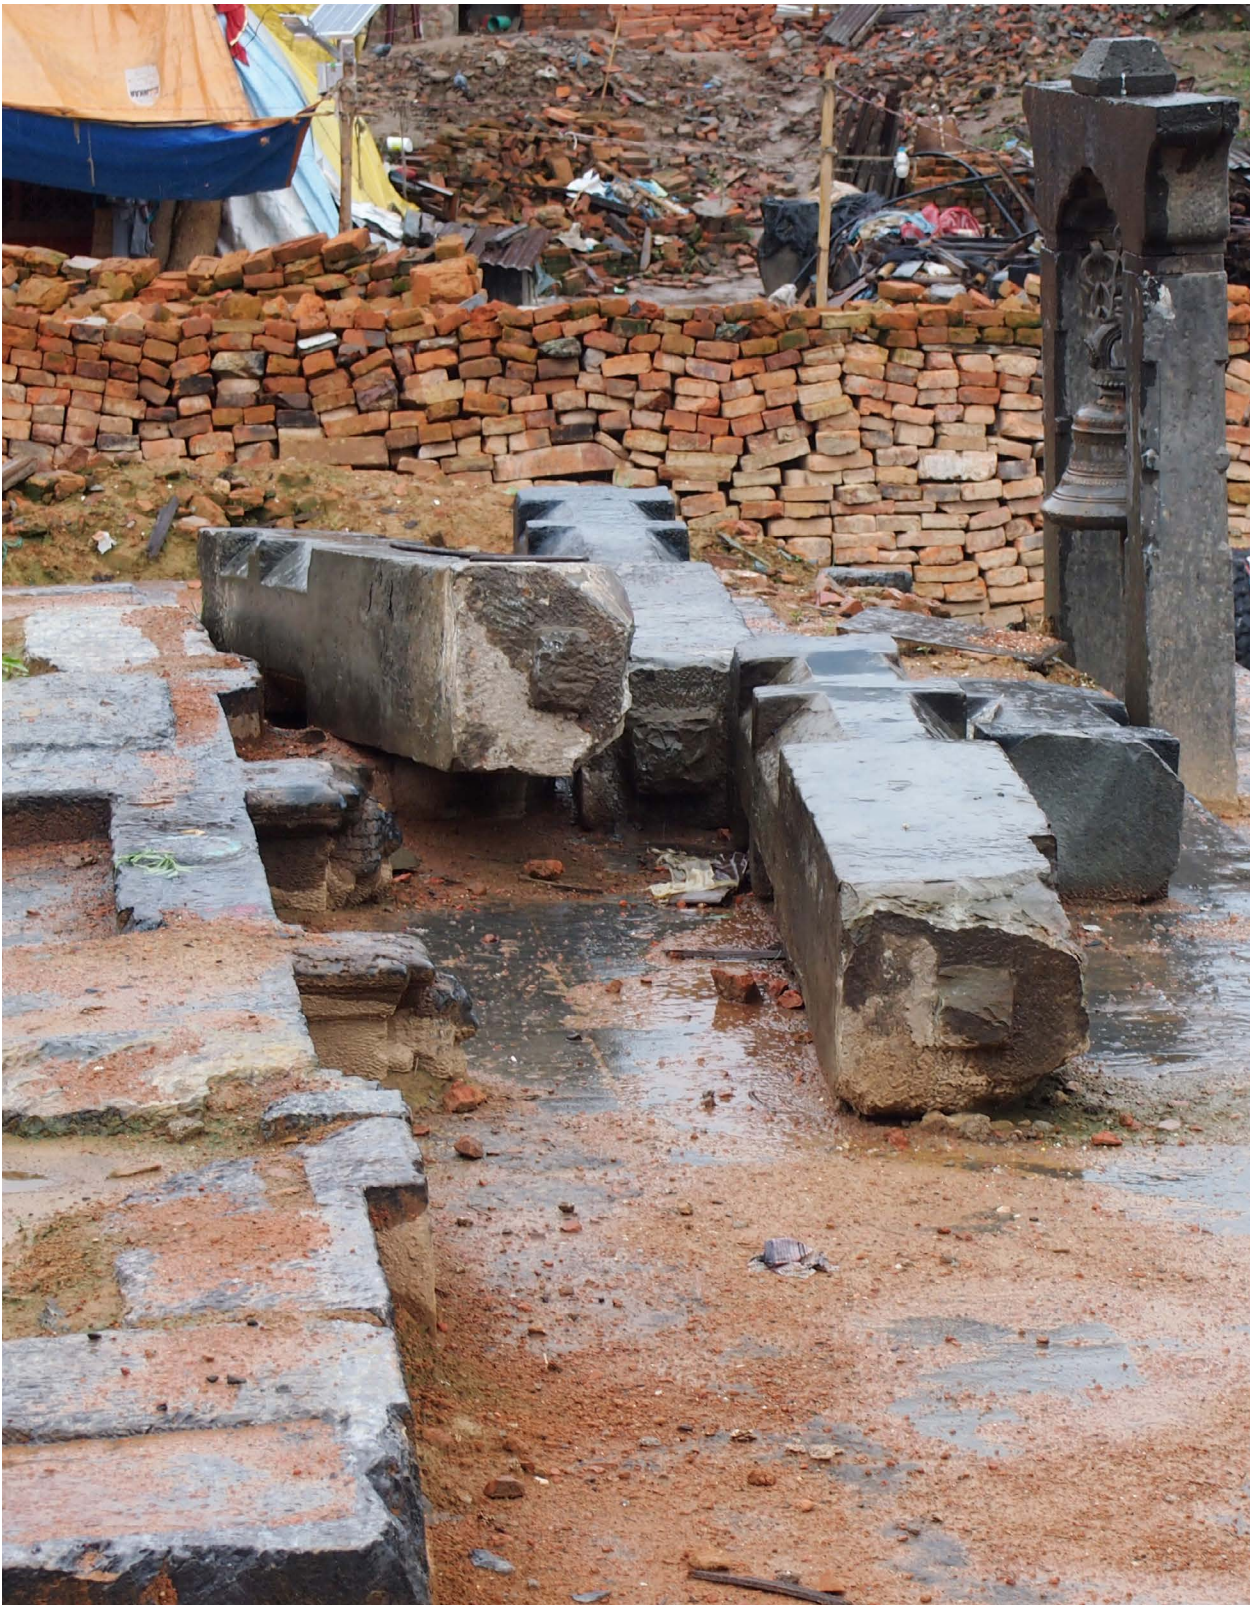
Post disaster inspection revealed that the 20 massive stone pillars supporting the outer edge of the structure were only loosely resting on the plinth below. Traditionally, stone pillars are connected by means of deep mortise and tenon joints to large horizontal base stones that often form the edge of the plinth and evenly distribute the weight of the superstructure to the base. This design detail should be considered for the reconstruction.

Four of the 20 stone pillars which supported the arcade
Note the very shallow tenons which did not provide sufficient positive bond to the structure below.
Photograph Thomas Schrom | July 20, 2015

In order to strengthen the connection between foundation, base stone and pillar the use of stainless steel pins is highly recommended. Similarly, the structural stability of the connection between pillar, corbel, and cross beam can be improved by stainless steel connectors.

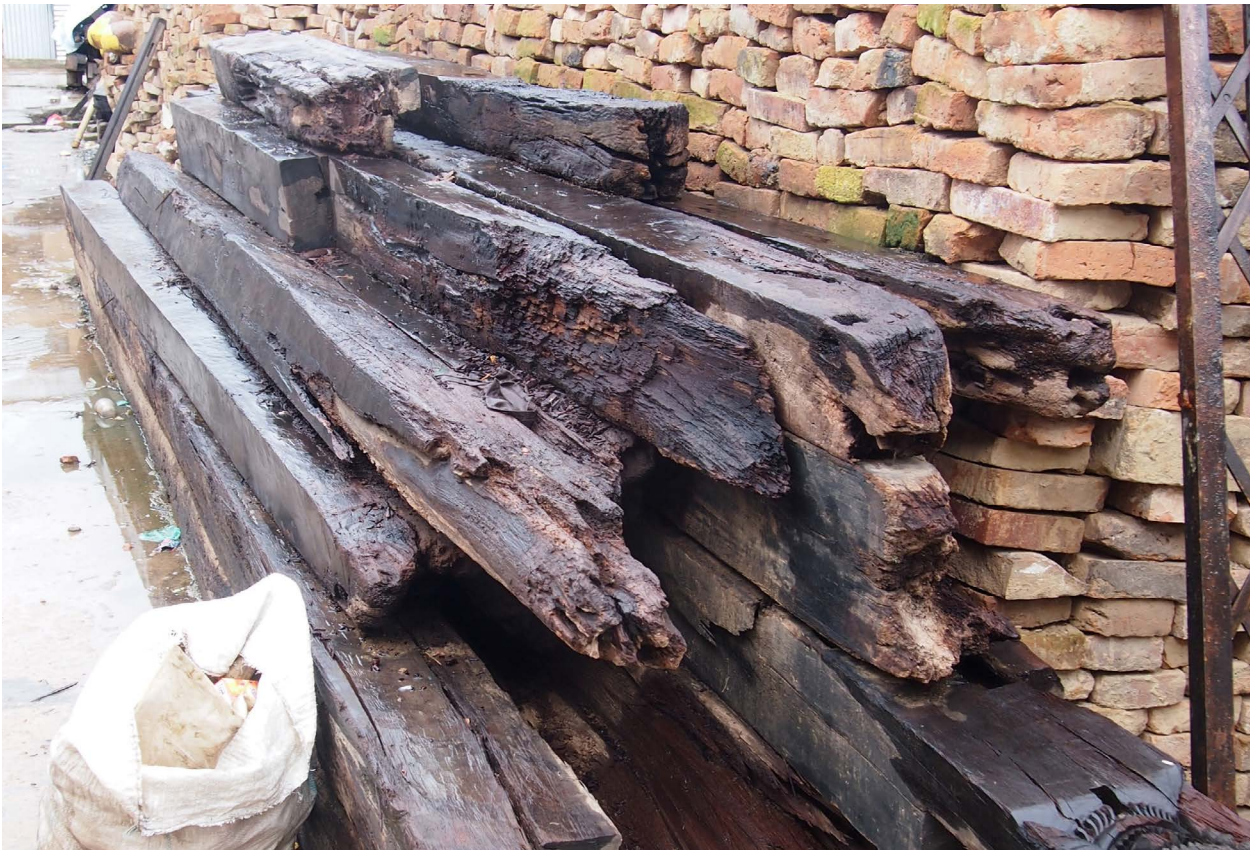
Remnants of the timber structure

Continuous water infiltration particularly around the edge of the building had caused massive decay and rot of bearing beams. Post earthquake inspections confirmed that almost all structural timber has been severely affected by rot. All salvaged timber components have been stacked

All of those beams are severely deteriorated and structurally unsound. Very little of the original material will be reusable in the reconstruction.
Photograph Thomas Schrom | July 20, 2015

All of the main bearing timber beams will need to be replaced with new hard wood (*sal*) timber. It will be difficult if not impossible to find the massive beams required at the Kathmandu timber yards. Sourcing of trees from the Terai will require considerable time and effort.

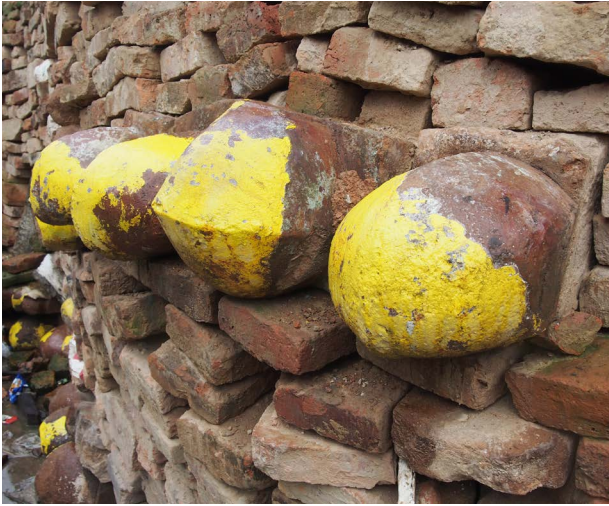
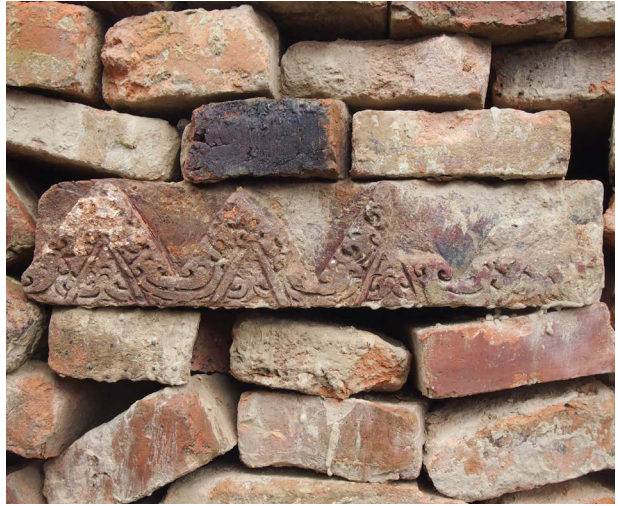
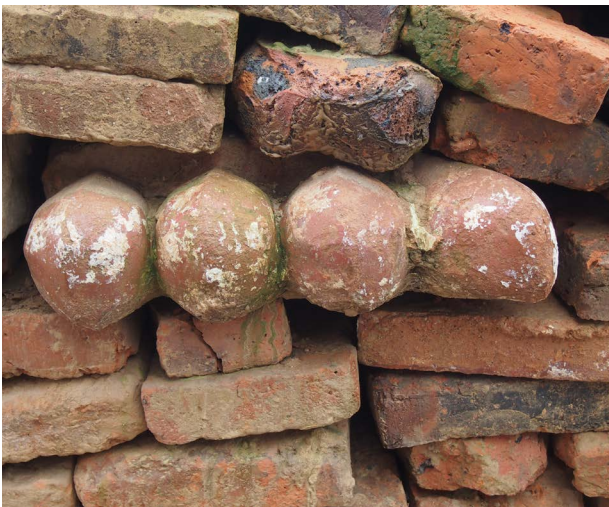
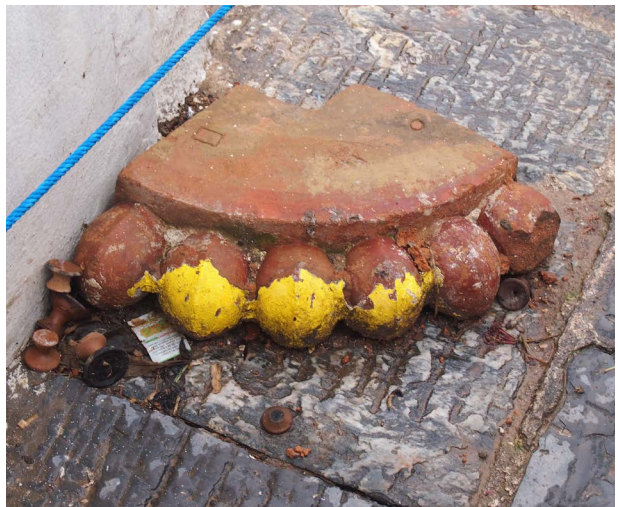
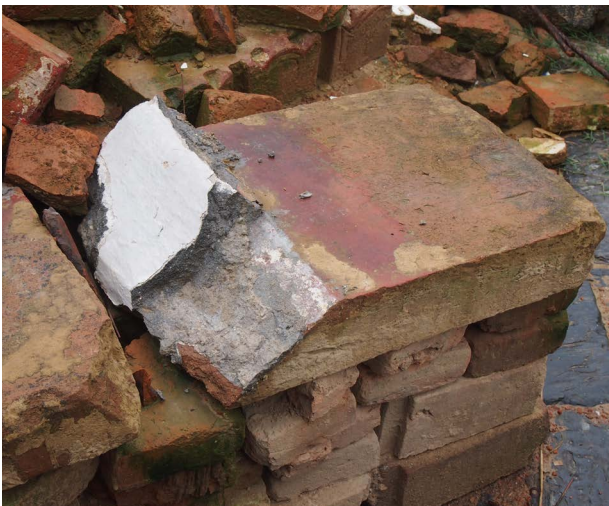
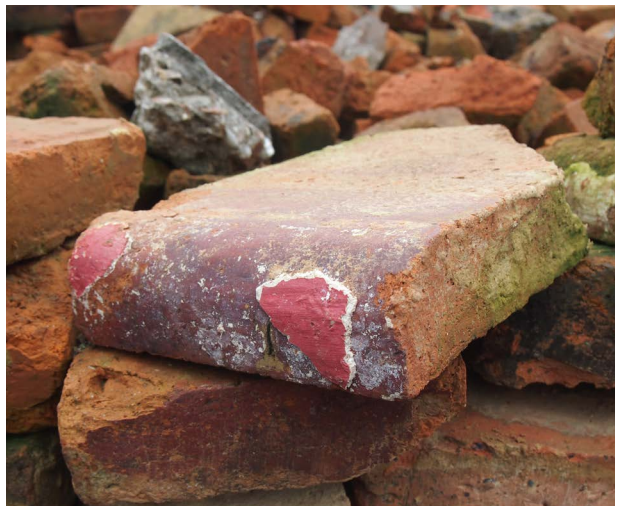
Examples of custom-made brick found in the rubble

Only a small percentage of historic brick will be reusable for the reconstruction. The production of these special bricks is an expensive and time-consuming process. Only a few brick kilns in the valley can supply such brick.

As the examples on the next pages illustrate the design requires many customs-shaped bricks. Finding the expertise to produce and fire such bricks is not easy and should be initiated immediately.

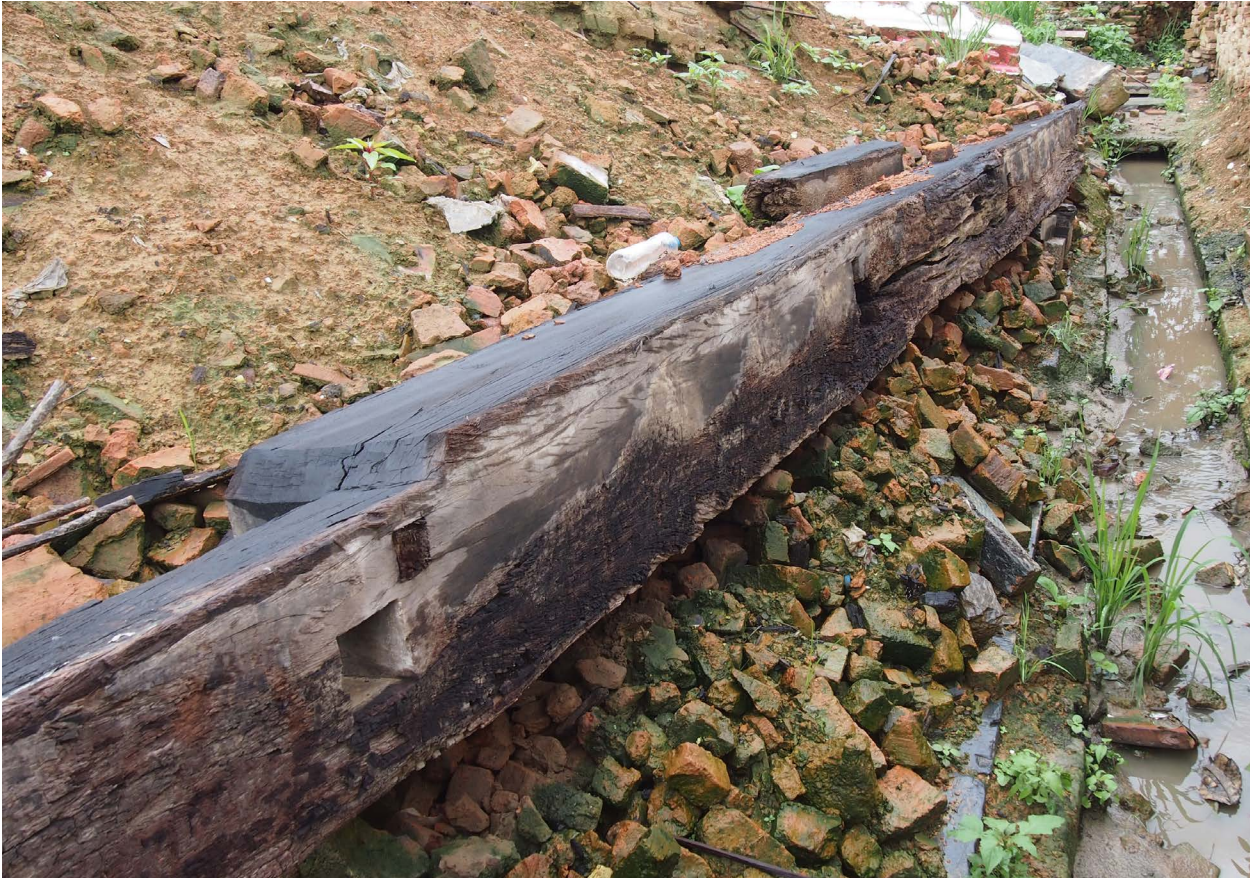
Main beam

Most of the bearing timber components are in similar state of decay and will not be usable in the reconstruction of the temple.
Photograph Thomas Schrom | July 20, 2015

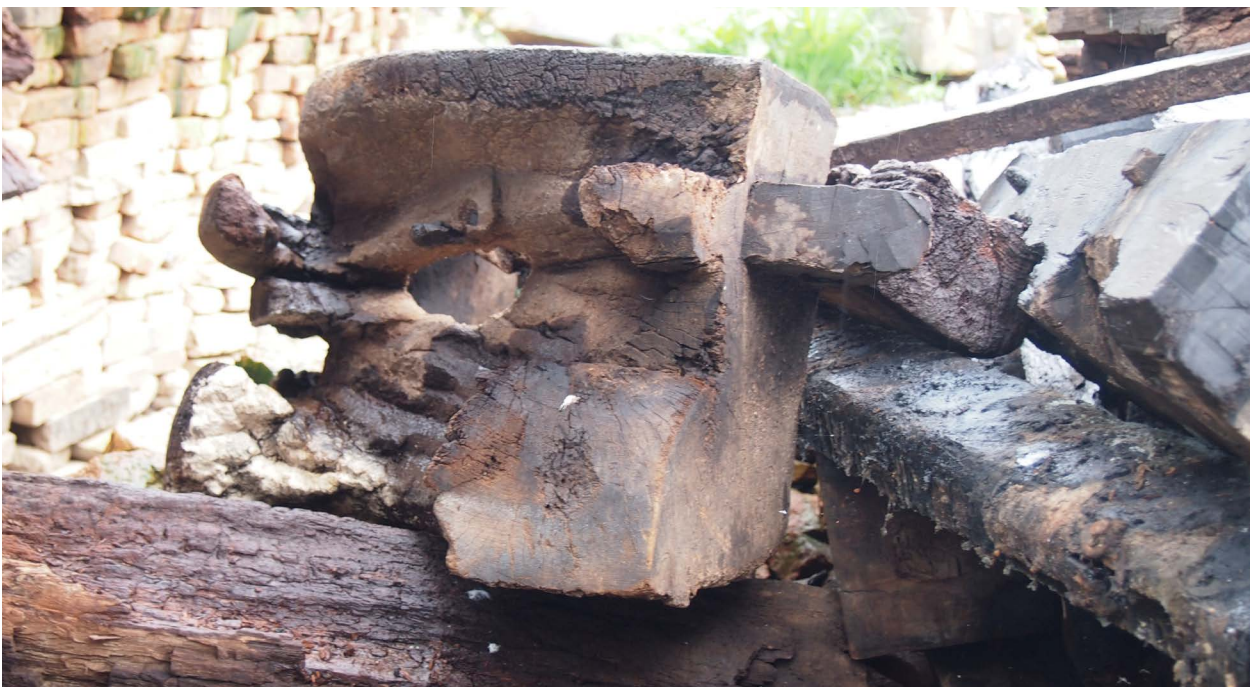
Beam end

This is an extreme example of the effects of wet rot.
Photograph Thomas Schrom | July 20, 2015

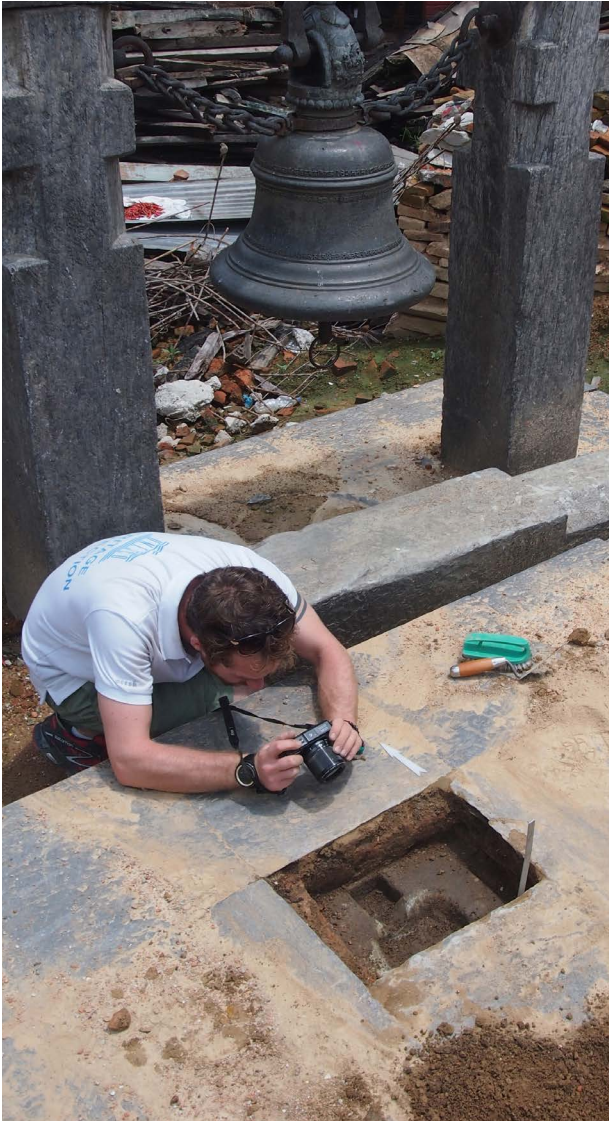
Base of pillar near the north-east corner
 The flagstone paving laid in mud mortar was probably added after the 1934 earthquake.

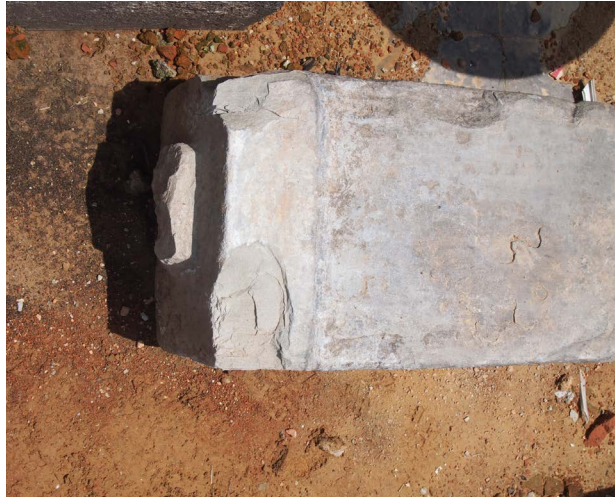
End of stone pillar
 Part of the pillar's base was covered by flagstone paving.

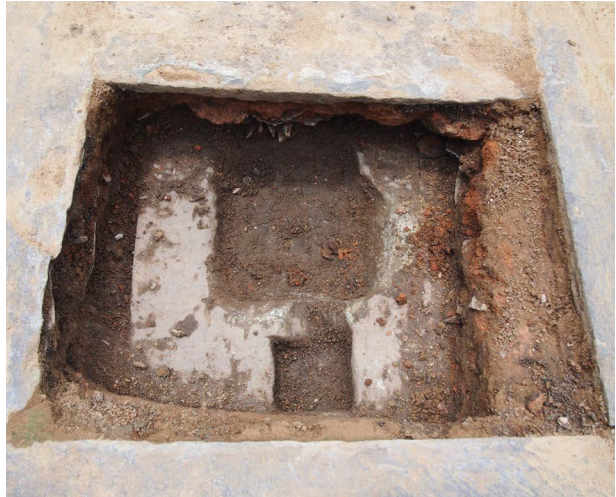
Base stone
 It is unclear why the base stone features two mortises since the pillar only has one tenon.

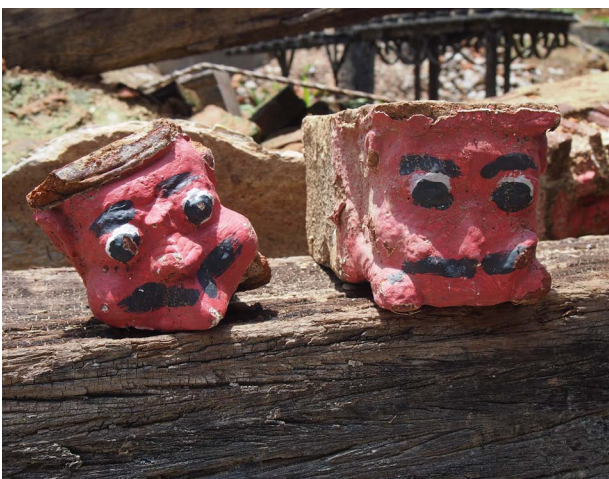
Fragments of a band of decorative terra cotta moldings
 Each side of the temple featured about 40 such heads called *dhalay khow* in Newari. According to an informant the heads represent Garuda, tigers, horses and lions.

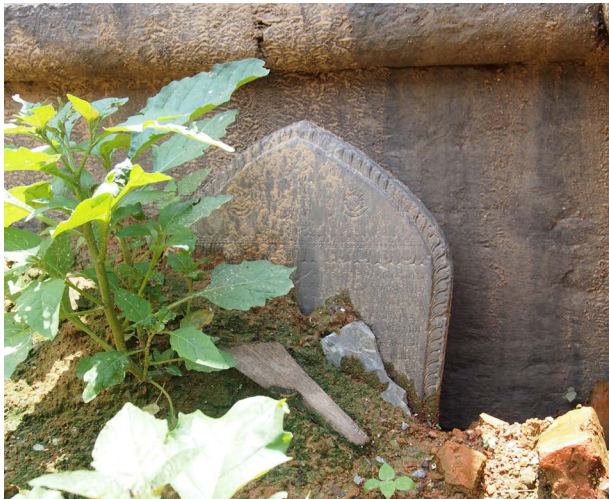
Stele on the northern lower plinth
The inscription is partly obscured by debris. It should be brought to a safe storage area.

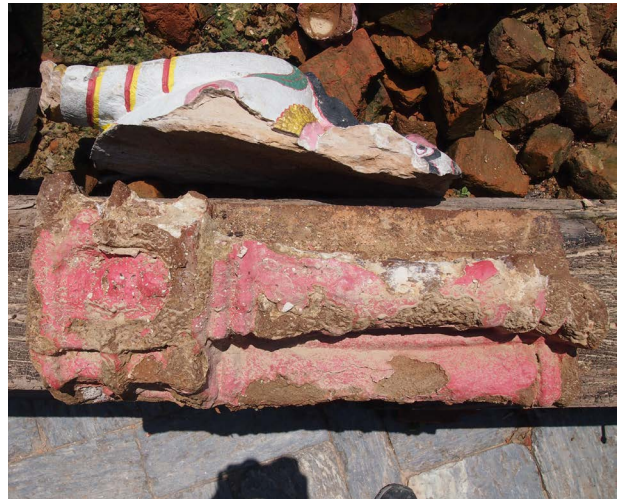
A column from one of the 12 terra cotta niches
Heavy layers of lime and enamel paint obscure this terra cotta fragment which makes identification of the figure impossible.

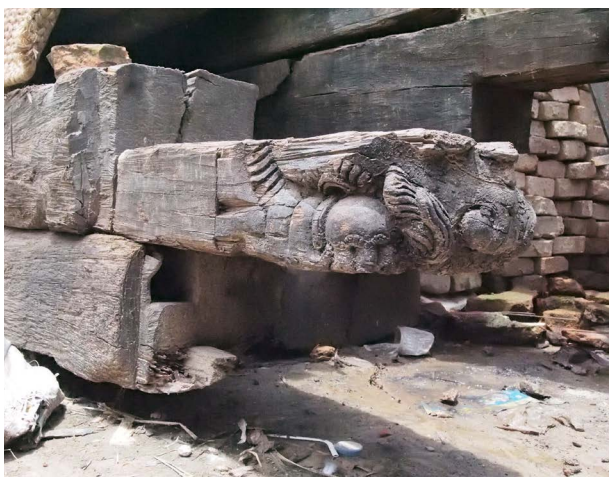
Beam end from the inner cella
This beam is most likely part of the original 17th century temple and could possibly be reused in the reconstruction.

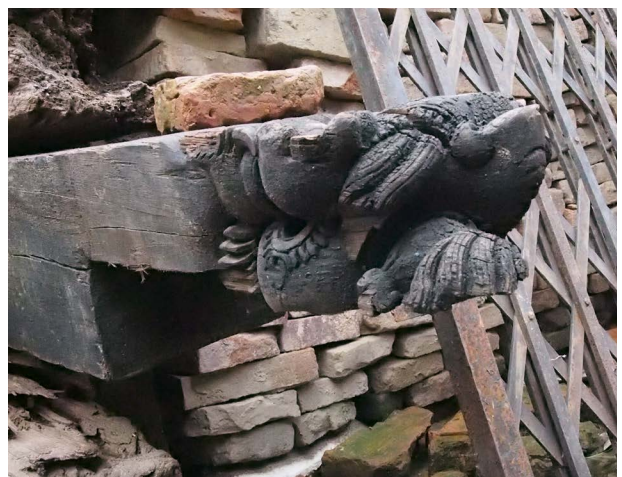
Beam end from the inner cella
This beam is most likely part of the original 17th century temple and could possibly be reused in the reconstruction.
