LAKSHMI NARAYAN TEMPLE

KATHMANDU DARBAR INITIATIVE

FINAL REPORT

ROHIT K. RANJITKAR * LUMANTI JOSHI
KATHMANDU VALLEY PRESERVATION TRUST
AUGUST, 2007

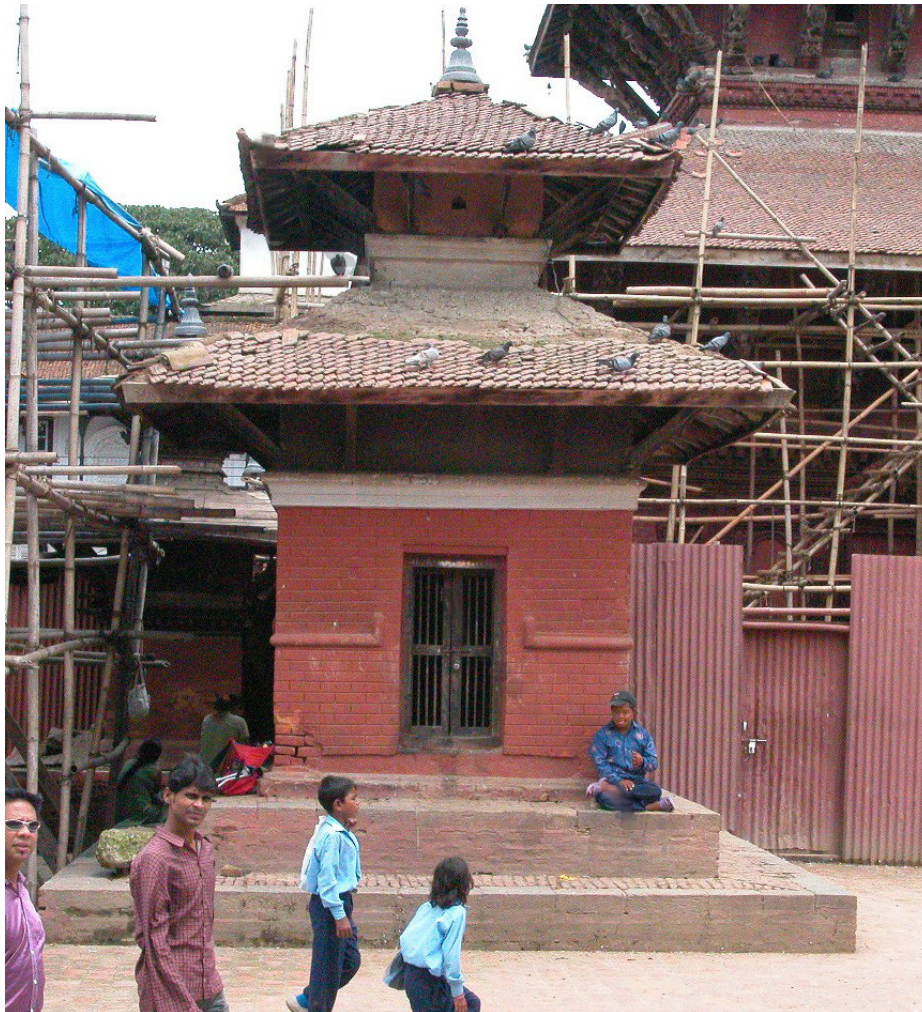
left: Lakshmi Narayan Temple, 2004. The original configuration of the temple was completely lost. When the Trust started its documentation, the roof structure was in a dilapidated state. The rafters were of inappropriate length and 50% of the roof tiles were lost, thus, allowing the rainwater to penetrate into the structure. The cement plaster had damaged exposing the corroded brick work. *Photo by: Lumanti Joshi, August 2004.*

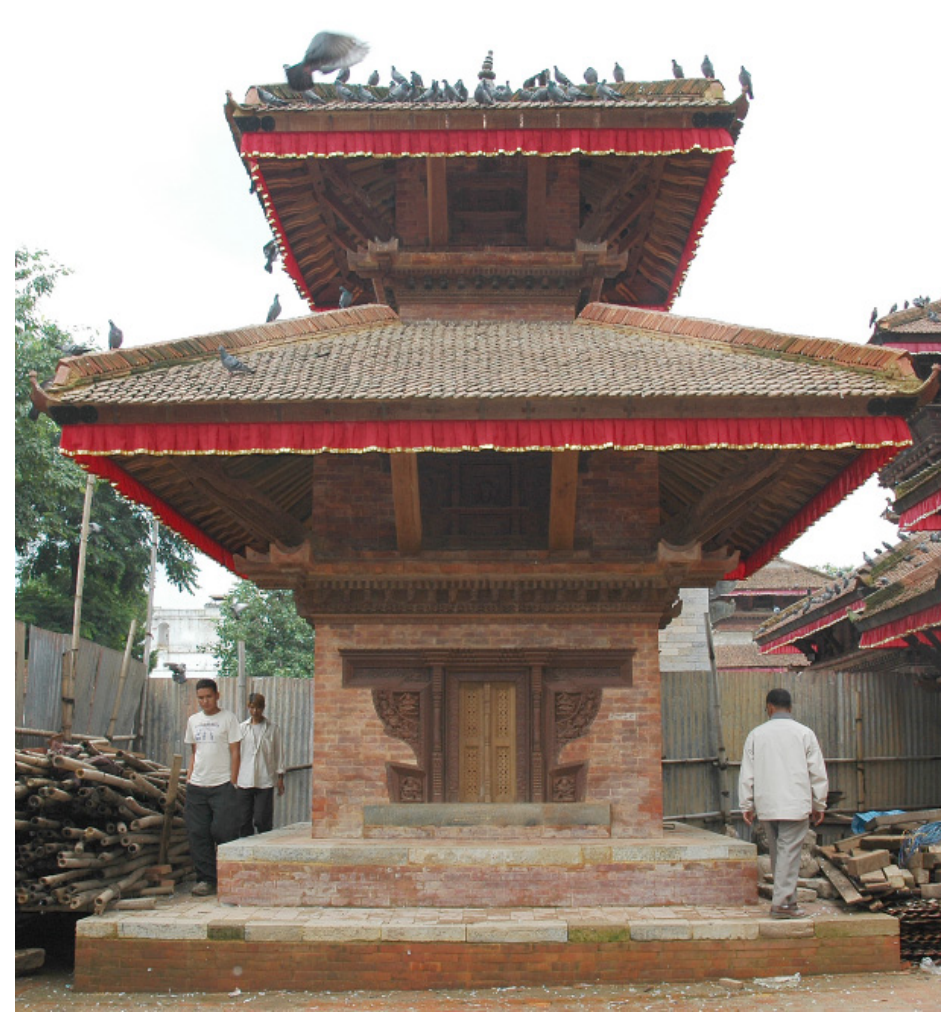
right: Lakshmi Narayan Temple, 2007. The entire structure was recreated with the help historical photographs. After a detail study of elements from similar temples of the same time period, carving details such as the doors, windows and the cornices were carved. *Photo by: Lumanti Joshi, August 2007.*

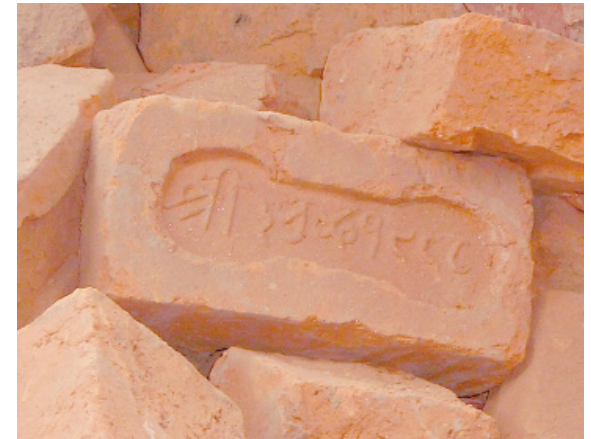
When the structure was dismantled in 2006 during the restoration, bricks inscribed with the name of Juddha Shamshe Rana and a date (1940/41 A.D.) were discovered. This information sheds light on the fact that the temple was reconstructed nearly seven years after its collapse in the catastrophic event. The earthquake measuring 8.5 in Richter scale was extremely destructive, damaging more than 2000 monuments in the valley and killing 1500 people. Rana, the then Prime Minister of the country executed an extensive repair and restoration works of the monuments of the valley which were damaged. Since the scale of damage was massive, many of the structures were haphazardly rebuilt regardless of its original design as in the case of Lakshmi Narayan Temple.

top: While dismantling the dilapidated brick masonry, the bricks inscribed with the name of the then Rana Prime Minister and the date of reconstruction, B.S. 1998 (1940/41 A.D.) were discovered. Considering this date, it can be said that temple was reconstructed only seven years after its collapse in the 1934 earthquake. *Photo by Lumanti Joshi, December 2006.*

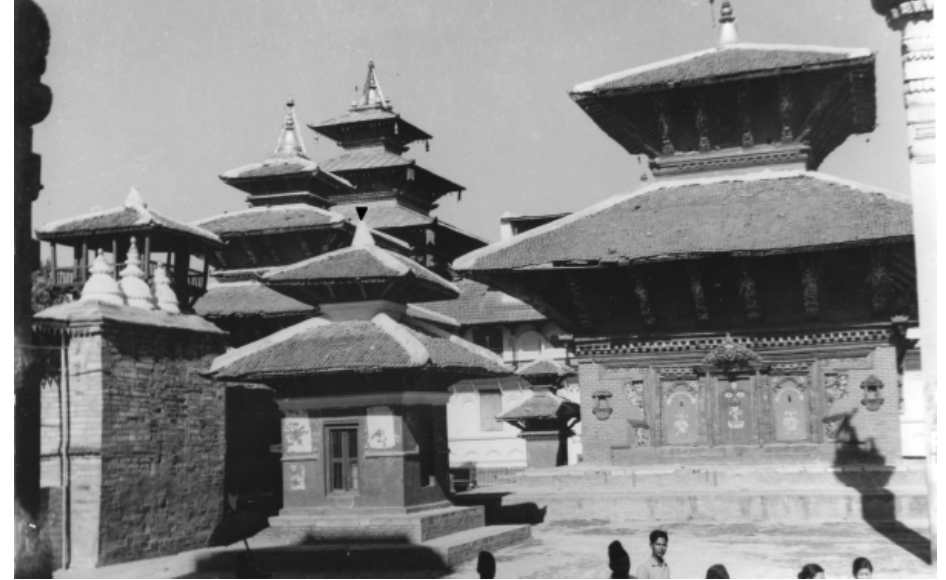
top right: The configuration was drastically changed with shorter roof line during the 1936 reconstruction. Photo taken in 1960 A.D. *Photograph courtesy: Babadur Photo Studio.*

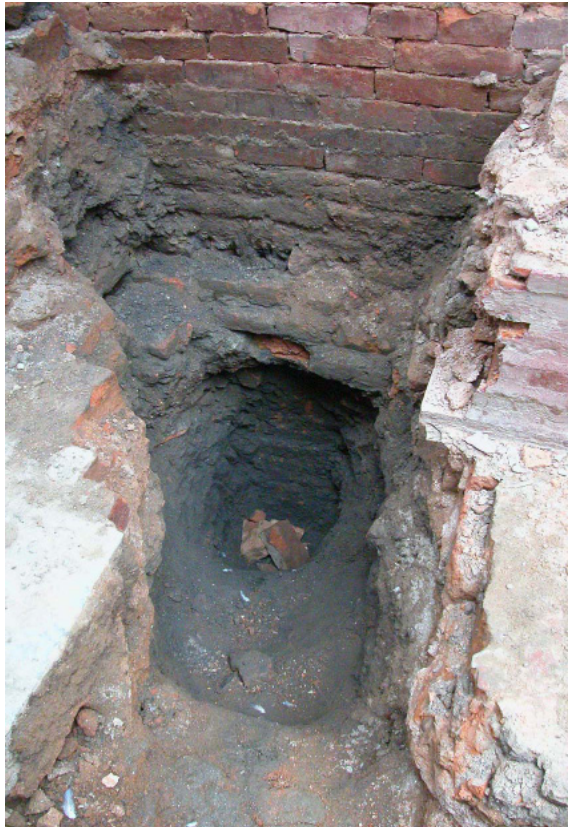
top: A trench was excavated at the east section of the plinth to evaluate the condition of the foundation. The area below the plinth still had the original ma appa bricks. Thus, the 1940/41. *Photo by Lumanti Joshi, October 2005.*

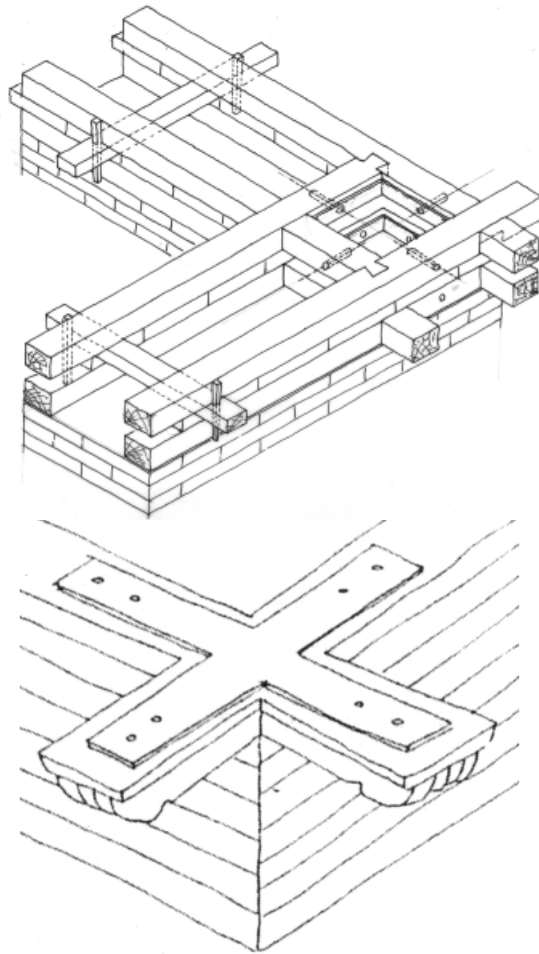
top : Steel bracing between the inner and outer walls acts as a ring beam.

bottom: The cross metal piece tying two corners of the timber cornices prevents them from breaking under the heavy load of the terracotta pieces.

The corner decorative timber cornices (lah-kah in Newari) just below the corner struts bear heavy terracotta corner pieces. Since the timber corner pieces are half notched, their section is insufficient to bear the heavy load. This often leads to broken corners creating a weak joint which may fail under the load of the strut. So, to prevent this, a metal cross piece was screwed on top of the lah-kah. the terracotta pieces rest above there by concealing its presence. Another of the seismic strengthening measures incorporated during the reconstruction is steel bracing (L-sections), which were introduced at the joints between the outer and inner wall plates at all levels. This will help the existing wall plates to act as a ring beam in the event of seismic movement.

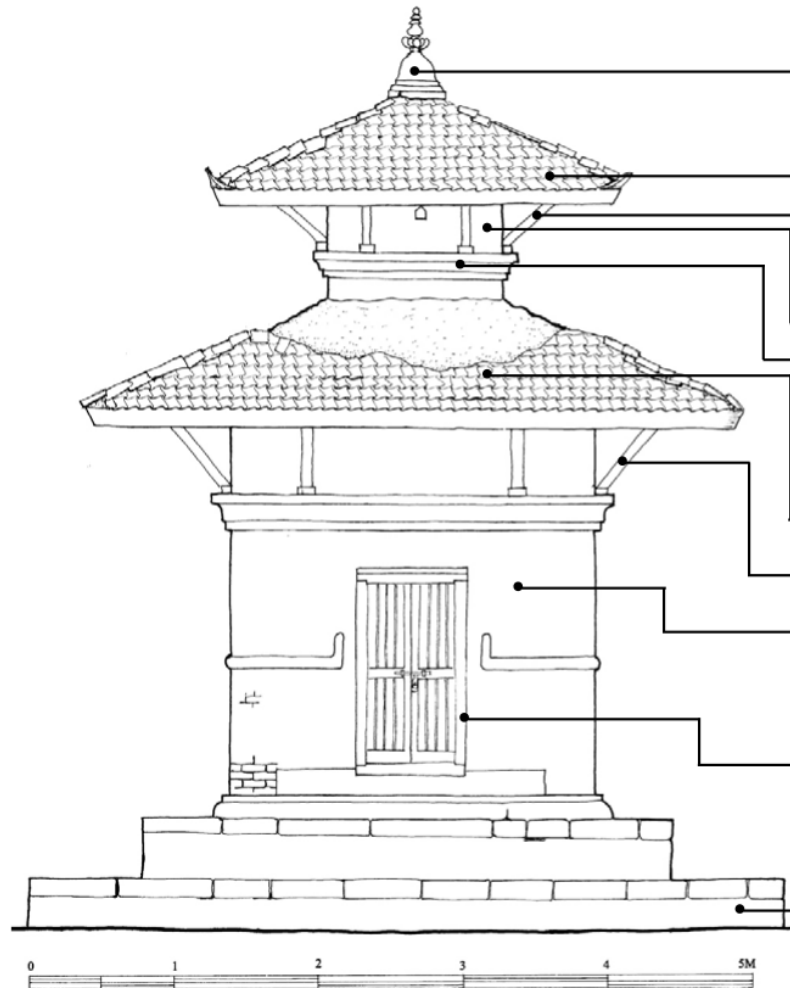
West Elevation: Existing Conditions and Construction History (documented in July 2005)

All components are from post 1934 earthquake reconstruction. The overall configuration of the temple has been drastically altered and roof structure reduced. The temple was renovated in 1958 (Kathmandu Valley Inventory Vol 2, Published by UNESCO 1975)

- **Roof tiles:** It is in rather poor condition. Several roof tiles at the edges have fallen off on all sides, exposing the mud bed. No ridge tiles remains. Corner tiles on NE and SW are broken and NW and SE are lost.

- **Roof struts:** All corner struts and others are plain (total 12 in number) and are in fair condition. All are of smaller sections than what should be historically. However, the upper inverted portions of these are affected by bird droppings.

- **Wall structure:** Constructed with large bricks in yellow mud mortar. Has been lime plastered and red washed with small blind niches on all four sides. Though it is not in historic configuration, brick work is in fair condition and plaster work intact.

- **Cornice:** Layers of traditional timber cornice has been replaced with lime plastered detail. Constructed of lime *surkhi* and white washed, even covering the lower portion of the wall.

- **Roof tiles:** Is in very poor condition. Many of the tiles at the upper level displaced and lost from their positions, exposing the mud bed. The corners and ridge tiles are lost.

- **Roof Struts:** Struts on all side are plain (total 12 in number) which were probably change during 1936 reconstruction. Are in fair condition.
- **Wall Structure:** Constructed with 5cm thick brick on yellow mud mortar. Windows are missing and the upper wall portion (above the cornice detail) has been plastered and painted with brown enamel. Cracks have developed in the area where pegs from the wall plates meet the wall. Traditional timber cornice has been replaced with brick and *bajra* or *lime surkhi* construction and has been white washed. The *bajra* is broken at corners exposing the bricks. A plastered layer with *nagol* was added to the wall structure. Wall is plastered with lime *surkhi* and brick pattern engraved in this plaster. However the plaster is damaged at many places, like lower portions on east, north and south facades and more severely at the north west corner of the wall, exposing the bricks.

- **Doorway:** All of the four original carved doors are lost and replaced with a plain door, probably during 1936 reconstruction. The door frames do not have any carvings. Other openings are blocked with brick walls and are plastered. Each has a hole which in *Newari* is known as *Nasa Powa*.

- **Plinth:** Constructed with common bricks and the joints have been cement pointed, is in fair condition. Plinth apron stones are intact.

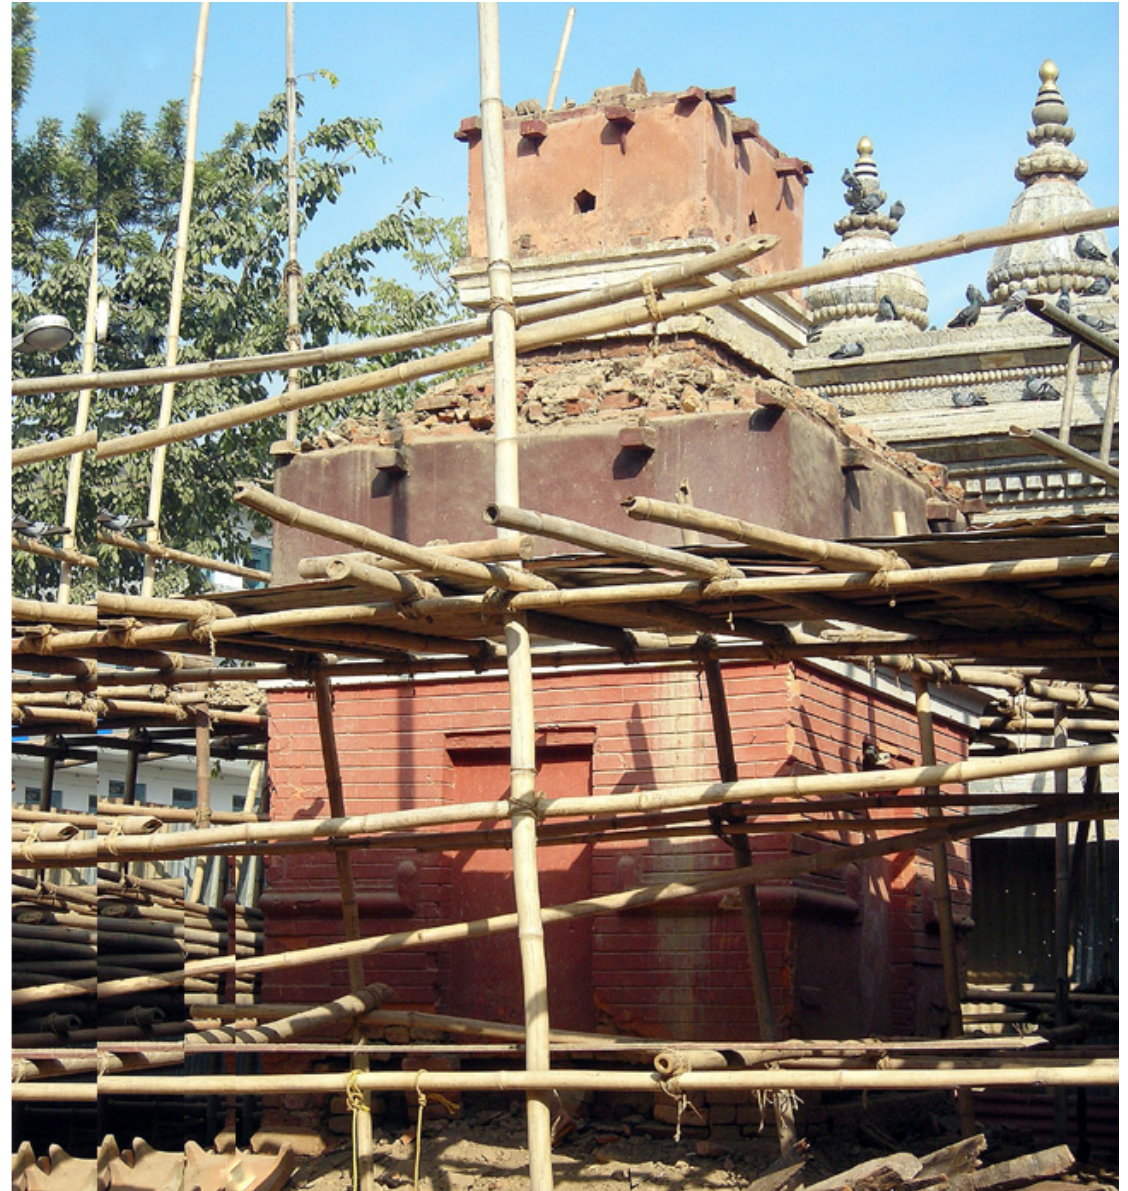
right: Since the existing structure was in dilapidated state and virtually, non of the pre 1934 earthquake elements survived in the super structure, excepting for the main beams, it was dismantled. *Photo by: Lumanti Joshi, December 2006*
