Structural Report

Taleju Temple, Patan Durbar Square

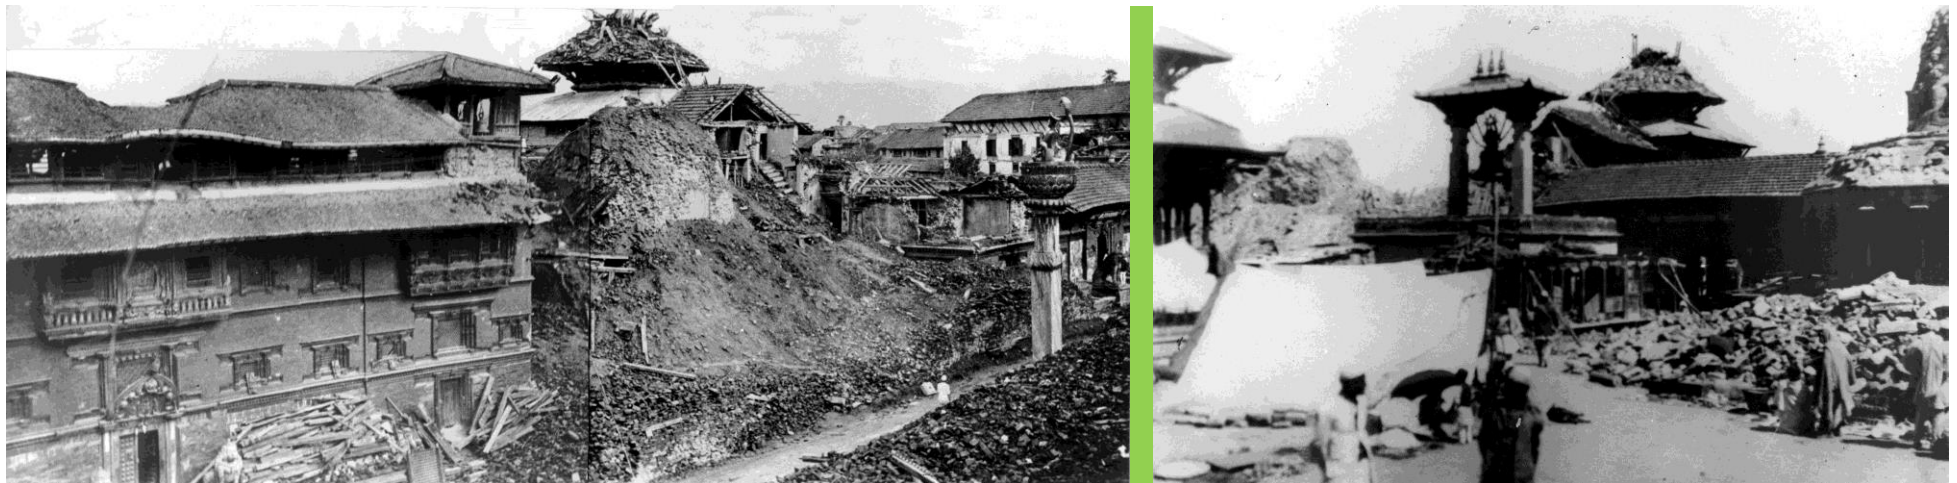
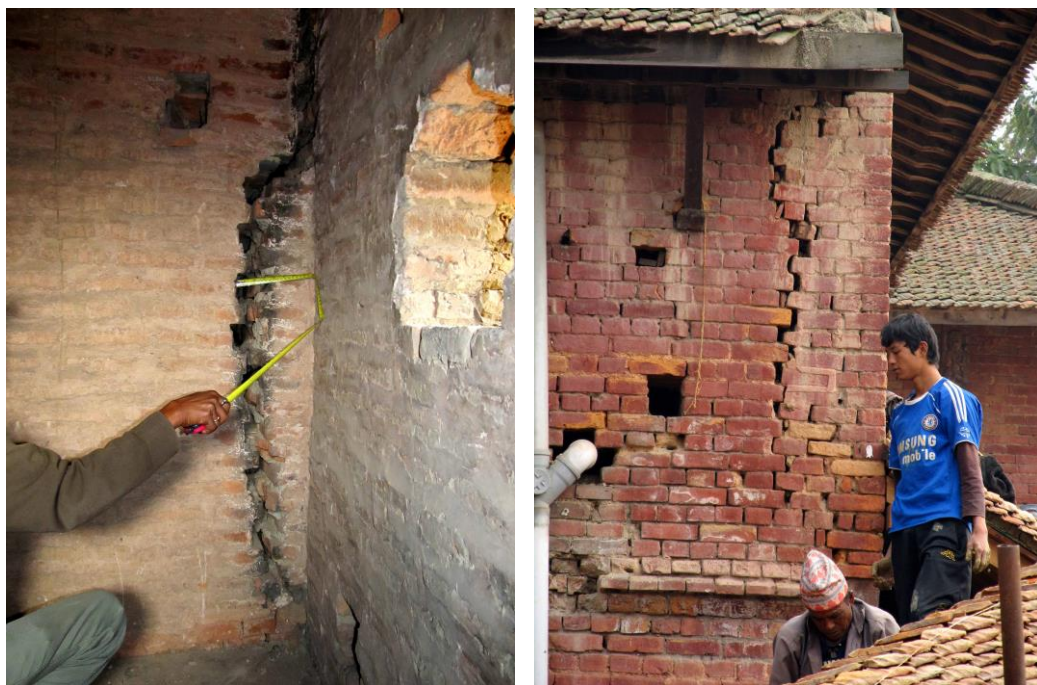
Damage from the 1934 Earthquake. Upper two levels of roof were completely collapsed in Taleju and adjacent wing on west lost more than half.

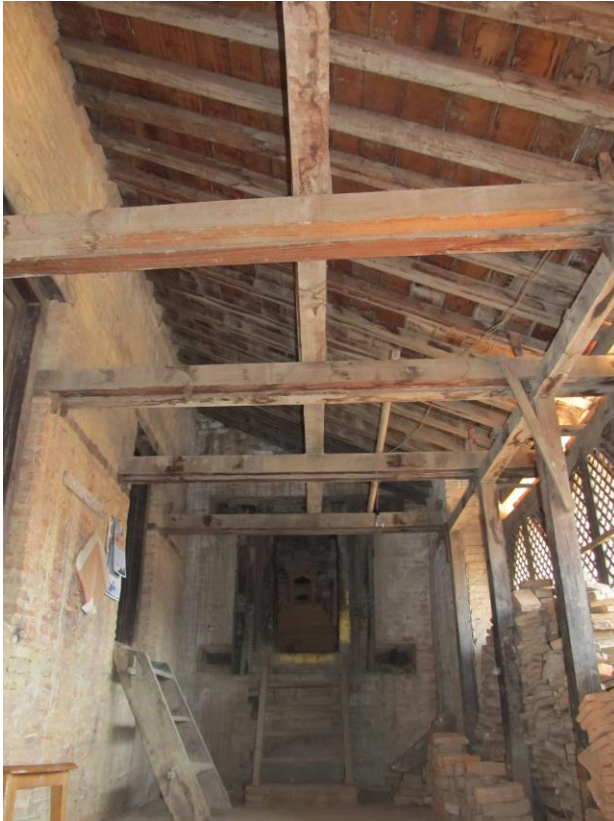
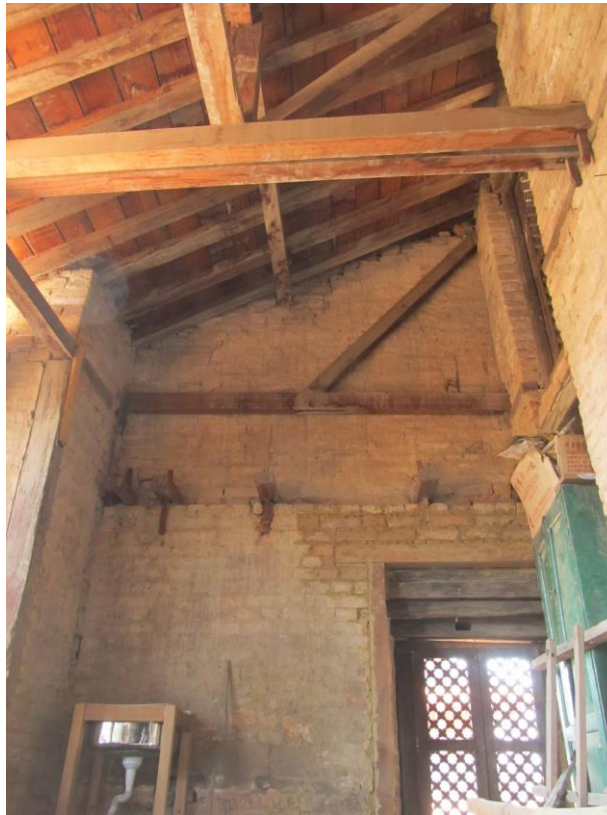
2nd floor level:

The gallery level, more appropriately the 2.5th floor due to its location as a split level between the 2nd and 3rd floor level. The shear walls facing the courtyard appear to be in a bad condition; there is also no interlocking to the outer 3rd floor sanctum walls. Furthermore, this gallery space is insufficiently braced, with an open roof system covering it and no load distributing elements between the shear walls.

- Remove and rebuild all masonry walls surrounding the gallery space, thereby providing sufficient interlocking with the adjacent cross walls and at the transition of the 3rd floor outer walls (at sanctum space).
- Install a horizontal timber truss to stiffen the roof level of the gallery space. Timber diagonals (14cmx14cm) shall be installed between the existing horizontal beams. Blocking shall be provided between the 12mm gap between the pairs of horizontally running beams. Further blocking shall be provided between the ends of the existing beams to provide force-fit connections. Connections to be carried out with 12mm stainless steel bolts and steel plates on bottom and top side of the joints. The thereby achieved warren truss will help to stabilize the upper part of the gallery space.

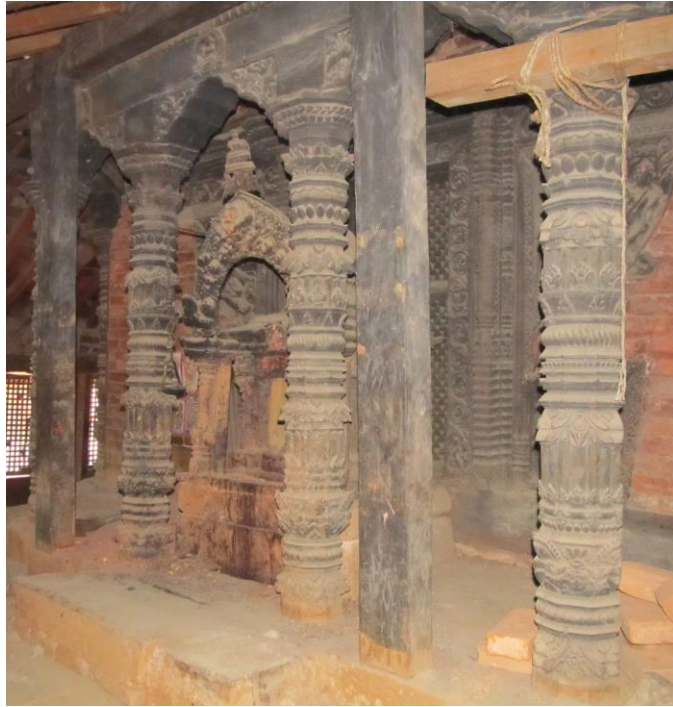
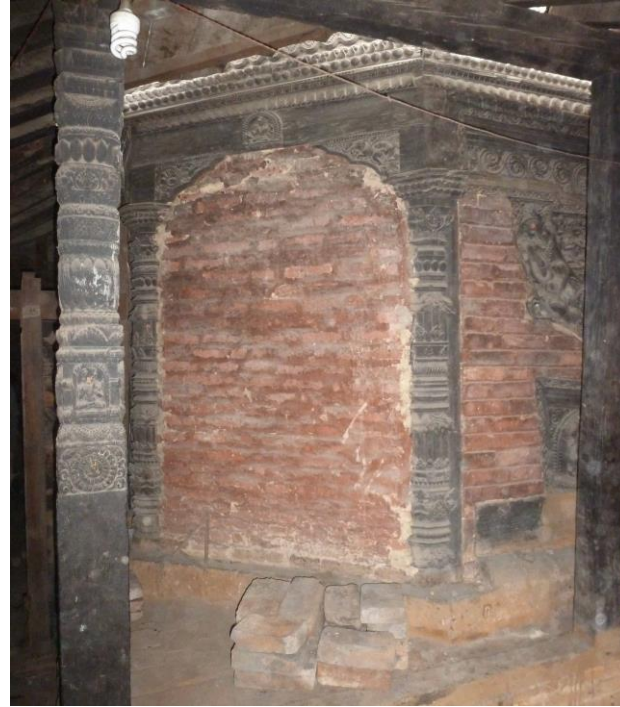
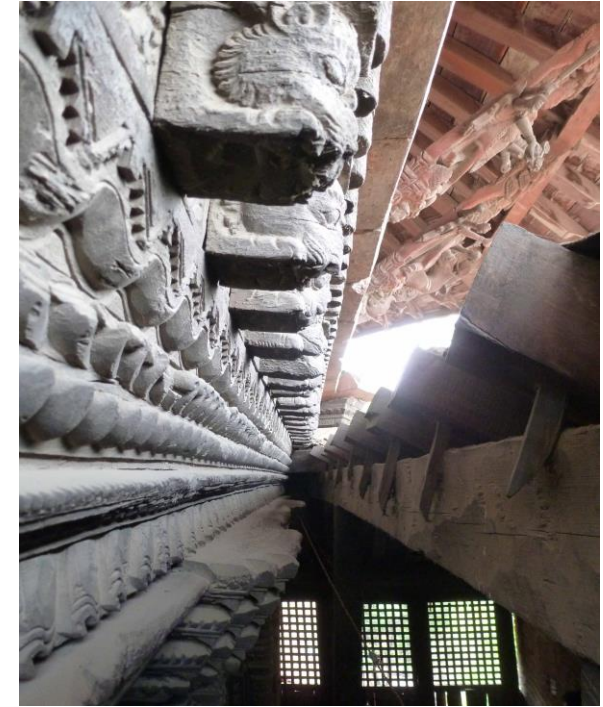
3rd floor level:

The sanctum of Taleju is situated just above the massive masonry core on the third floor level. The rectangular space is framed by masonry wall, whereas on the eastern and western side an open timber arcade takes up the octagonal shape of the tower. (The western side of the open arcade has been sealed with a masonry wall, supposedly post 1934).

The outer walls that surround the inner sanctum are a later addition. Already in place in 1934, they were also destroyed in the earthquake and rebuilt shortly after. The masonry of these walls is in general in an unsatisfactory condition, partially sloping outwards and apparently built in haste as the substandard execution suggests. An additional roof system was also added, covering the space between sanctum and outer walls. On the inside, this roof is separated from the core by an app. 25cm wide gap (of varying width on different sides). The inner support is provided by wooden beams at each face, which are propped in the corners, and additionally at each third of its length. Thus, no connection is provided between the roof and the inner walls.

- Rebuild the outer walls of the space surrounding the sanctum.
- Provide continuity between the octagonal sanctum core and the outer wall by introducing a force-fit transition at the roof level. New inner roof beams shall be installed adjoining to the wooden cornice of the sanctum. The beam depth shall make use of the height of the cornice (app. 24cm) below the cornice made of protruding lion-heads. Two columns (instead of the four existing) shall support each of the four beams, situated just before the wooden columns at the corners of the octagonal sanctum. Beams shall be installed along each of the eight faces of the cornice. Connections at the joints shall be executed with steel plates at the top and bottom, plus lap-joints at the four corners of the outer square. The thereby achieved arrangement will tie the inner core to the outer walls of the third floor level.

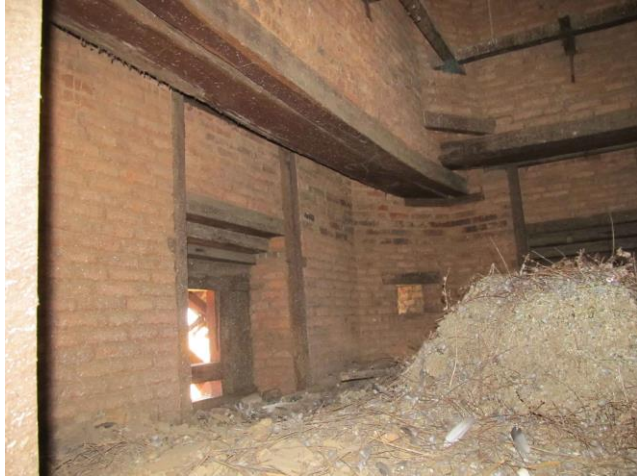
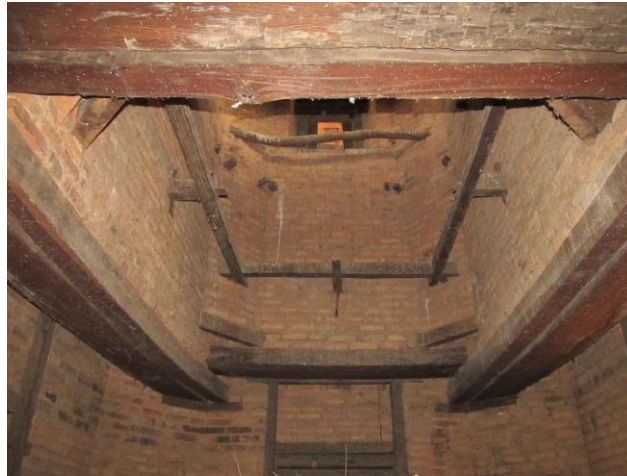
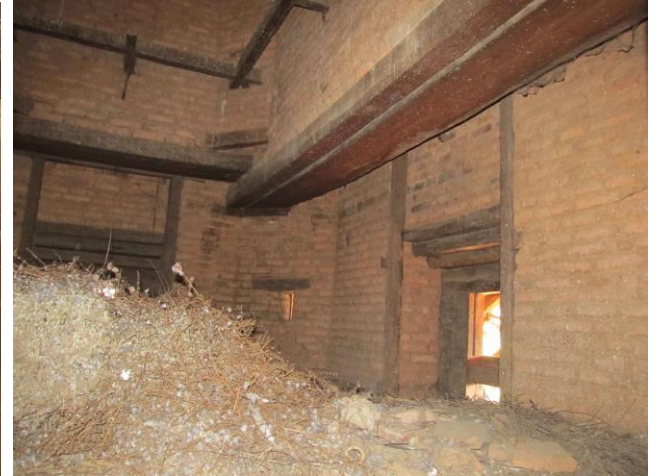
4th floor level:

The walls step back at mid-height of the fourth floor level. This shift is provided by small wooden beams that are both decayed and undersized, resulting in huge deflections. Above the beams, the masonry is cracked severely due to inadequate support conditions.

- Provide K – frames made of steel with a horizontal tie below the sagging undersized beams where the walls step back. Install top part of K-frame tightly beneath the transfer beams to relieve them and prevent further deflection. Provide sufficient support at each end and embed the ends in the masonry walls.

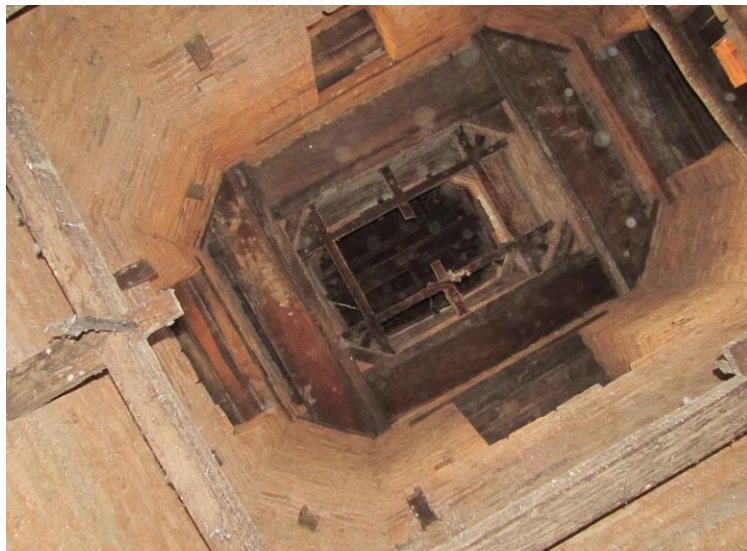
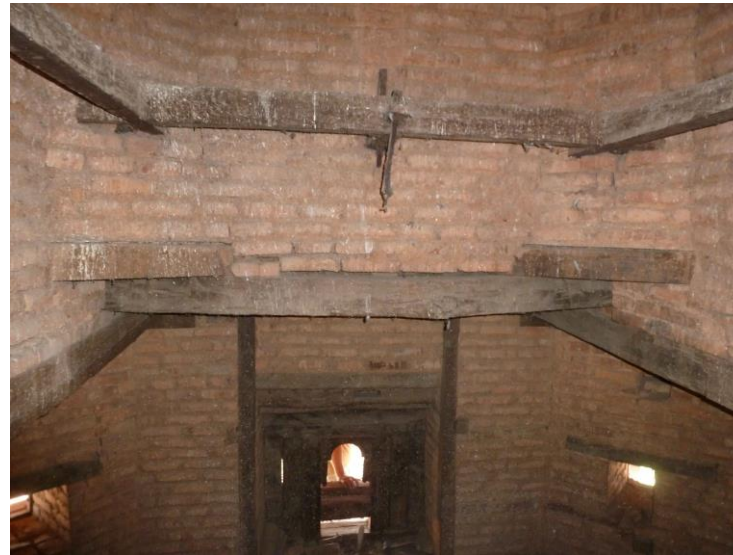
5th floor level:

This level could at this point only be examined from the fourth floor level. The walls step back again at this level. Unlike below, the beams appear to be in a much better condition at this location.
