## RESTORATION AND SEISMIC STRENGTHENING OF THE SOUTH TALEJU TEMPLE

PROGRESS REPORT | MAY 2014

THE KATHMANDU VALLEY PRESERVATION TRUST

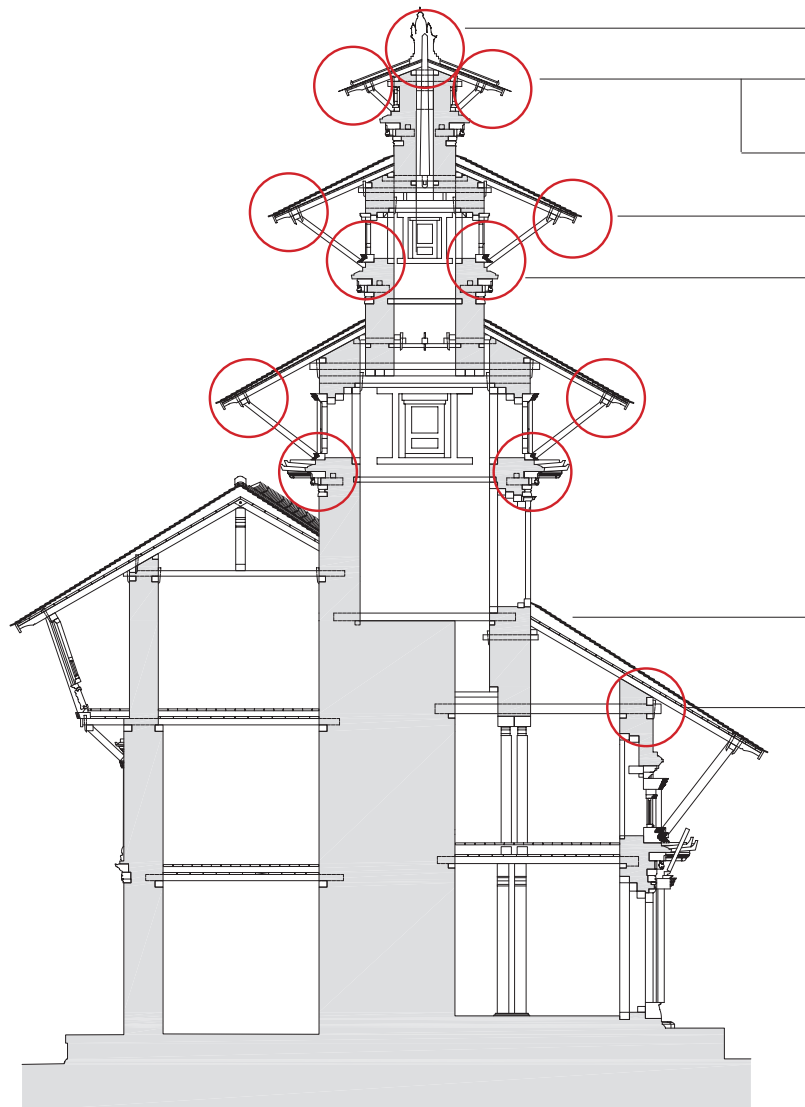
SOUTH TALEJU TEMPLE | SOUTH-NORTH SECTION

**Location of structural interventions** | January 2014  
 The drawing shows the locations of the ongoing structural interventions. The work implemented during the current reporting period was focused primarily on the third tier of the temple.

- Reconstruction of pinnacle armature
- Reconstruction of roof at 28-degree pitch and restoration of damaged roof carpentry
- Replacement of timber collar
- Connection of rafters and purlins using ½" thick galvanized steel pins
- Connection of inner and outer wall plates with steel braces to create a ring beam; reinforcement of corner lap joints

- Temporary removal roof cover to reinforce timber support structure
- Installation of iron I-Sections to strengthen ceiling joists

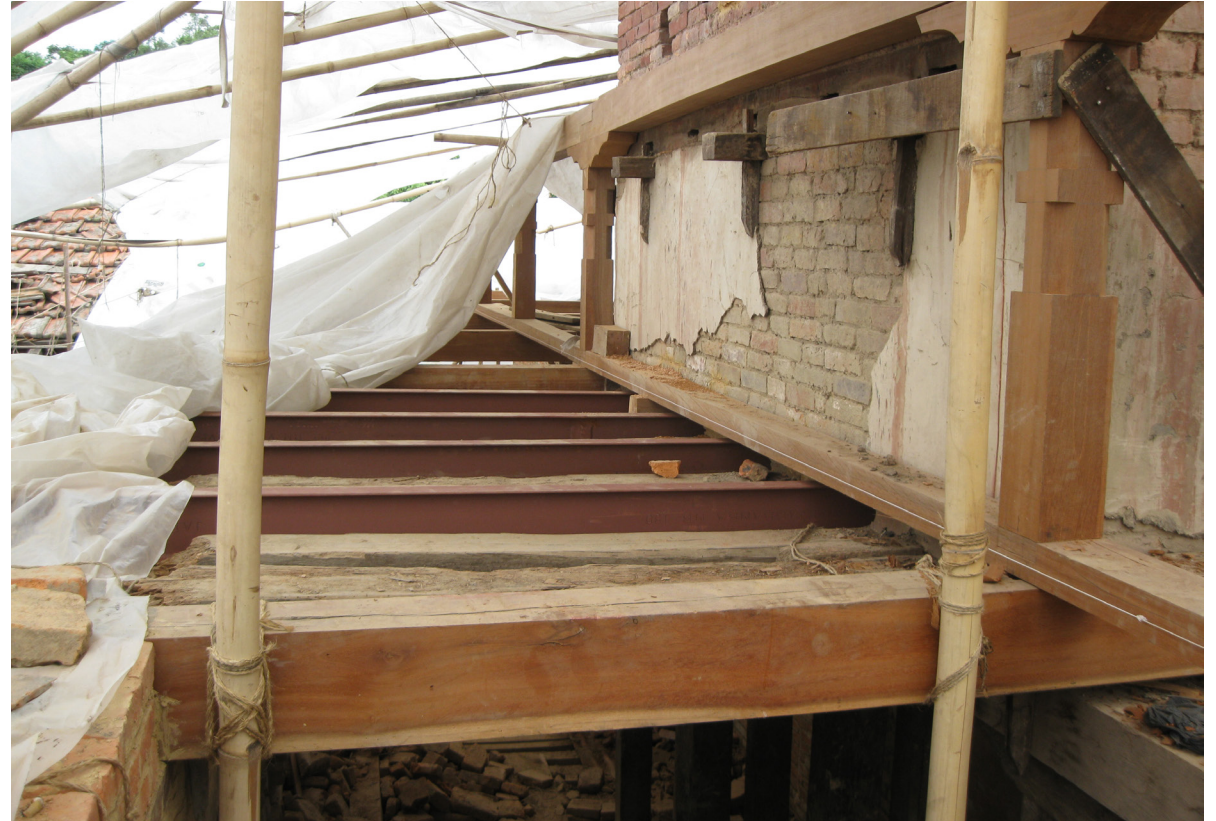
As an emergency stabilization measure, iron I-Sections and newly fabricated timber tie-beams were added to the existing ceiling joists to strengthen the rigidity of this crucial support structure.

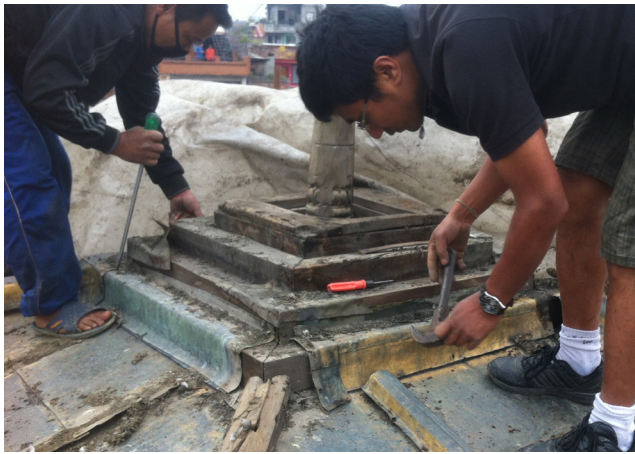
**Removal of historic gilt sheeting** | March 2014  
The gilt sheeting was found to be extensively damaged with several holes allowing water to enter the timber structure.

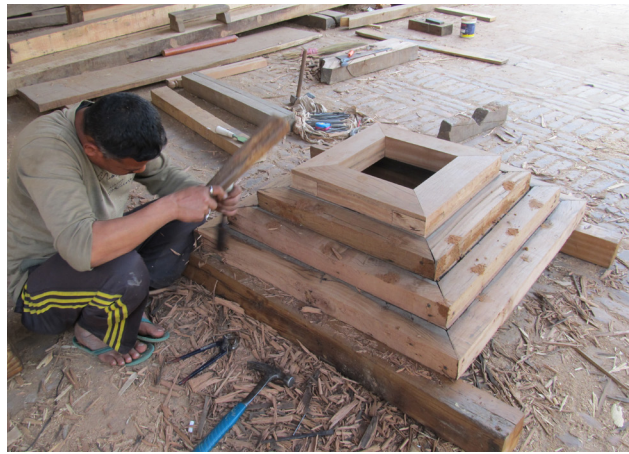
**Reconstruction of timber structure** | April 2014  
Carpenters constructed a new timber structure for the stepped plinth of the miniature *sikhara* temple on the pinnacle.

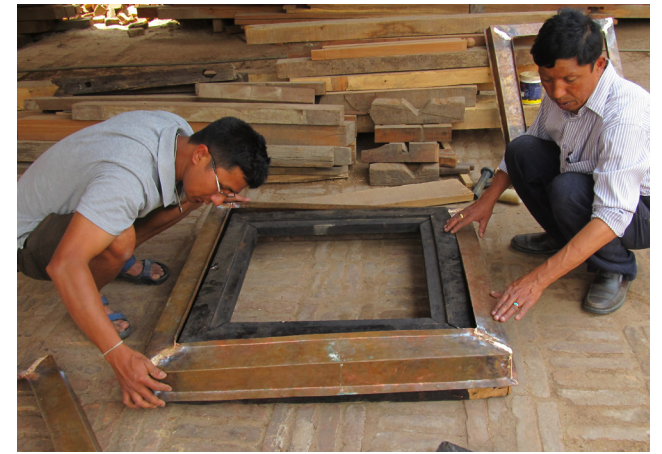
**Sealing with protective copper sheet** | April 2014  
This protective copper sheet will prevent water infiltration into the timber structure.

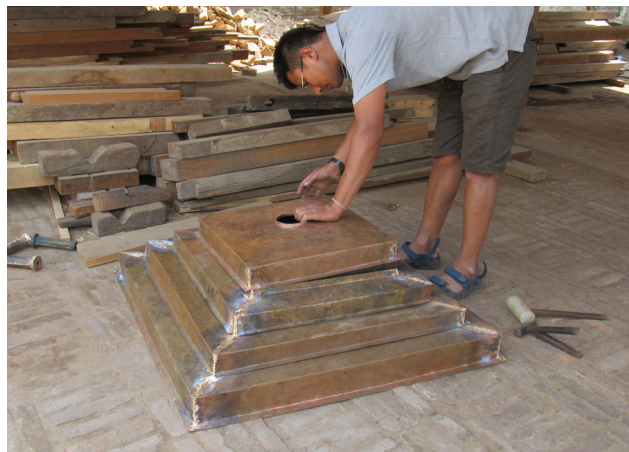
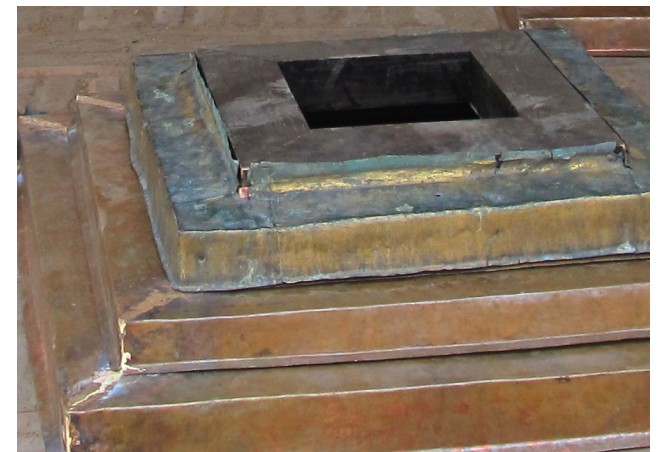
**Reassembly of historic gilt sheeting** | April 2014  
The historic gilt sheet was installed over the new protective copper sheet. This original sheet was left intact since any restoration effort would risk damaging the gilt surface.

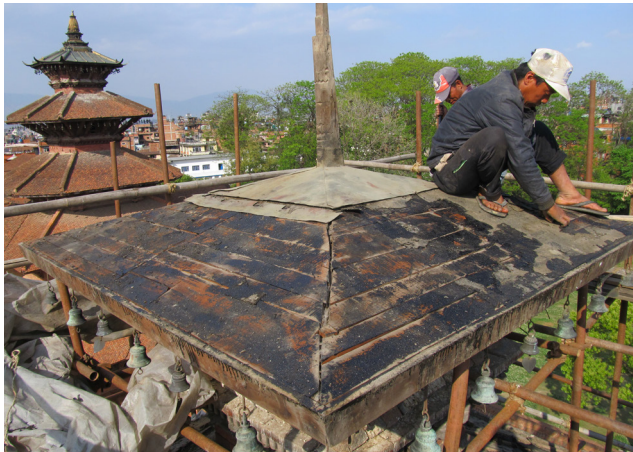
**Removal of existing roof cover** | April 18, 2014  
The removal of the roof cover revealed heavily damaged timber planking.

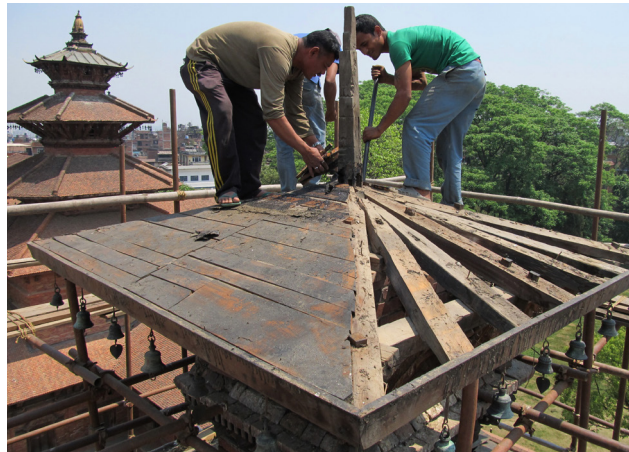
**Removal of timber planking** | April 22, 2014  
The quality of the existing timber varied considerably: relatively new rafters were supported by rotten wall plates.

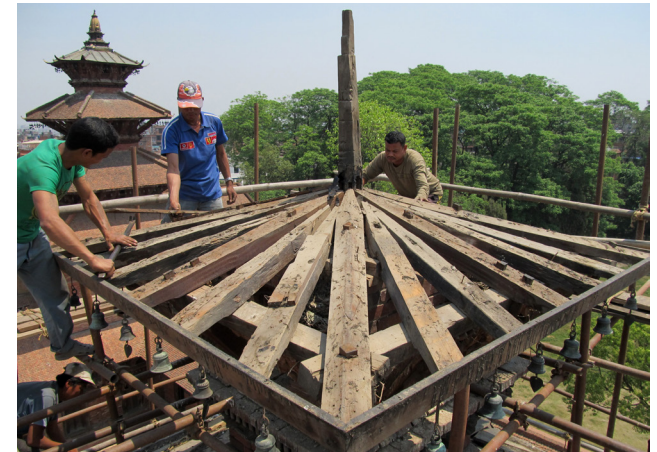
**Inspection of existing rafters** | April 22, 2014  
All of the rafters were found to be unusable.

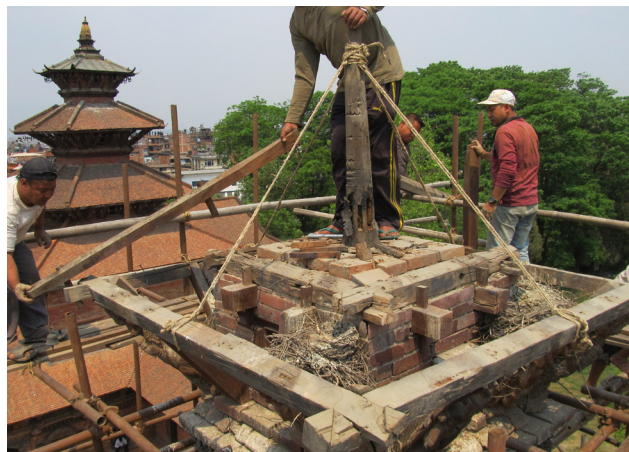
**Removal of corner rafters and timber collar** | April 24, 2014  
The existing timber collar beams were found to be rotten.

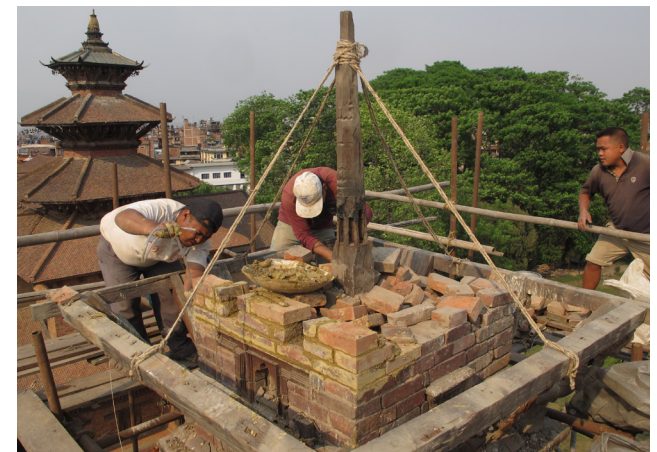
**Reconstruction of masonry walls** | April 25, 2014  
The masonry wall was raised in preparation for the installation of the newly constructed hardwood collar (*see page 19*)

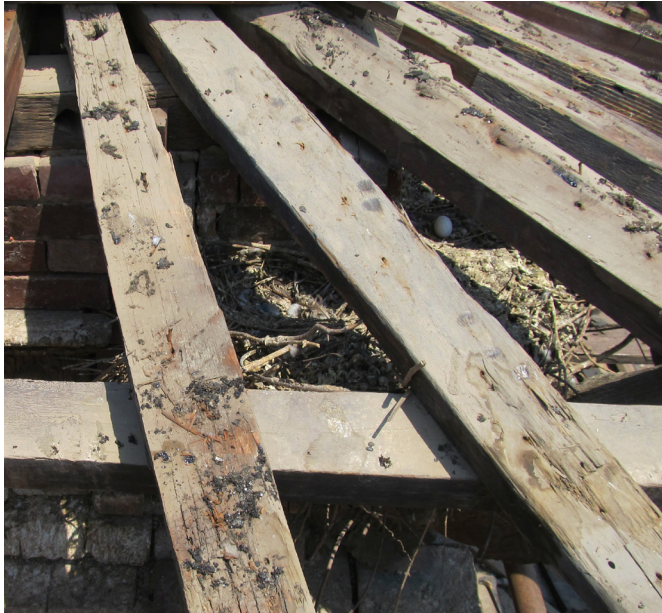
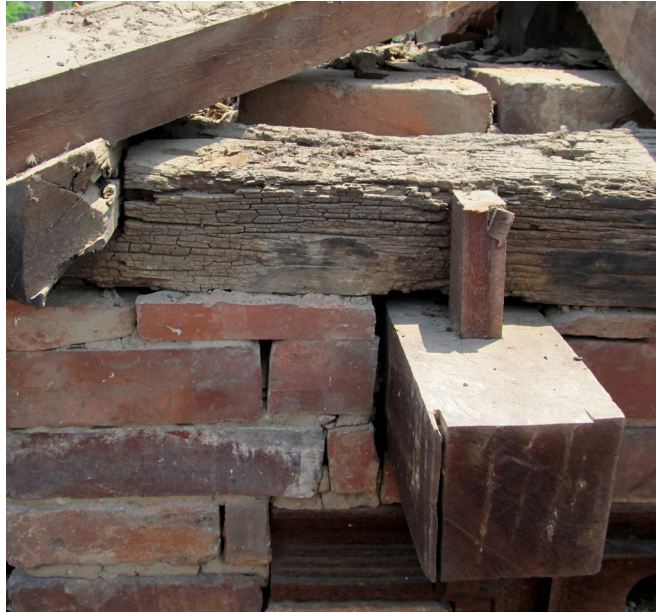
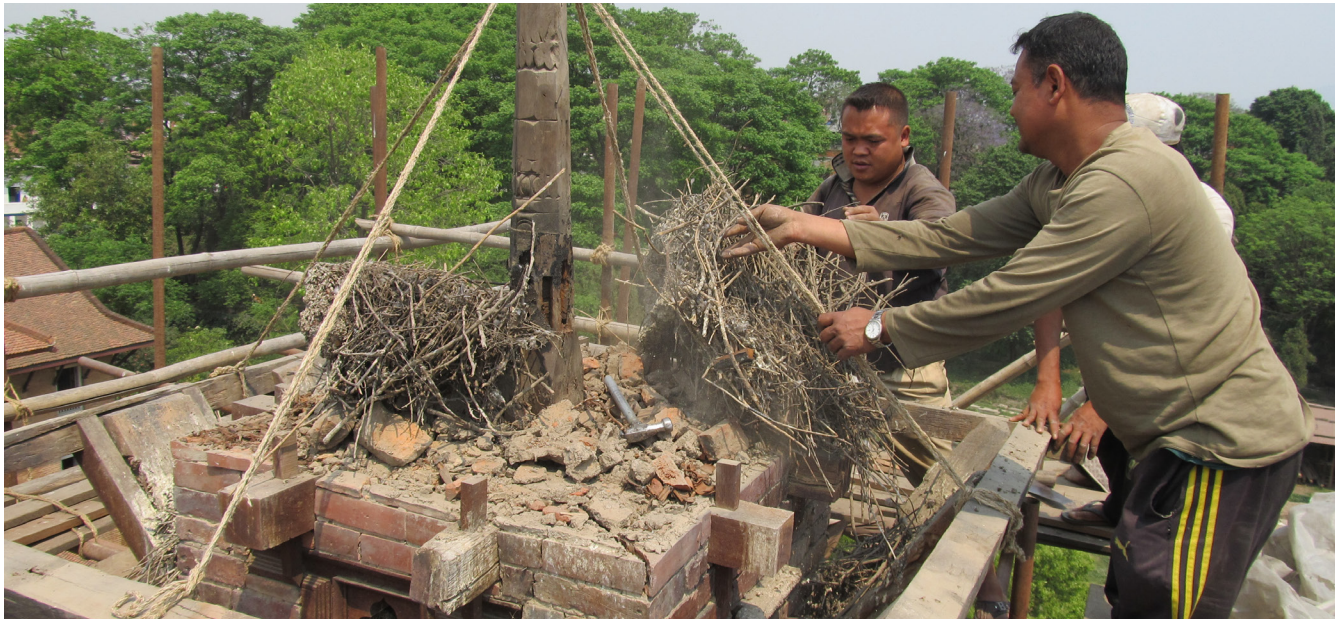
**Existing conditions of roof carpentry** | April 22, 2014  
The roof structure was examined more closely after the removal of rafters. There was considerable variation in the quality of the structural timbers, with several rotten timbers connected to relatively new ones. Some of the timber elements date to the 1938 reconstruction while others were likely added in the 1970s. Up to 75% of the structural timbers were affected by dry rot and in need of replacement. Parts of the interior timber frame have been damaged by water and rising damp. Brick and timber surfaces had also been affected by the acidity of pigeon excrement. The four pigeon nests that were found beneath the rafters were removed.

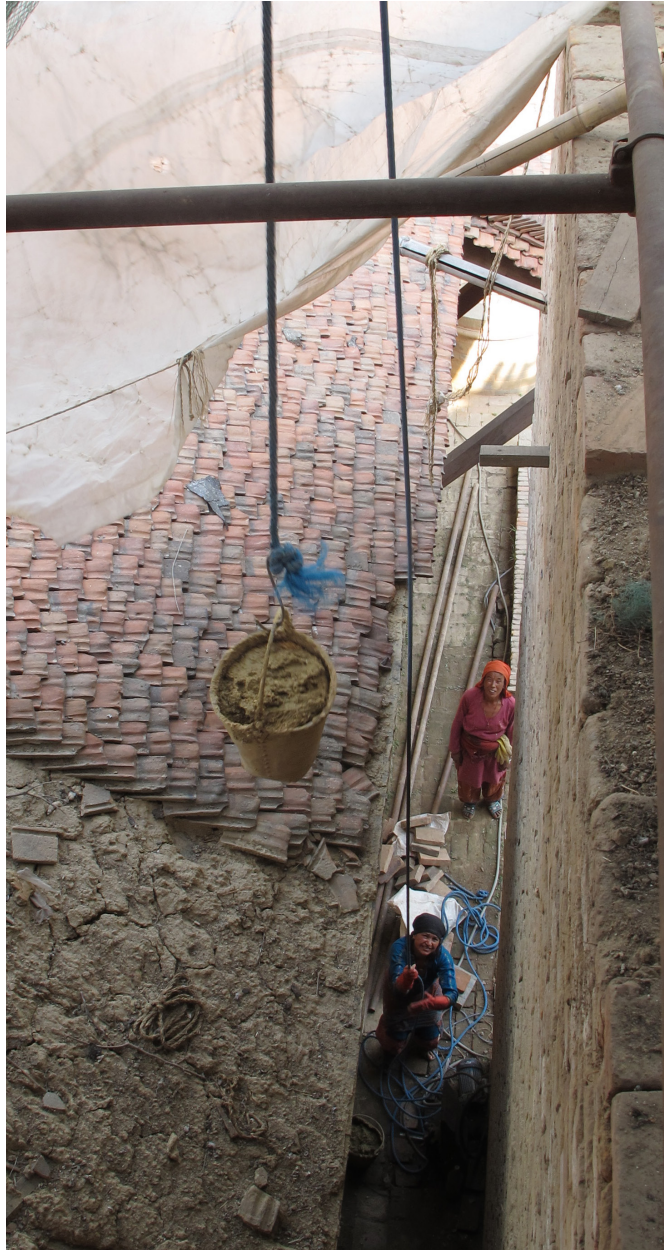
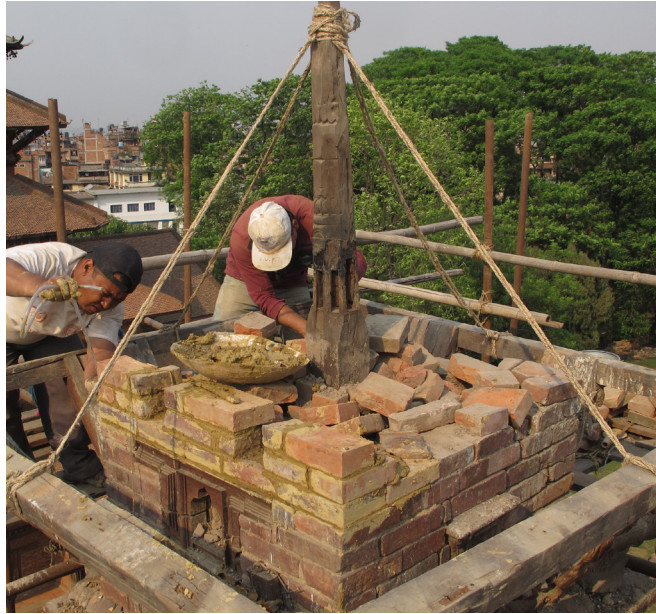
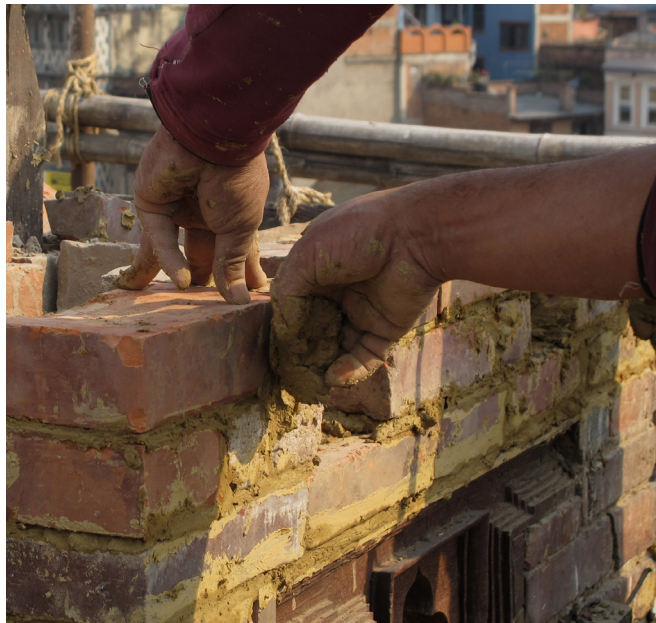
**Rebuilding masonry on the third tier** | April 25, 2014  
Mud mortar was transported to the top of the temple using a pulley through the gap between the roofs of Mulcok and Sundaricok. The masonry was raised to support the new roof structure. Traditional mud mortar is preferred as it is a flexible bonding material with shock absorbent properties.

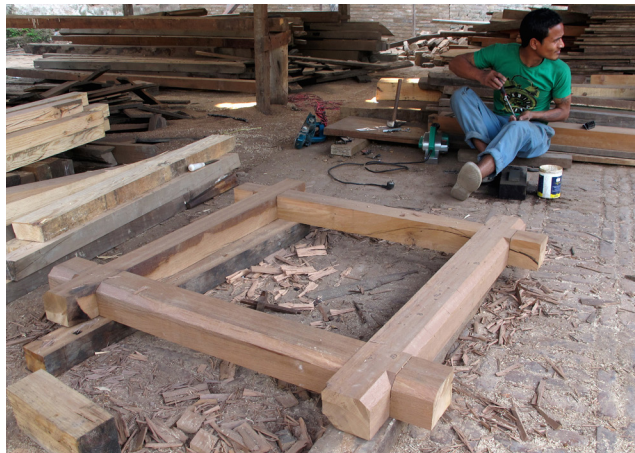
**Reconstruction of timber collar** | April 24, 2014  
Carpenters fabricated a new timber collar using sal wood. The four timber elements were half-lapped to form a ring anchor.

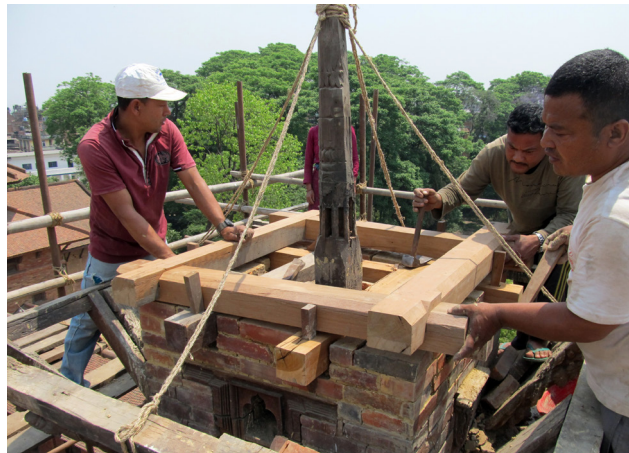
**Installation of timber collar** | April 27, 2014  
The new timber collar was installed on top of the raised masonry on four cross pieces, optimizing the bond of the timber structure to the masonry.

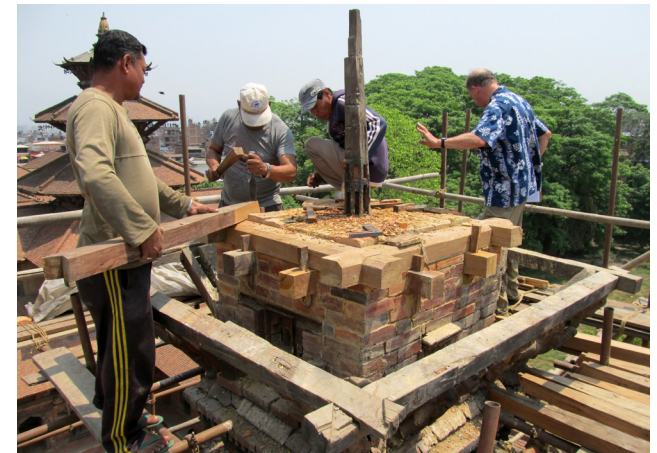
**Fixing of rafters** | April 27, 2014  
A new joint was created 1' above the existing joint to fix the rafters to the existing central timber post.

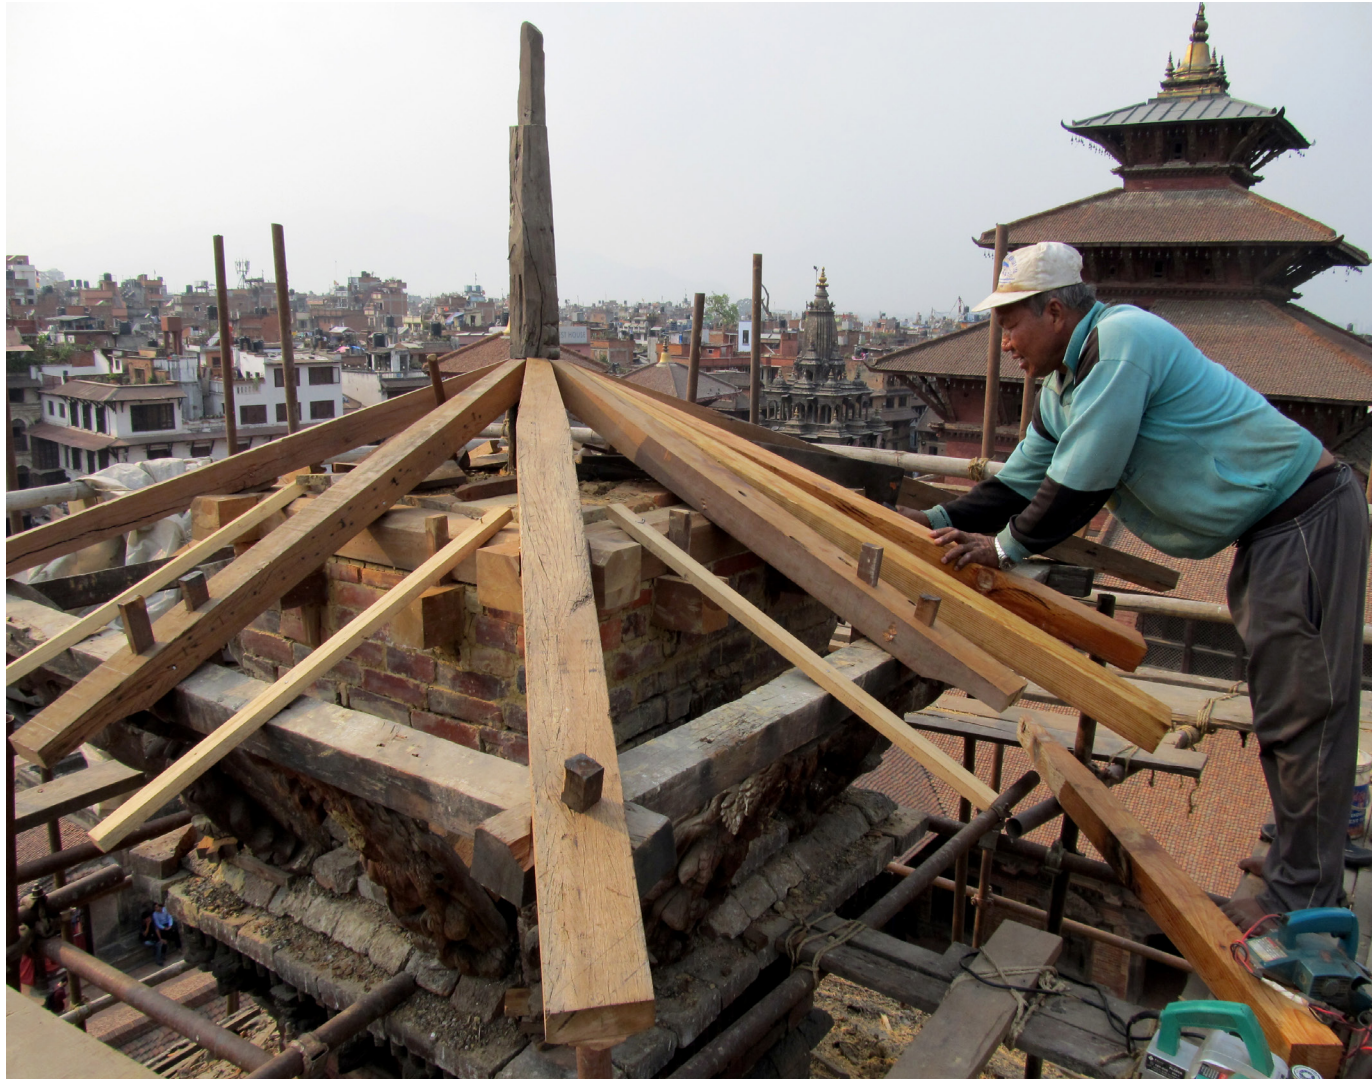
The central and corner rafters (Sal wood) were joined to the purlins using traditional timber pegs. In this photograph, common rafters (pine) are being fixed in place before being cut to size.

½" thick galvanized steel bolts were fixed to alternate rafters to strongly connect them to the purlin.

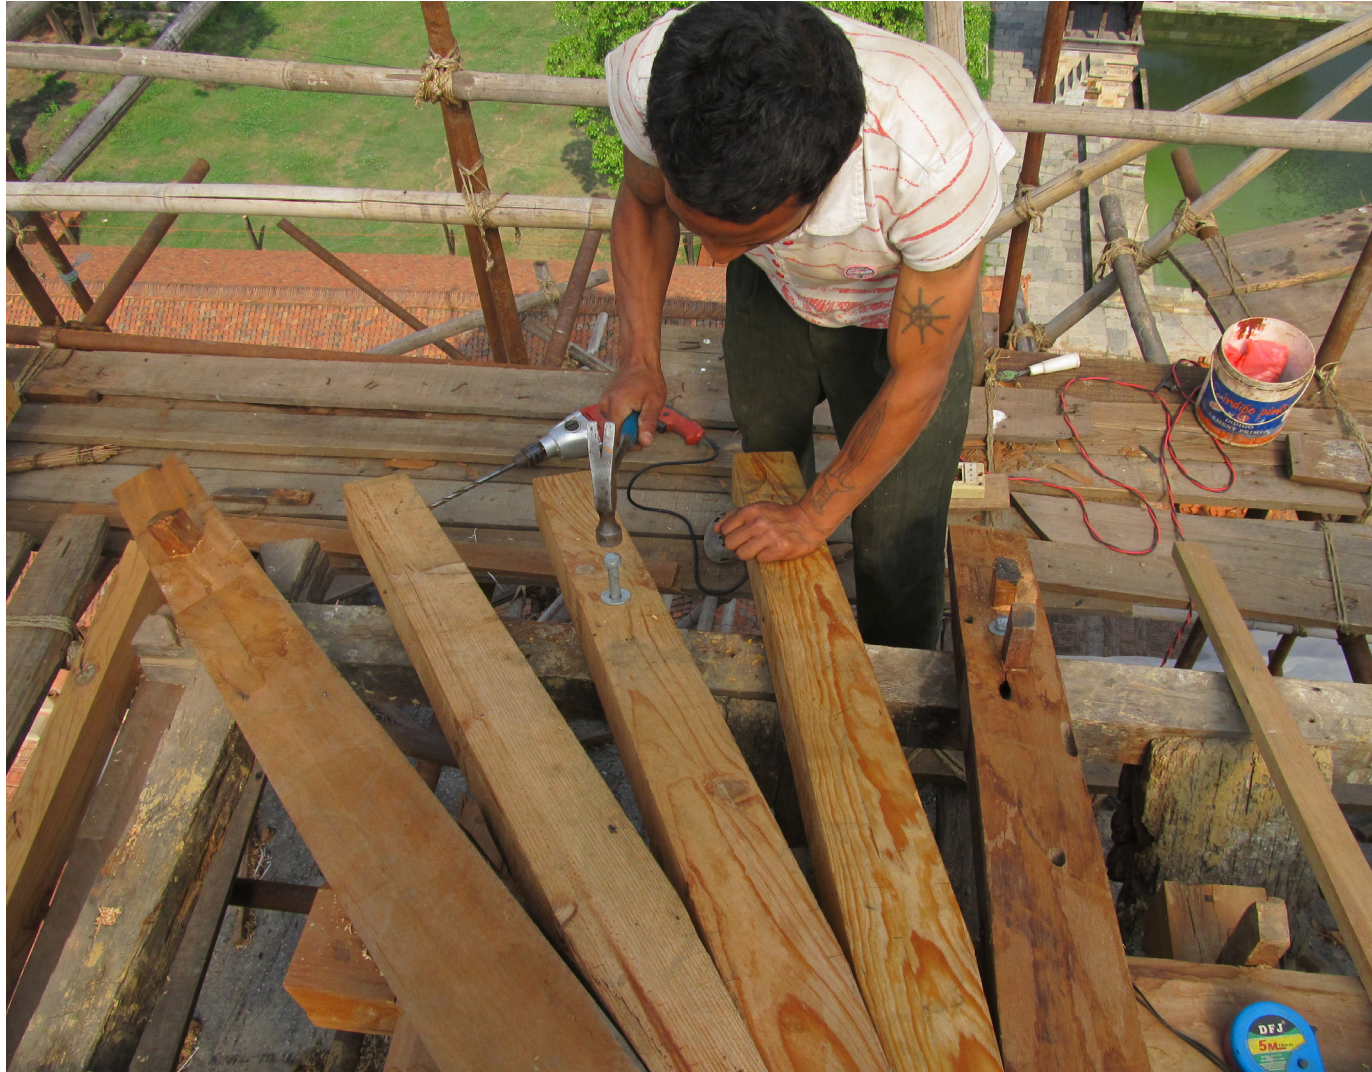
**Rafter-purlin joint** | April 30, 2014  
Traditional joinery uses timber pegs (*chukul*) to connect rafters to purlins. These joints must be reinforced with steel to provide additional rigidity in the event of seismic movement. In this photograph, a carpenter fixes a ½" thick galvanized steel bolt on alternate rafters on the third tier.

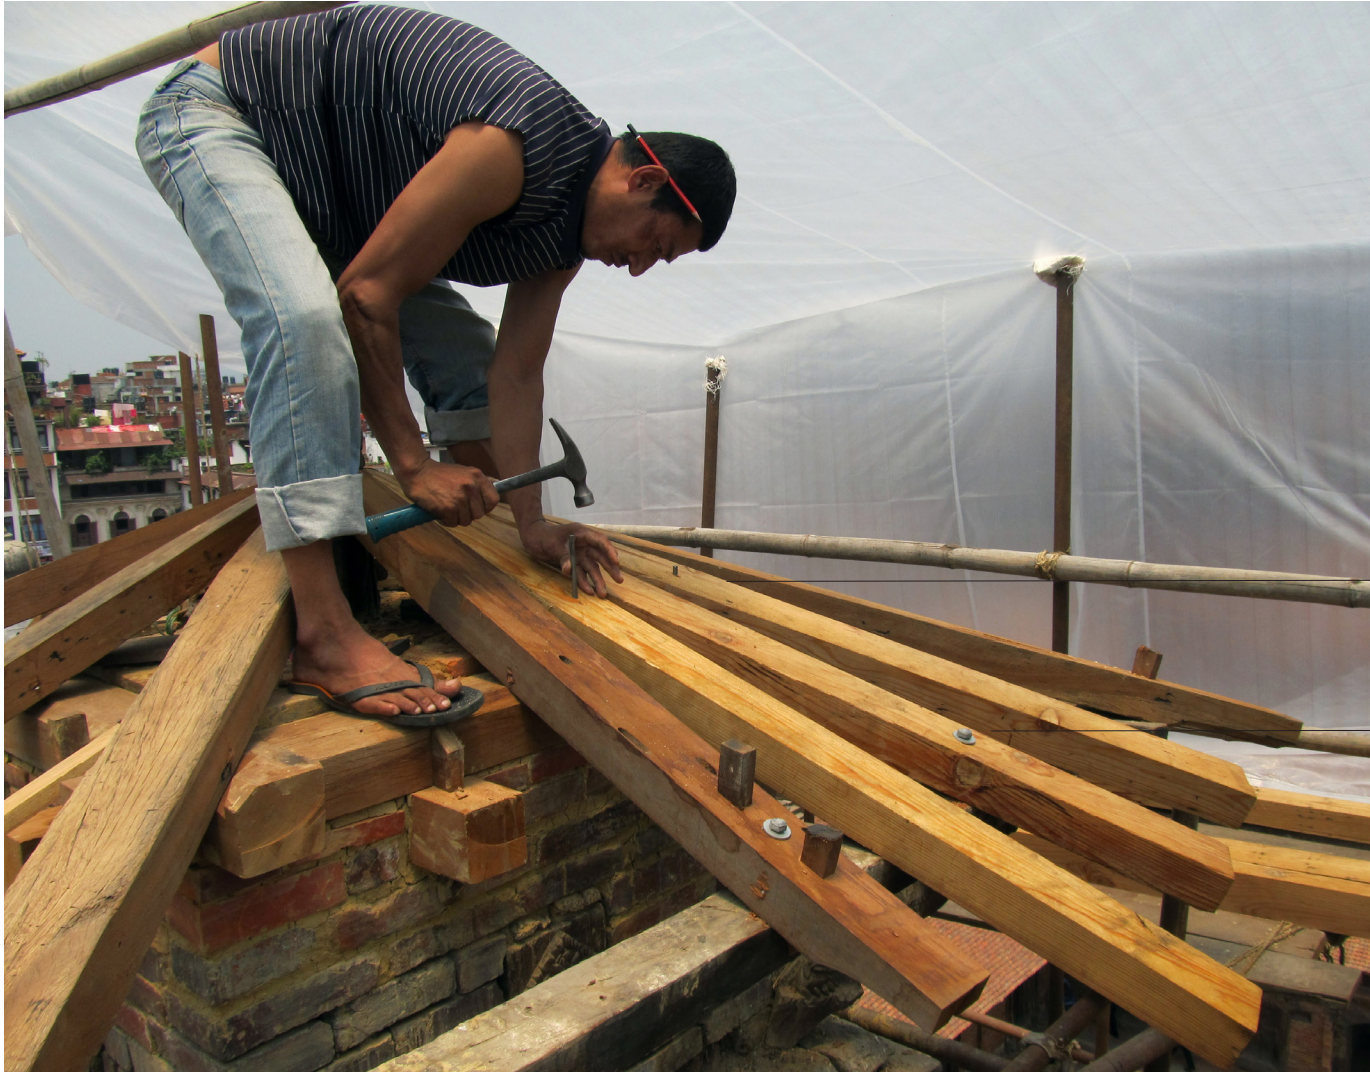
**Rafter-collar (wall plate) joint** | April 30, 2014  
In traditional structures the rafters are not notched to the wall plates. This is not sufficient to resist the impact of seismic motion. In this photograph, 3/8" stainless steel pins are being used to join the rafters to the timber collar of the third tier. This will firmly pin the rafter to the plate and thus prevent any downward sliding movement of the rafters.

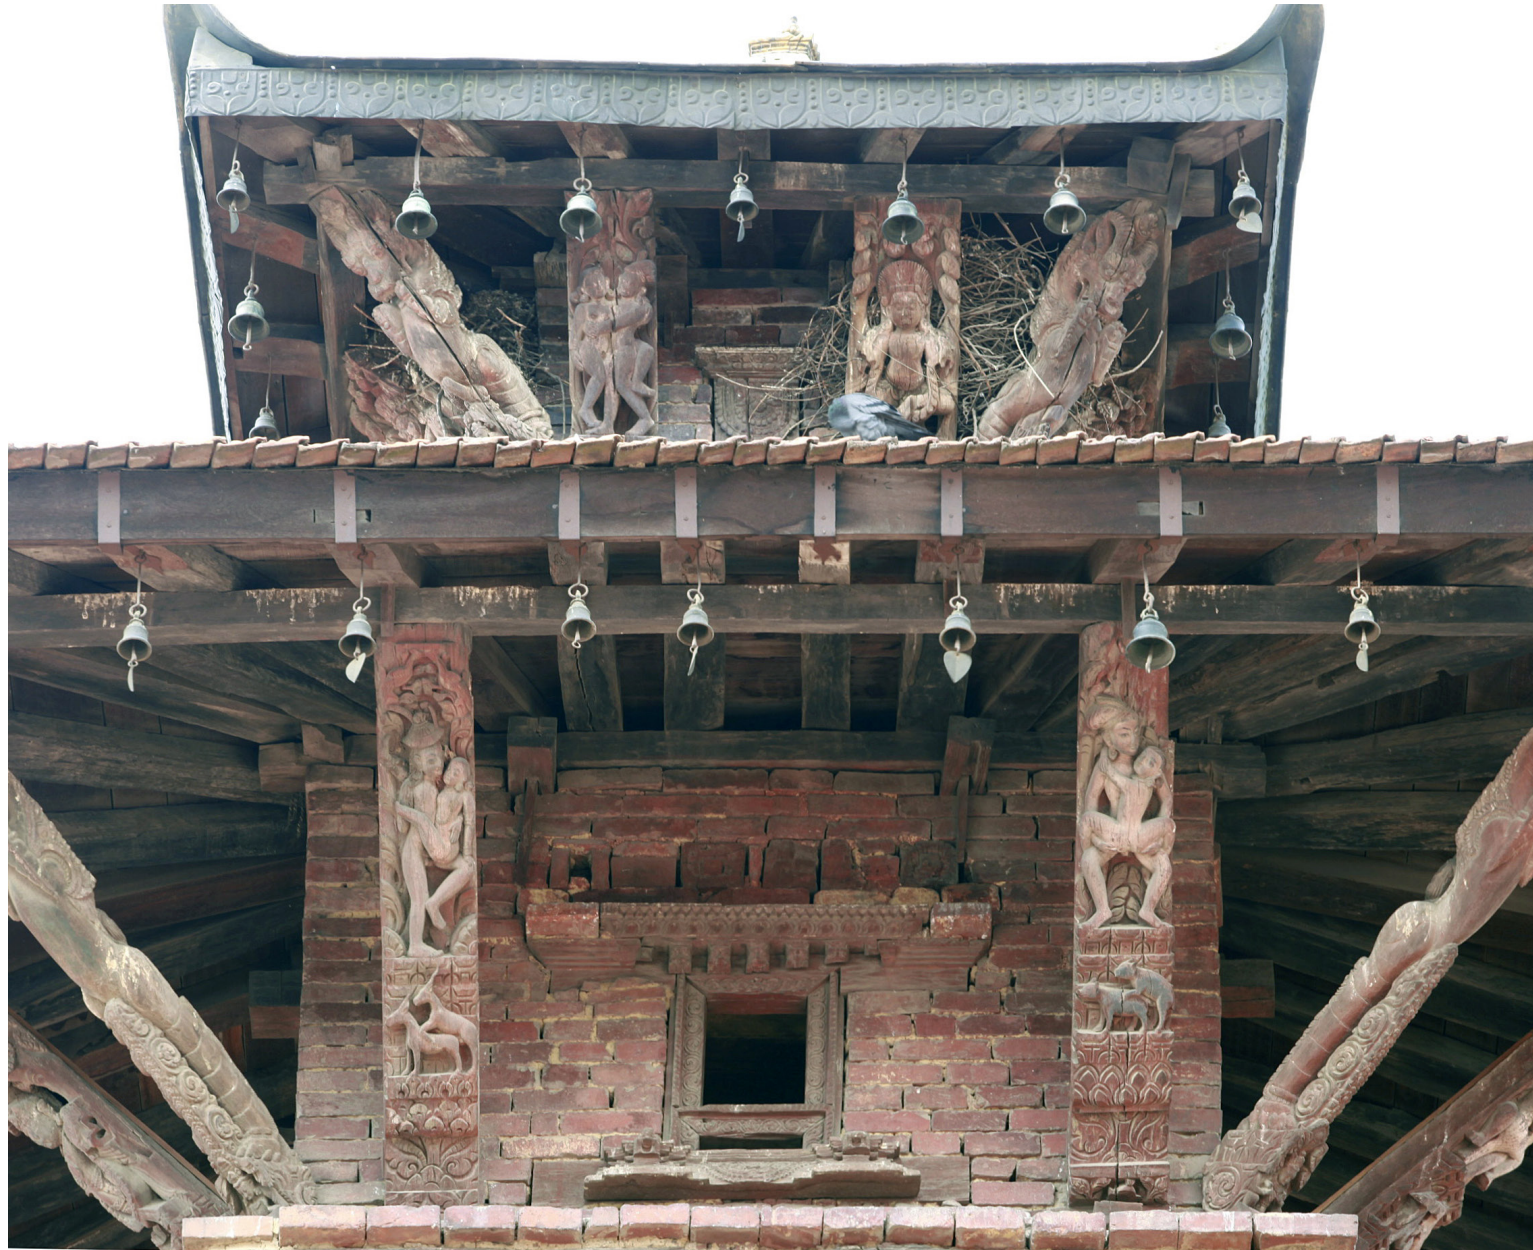
**Second and third tiers | May 2013**  
This photograph shows the condition of the struts, rafters, and purlins of the second tier. Some of the struts depict Tantric divinities, while others feature various manifestations of Bhairabs and Matrikas. The 6 plain struts dating to 1994 were left intact.

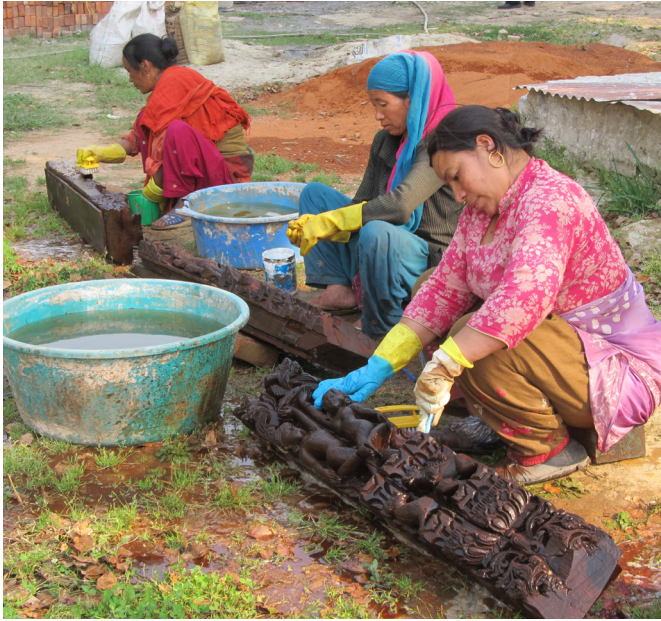
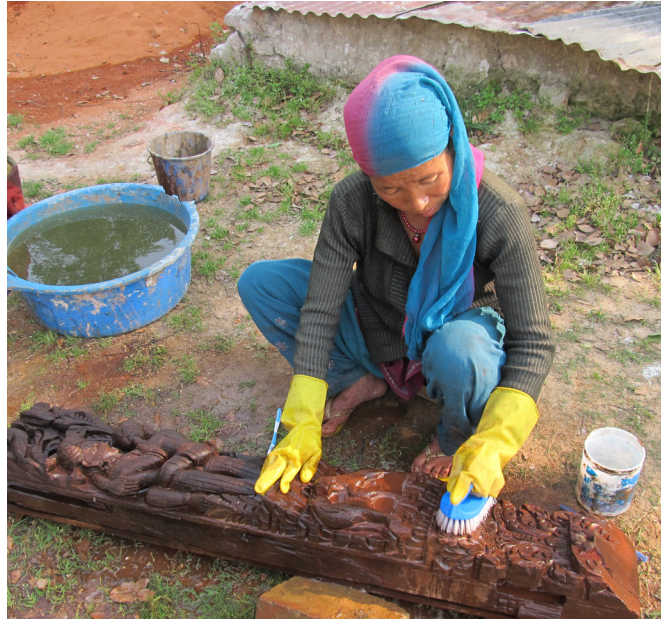
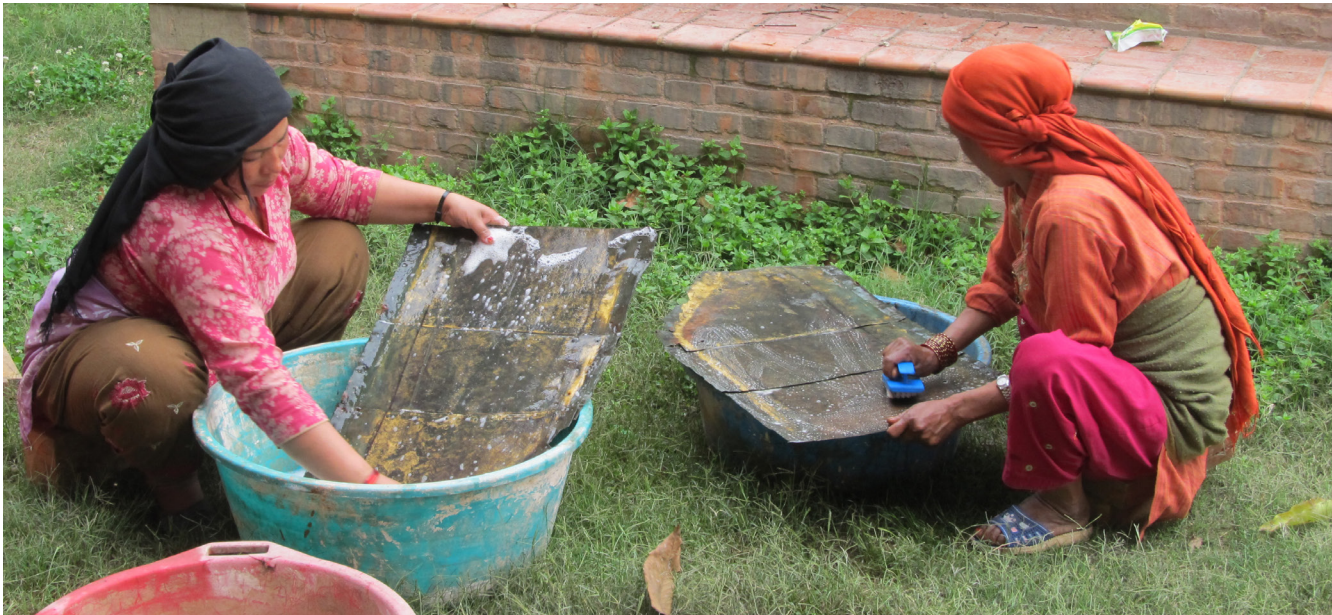
**Cleaning of struts and gilt copper sheet** | March 2014  
The removal of the water-soluble polychrome paint, which dates to King Mahendra's royal coronation in 1956, makes the relief carvings on the struts much more legible. The copper sheet of the third tier was carefully cleaned with plain water and brushes.
