THE RESTORATION OF
THE MUL CHOWK GOLDEN DOORWAY ENSEMBLE
AT THE PATAN ROYAL PALACE COMPLEX – A UNESCO WORLD HERITAGE SITE

PROJECT APPLICATION | OCTOBER 2011

THE EMBASSY OF THE FEDERAL REPUBLIC OF GERMANY, KATHMANDU, NEPAL

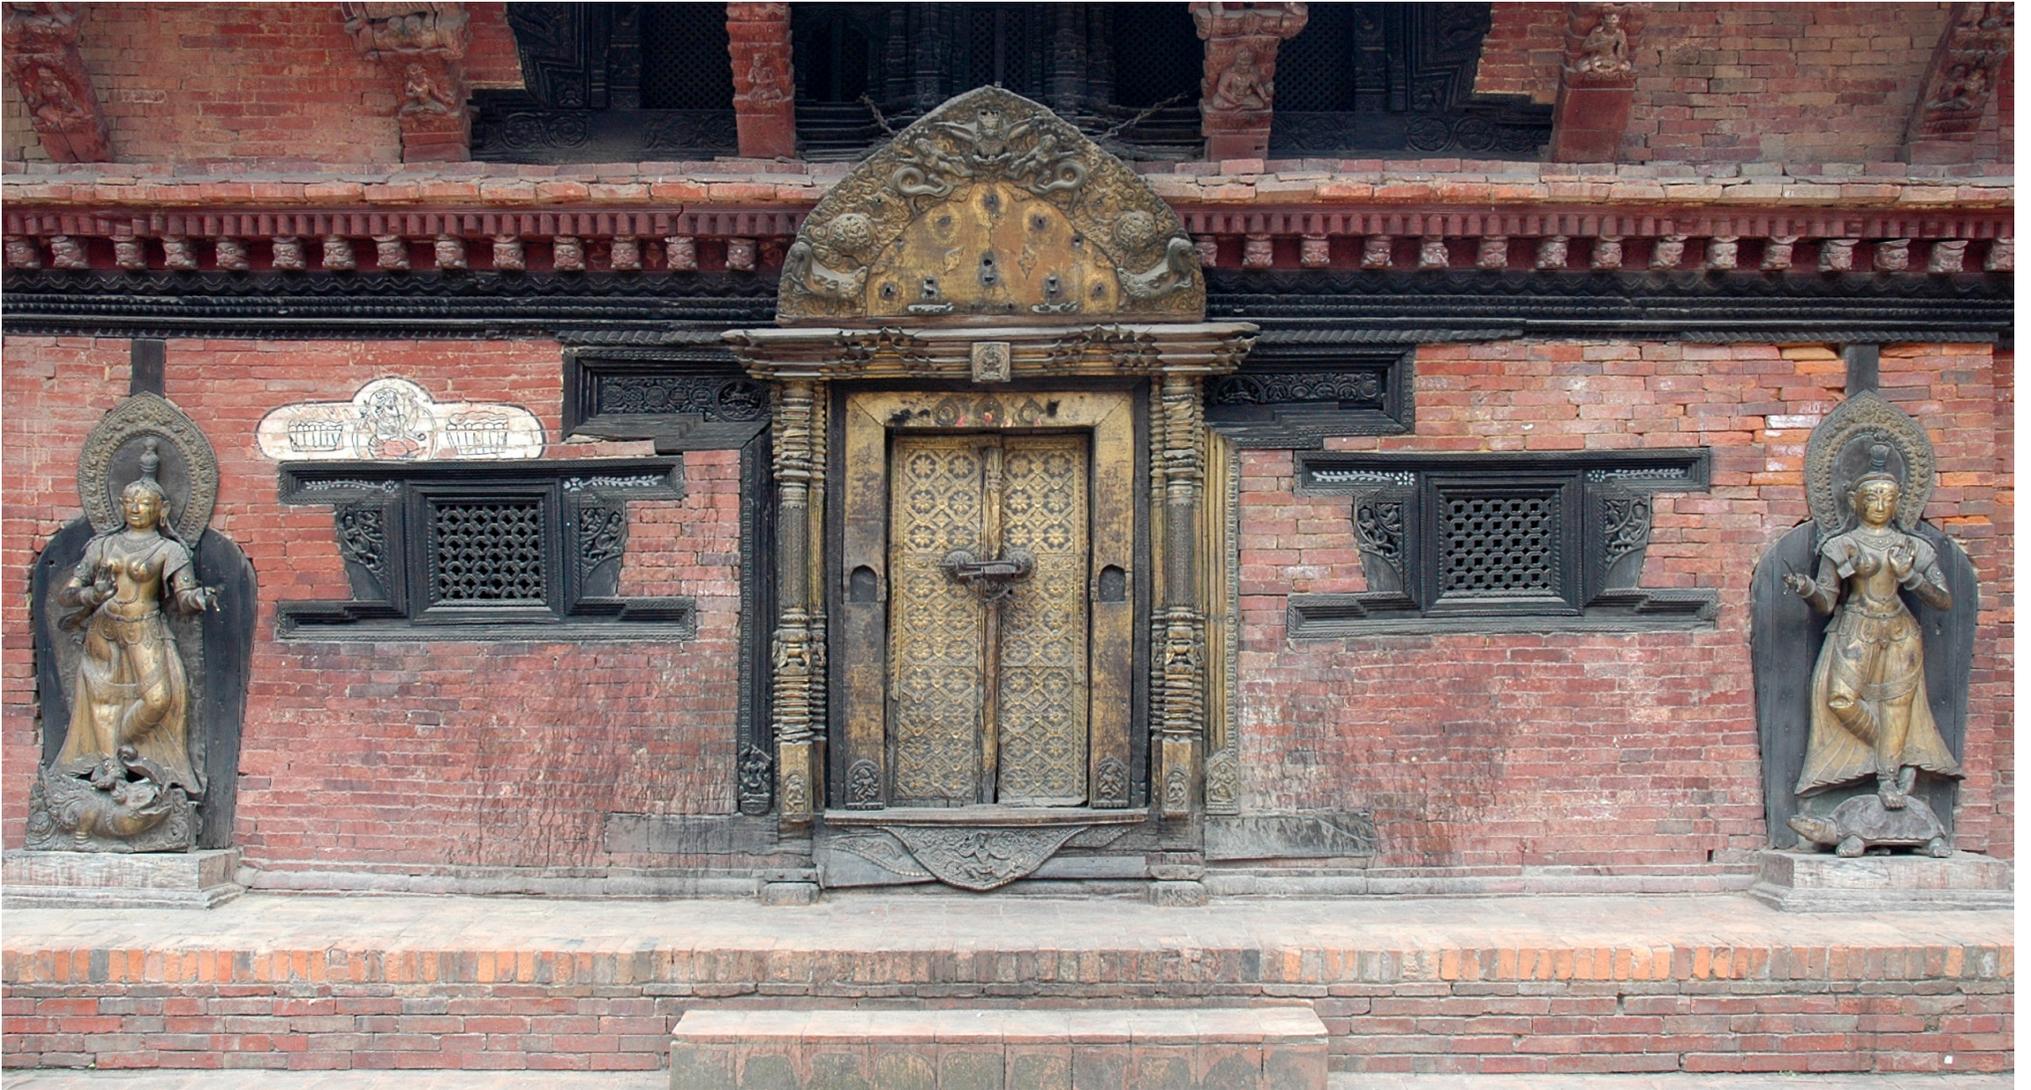
Frontal view of the Mul Chowk Golden Doorway Ensemble | Sep 19, 2011
Facing the courtyard façade of Mul Chowk's south wing, Yamuna flanks the doorway and tympanum to the right, while Ganga stands on the left.

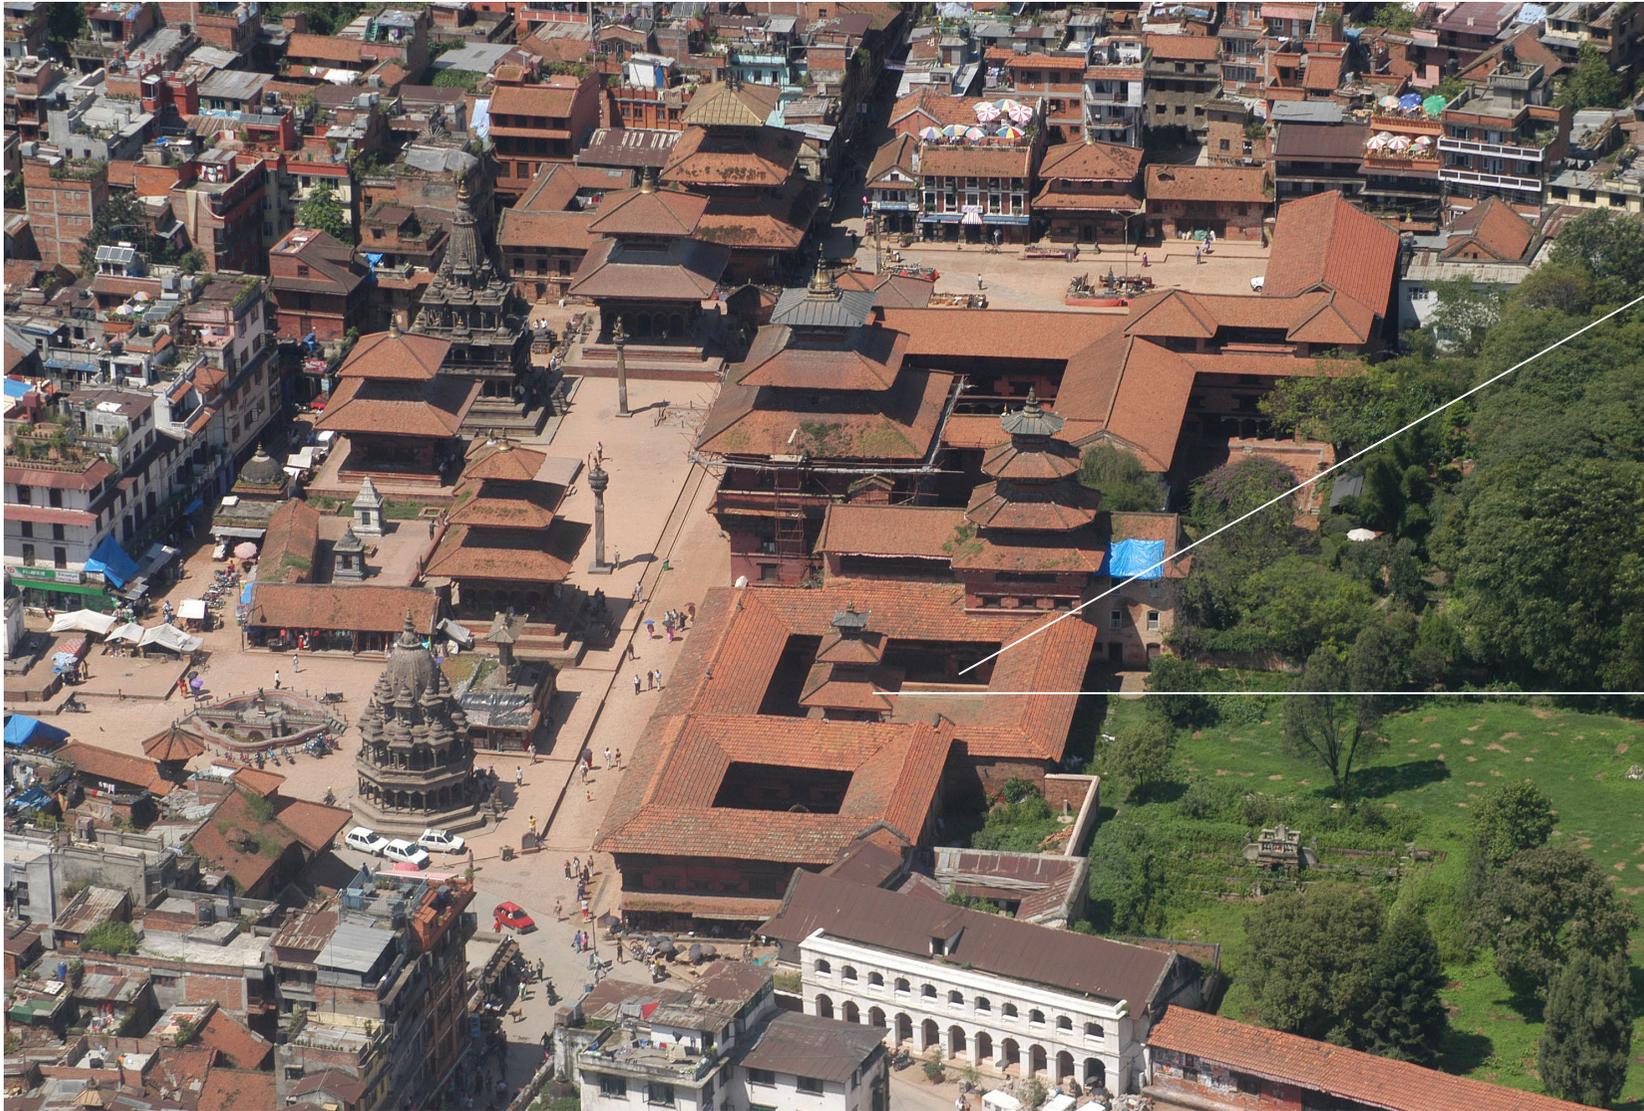
Mul Chowk
The Golden Doorway ensemble is located in the south wing of the Patan Palace Complex's Mul Chowk, Nepali for "main courtyard".

Taleju Temple
The Golden Doorway marks the entryway to this three-tiered temple, and is located just beneath it here.

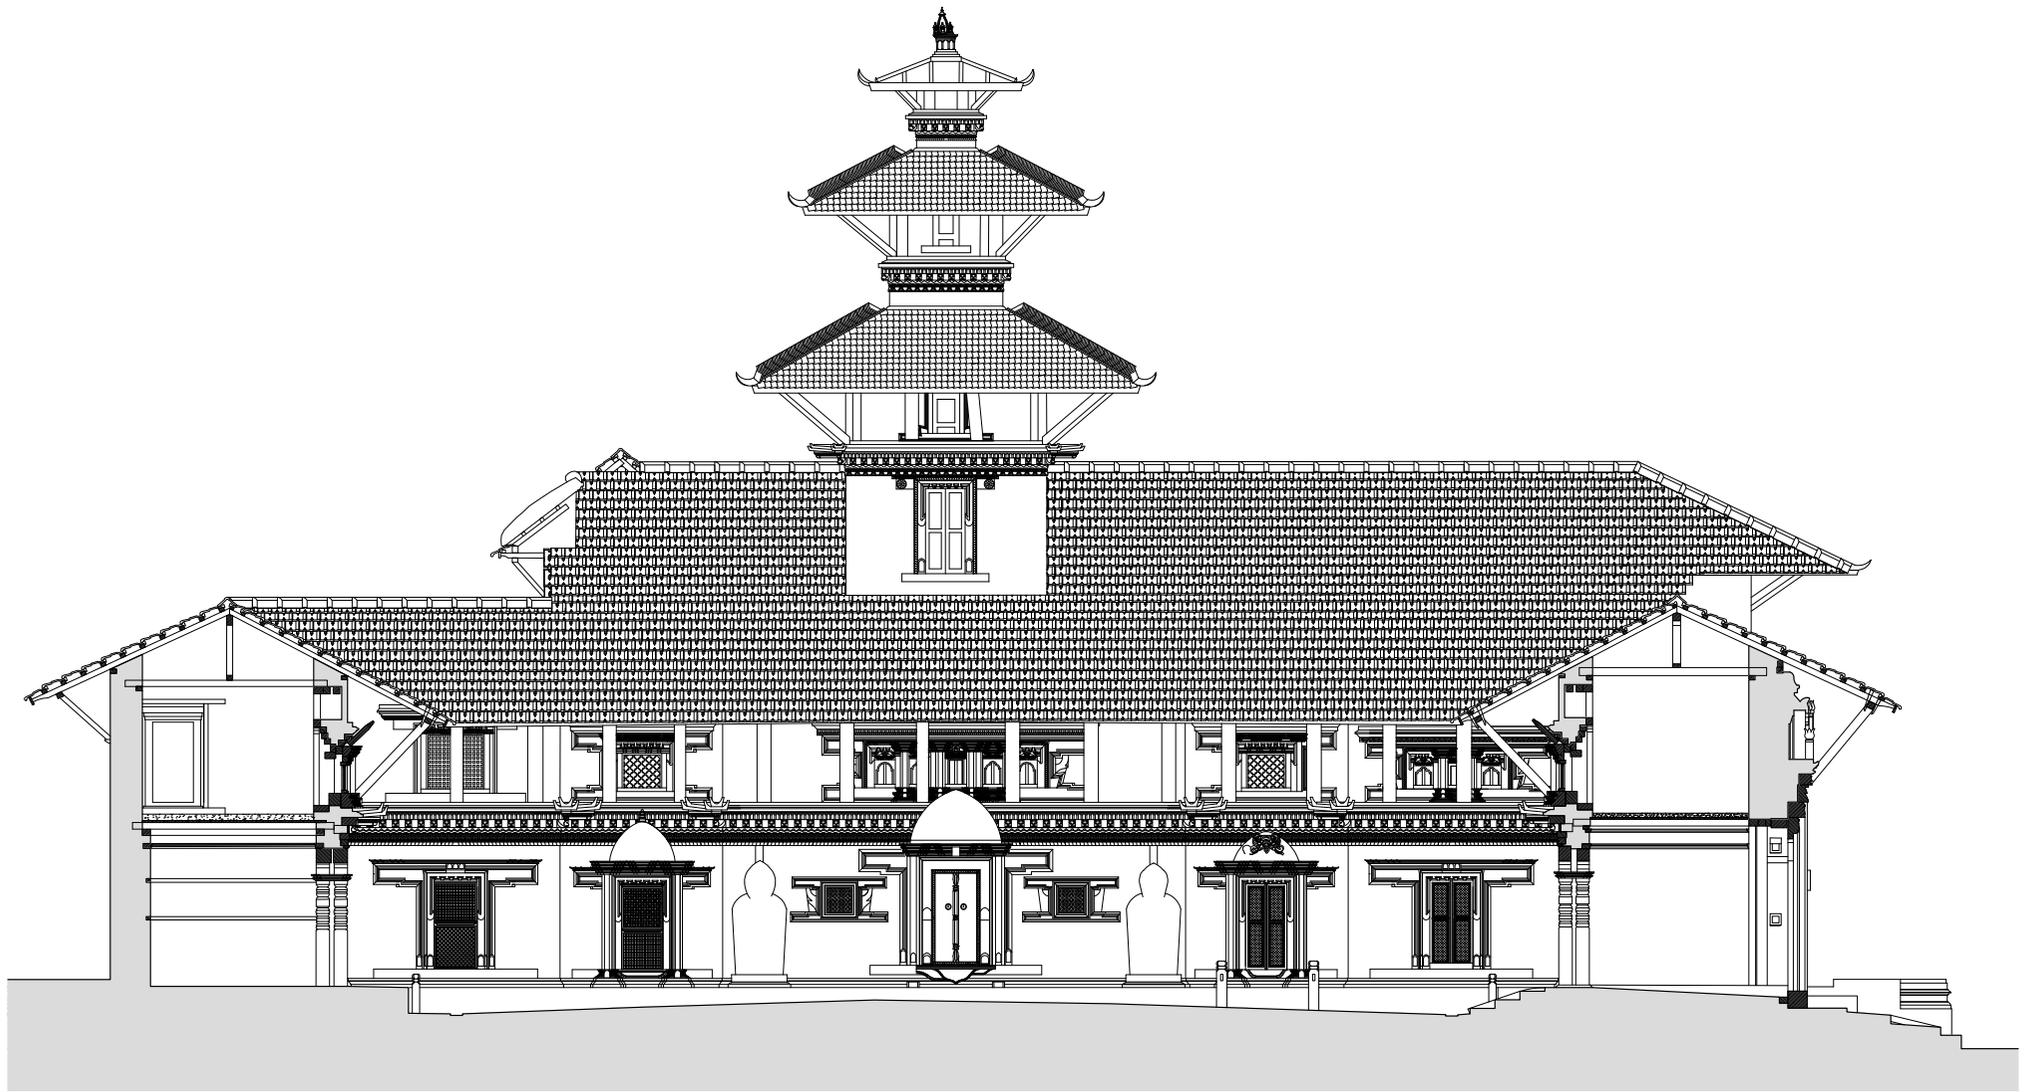
Elevation Drawing of Mul Chowk's south façade | Sep, 2011

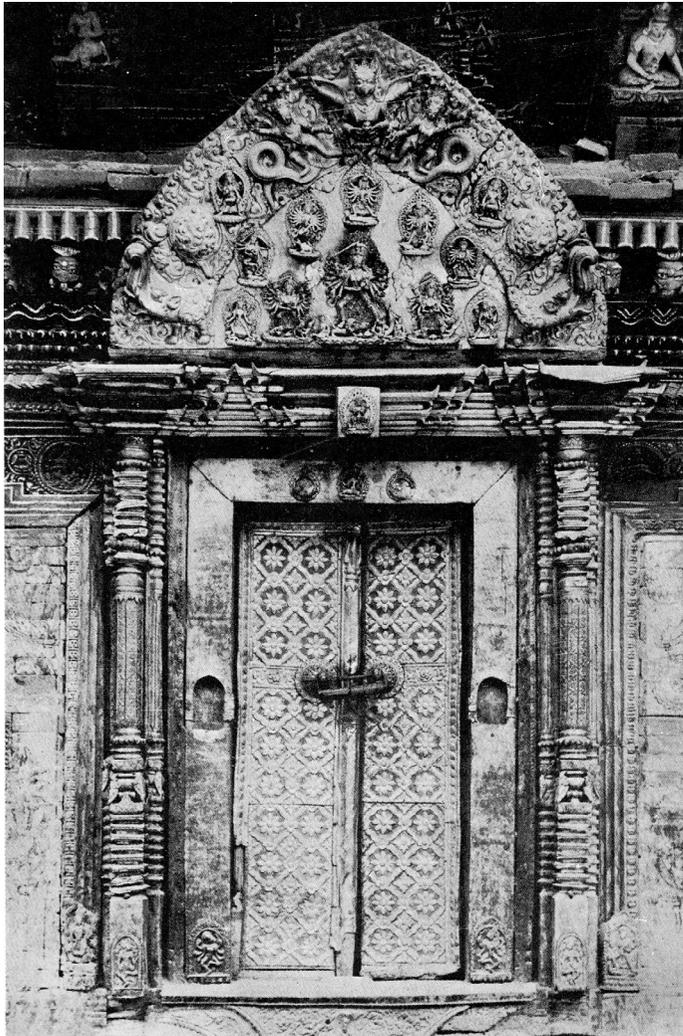
The Golden Doorway | approx. 1966 – 1972
 Photo by N.R. Banerjee, Archaeological advisor to His Majesty's Government. Published in "Nepalese Architecture", (1980), Delhi.

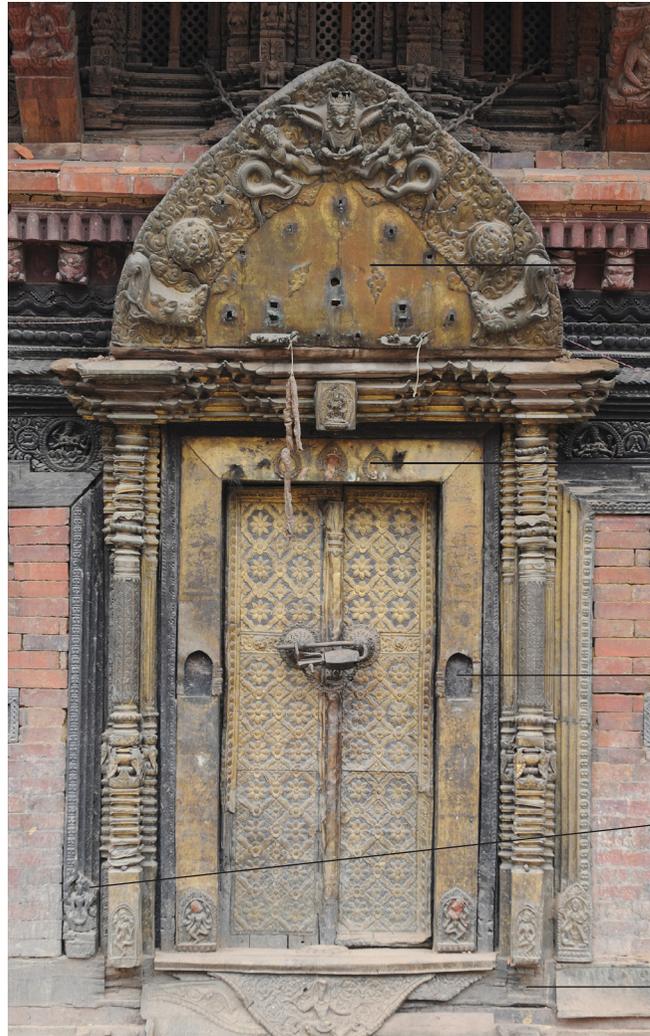
The Golden Doorway | Sep 19, 2011
 This image illustrates how many details, particularly the small statues of the tympanum, are now missing.

Missing small sculptures from the tympanum
 All sculptural deities were stolen sometime after the late 1960s, as documented by Dr. Slusser's photographs.

Missing deities from top door frame
 The three deities originally placed on the top of the door frame, and depicted in the historic photograph on the left, are now missing.

Empty niches in doorjamb
 The niches present in each doorjamb might have once housed deities. It is impossible to know who these deities were as there is no existing documentation.

Guardian god missing repoussé covering
 This guardian god on the far left outer door molding is missing its copper repoussé covering, which all four other guardian gods still retain.

Missing pillar base | Sep, 2011
 The obvious gap between the abrupt end of the pillar and the ground level indicates that the original base of the pillar is now missing. The base was likely a lion, as lions are typically used throughout the valley.

1. **Structural Repair and Replacement:** mechanical repairing and rectifying of the damaged moldings, including the fabrication of missing pieces.
2. **Dry Cleaning:** cleaning with soft brushes and compressed air. Mud can be gently removed with wooden spatulas.
3. **Wet Cleaning:** cleaning with potable water and soft sponges, followed by immediate drying with soft towels in order to avoid stains. Final drying in the sun.
4. **Protective Coating:** Applying a protective coating of micro-crystalline wax to protect against pigeon droppings and accumulated residues. This coating will only be applied if its maintenance can be ensured, and a thorough plan for the coating's care will be devised.
5. **Replacing Missing Deities:** Replicas of the lost deities will be made using historic evidence from the photos, and then fire gilded. The new replacements will be installed above the door frame.

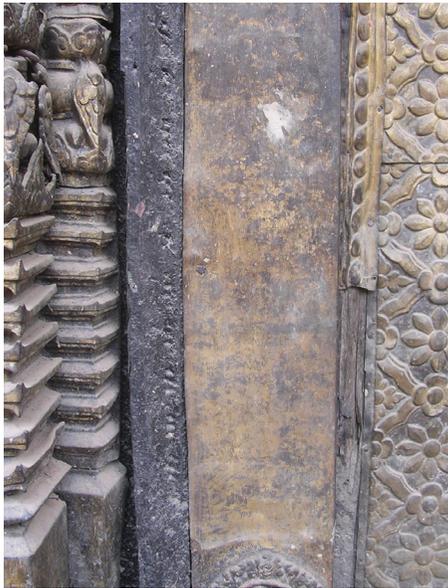
Existing condition of doorjamb | Sep 21, 2011
The doorjamb in its existing condition. Here the thick patina of grime, dust, and animal blood from sacrifices can be observed.

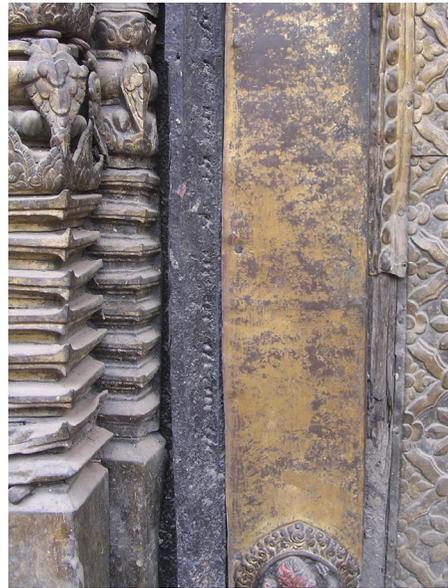
Doorjamb after dry cleaning | Sep 22, 2011
The doorjamb after the first stage of cleaning. In this stage of “dry” cleaning, soft brushes and compressed air was used.

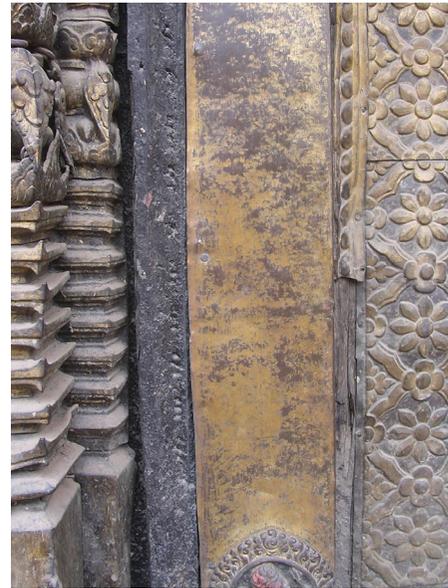
Doorjamb after wet cleaning | Sep 22, 2011
The doorjamb after the second stage of “wet” cleaning. Here potable water was applied with soft sponges. The water was then immediately dried with soft towels in order to avoid staining.

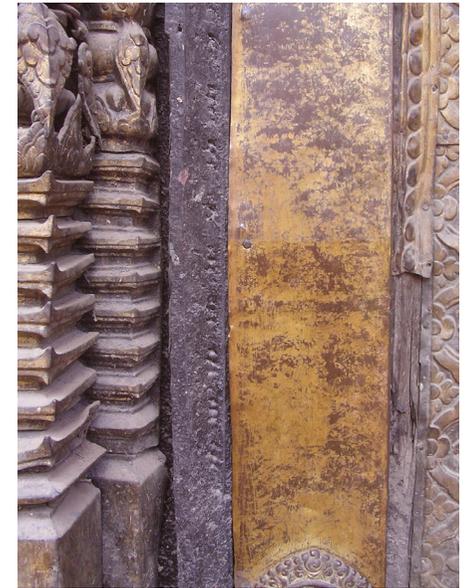
Doorjamb after application of protective coating
Here, a protective coating of micro-crystalline wax was applied to protect against pigeon droppings and accumulated residues. This wax not only protects against further deterioration, but also brings out the shine of the original gilding.

Pictured above are details of the Golden Doorway’s left doorjamb as it underwent three successive stages of cleaning. KVPT’s visiting consultant used this area to test out a proper conservation treatment. This labor intensive process of carefully removing unwanted materials and grime without damaging the fragile surface will be an important part of planned on-the-job training for Nepali conservators.

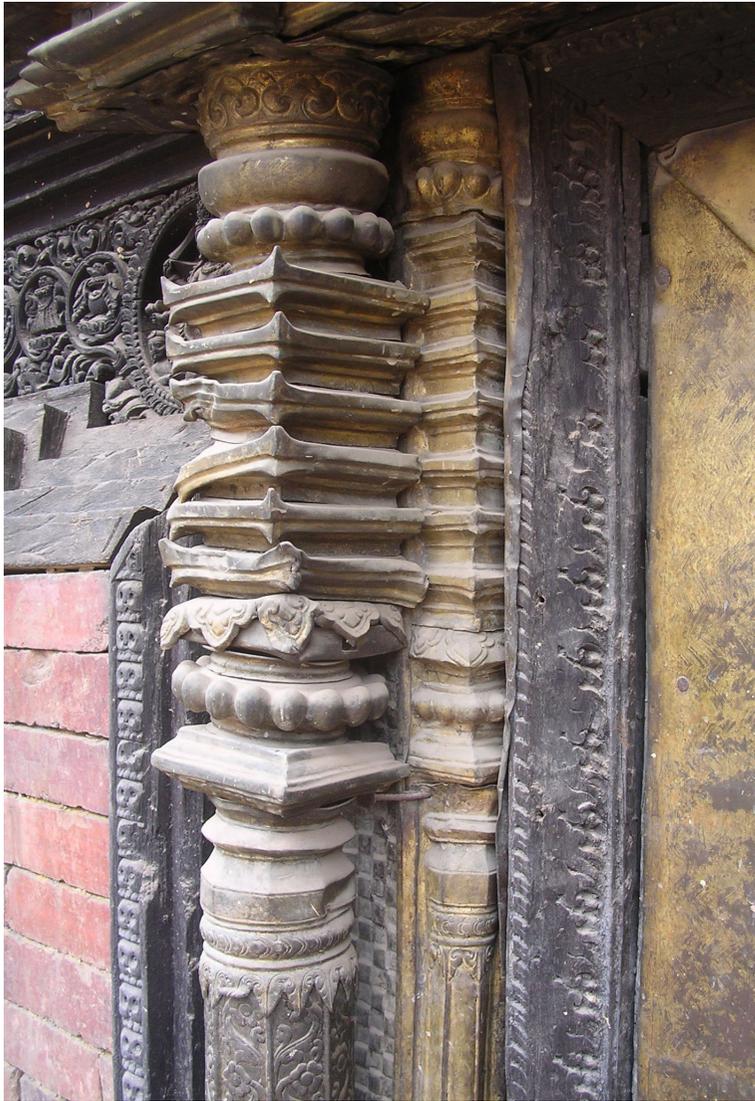
Detail of the doorjamb and pillar | Sep 21, 2011

The intricate craftsmanship of the three-dimensional pillar moldings, and the fine chasing and detailing work is seen here. The different conditions of surviving gilding can also be observed in this image.

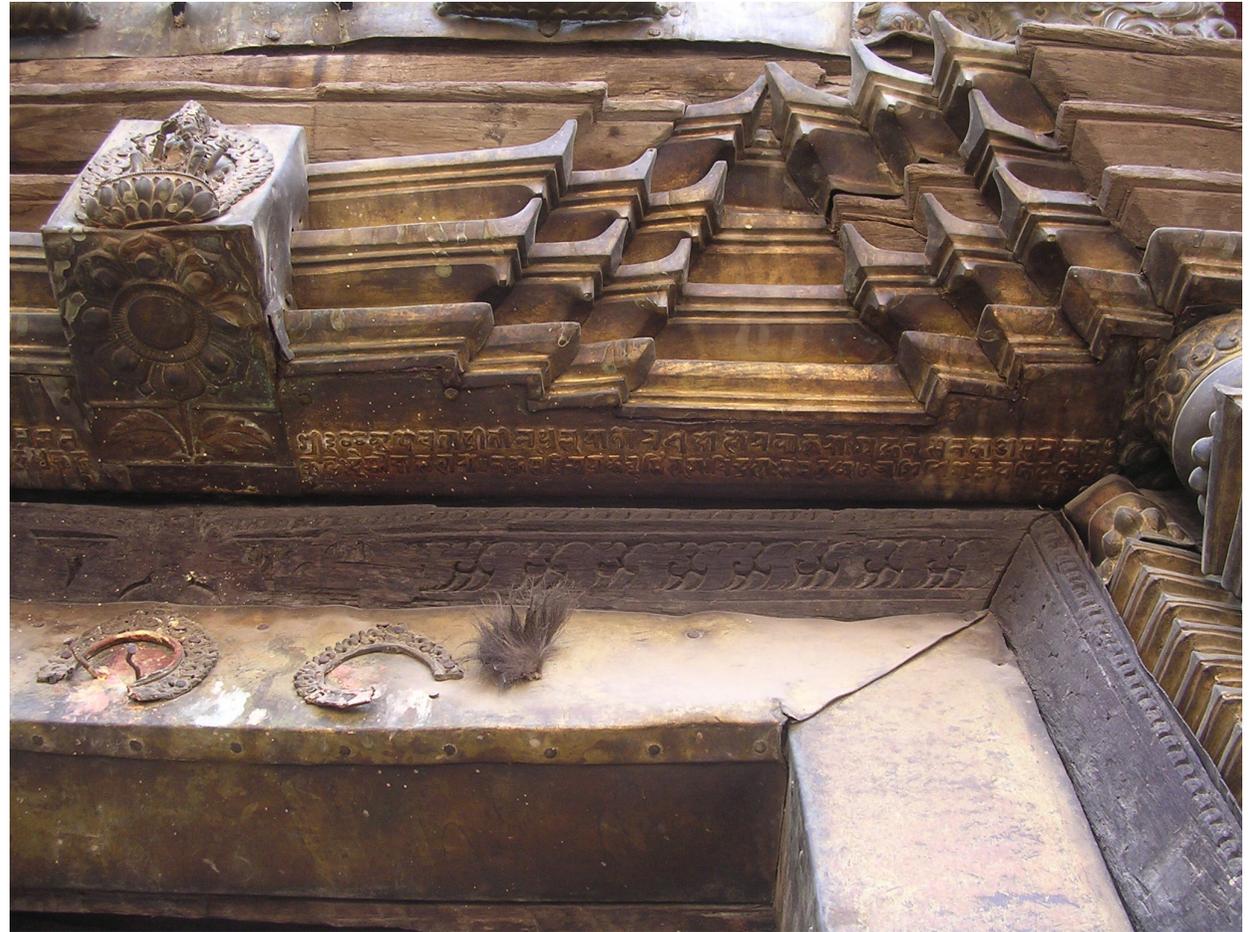
Detail of lintel, cornice, and inscription | Sep 21, 2011

Here the inscription by King Riddhinarasingh Malla beneath the cornice can be seen. It reads "Anyone who steals or takes this will go to hell." On the top door frame, the missing deities, as well as bits of buffalo hair placed there after the recent Dashain festival sacrifices, are seen in detail.

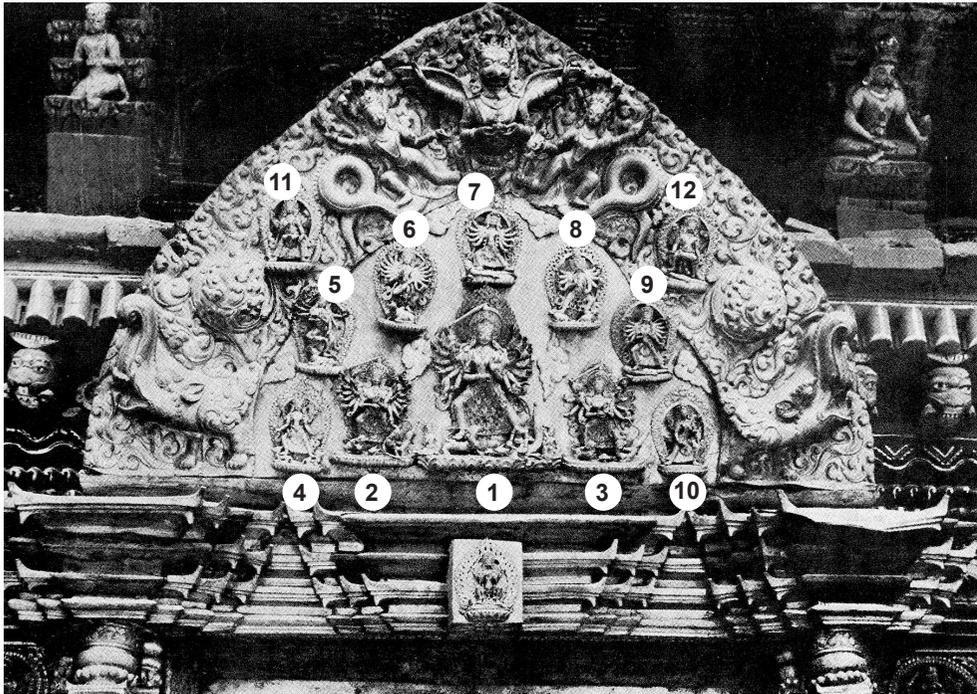
Intact tympanum | approx. 1966 – 1972

This historic photograph taken by N.R. Banerjee shows that the tympanum was still be intact in the 1960s. Here all of the sculptural elements affixed to the inner tympanum, as well as the two small deities affixed to the outer tympanum, can be seen.

4. **Replacing Missing Sculptural Elements:** Gilded replicas of the missing sculptural elements of the tympanum will be made and installed. These sculptures are crucial aspect to bringing the ensemble back to its original significance.

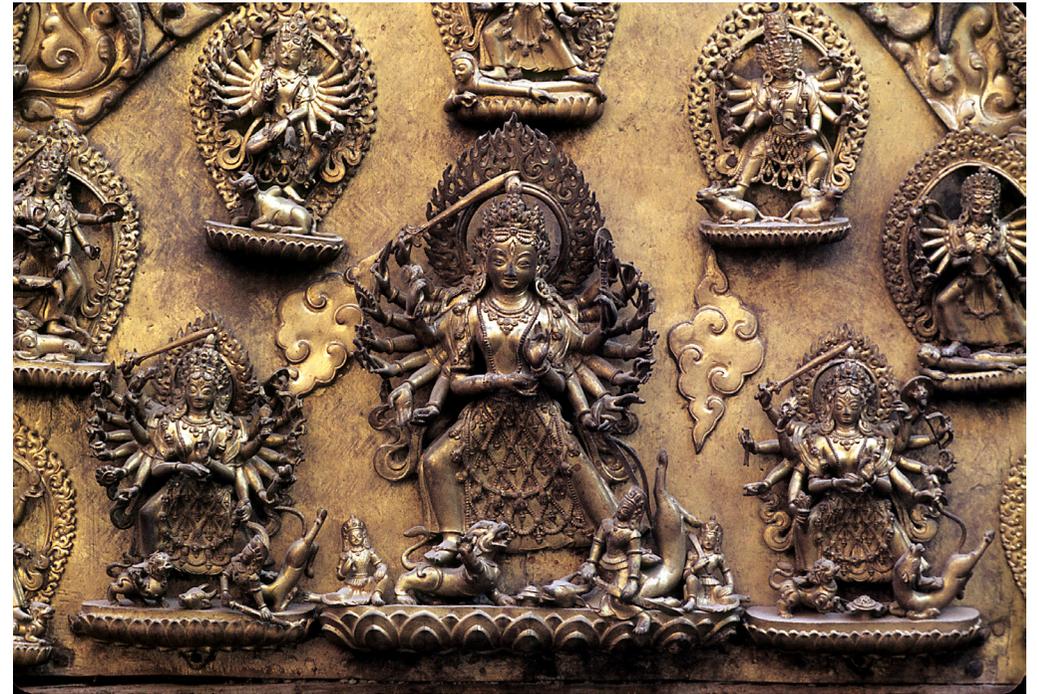
Detail of inner tympanum | 1968

Fortunately for KVPT's restoration efforts, his photo by the eminent scholar Mary Slusser shows the figures in sufficient detail to be identified. Due to the high quality of the photo, the deities can be identified and will be replicated and fire gilded to the highest achievable standards.

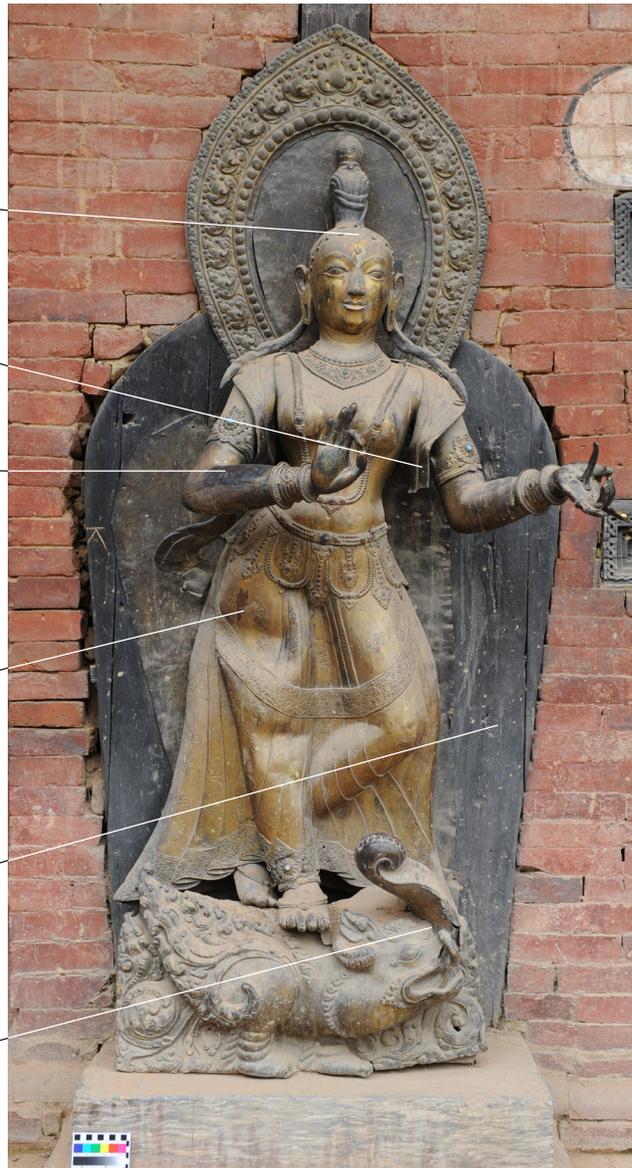
Damaged crown

Ganga's crown is entirely missing. A replica modeled on Yamuna's crown remnants will be made.

Damaged shawl

Pieces of Ganga's shawl are missing.

Worn gilding

Ganga's gilding has been entirely worn off on these large patches on her forearms. This is a result of centuries of religious worshippers devotionally touching Ganga on her extended arms.

Dents in Ganga's right leg

The thigh on Ganga's standing right leg has been significantly dented. This cannot be repaired in-situ, but must be hammered out from behind after the statue is removed.

Missing metal covering

The timber backing behind both statues is missing its original metal sheeting, and can be seen here still intact around both goddess' heads.

Damages to the makara

The makara's trunk is bent entirely backwards, while the body suffers from severe dents and resultant cracking.

Ganga atop of her makara | Sep, 2011

The severe deformation to Ganga's right leg, and the missing elements are immediately noticeable.

4. **Cold Shaping:** Tapping out of the dents and deformations with leather or rubber hammers. Mechanically pushing out of the metal using metal clamps and pieces of timber. This should be performed by a close cooperation between the local coppersmith under the instruction and supervision of a professional conservator. There will be absolutely no heating of the metal. If the metal is heated, the metal's consistency will change, leading to local corrosion caused by tension. In addition, by heating the object, the original surface and patina would be lost.

6. **Closing of cracks:** Filling of cracks will be done using an epoxy resin with a layer of metal sheet underneath. The resin could then be tinted with copper pigment to better match the surrounding area.

7. **Replacement of Missing Elements:** Replicas of the missing pieces, such as the goddesses' crown, shawl, and precious stones, will be made and installed in their original positions.

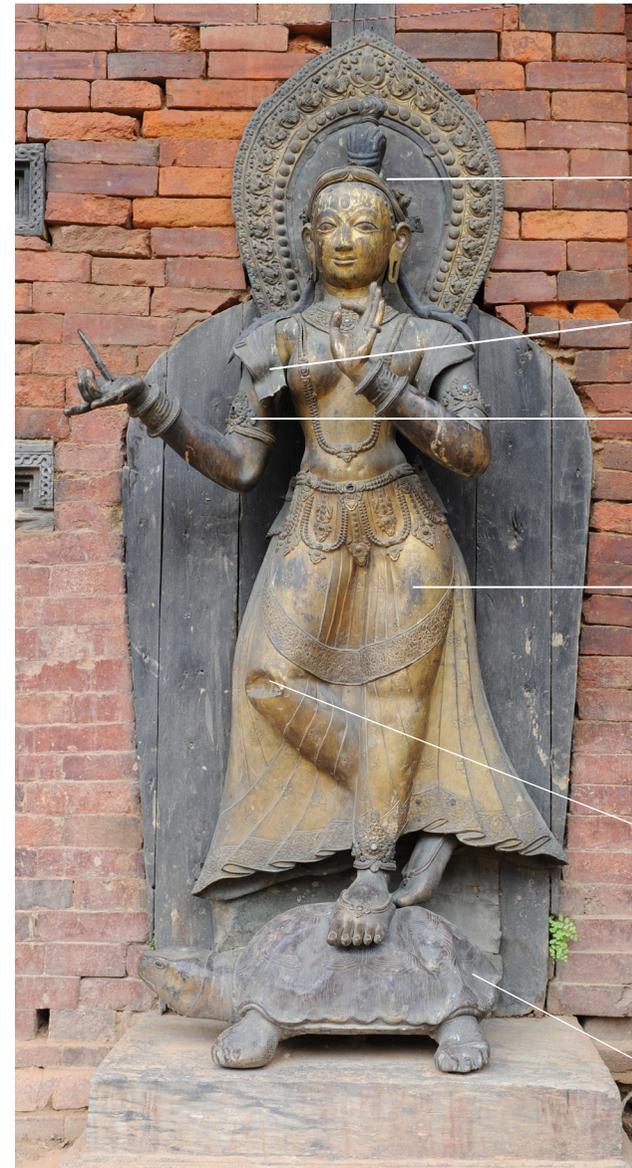
Damaged crown

Yamuna's crown is missing it's central component, of which there is a remnant.

Damaged shawl

Pieces of Yamuna's shawl are missing.

Missing stone

The turquoise stone on Yamuna's left arm band, is missing on her right.

Worn gilding

The gilding has been entirely worn off on these rather large patches on both of Yamuna's thighs. This is a result of centuries of religious worshippers devotionally touching Yamuna in these areas.

Dents in Yamuna's right leg

Yamuna's bent right leg has a severe dent, which cannot be repaired in-situ, but must be hammered out from behind after the statue is removed

Dents in the turtle's shell

The severe dents to the turtle's shell

Yamuna atop of her turtle | Sep, 2011

The large dent in Yamuna's bent right leg, and her damaged shawl and crown can be easily seen here. The overall loss of gilding is also very apparent.

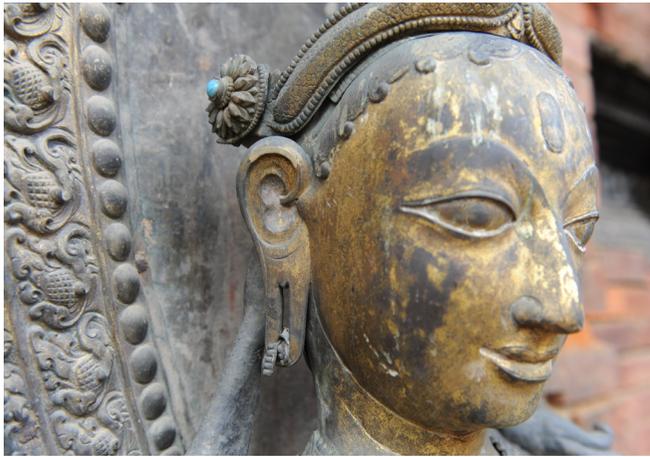
Yamuna's crown & jewelry | Sep 2, 2011

Yamuna's crown is pictured here, still intact, unlike Ganga's below. The turquoise stone is the only remaining crown ornament on the two statues and will serve as an example for replicating the missing three. A remnant of Yamuna's earring is also present here, and remains nowhere else.

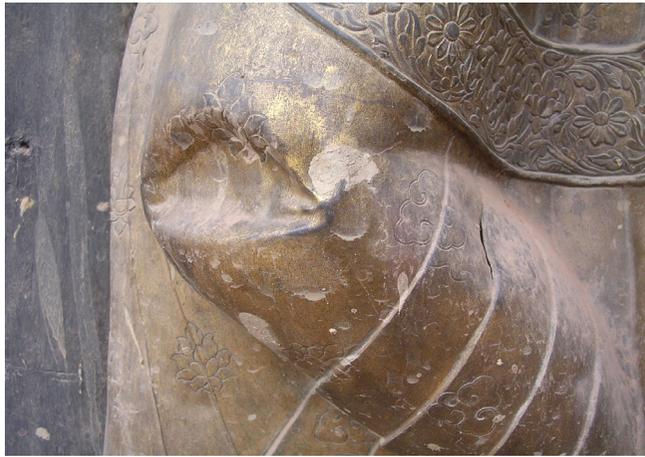
Detail of Yamuna's right leg | Sep 2, 2011

The severe dent pictured above cannot be repaired in-situ and mandates removal of the statue, and gently hammering the dent out from behind. A crack in Yamuna's calf, measuring four centimeters, is also seen here.

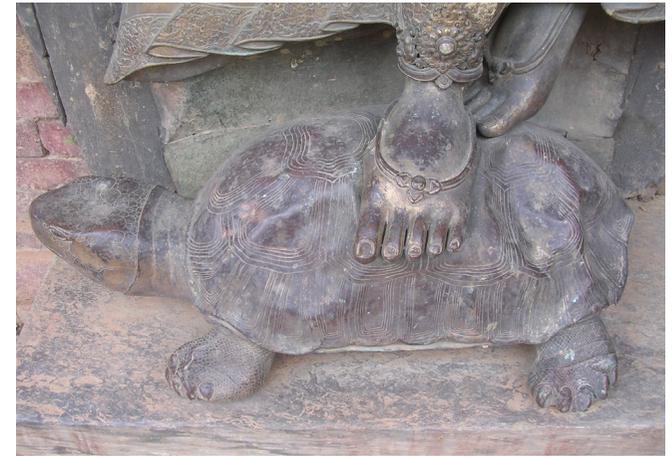
Yamuna's turtle | Sep 2, 2011

The badly deformed turtle will also require disassembly and re-shaping of the copper body. Renewed gilding will be considered for the body of the turtle.

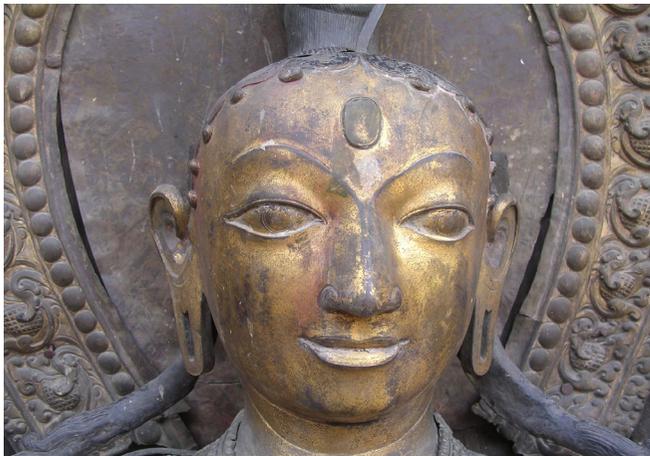
Ganga's missing crown & jewelry | Sep 2, 2011

Ganga will be restored with the same crown as Yamuna, as well as with the same jewelry, including earrings in both ears and the crown ornaments.

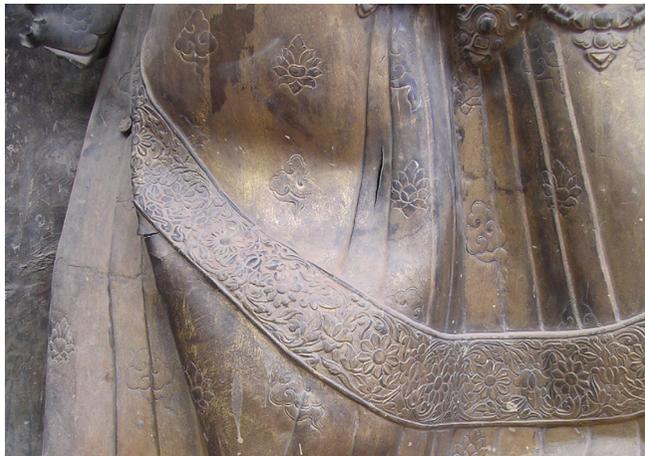
Detail of Ganga's right leg | Sep 2, 2011

Ganga's extensively damaged thigh is pictured above. Rectifying the severe damage, including a significant crack, will also require re-surfacing and re-gilding of the affected areas.

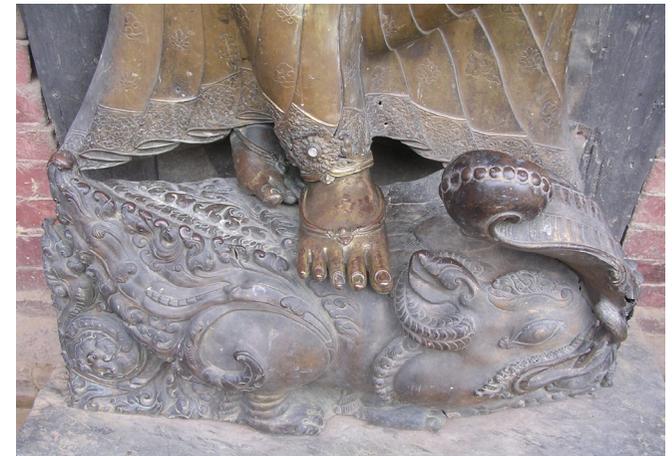
Ganga's makara | Sep 2, 2011

The trunk of the makara has been completely bent backwards. Once held up at an angle, the trunk now lies flat against the makara's body. There are also damages to the body of the makara, requiring disassembly and hammering out of deformities. Renewed gilding will also be considered for the body of the makara.

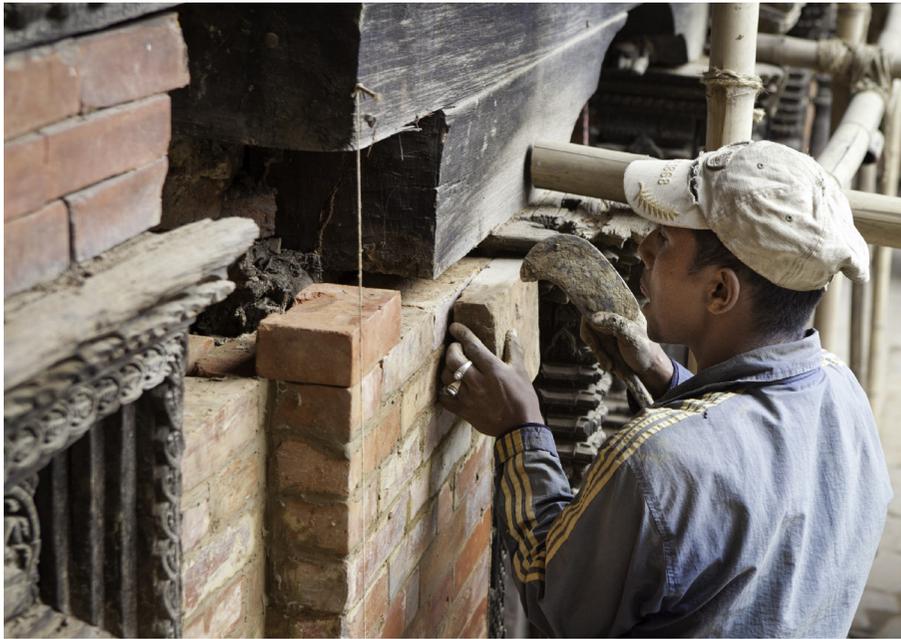
Mul Chowk masonry work | May 20, 2011
Repairs being made by a KVPT trained mason on the southwest corner of Mul Chowk.

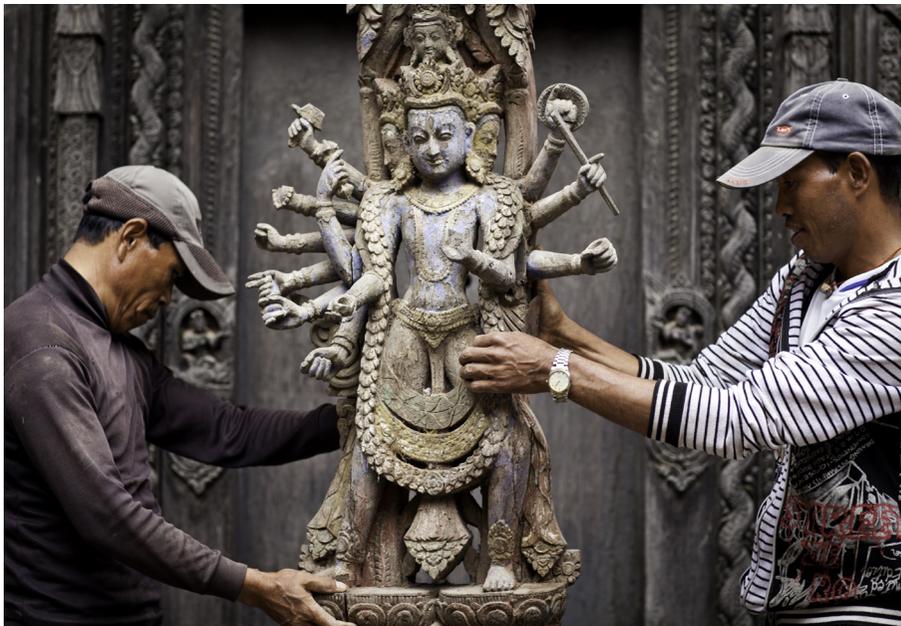
Documentation of Mul Chowk roof struts | Apr 16, 2011
Workers are putting in place a 17th century strut to be photographed for record-keeping before restoration work is commenced.

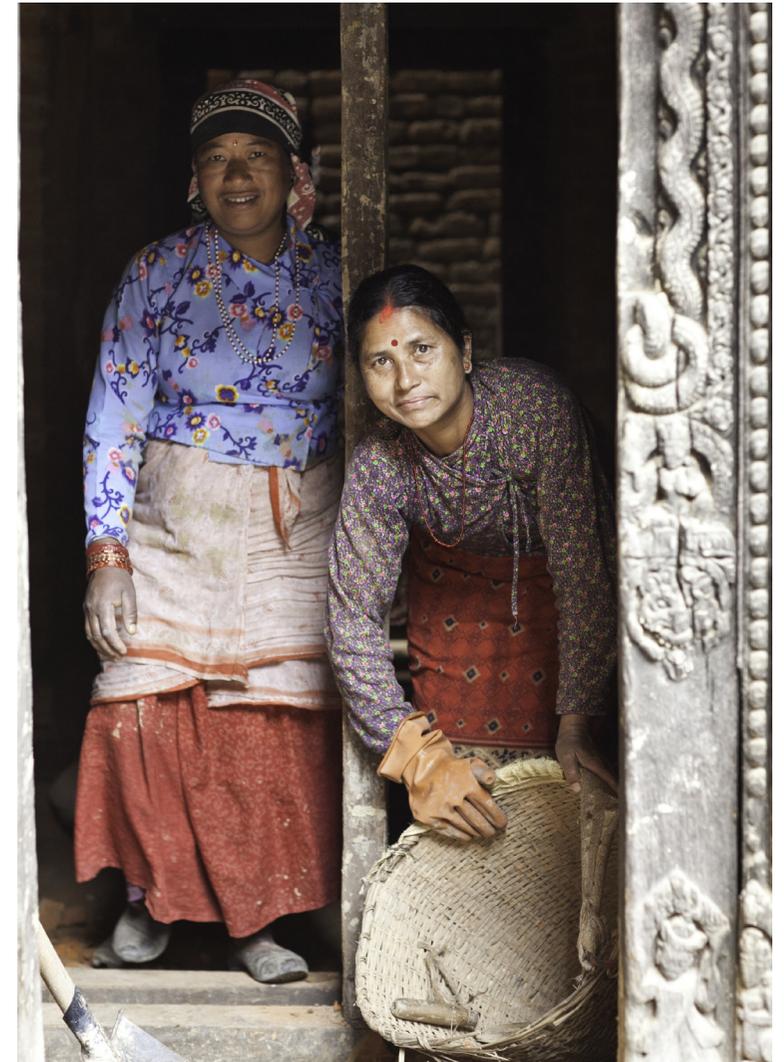
KVPT Female Staff Members | May 20, 2011
The majority of semi-skilled workers on the construction site are women, who have quickly learned the necessary skills to deal with fragile and precious historical artifacts.

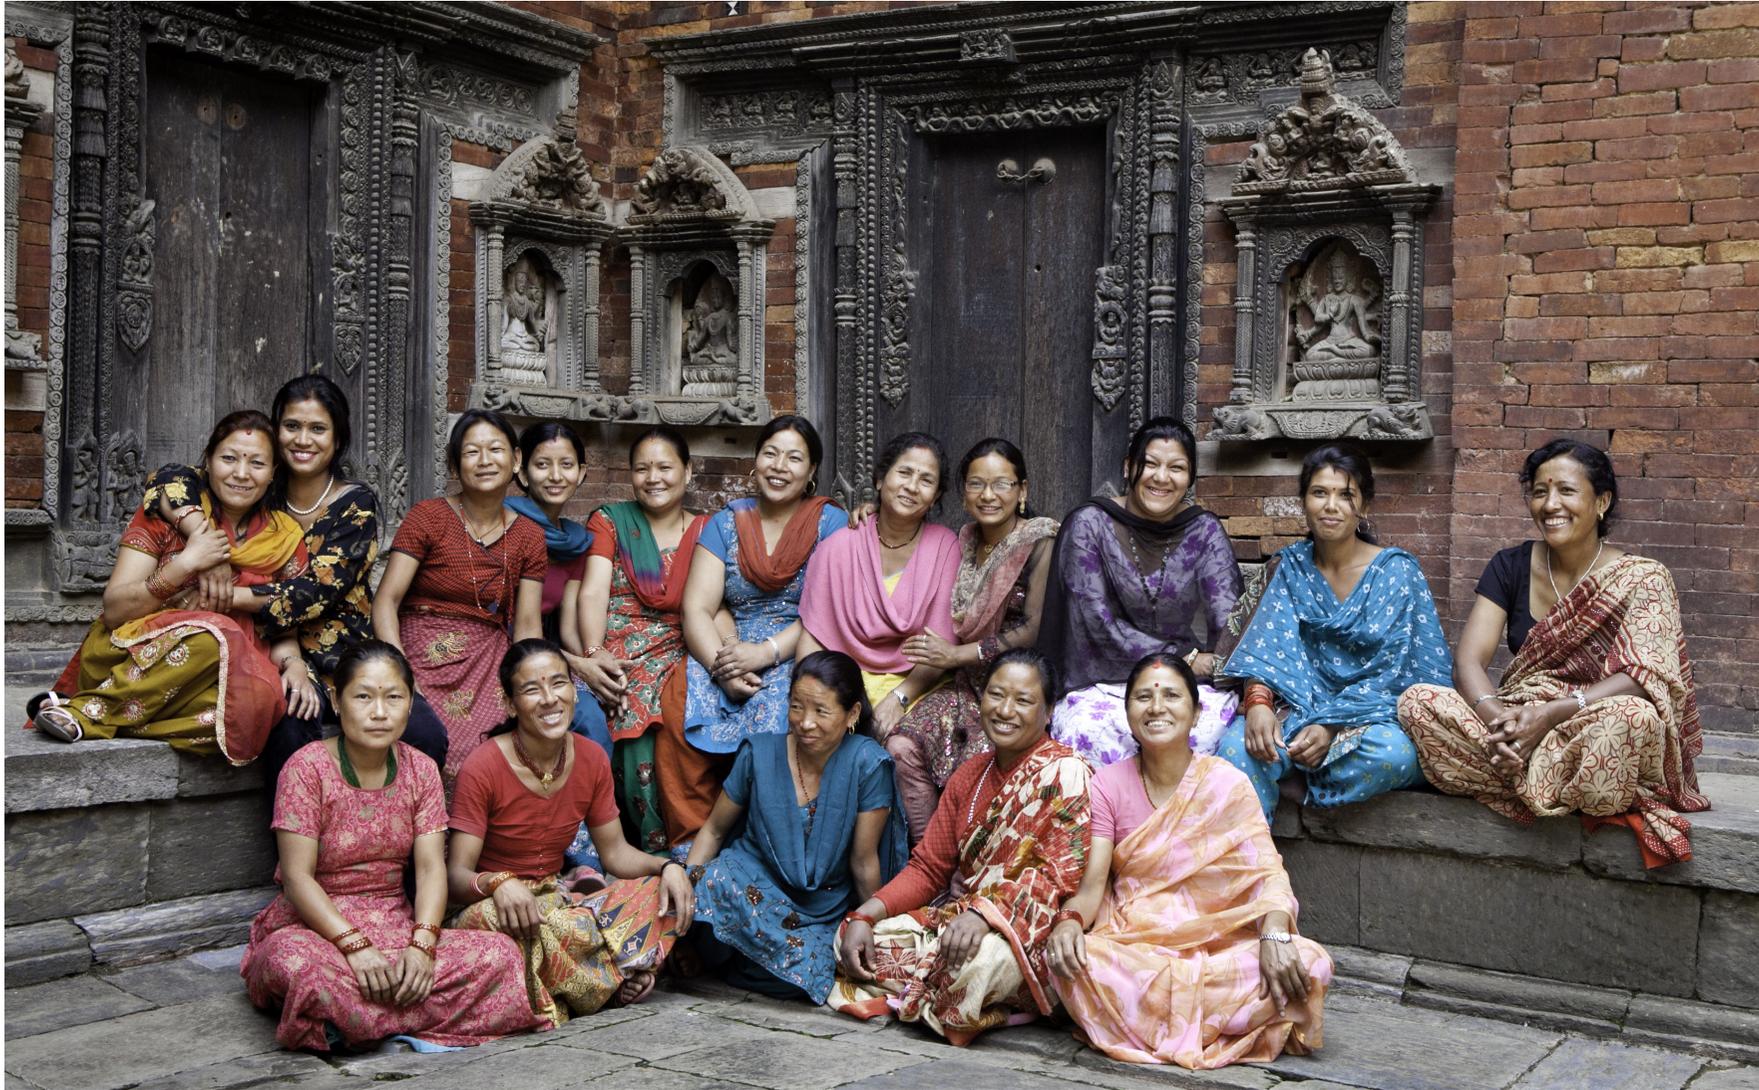
KVPT Female Staff Members | May 20, 2011

The female workers of the Trust are specially trained in conservation treatment, including careful cleaning techniques, stone treatment, and mortar mixing. The women are seated here in the southeast corner of Sundari Chowk.
