THE RESTORATION OF
THE GILDED PINNACLE OF SOUTH TALEJU TEMPLE
AT THE PATAN ROYAL PALACE COMPLEX – A UNESCO WORLD HERITAGE SITE

PROJECT APPLICATION | OCTOBER 2013
SUBMITTED TO THE SUMITOMO FOUNDATION

THE KATHMANDU VALLEY PRESERVATION TRUST

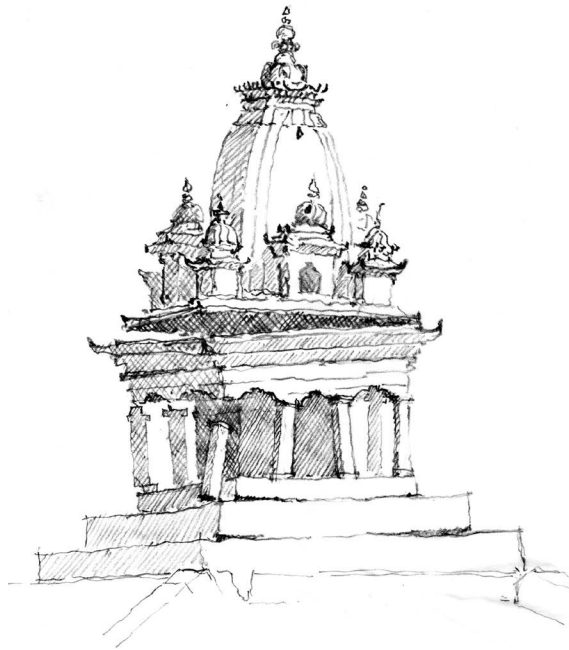
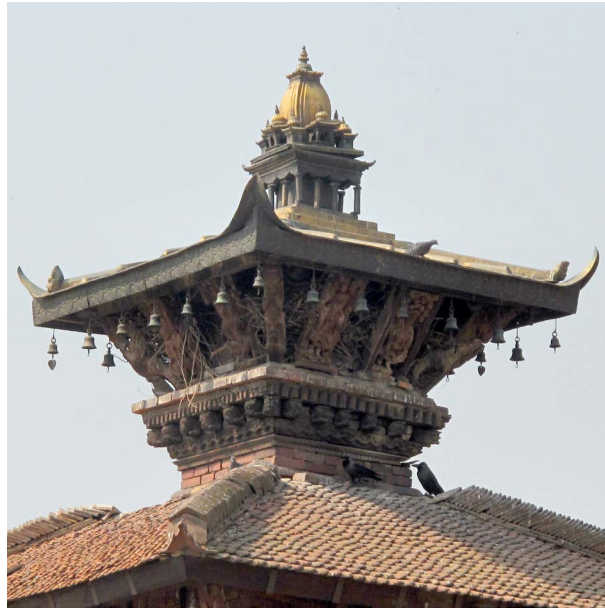
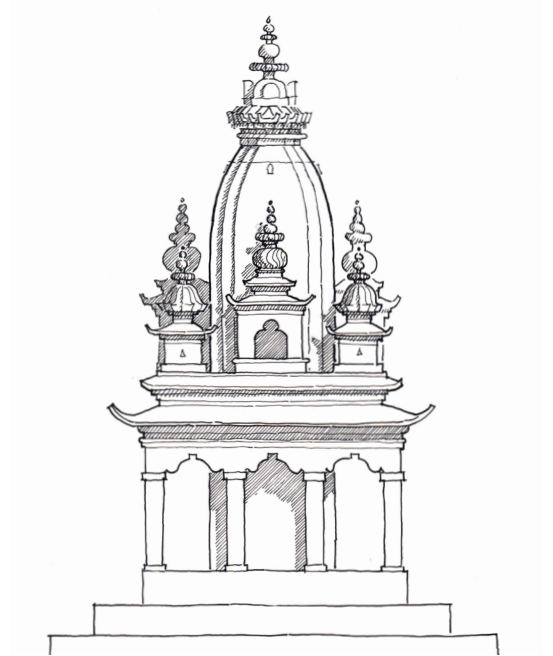
cover: **South Taleju's Golden Pinnacle** | March 2013
The center image shows the damaged condition of the temple's pinnacle. On the left is a rendering of the damaged existing conditions, on the right is a rendering of the pinnacle after the proposed restoration work is carried out.

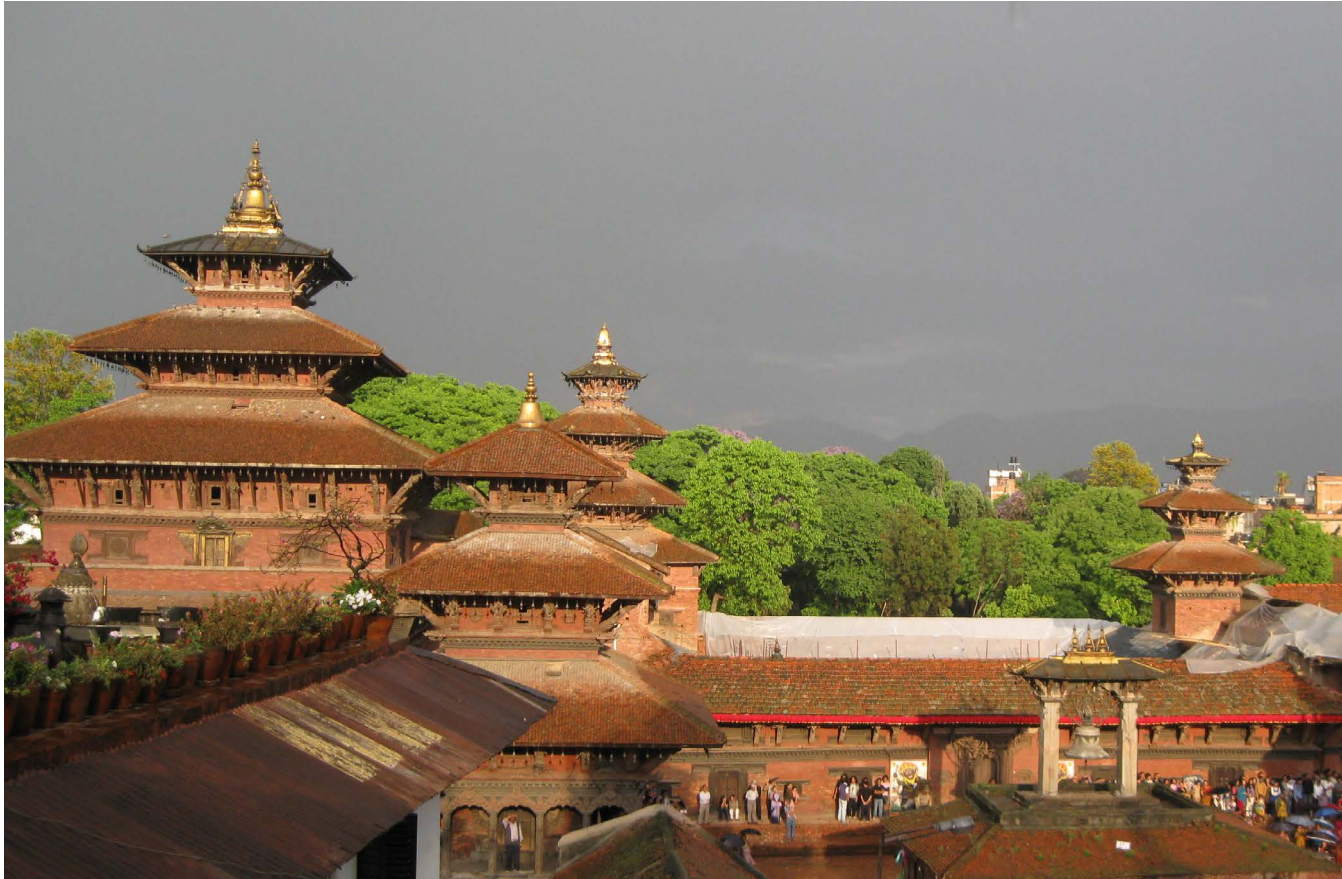
The gilded pinnacles of the Patan Palace Complex | May 2011
The gilded pinnacles glow in the afternoon sun after a monsoon storm. Even from this distance the leaning orientation of South Taleju's pinnacle (on the far right) can be seen here.

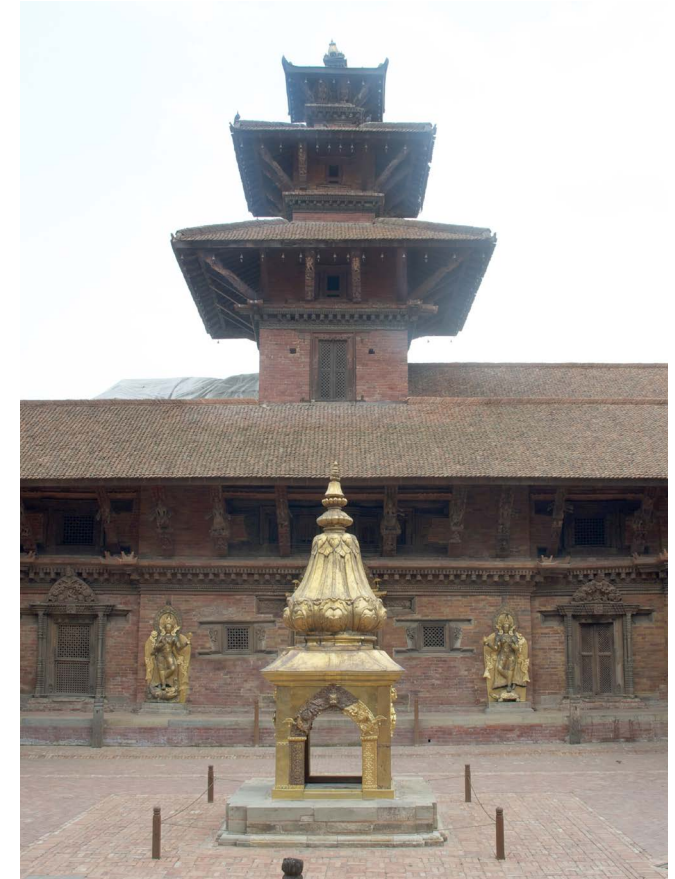
South Taleju as seen from Mulcok courtyard | May 2013
The South Taleju temple towers above the roof of the Mulcok palace courtyard. The two goddess statues were restored and re-gilded with funds from the Sumitomo Foundation in 2011.

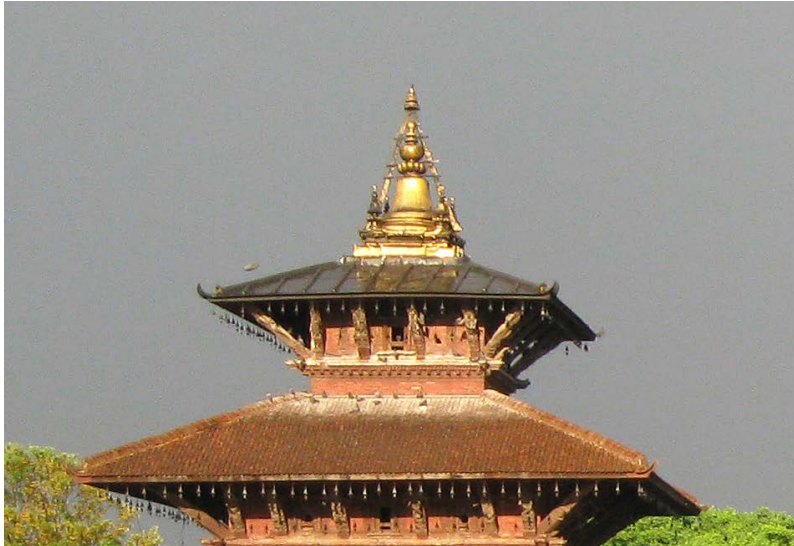
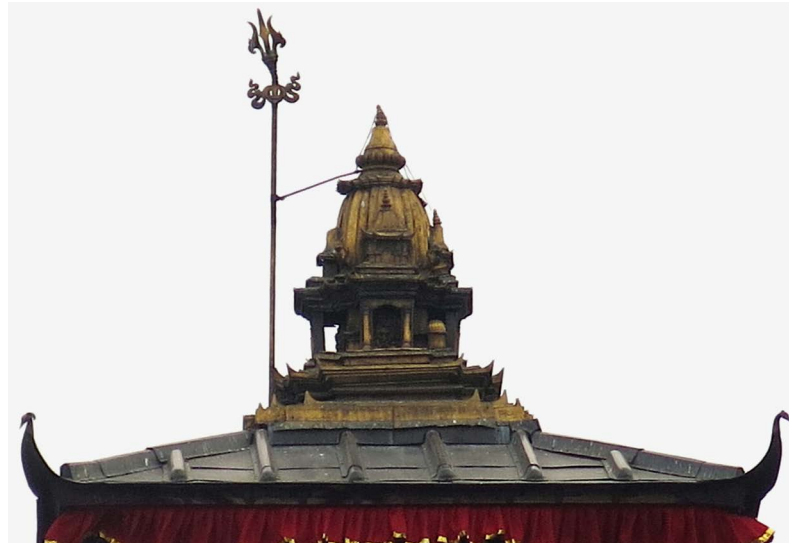
Comparative views of temple pinnacles
clockwise from top, left:

Degu Taleju Temple, Patan Palace | 2013
Degu Taleju, the largest of Patan Palace's three rooftop temples, features a traditional pinnacle in the shape of a bell.

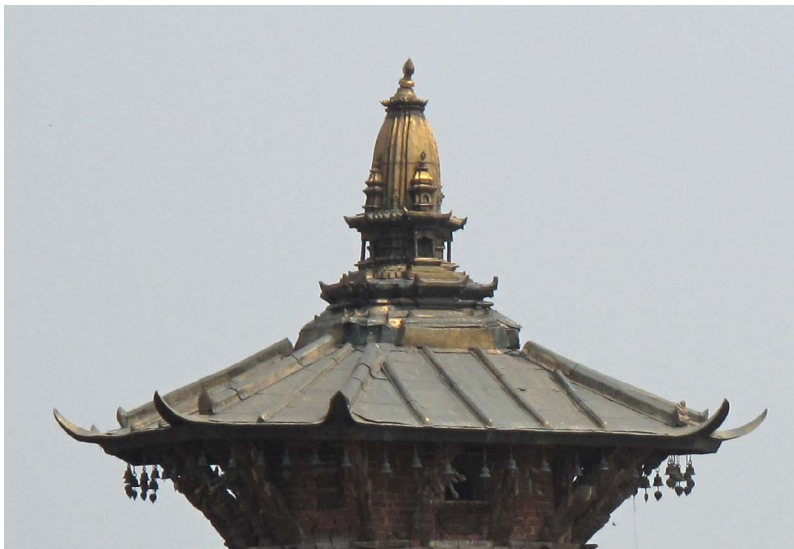
Malla Agamchen, Kathmandu Darbar Square | 2013
This pinnacle is modelled after a *sikhara* temple, but is in better condition than the pinnacle of South Taleju.

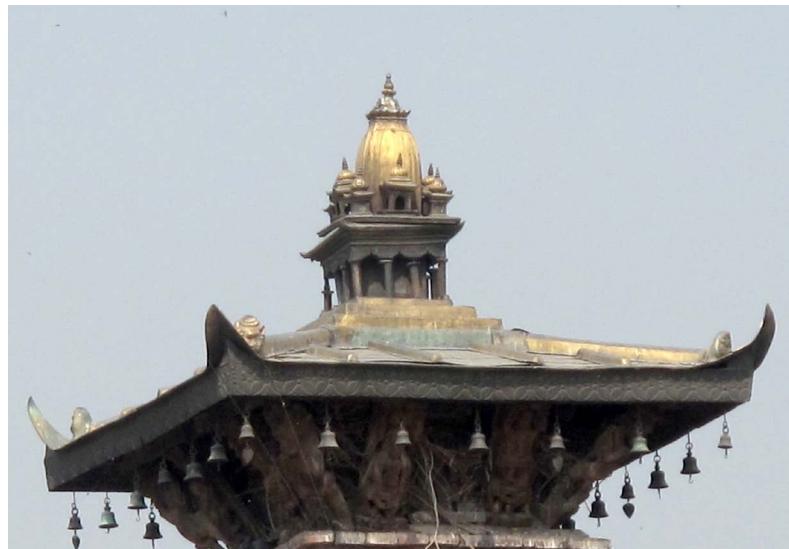
South Taleju Temple, Patan Palace | 2013
The pinnacle proposed for restoration is severely damaged, as is exhibited here by the displaced columns and the pinnacle's leaning orientation.

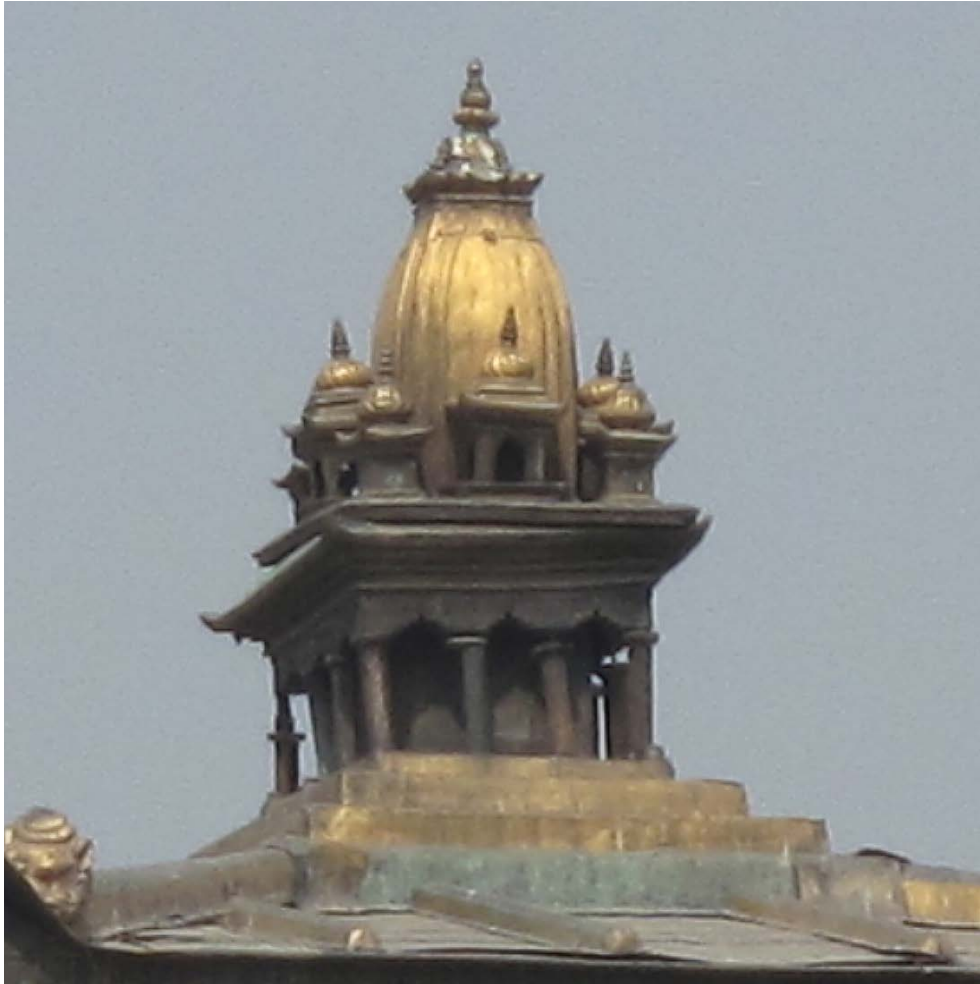
South Taleju Pinnacle view from the south | March 2013
This view shows the pinnacle's poor condition. Much of the gilding has worn off and separation of copper sheets can be observed.

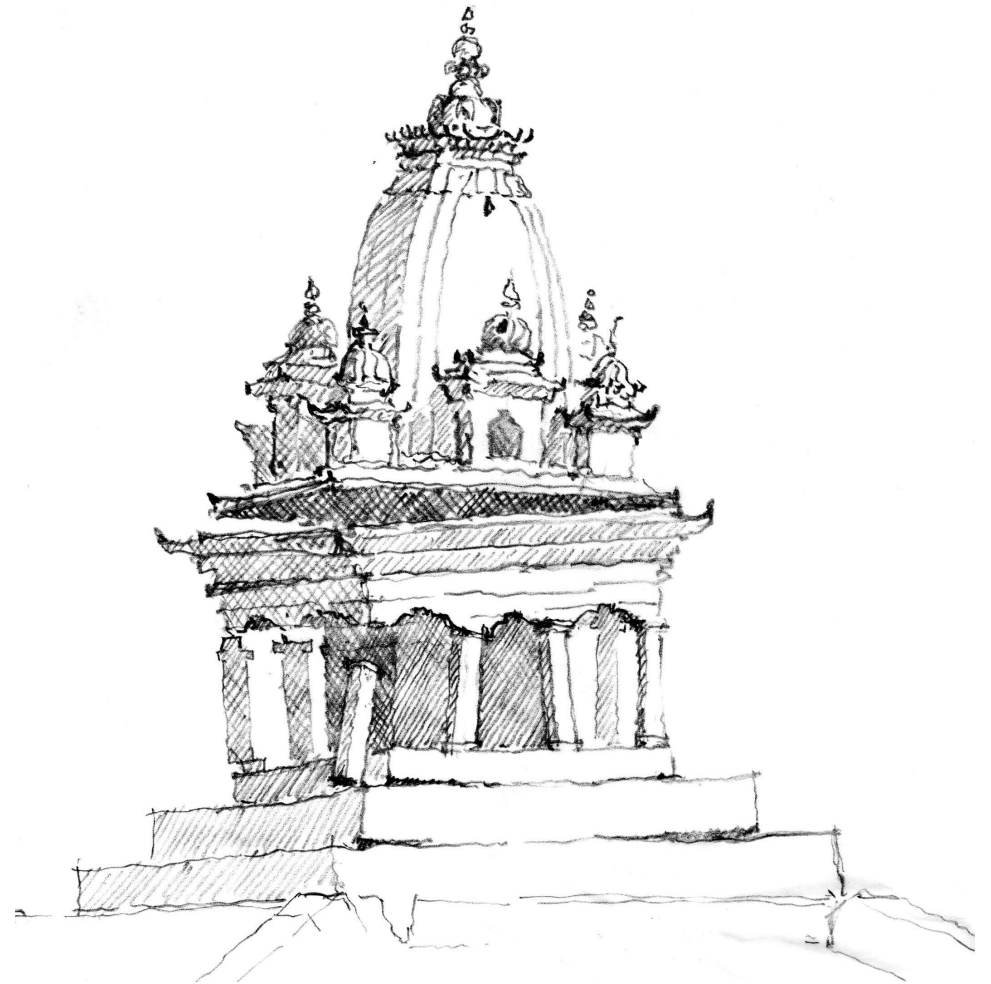
South Taleju Pinnacle view from the southwest | October 2013
This sketch shows the displaced corner column and the splitting between the sculpture's upper half and lower half.

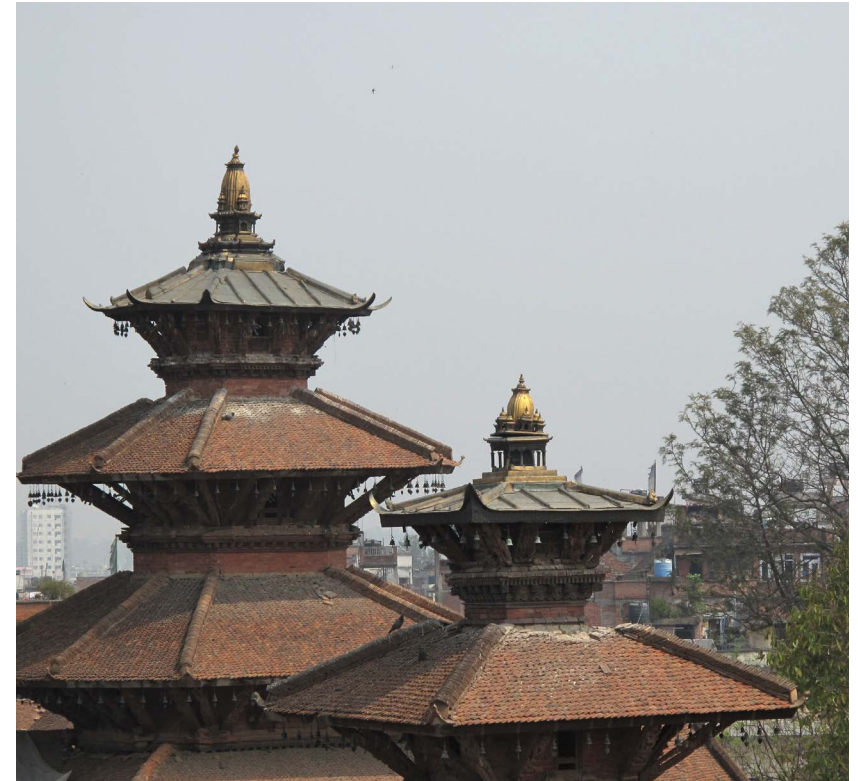
View from the south | March 2013
The South Taleju temple is seen here with the North Taleju temple in the background. The lower roof has been rebuilt with traditional terracotta roof tiles (*jinghati*) since the photo at left was taken.

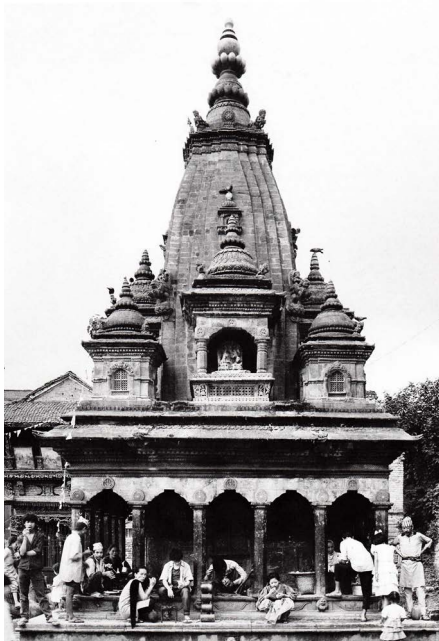
Umamahesvara Temple, Nugah Square, Patan
Photo by Stanislav Kimek, August 8 1992

Two *sikhara* temples frame the entrance to Patan at Nugah Square. The east elevation of one of these temples, Umamahesvara, is depicted here. The style of this particular temple is very similar to the temple sculpture of South Taleju’s pinnacle.

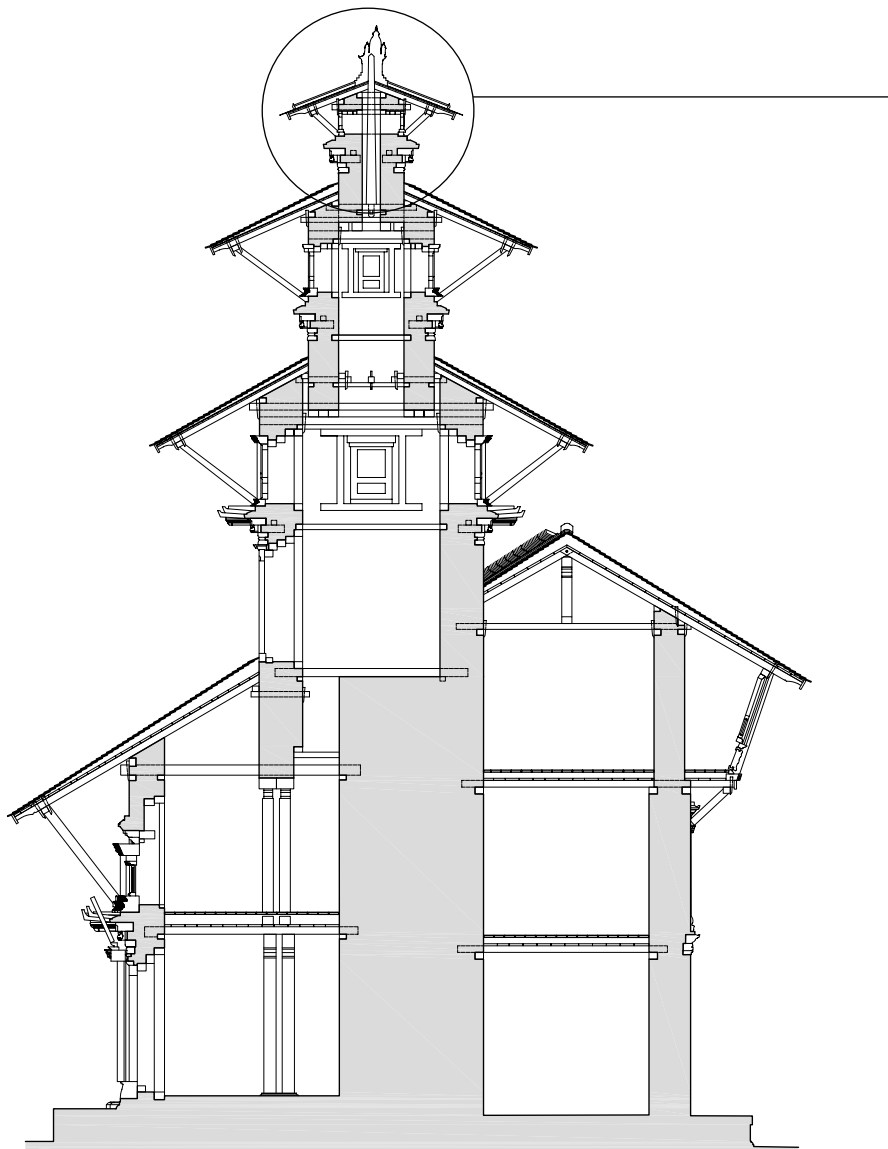
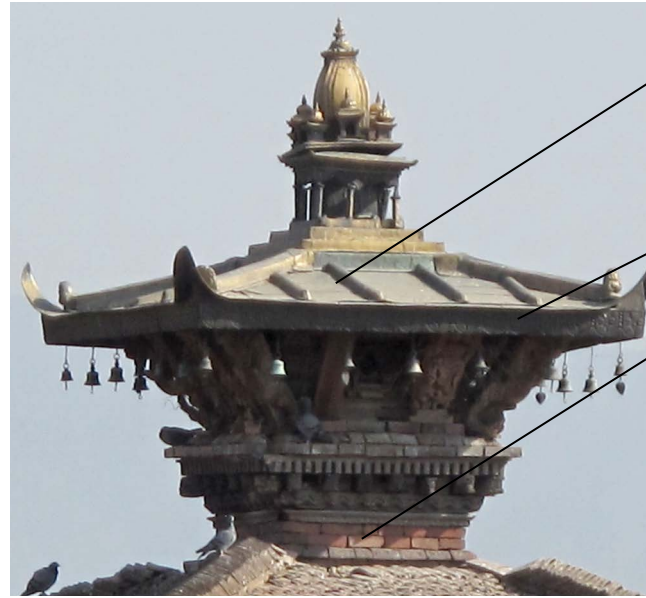
The copper sheeting has lost the majority of its gilding and has split in places along the joints, causing water infiltration into the timber structure below.

The repoussé metal eave board cladding is worn and damaged in places.

The brick walls, seen here between the second and third tiers, support the temple's central timber post. Many of the bricks have been dislodged after minor tremors and no longer properly support the central post on which the pinnacle rests.

The South Taleju Temple's uppermost third tier roof and crowning pinnacle are in urgent need of repairs after years of neglect, exposure to the elements, and numerous minor earthquakes. South Taleju's sikhara temple pinnacle is precariously leaning and is missing a number of key elements. The gilded metal cover roof is damaged, causing water leakage and threatening the structural integrity of the temple.

The interior brick core of South Taleju Temple extends through to the third tier roof level. A central timber post, known locally as the *baymvah* or *galathan*, runs up through the interior of this brick core and extends into the pinnacle, providing the structure over which the gilded copper pieces are fit. The brick fabric of the uppermost level exhibits numerous cracks and many bricks have been dislodged. Frequent seismic movements, in combination with the poor mud mortar in which the bricks are laid, have led to the overall weakening of the brick fabric at the uppermost level. Furthermore, the upper layers of this brick core need to be rebuilt because they are not properly supporting the central timber post, as is indicated by the leaning pinnacle.

In many areas, joints between the metal sheets have opened up allowing water leakage into the timber substructure. This water penetration has caused the timber planking below to rot. Furthermore, the copper sheeting on the roof level has lost the majority of its gilding due to its exposure to corrosive pigeon droppings.

The repoussé metal eaves board cladding, which is decorated with a chased floral motif, is significantly worn and is bent and loose in places.

The brick fabric of South Taleju Temple's third level tier will be extensively repaired. In order to conduct this repair work, scaffolding will be erected around the entire temple. Damaged, dislodged and cracked bricks will be replaced with traditional *dacci apa* brick, which will be re-laid in an appropriate traditional mud mortar to better support South Taleju's central

timber post. Furthermore, the new brick walls will be anchored to the central timber post via stainless steel straps in order to ensure that shifting and displacement does not occur during future seismic movements.

Splits and cracks will be closed by soldering the metal pieces together, thus properly sealing the roof. It is likely that some sections of the copper are corroded beyond repair and will require replacement sheets. All roof ridges, which are crucial to seal the gaps between the copper roofing sheets, will be completely refurbished and if necessary replaced with newly fabricated replicas. The interior timber pieces will most likely require complete replacement. The gilded copper sheeting will then be properly cleaned in order to better expose the remaining original gilding work. The metal repoussé eaves board cladding will be carefully cleaned and deformed pieces re-shaped or replaced as necessary.

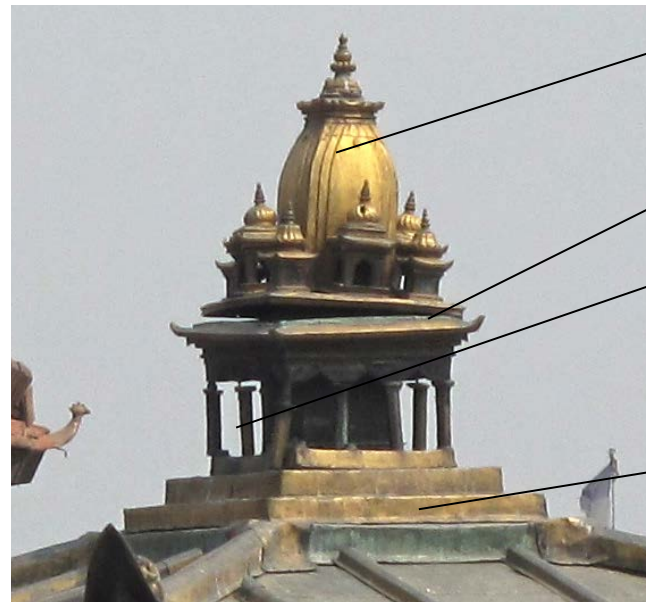
The dome of the gilded temple is leaning northward, indicating that South Taleju's central post is likely damaged.

The upper half of the temple has split from the lower half along the cornice.

Two of the supporting columns are lost and the southwest corner column has slipped off its base. The column's displacement has contributed to the leaning of the pinnacle.

A timber stepped platform covered in metal sheeting supports the temple. The metal sheeting is deteriorated and worn, and as a result, the interior timber pieces are likely also decayed.

The metal components of the sculptural sikhara temple pinnacle are deformed and loose, and the entire temple is precariously leaning.

Two of the temple's supporting columns have been lost and the south-western corner column has slipped significantly. This column's displacement has contributed to the split of the temple's upper half from the lower.

The dome and surrounding archways have separated from their base along the cornice. The dome of the gilded temple is leaning northward, indicating that South Taleju's central post is damaged.

The metal components of the sculptural sikhara temple pinnacle will be extensively cleaned and soldered together in those areas where they have separated. The entire pinnacle will be rectified so that it stands on its original vertical axis.

The copper sheeting of the timber-stepped platform will be repaired in those areas where it is deteriorated and worn. The new and repaired metal sheeting will be properly joined together over these timber pieces to prevent future water penetration into the timber interior.

The gilded copper coverings of the temple's columns will be repaired. The two missing columns will be replaced with newly fabricated pieces. The displaced south-western corner

column will be placed in its proper position and securely fastened to its base. Any interior timber pieces will be inspected for their structural integrity and replaced if necessary.

The dome and surrounding archways, which have separated from the temple's cornice, will be repaired and soldered. The dome's leaning position will be corrected by the repair and proper rectification of the central post. The copper repoussé work will also be thoroughly cleaned.

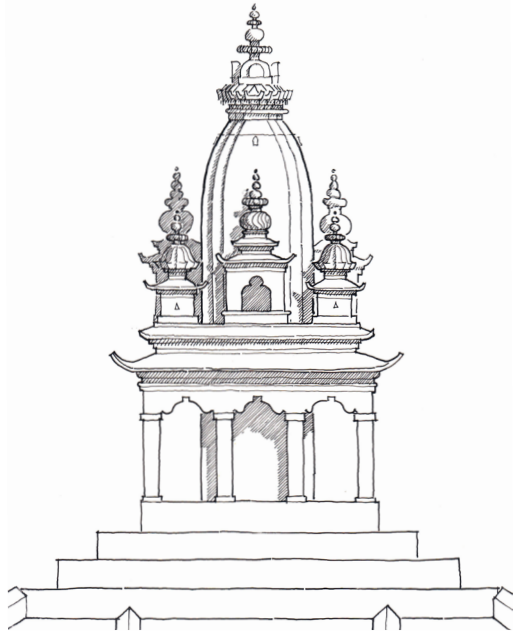
Proposed restoration | October 2013
 This sketch demonstrates how the pinnacle will appear after the proposed restoration program. Note the rectified central dome, the replacement of all columns, and the repair of the split along the pinnacle's cornice.

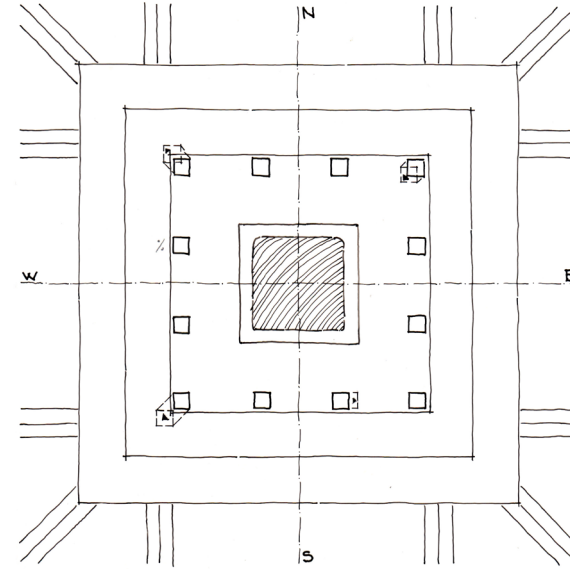
Floor plan | October 2013
 The floor plan of the South Taleju pinnacle. The columns which are missing or displaced have been marked. These columns will be re-made or repaired and placed in their proper position.
