RESTORATION OF THE PATAN ROYAL PALACE COMPLEX

MULCHOWK PALACE
KOT PATI
STONE GATES
BAHADUR SHAH WING

AFCP 2009 LARGE GRANT - 2012 EXTENSION

FINAL REPORT

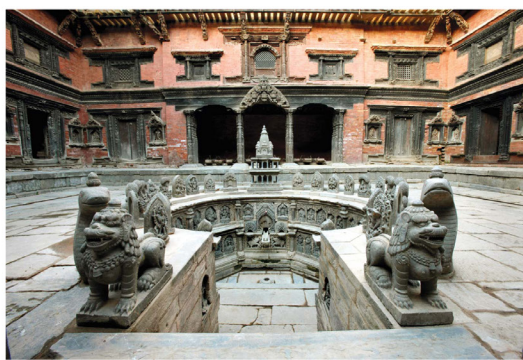
FACELIFT. Tusha Hill (above and left, here, yet unrestored). The royal step-well is the main focal point of Sundari Chok with its extensive iconographic program. Prior to restoration, many tiles were damaged or missing. The well was not used for bathing, as is sometimes believed, but for the king's religious rites. In 2011, the copper tap was recovered by Nepal Police after being stolen a year earlier. A replica will adorn the fountain while the original will be displayed in a nearby wing as part of a new Architectural Gallery, set to open in 2016.

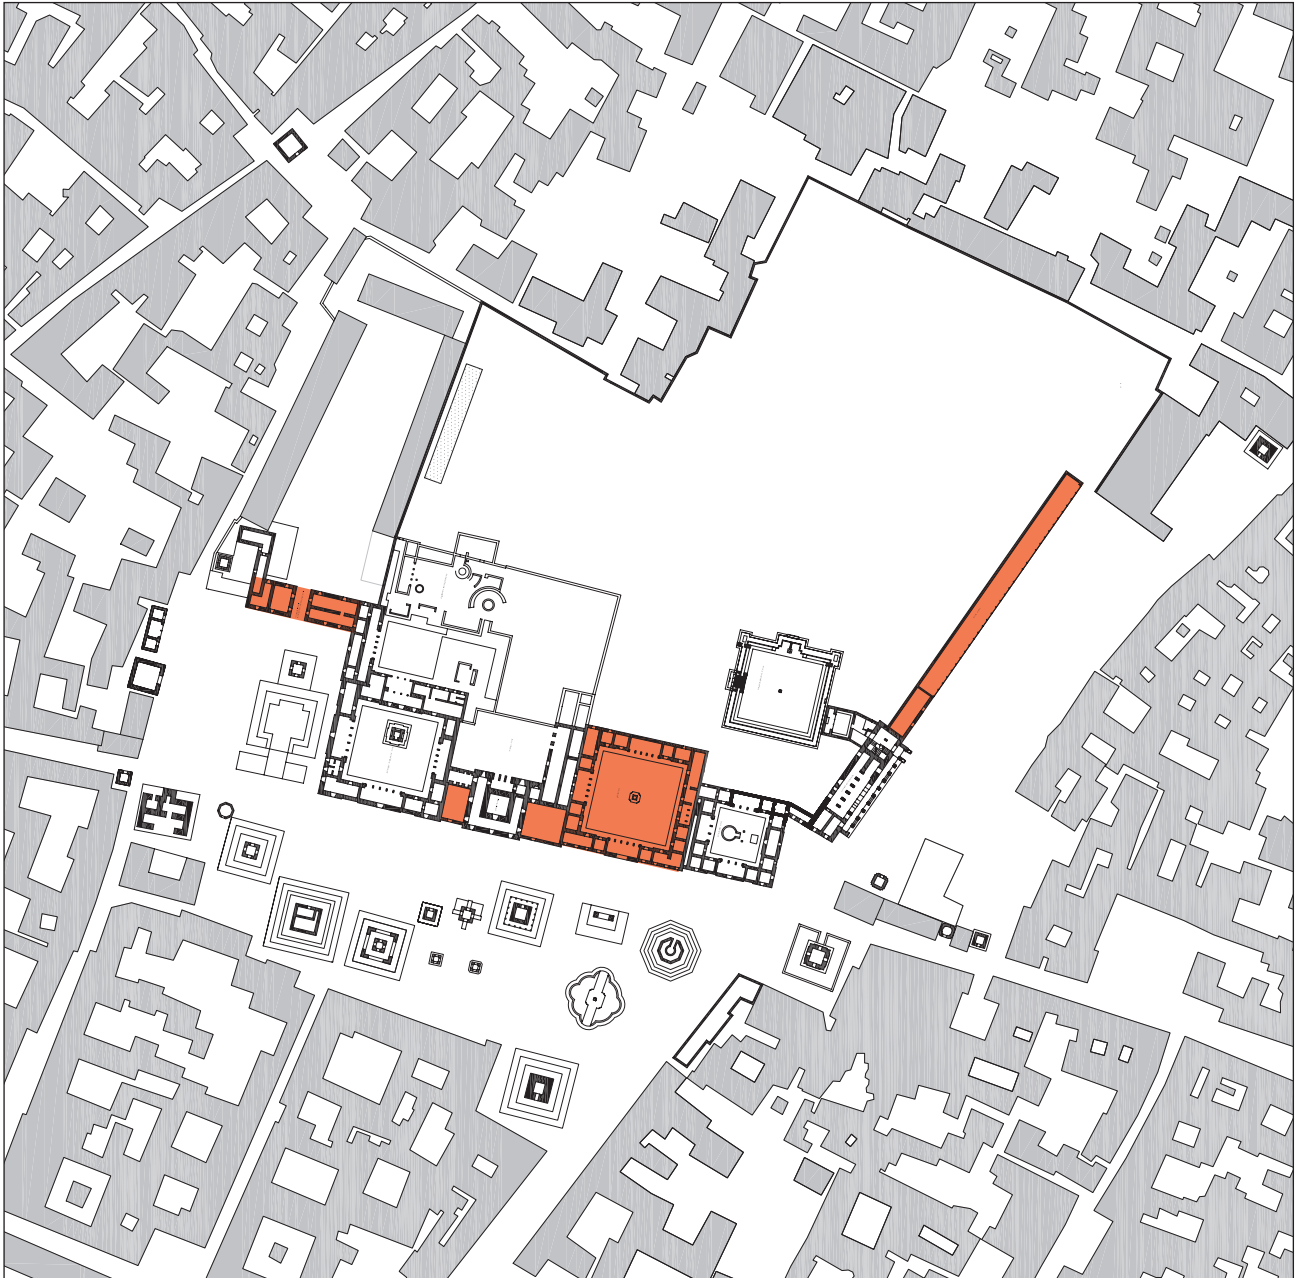
Site plan of Patan Darbar Square | 2014

The plan shows project components that were completed with the support of the 2012 grant extension.

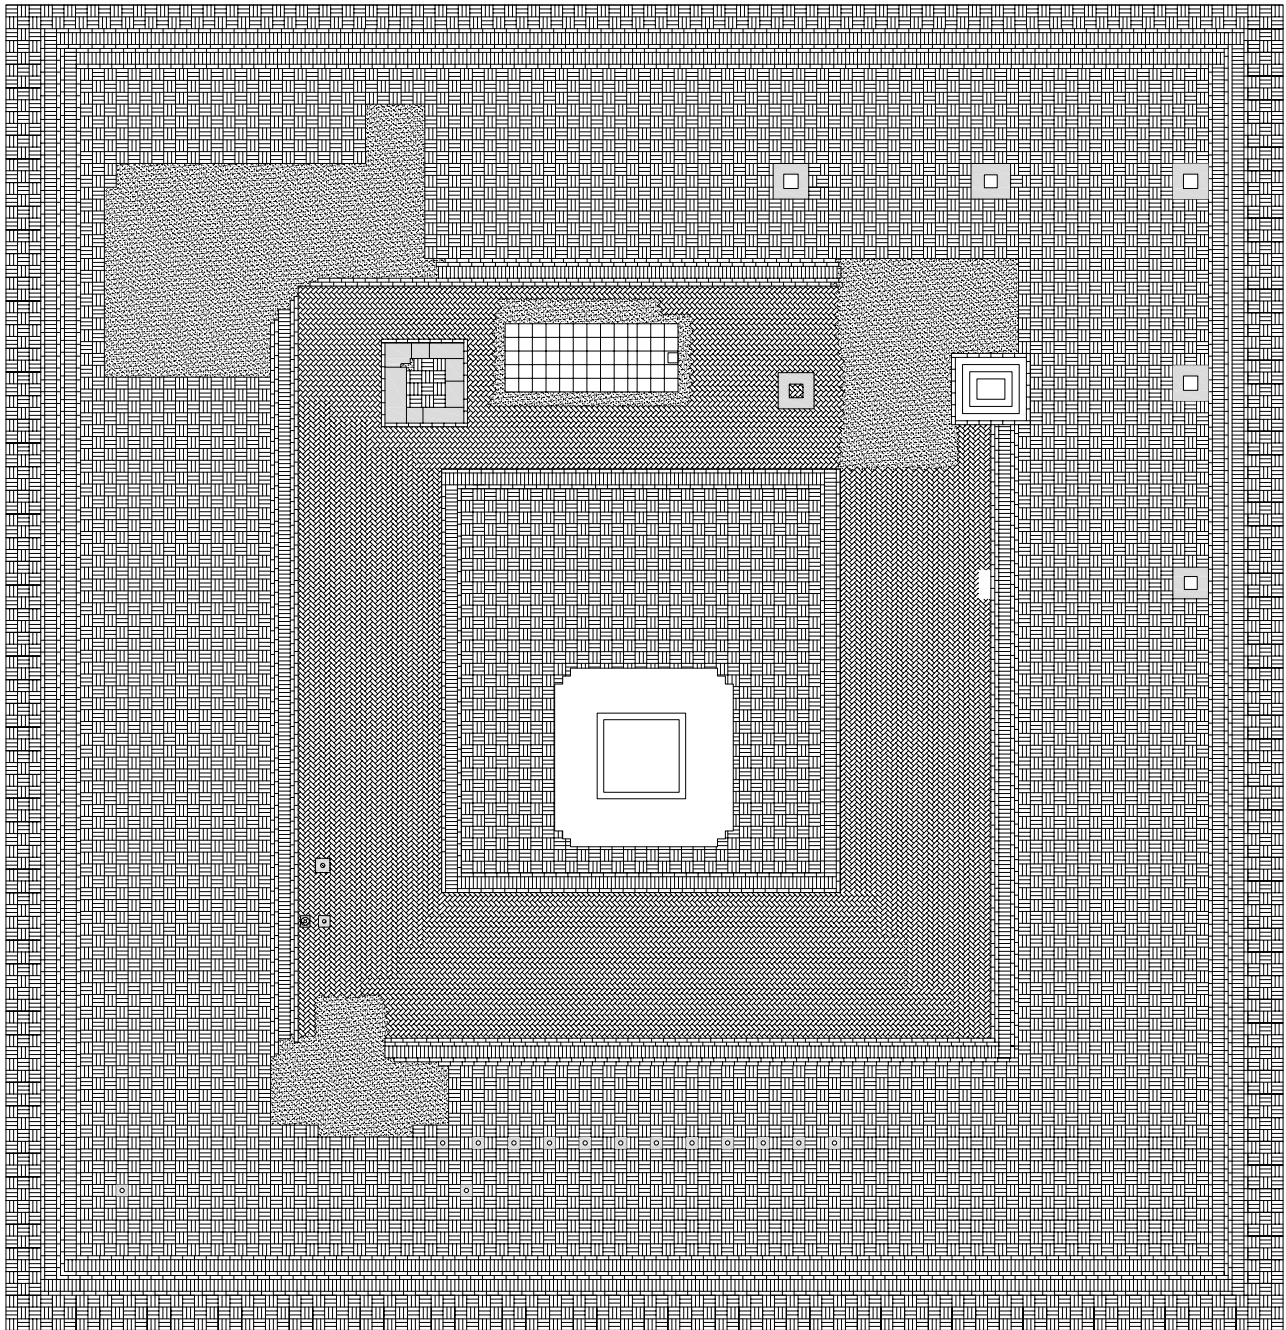
Plan of historic brick paving

The excavated historic on-edge brick pavement of Mulchowk courtyard was documented and analyzed before an appropriate restoration design was developed.

- The courtyard was re-paved at the historical level (approximately 5-6 inches lower than the modern tile floor dating to 1972) according to careful documentation. 50% of the original bricks were reused and the remaining bricks were ordered from Thimi as per the historic samples. The paving was re-set in the historical pattern, a sophisticated and complex design.

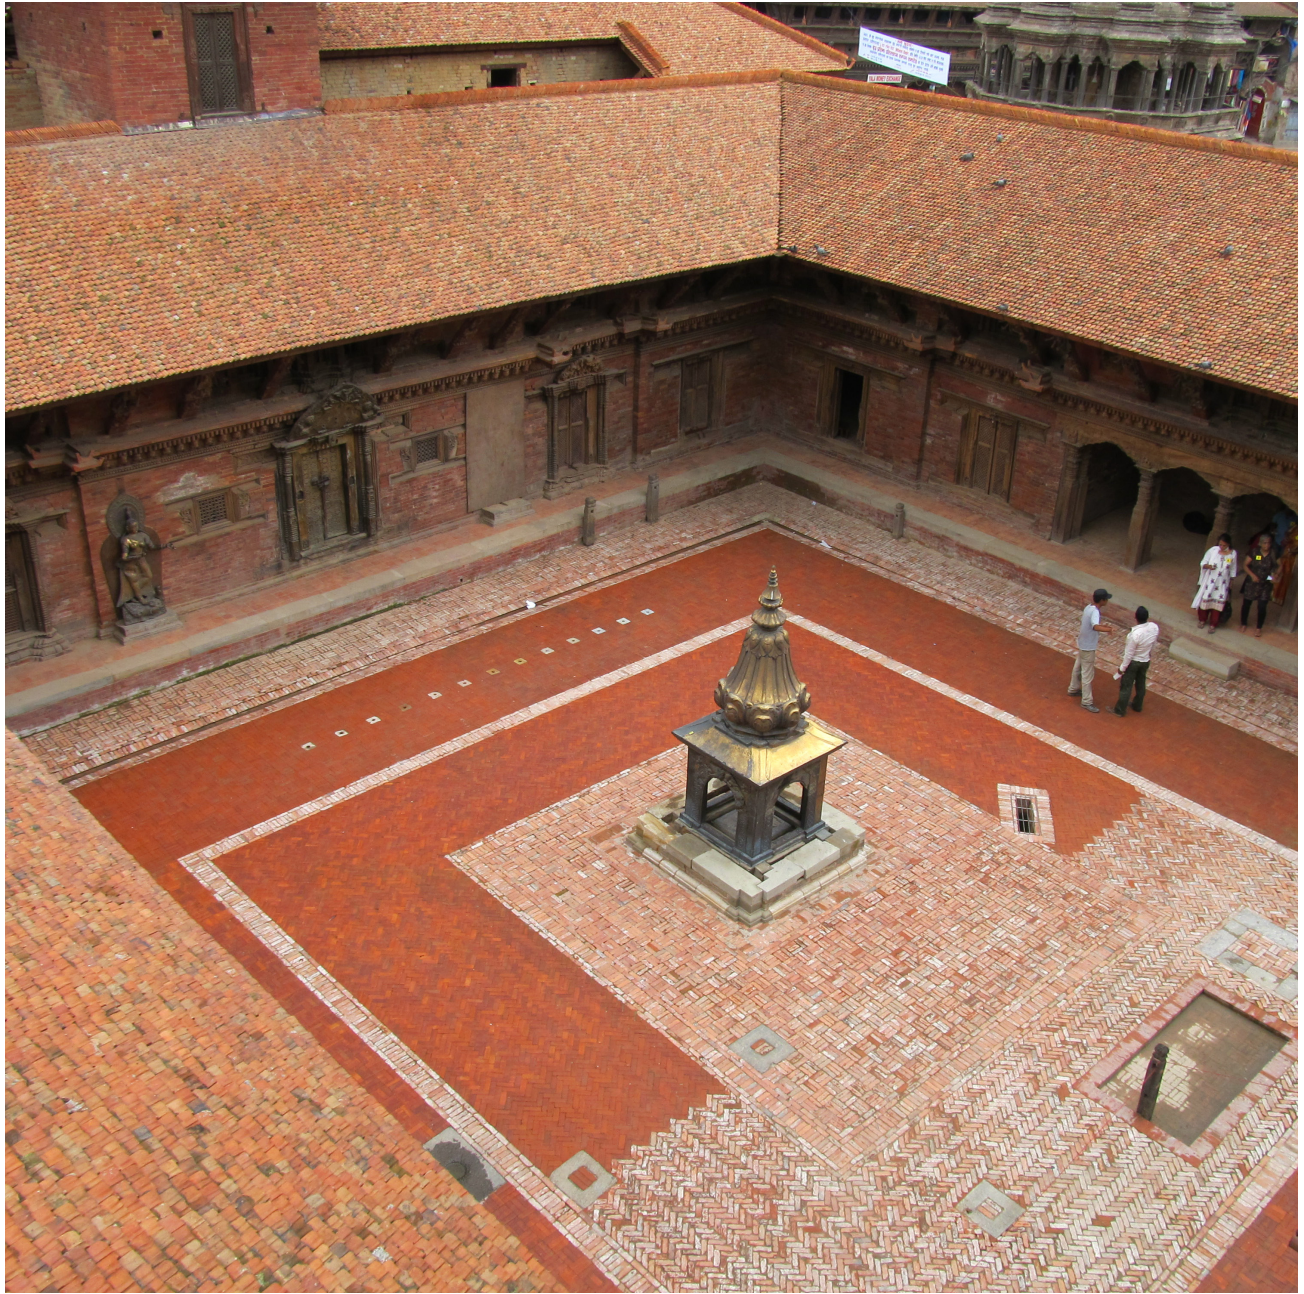
Restored paving of Mulchowk courtyard | 2012

View of the courtyard paving shortly after its restoration in its historical configuration that was discovered during excavation. The difference in color between historic and new bricks is clearly visible.

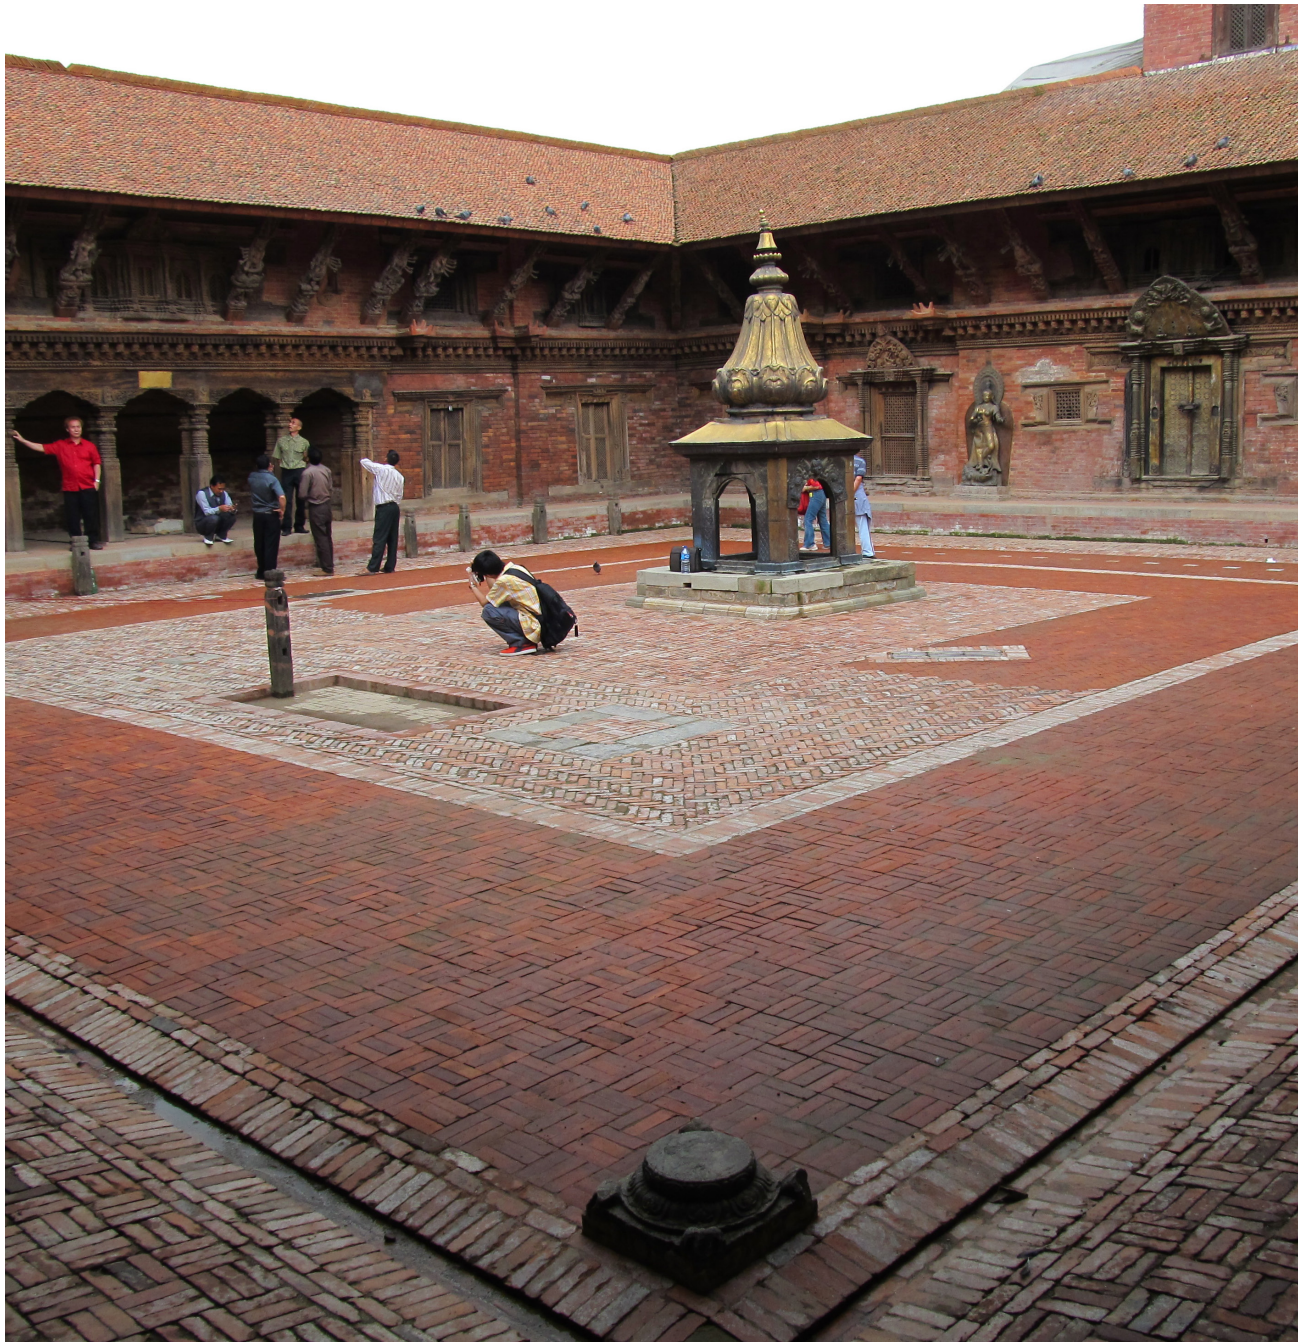
Restored paving of Mulchowk courtyard | 2012

The new courtyard paving was sloped to efficiently channel rainwater out of the courtyard along surface drains. The courtyard restoration included two sub-projects supported by other donors: the Yantaju shrine in the center of the courtyard was restored in late 2012 with support from Lamu Amatya, a Nepali private donor, and the Golden Door (far right) was restored in 2012 with support from the Government of the Federal Republic of Germany, The Sumitomo Foundation, and local craftsmen.

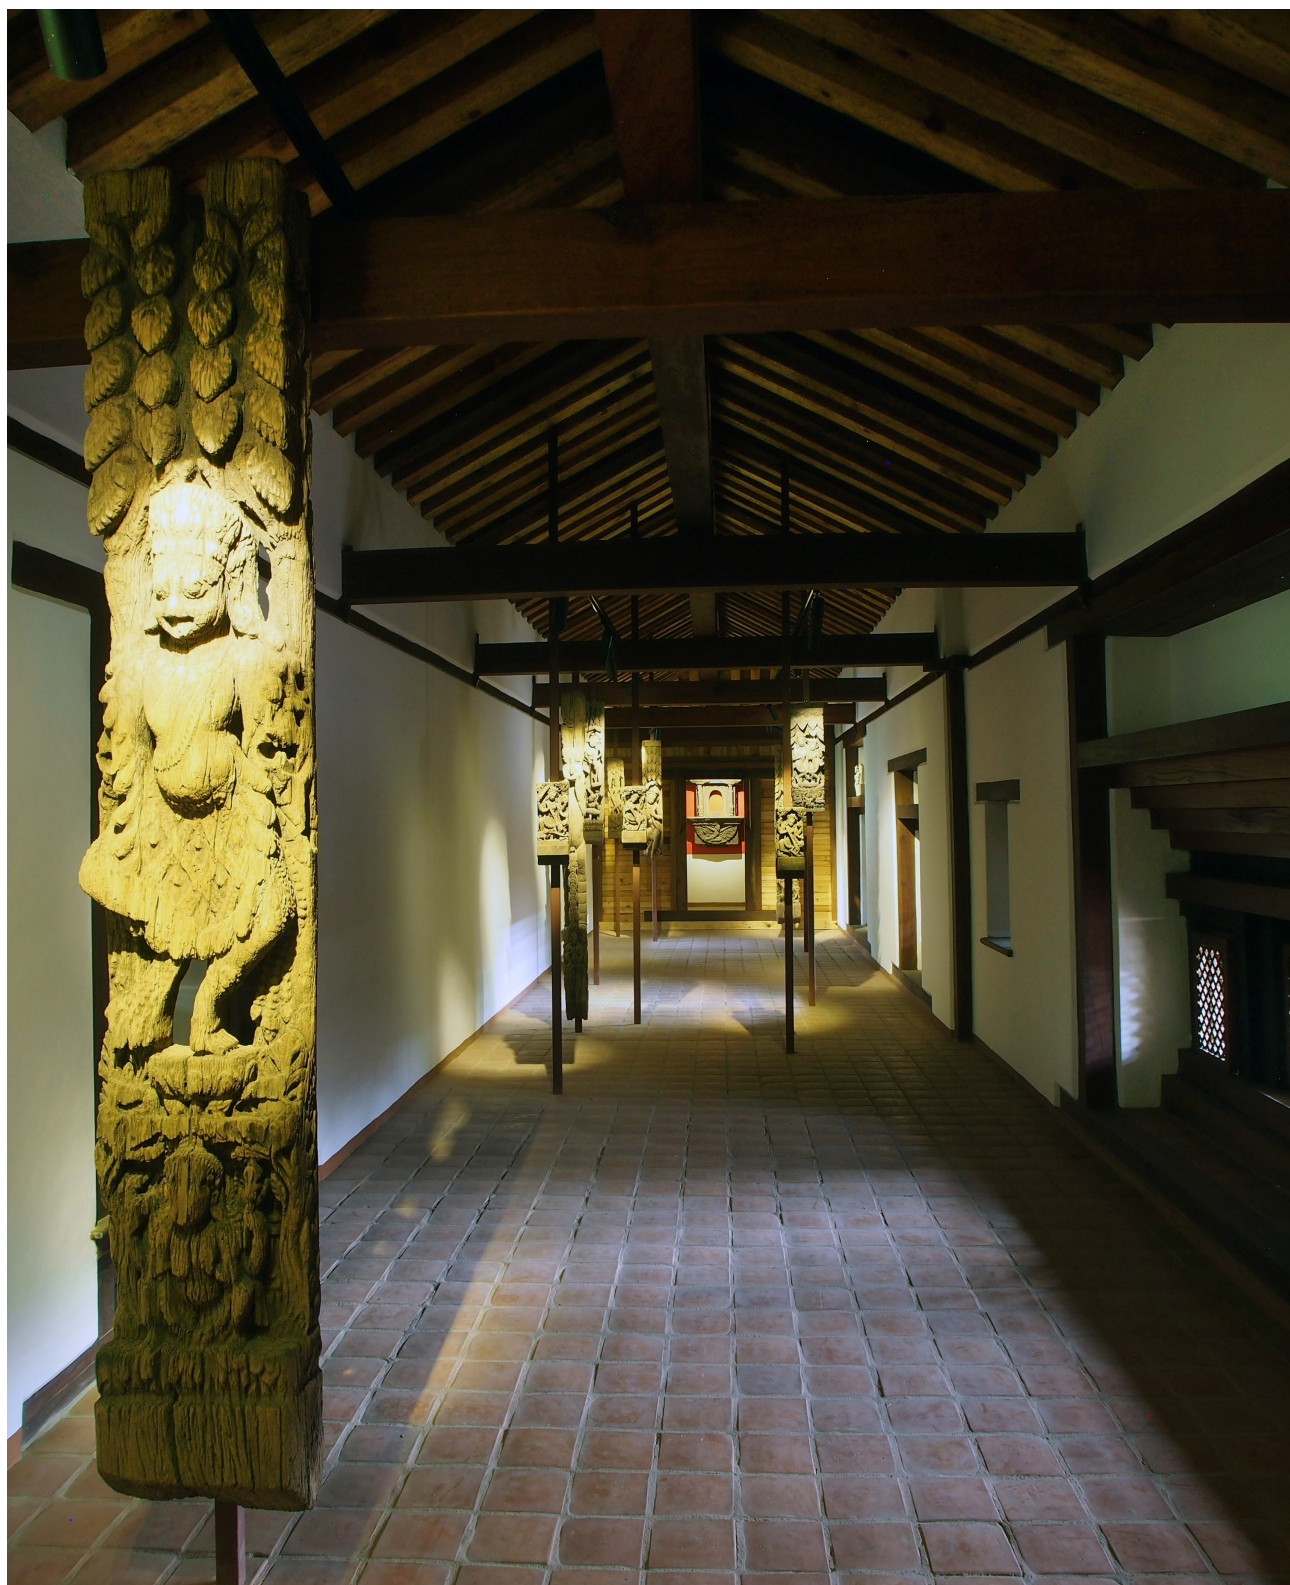
Kot Pati before restoration | 2006

The dilapidated condition of Kot Pati before restoration is clearly visible in this photograph. Makshift doors and partitions were added by shopkeepers with little regard to the building's historic fabric.

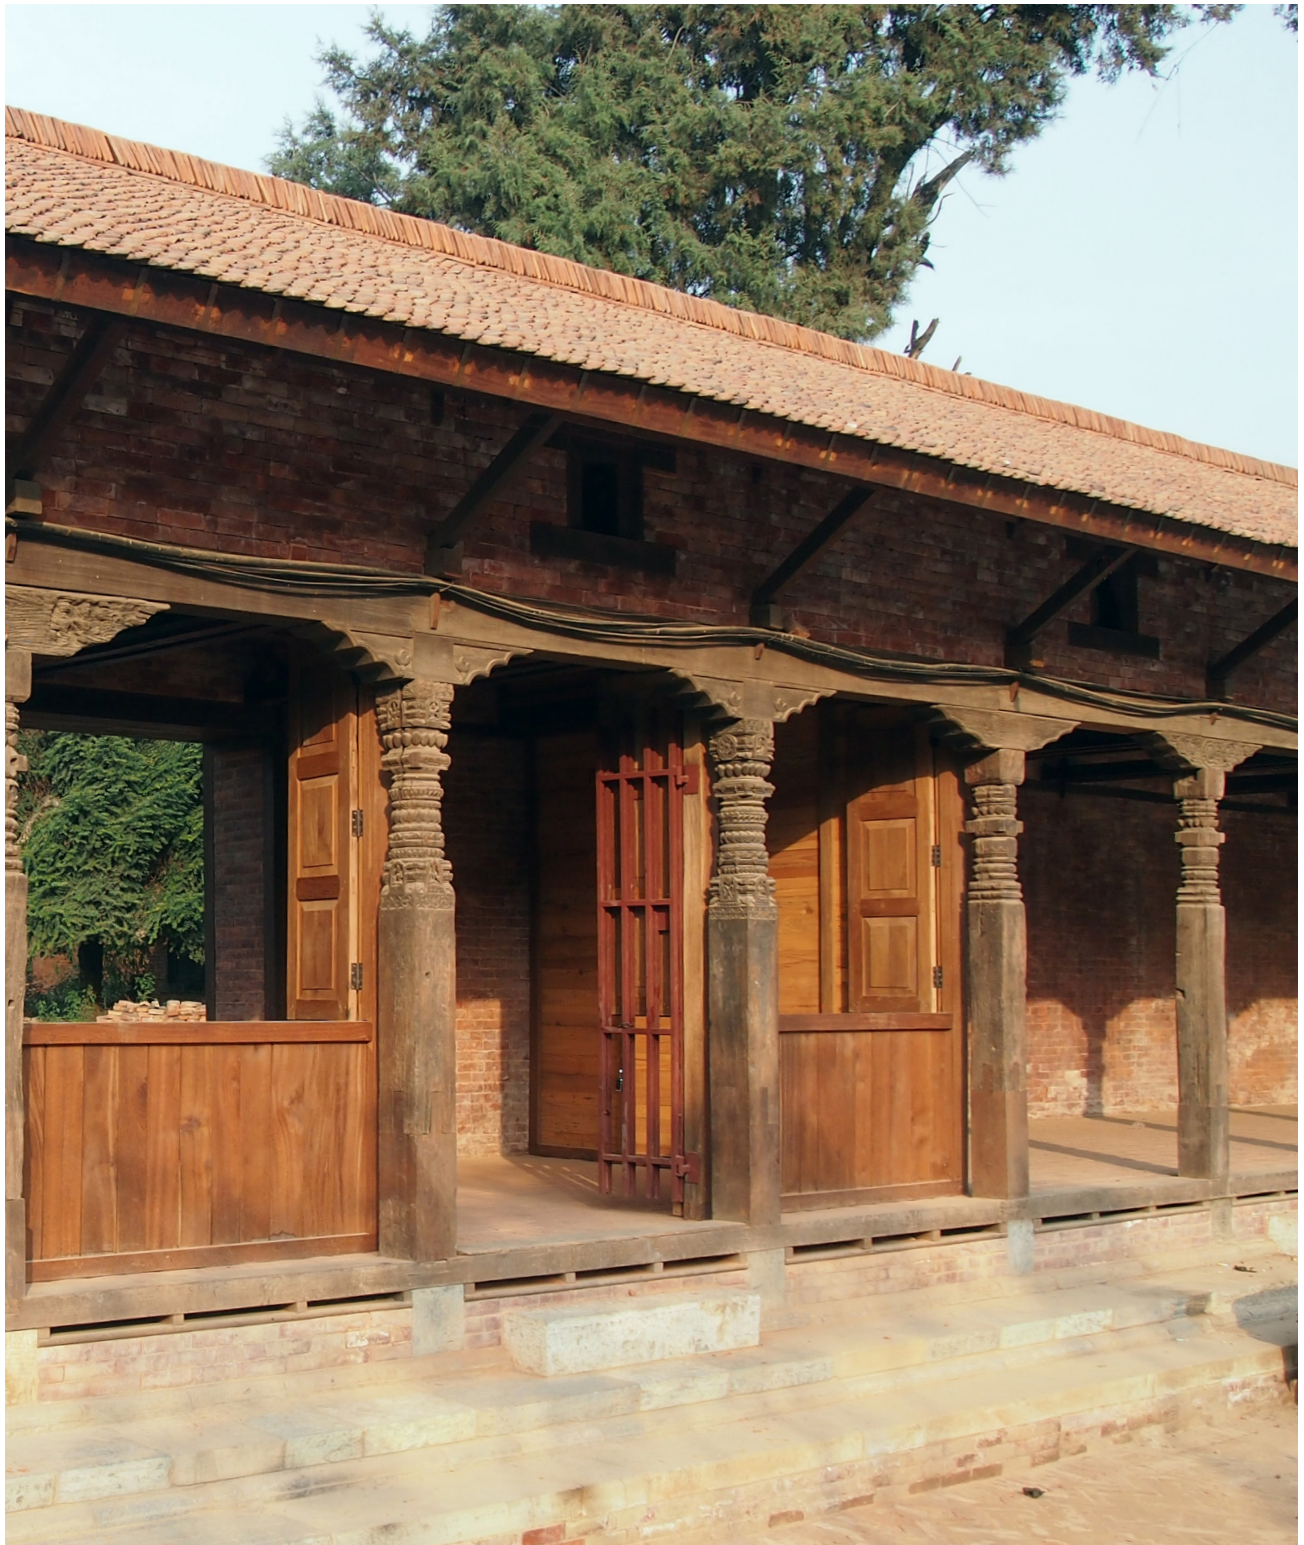
Kot Pati entry after restoration | March 2014

An entry room to the rear garden behind the palace was created with newly designed timber partitions, panel windows, and security bars. The rest of the Pati will remain a continuous arcade.

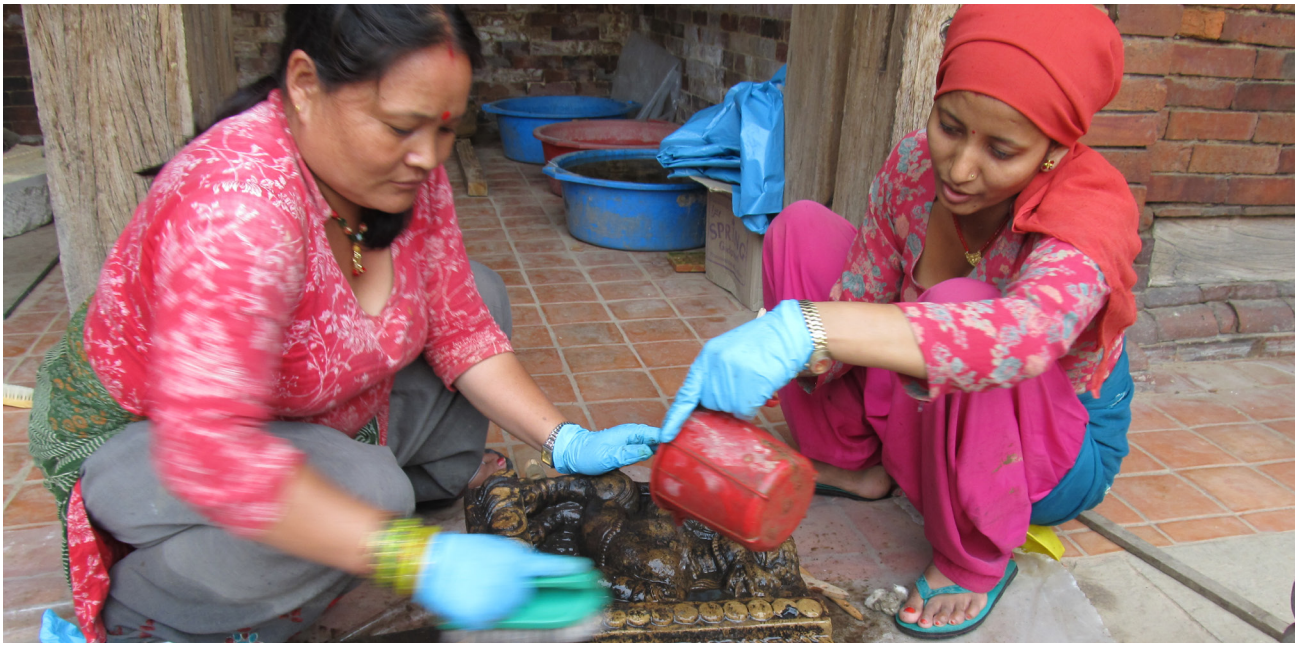
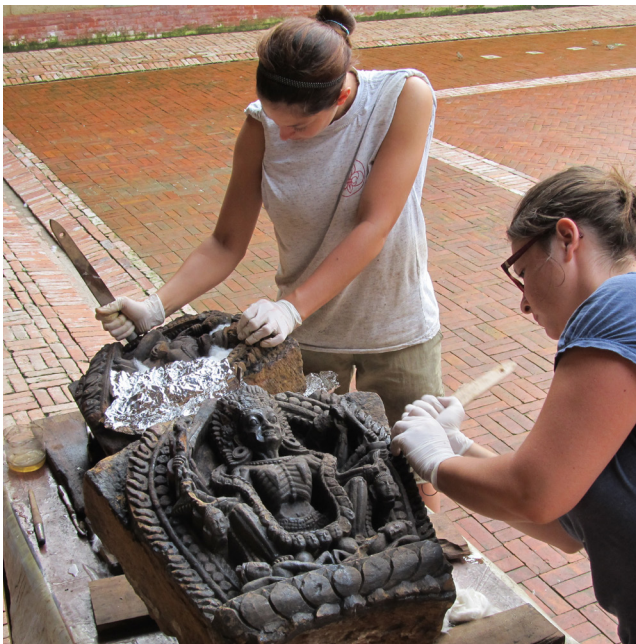
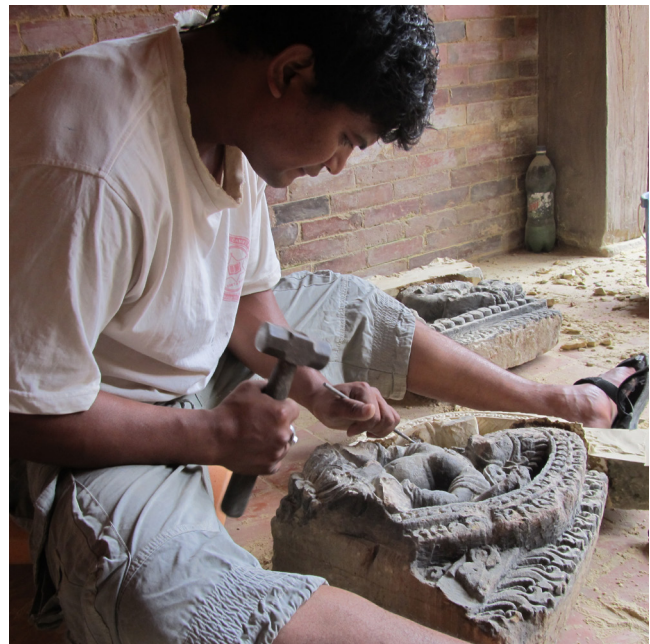
Initial cleaning and repair | September 2013

Initial cleaning and repair of stone elements of the south stone gate. The sculptures were heavily damaged by Portland cement infill which had to be carefully removed without damaging the surface of the stone.

- Portland cement in-fill was removed from the brick wall fabric .
- The heavily damaged walls in which the gates were set were reconstructed using both existing and new bricks.
- The brick paving of both courtyards was excavated and re-set in the traditional configuration.
- The staircase of the north courtyard was repaired, plastered, and painted.
- Stone sculptures were carefully cleaned and treated after reassembly with the help of a conservation team from the University of Applied Arts Vienna.
- The stone sculptures were cleaned with state-of-the-art laser technology to clean the deep-set layers of dirt and black tar. Years of careful testing of different solvents did not yield the expected results, which necessitated the use of the laser.

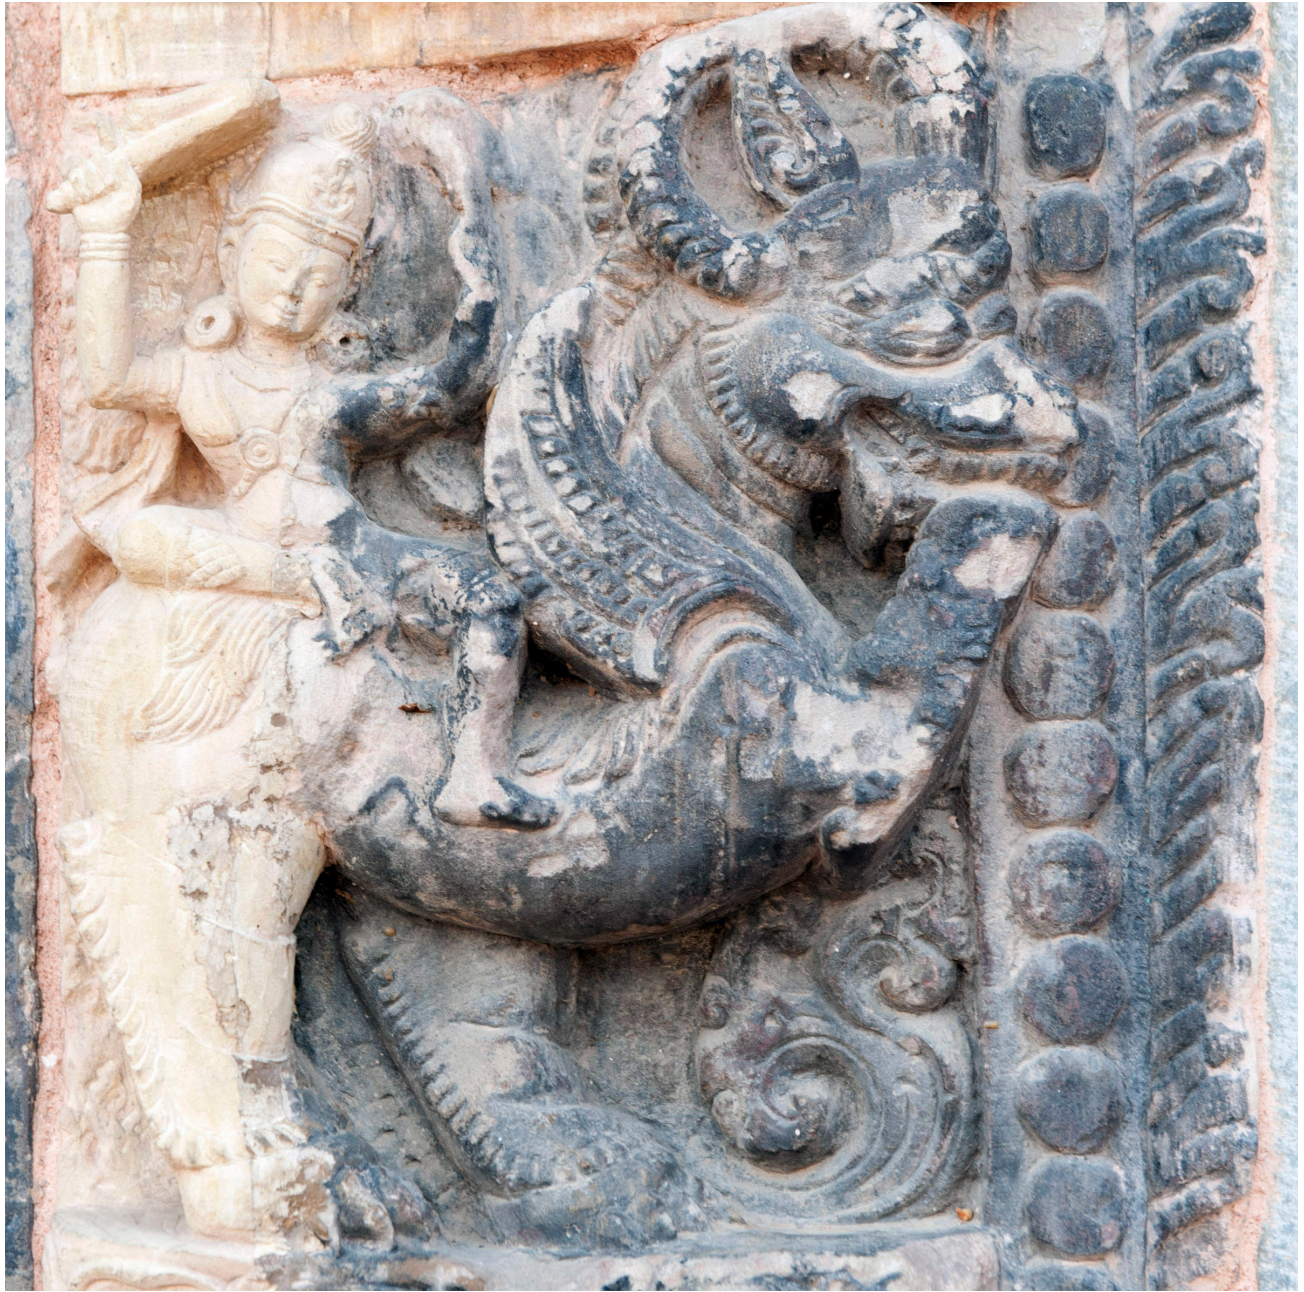
Repaired stone image of Vishnu | September 2013
The stone sculptures were fixed to the gate with lime and brickdust mortar (*surkhi*) after cleaning and repair. The left part of this sculpture was recarved.

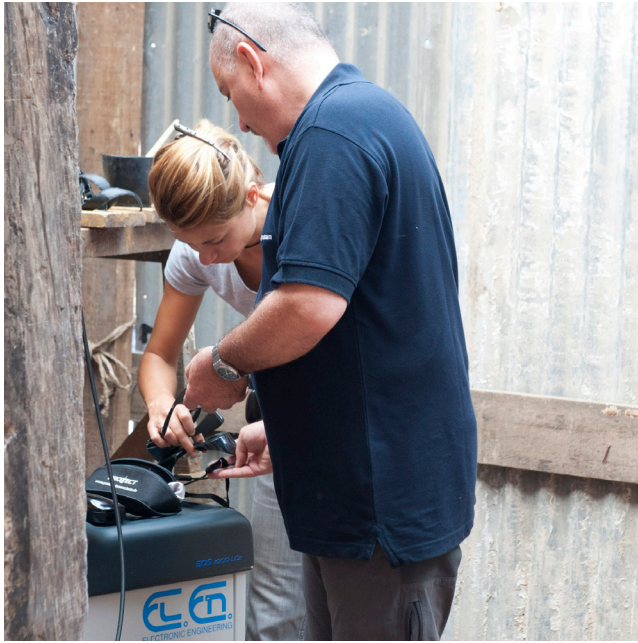
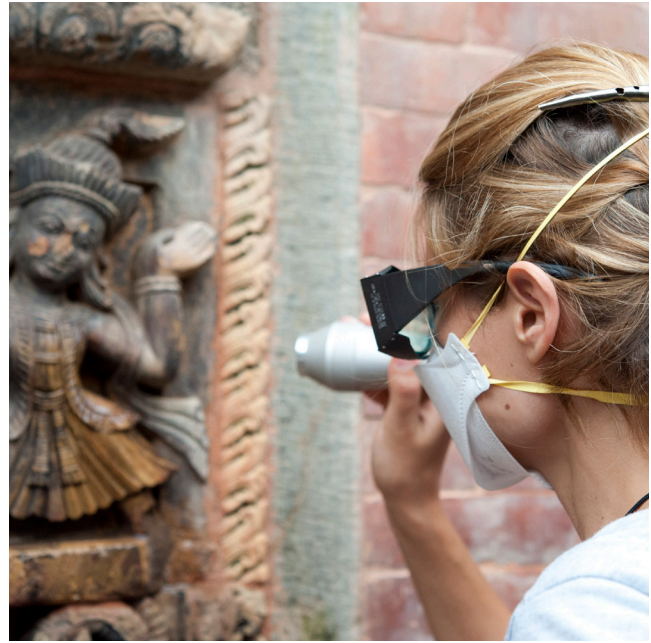
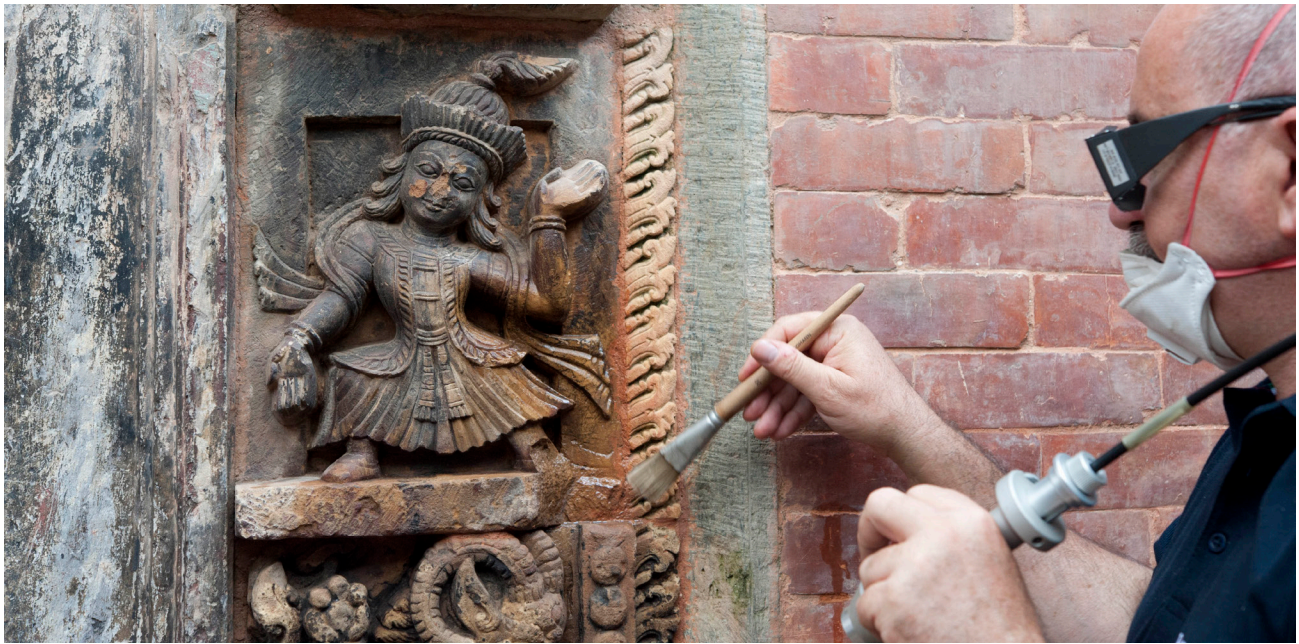
Laser treatment | August 2013

The sculptures required laser treatment for additional cleaning of deep-set layers of tar paint. Dr. Alessandro Zanini from the University of Applied Arts Vienna was responsible for laser ablation of the individual stone sculptures of the south stone gate. Careful attention was also paid to the patina and joints.

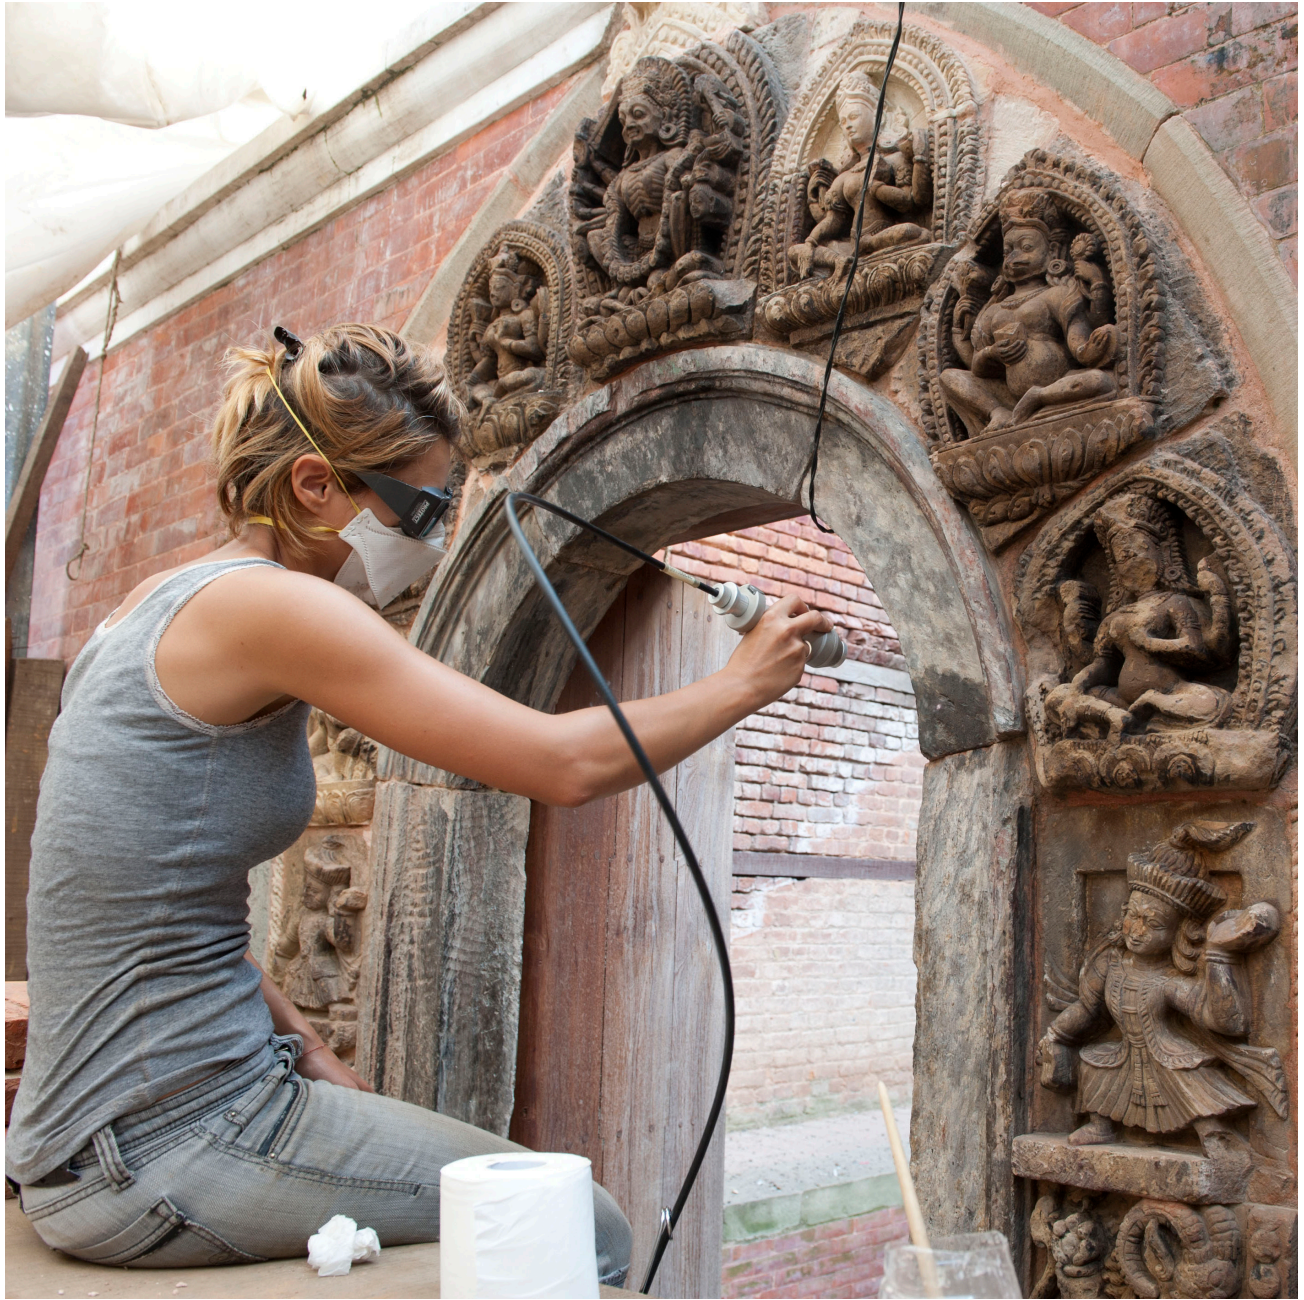
Laser ablation of tar paint | August 2013
The use of the laser enabled highly selective and targeted cleaning while avoiding surface damage.

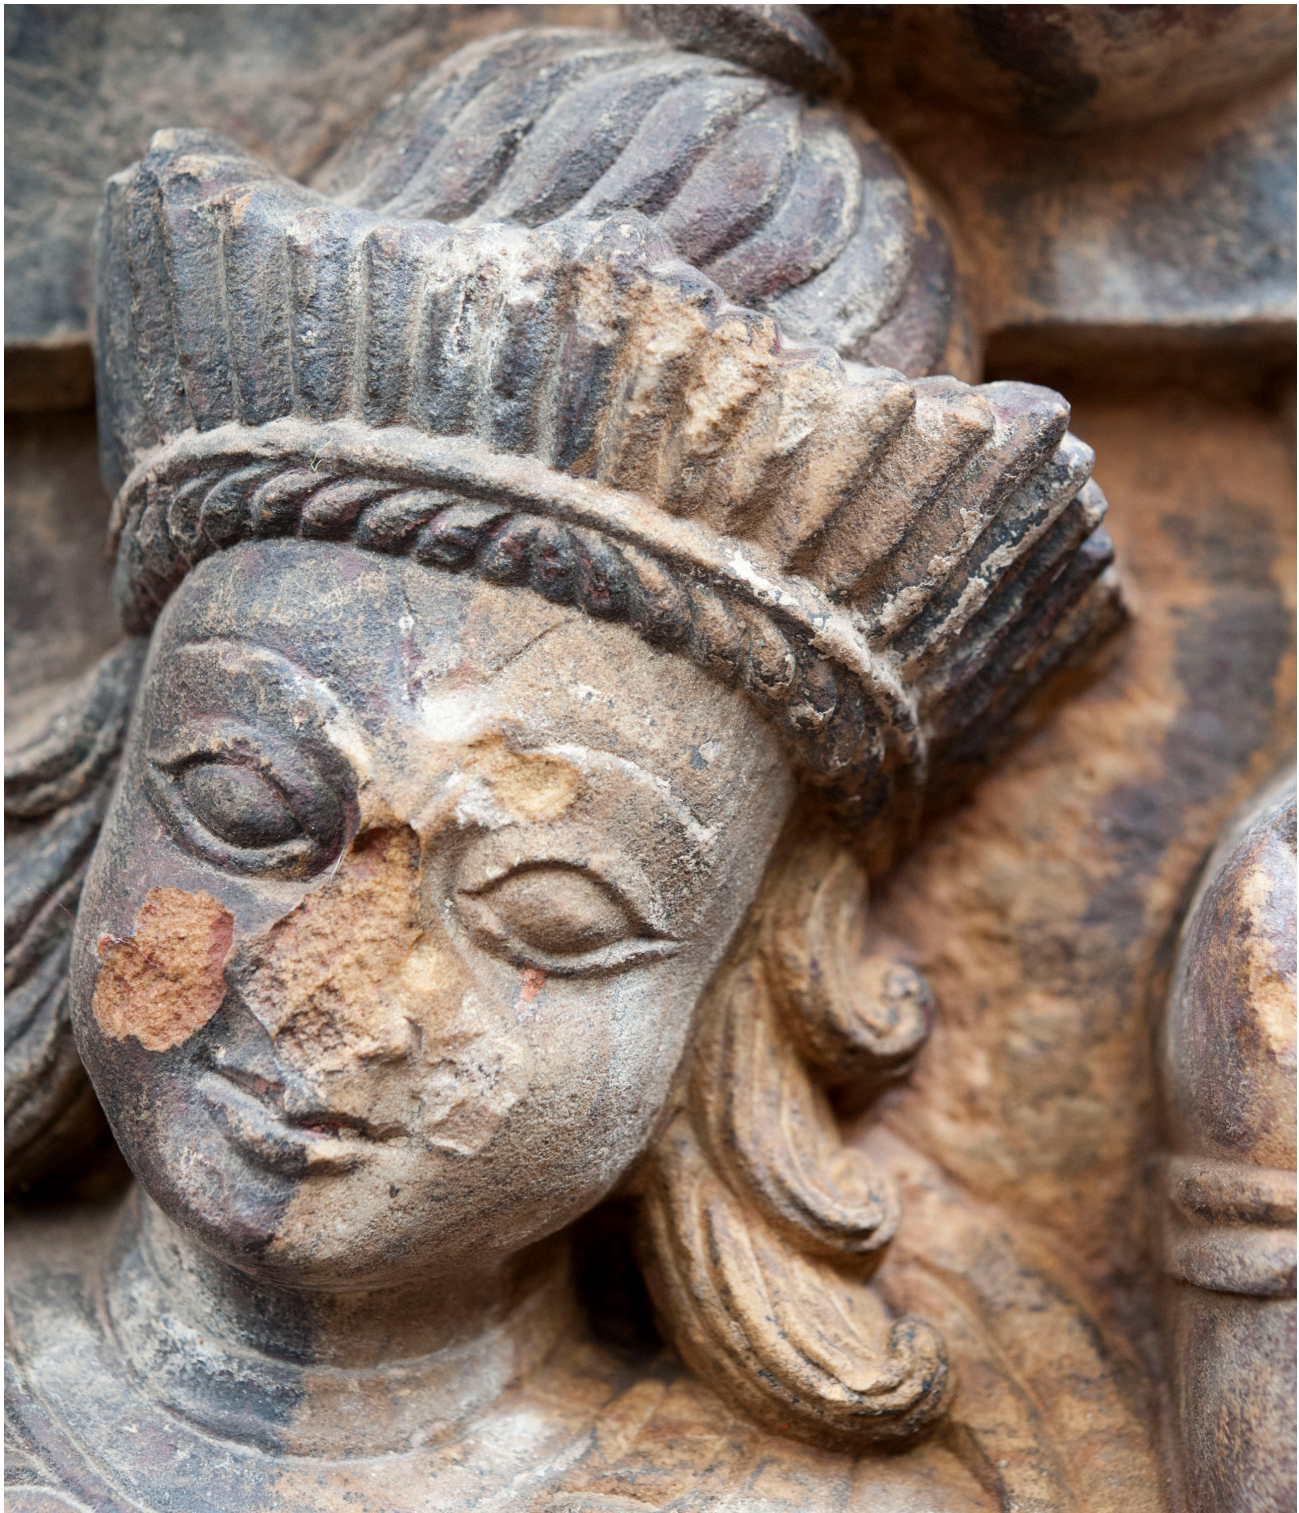
Chromatic difference after laser ablation | September 2013

The chromatic difference before and after laser treatment is clearly visible. The right half of the deity's face has been treated with the laser.

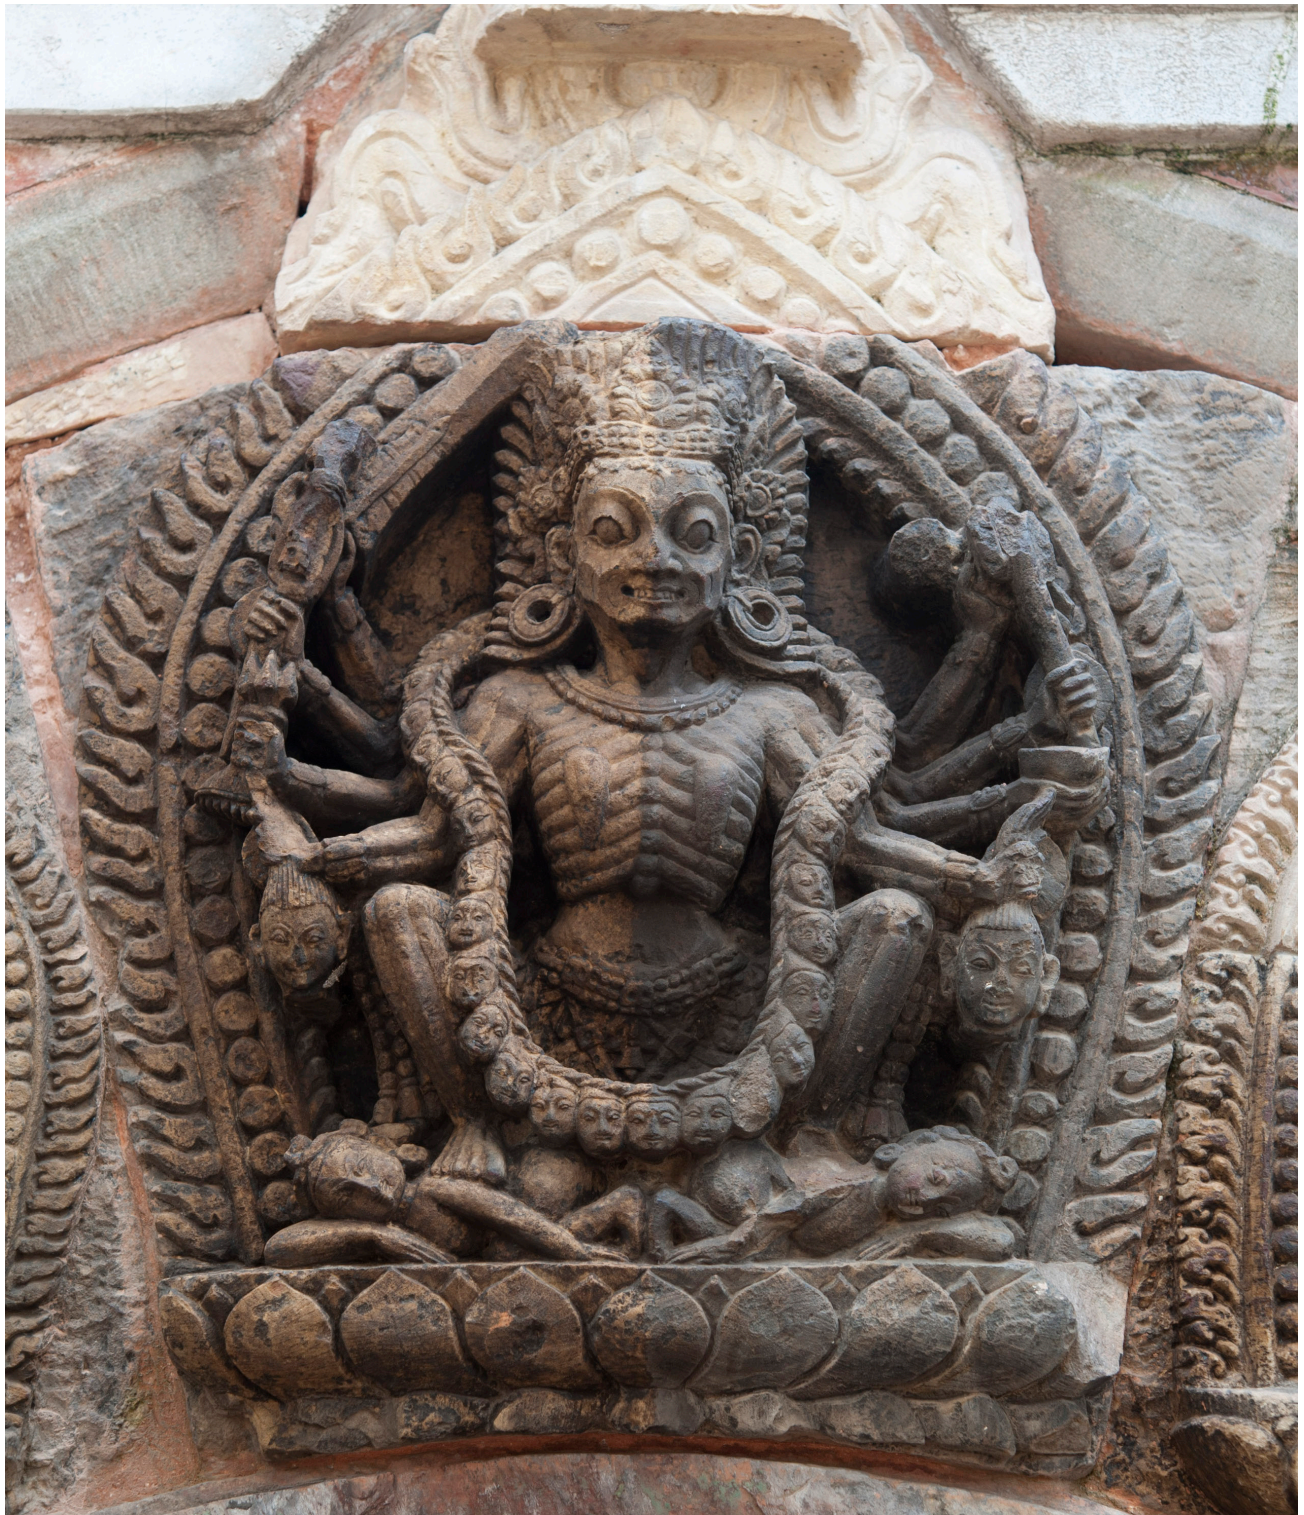
Image of Kali before and after laser treatment | September 2013

The left half of this image of Kali with a garland of heads has undergone laser treatment, removing several layers of deep-set black tar paint. The detail of the carvings are far more legible after being treated.
