RESTORATION OF THE PATAN ROYAL PALACE COMPLEX

MULCHOWK PALACE
KOT PATI
STONE GATES
BAHADUR SHAH WING

AFCP 2009 LARGE GRANT - 2012 EXTENSION

FINAL REPORT

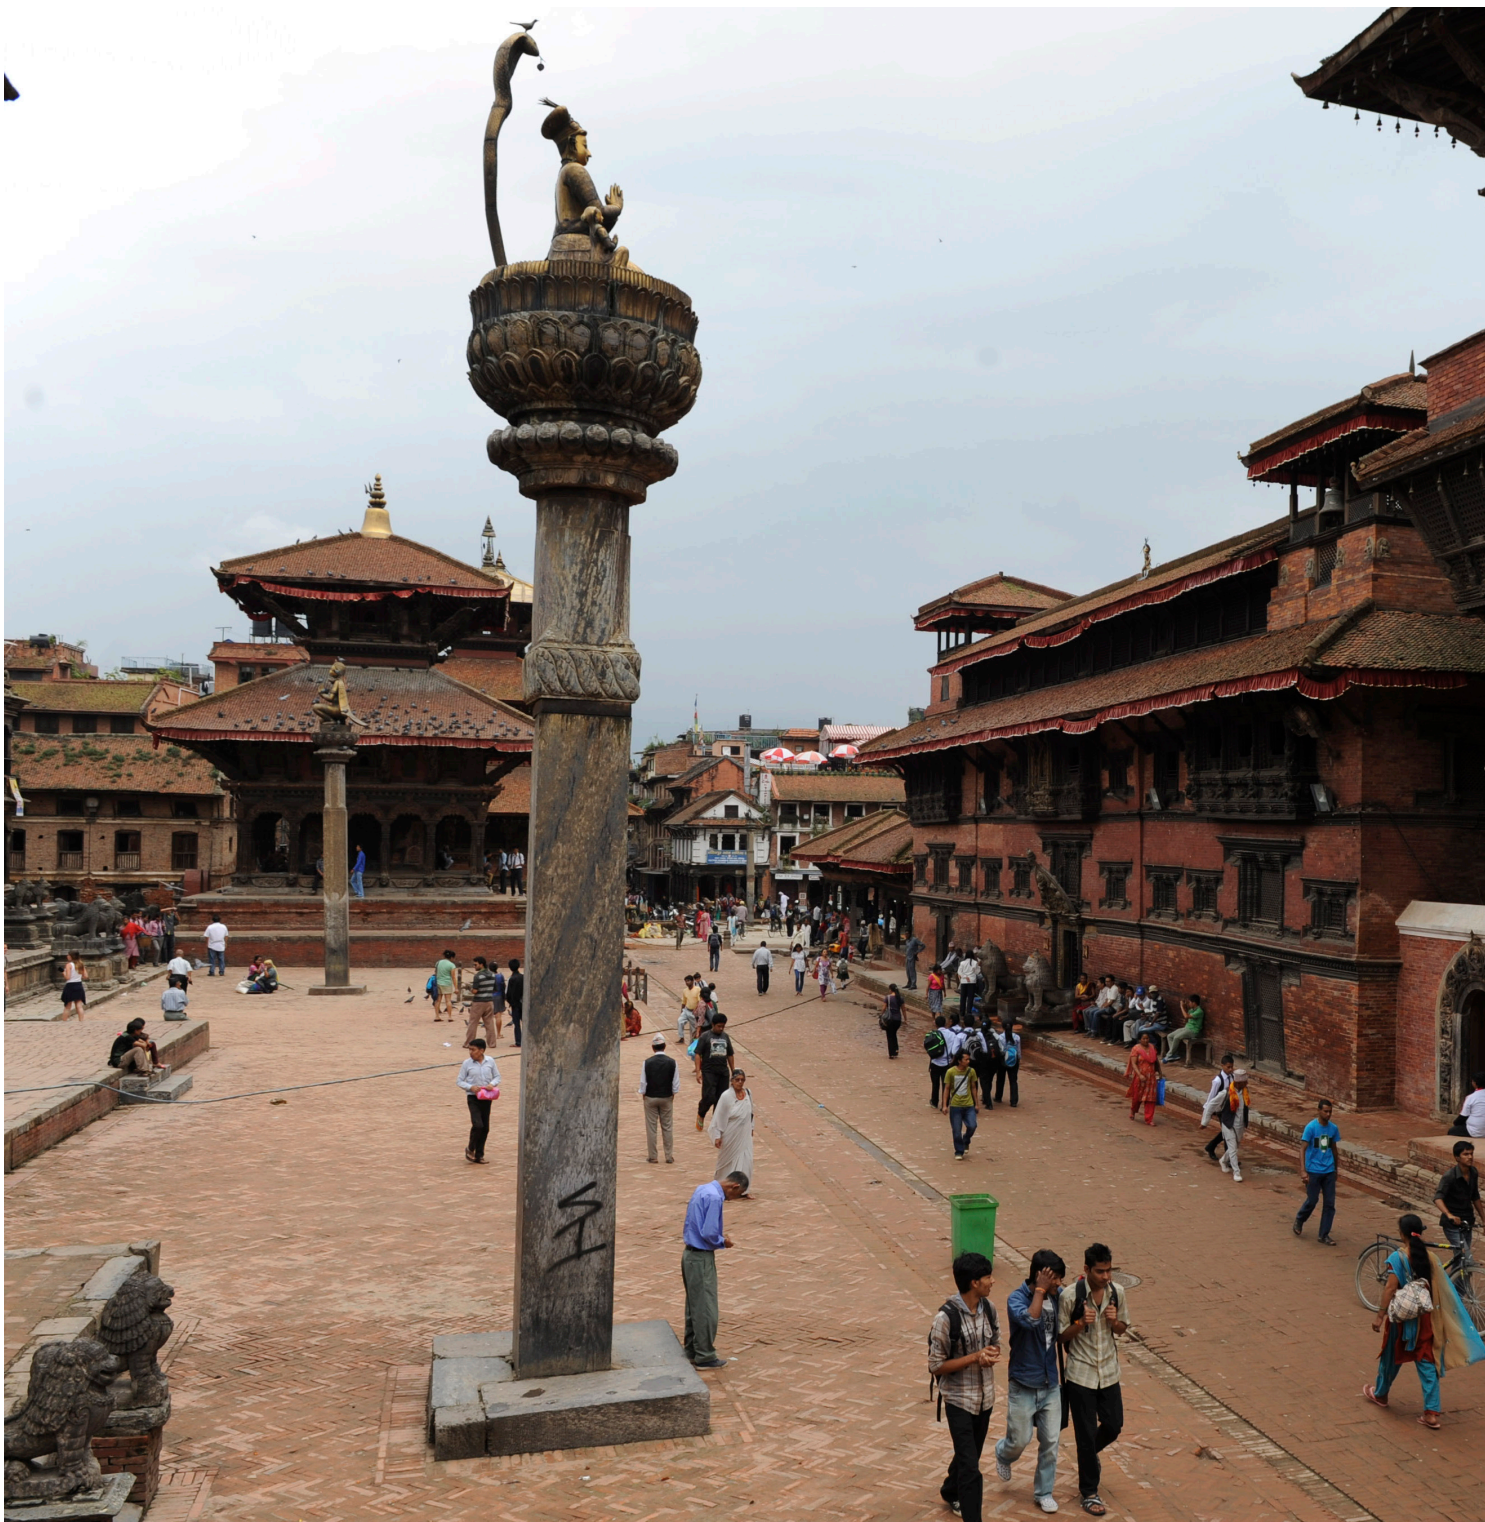
The left half of this image of Kali with a garland of heads has undergone laser treatment, removing several layers of deep-set black tar paint. The detail of the carvings are far more legible after being treated.

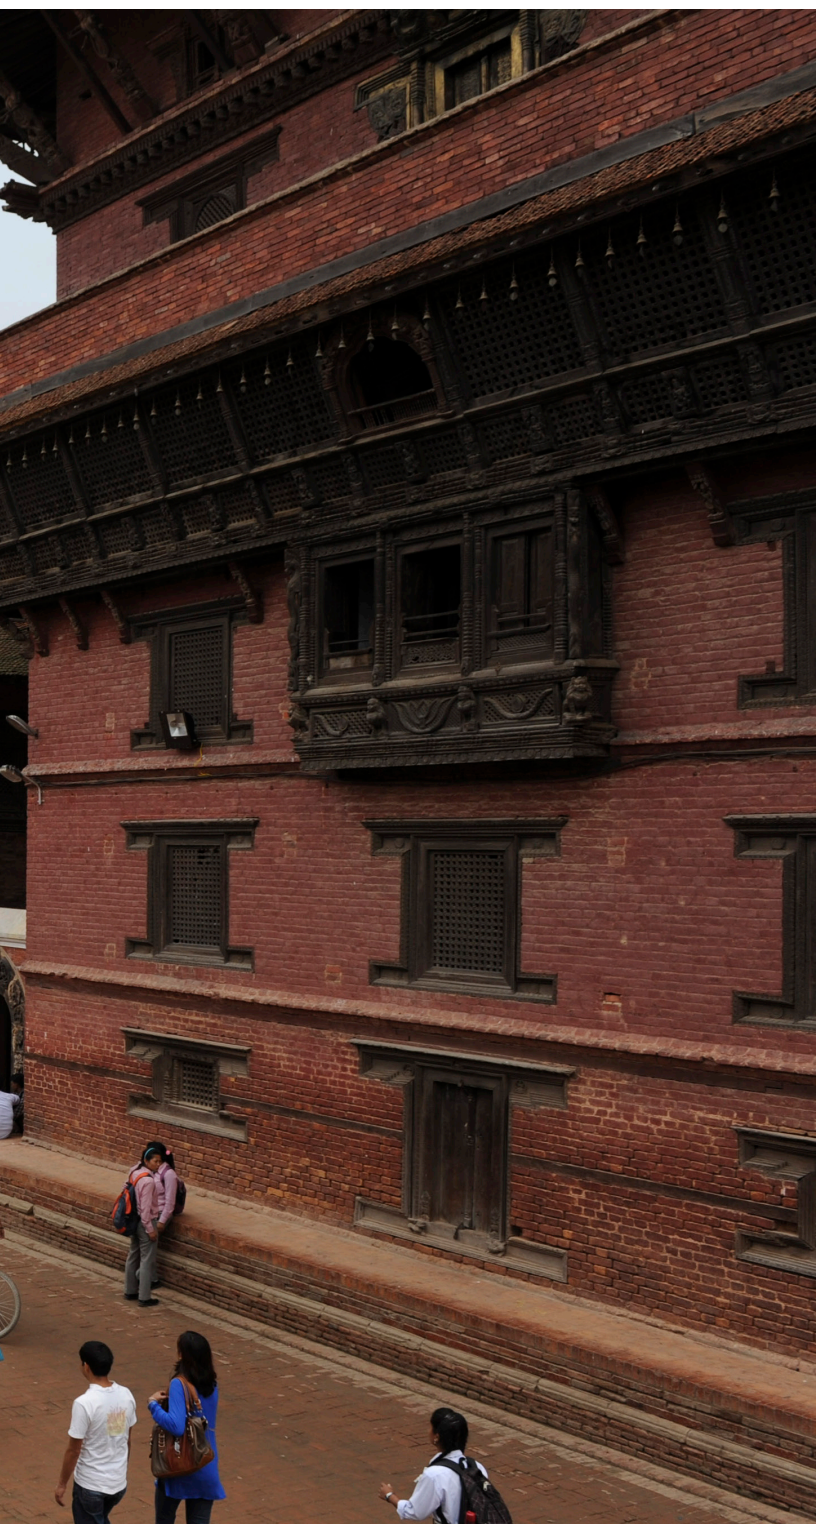
Patan Darbar Square | 2013
The north stone gate as seen from the steps of
Harishankar Temple on Patan Darbar Square.

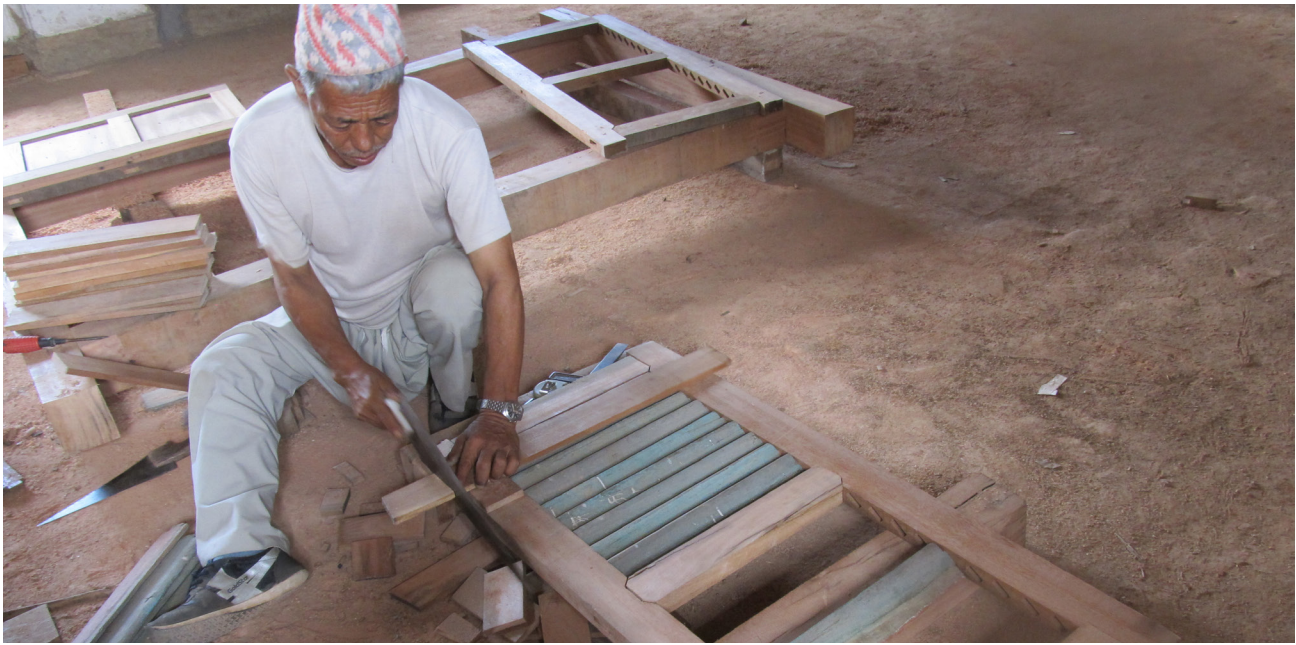
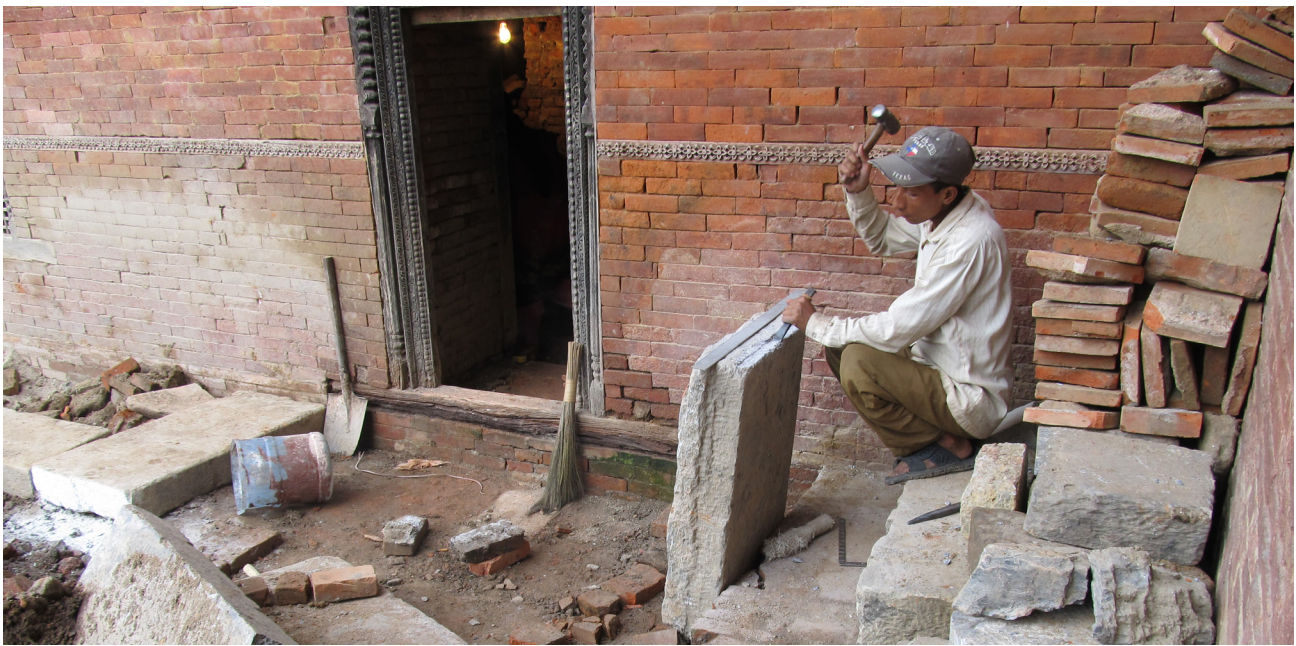
Restoration of window frames | August 2013

A carpenter repairs panels for the second floor French windows with louvers.

A stone mason shapes and sizes a plinth stone by chiseling.

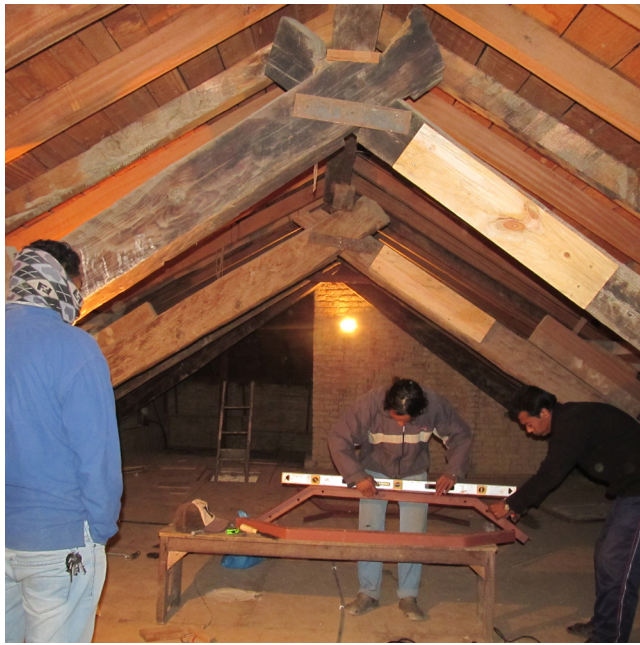
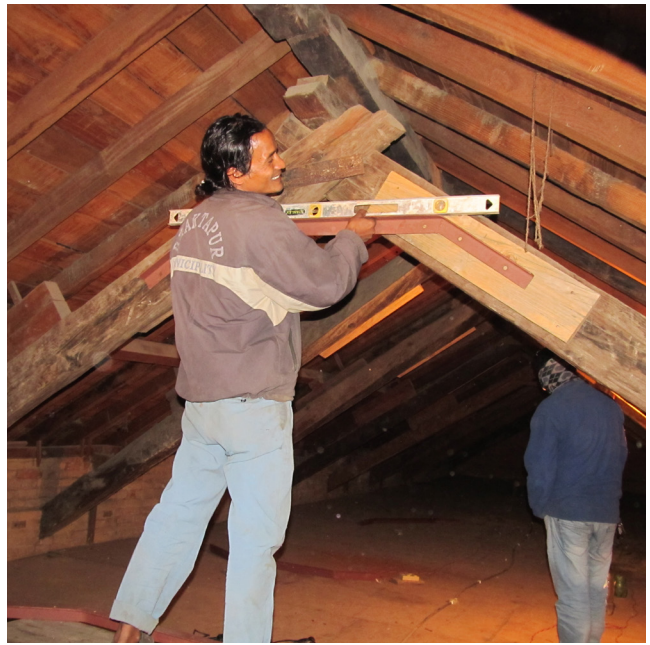
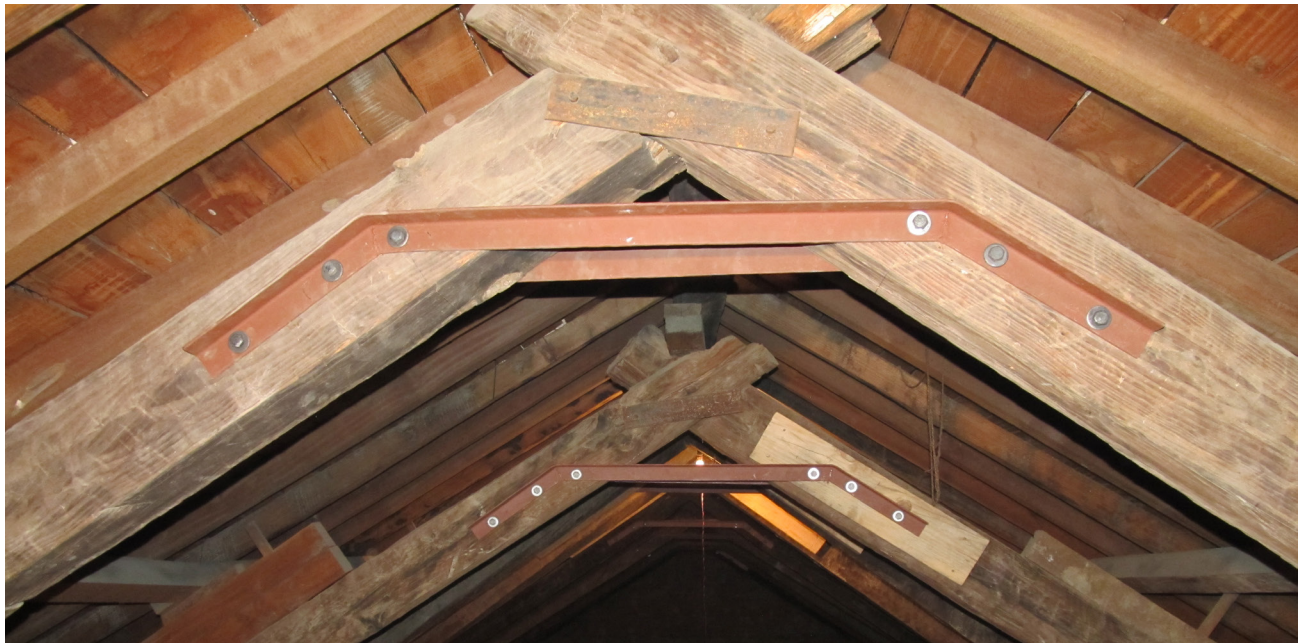
Structural reinforcement of the roof with steel collar braces | January 2014
 Steel collar tie braces were firmly attached to the rafters with 1/2" bolts. This structural reinforcement will help improve the roof's resistance to seismic motion.

- All mud was removed from the attic floor and disposed to reduce the excess weight on the ceiling, improving the building's seismic performance in the event of an earthquake.
- A few pieces of ceiling planking were found damaged and replaced with new hardwood planks.
- The entire attic floor was covered with an additional layer of marine grade plywood. 4' by 8' plywood sheets were installed in a staggered layout and firmly nailed to the planking and ceiling beams underneath, forming a strong diaphragm providing extra strength to the building in case of seismic movement.
- Metal tie braces were added to support the rafters.

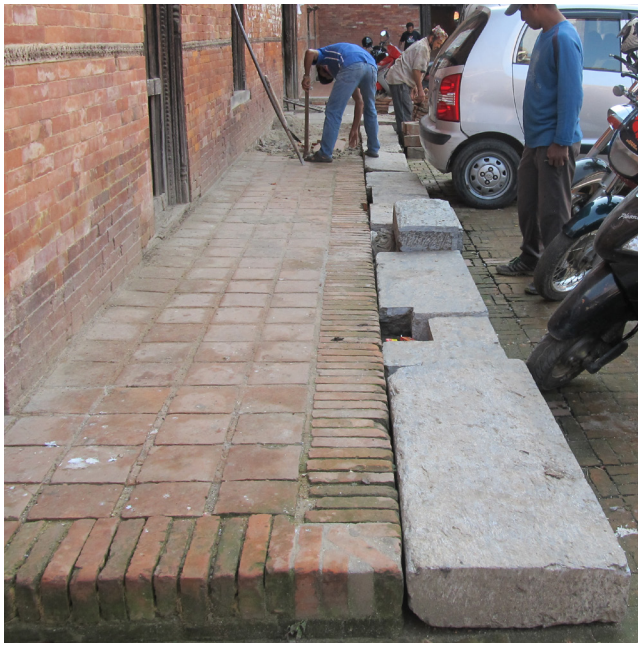
Existing condition of plinth | September 2013
New edge stones were cut to match the level of the existing plinth, consisting of tiles and on-edge bricks.

- The initial restoration plan for the Bahadur Shah building foresaw the reconstruction of the plinth at its historic level. However, it was not possible to restore the plinth to this level without lowering the paving of Darbar Square, which has been raised over time to 14" above its historical level. Since such an undertaking was beyond the scope of the project, KVPT decided to restore the plinth at its existing level using new edge stones and terracotta tiles.

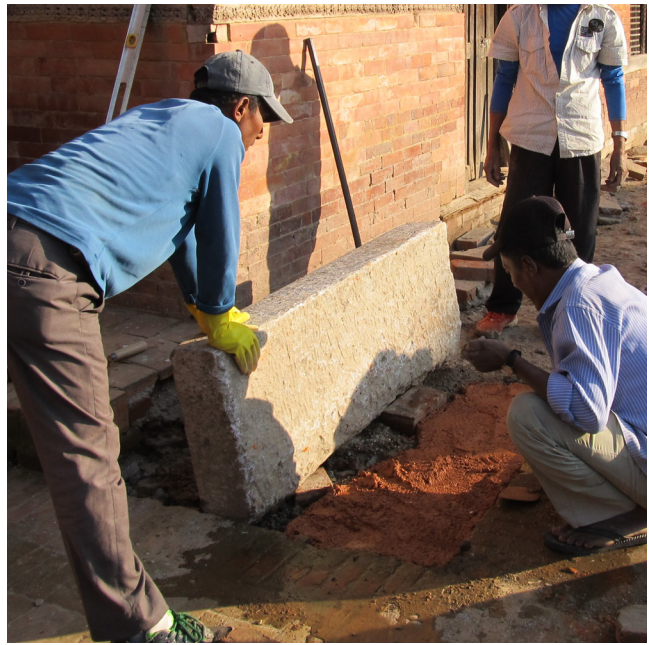
Placement of edge stone | September 2013
The plinth was dismantled and the new edge stones were laid in place on top of a bed of lime and brickdust mortar (*surkhi*).

- New manholes were constructed to facilitate cleaning and maintenance.
- The modern plinth on the west façade was completely dismantled and replaced with a properly designed plinth employing a stone edge and traditional paving tiles (*chikah-apa*).

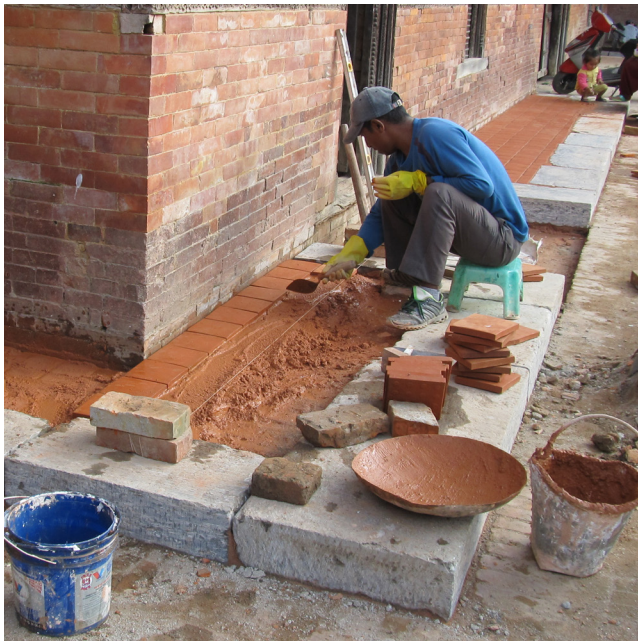
Laying tiles in *surkhi* mortar | October 2013
Lime and brickdust mortar was applied between the stones and on the surface of the plinth.

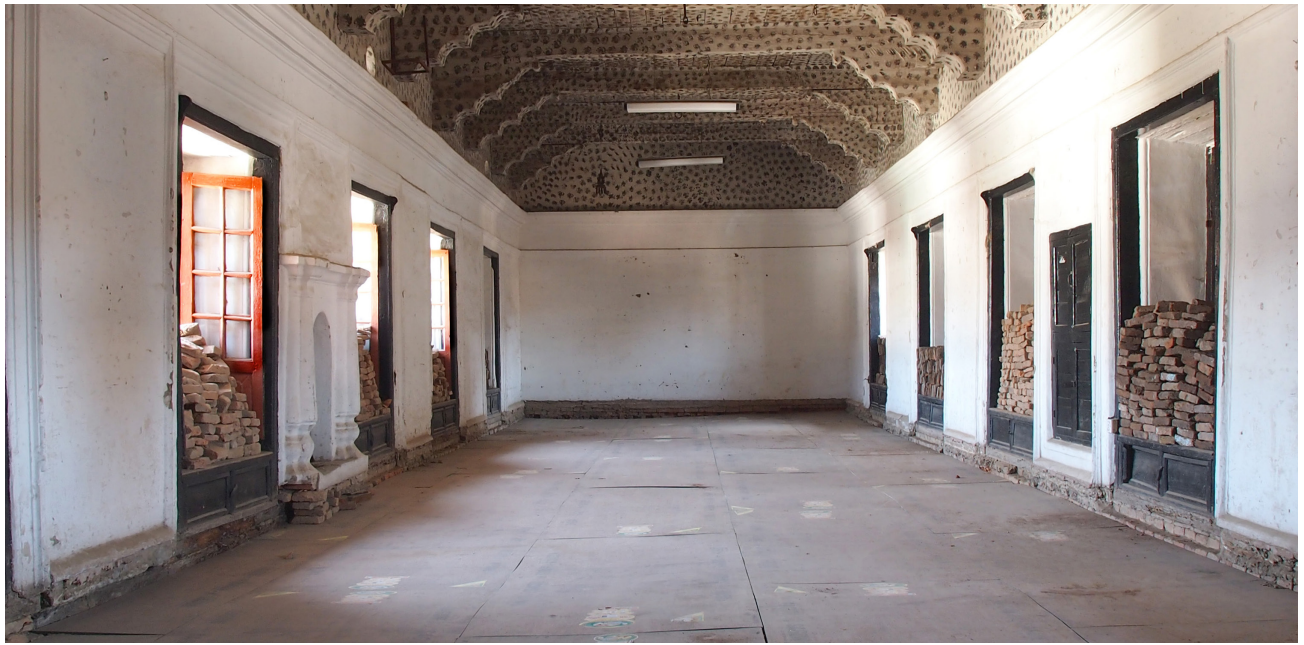
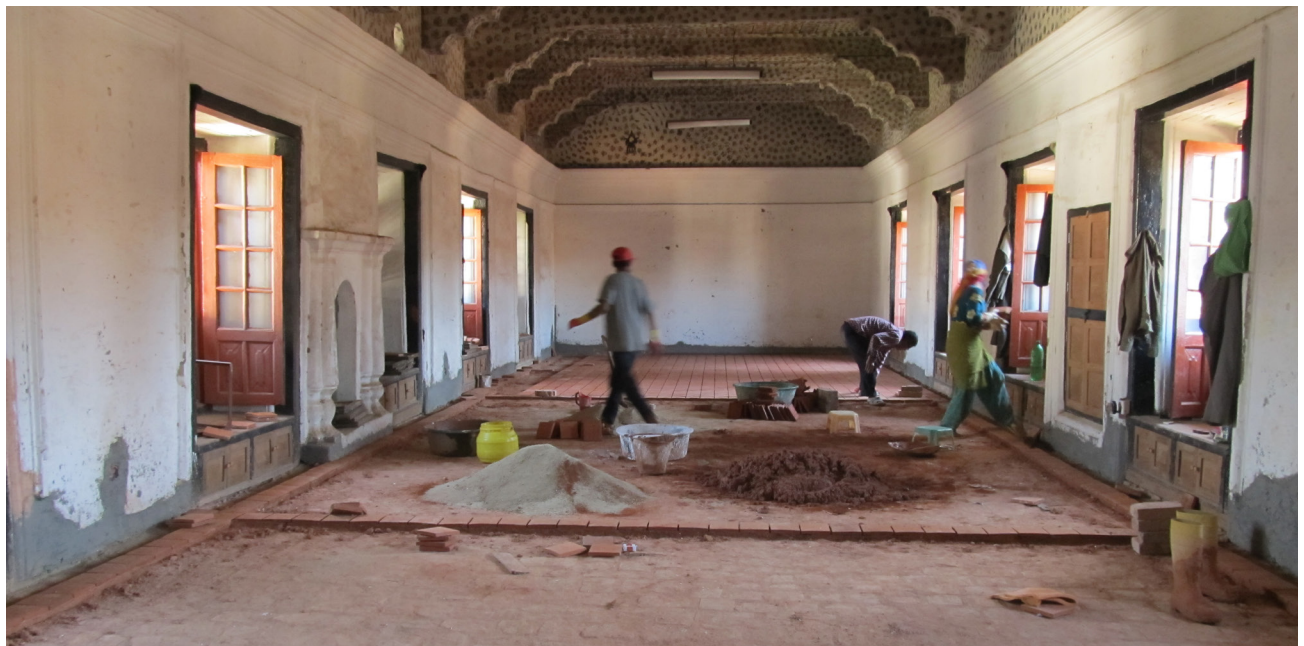
Reconstruction of the floor cover on the second floor | March 2013, November 2013
Terracotta floor tiles with lime and brickdust mortar on brick soling (bottom) were placed above a layer of plywood planking (top).

- All damaged cabinets under the windows were restored, and all missing panels and interior planking was replaced.
- All windows were completely restored. Missing slats from the louvers were replaced and damaged frames and panels were professionally repaired.
- The stair openings received entirely new frames as the existing ones were damaged beyond repair. The staircases needed some repairs and were securely re-installed.
- Missing balcony railings were reproduced following historic examples.
- Staircase, lobby and main hall were paved with traditional floor tiles (*chikah-apa*) in a lime and brickdust mortar (*surkhi*).
- Mud plaster was applied to the walls.

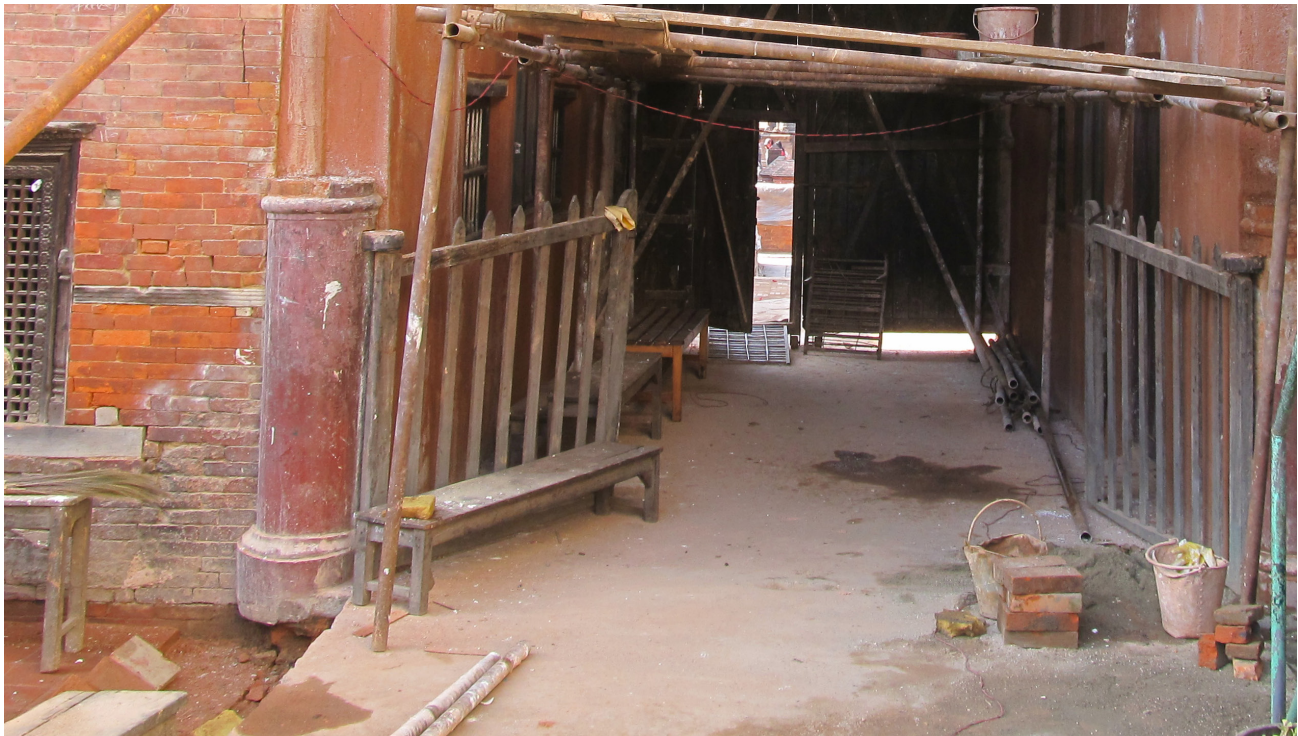
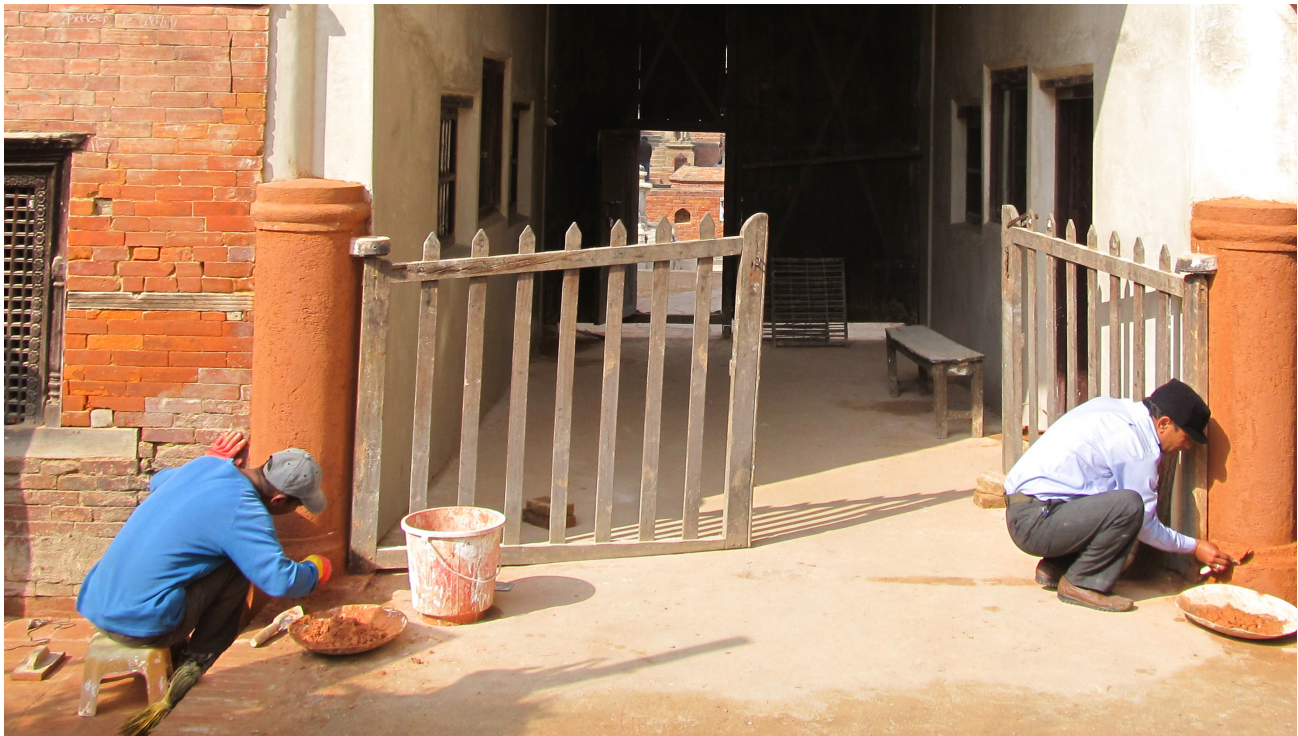
Restoration of the Elephant Gate | February 2014

The central passage through the building was thoroughly cleaned, repaired, and re-coated with plaster and lime mortar. The oversized gate allowed for the passage of elephants to the stables behind the building, now the playground of the Adarsha Kanya Niketan School.

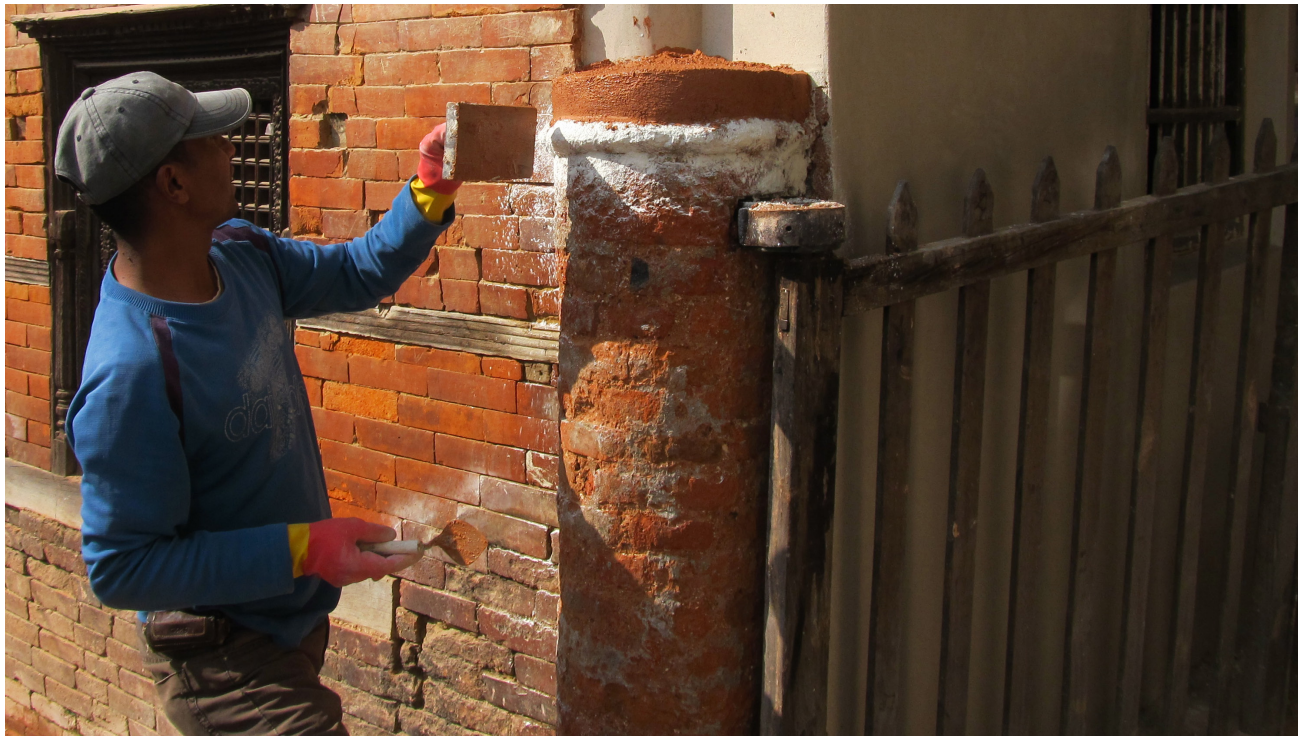
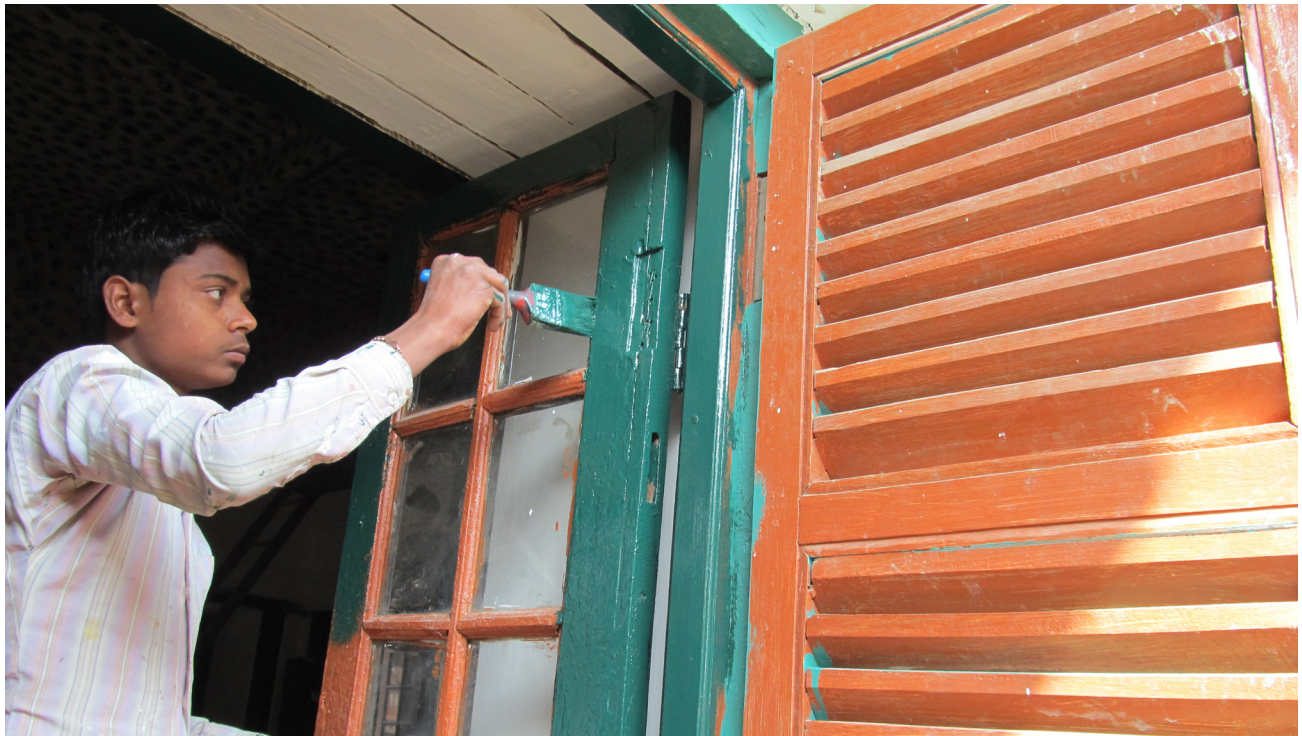
Repainting Bahadur Shah exterior | February 2014

All painted areas of the building were repainted, including second floor balcony windows (bottom). The windows were painted in their original green, a ubiquitous color in Shah and Rana period architecture of the Kathmandu Valley.

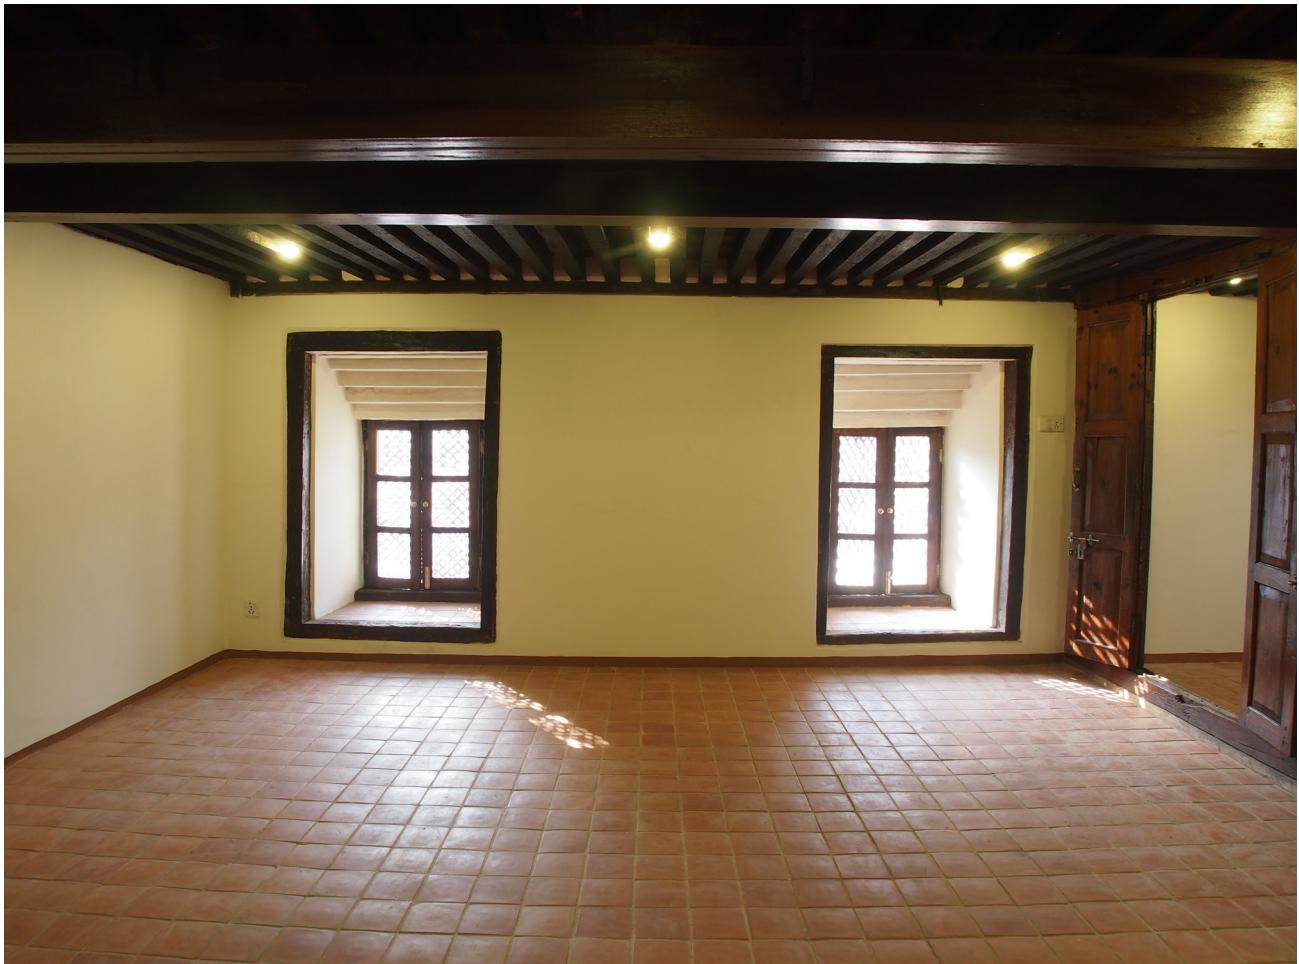
Restored room at Bahadur Shah, first floor | March 2014
View of a room on the first floor after restoration. The window openings represent a hybrid of traditional Newari scale and the European design idiom introduced by Bahadur Shah.

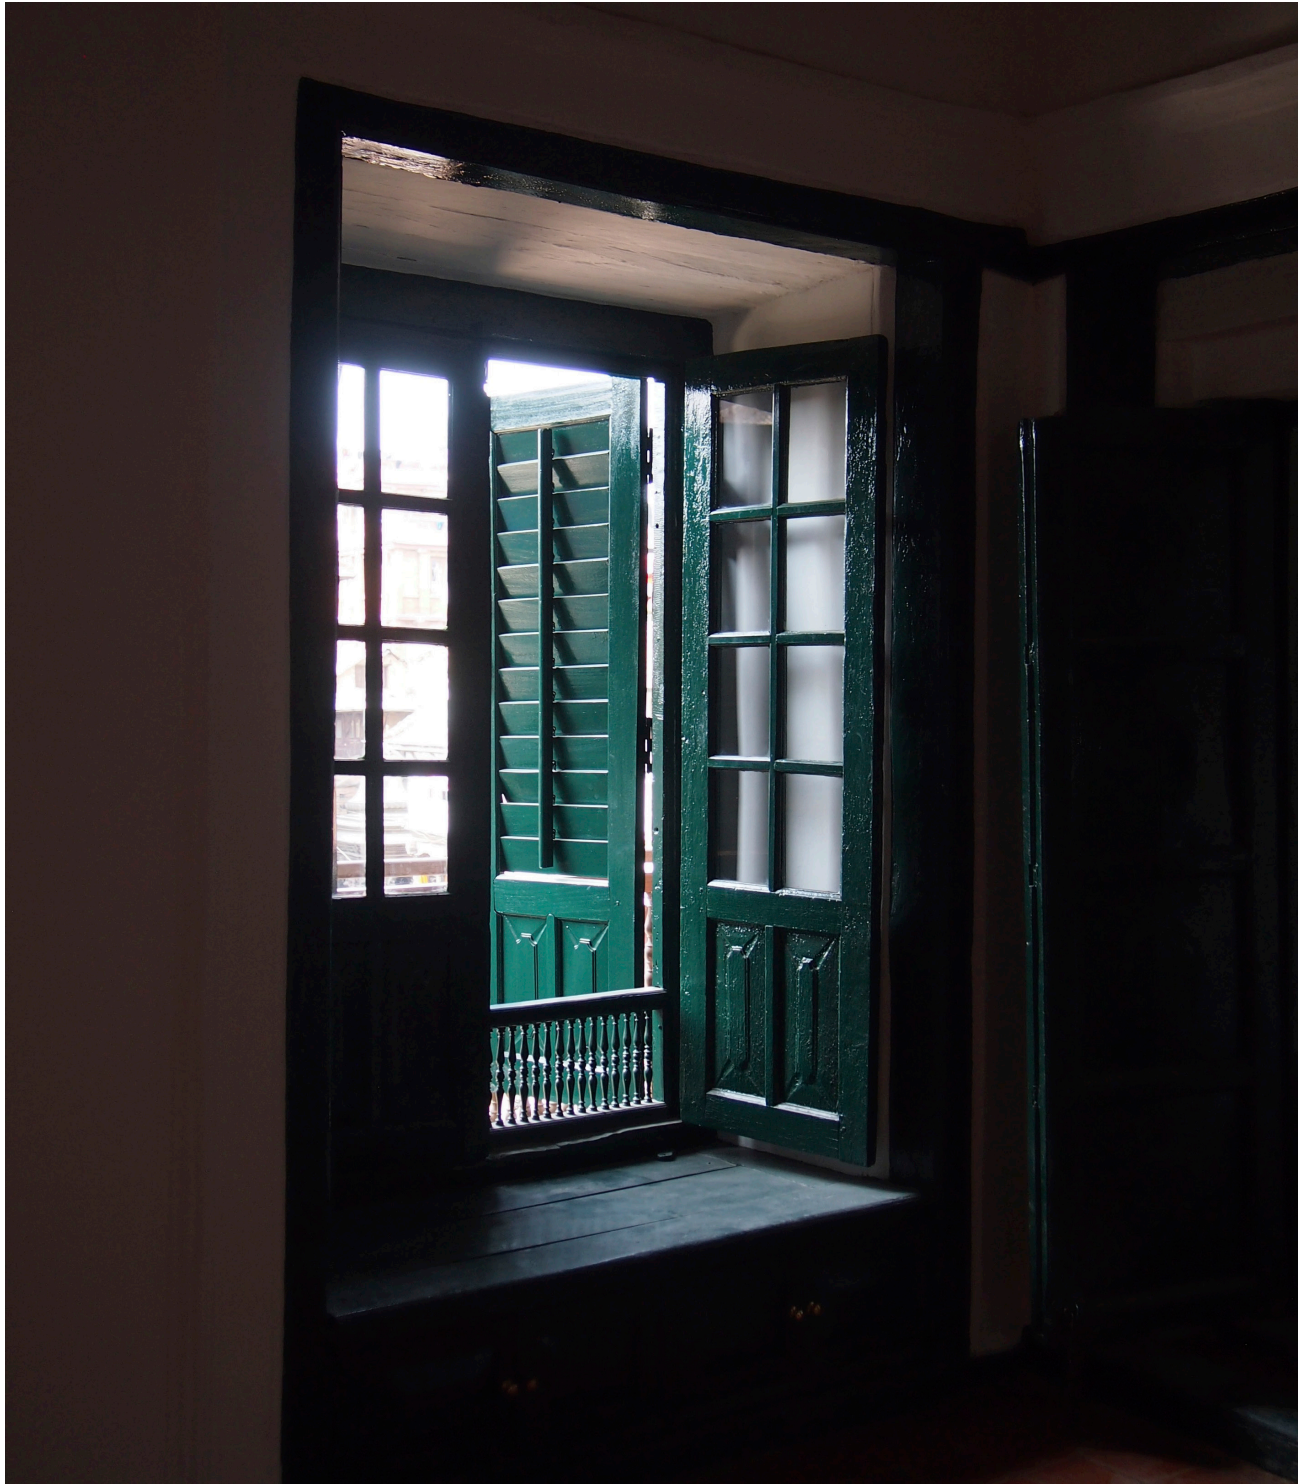
Restored French windows , second floor | March 2014

Bahadur Shah features French windows with glass, wooden louvers, and under-window cabinets. The windows are notable for being the first of their kind in Nepal and were to become a fashion in the 19th century.

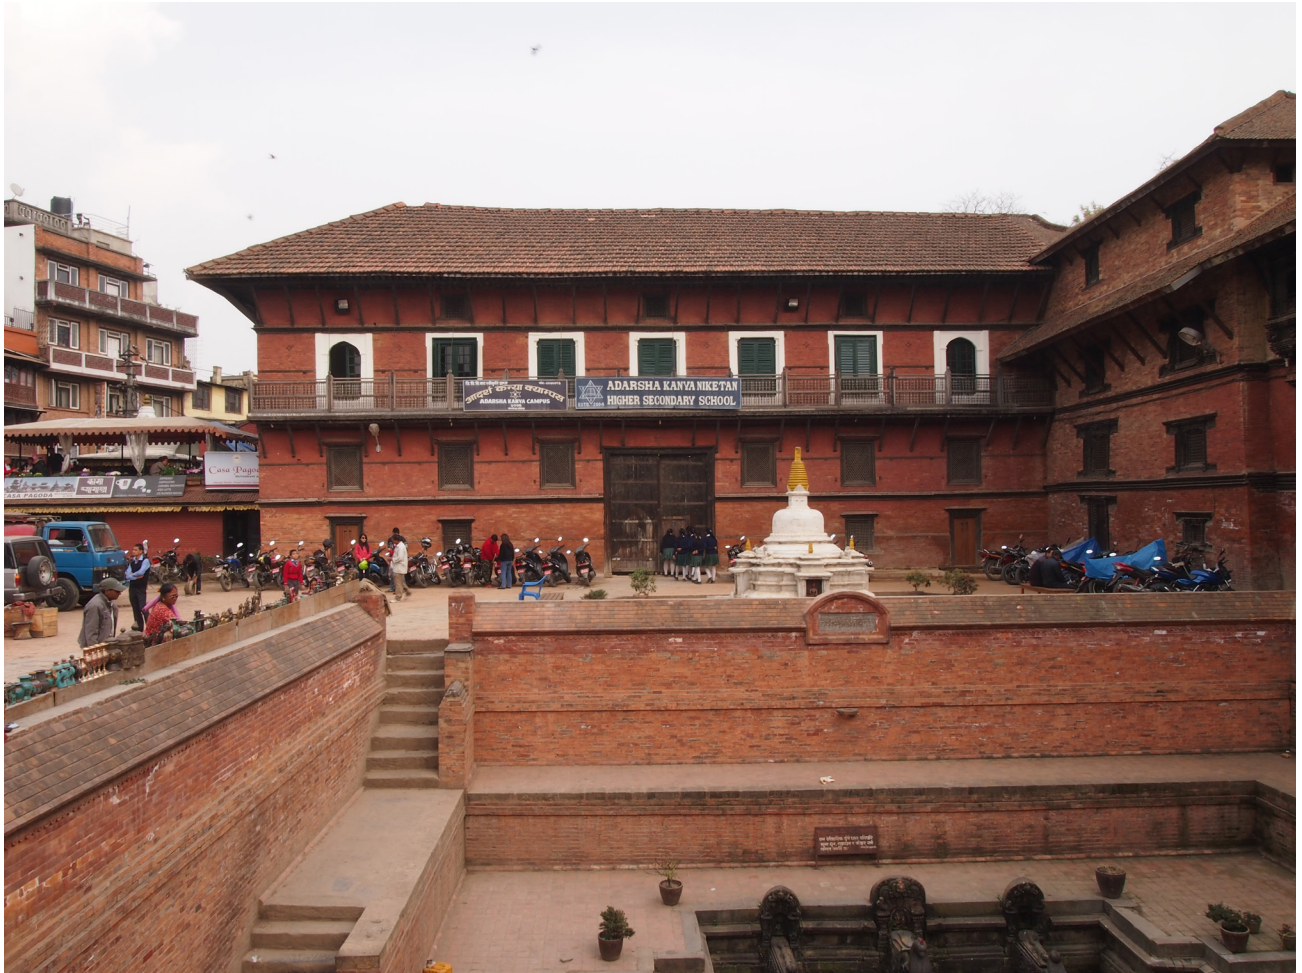
Bahadur Shah from across Mangahiti | March 2014

The restored Bahadur Shah building as seen from across the Mangahiti step-well on Patan Darbar Square.
