YETKHA BAHA AGAMCHHEN
FINAL REPORT

A JOINT PROJECT OF
DEPARTMENT OF ARCHAEOLOGY, HMG OF NEPAL
KATHMANDU METROPOLITAN CITY
UNESCO KATHMANDU OFFICE
SHREE ARYANAMA SANGATI (BHASKAR KRITI MAHAVIHARA)
AND
KATHMANDU VALLEY PRESERVATION TRUST

ROHIT RANJITKAR * RAJU ROKA
KATHMANDU VALLEY PRESERVATION TRUST
MARCH 2003

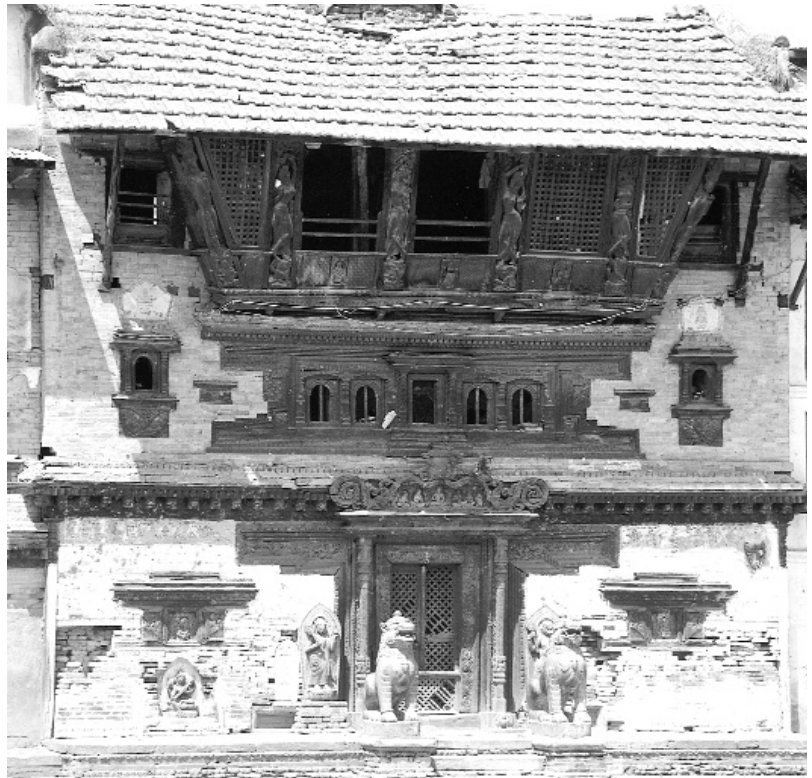
A view of shrine house from 1968. Photo: Marry Slusser.

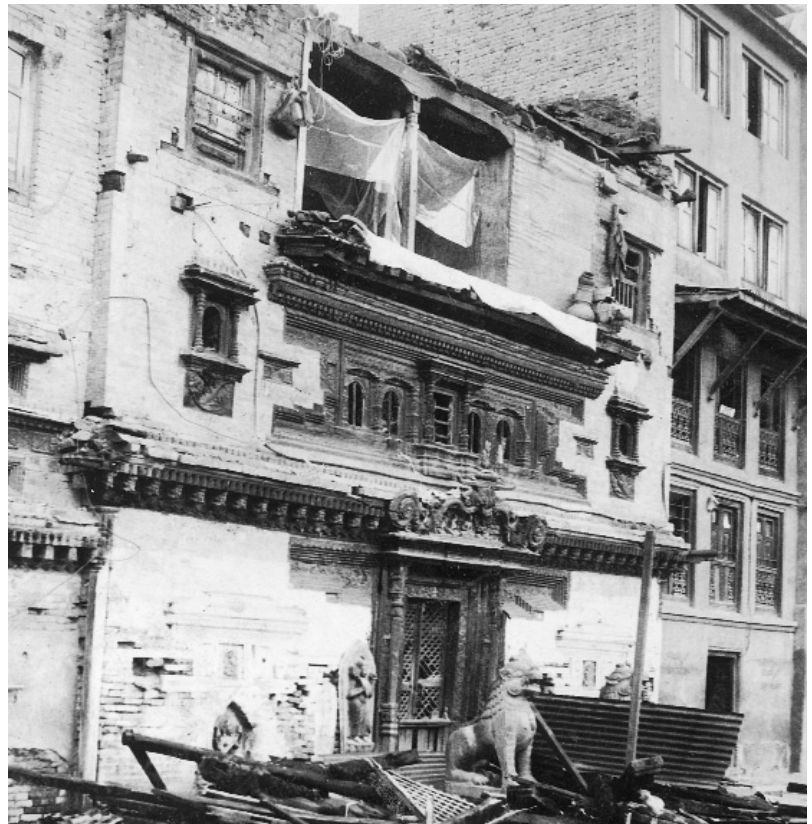
A picture showing complete collapse of roof in 1987.

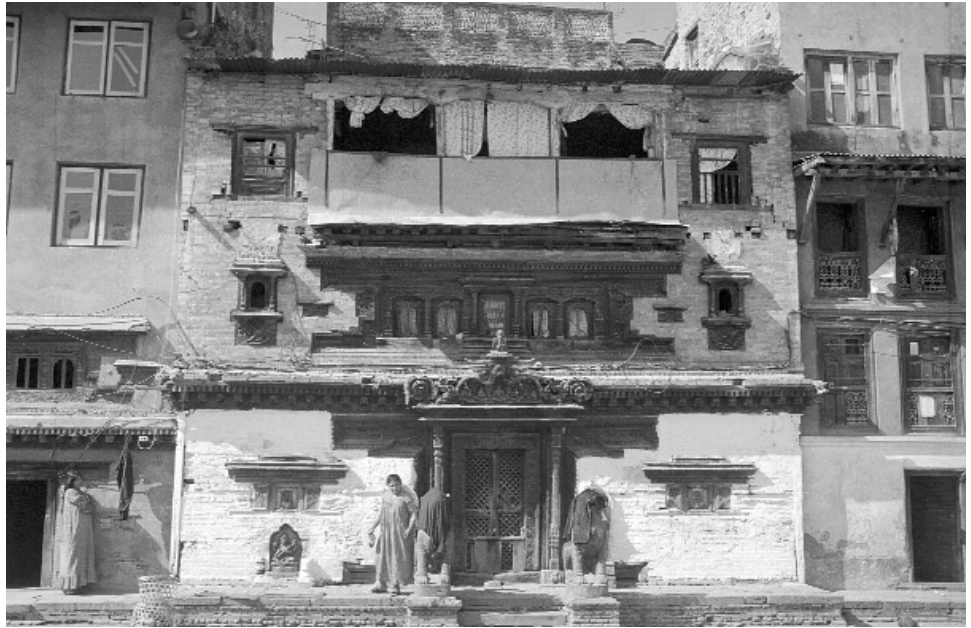
A view of shrine building before restoration in 2000. Photo: Raju Roka.

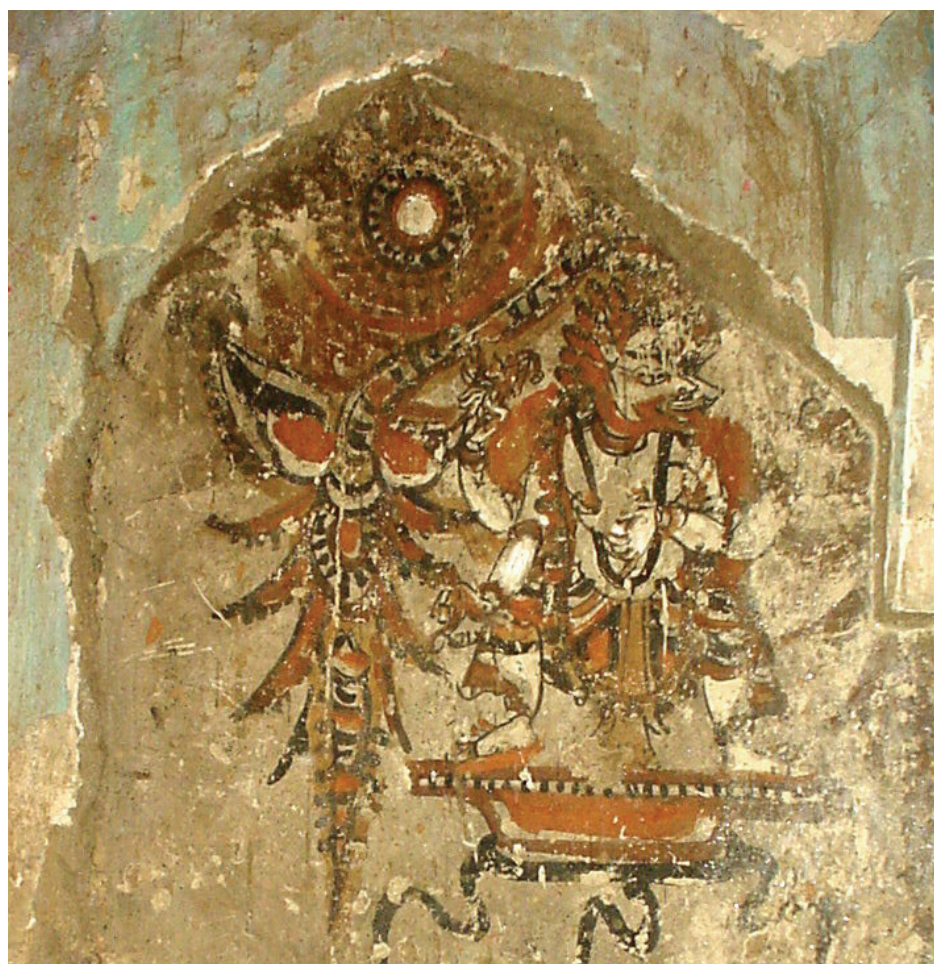
The Yetkhabaha wall painting. Photo: Heike Pfund, December 2002

Accidentally, wall paintings were detected on a layer of the mud plaster, well hidden by the stone image on both side of the door. The painting are carried out on a smooth mud surface. Assumingly, the guardian deity *Singhini* is depicted (lion-head), is depicted on the left side of the wall. On the right side of the door, on the small remaining patch of plaster fragments of the counterpart, *Vyaghini* (tiger-head), could be revealed.¹

The wall painting will be covered by the stone images after the examination and documentation process is completed. Covering these paintings will be the best way to preserve them for the future. This will help prevent greasy dirt from the highly polluted air in Kathmandu from accumulating on the surface and the threat of mechanical damage will be avoided. (See attached report for further information and analysis result).

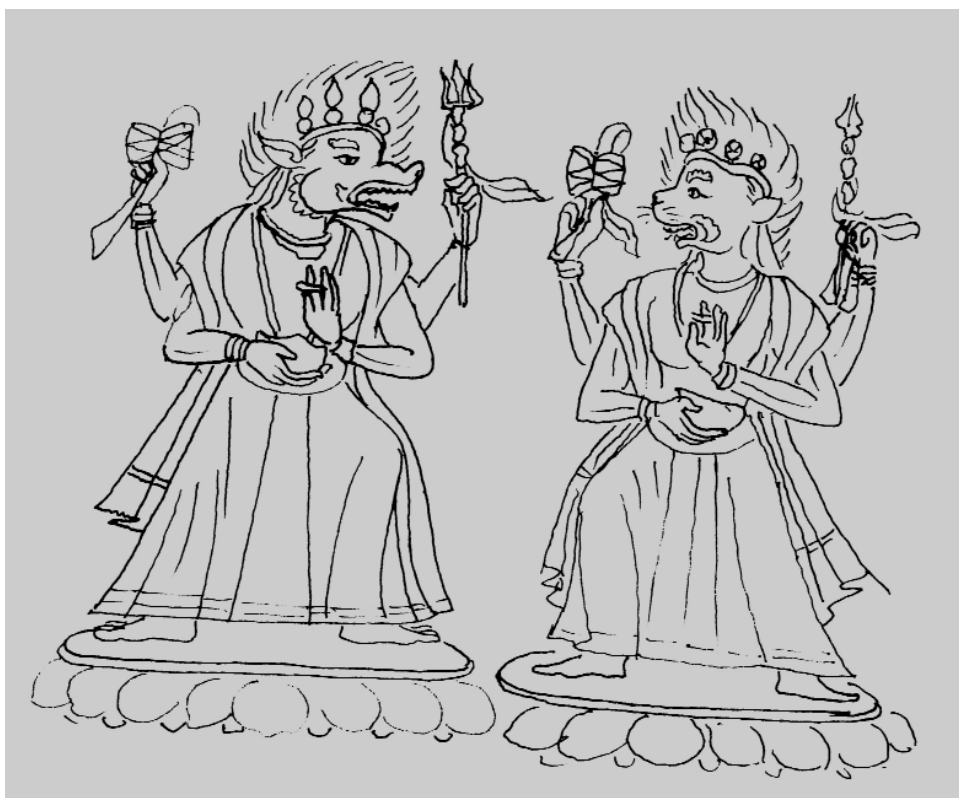
Singhini and Vyaghini. ¹

The measurements of the visible part of the *Singhini* painting, which is left of the entry to the secret shrine, are approximately: 60 cm high, 40 cm wide. Part of the painting is still hidden under mud plaster. More mud plaster was removed to reveal the entire figure and to determine their identity. The painting is in decent condition, the paint layer is strong enough to be cleaned with soft brushes and a special eraser-sponge ("Wish - ab). The slightly shiny surface indicates the use of animal glue as a binding agent. No chemical analysis has been carried out to date.

The painting was produced in three colors: black, red and white. These colors are considered by painters to be the most powerful. BLOM wrote, "The white colour is 'considered to bring about all kinds of good influence, freedom of fear' and it can be associated with the 'foreboding of wealth or

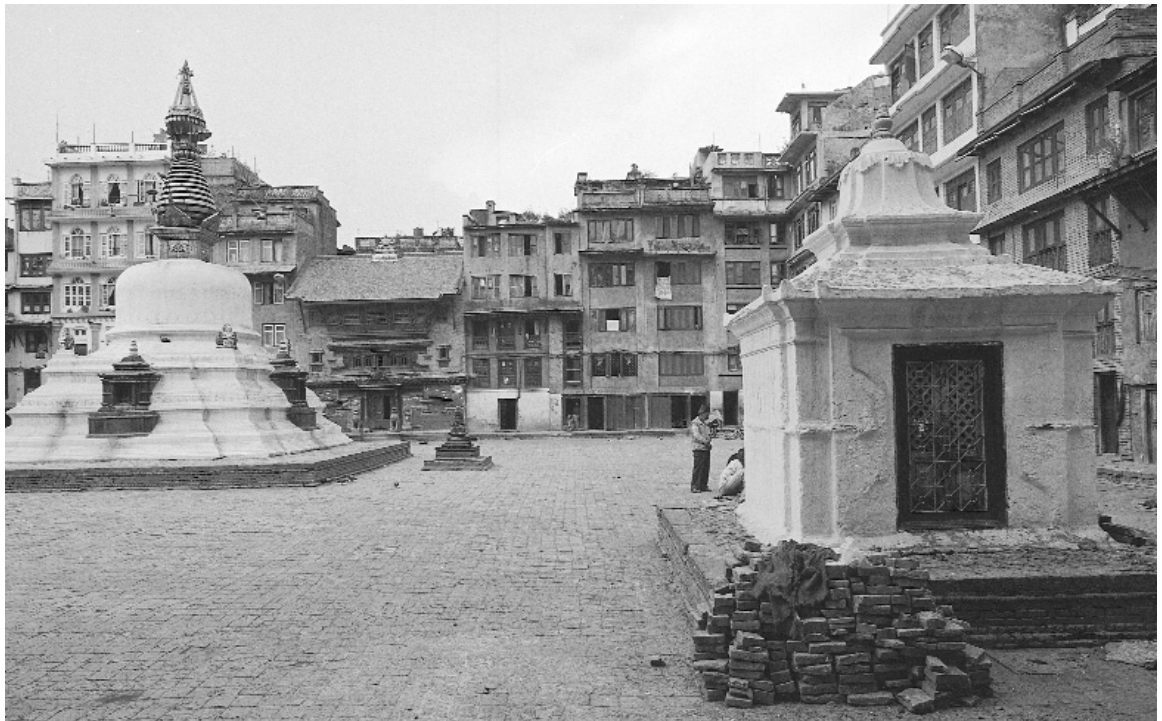
A comparative view to historical photo showing significant changes. Photo: Brandon Smith, March 2003.

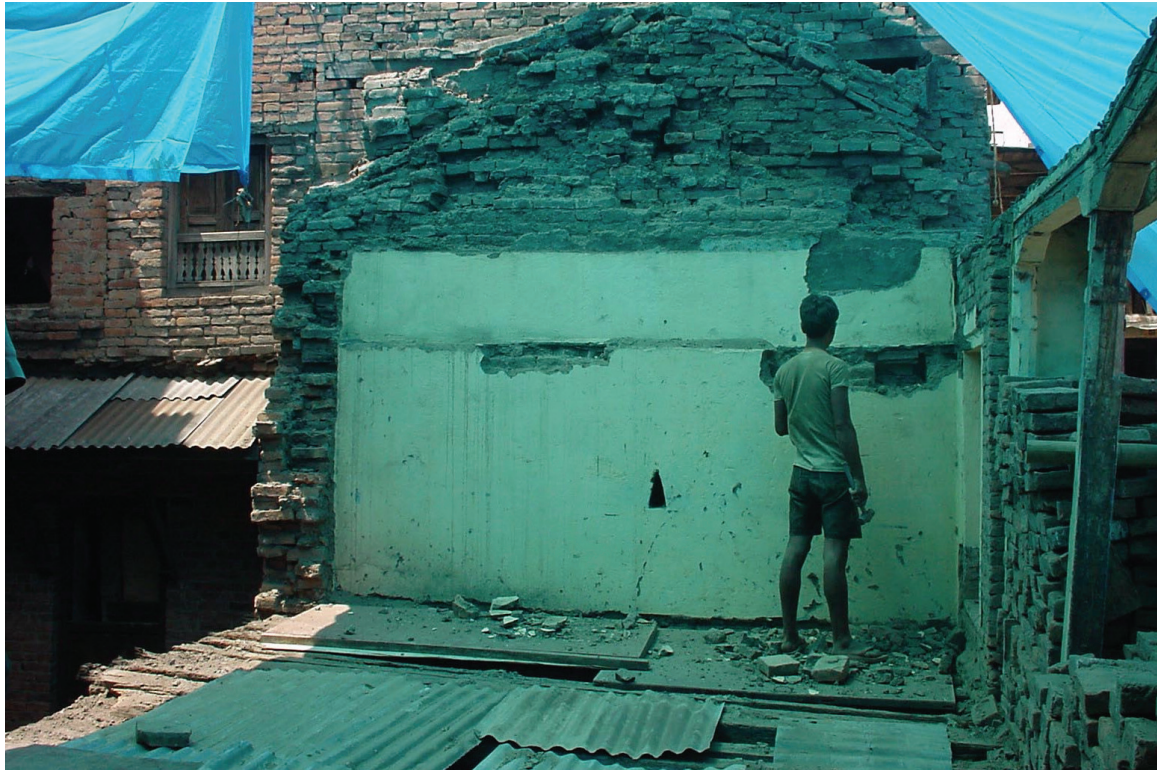
Later added zinc sheet roof and 2nd floor level brick wall dismantled in order to rebuild in historic figure with traditional material. Photo: Raju Roka, May 2002.

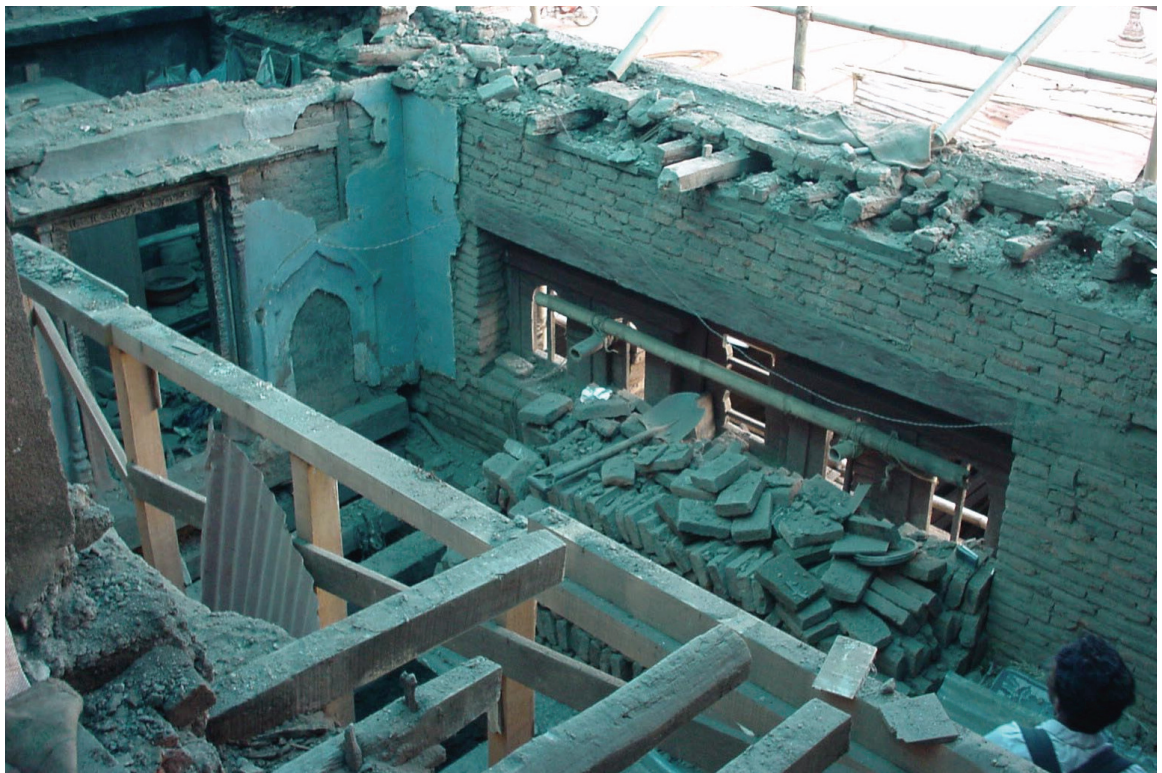
Joist at attic and 2nd floor level dismantled to replace with historic size timber and spacing. Photo: Raju Roka, May 2002.

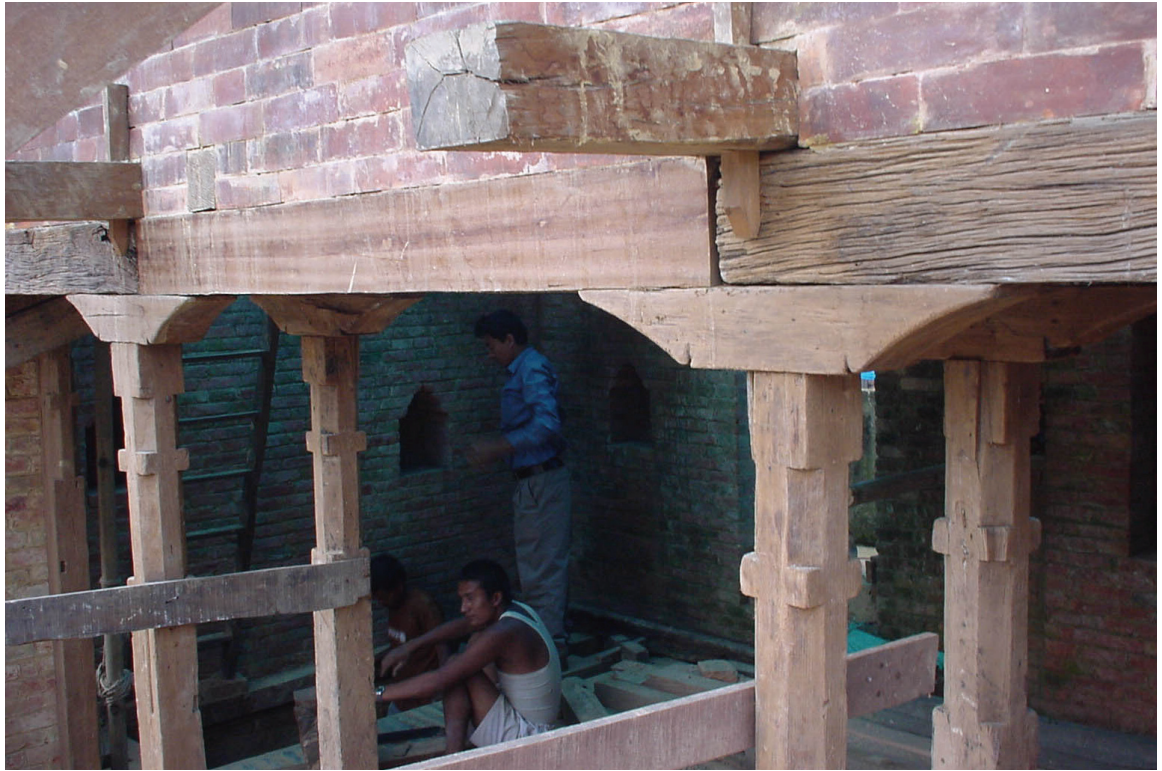
The historic pillars, capitals and beams were reinstalled after cleaning. New beams added to replace the deteriorated portion. Photo: Rohit Ranjitkar, August 2002.

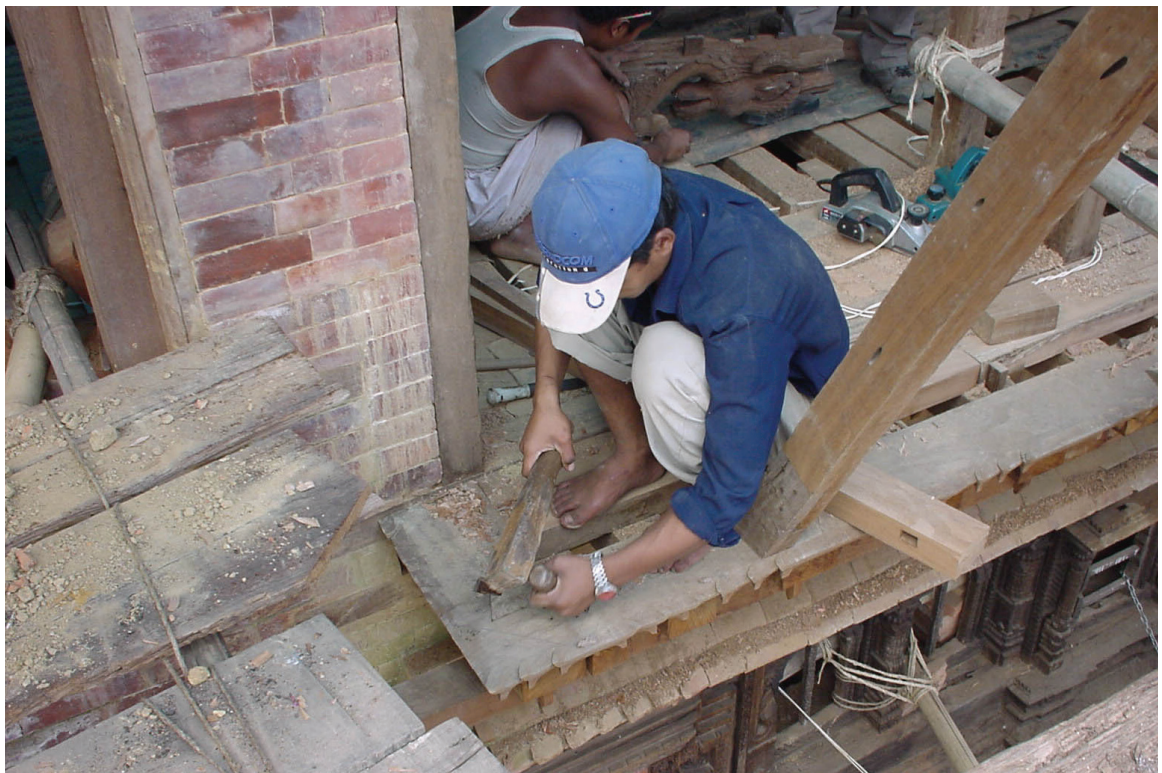
A carpenter fitting the historic corner strut. Photo: Rohit Ranjitkar, August 2002.

replaced. The upper most level the façade was re-faced with new brick as required. This shrine house is another successful example in the use of the brick work developments. The entire plinth of the building was replaced to its historic detail due to its deteriorated condition. The five bay windows were also reconstructed by retrofitting the historical struts that were preserved into the restored façade.

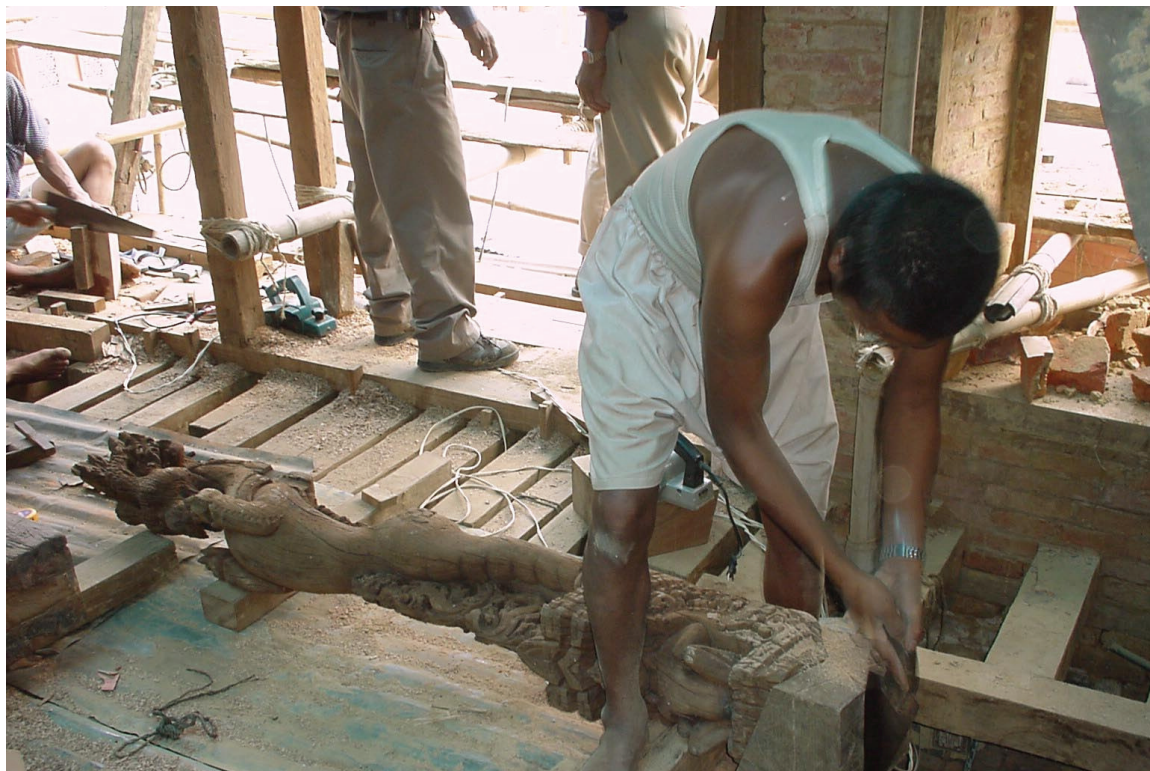
A carpenter shaping the timber for replacing rotten base area of the historic strut. Photo: Rohit Ranjitkar, August 2002.

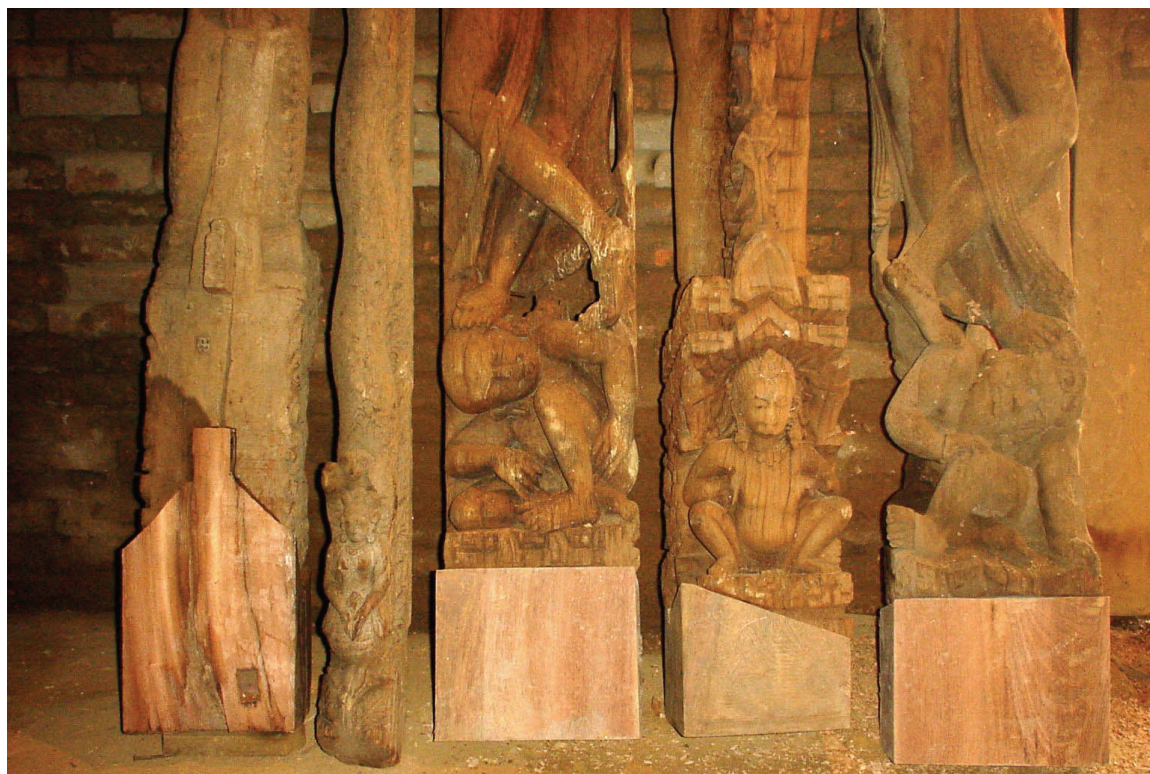
The 13th c. historical roof struts were repaired by replacing decayed portion of the struts. Photo: Raju Roka, August 2002.

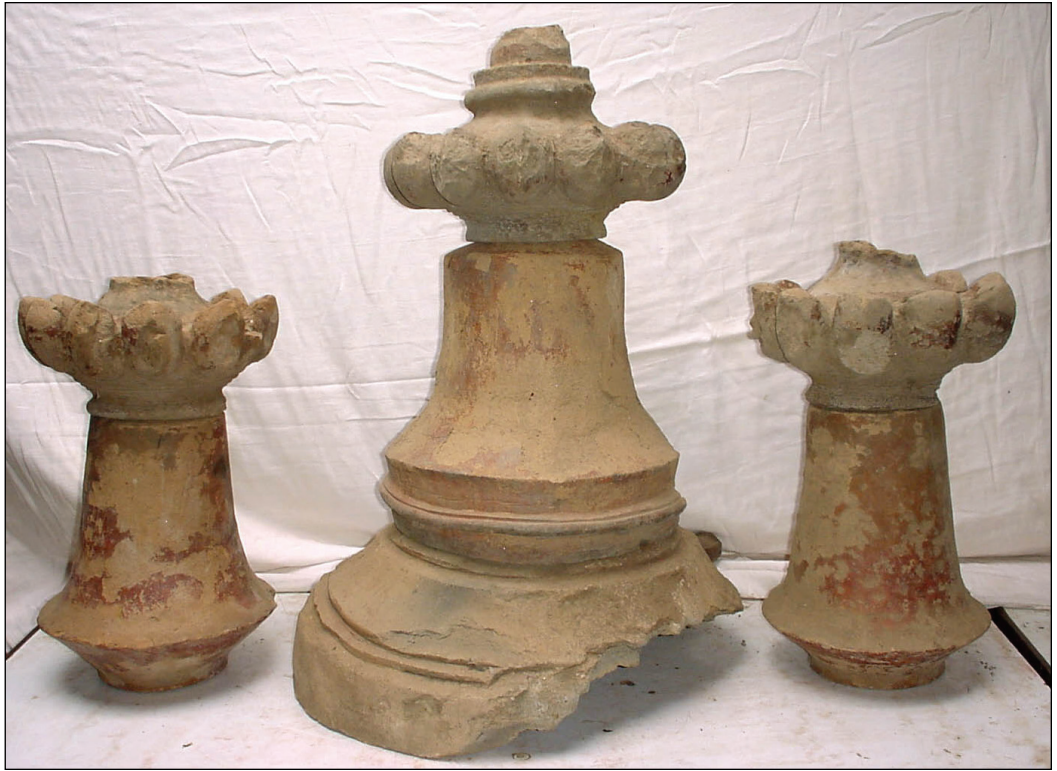
Remaining fragments of the historical terracotta pinnacle. Photo: Raju Roka, September 2002.

Architect, Lumanti Joshi and two carpenters are in continuous training to work with historical buildings. With the completed documentation of the historic terracotta pinnacle, a copper replica has been fabricated and installed. Lumanti is also handling the final documentation of other KVPT projects which were completed before she joined KVPT and also worked on the documentation of restored condition drawings of Yetkha Baha, including detail drawings of carved figures. Lumanti completed her architecture study in Nepal Engineering Collage, Changanarayan, Bhaktapur. Two additional architectural students, Shrijan Joshi, from the School of Planing and Architecture, New Delhi and Maie Kitamura, from Paris Architectural School, completed a two month internship training program with KVPT on architectural heritage of the Kathmandu Valley. Typically carpenters are not skilled to work with historical buildings. The goal of training is to educate them to be able to work with the historical monuments. Extensive training allows these carpenters to expand their knowledge; use their eyes and and minds to create exceptional wood carvings and the general understanding on how to replicate the damaged historic carvings.

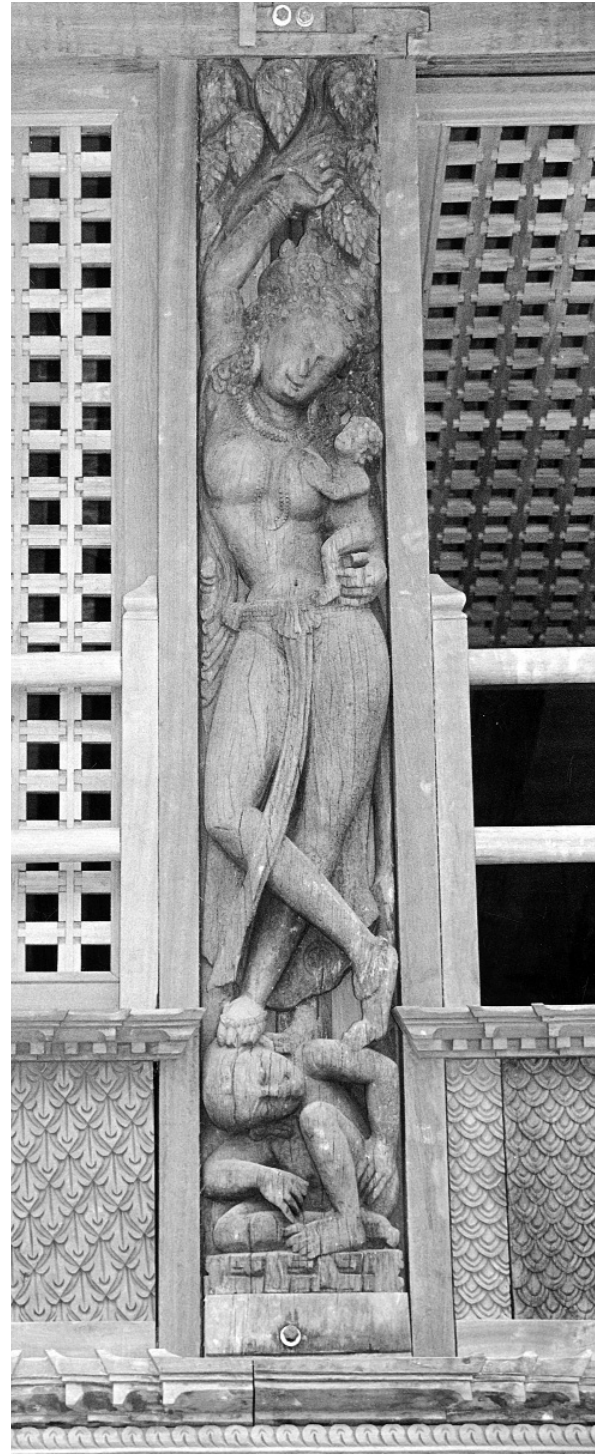
The preserved historical 13th century roof struts belonging to bay window. Photo: Raju Roka, February 2003.

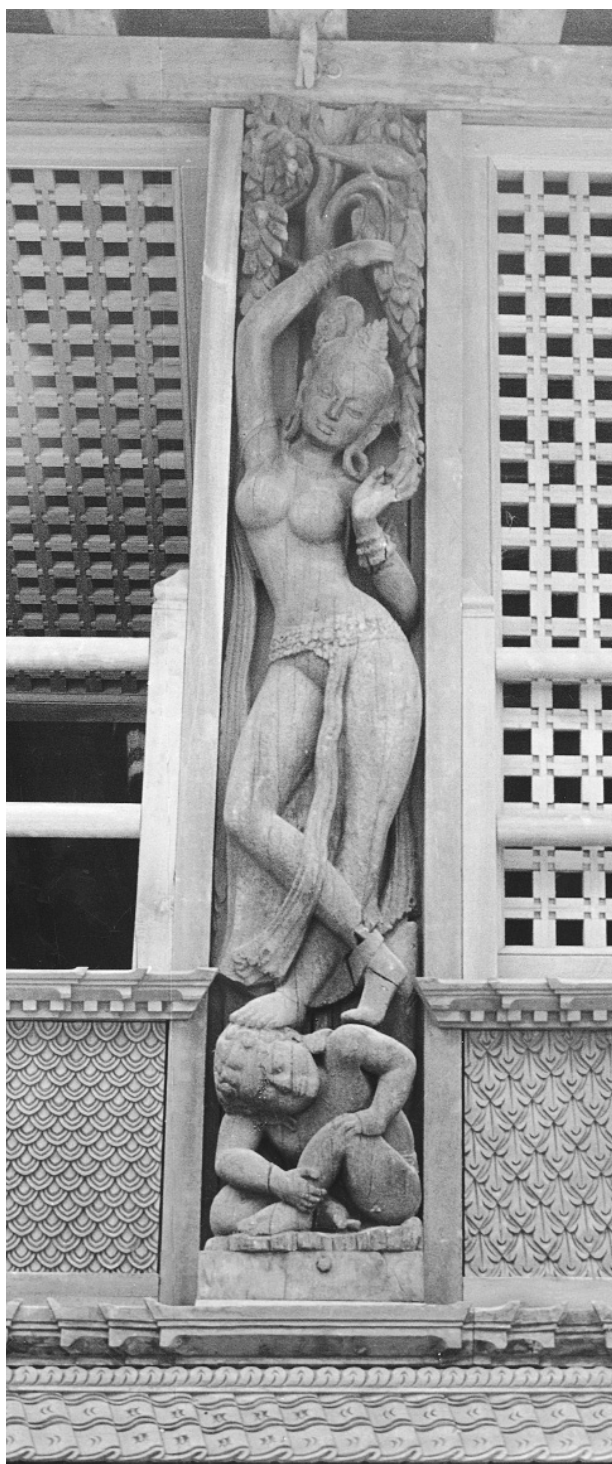
The preserved historical 13th century roof struts belonging to bay window.. Photo: Raju Roka, February 2003.

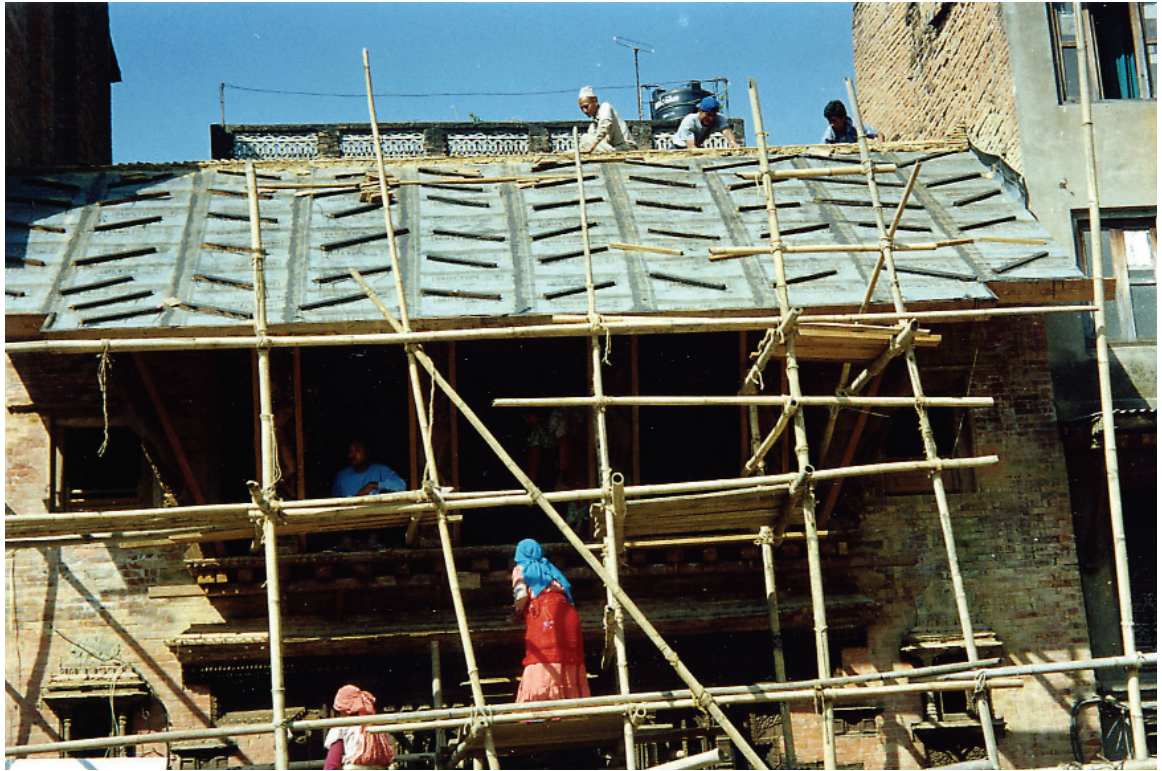
Roof water proofing membrane being laid over planking to prevent water penetration during the rainy season. Photo: Raju Roka, October 2002.

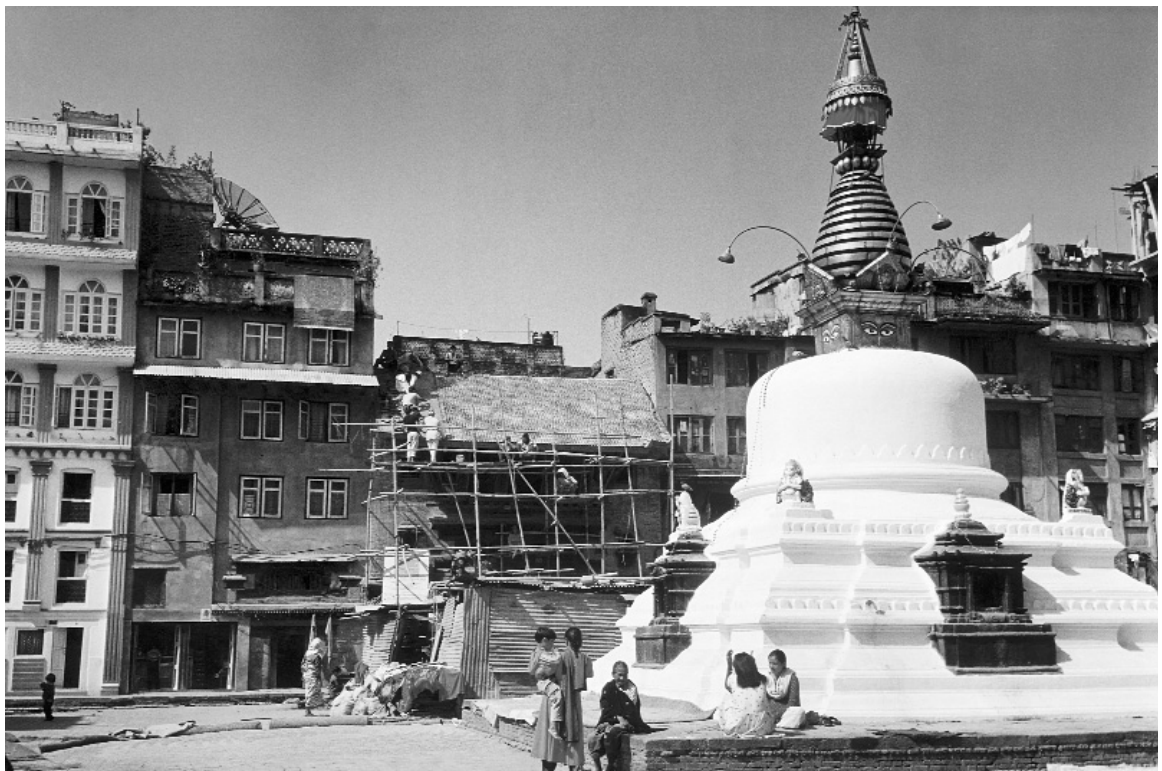
Jhingati (historical roof tiles) being laid over the mud bed. Photo: Heike Pfund, October 2002.
