THE PATAN ROYAL PALACE RESTORATION AND CONSERVATION PROJECT

JOINT MISSION REPORT

DECEMBER, 2006

JOINT MISSION (MAY 1-6, 2006)

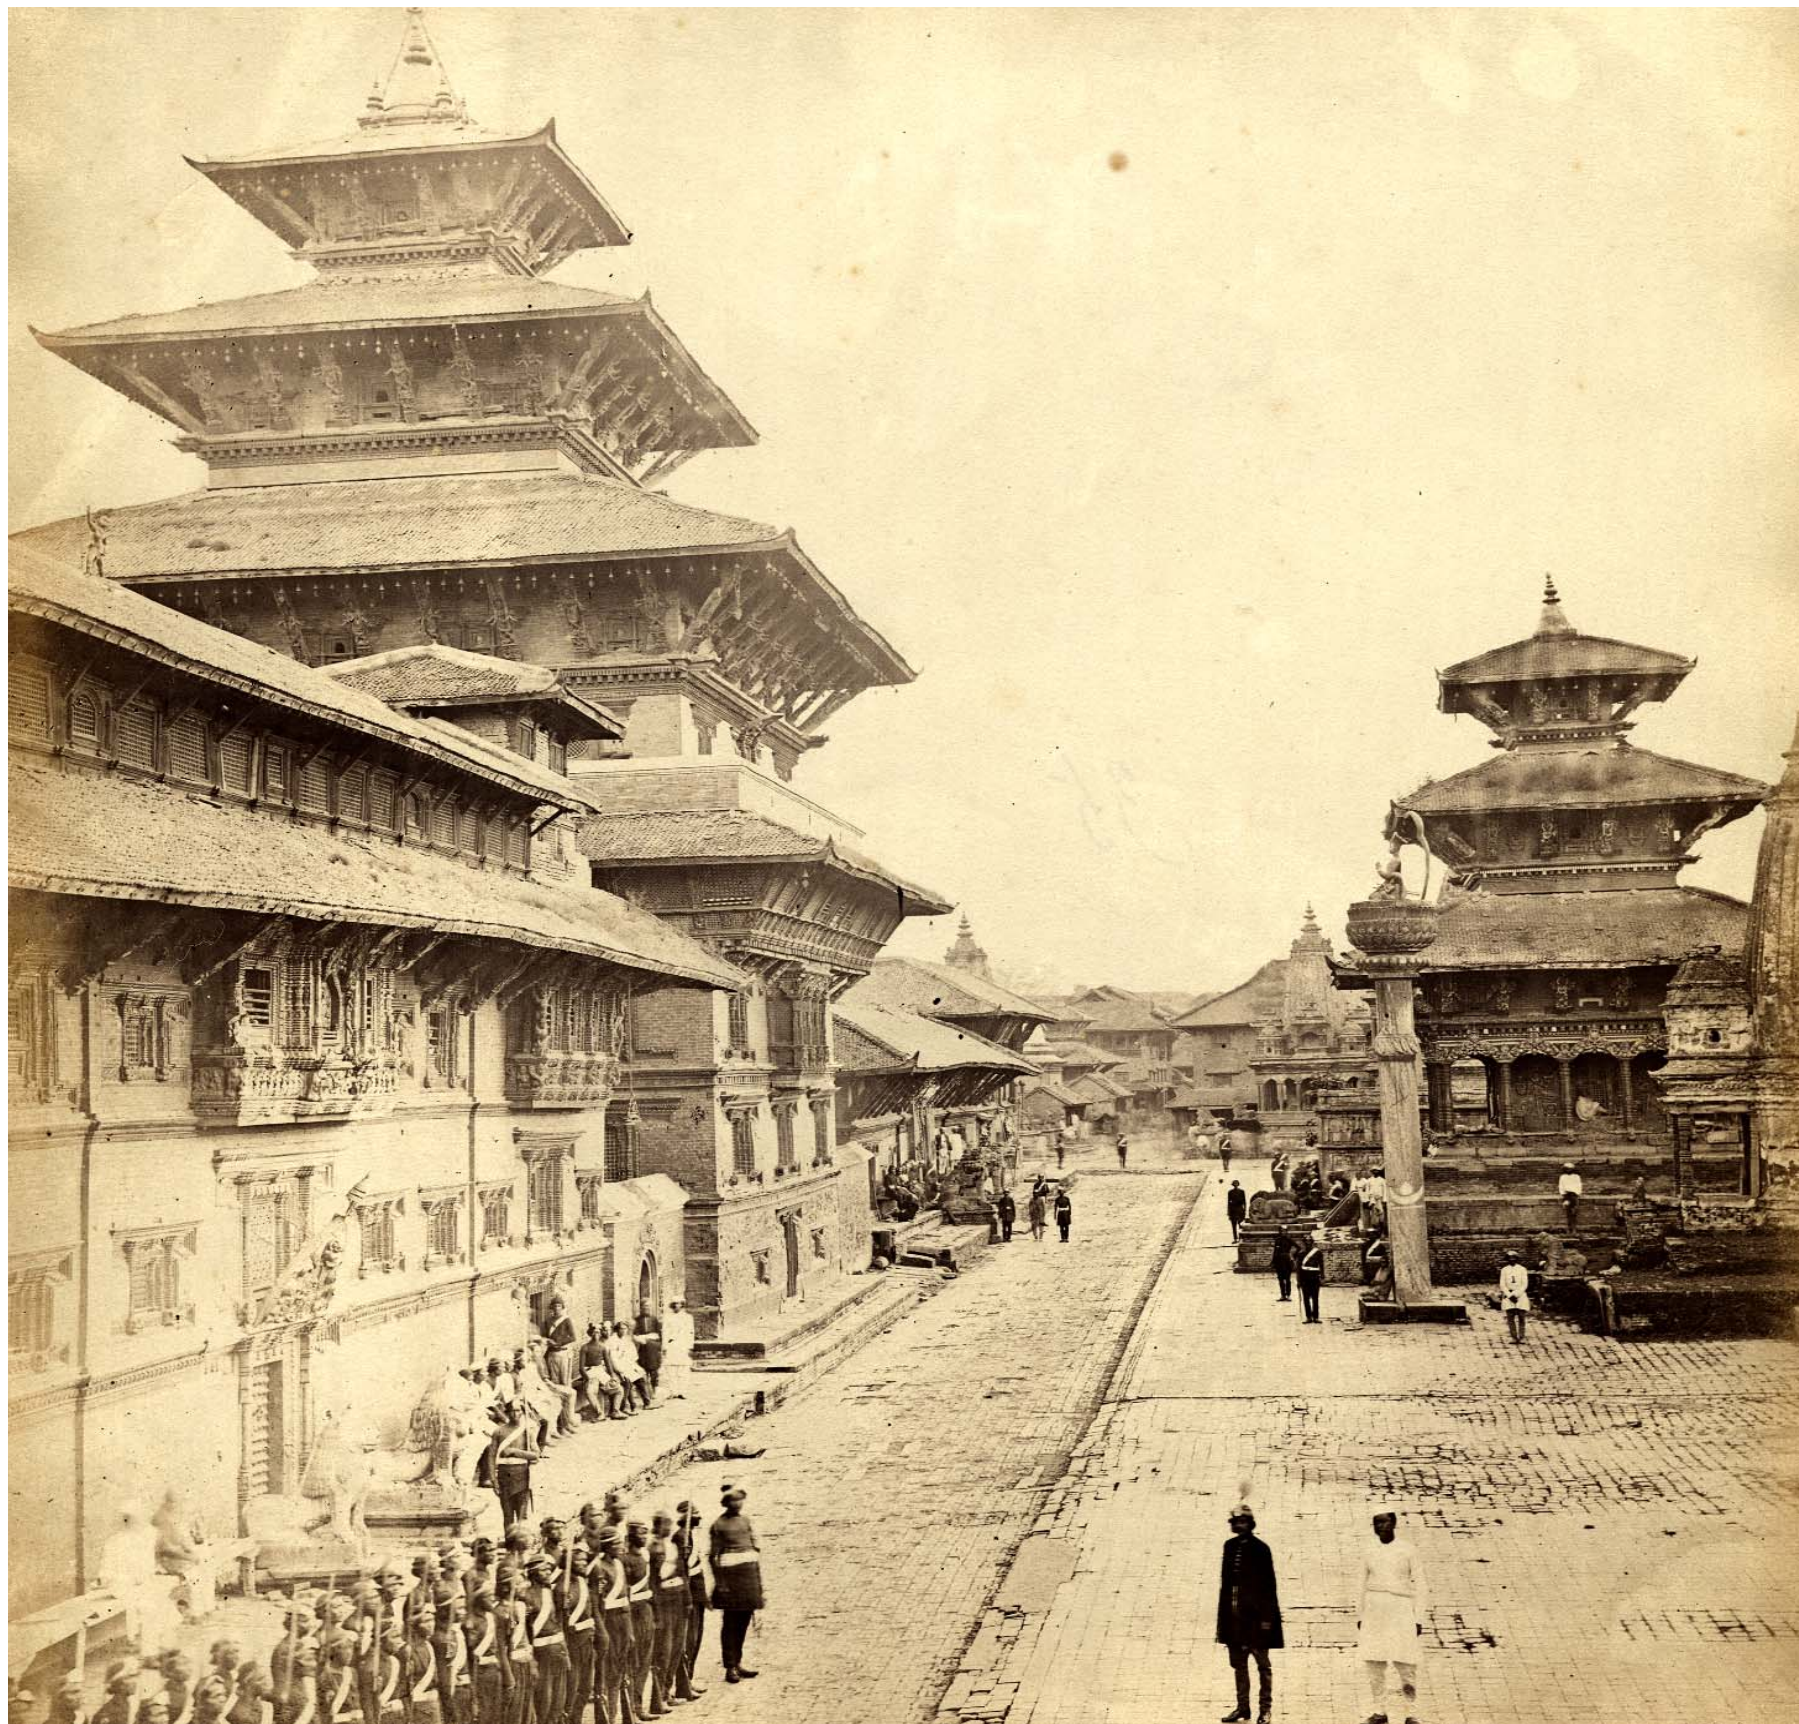
Patan Darbar Square from the north

One of the earliest views of the square with Mul Cok and Sundari Cok at the center. Comparison with contemporary photos shows that the historic ridge levels of the two palaces were more than 60 centimeters higher than at present.

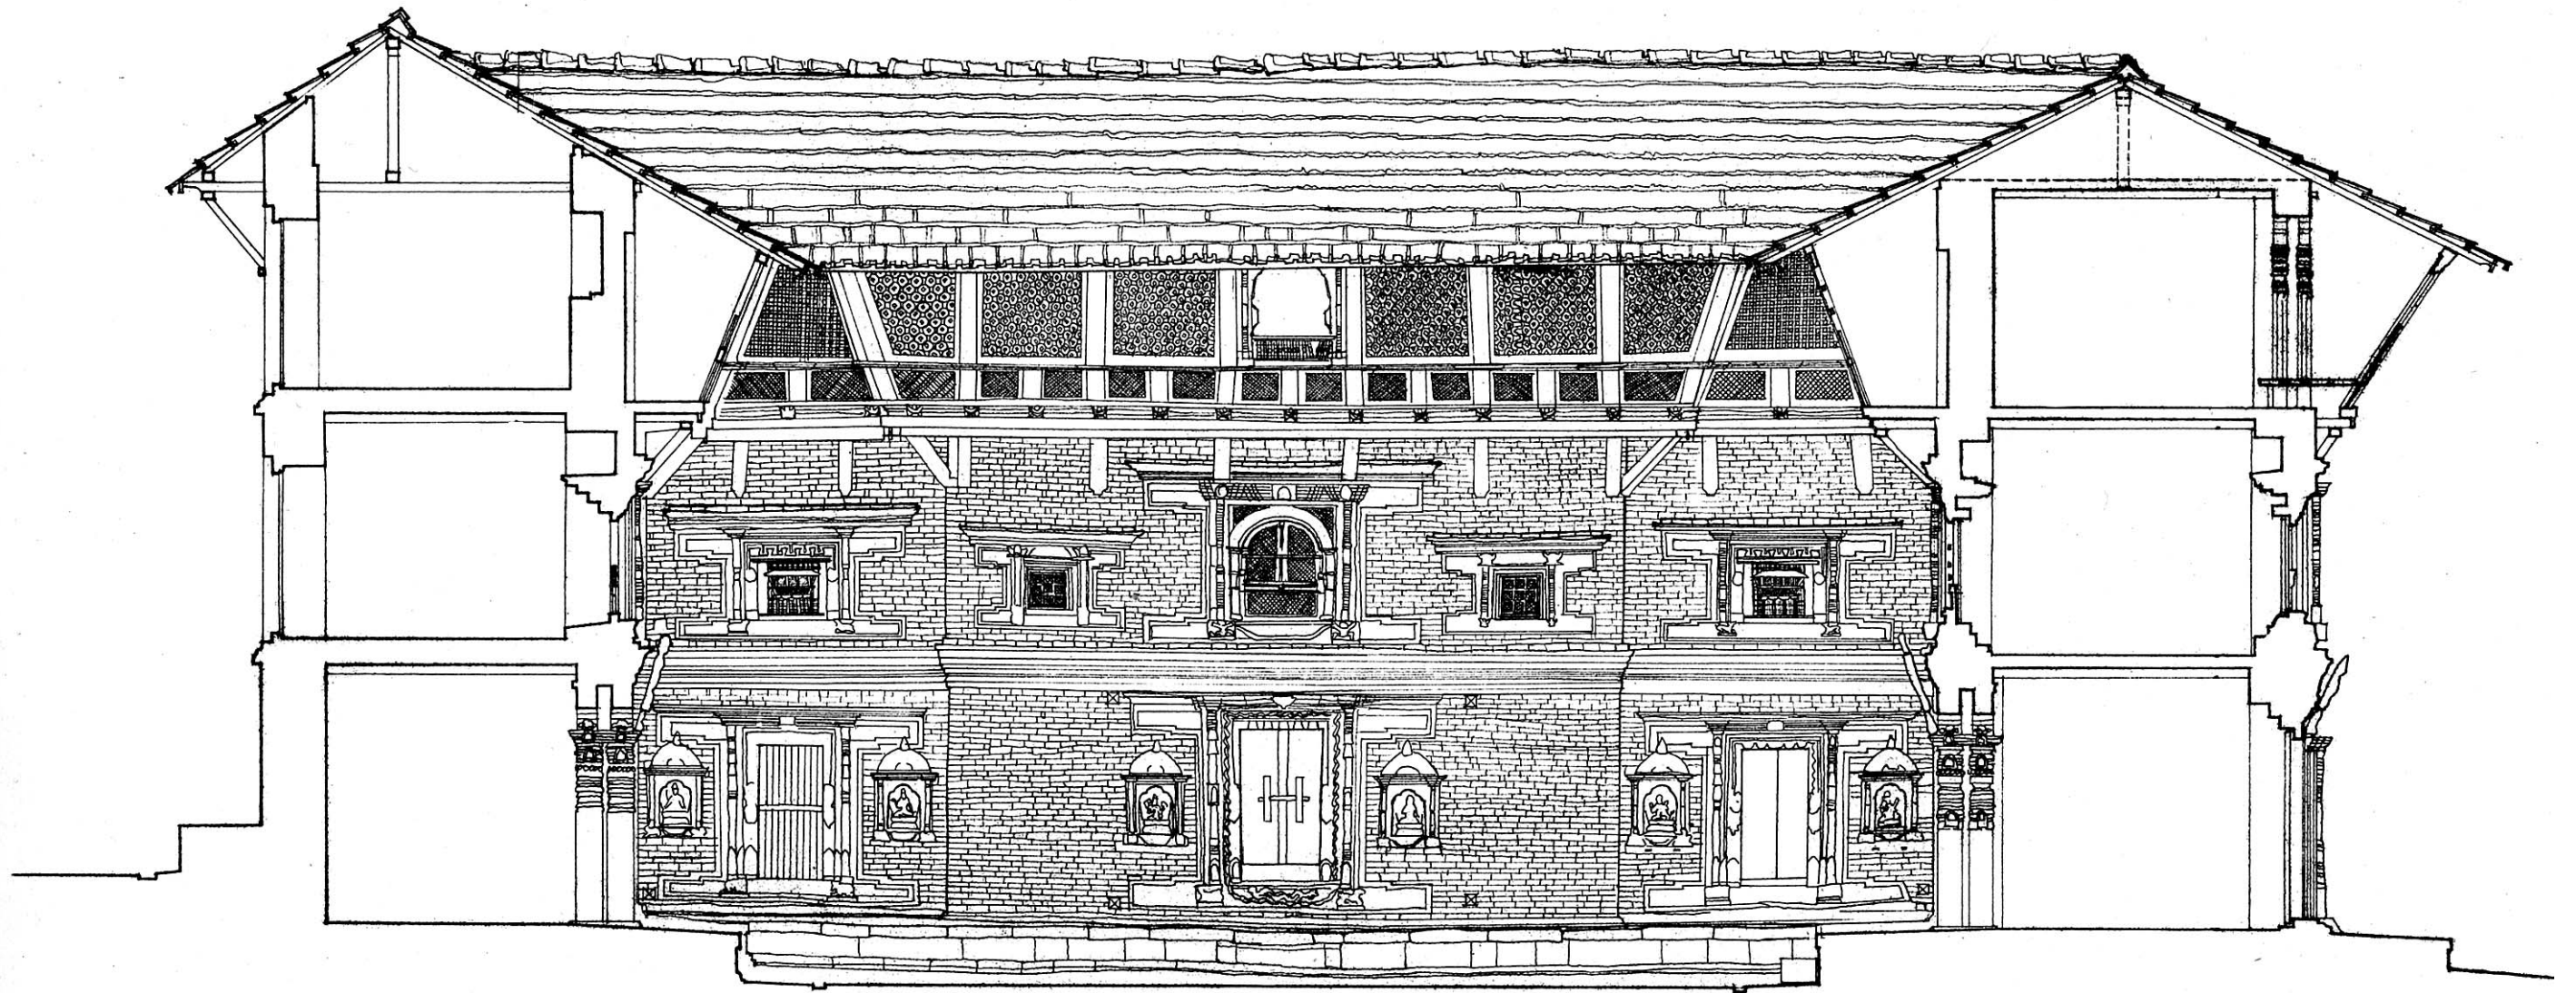
Sundari Cok - section looking south
Existing conditions
Survey by the Nippon Institute of Technology, December, 1977

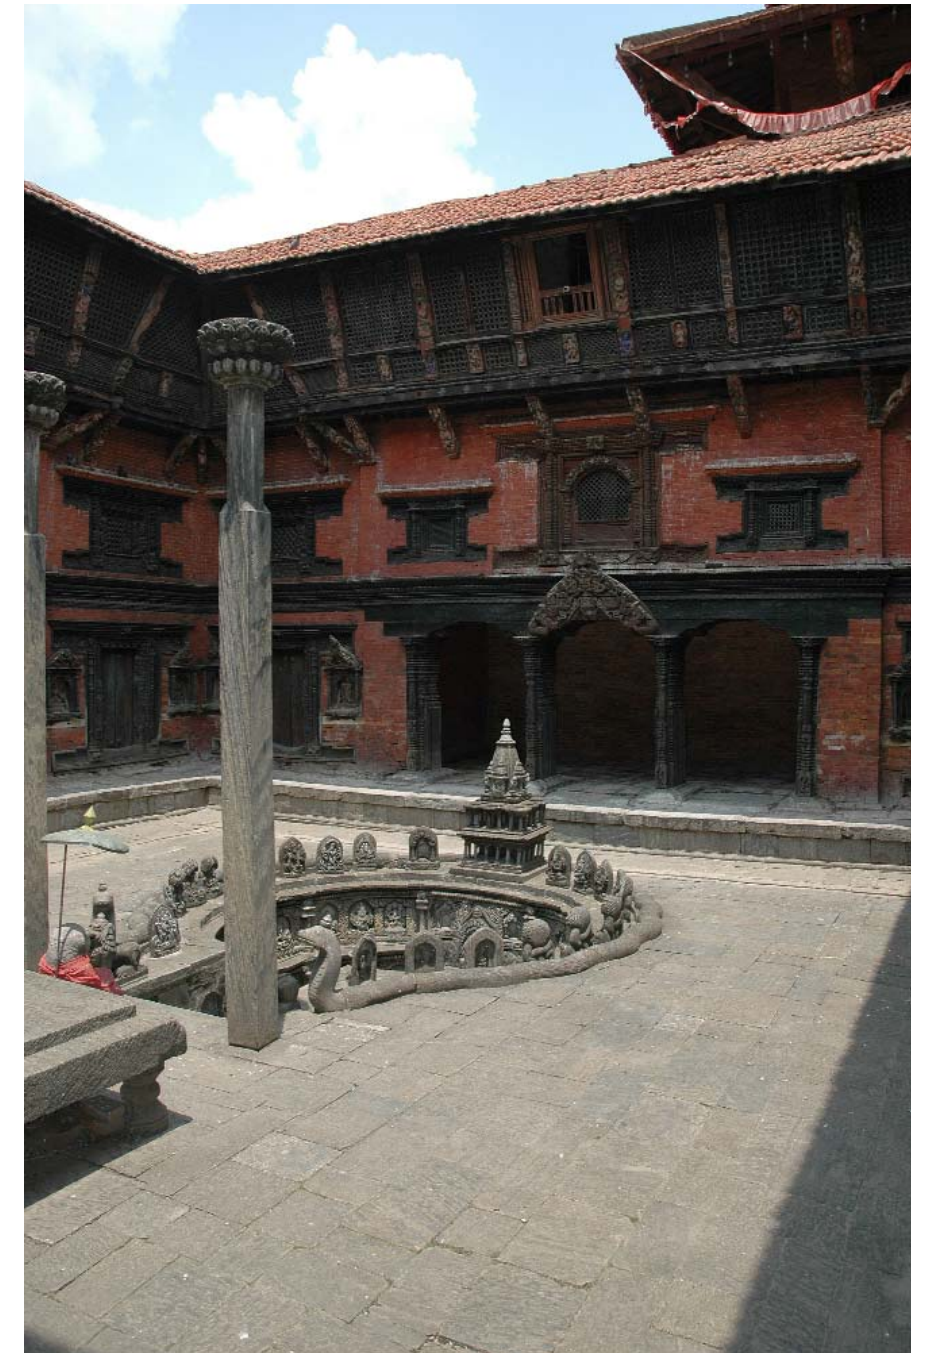
Sundari Cok courtyard and Tusha Hiti
Photograph May 2006

The royal fountain, or Tusha Hiti, appears to be in relatively intact condition but has been sloppily repaired and repointed in recent decades. Some images from the rich iconographic program of stone sculptures that adorn the bath appear to have been stolen or replaced. Water does not presently flow from the tap. The gilded copper tap and attendant figures appear to be in good condition but some elements may be missing.

Original construction techniques and pointing materials for the Tusha Hiti will need to be studied as will the appropriateness of recreating missing stone and metal elements. As with the wood carvings of Sundari Cok, the preparation of an exhaustive survey of the program of carved stone and gilded copper elements will help inform an appropriate conservation design for the bath. If water supply to the Tusha Hiti is to be re-established, a recent proposal for the restoration of the water source of the Tusha Hiti will need to be coordinated with conservation work there.⁴

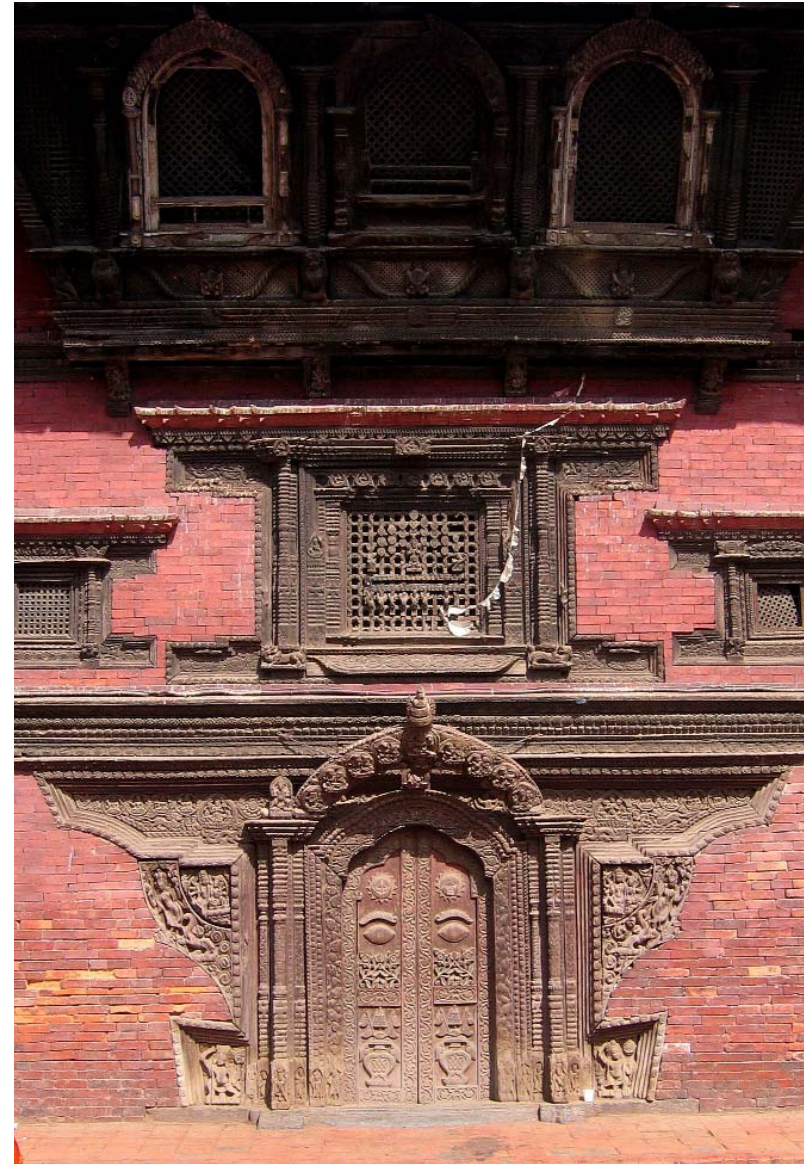
Sundari Cok's main entry
 With the exception of inappropriate carved doors which date to recent renovations the appearance of the main entry has changed little in 130 years. Traditionally such door leaves would have been unadorned slabs of timber.
Photograph, May, 2006

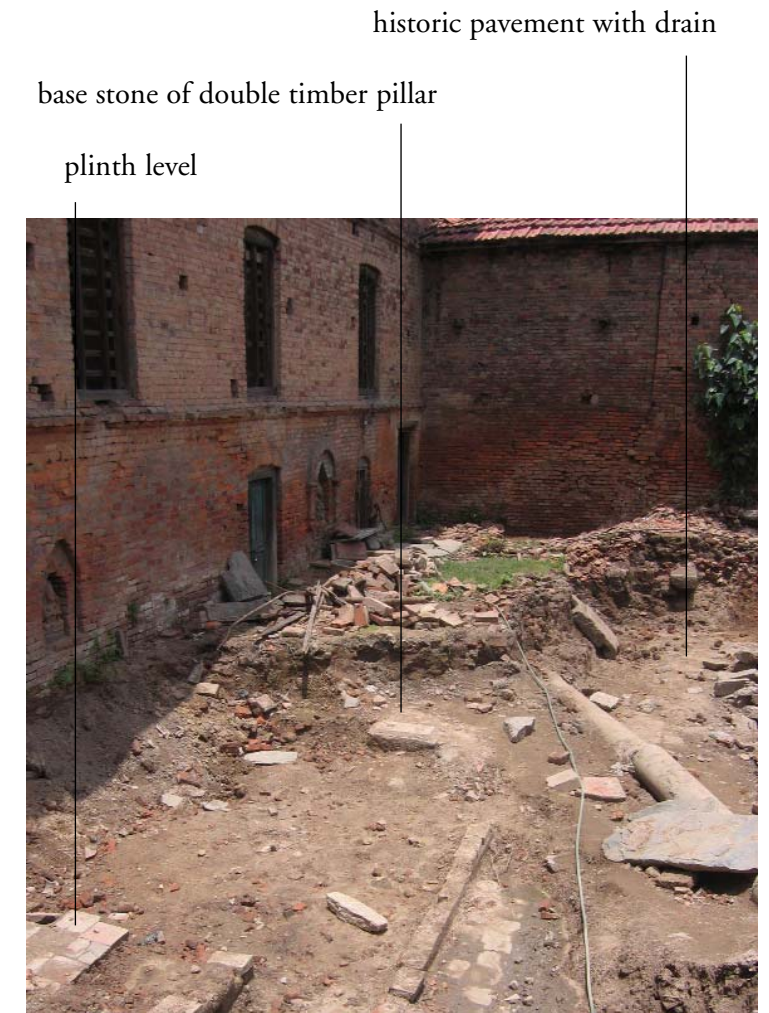
Sundari Cok, garden courtyard

Excavation carried out in May 2006 revealed the historic paving level matching the height of the interior courtyard. Several base stones for pillars were found, indicating that there might have been an open arcade adjacent to Sundari Cok's Eastern wing.

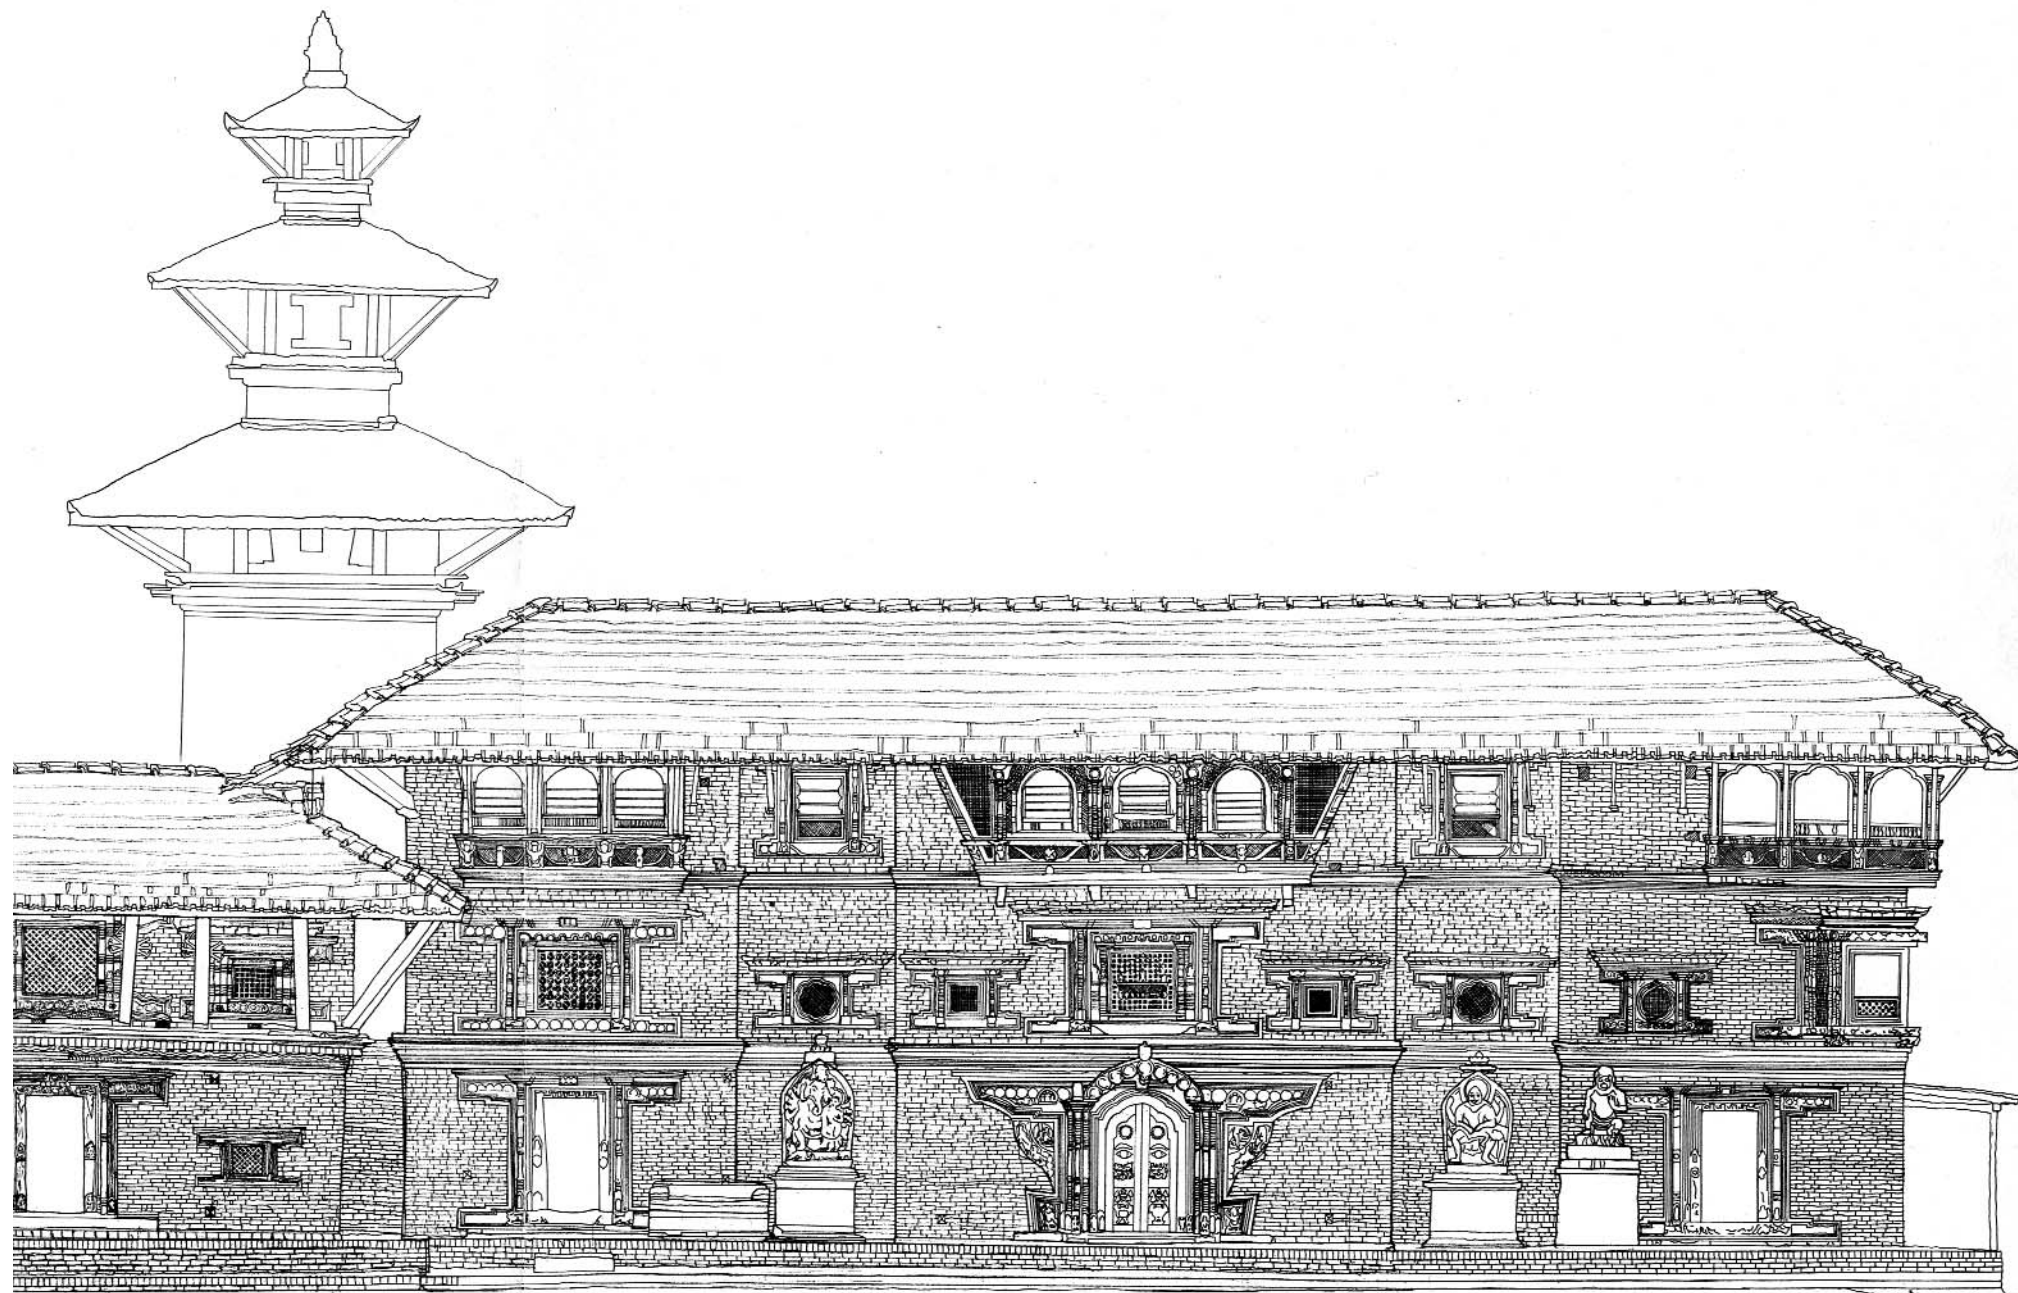
Sundari Cok - principal facade
Existing conditions
*Survey by the Nippon Institute of Technology,
December, 1977*

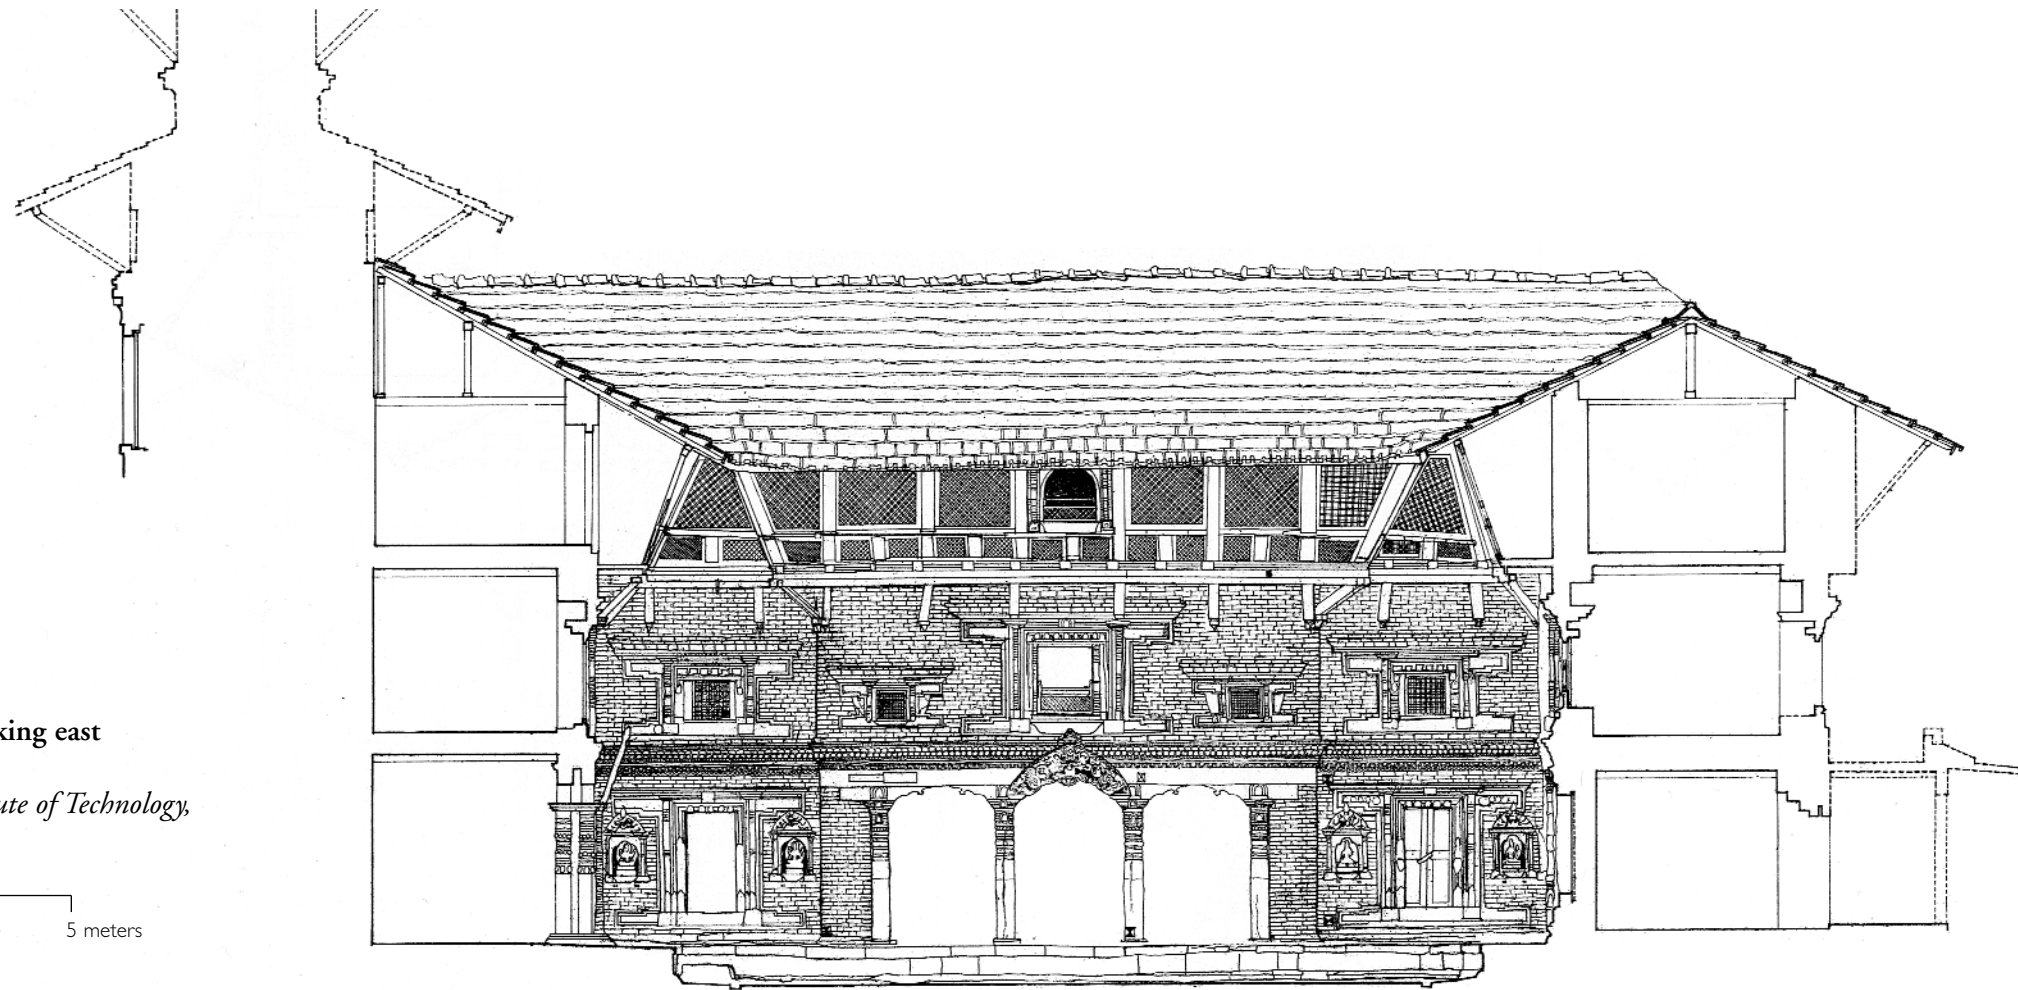
Sundari Cok - section looking east
Existing conditions
*Survey by the Nippon Institute of Technology,
December, 1977*

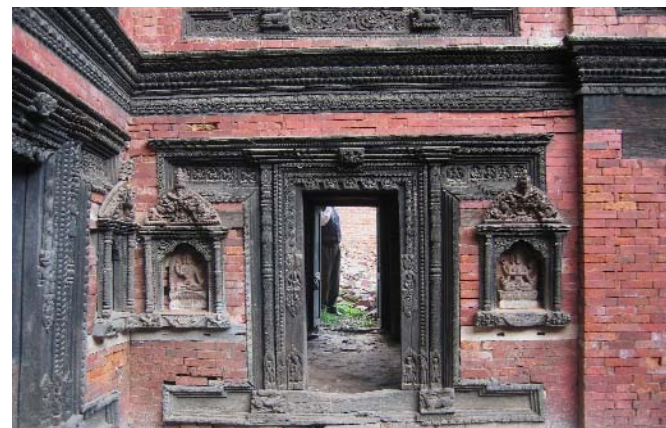
Northeast gate leading to the Bandharkhal Tank and Garden

The surface of the historic brickwork shows damage due to rising damp. Note that the timber threshold has become dislodged. Only one of sixteen original carved timber figures in the niches that flank the doorframes in all elevations survive; the remaining 15 have been replaced in poor quality.

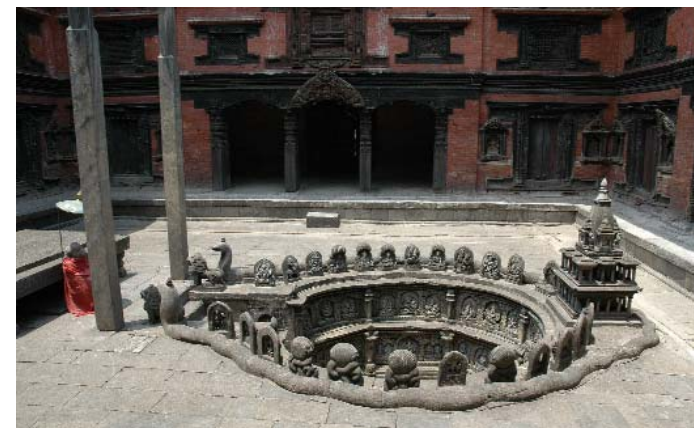
Tusha Hiti

Siddhinarasimha's carved stone ritual bath with a miniature version of the Krishna Temple at its north edge. Stone conservation measures will need to be developed that take into account original construction methods and pointing material.

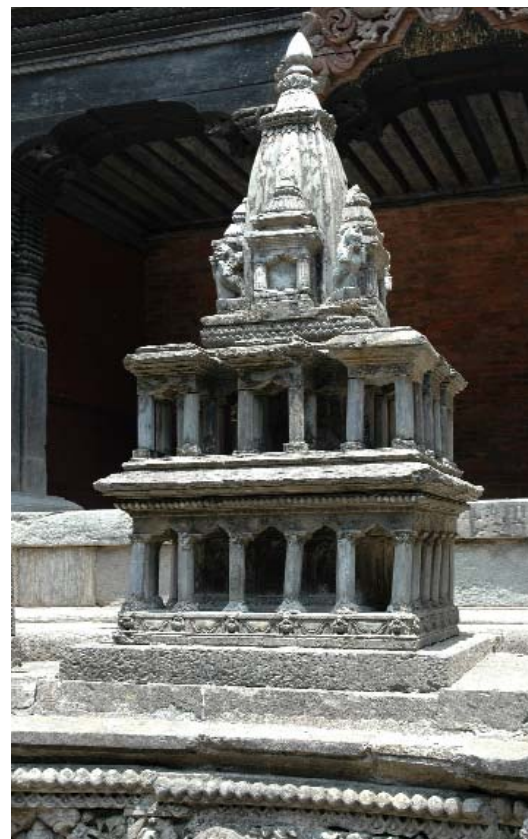
left: A miniature Krishna Mandir
It is unclear how the stone elements were originally fitted together and pointed. *Photograph, May, 2006*

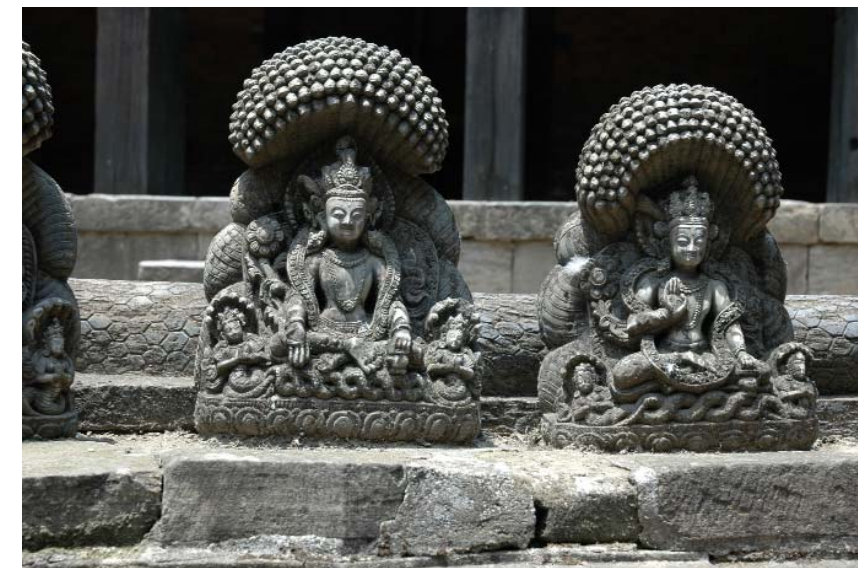
above: Stone carved deities surrounding the bath
Portland cement has been used to reset many stone elements of the bath. *Photograph, May, 2006*

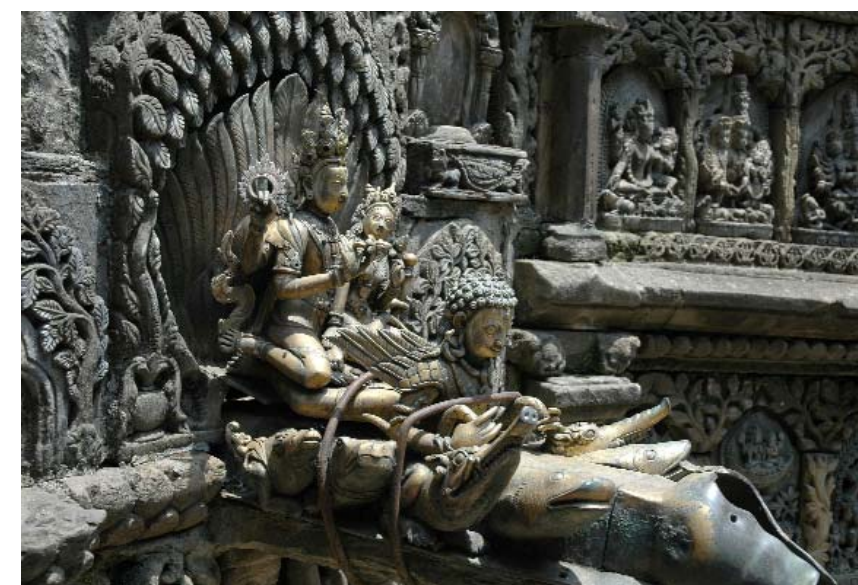
above: Gilt copper tap of the bath
Metal conservation and restoration methods will need to be developed to address cleaning and replacement of missing elements.

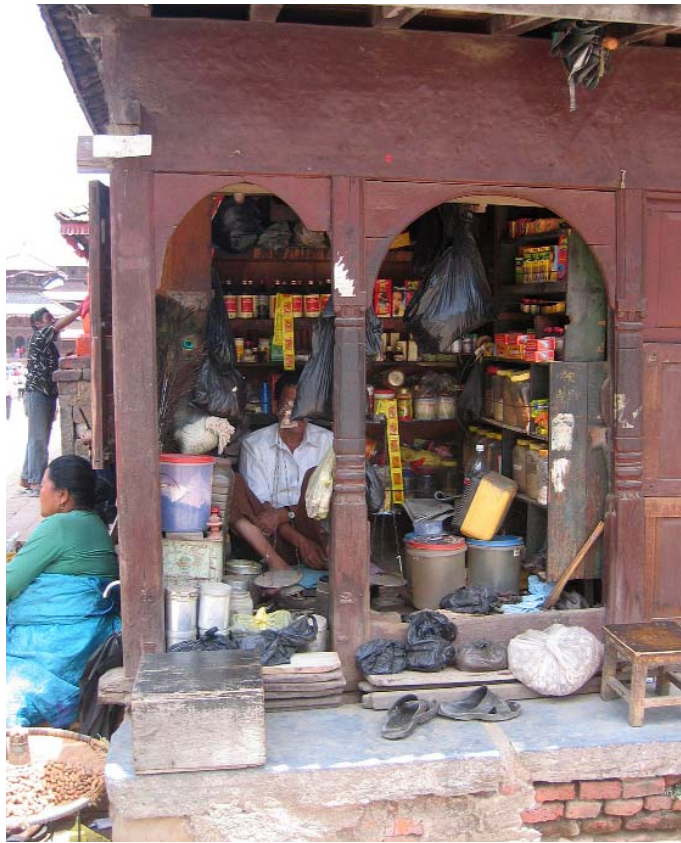
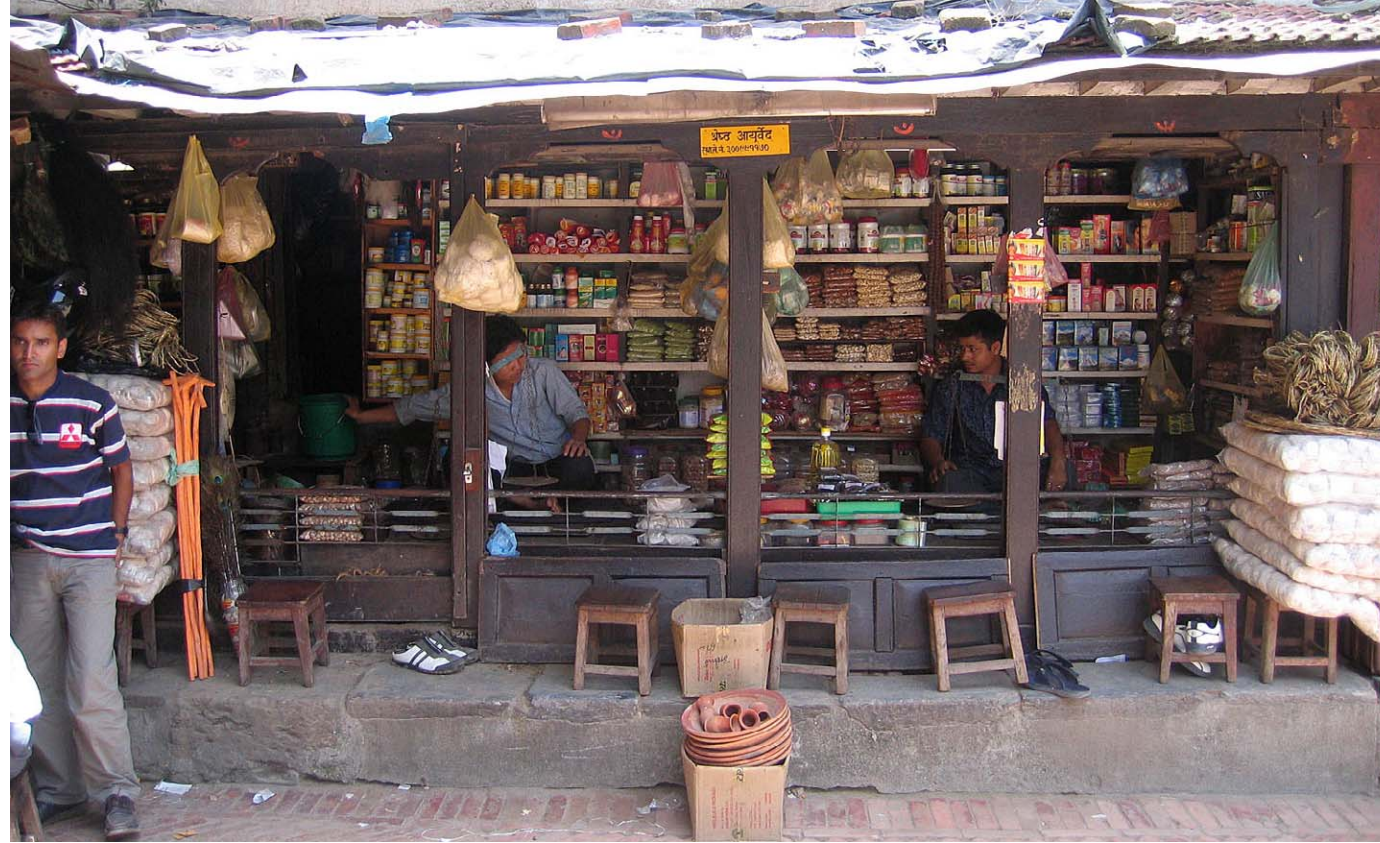
far left and left:
Medicine shops in front of Sundari Cok and the Court Building
 Ever since the earliest photographic documentation available these small shops have been occupied by traders of Ayurvedic medicine and other food and household items. Adjacent lower and first floor rooms in Sundari Cok and the Court Building serve as storage rooms. The stalls' roofs are in poor condition and only a few carved timber elements remain from the 19th century.
Photograph, 2006.

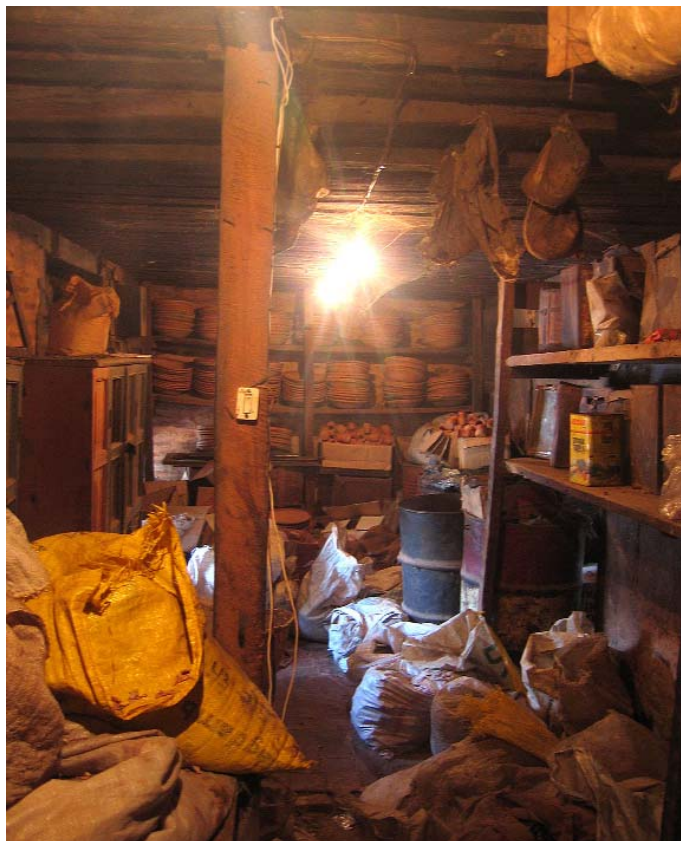
far left:
Storage room on the first floor of Sundari Cok
 Parts of the courtyard's southern wing is used for storage by the medicine shops located in the southern shed.
Photograph, 2006.

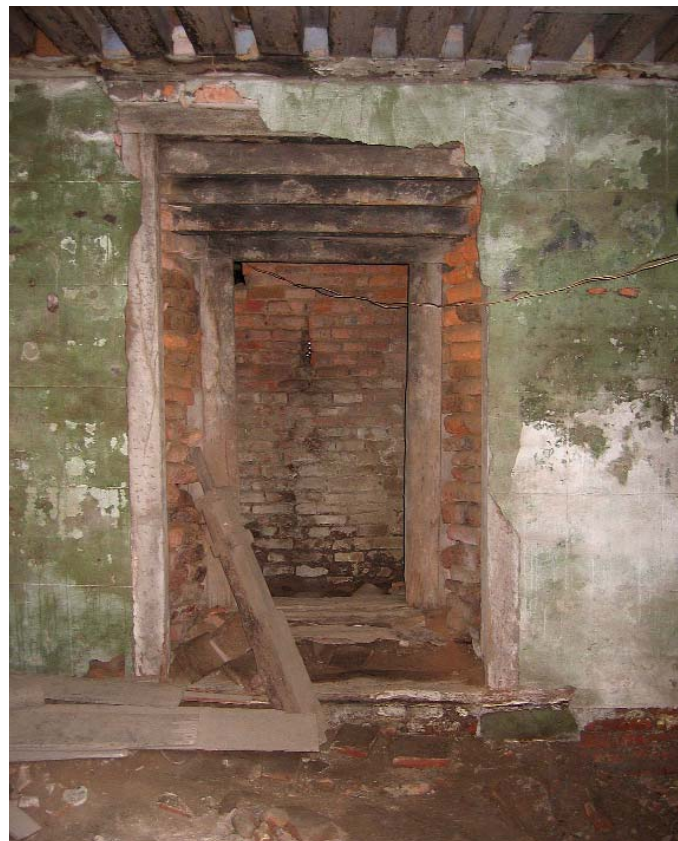
left center:
Ground floor room in the northwest corner of Sundari Cok
 Rising damp has taken its toll on brick walls and ceiling joists. Broken floor tiles and cement patching of walls reflect the poor maintenance record.
Photograph, 2006.

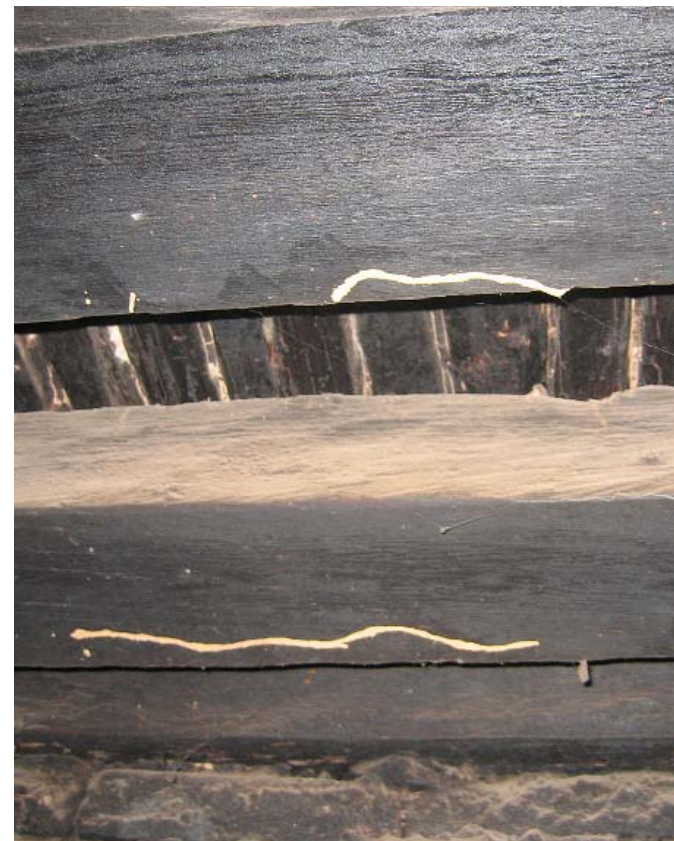
left:
East wing ground floor
 Termite infestation can be observed throughout the building.
Photograph, 2006.

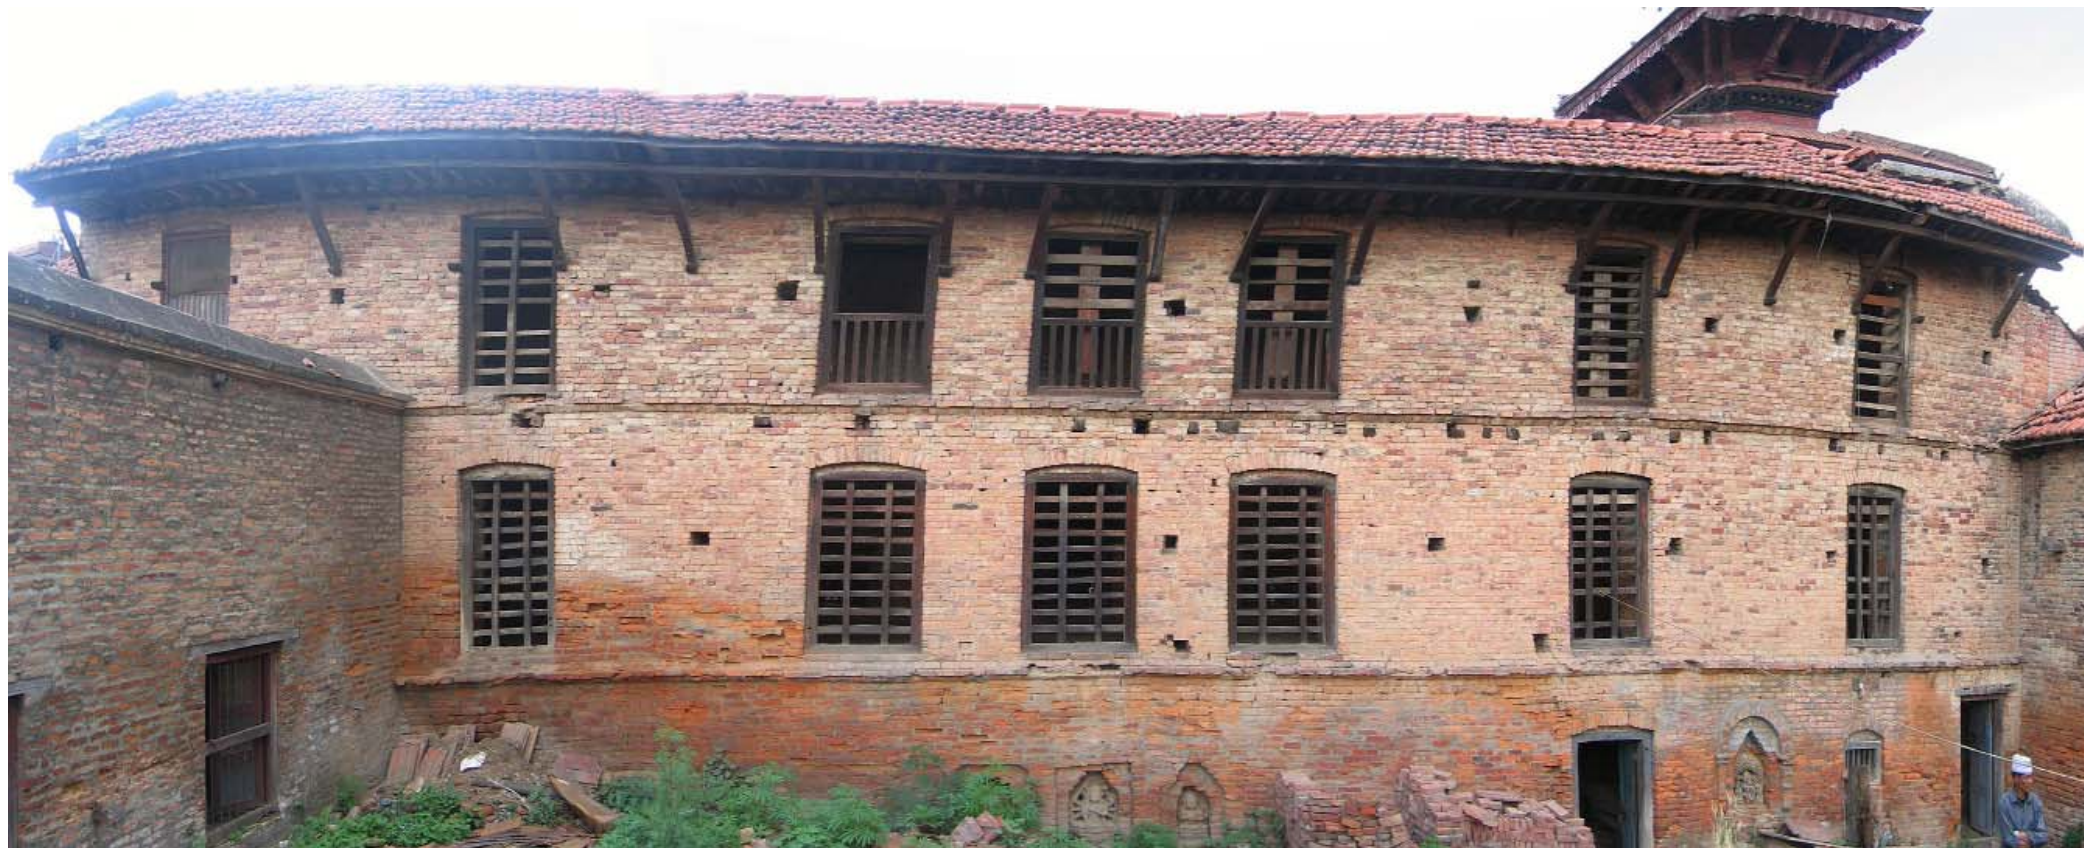
Rear (east) facade of Sundari Cok

This part of the east wing was rebuilt after the 1934 earthquake. Due to shortage of funds and building materials regular bricks were used and simple windows installed. The historic configuration of this facade was most likely similar to the other facades although no historic records of what it looked like exist. The building to the left is an addition dating from the 1970s when Sundari Cok was used as a police post and temporary jail.

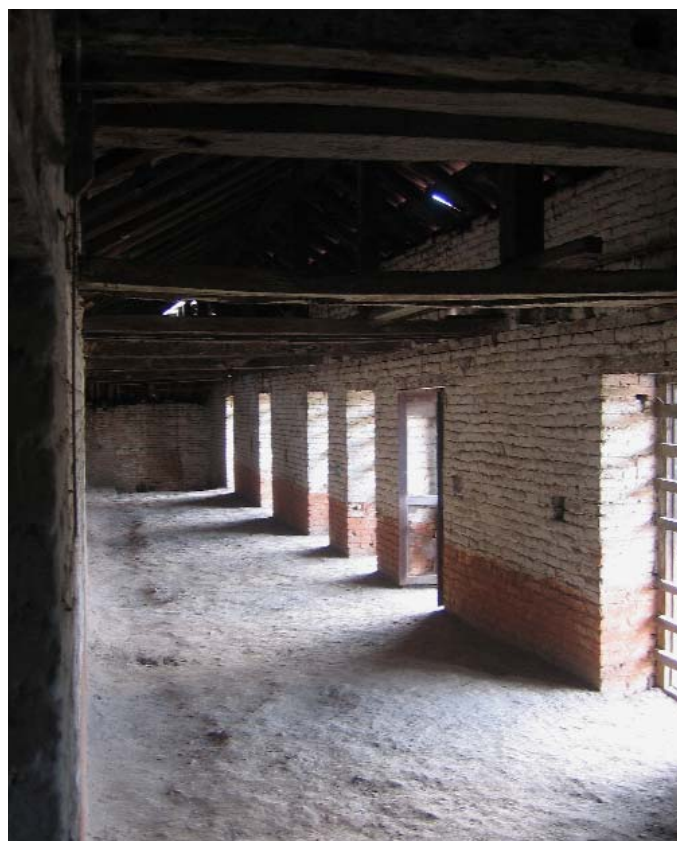
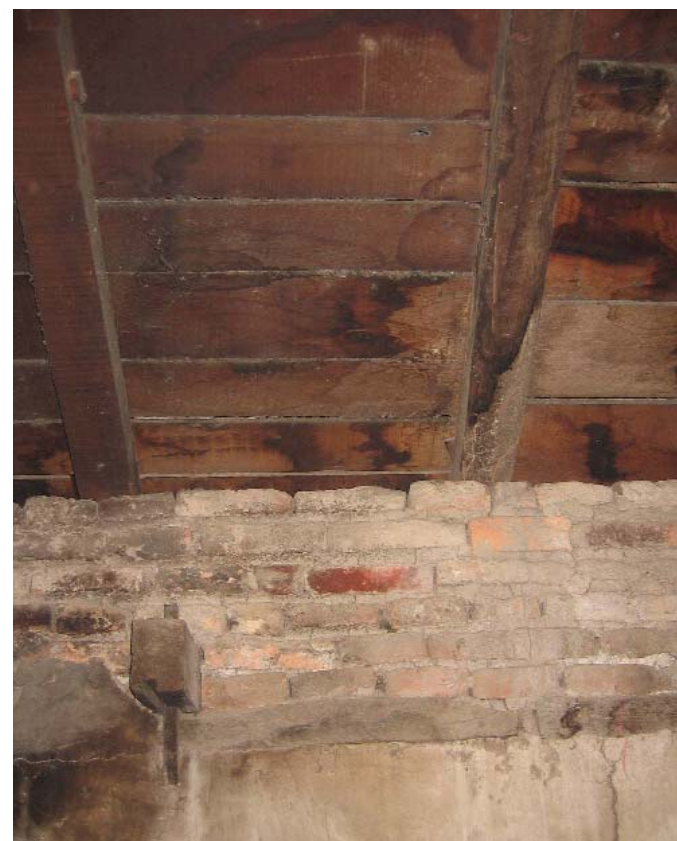
East wing of Sundari Cok, top floor

This photos illustrate the poor state of repairs. The roof framing incorporates salvaged timbers, possibly from collapsed buildings after the 1934 earthquake. Rafter dimensions and spacing do not match historic examples. The modern tile roof is damaged in many places causing severe water infiltration. This room will be used as a gallery for the proposed architecture or crafts museums.
