THE PATAN ROYAL PALACE RESTORATION AND CONSERVATION PROJECT

JOINT MISSION REPORT

DECEMBER, 2006

JOINT MISSION (MAY 1-6, 2006)

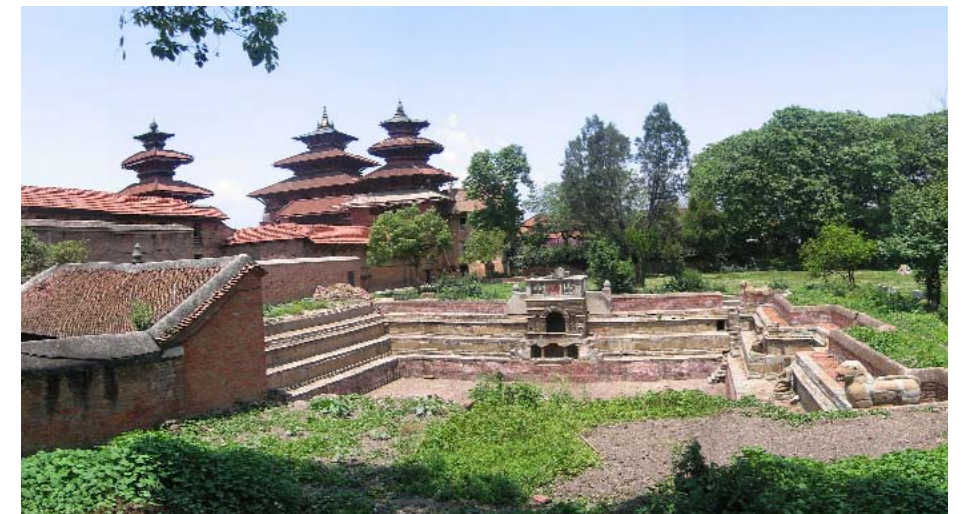
Bhandarkhal Tank seen from the South
Originally, the level of the surrounding park was at least 1 1/2 meters lower.
Photograph, May, 2006

The raised grade level around the tank and the resultant third terrace surrounding the entire structure substantially effects the perception of the volume of the terraced tank and the reading of the north pavilion as a discrete and partially freestanding structure. Investigative excavation around the tank to determine historic paving levels is recommended as is consequent re-grading and repaving to historic levels.

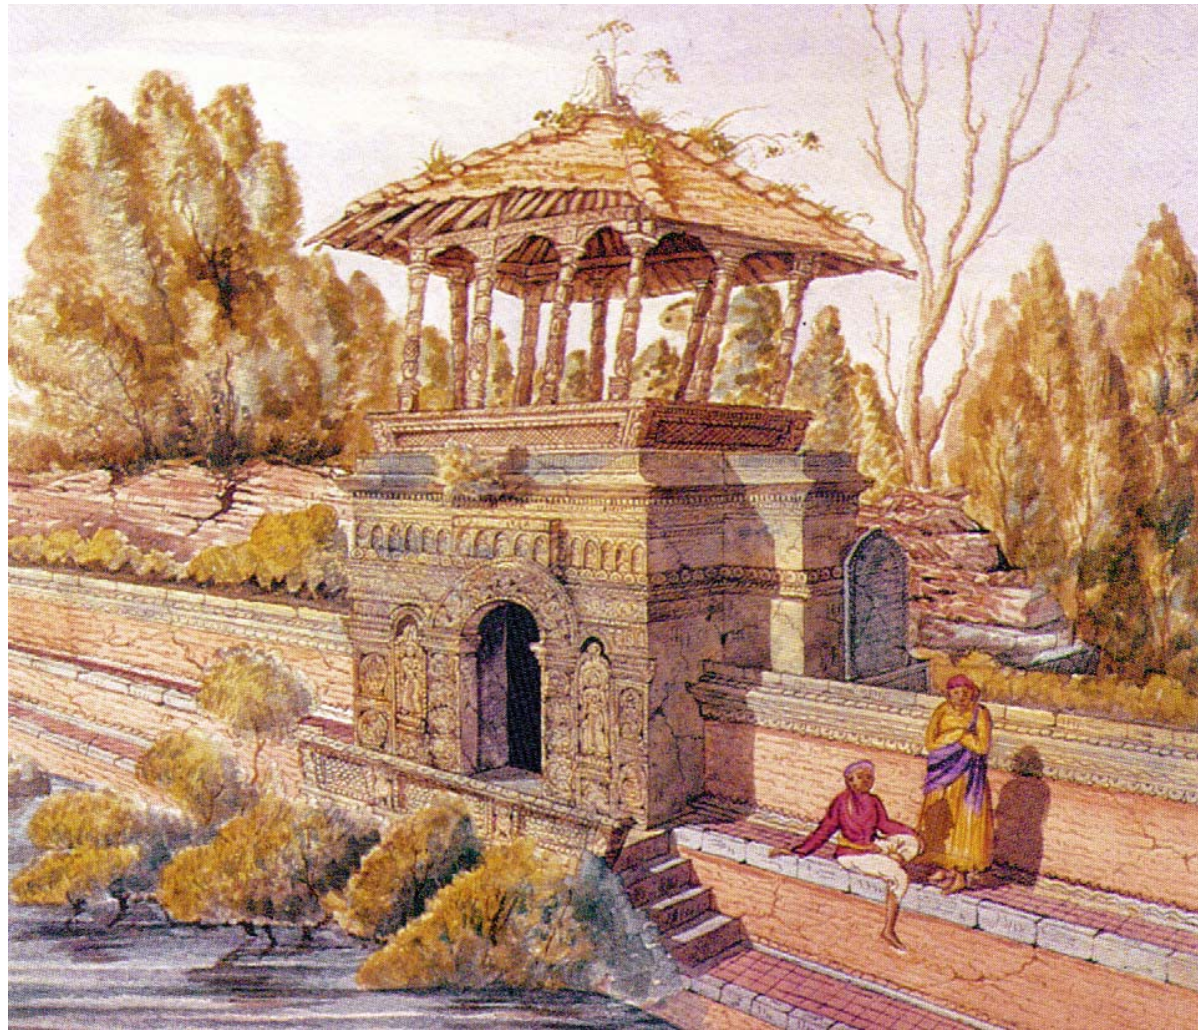
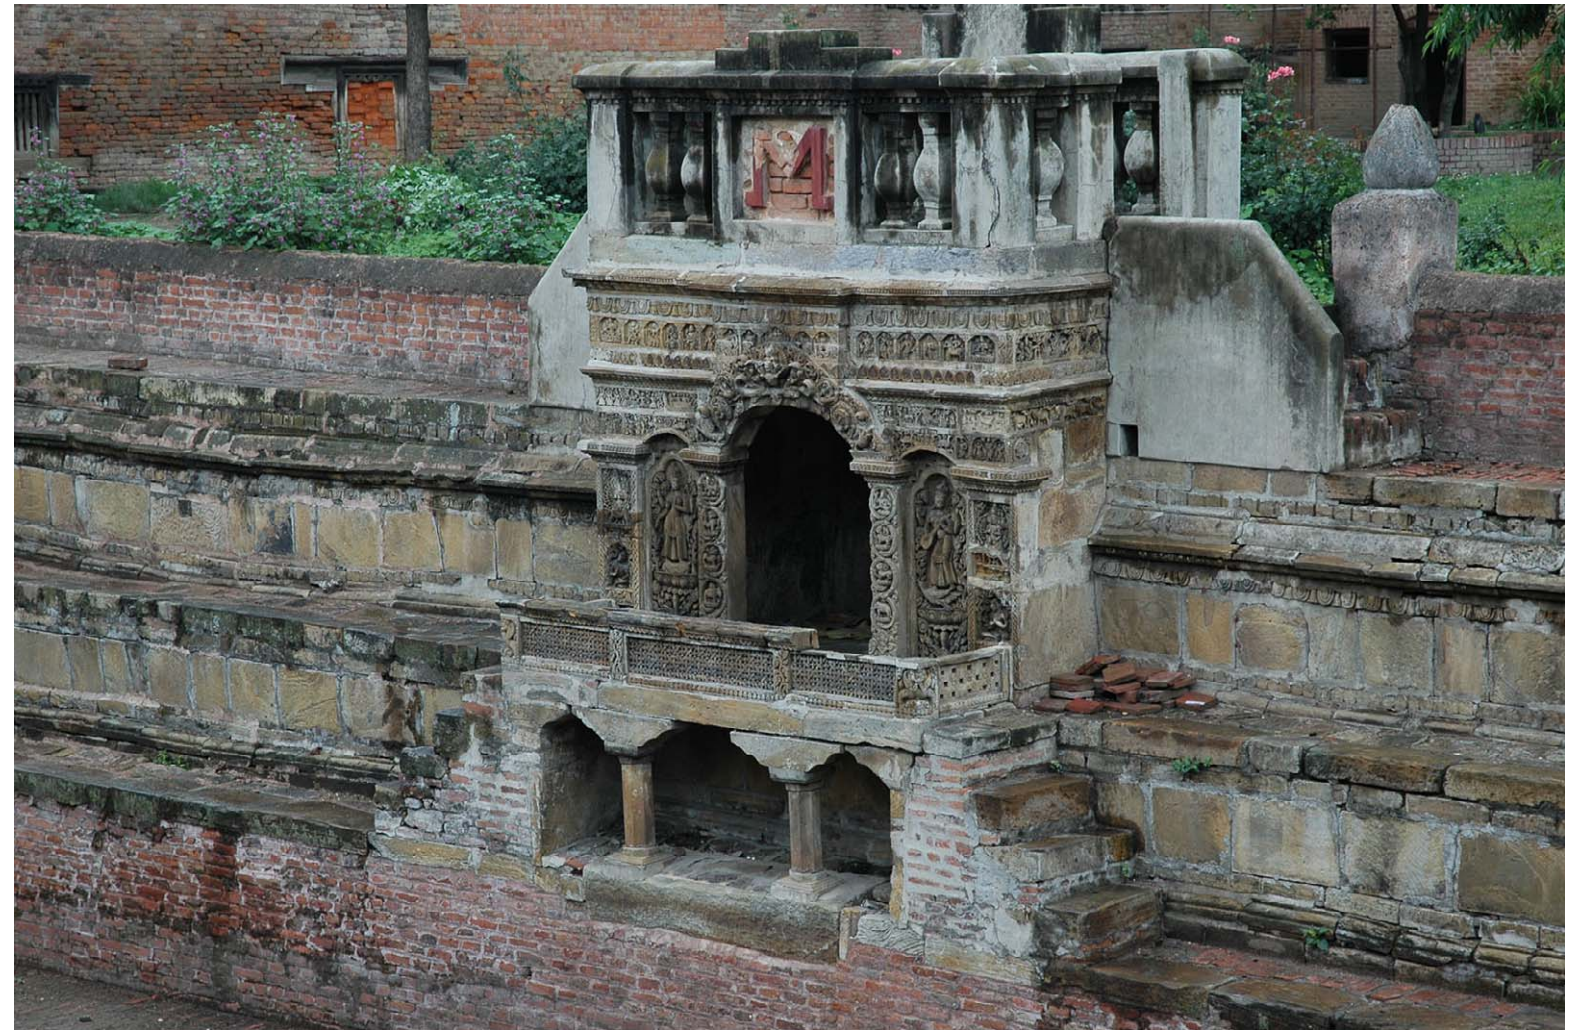
Comparative Views of the Bhandarkhal Tank Pavilion

Early 19th century views confirm a lower grade level around the Bhandarkhal Tank. Accumulation of debris around the tank has essentially “buried” the north pavilion which originally appeared as a free standing element at the north side of the upper retaining wall. Note the renovations to the pavilion’s superstructure completed for King Mahendra’s coronation in 1955.

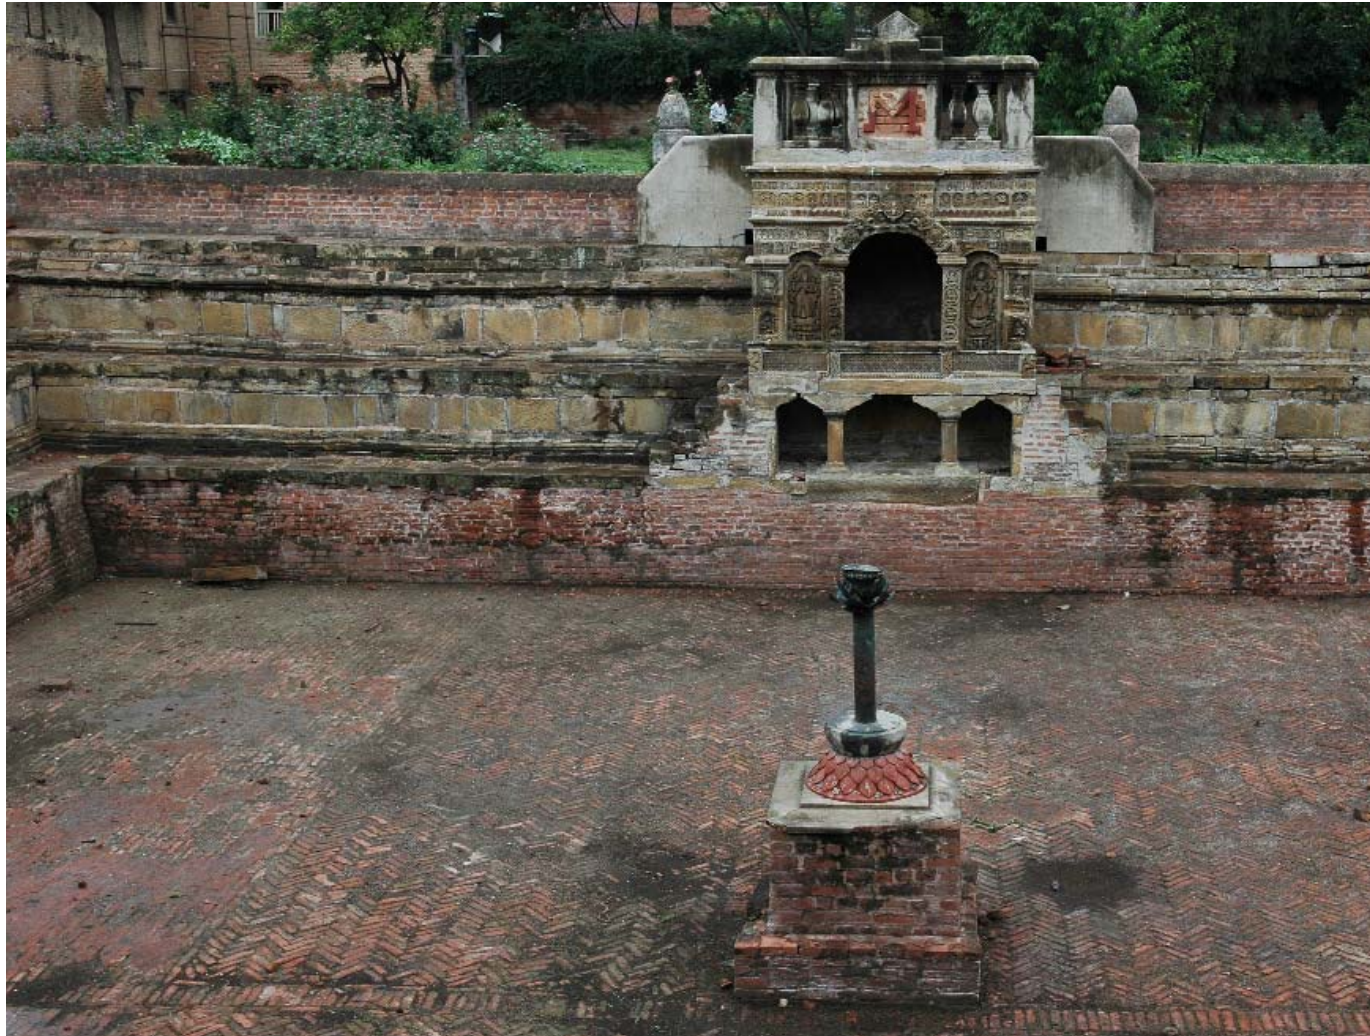
View of the Tank looking North

Recent brick relining of the tank failed to make it water-tight. The generally poor condition of the stone facing has been exacerbated by poor repointing and damaging chemical cleaning. The gilt copper lotus was likely originally installed at water level. Note upper brick retaining wall added after the 1934 earthquake to accommodate a change in grade.

If function to the tank is to be re-established it will need to be relined. The restoration of function to other historic tanks in the Valley has involved the removal of modern brick lining and the installation of a new layer of lime cement over a moisture barrier. These projects should be studied for reference.

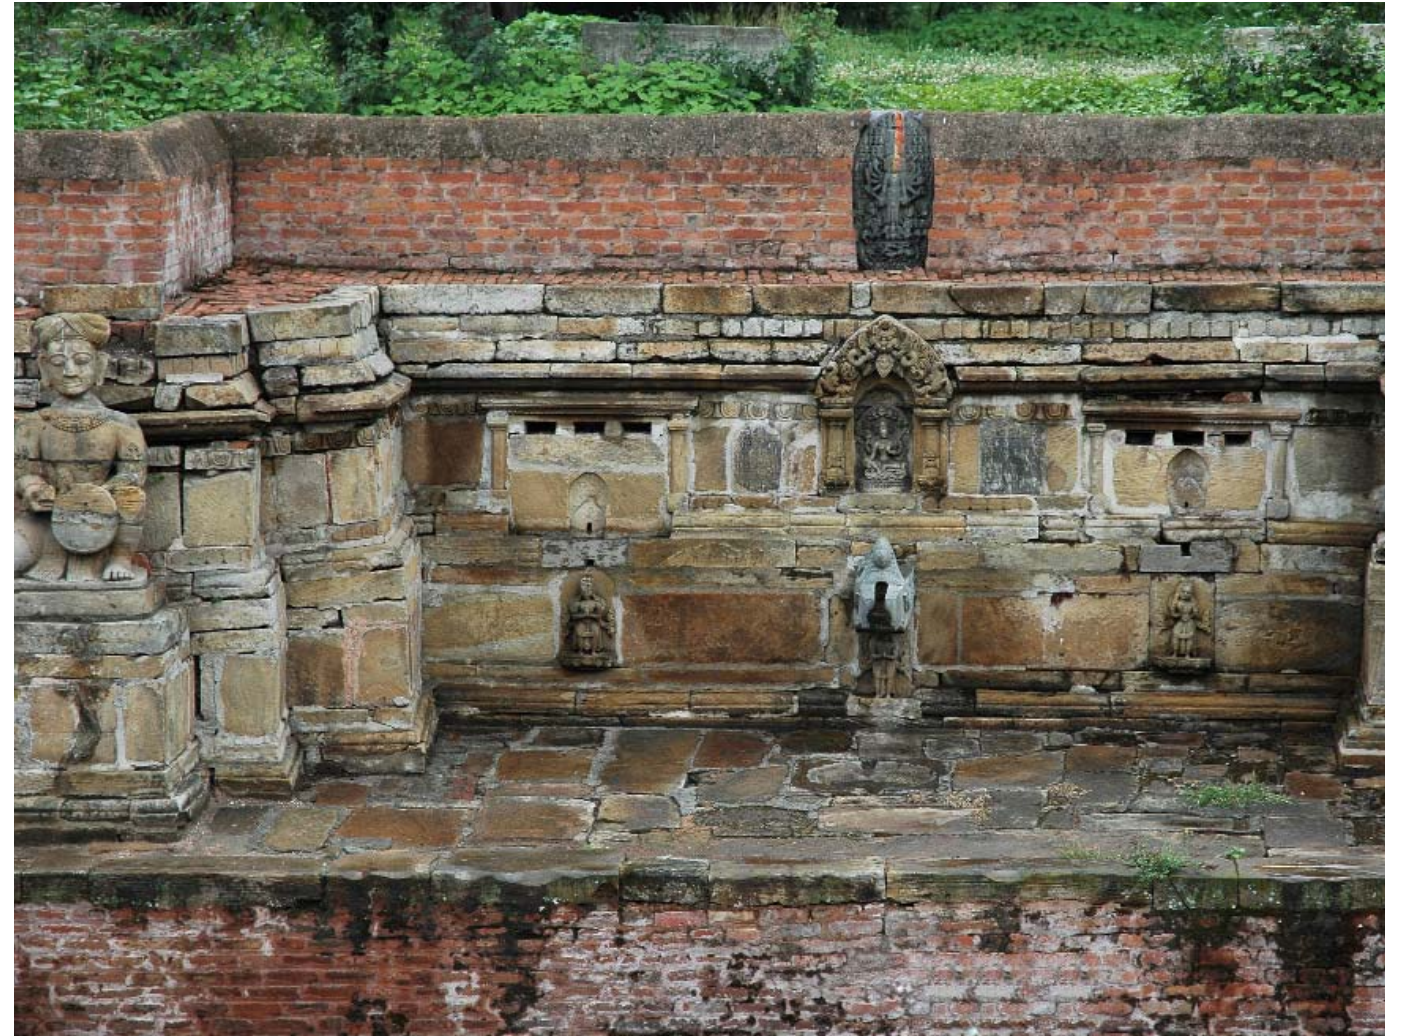
Tap and Votive Images at the East Terrace of the Tank

A traditional stone tap was the water source of for the tank. A Licchavi period image of Vishvarup Vishnu, now embedded in the brick retaining wall, is still actively worshiped.

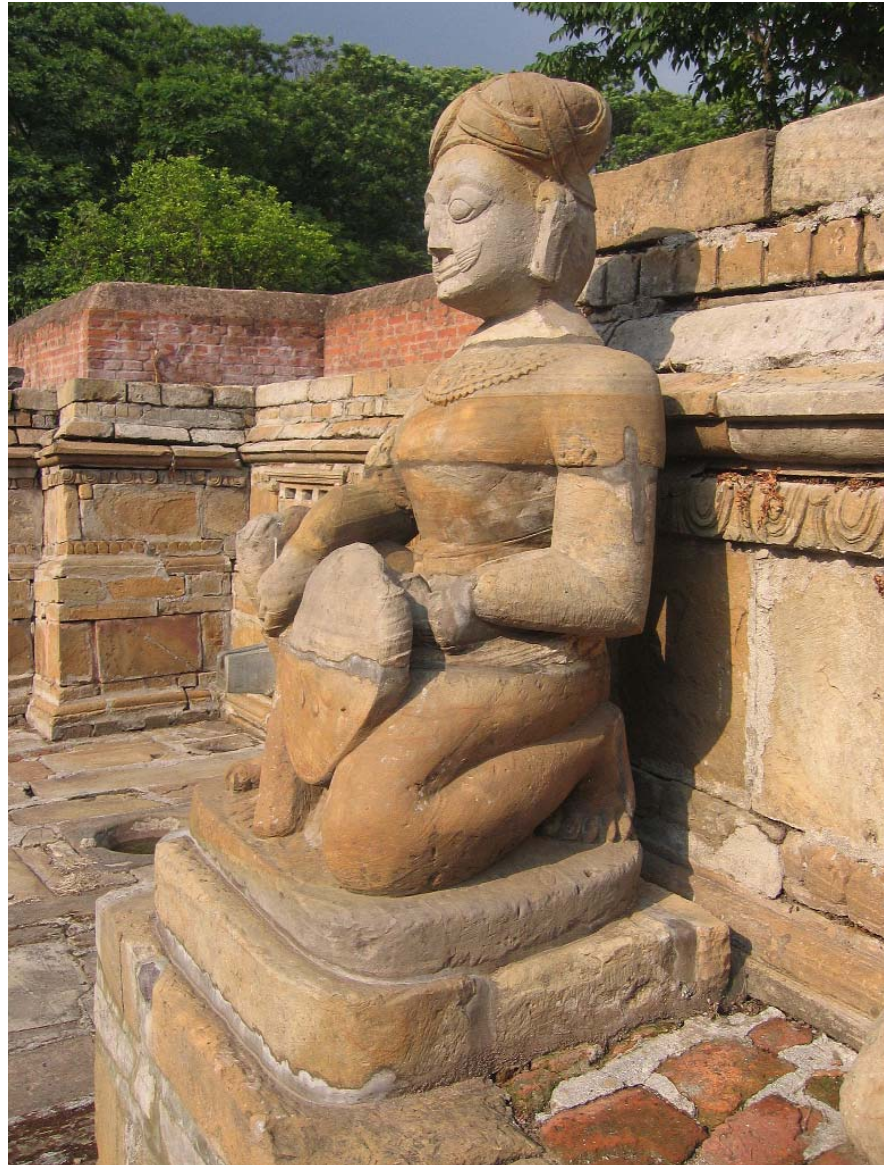
Guardian figure

Recent repointing of this figure characterizes the typical nature of repair where Portland cement appears to have been used.

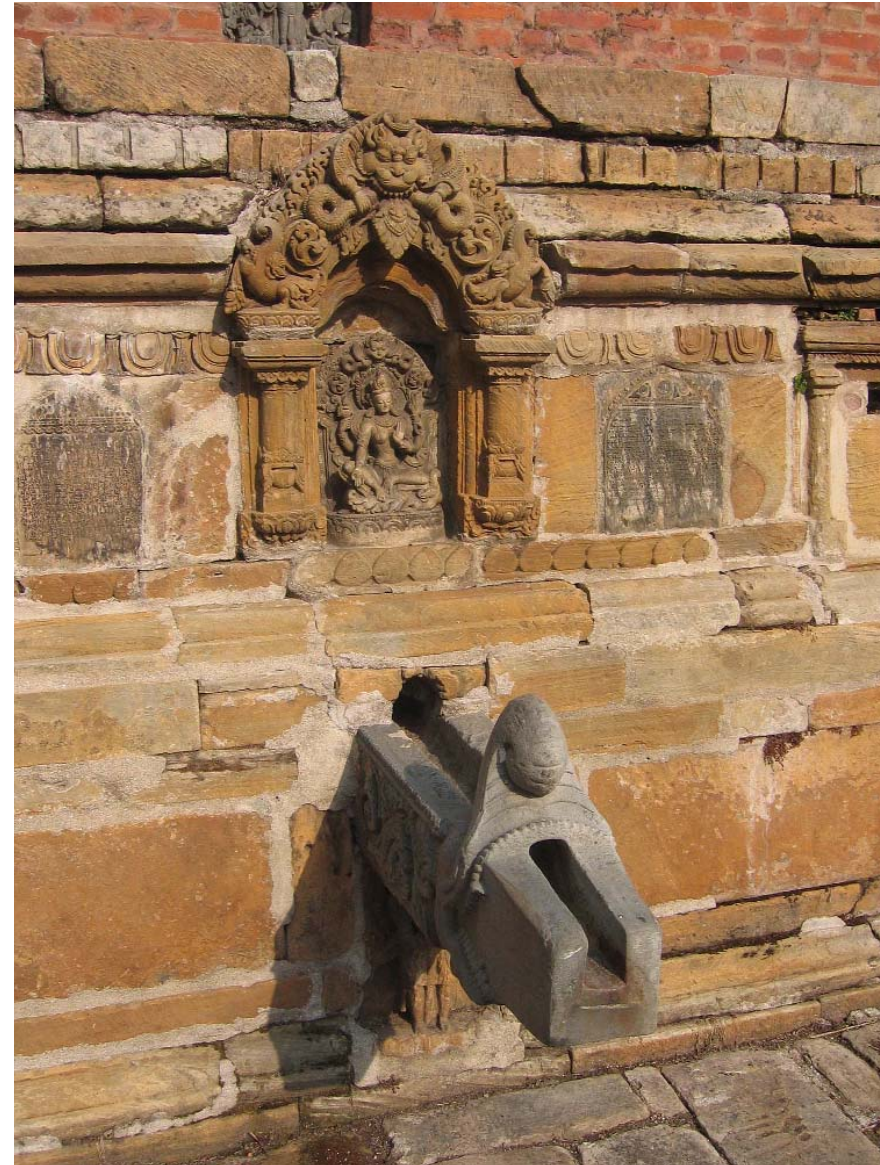
Stone spout

Waterflow at the tank's spout has been interrupted for many years due to an acute water shortages and damage to the historic supply sources. Above the spout is a stone image of Ganga, flanked by two Malla period inscriptions.

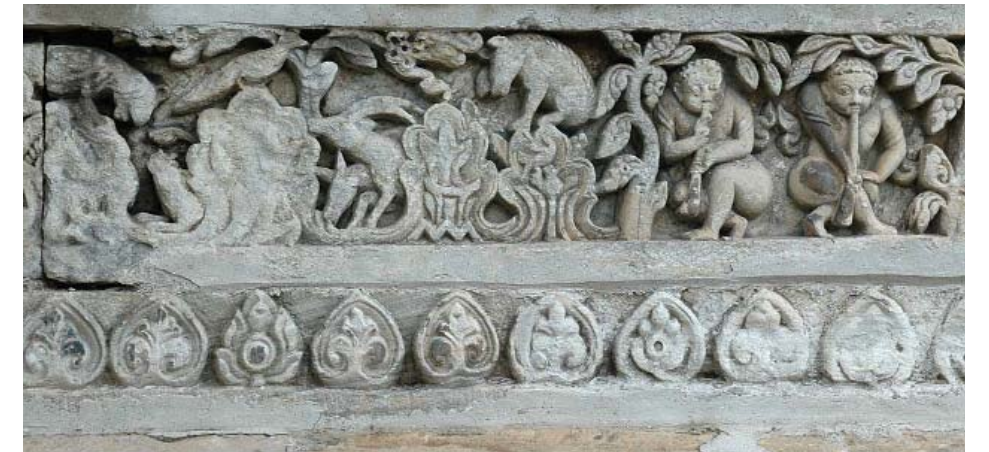
Relief carving

These genre scenes are unique to the carved stone pavilion of the Bhandarkhal Tank. Note the use of Portland cement pointing.

The stone carvings of the north pavilion were apparently damaged during a cleaning campaign in the early 1990s. Careful cleaning and pointing methods will need to be developed to redress this damage and prevent future deterioration.

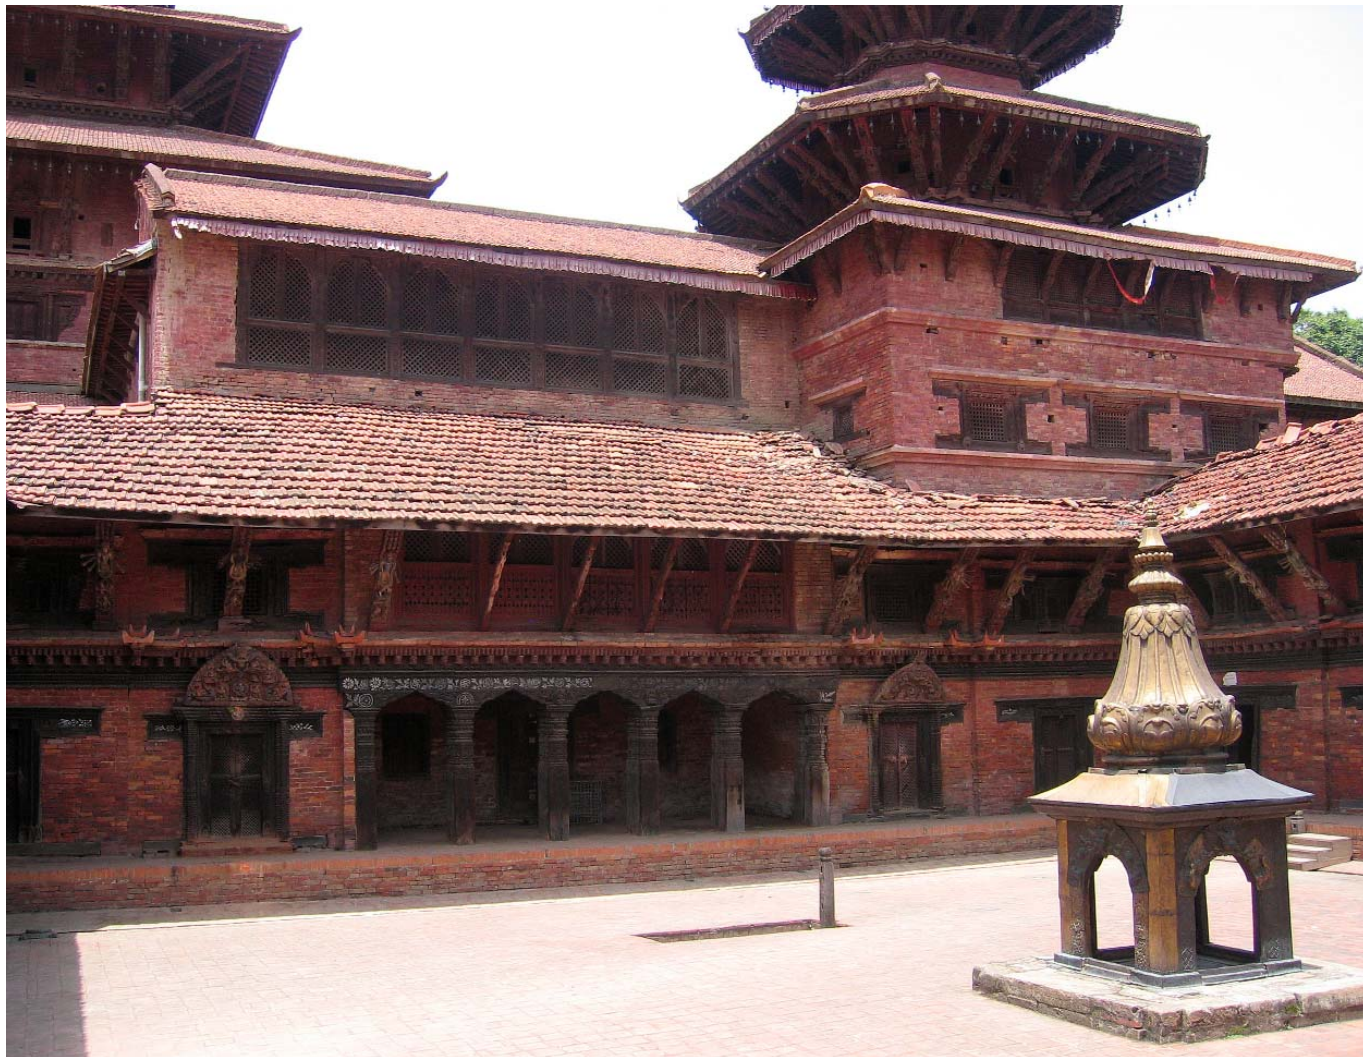
Mul Cok courtyard looking north
Reconstruction of the entire roof structure is recommended.
Photograph, May, 2006

As in Sundari Cok the roof of Mul Cok is in poor condition and in urgent need of repair. Only four rooms on the ground floor level are presently used for ritual purposes. One room of the first floor level which had been used for tantric rituals (*Vidyapith*) has been closed for about 20 years since ritual obligations there became obsolete. The remaining rooms have been largely neglected and unused for a generation. Typical post-1934 earthquake reconstruction included the use of non-historic pan tiles, incorrect widely spaced rafters and ceiling joists, and the lack of any attempt to accurately reconstruct non-public garden facades. While the courtyard contains superb historic roof struts most are missing arms and attributes and many have been replaced with inferior facsimiles. The garden façade displays a patchwork of a variety of brick sizes that document successive repairs since the 1934 earthquake.

Any conservation program must include the complete rebuilding of the roof structure and cover. As in Sundari Cok the mission is of the opinion that a restored roof should include historically accurate rafter spacing and a traditional mud bed and correct historical tile roof cover. While the south “kitchen wing” of Nasal Cok appears to be in relatively stable condition its roof structure and cover need to be studied to determine whether there too reconstruction is required.

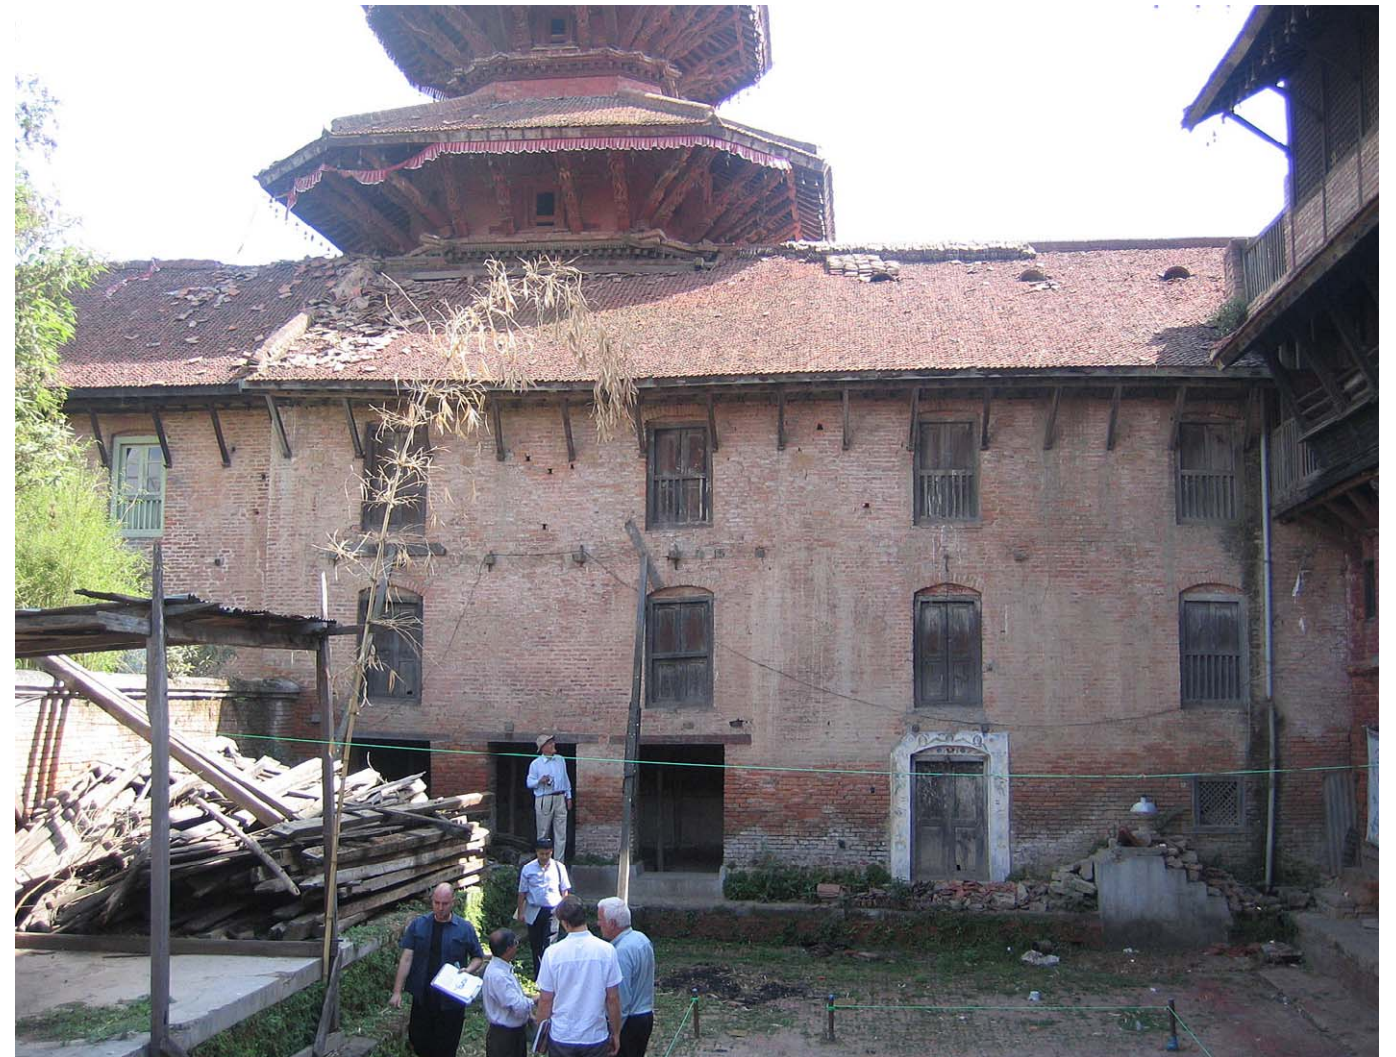
Nasal Cok looking south
Assessment of roof is required to determine if reconstruction is recommended.
Photograph, May, 2006

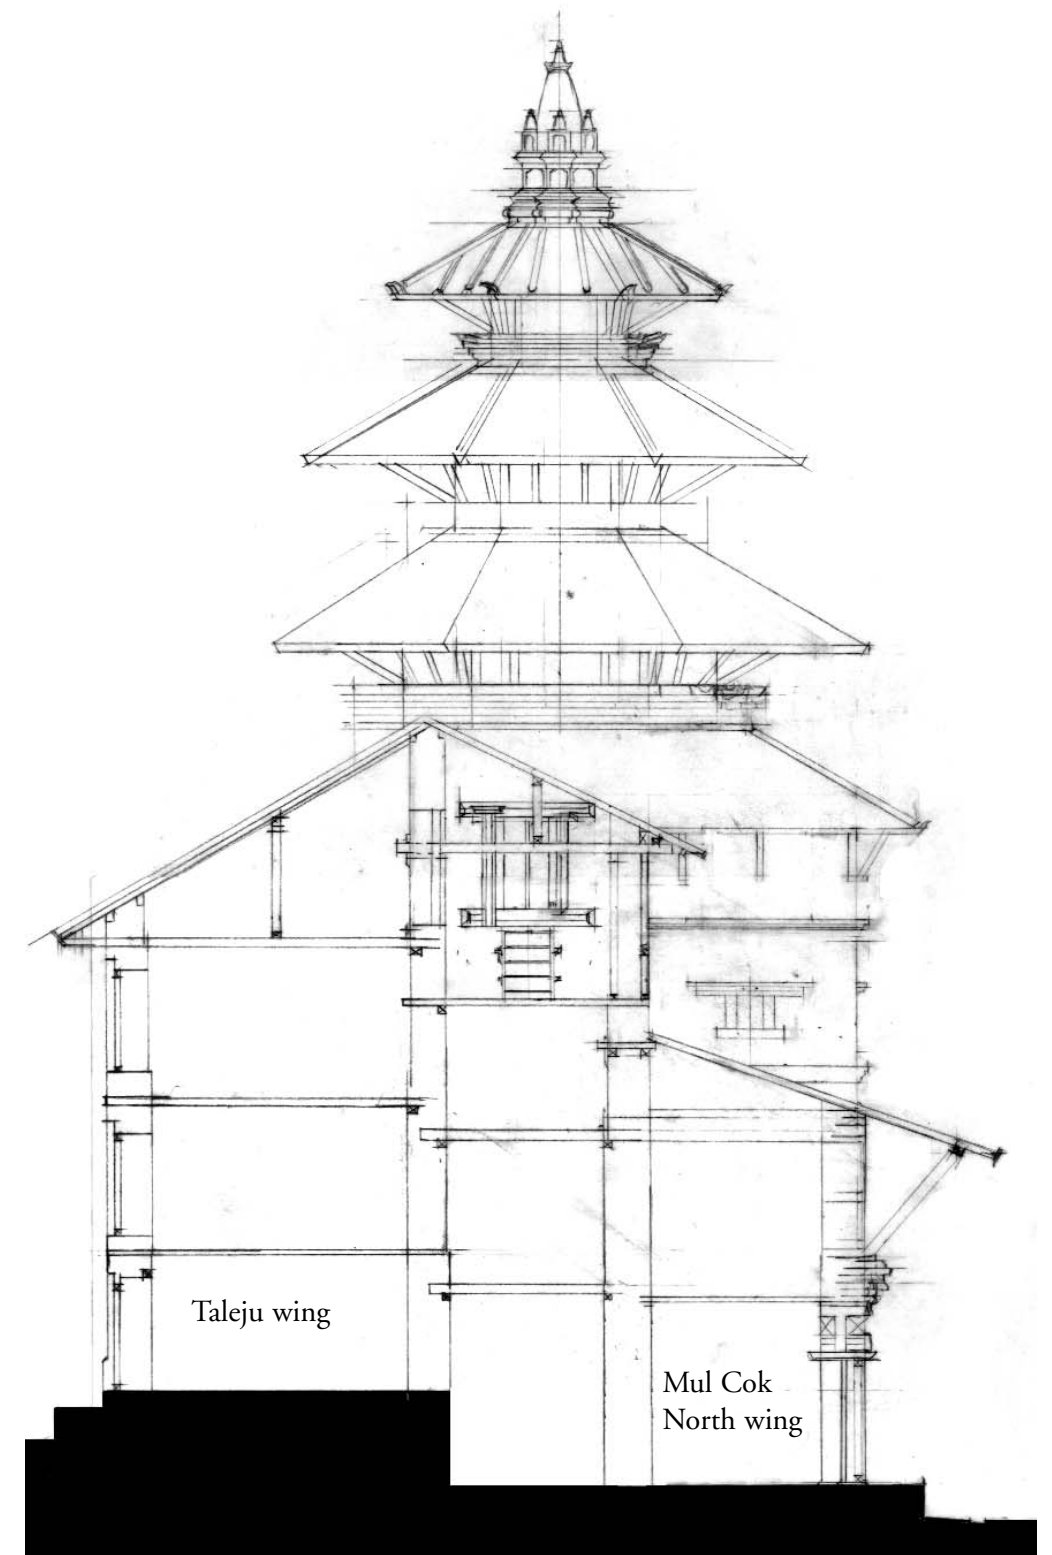
N-S section through Taleju wing and Mul Cok, North wing
Rooms in the Taleju wing will provide additional exhibition space
Drawing Suresh Shrestha, 1997

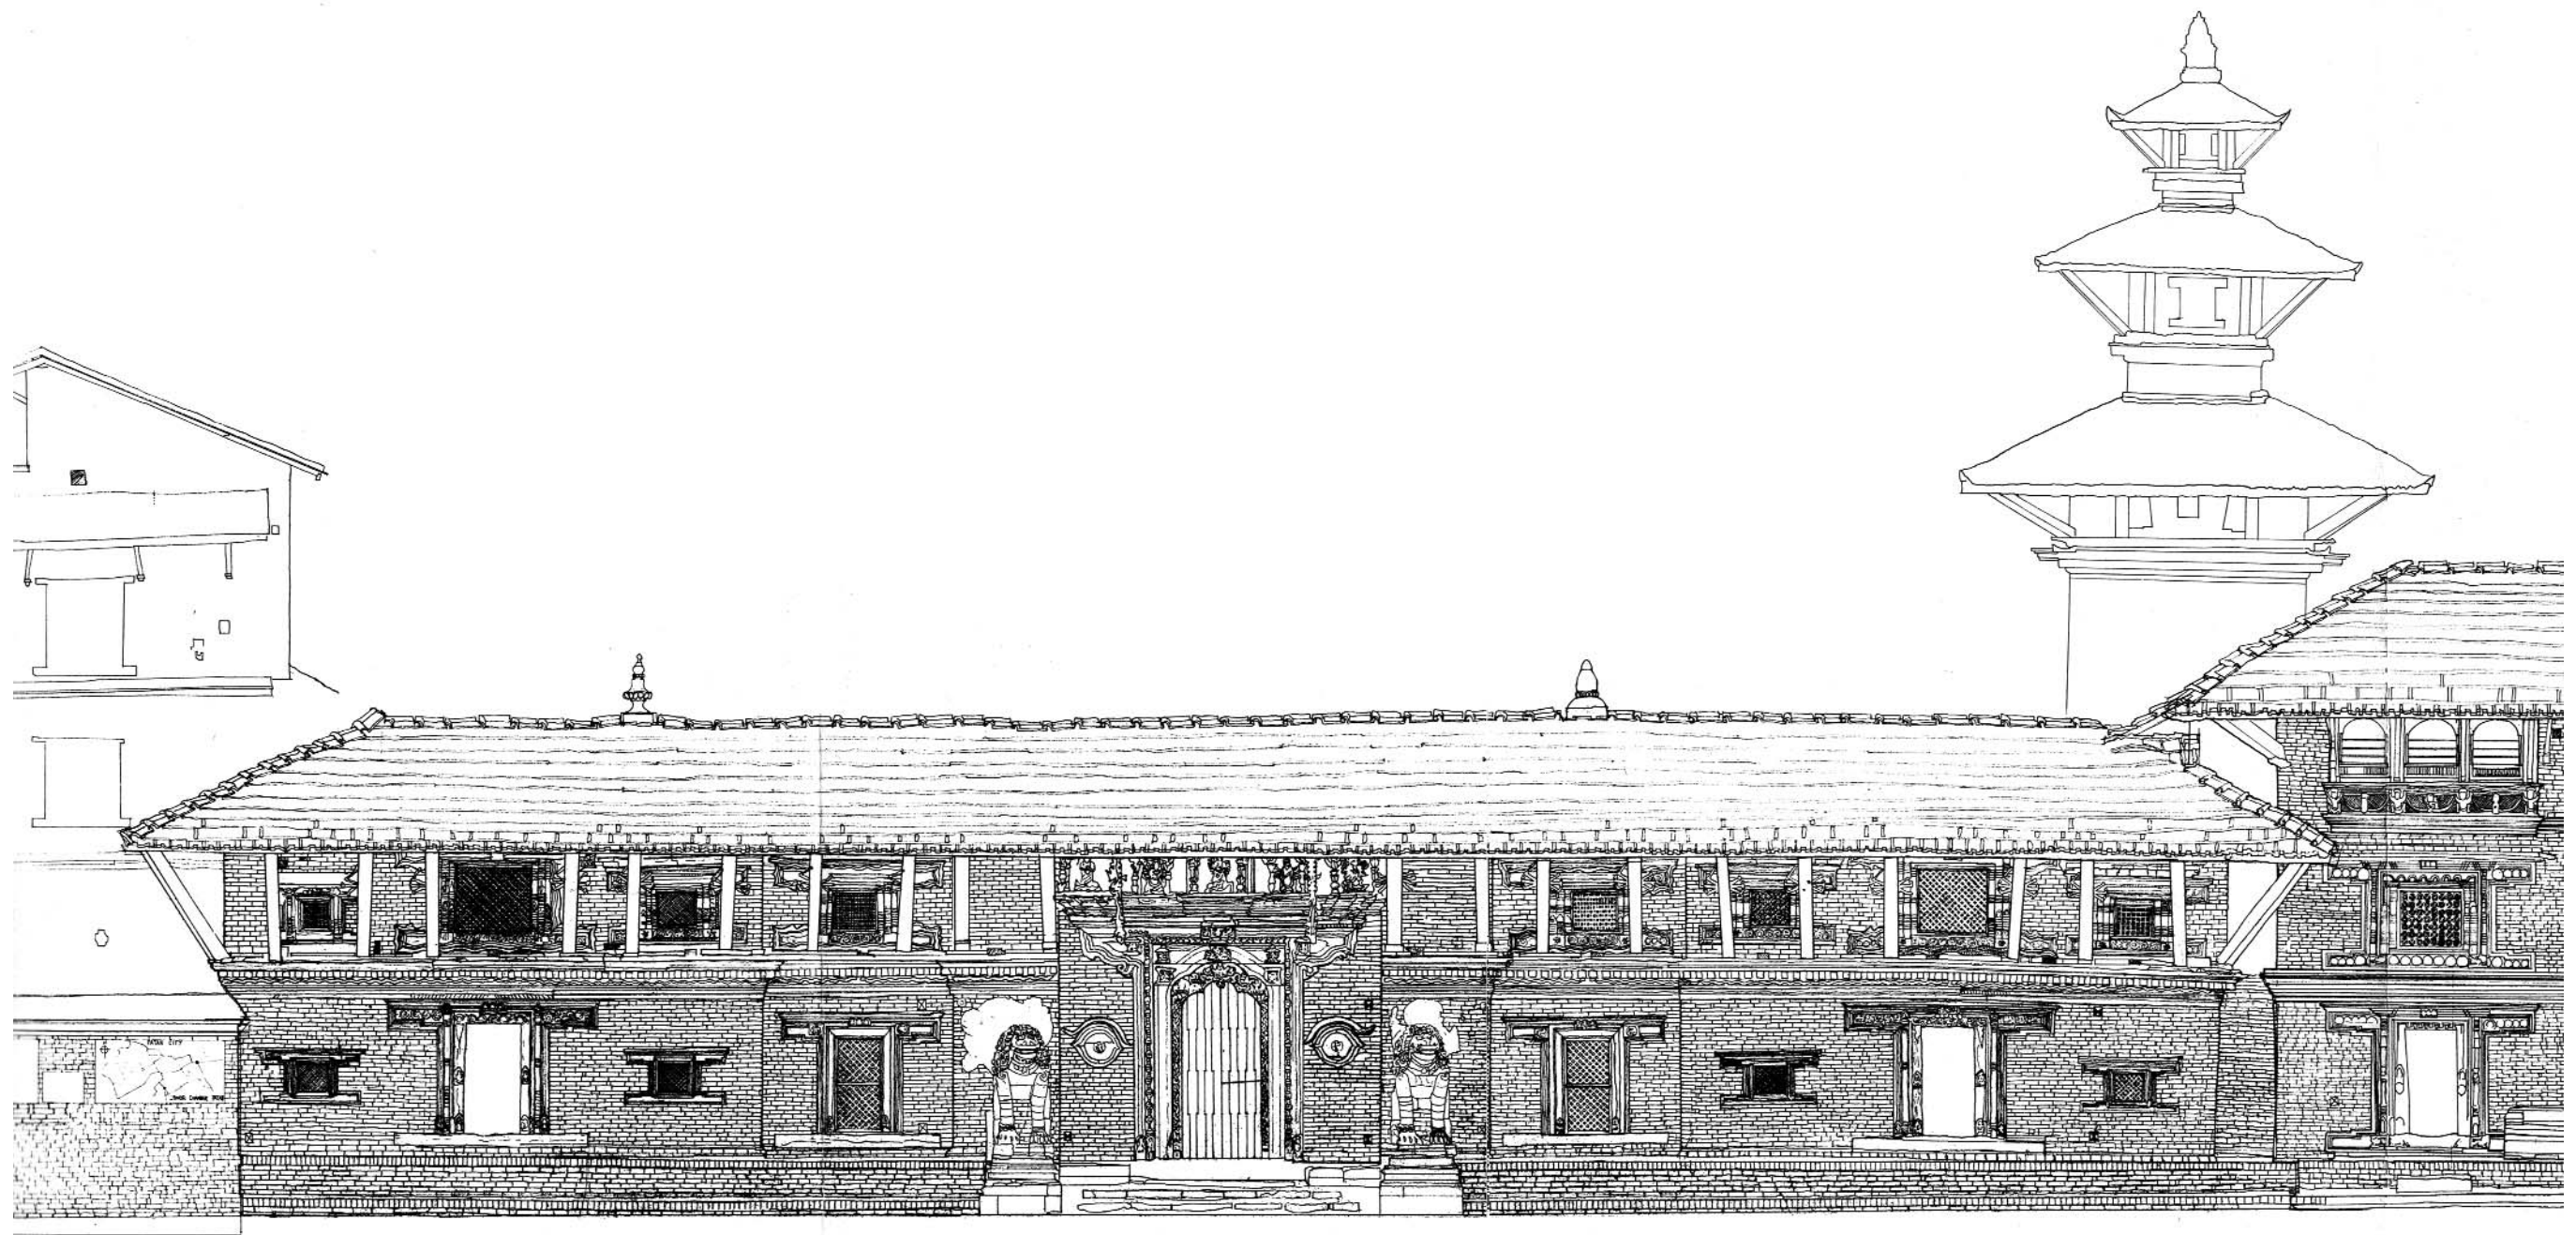
Principal facade of Mul Cok facing the Darbar Square
Existing conditions
Survey by the Nippon Institute of Technology, December, 1977

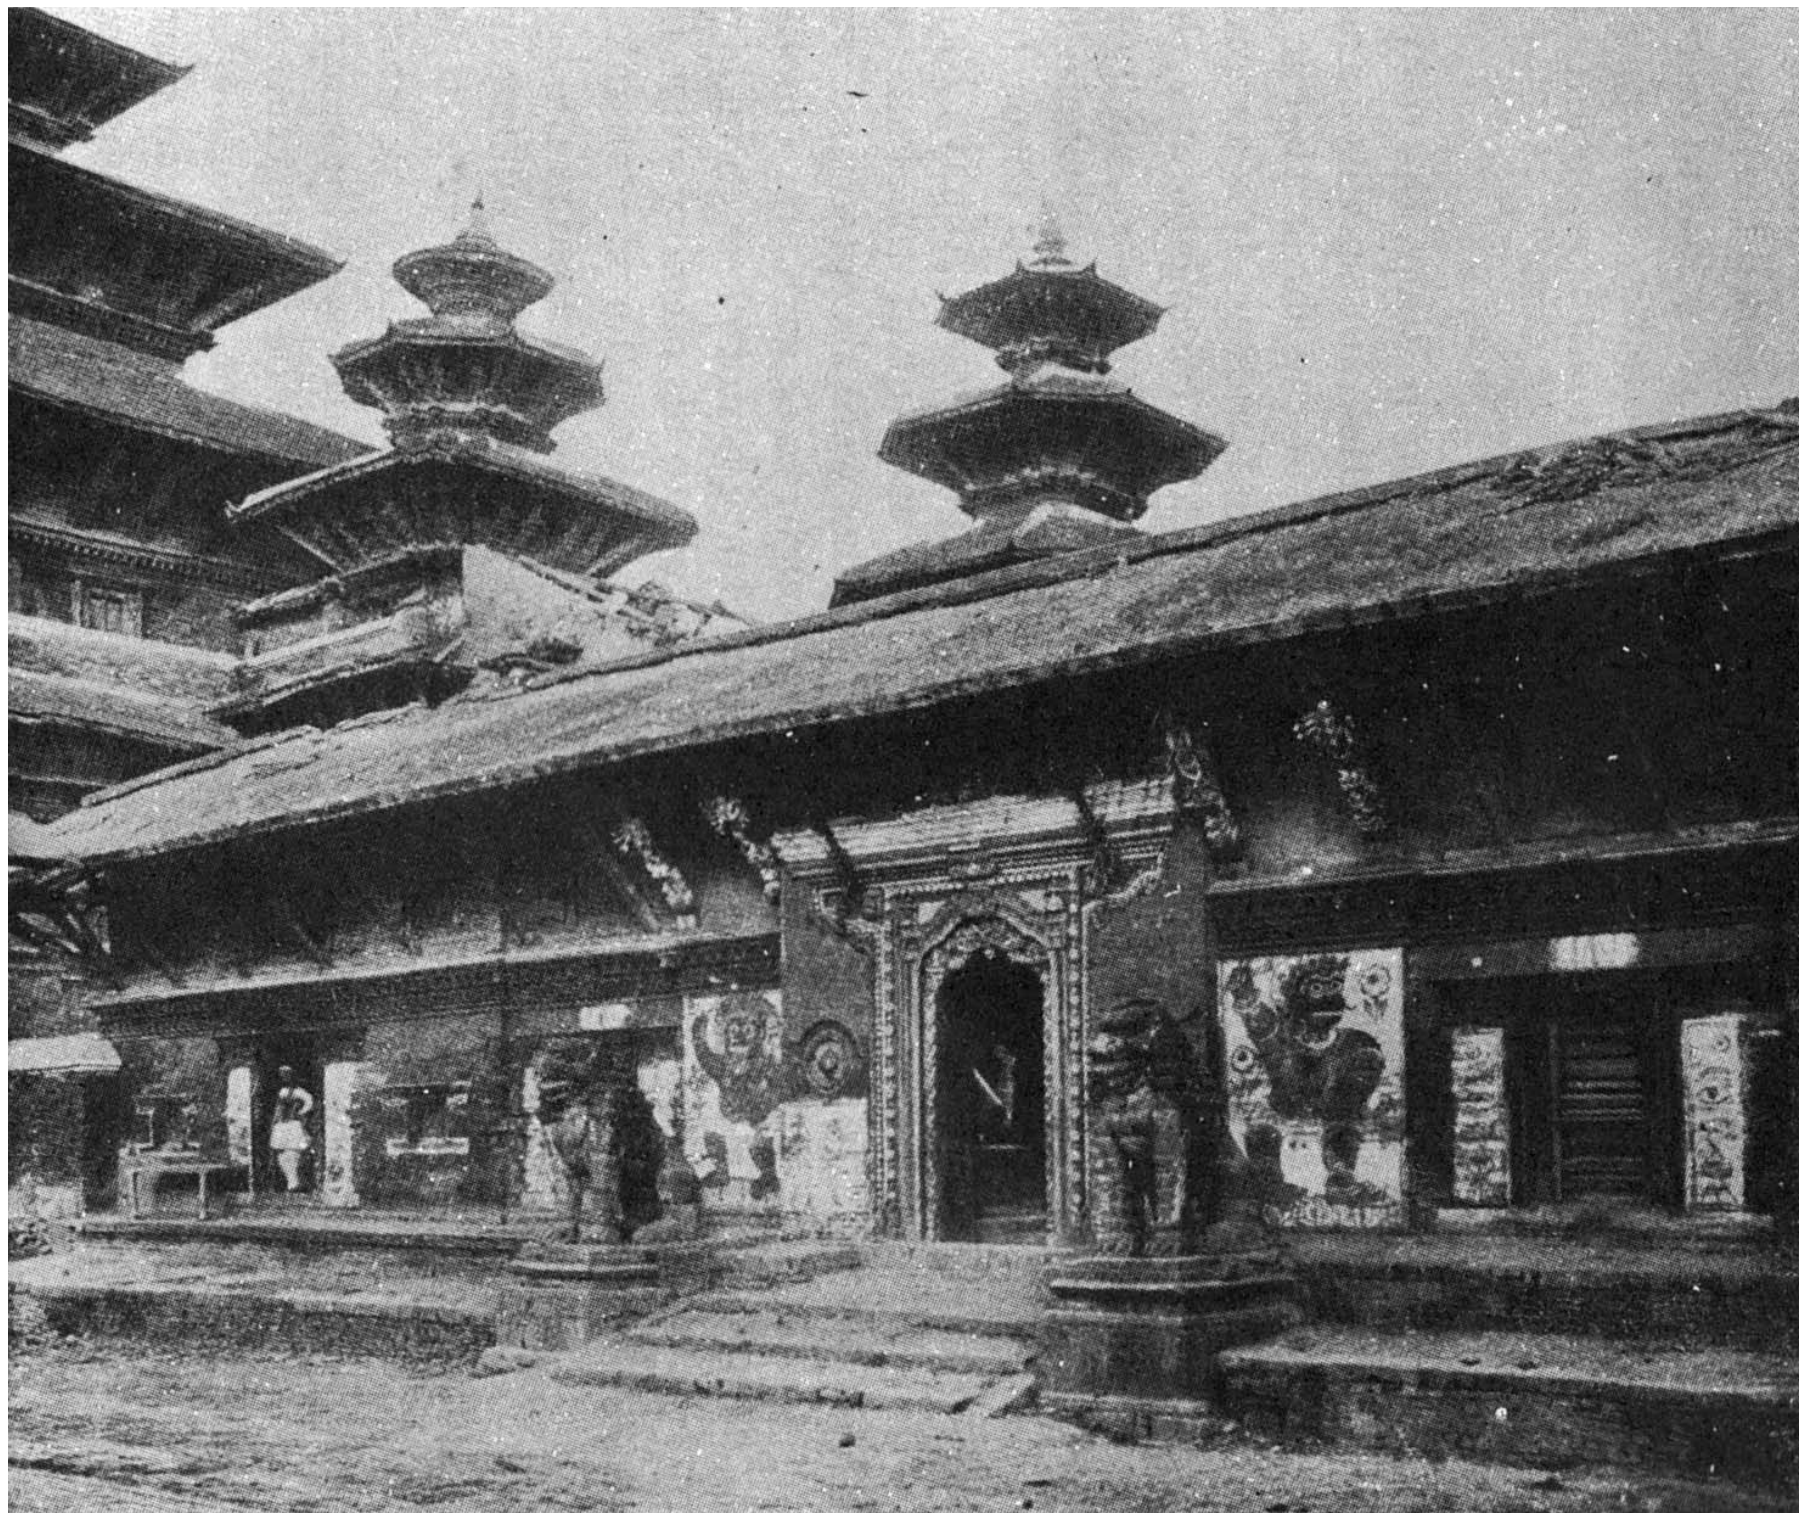
Principal facade of Mul Cok

Till the 1920s Mul Cok's roof was still covered with the traditional roof tiles laid in a mud bed. Other historic photographs attest to a number of

renovations: during the 1930s the roof cover was replaced with corrugated metal, and after the 1934 earthquake it was covered with large modern tiles.
