THE PATAN ROYAL PALACE RESTORATION AND CONSERVATION PROJECT

JOINT MISSION REPORT

DECEMBER, 2006

JOINT MISSION (MAY 1-6, 2006)

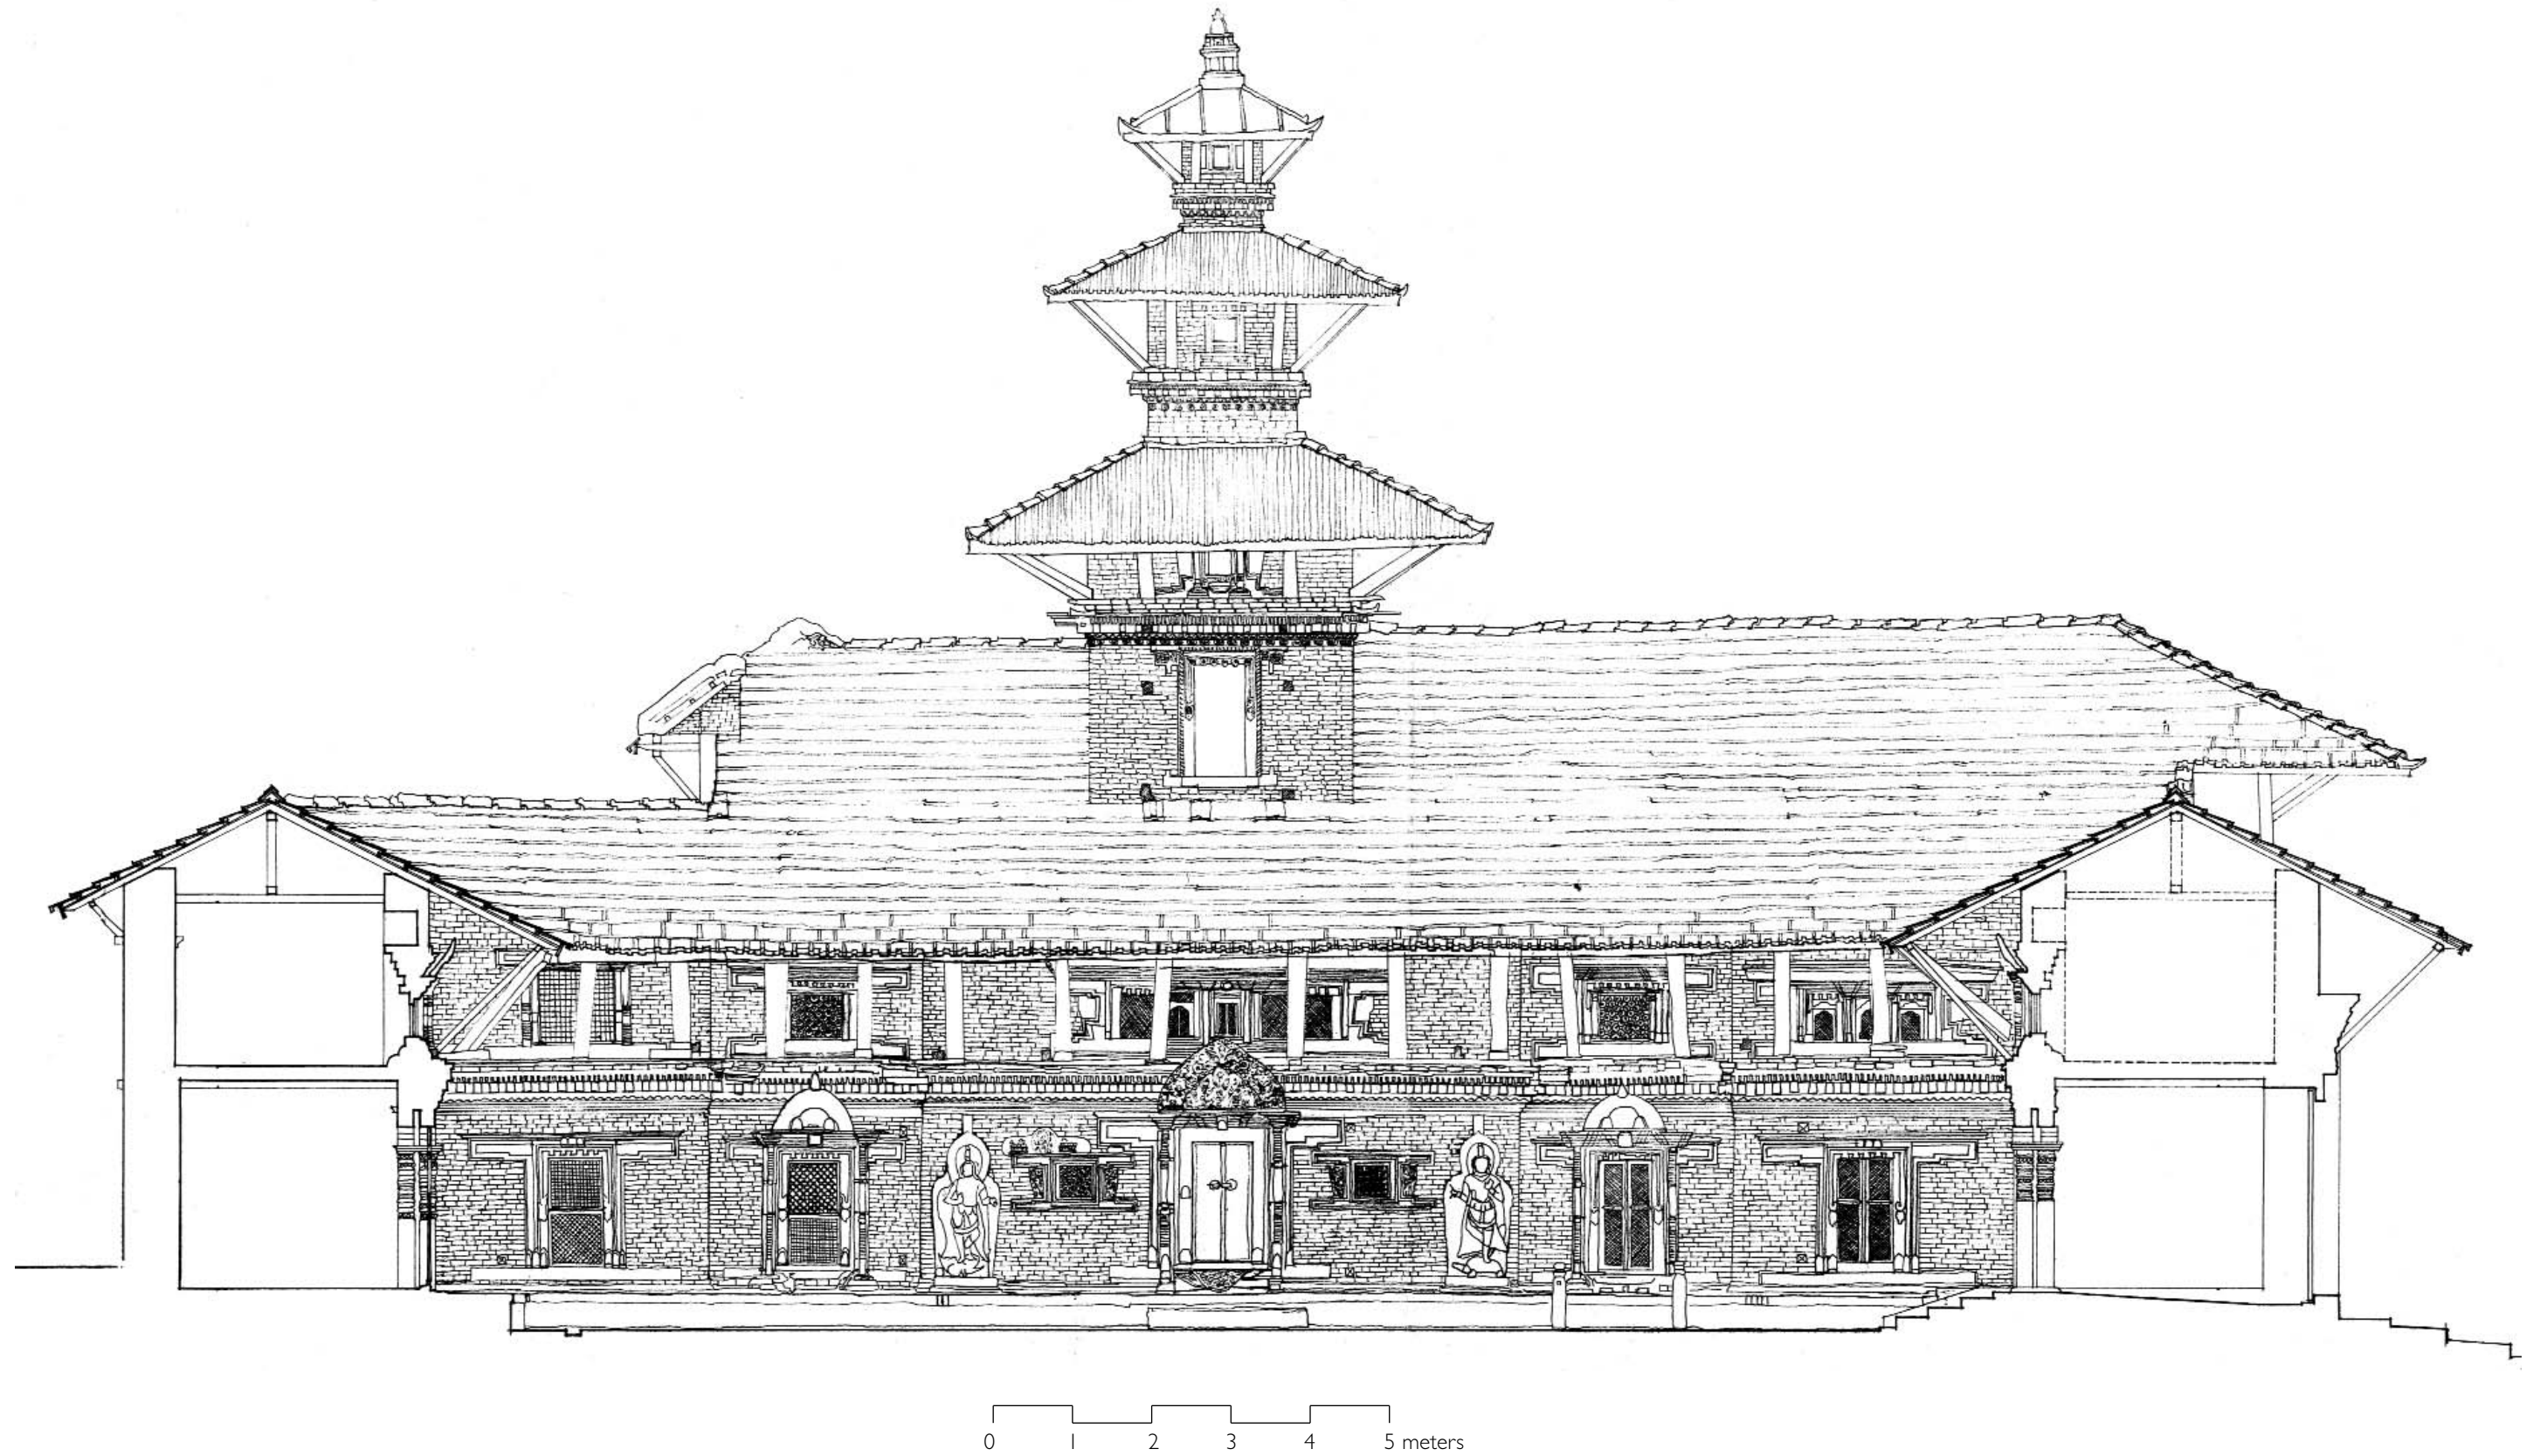
Mul Cok - courtyard facade looking south
Existing conditions
Survey by the Nippon Institute of Technology,
December, 1977

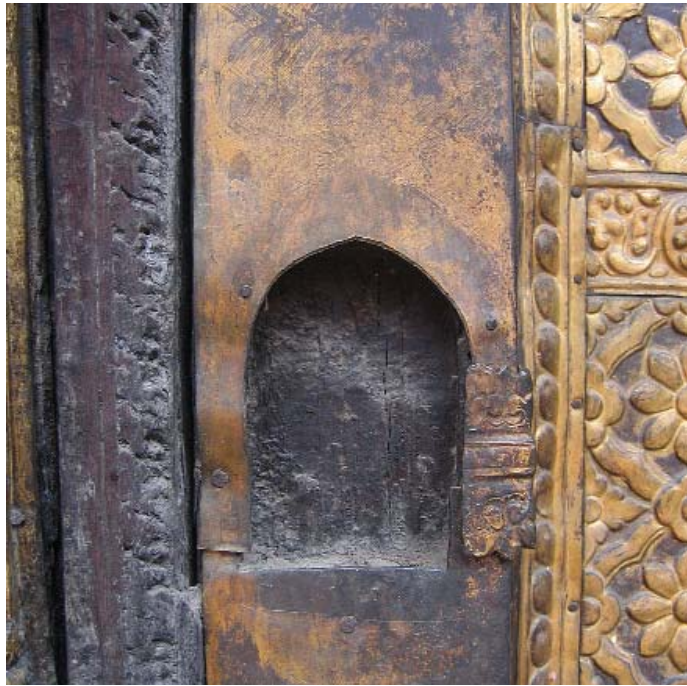
Small niche in the left door jamb

The deity that was once housed in this niche cannot be clearly identified in the historic photo on the right.

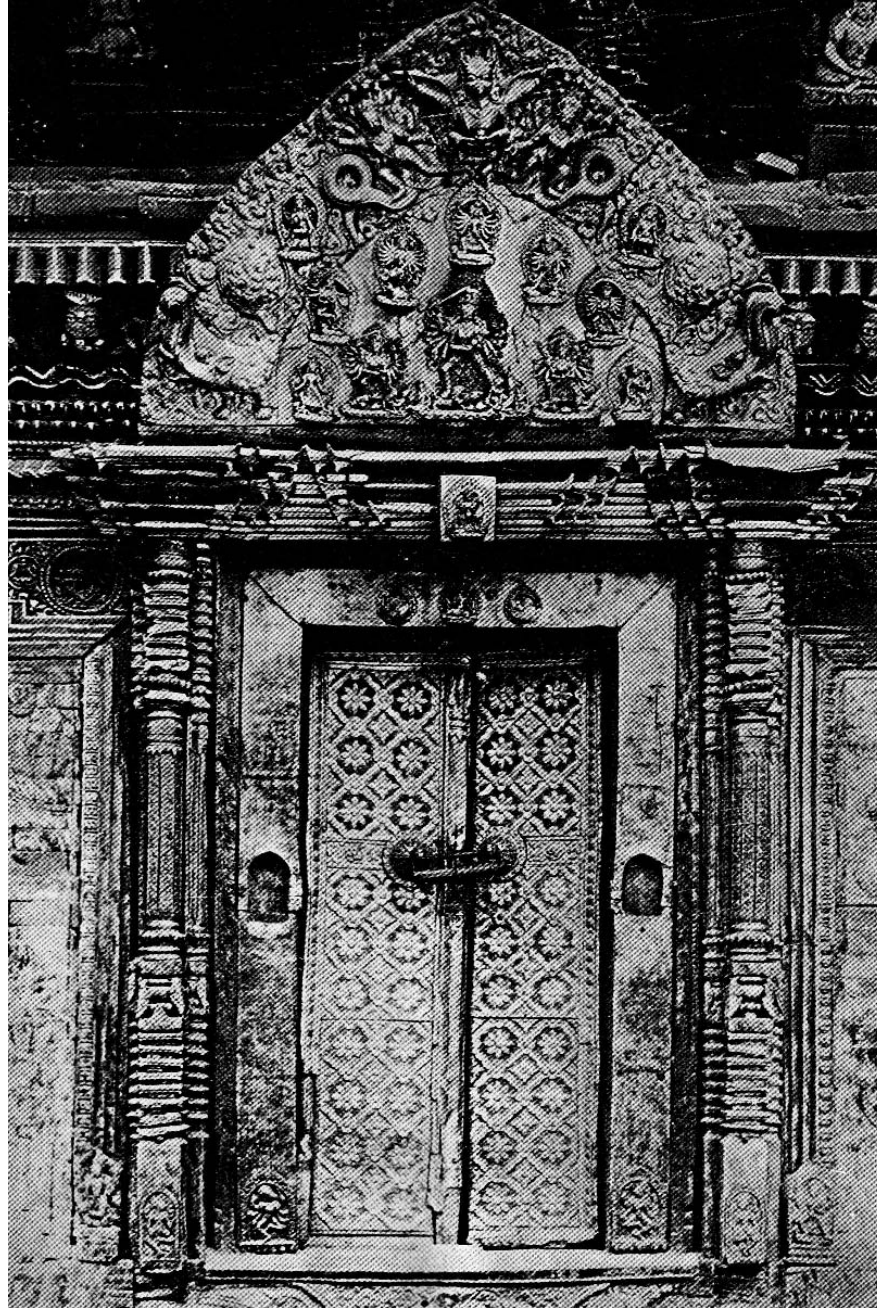
Entrance to the Taleju Shrine in 1962

Although the photograph is not very clear it appears that the sculptures and door details were intact.

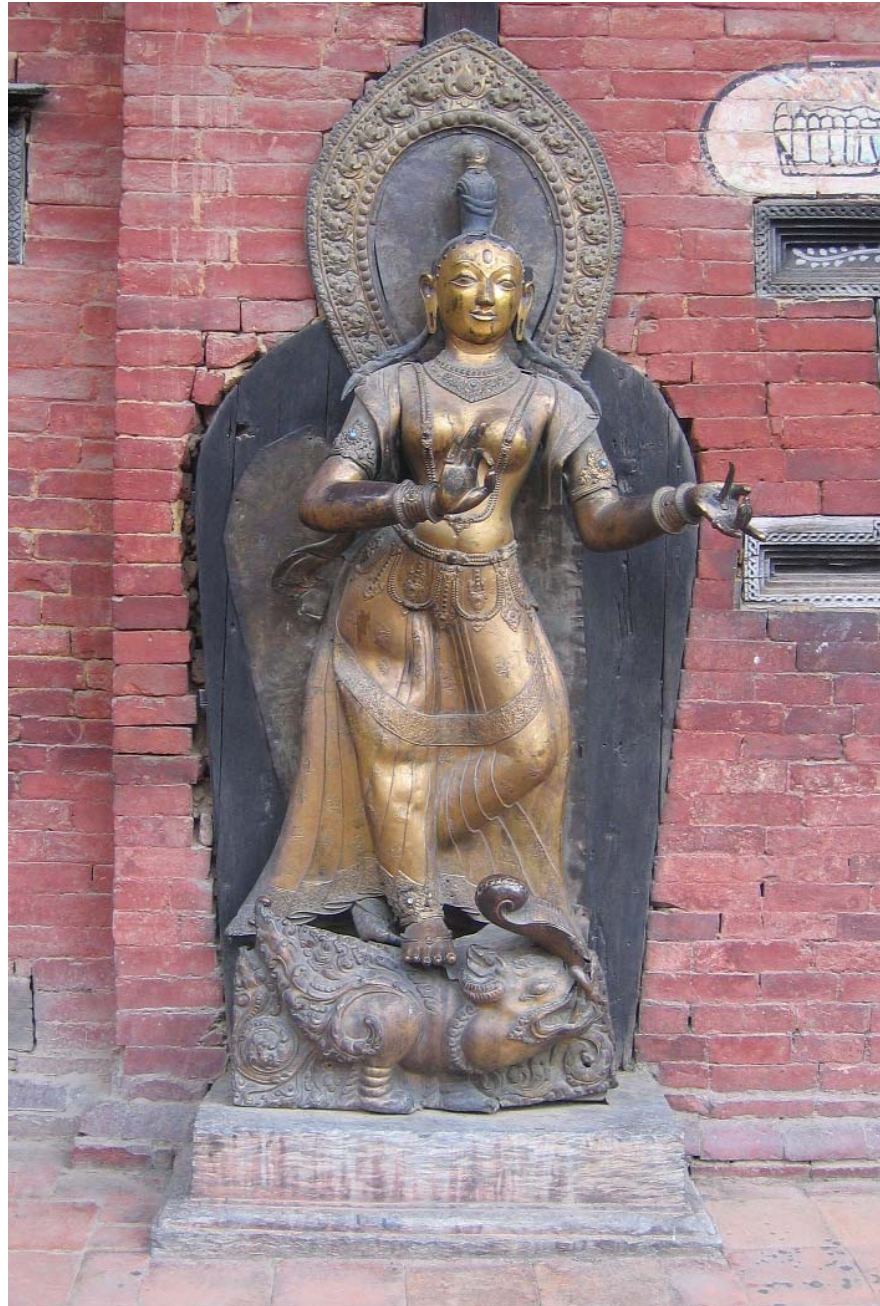
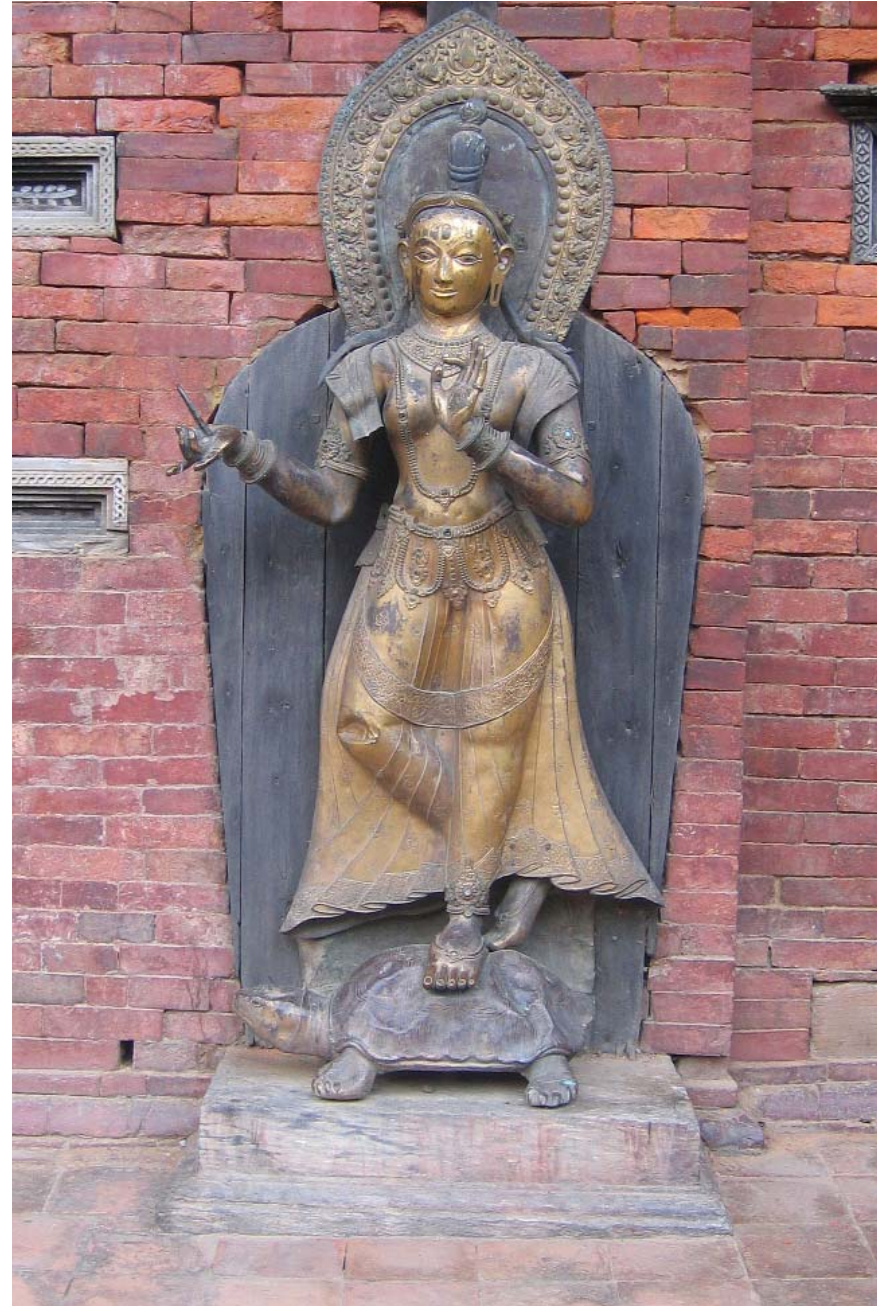
Ganga (on a makara) and Yamuna (on a tortoise) guarding the entrance to Taleju Shrine
 The river goddesses in anthropomorphic form were produced in gilded copper repoussée in the second half of the 17th century. Both images are damaged in many places and will require repair.
Photograph, May, 2006

Metal conservation and restoration measures for the gilt repoussé figures of Ganga and Yamuna and the vandalized tympanum need to be studied with the aim to develop strategies for the repair of damage and the possible replacement of missing elements.

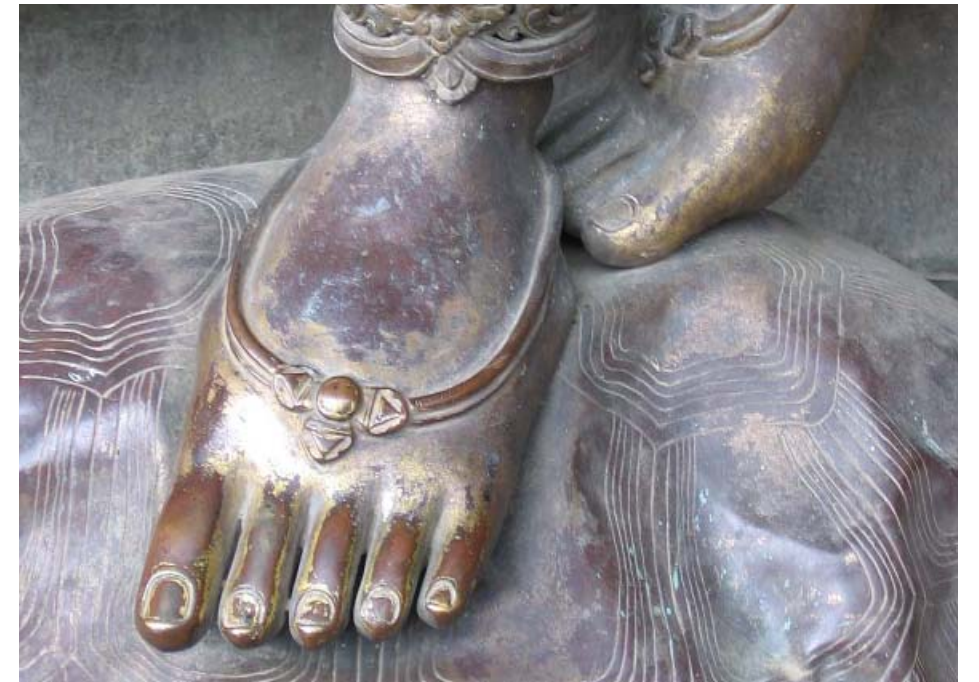
The feet of Yamuna on the tortoise
 The tortoise has been dented and most of the gilding has been lost.
Photograph, May, 2006

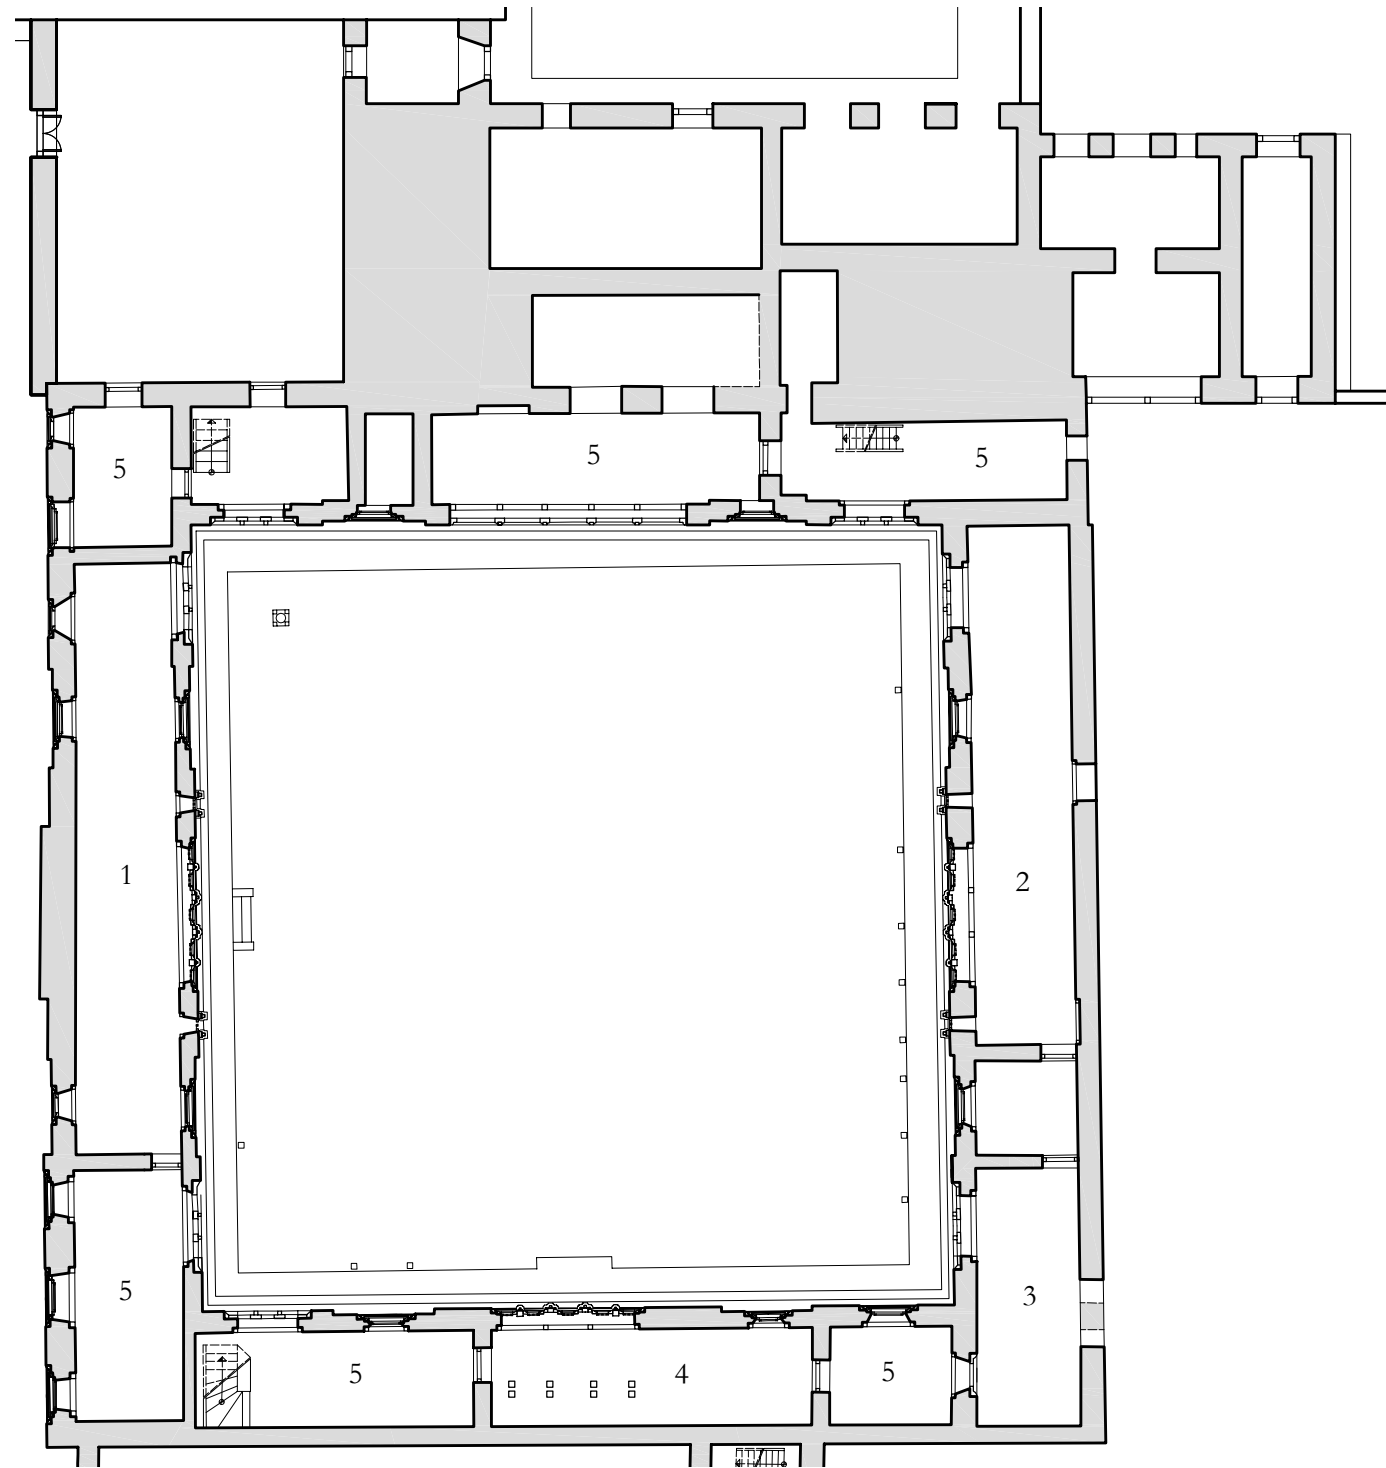
Mul Cok - First floor plan

Existing conditions

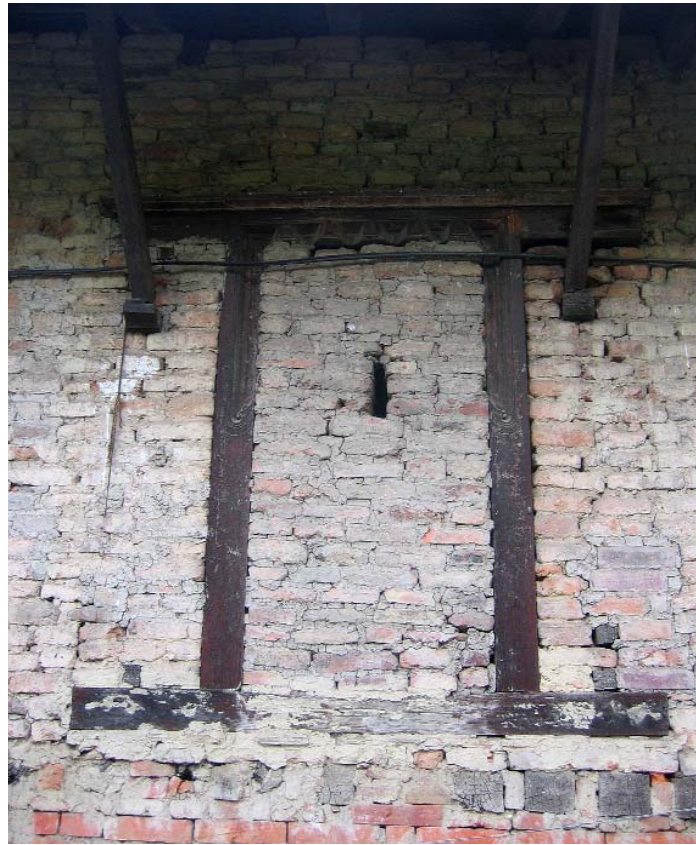
far left:
Door frame on first floor, East wing, garden facade
 This bricked up door might indicate that there was once a balcony or open arcade built against the East wing.

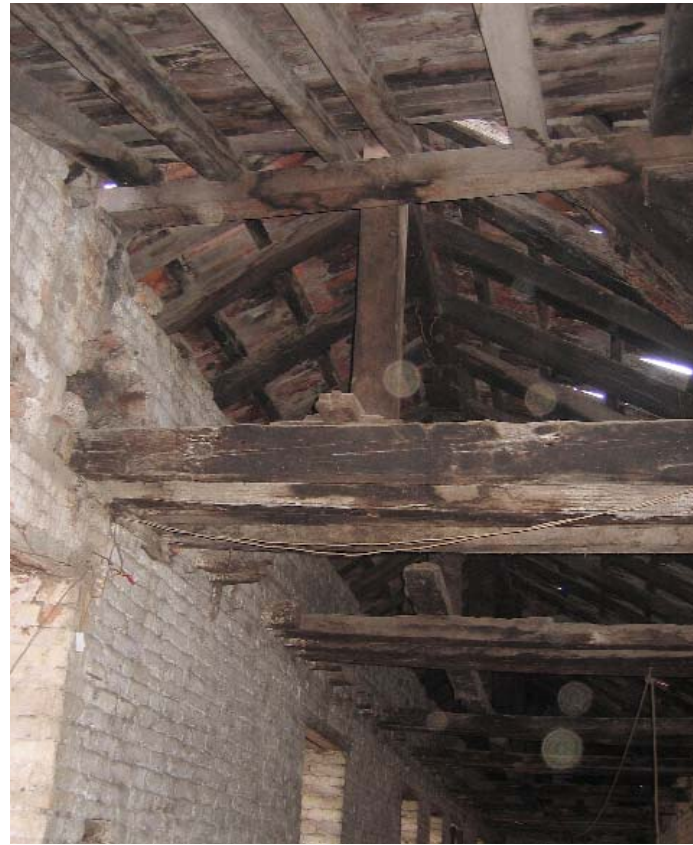
center left:
East wing roof framing
 The make-shift roof was built of salvaged timbers of different size and quality. Rafter spacing is much wider than historical examples, many joists have failed, and leaks occur just about everywhere.
Photograph, May, 2006

Any conservation program must include the complete rebuilding of the roof structure and cover. As in Sundari Cok the mission is of the opinion that a restored roof should include historically accurate rafter spacing and a traditional mud bed and correct historical tile roof cover. While the south “kitchen wing” of Nasal Cok appears to be in relatively stable condition its roof structure and cover need to be studied to determine whether there too reconstruction is required.

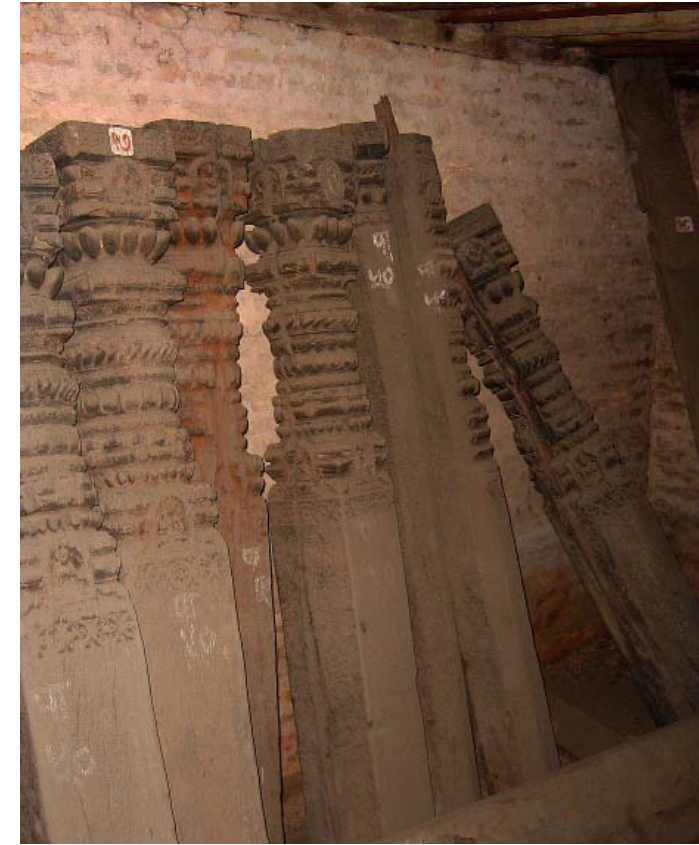
left:
North wing, storage room on the first floor
 17th century timber columns. These columns may have been salvaged from destroyed temples or lost palace structures during the 1934 earthquake. Research on their provenance and the creation of an inventory is recommended.
Photograph, May, 2006

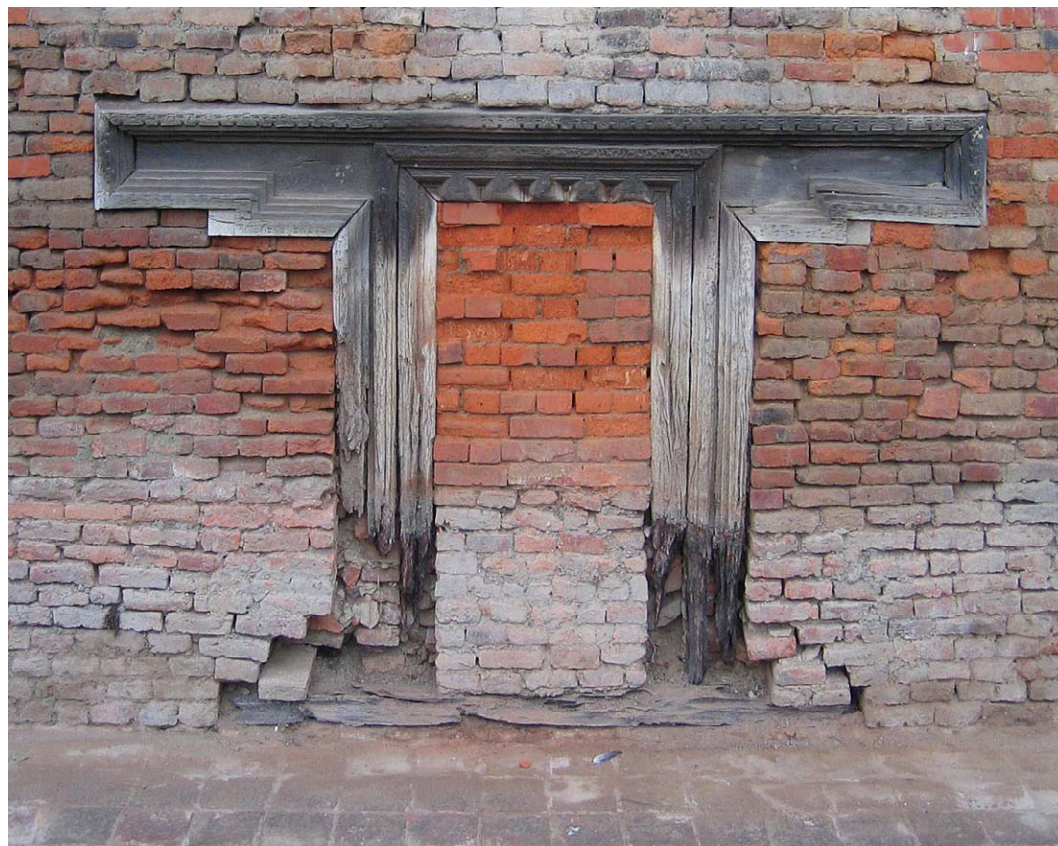
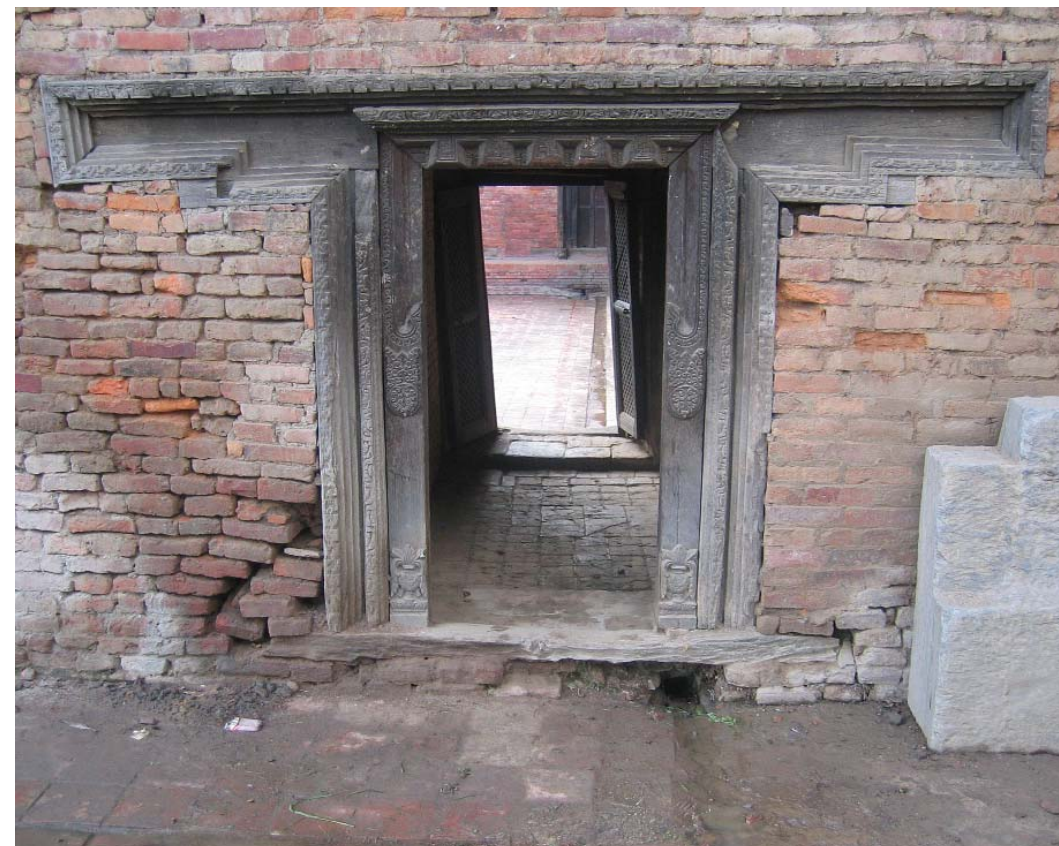
far left and left:
Two doors on the Garden facade
 Until recently, the back courtyard was covered with debris which caused irreversible damage to the doors.
 A large variety of bricks found in this wall suggests that this part of the building has been repaired in patches until very recently. Some historic *daci-apa* bricks can be found only in isolated locations. They are certainly not found *in situ* but were reused from demolished walls.
Photograph, May, 2006

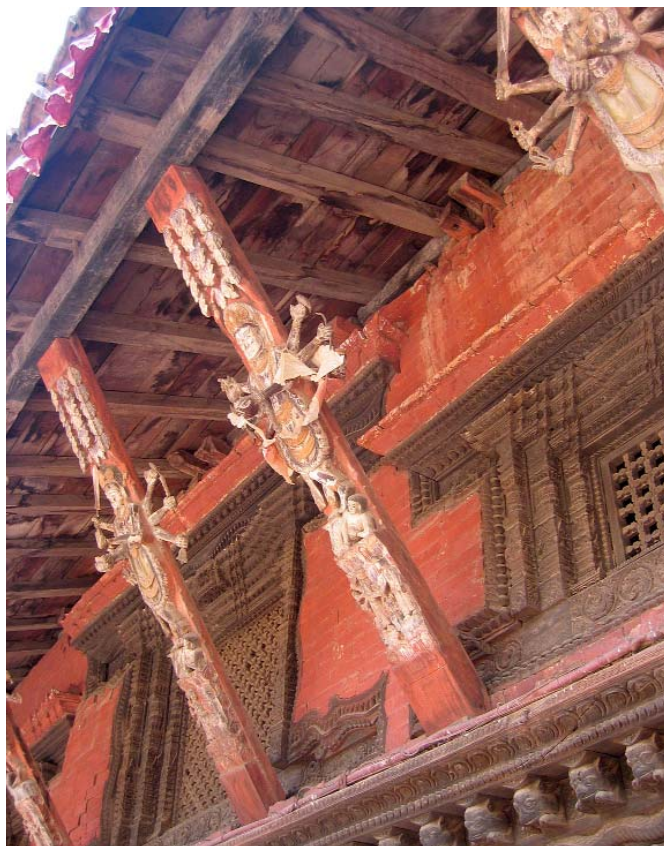
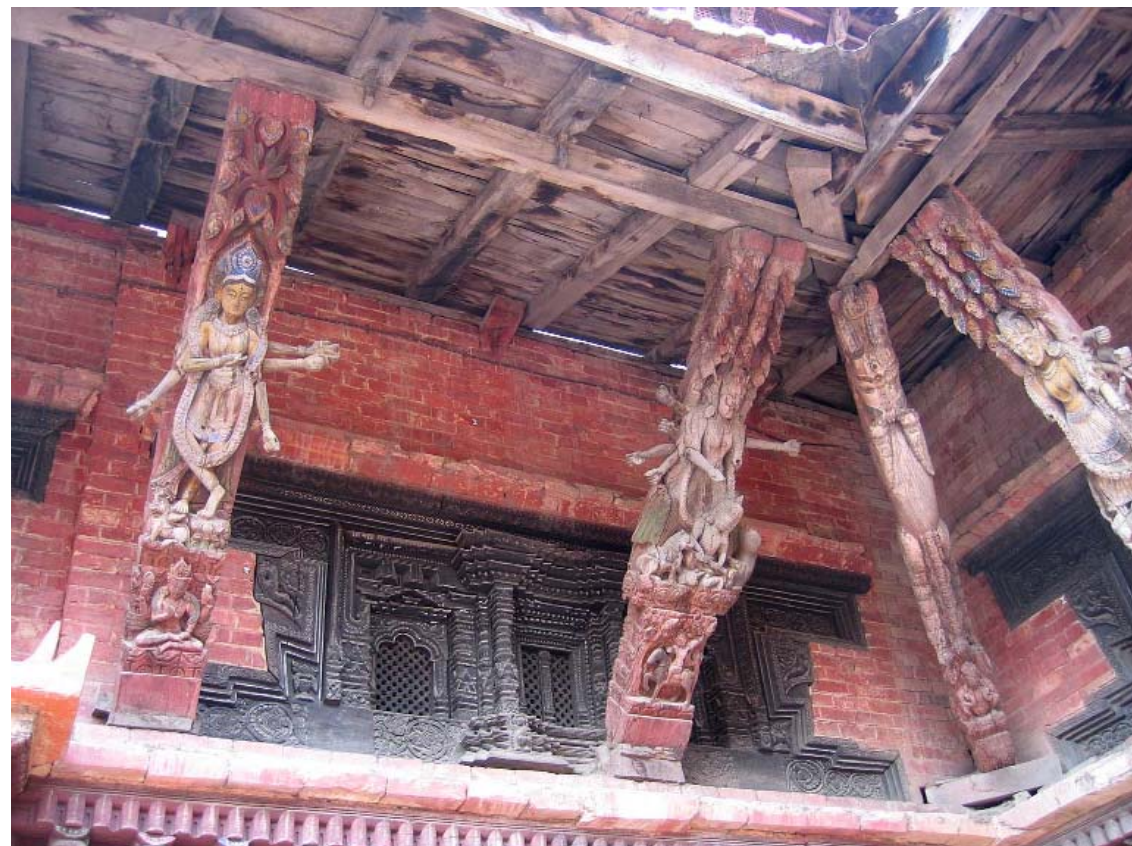
Struts on the principal facade

Although of excellent artistic quality most roof struts are in a bad state of repairs. Many arms and attributes are missing. The poorly reconstructed roof (dating from the 1980s) and altered roof pitch necessitated shimming of most struts. Roof leaks can be seen in many places and the structure appears to be unsound.

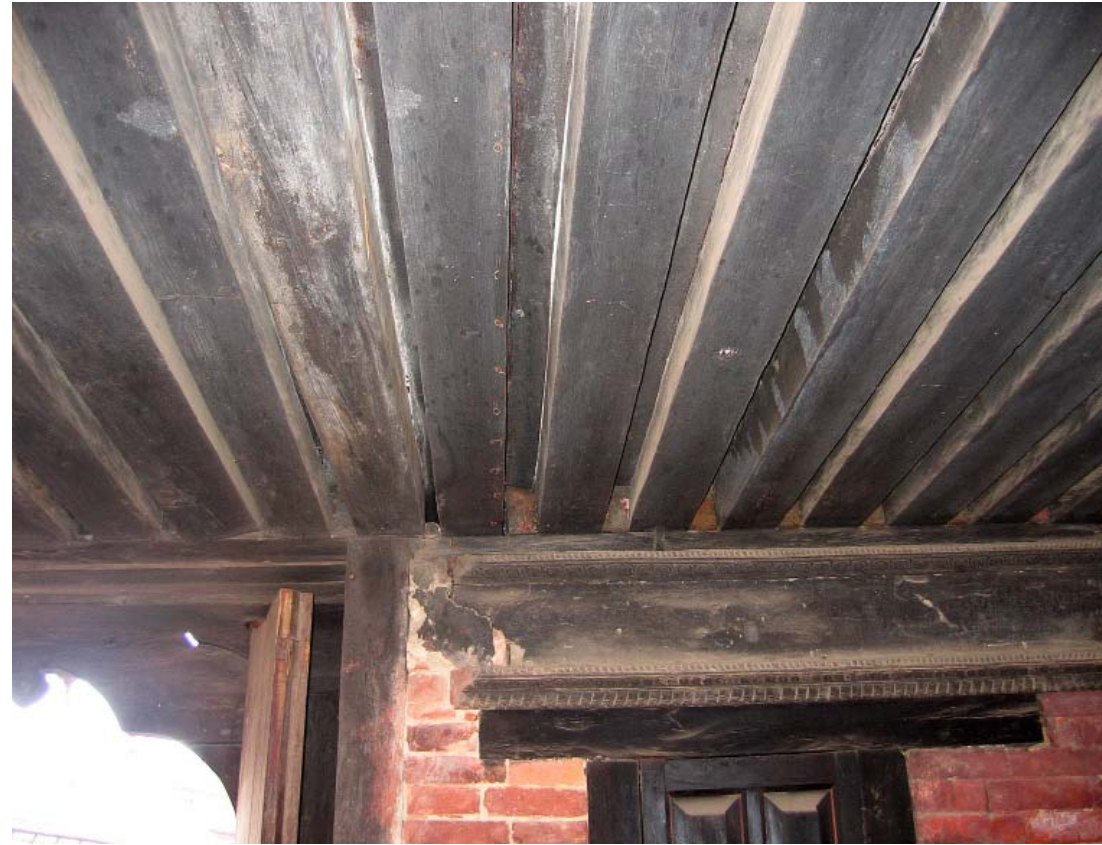
Ceiling joist, ground floor arcade

These 17th century joists confirm historically correct dimensions and spacing. It would appear that a now lost frieze existed between the brick and ceiling.

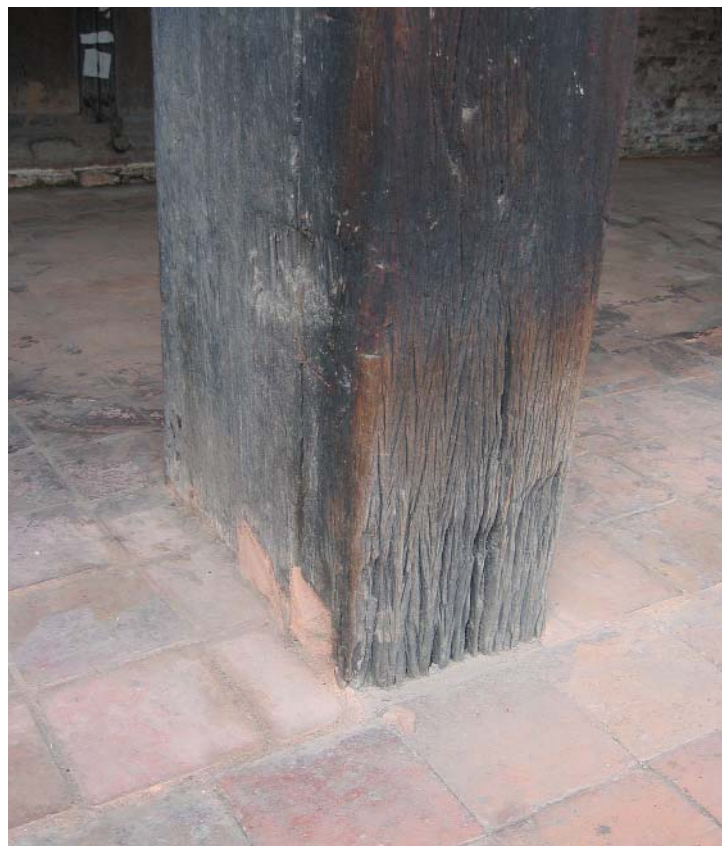
Column in north arcade

Some of the column base stones have been either lost or were covered up by recent repairs. The timber column shows signs of advanced decay and will require repair.

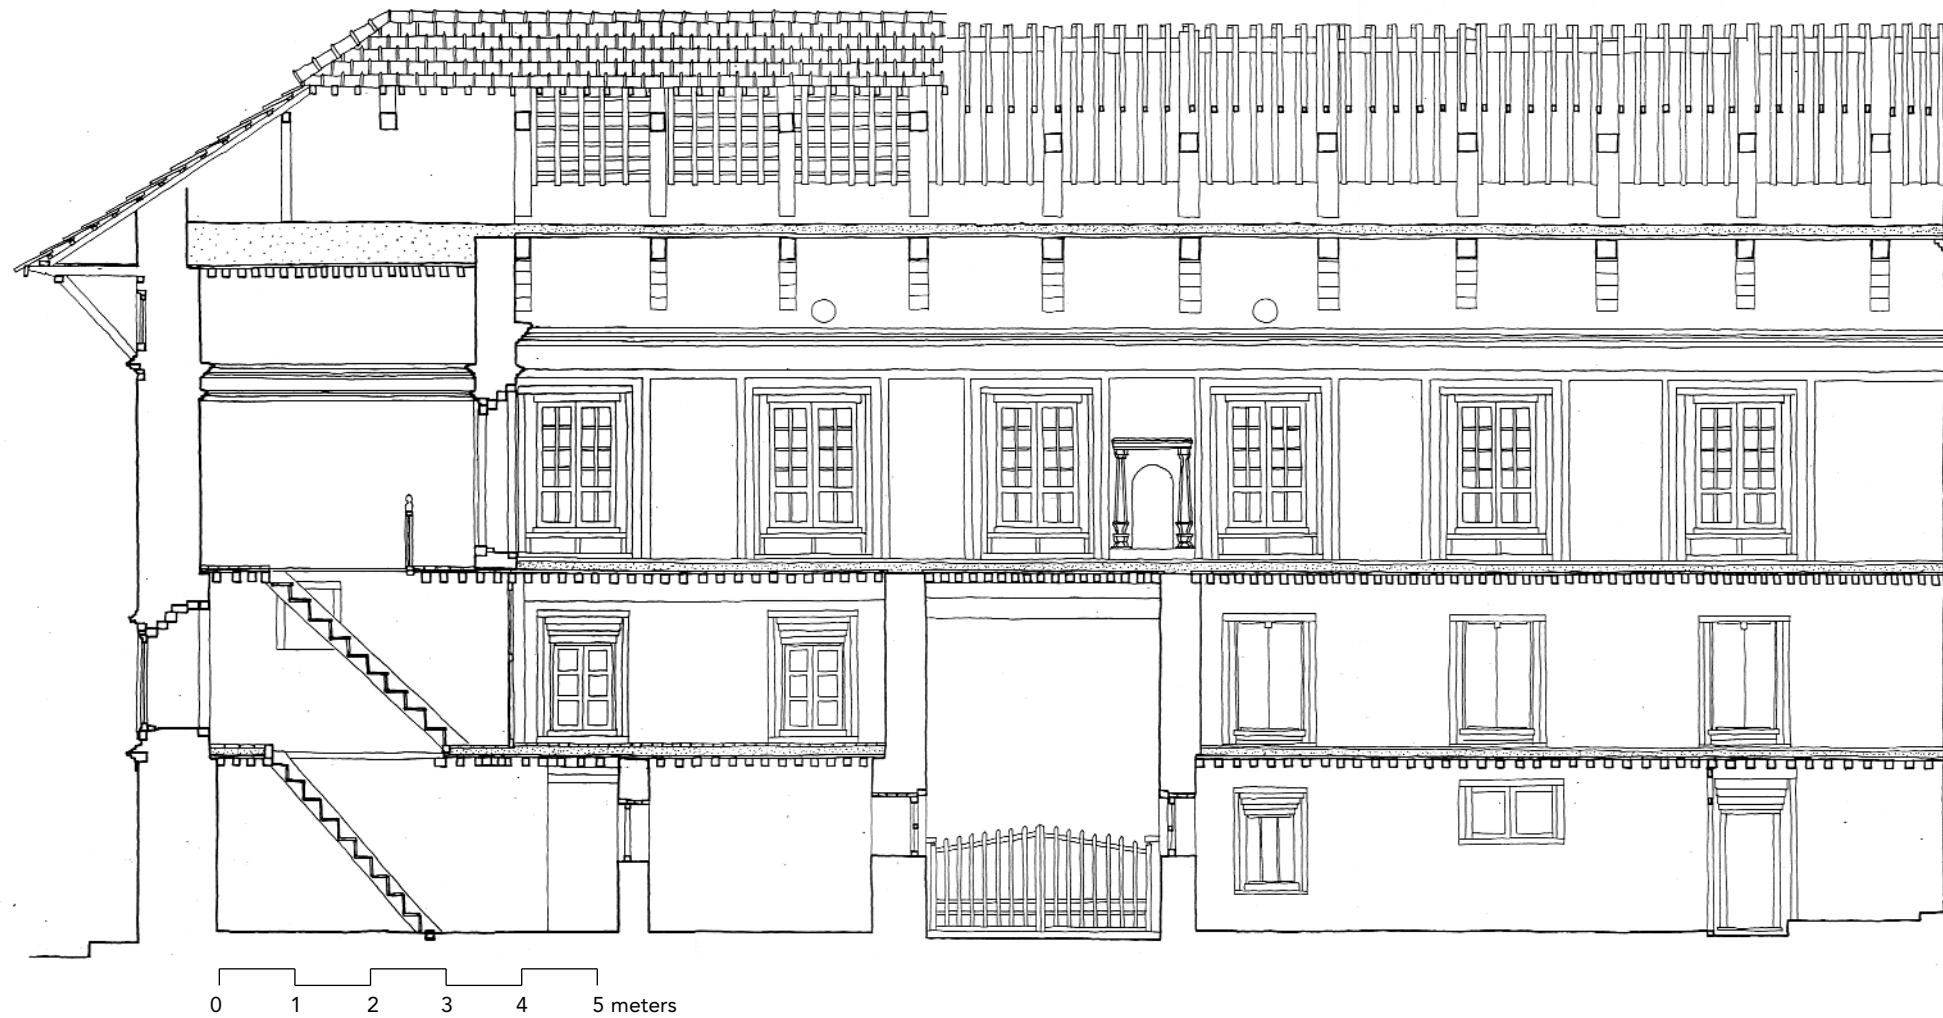
North Wing - longitudinal section looking east
 Existing conditions
 Survey by Gyanendra Joshi, December, 1993

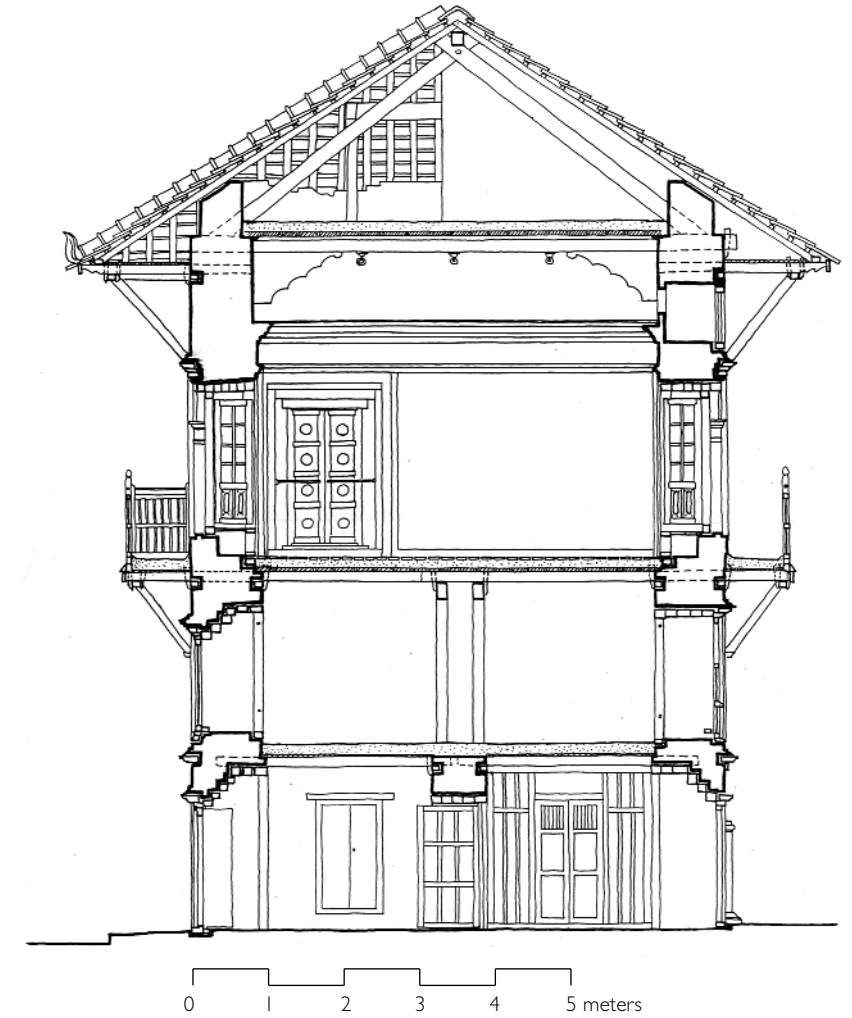
North Wing - section looking south
 Existing conditions
 Survey by Gyanendra Joshi, December, 1993

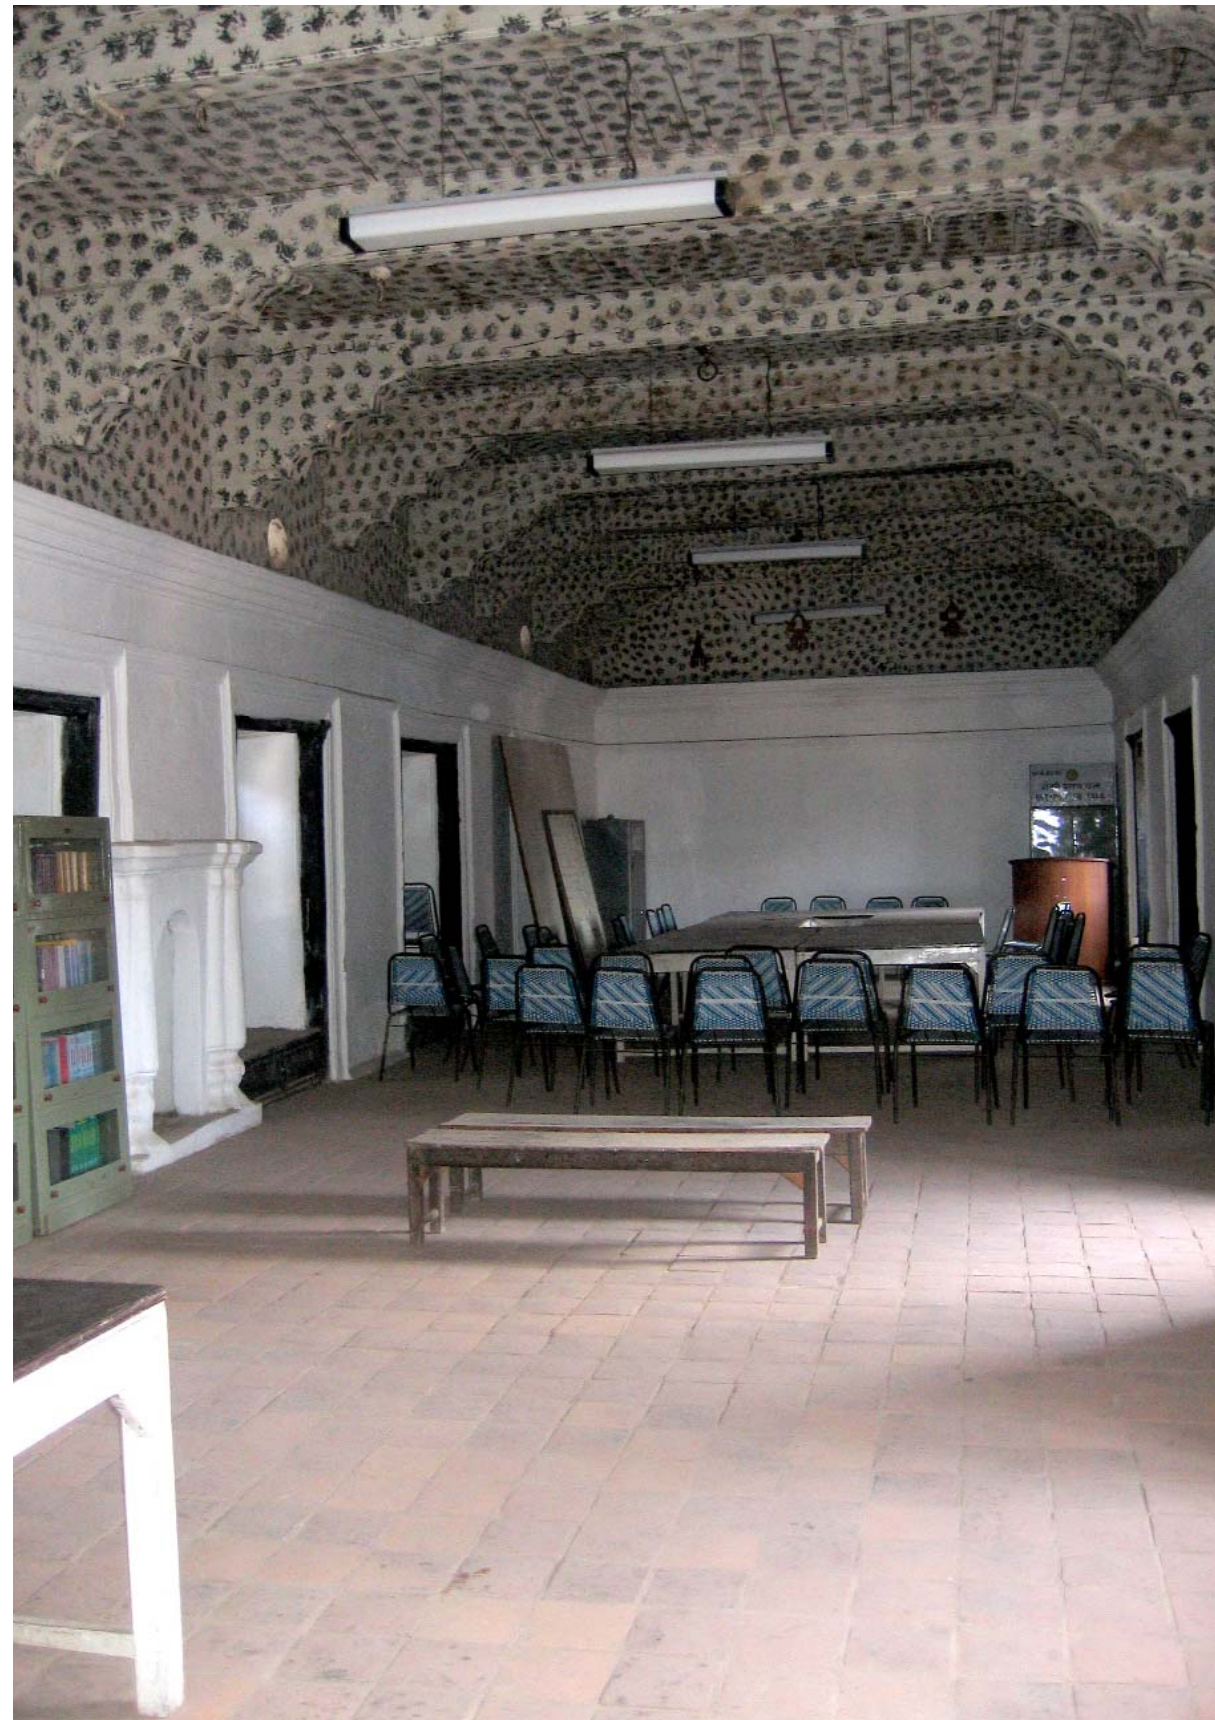
North Wing - main hall on the top floor
This is the first building in Nepal featuring a room of more than 5 meters in width. The roof incorporates heavy timber trusses.
Photograph, May, 2006
