THE PATAN ROYAL PALACE RESTORATION AND CONSERVATION PROJECT

JOINT MISSION REPORT

DECEMBER, 2006

JOINT MISSION (MAY 1-6, 2006)

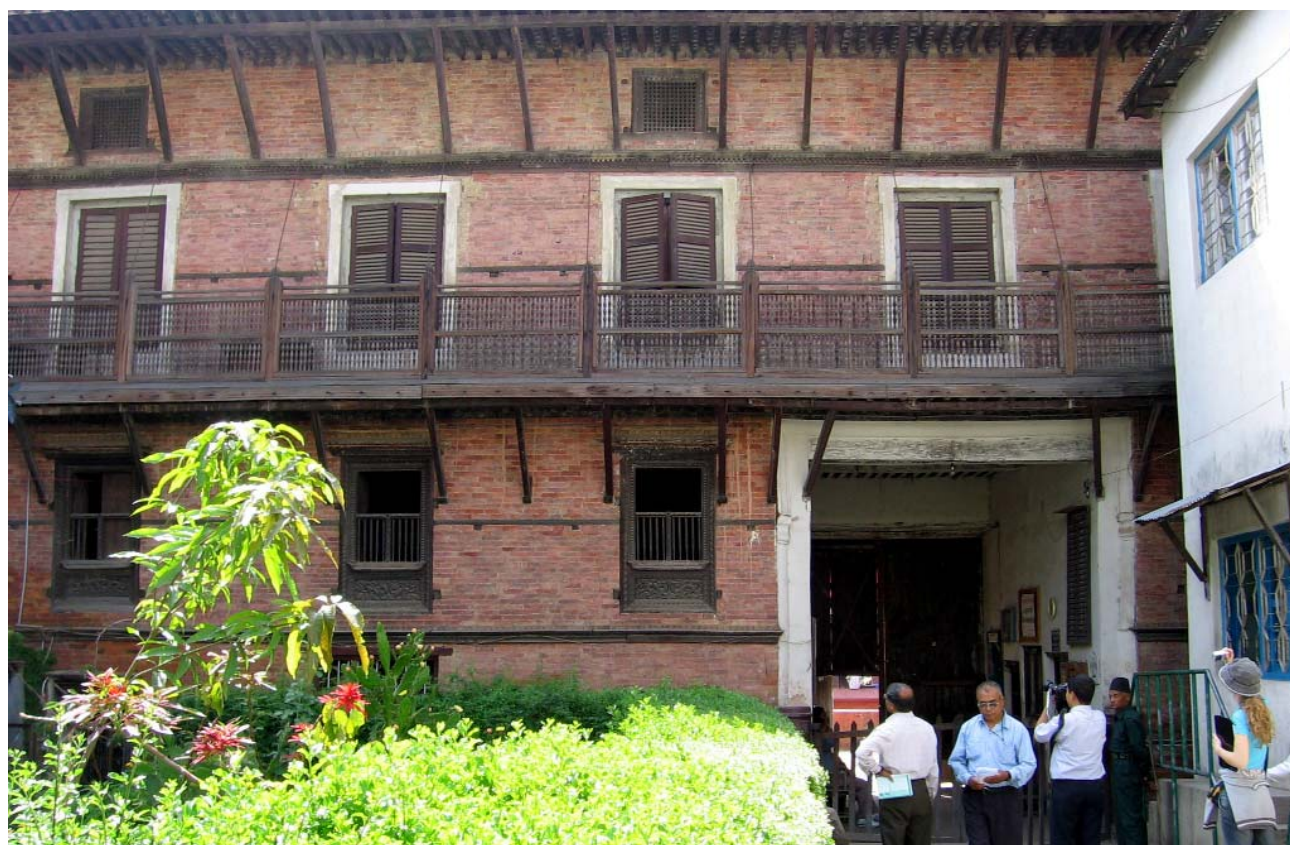
North wing - east facade
 This part of the building retains most of its original form. Repairs of doors, windows, balcony, and roof were carried out with the support of the German funded Urban Development through Local Efforts Programme in 1995.
Photograph, May, 2006

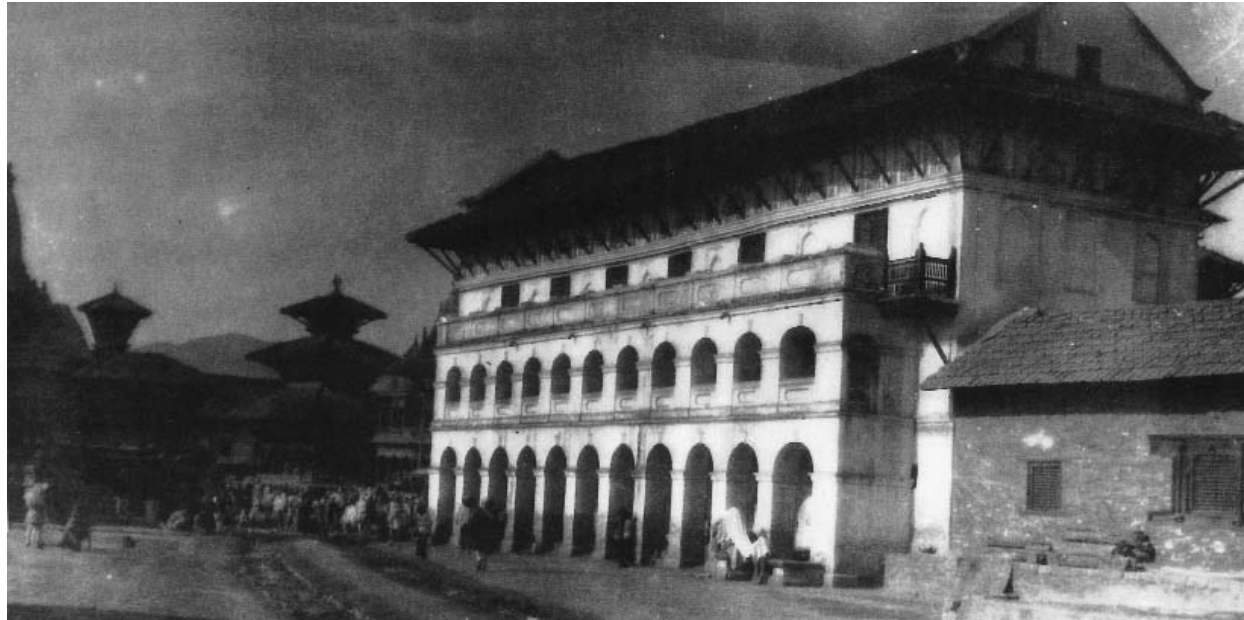
Early 20th century photograph of the Court Building

This photograph documents the original three story form. The masonry arcade was later added to the structure leaving only a small portion of the original balcony.

The absence of the original upper story of the Court Building greatly diminishes its urbanistic and formal function of marking the edge of the Palace Complex. The mission recommends the reconstruction of the original upper story and traditional tile roof cover. Similar early 19th century structures at the Hanuman Dhoka Palace in Kathmandu together with historic photographs need to be studied to develop appropriate details for reconstruction.

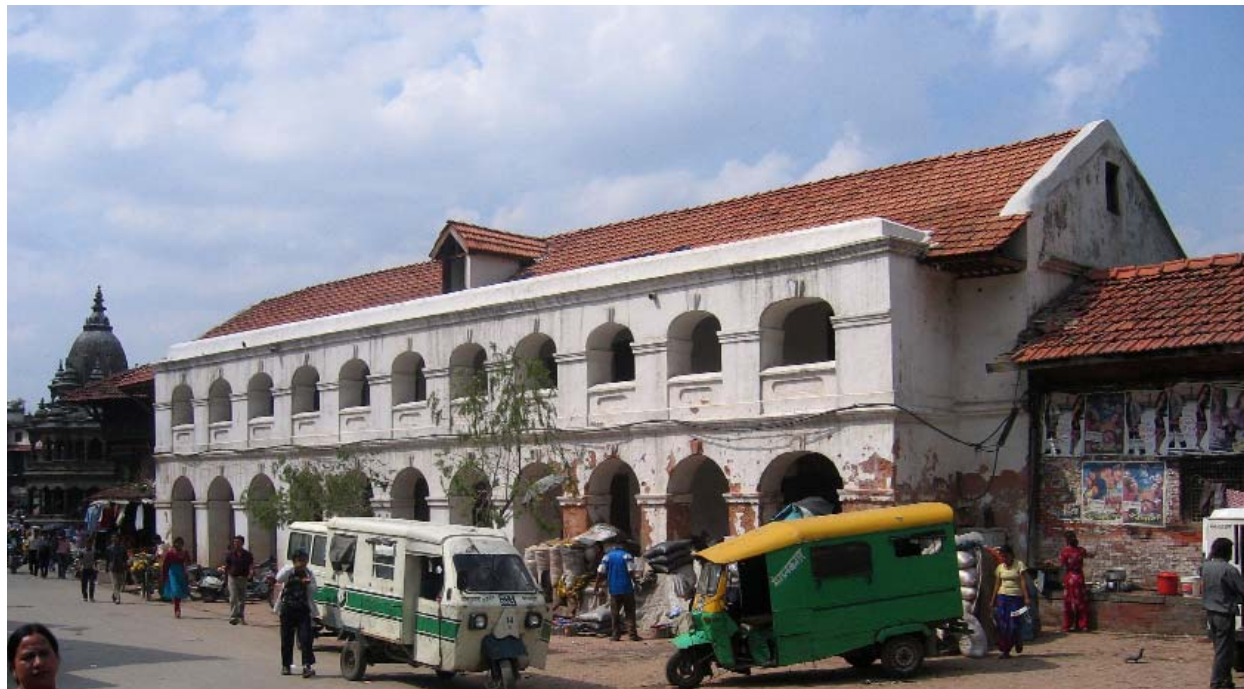
Court Building, view from South

The Court Building as it appears today with the recent roof repair completed by the Department of Archaeology. Hawkers occupy the lower level of the arcade.

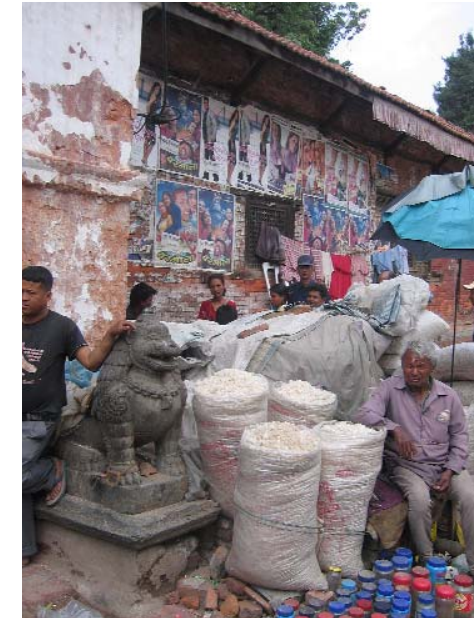
Salt traders at the entrance to the Court Building
The presence of salt has caused extensive damage to the traditional lime-brick plaster finishes.

The destructive presence of salt sellers at the front arcade should be permanently prohibited in order to prevent further damage to historic lime finishes. The sole remaining example of sgraffito ornament needs to be conserved and restored. This and other examples of the technique should be studied for the recreation of such ornament on a reconstructed upper story.

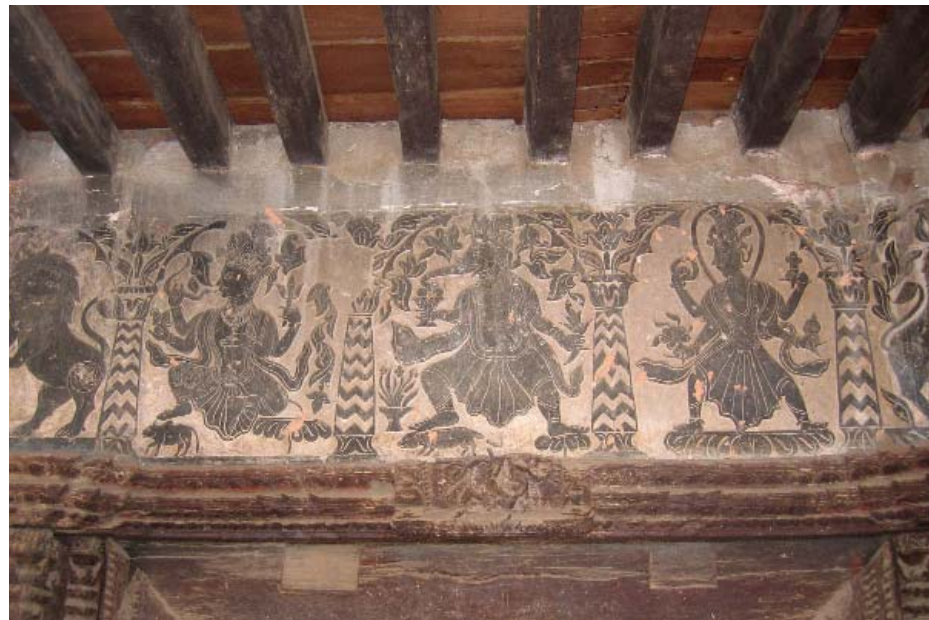
Sgraffito frieze above the main entry to the Court Building
A rare surviving example of sgraffito offers the opportunity to develop conservation and restoration methods for this decorative technique employed on early 19th century buildings.

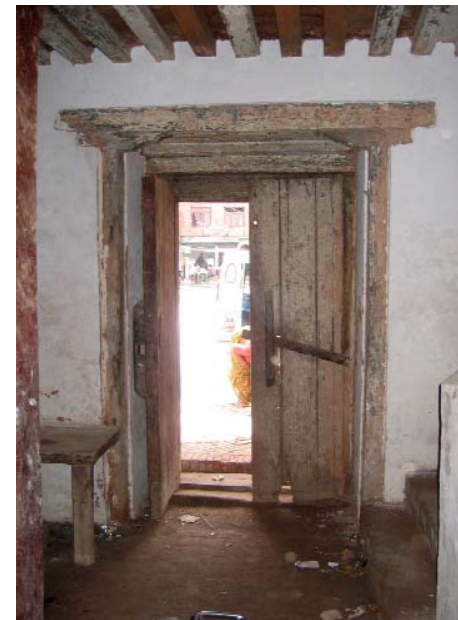
Interior view of the main entry
The large scale of this doorway was a departure from the diminutive scale favored by traditional Newar builders. Note that the outside grade is higher than the threshold of the door.

The problem of a higher grade at the north and south of the building will need to be addressed to halt further water infiltration.

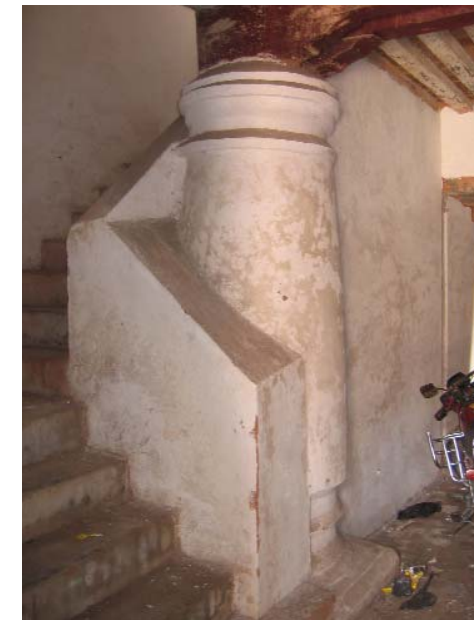
The main stair of the Court Building
This unique pier marks the grand ascent to the upper floors. The original tile treads and risers were recently covered with Portland cement plaster.

A recent Portland cement finish to the original masonry stair should be removed and the original tile should be restored and/or replaced with appropriate replacement tiles.

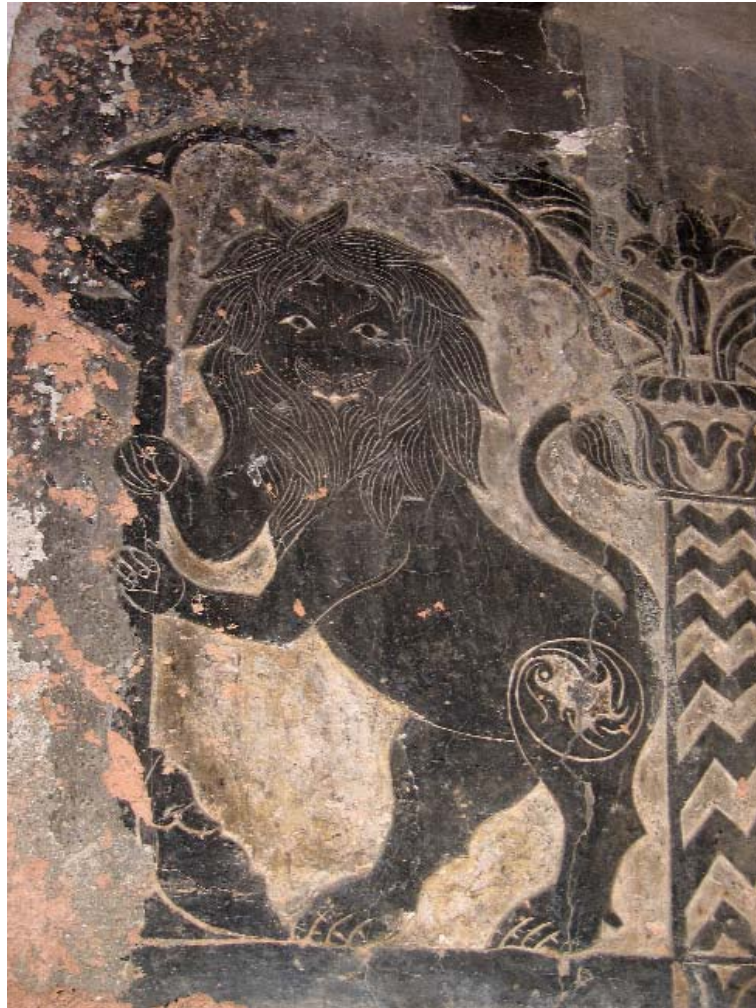
Detail of the fine sgraffito frieze above the main entry of the Court Building

Cracking and flaking of the plaster should be checked as soon as possible. Expert advice will be required to stabilize the frieze's condition.

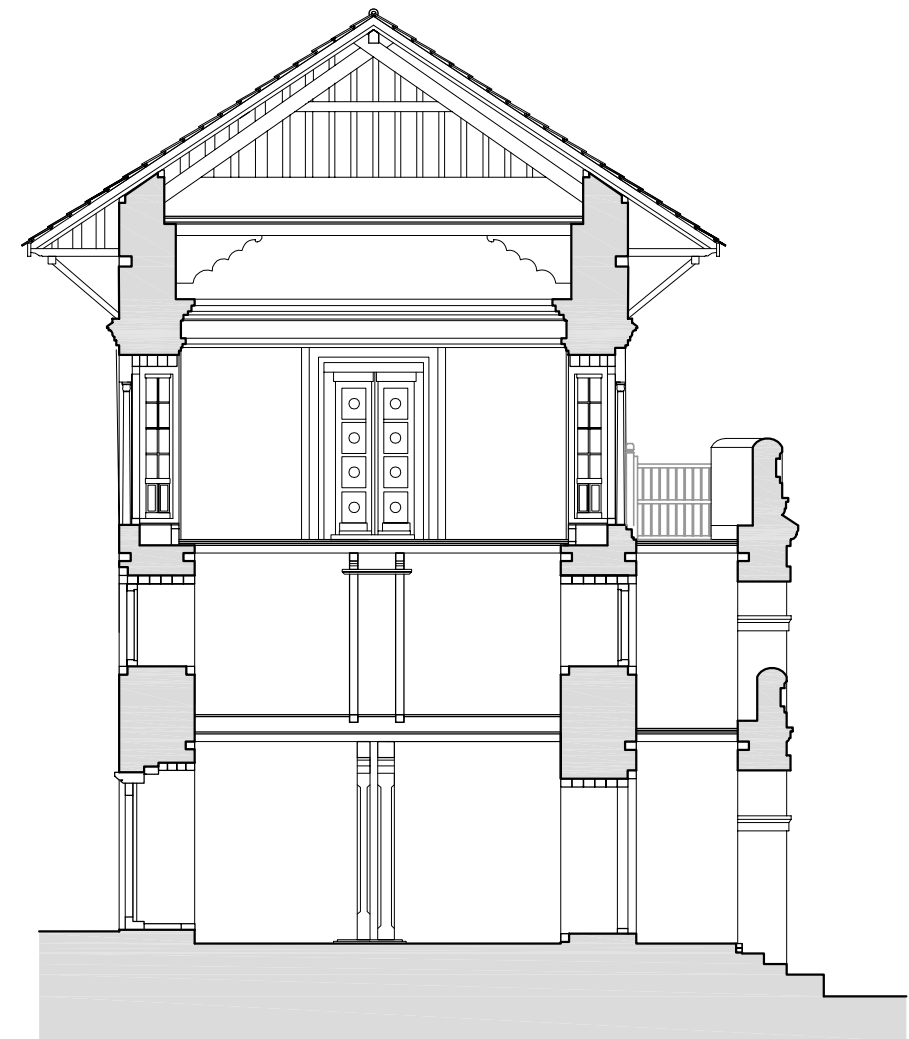
Court Building, south elevation, proposed reconstruction

The reconstruction scheme includes the rebuilding of the lost upper story and balcony.

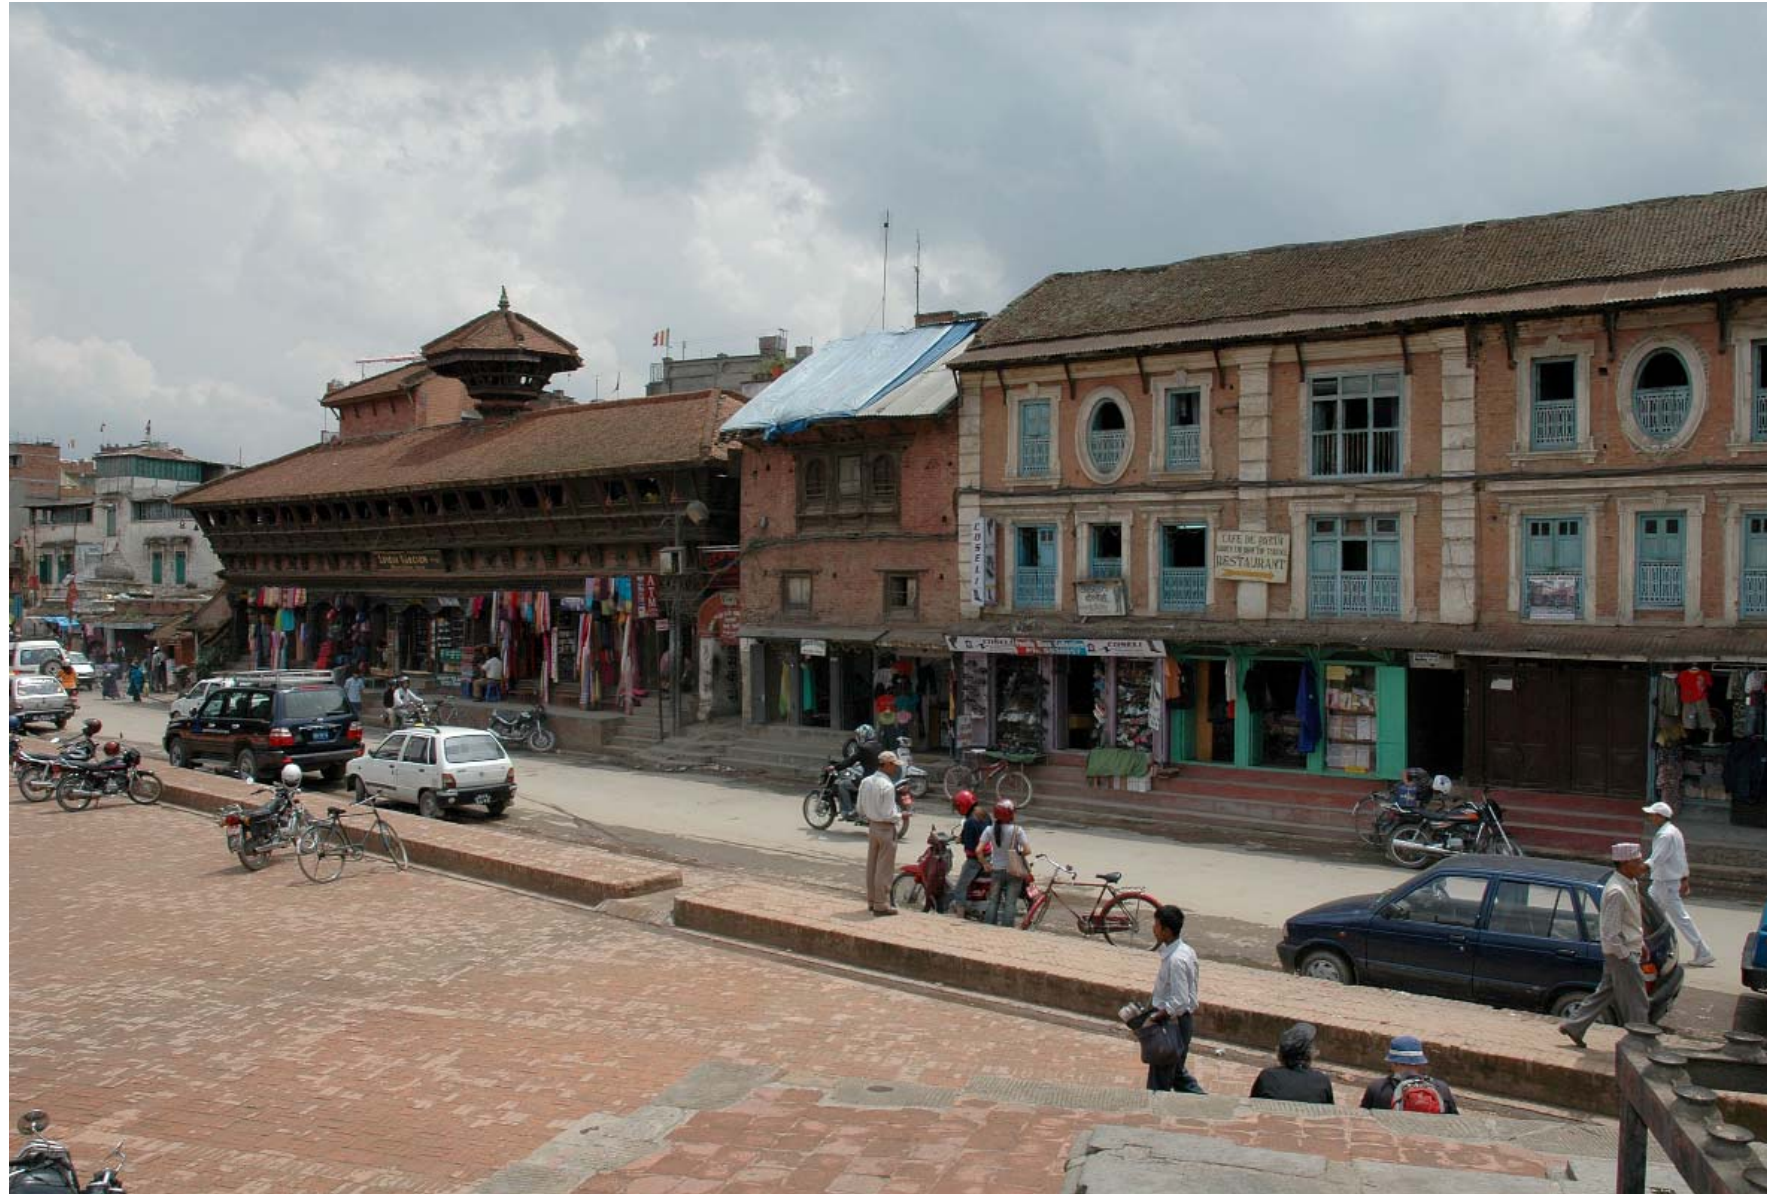
Small residential house facing the South side of Patan Darbar
The ensemble with Lam Pati on the left and post-earthquake residential buildings on the right form the southern edge of the square. Restoration of the traditional roof cover would likely decrease the risk of their loss.
Photograph, May, 2006

Another project addresses the issue of the numerous private buildings that create the southern edge of the square and whose loss or modification would detract from the historical and artistic environment of the World Heritage Site. It is clear that small scale assistance to such buildings, especially for the repair of the traditional tile roofs, would greatly decrease the risk of their loss or unsightly modification. The row of townhouses which define the southern edge of the square can be identified as a potential focus for roof repairs. Many of the buildings in this row retain their tiled roofs, although damaged areas, patches with corrugated metal, and temporary tarpaulin cover suggest that these roofs will not last much longer.

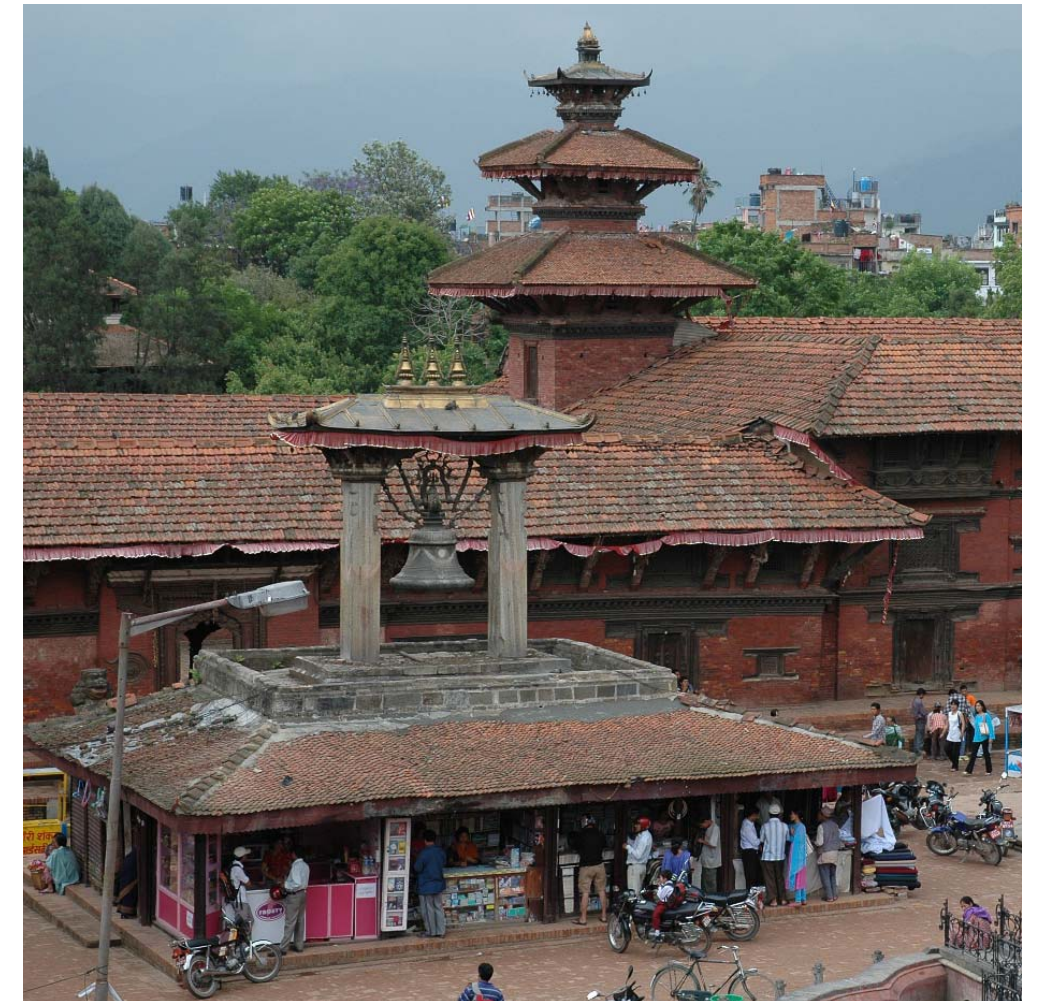
View of the Taleju Bell with Mul Cok, Sundari Cok and the Taleju Temple in the background

The shops around the bell, although located in a prime retail space, do not generate sufficient income for the guthi to properly maintain the structure.

One such project is the deteriorated roofing of the shops that surround the Taleju Bell facing Mul Cok. The bell and stone platform date to 1737 but it appears that the commercial space that surrounds the platform dates to the 19th century. Early 20th century photographs document the presence of an ambulatory and lime plaster balustrade above the shops. A study of the structure will determine the necessary repairs to the roof cover and explore the appropriateness of reconstructing the ambulatory and balustrade.

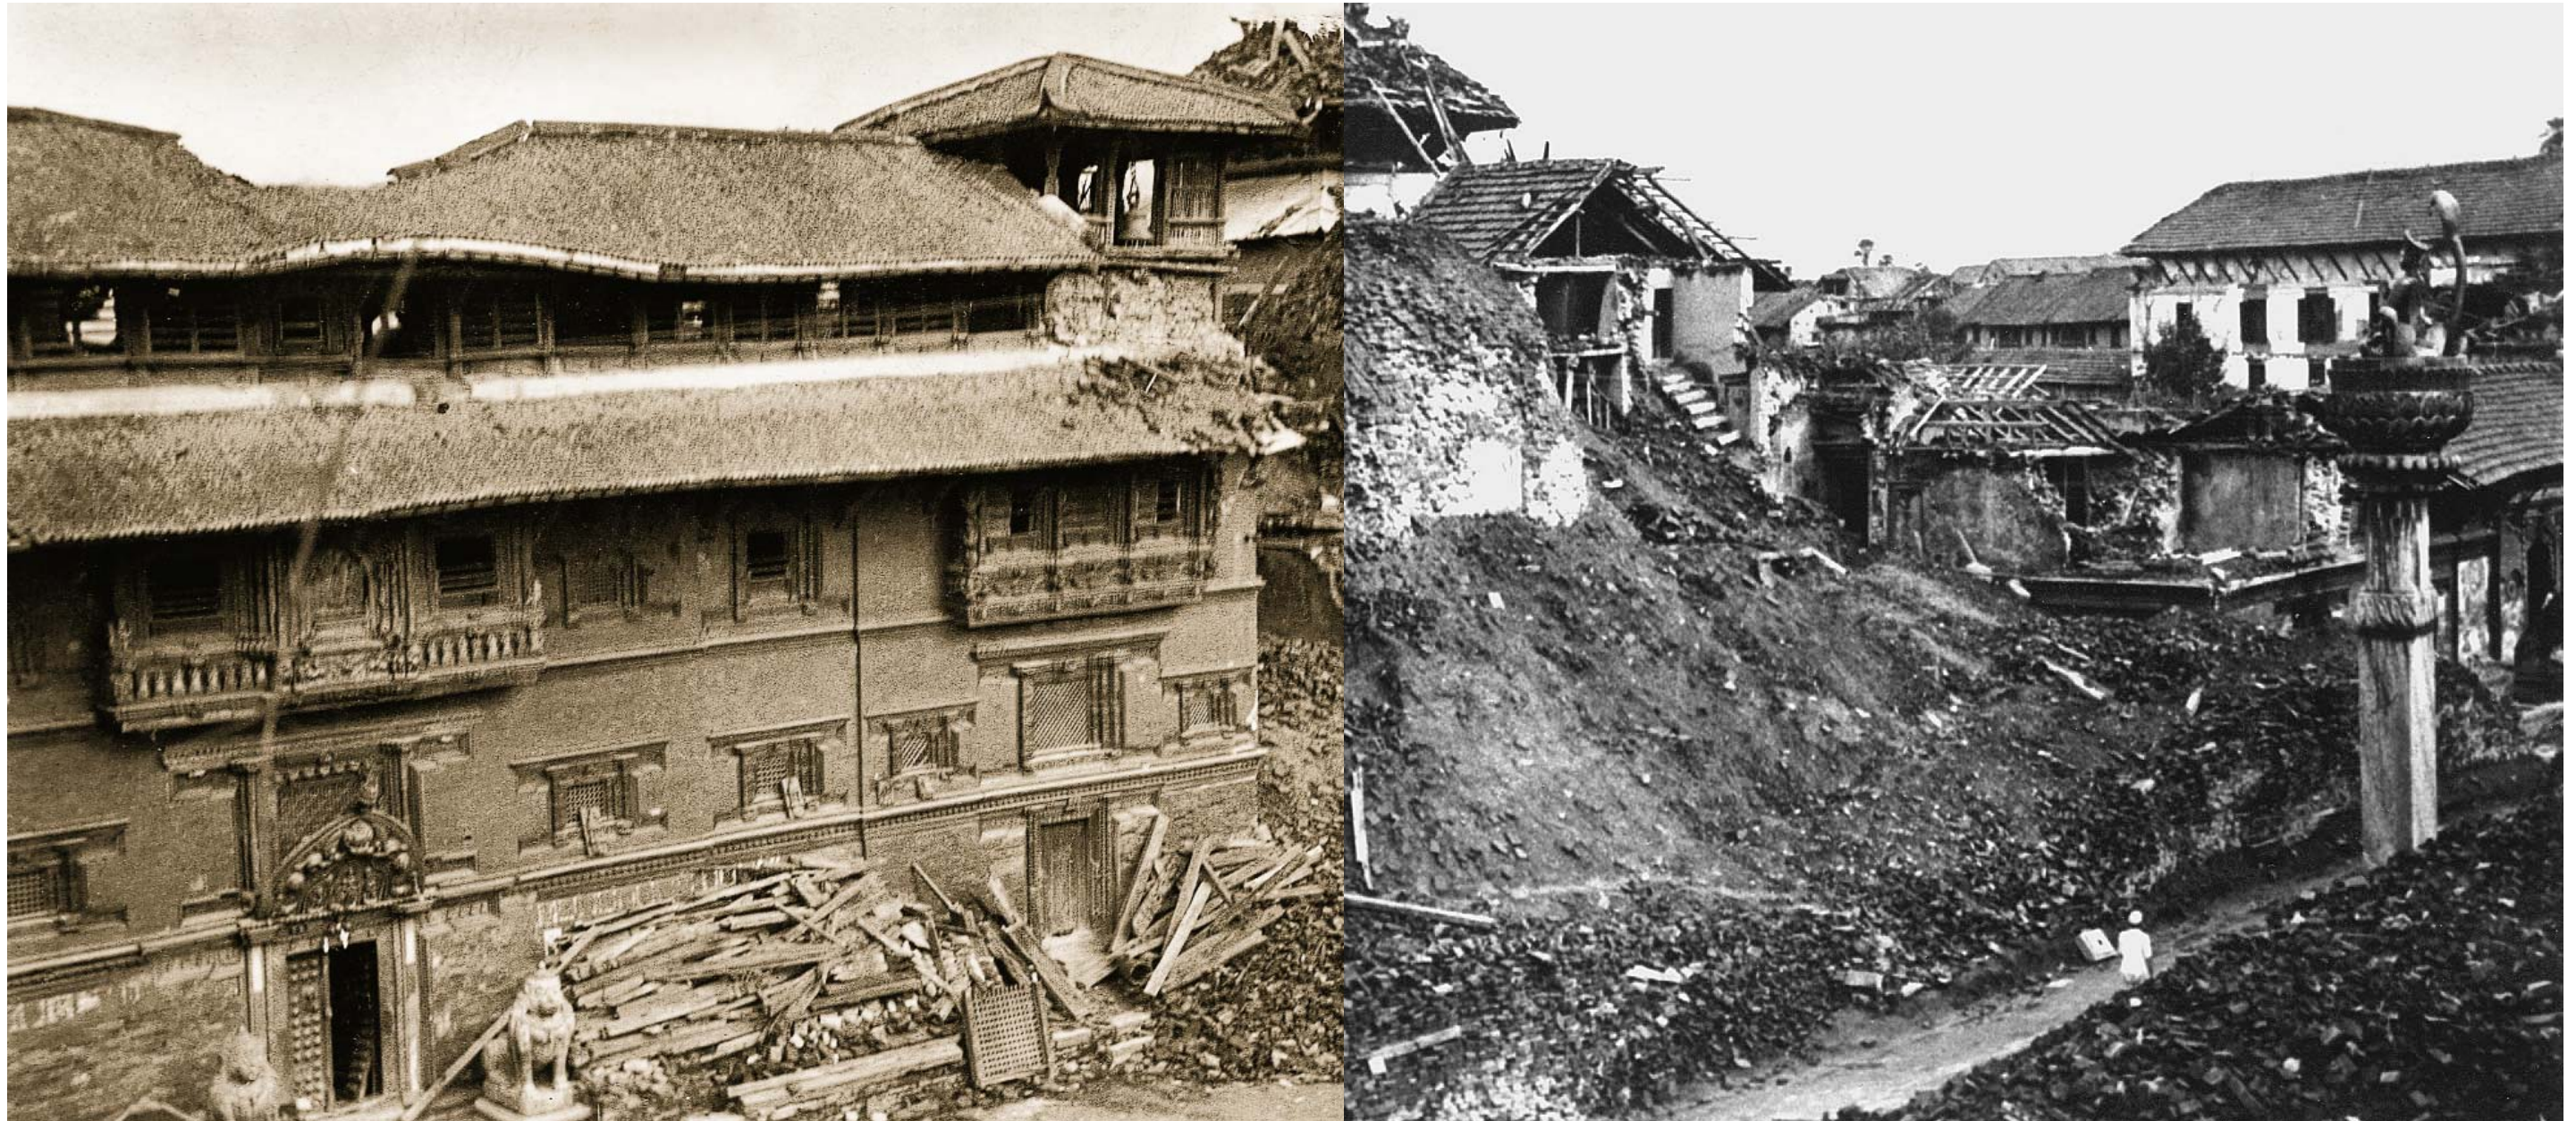
View of the Patan Palace complex after the 1934 earthquake
The Degutale Temple collapsed completely even though the lower two stories were built of thick and massive masonry.
Photograph, 1934

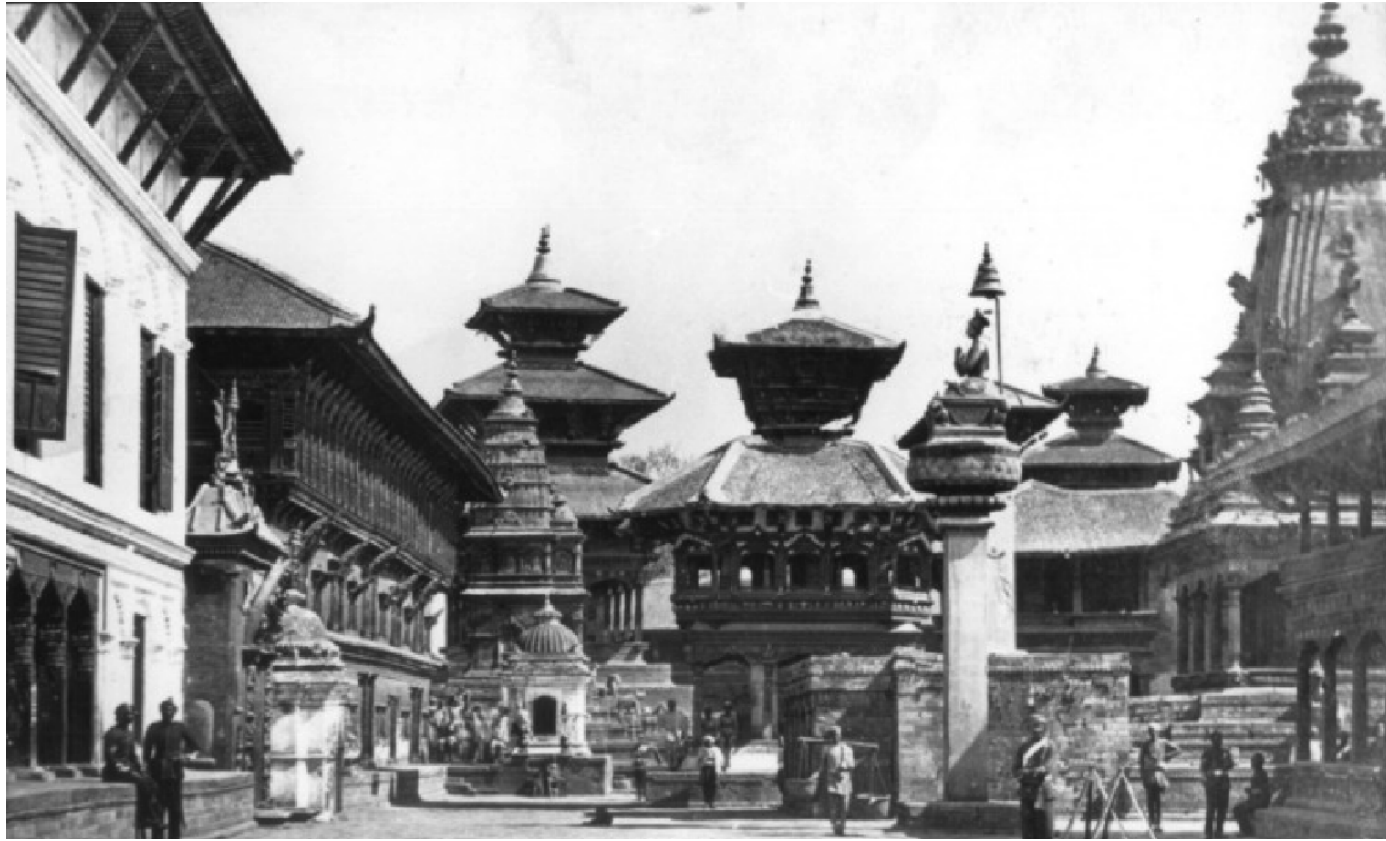
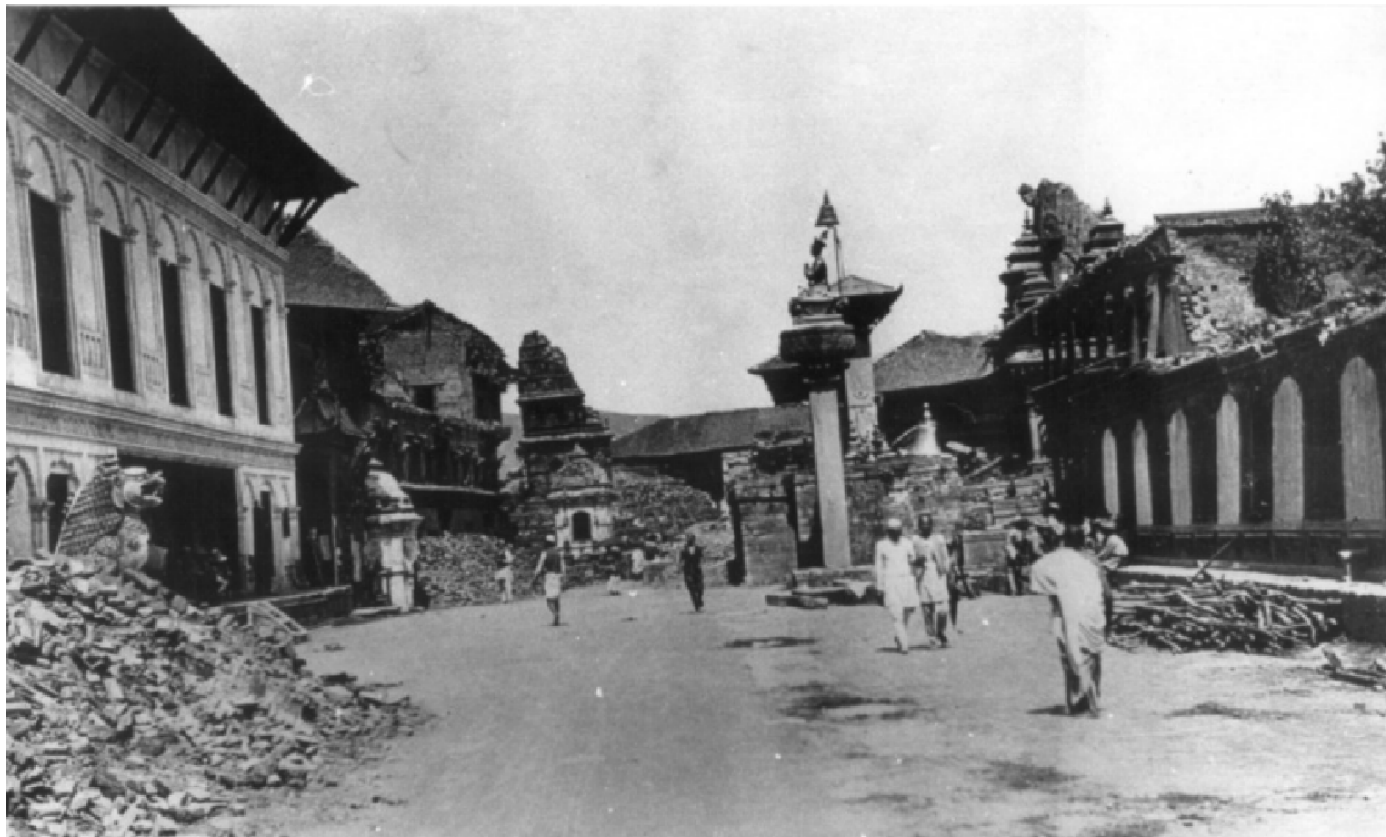
Bhaktapur Darbar Square
Comparative views before and after the 1934 earthquake

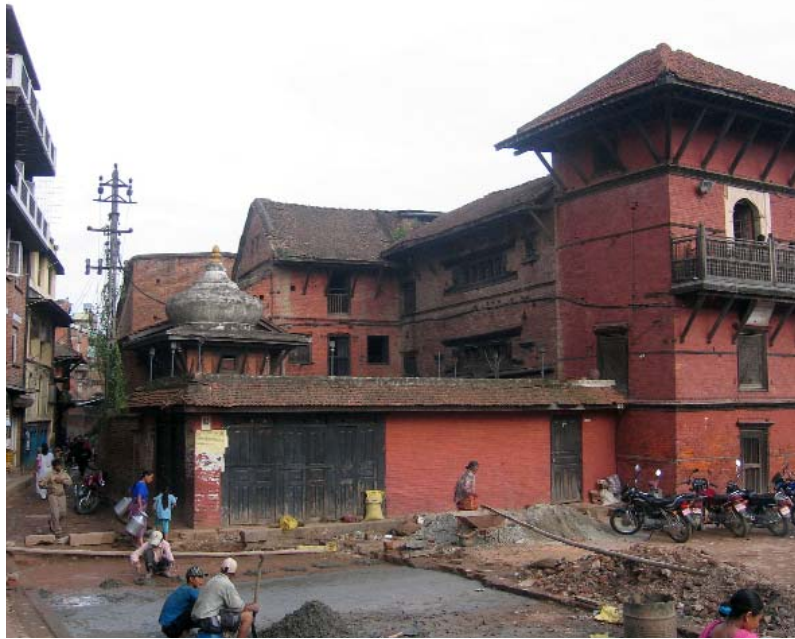
Object #01: one-story structures built illegally around the small Shiva shrine. After demolition there will be public access to the temple and the 17th century agam building.

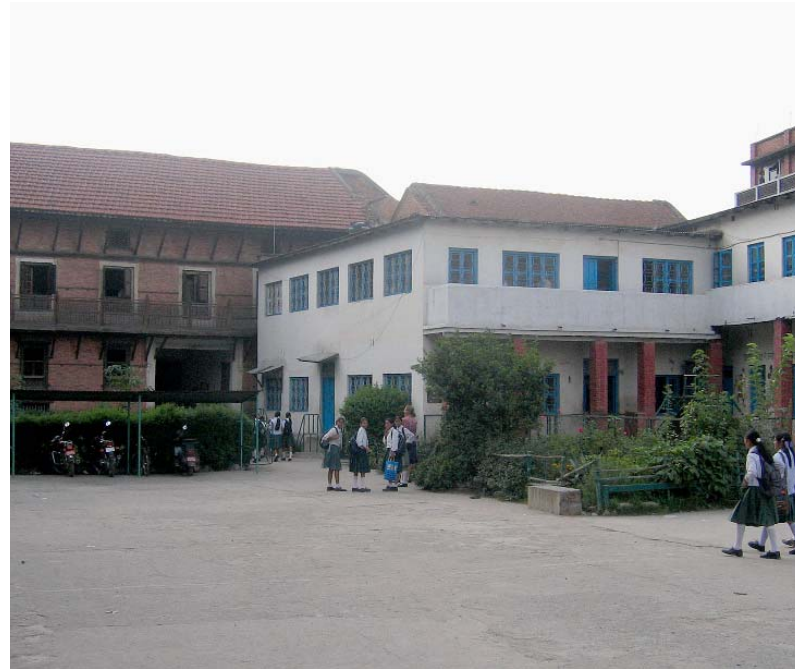
Object #02: extension of school building butting up against the 17th century shrine building and the North wing. A compromise could be found with the school to support construction of additional rooms in the main courtyard in exchange for demolishing this inappropriate structure.

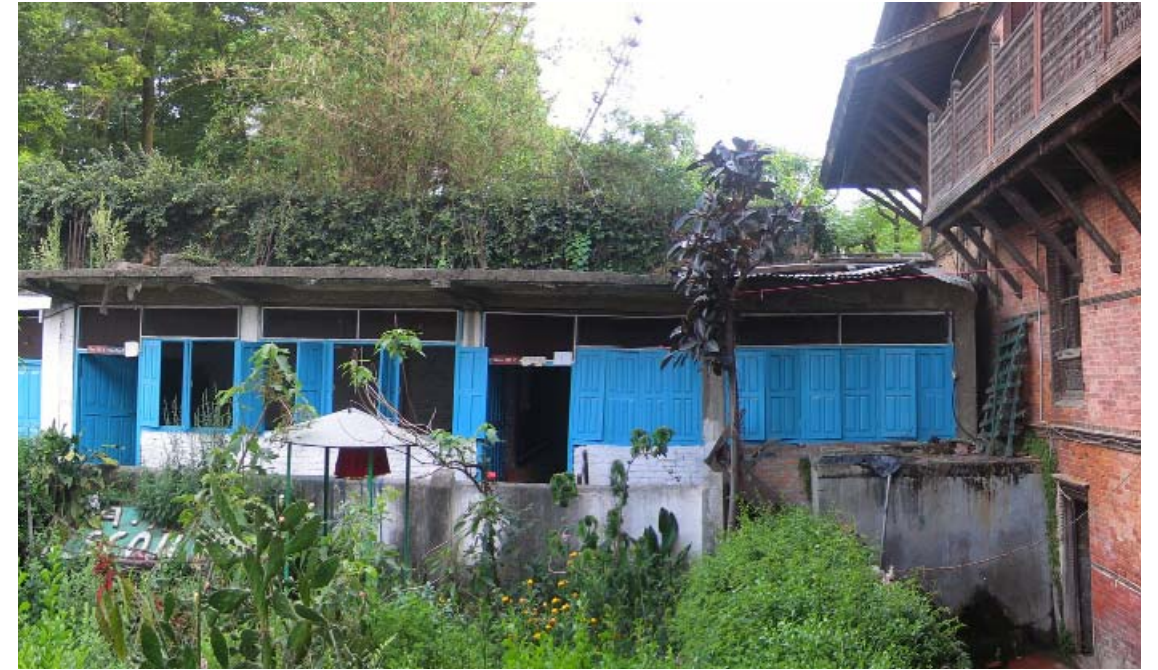
Object #03: one-story concrete and brick shack used for classrooms.

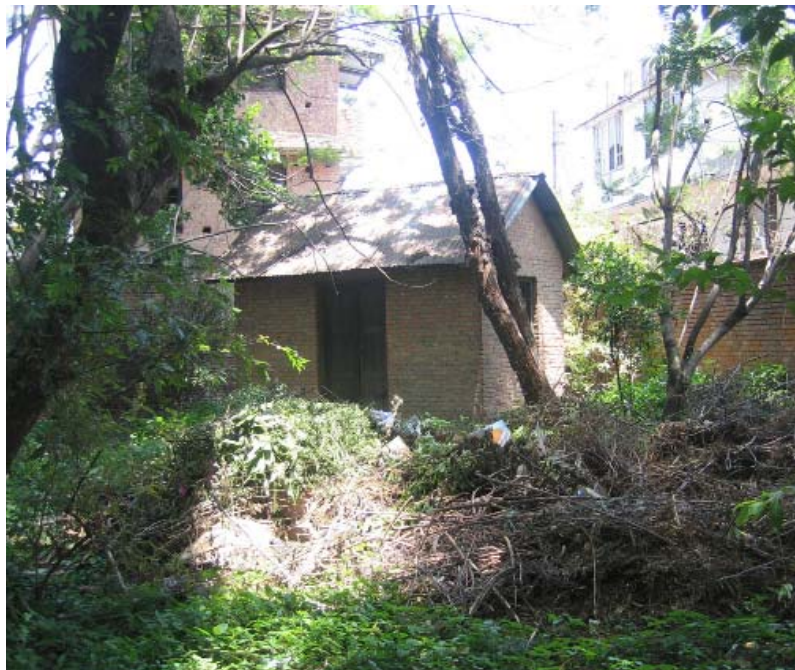
Object #05: brick shack with tin roof, filled with garbage

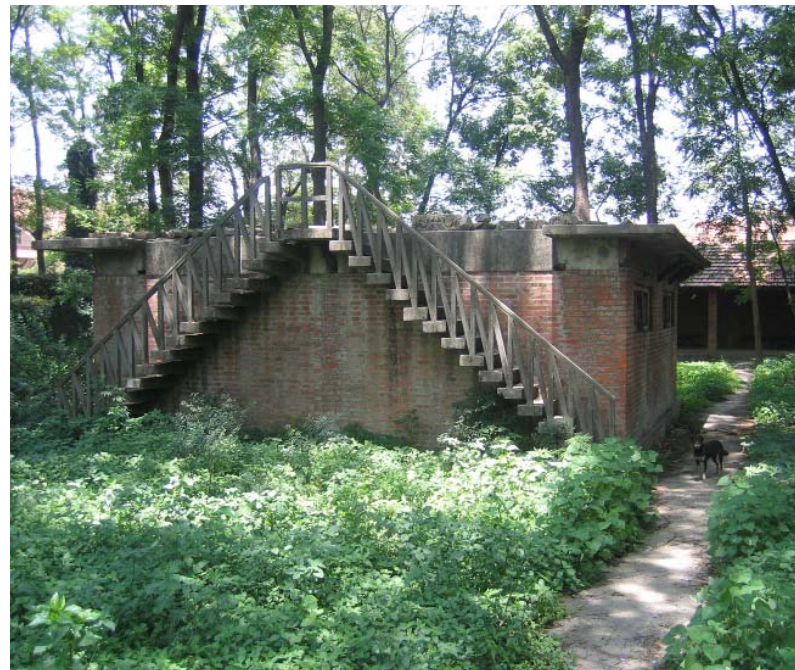
Object #06: brick and storage shack, mostly empty, some garbage

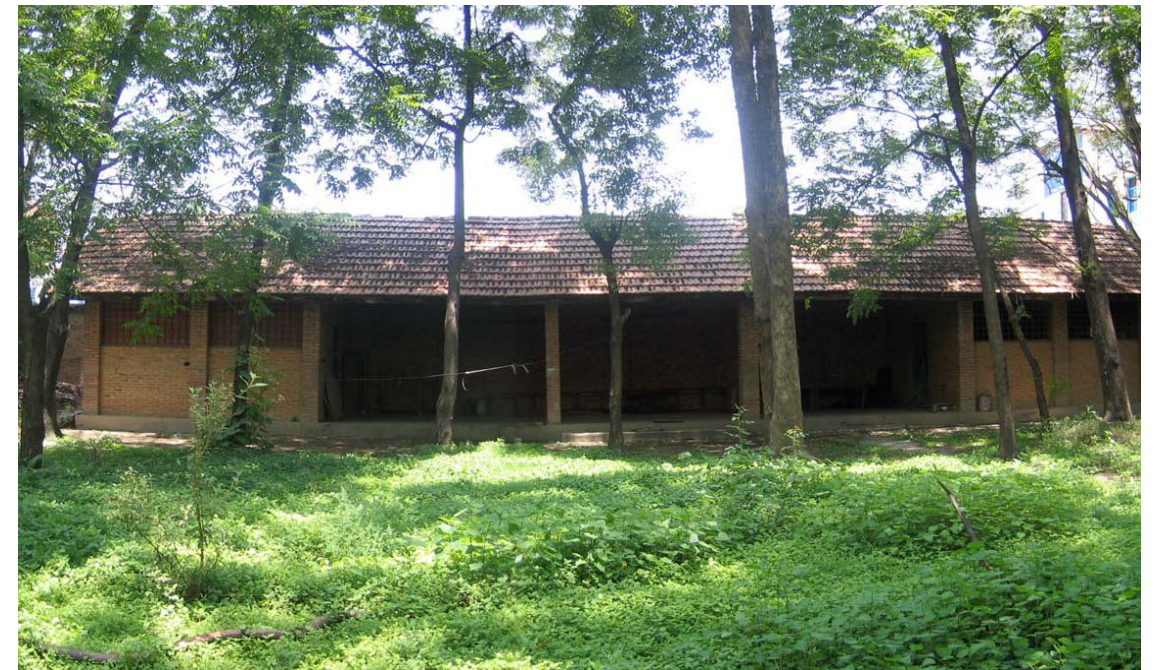
Object #04: storage shack for stone fragments and materials for Patan Museum garden maintenance

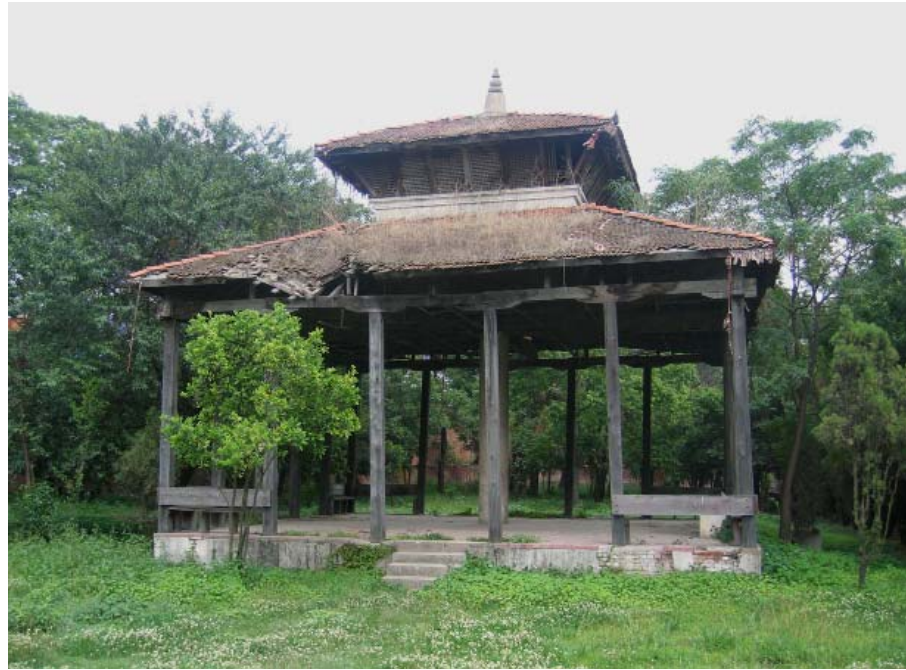
Object #07: Concrete and timber pavilion with collapsing roof, (built for King Birendra's coronation)

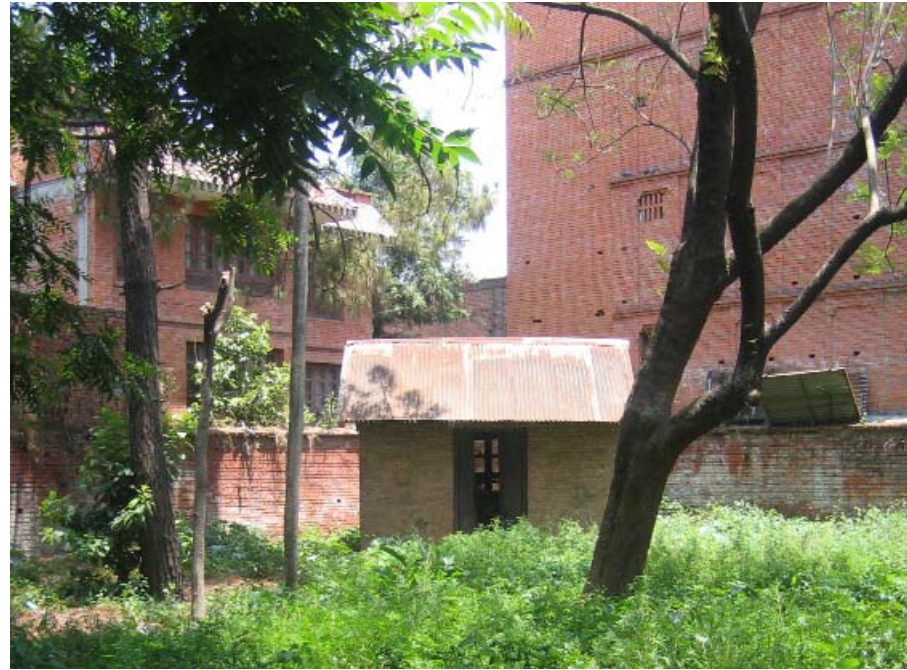
Object #08: Shack filled with broken furniture and garbage

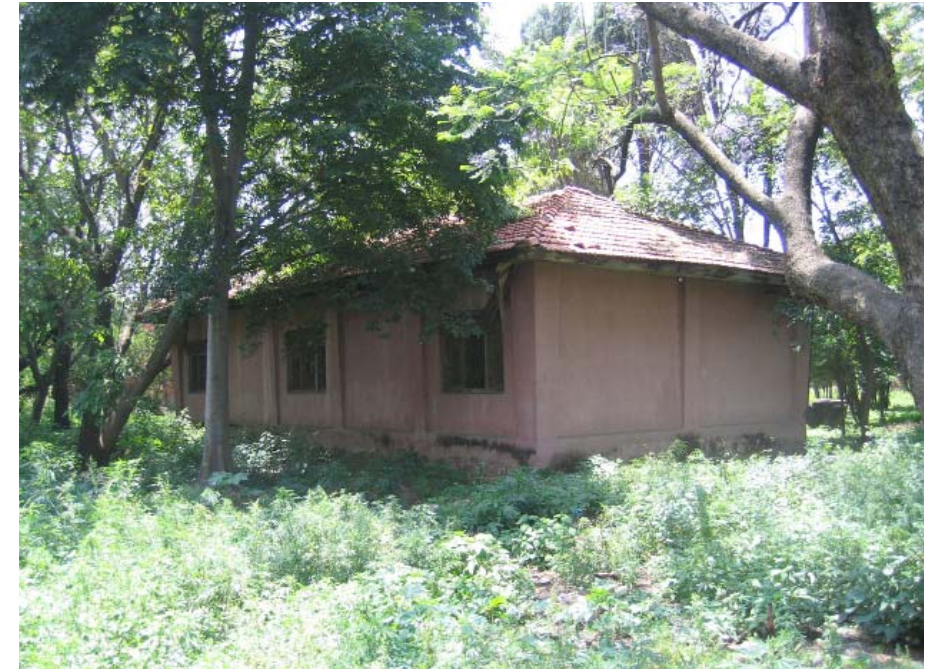
Object #09: storage shack for stone fragments and broken furniture

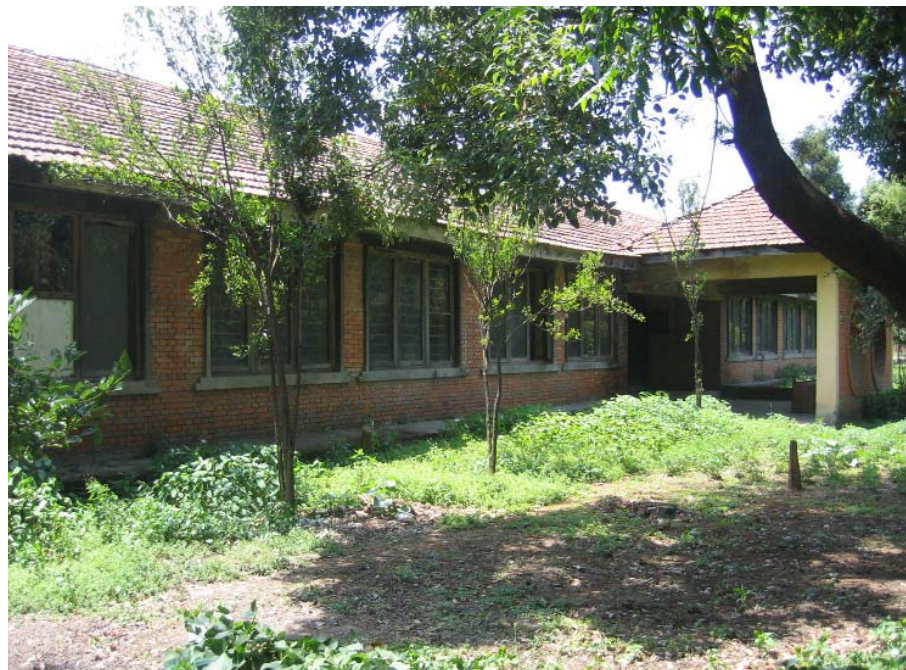
Object #10: Conservation Laboratory
This Government office is basically unused - relocation of the laboratory should be considered.

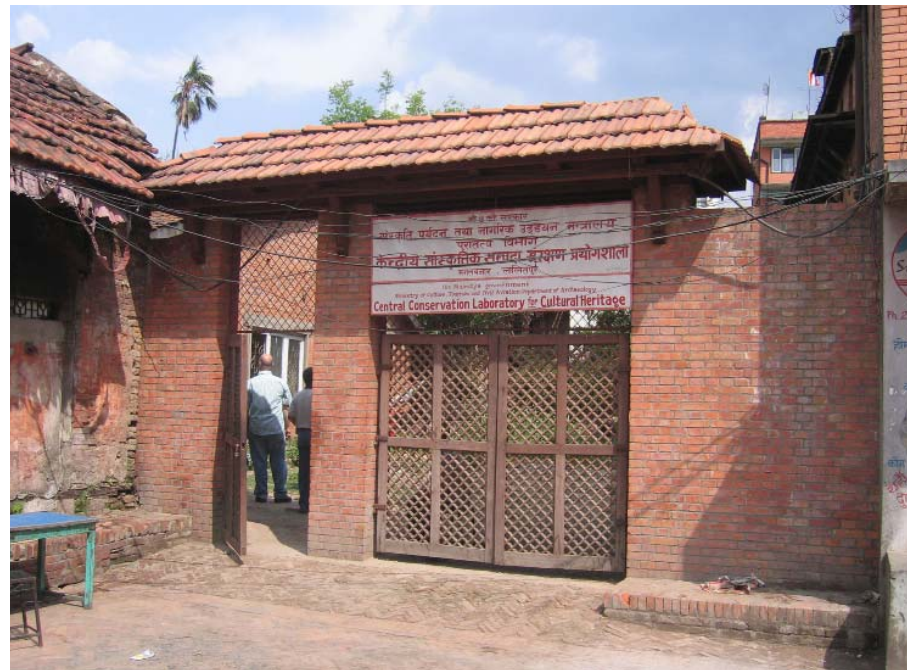
Object #10: Gate to the Conservation Laboratory
