THE PATAN ROYAL PALACE RESTORATION AND CONSERVATION PROJECT

JOINT MISSION REPORT

DECEMBER, 2006

JOINT MISSION (MAY 1-6, 2006)

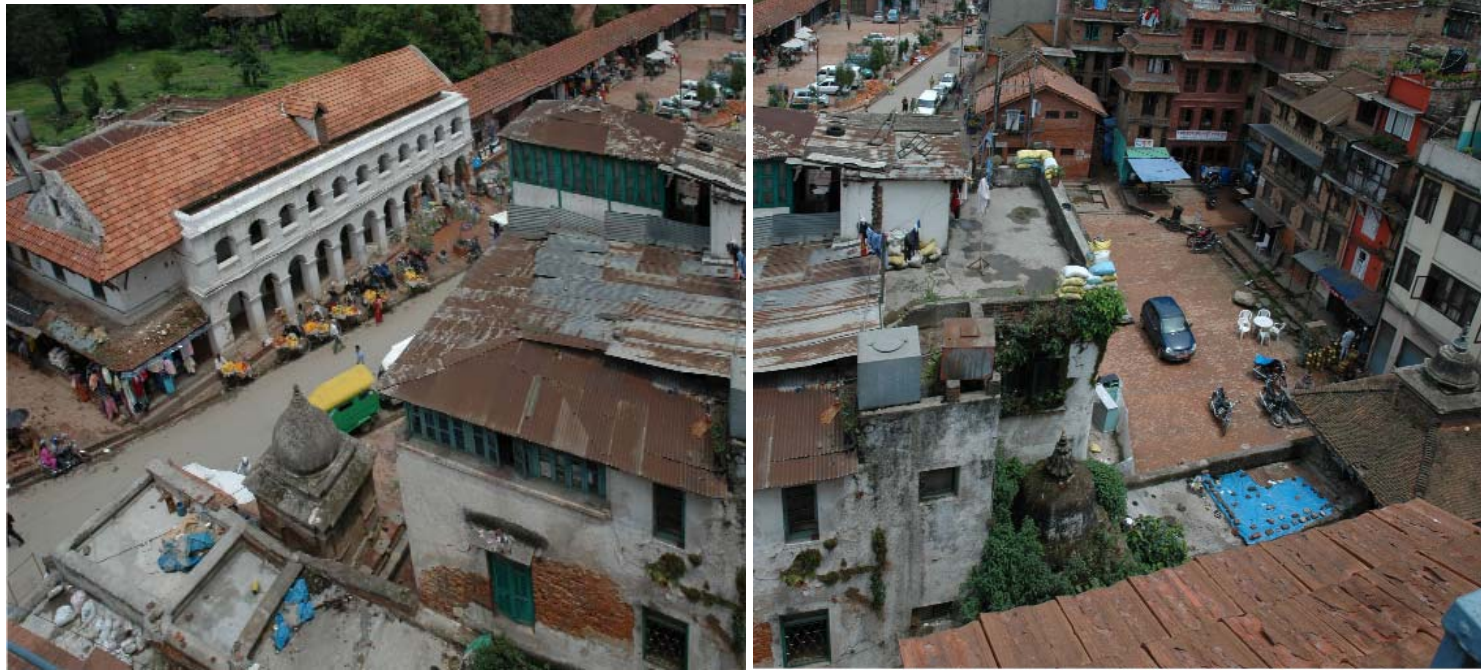
Birds eye view of Demolition Object # 13: Police Station
To the left the Court Building, in the background garden and Kot pati

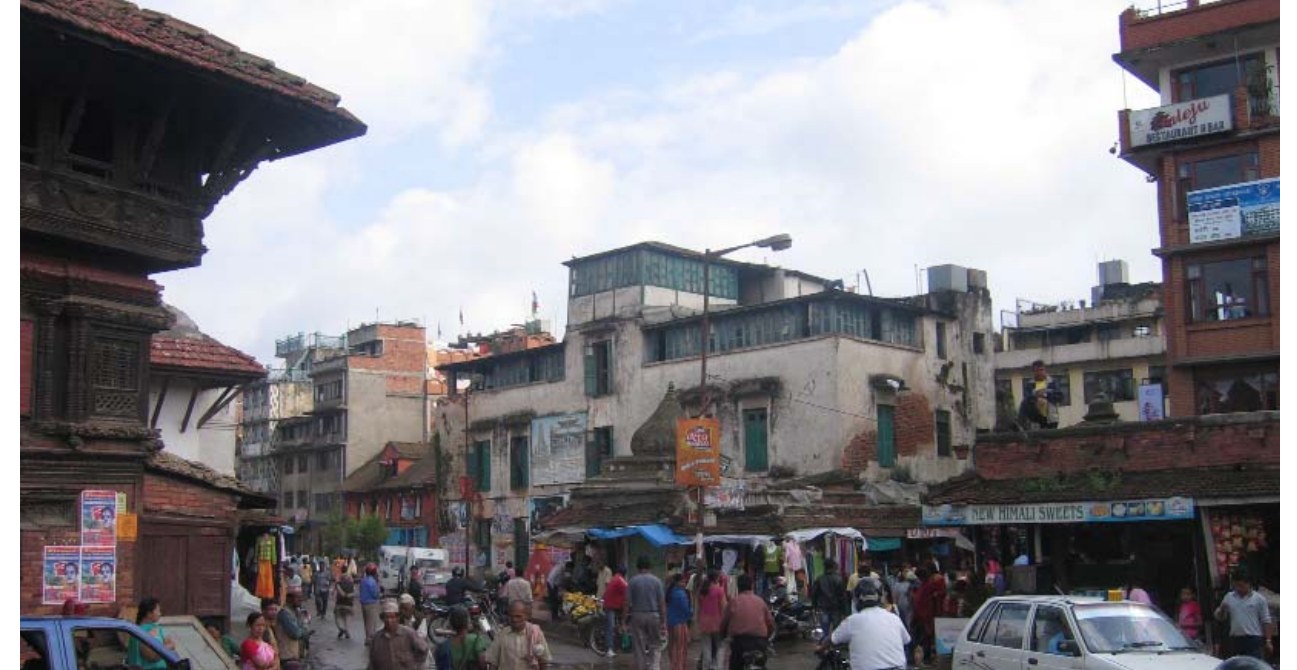
View of Demolition Object # 13 from Darbar Square
The South-West corner of Sundari Cok on the left and a modern 7-story building on the right.

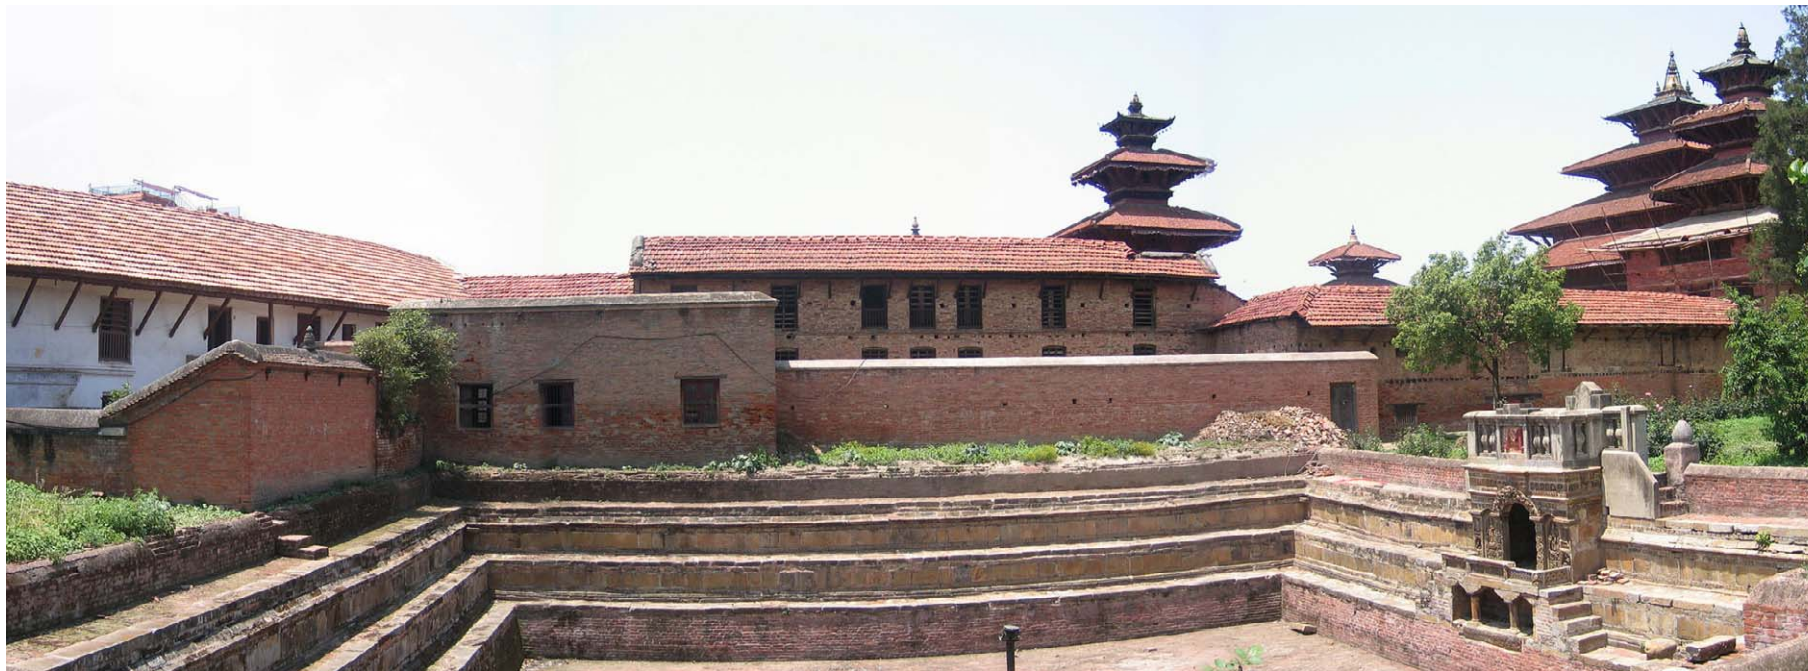
Demolition Objects # 11 and #12:
The rear wall of the abandoned police post and the new Boundary wall behind the tank. Note the grade level around the tank which is now 4-5 feet higher than it was 150 years ago.

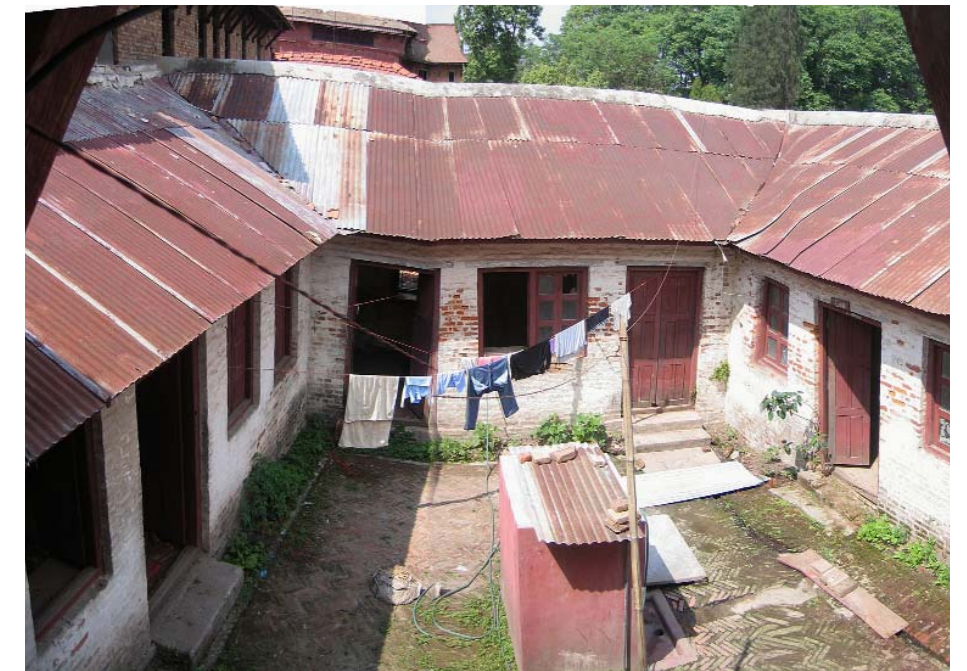
Demolition Object #12:
This make-shift construction previously housed the Mangal Bazar Police Post. It has been abandoned since 1994 and is now occasionally used by squatters.
