CHABAHA PATI

RESTORATION PROJECT

FINAL REPORT

ROHIT RANJITKAR*LUMANTI JOSHI
KATHMANDU VALLEY PRESERVATION TRUST
MARCH 2003

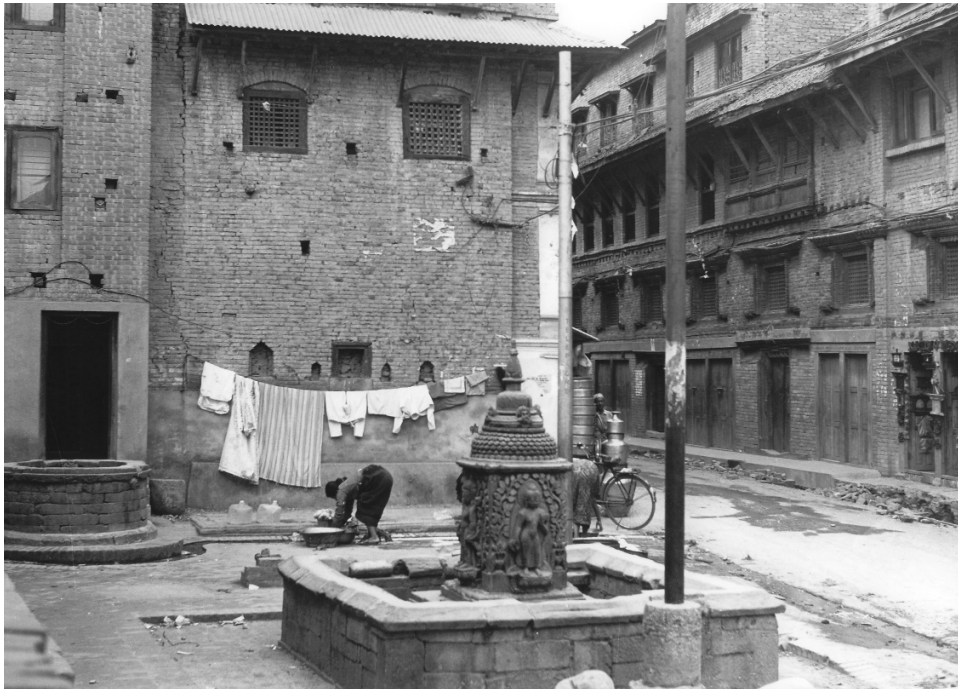
1. Chabaha pati was completely lost in the 1934 earthquake. Existence of the rest house was only visible on the wall of the adjacent residence, and from the old brick foundation.

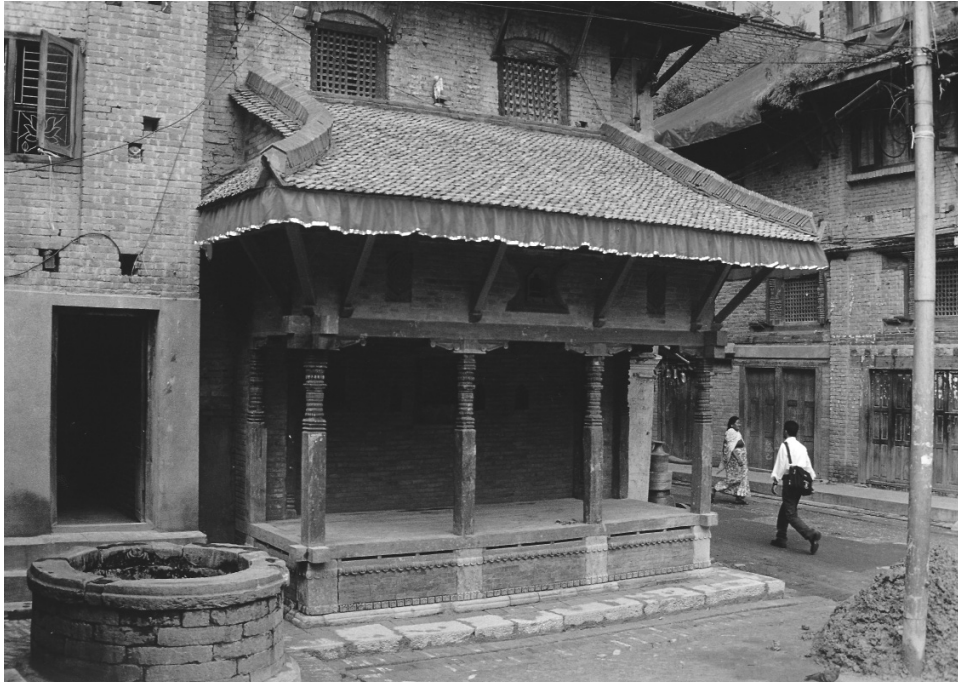
2. Chabaha pati was given back to the local community. It is now possible for the neighborhood to use it again for any kind of gathering, to play, and to rest.

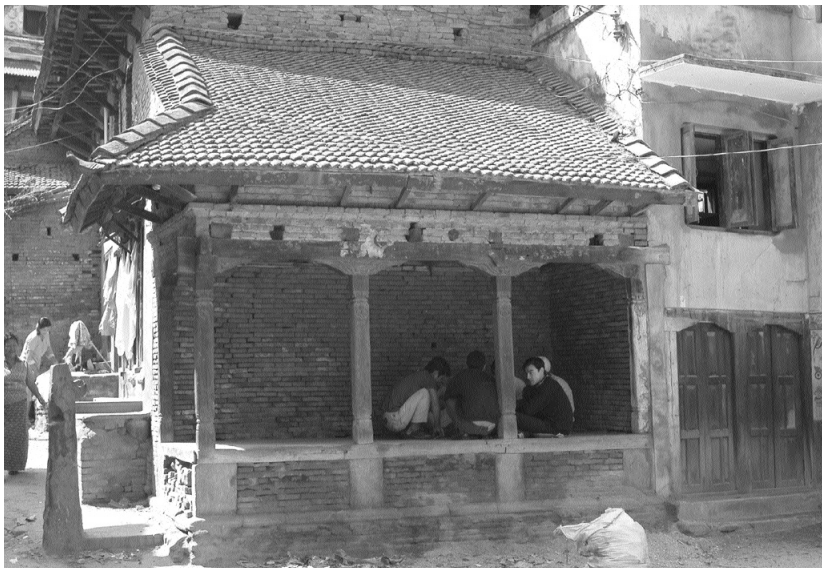
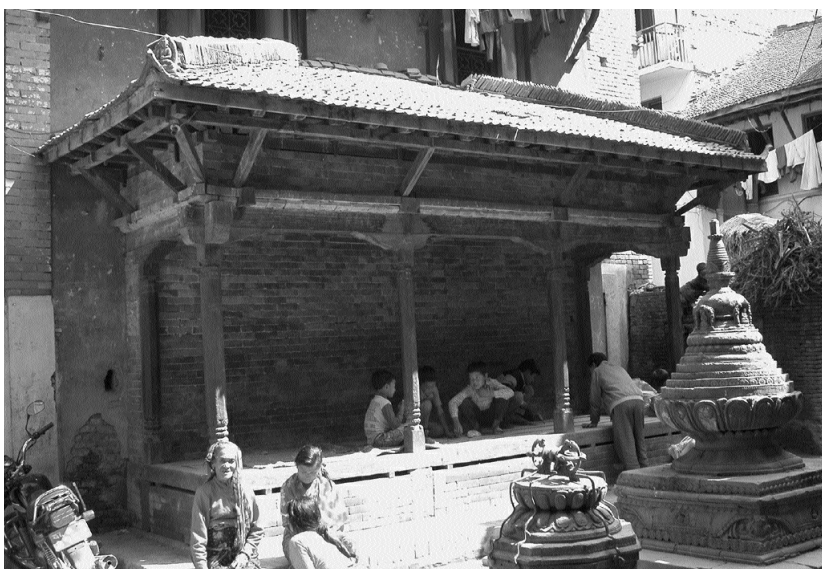
3. Some of the similar structures around Patan were carefully studied prior to the restoration of Chabaha Pati. Patis are still part of urban life there, used for different community activities.

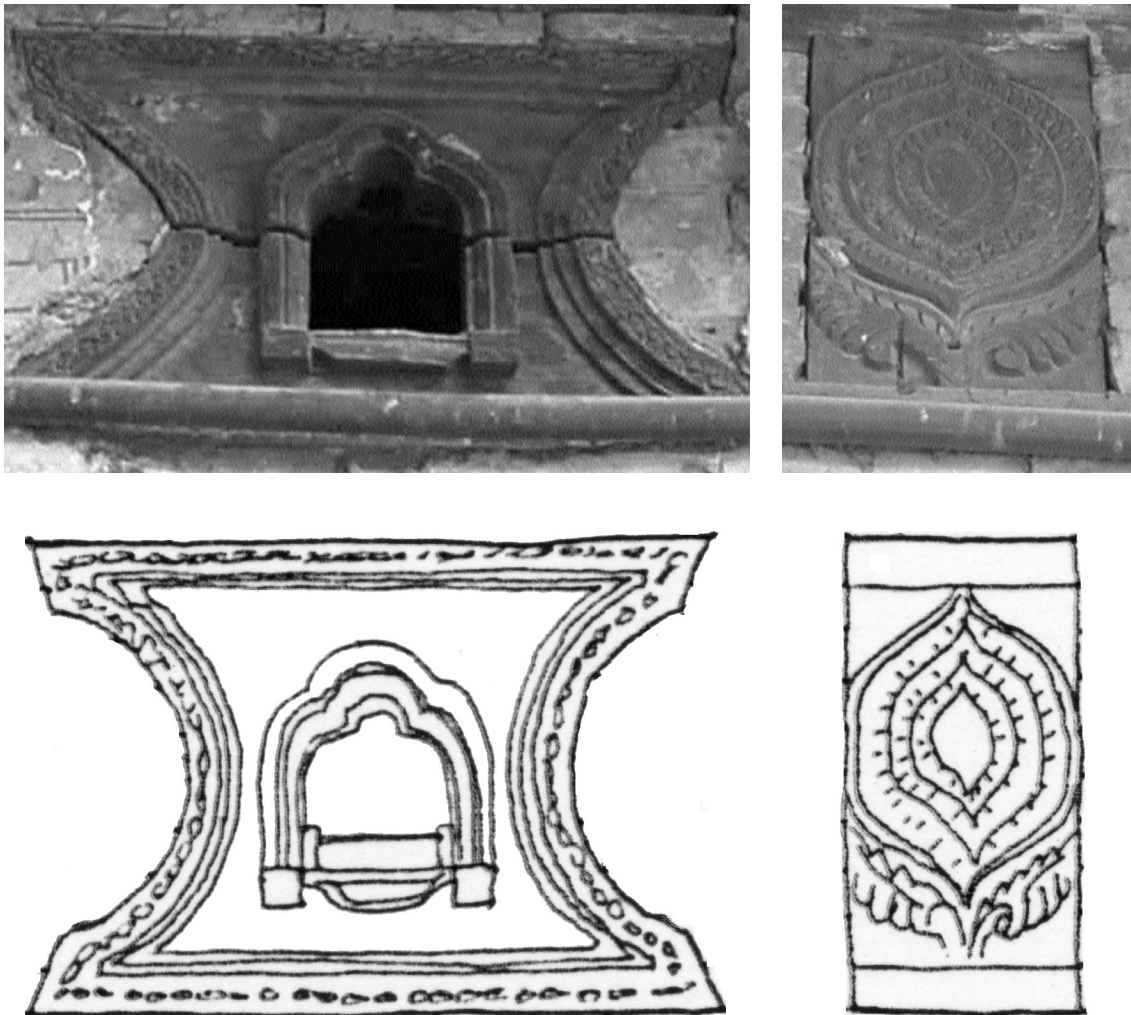
4. Samples of the wooden carved elements from a pati at Chochhe Galli were studied to recreate the new ones for Chabaha Pati. Drawings of these elements were prepared with reference to the ones at Chochhe Galli, Patan.

Stylistic analysis of the remaining carvings shows that the *pati* is from the 18th century. Two of the missing carved columns were reproduced according to the existing ones. The decorative windows were lost in the 1934 earthquake, and there was no way to determine their style. When various rest houses around Patan were studied for an answer, great variations in design and style were found. These elements were replicated from comparable example from the same period found at Choche Galli.

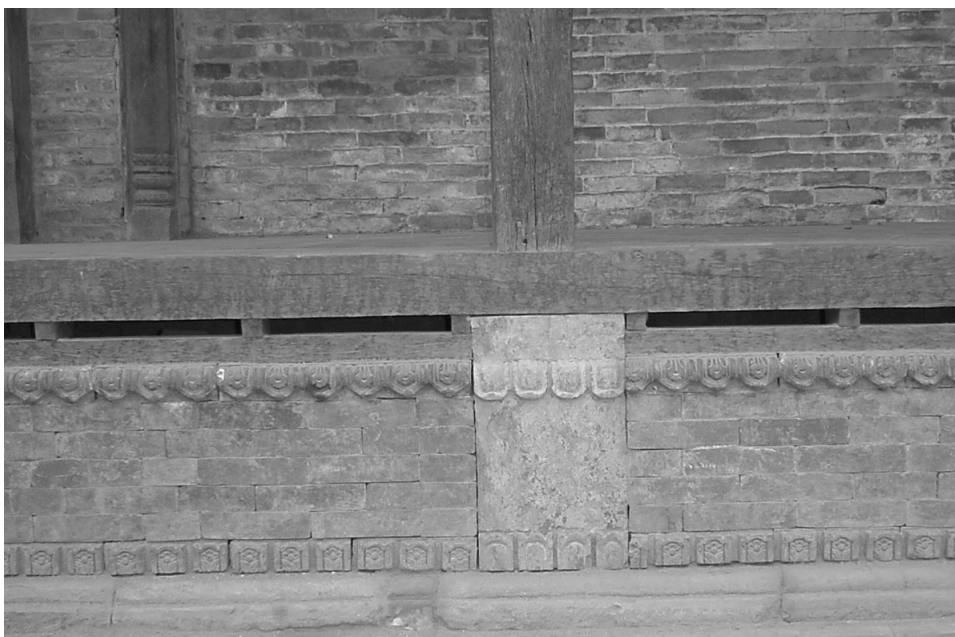
5. The plinth was reconstructed using traditional materials and technology.

Due to the complete collapse in the 1934 earthquake, nothing remained from its original form. The plinth was restored with reference to the similar structure at Chochhe Galli, Patan. “*Nagol*”, or encircling base stones, were placed. The plinth was raised using veneer bricks, or *dachi appa*, set in yellow mud mortar. The mud mortar construction greatly increases the performance of the structure in an earthquake as it is able to absorb the shock waves of an earthquake without fracturing adjacent bricks.

At certain intervals of the plinth structure, *ilohan*, or base stones to support the pillars, were installed. *Lakashi*, or the plinth tie beam, was installed along with the framework for the planking. The plinth is essentially hollow. A one-inch gap was introduced between the bricklayer and *Lakashi* to provide air circulation, and to avoid rotting of the planking. One-inch thick planking was placed in random widths and lengths on the *pati* floor.

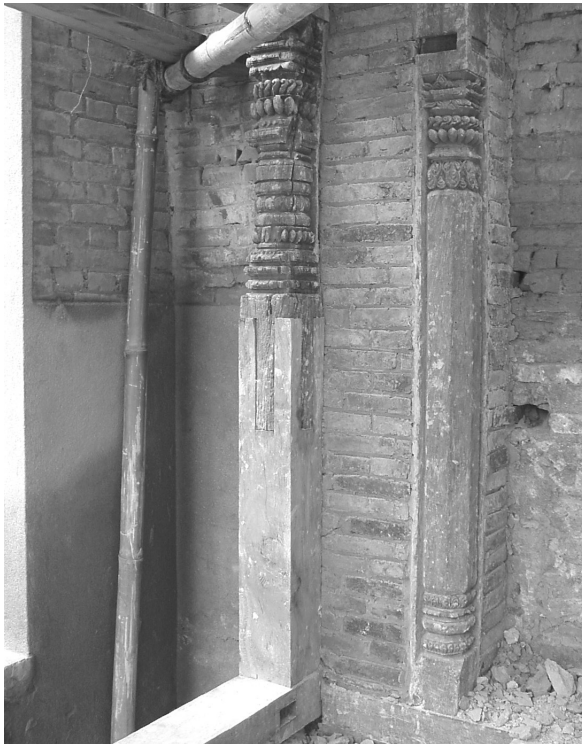
6. Newly carved columns being erected next to the old one. The base of one of the originals was retrofitted with new timber to provide stability to the structure.

The height of the recovered column was used to determine the actual height of the *pati*. The side walls were constructed to support the columns. Two of the lost decoratively carved wooden structural pillars were re-carved on the basis of the existing ones. The carved pillars were then installed with the well-fitted capitals. One of the structural pillars of the *pati* had to be retrofitted with a new base, as the older one was not in good condition. Saw tooth joinery was utilized to join the new ones to the old ones.

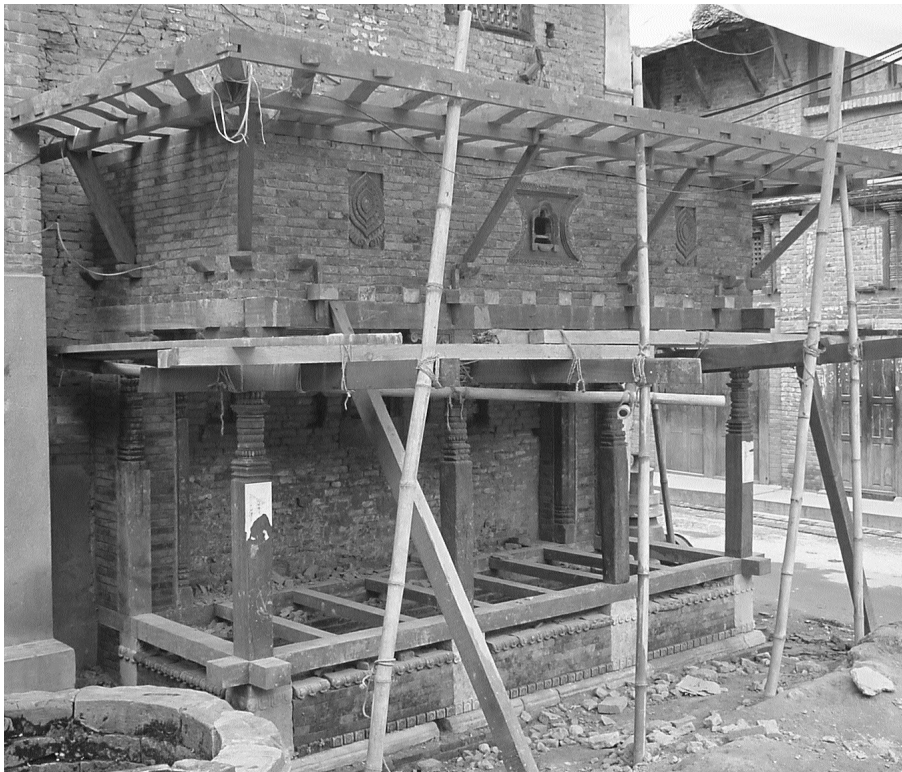
7. The upper wall above the beam built with newly carved elements in their positions.

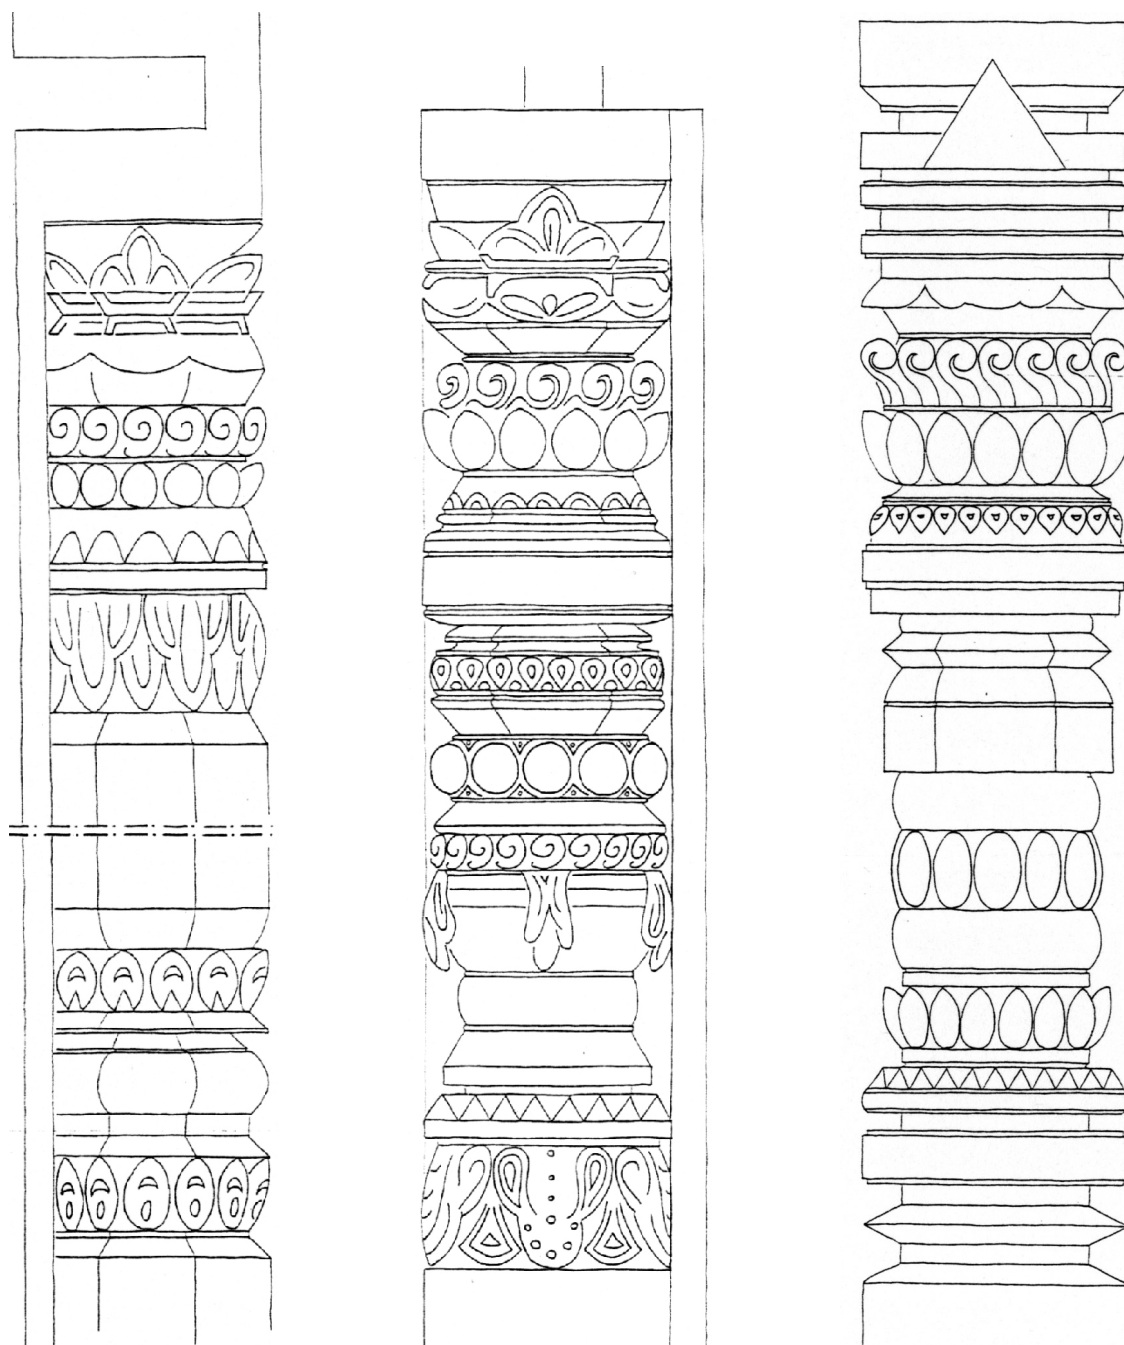
8. The details of the remaining columns were carefully documented and were used for re-carving the missing ones.

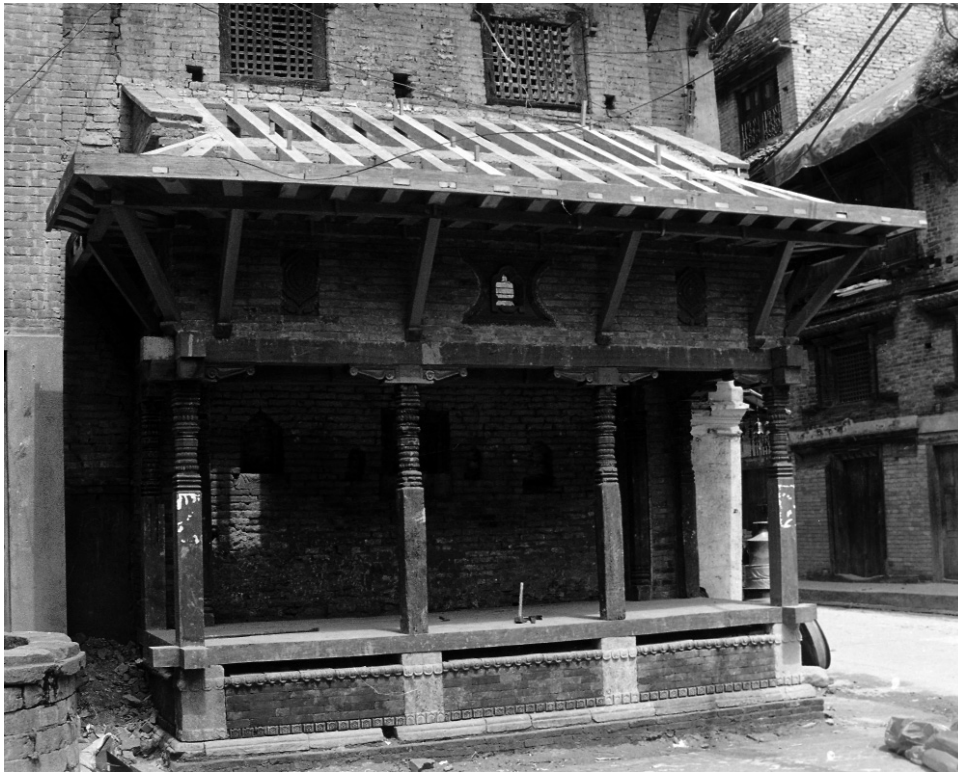
9. Rafters are installed with reference to the traces of a roof line on the wall of adjoining house.

After thorough investigation of similar structures around the city of Patan, we came up with five alternative designs for the roof structures. The one bearing the closest resemblance to the description given by the elderly of the local community was considered for the actual construction. The joists were installed above the beams over which the one-inch thick timber planking were placed. The supporting wall for the roof structure was built above the beams. Pine rafters were positioned on which timber planking were nailed.

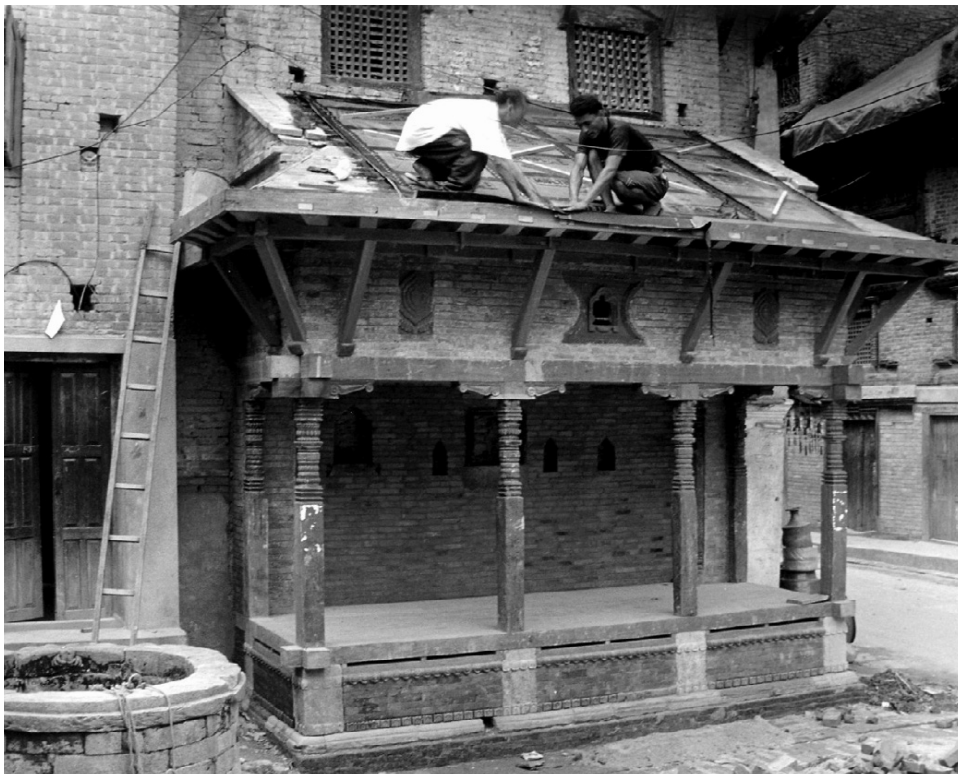
10. Waterproofing membrane being laid between the planks and the mud bed for tiles.

The plain struts were installed to support the roof structure. Waterproofing membrane was introduced under the mud bed to extend the life of the roof. Our experience shows that careful supervision of the various work components such as mud treatment, batten installation, etc is the most critical determinant of the roof life. Above the membrane, battens were laid in diagonal sloping pattern to allow water to run off. Salt was added to the mud used to prevent vegetation growth in the roof. Traditional roof tiles, or *jhingatis*, were laid on the thick layer of mud. The bottom roof tiles (above the eaves board) were drilled and nailed in place as they are highly susceptible to being knocked off.

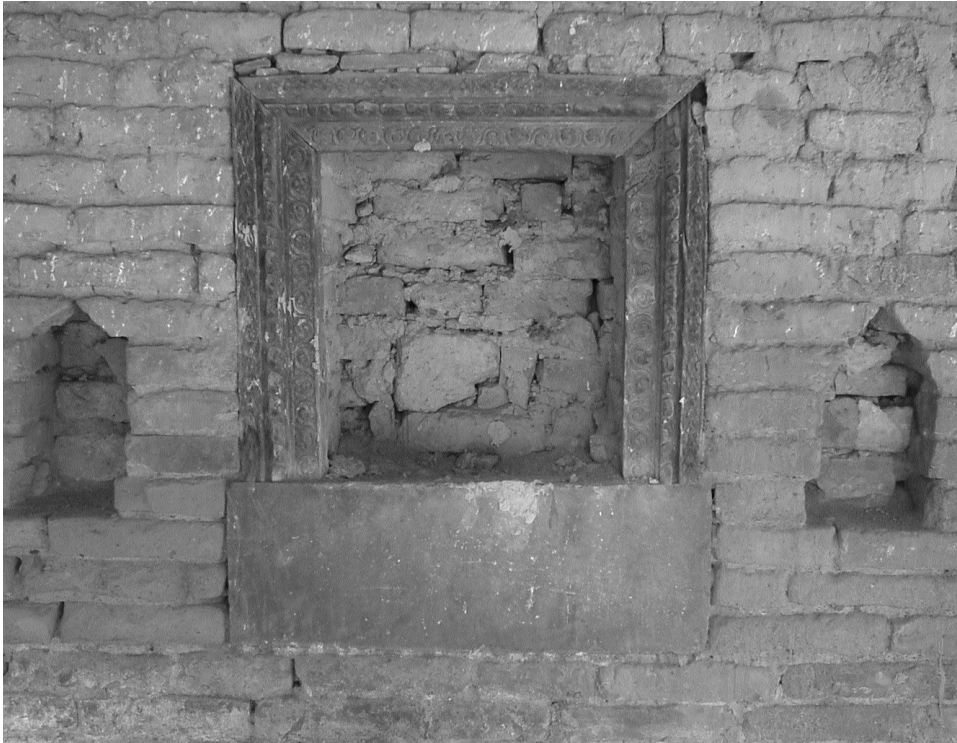
11. The deities in the niches were either lost or stolen.

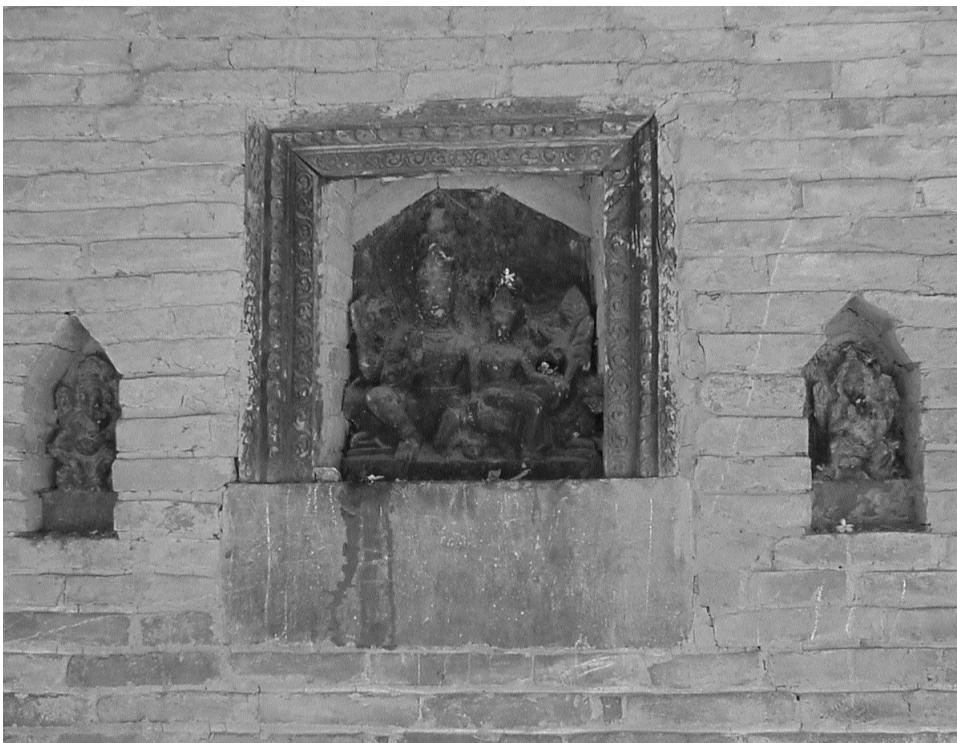
12. Newly carved stone images of Uma Maheshwor flanked by Ganesh and Kumar, were installed in the empty niches.

The stone images in the niches were either stolen or lost. Descriptions of elder local provided the required reference for reproducing the stone images. Images of different guardian deities such as Ganesh, Kumar, Uma Maheswar and other two deities were installed in the niches after an auspicious *puja*.

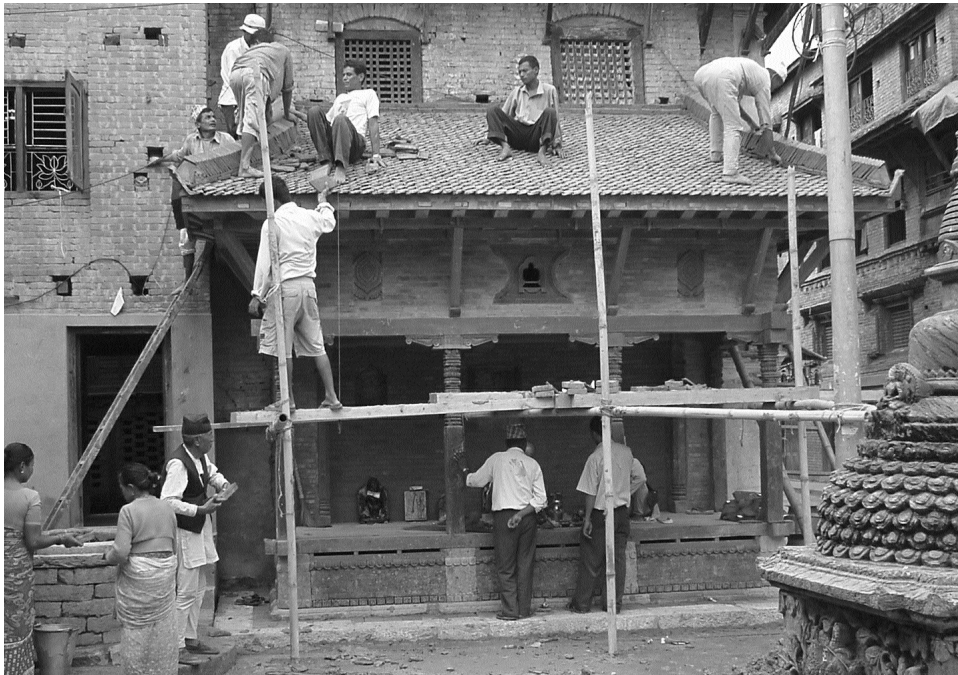
13. Jhingat, or roof tiles, being laid on a thick bed of yellow mud.

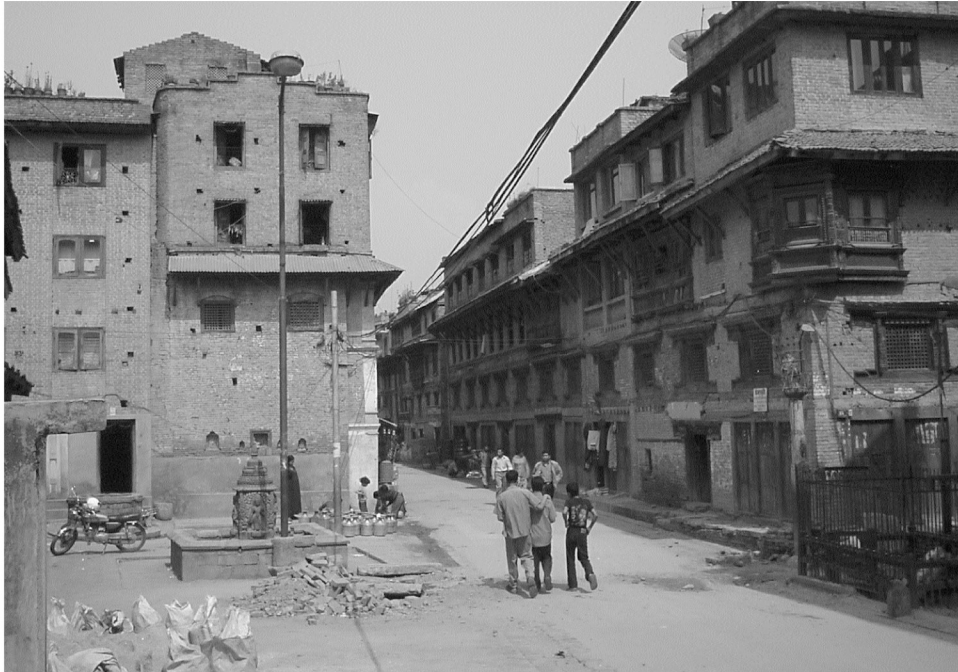
15. The area where the pati existed laid vacant before reconstruction.

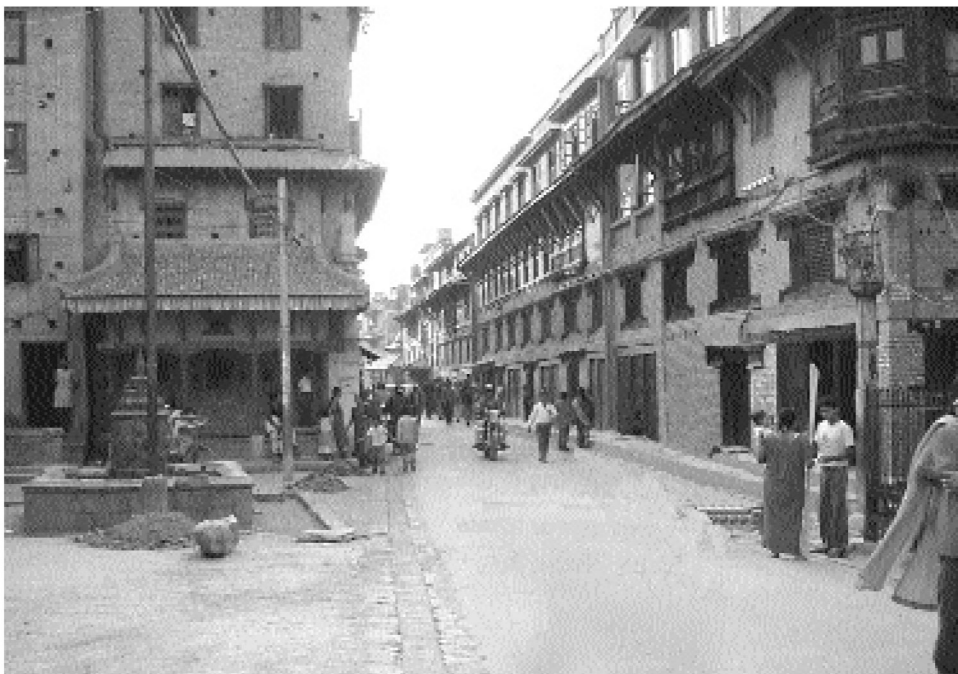
16. The pati has become a bustling place for community gathering after the reconstruction

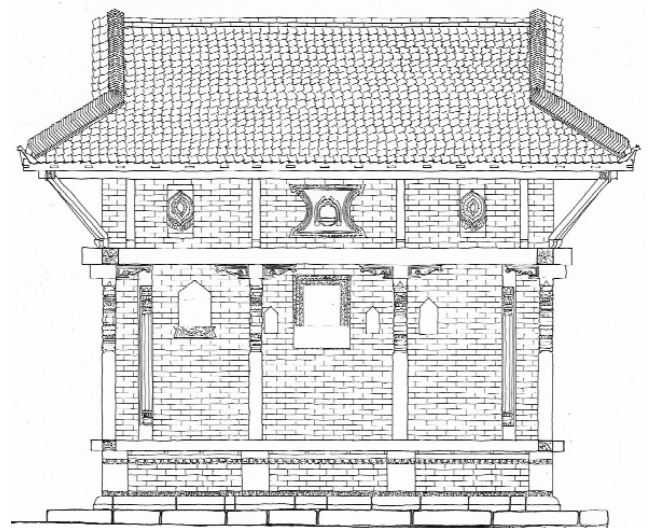
Proposed Elevation (Alternative IV)

17. The elderly from the community were consulted to determine the form of the roof line. Alternative IV was selected for the reconstruction according to their wishes.
