Phase I: Materials Analysis

ROYAL PALACE COMPLEX, DARBAR SQUARE

Patan, Nepal

February 2009

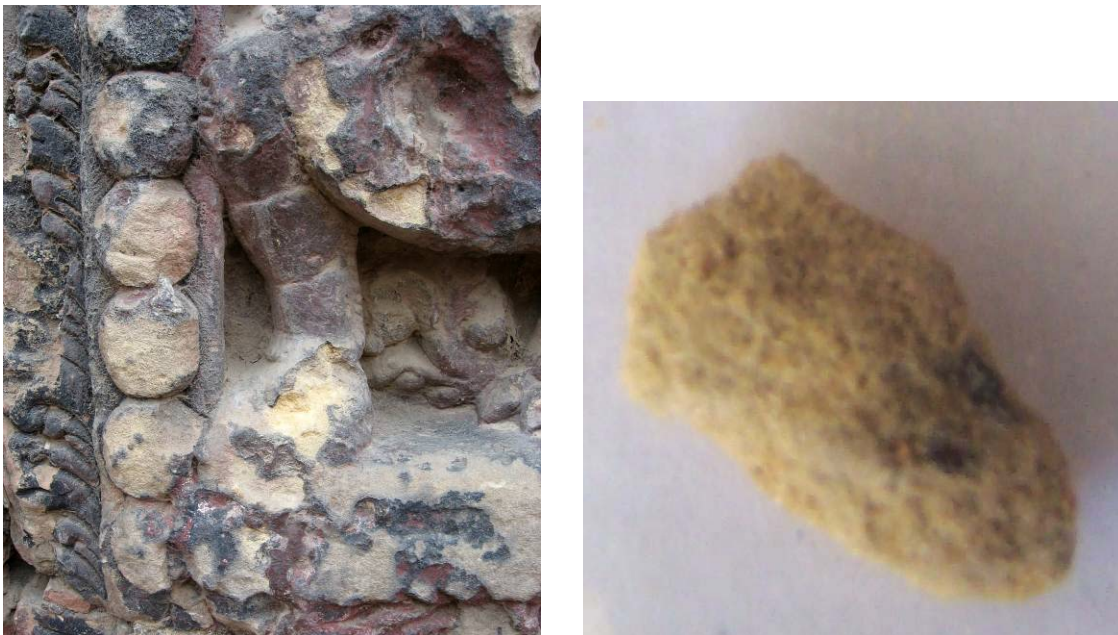
This stone is yellow in color and can be classified as a coarse siltstone or a very fine grained micaceous sandstone (sedimentary). The majority of its composition is quartz with feldspars and muscovite in smaller quantities. The intergranular spaces are believed to be iron hydroxide (limonite) which can act as a cement in sandstones. The porosity is estimated to be 5-6%.

Figure 2: Location of Sample S1 (left) at Nasal Cok Gate South and detail of sample (right).

The Himalayas are a known plate boundary, but also contain uplifted older sedimentary deposits from the Cambrian and Eocene ages in the high valley of Kathmandu. These sediments are part of the Tibetan Tethys series which crop out more extensively in the northwestern part of Nepal. It is believed that the remaining rock types are predominantly metamorphic, including phyllites. It is therefore possible to say that the stones identified here are probably from local sources.

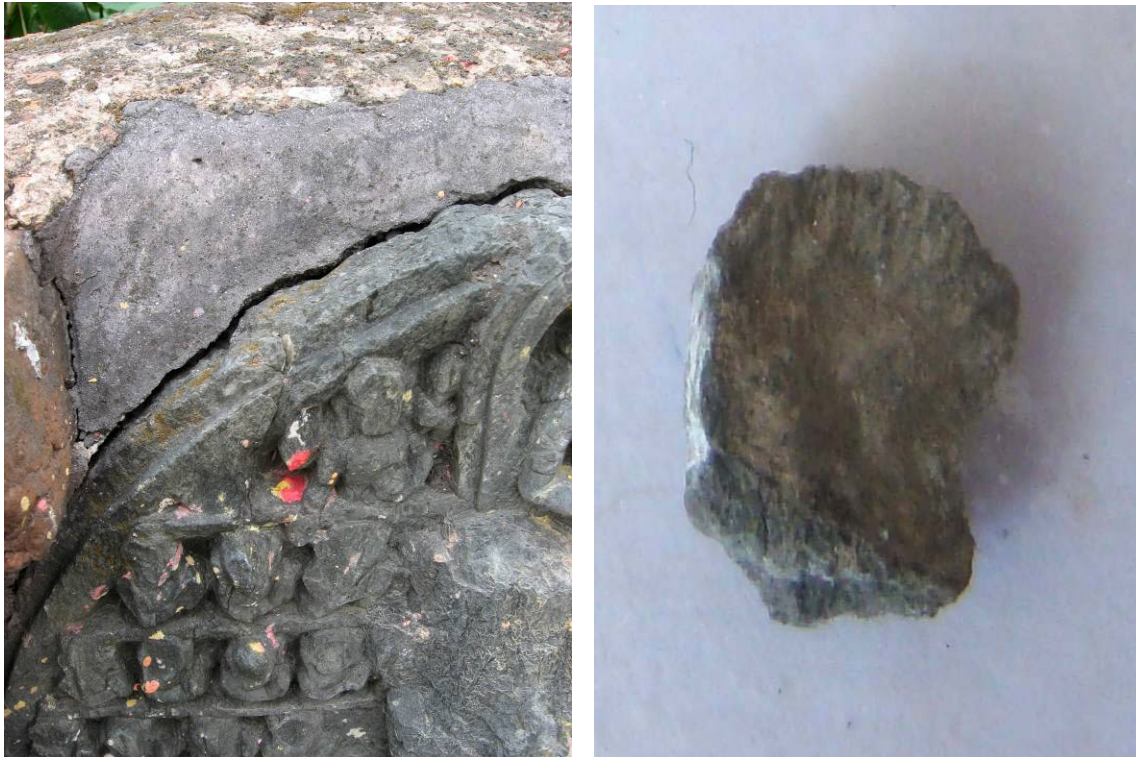
This stone is grey-black in color and can be classified as a phyllite (metamorphic). The predominant minerals are quartz and mica with a presence of chlorotoid, chlorite and corundum. The sample also contained a distinct layer at its surface that was composed of grains dissimilar to the underlying stone that were a coating or dirt. For example, calcite was not found in this stone, yet its grain size was not fine enough to suggest a whitewash or pigment. The in-hand specimen also contained bright red particles that appeared to be pigment.

Figure 3: Location of Sample S4 (left) at the Bhandarkhal Tank and detail of sample (right).

Further study on larger samples is required to positively source the stone and to more definitively identify the layer seen on the stone from the Bhandarkhal Tank.

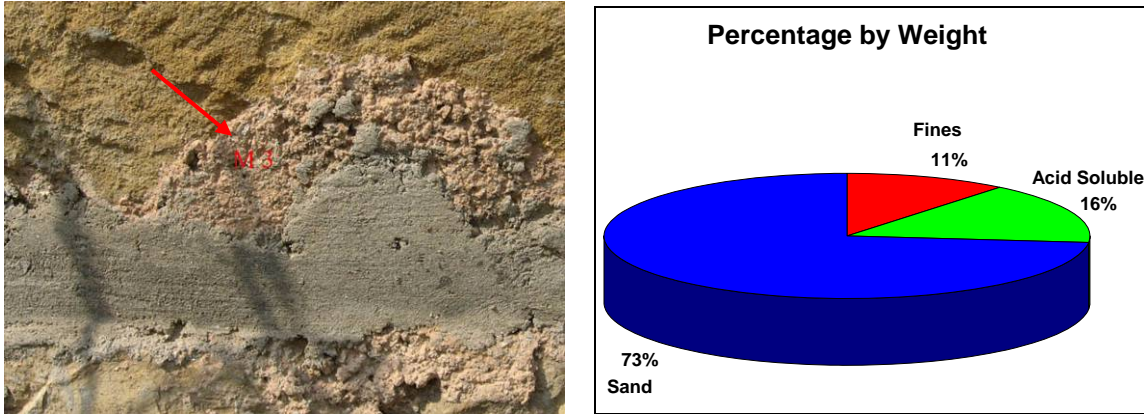
Sample M3 was extracted from the Bhandarkhal Tank and may be a traditional surkhi mortar, a pozzolanic mortar comprised, in part, of brick dust and fragments (Figure 5). The sample may come from repairs conducted following the 1934 earthquake. The mortar contained visible brick and mica fragments and was soft. Viewed in cross section, the overall mortar color most closely matched Munsell warm tan (7.5YR 7/3), with a visible pink binder. The exposed joint surface of the sample was heavily soiled and had aggregate that was clearly exposed, presumably from weathering. The gross sample weight before digestion was 5.57 grams.

Sand comprised approximately 73% of the sample by weight. The overall sand color most closely matched Munsell brown (7.5Y 5/3), and was composed of grains that were white, clear, and black, with many brick fragments and a considerable amount of mica. Grains ranged in size from very coarse (2 mm) to fine (0.25 mm), and were sub-angular in shape.

Fines comprised approximately 11% of the sample by weight, with an overall color most closely matching Munsell reddish yellow (7.5YR 6/6).

There were some lime blebs in the sample; strong gas evolution upon addition of acid to the sample indicated a moderate to high lime content. Approximately 16% of the sample weight was acid soluble.

Figure 5: Location of Sample M3 (left) at Bhandarkhal Tank, and chemical analysis data (right).

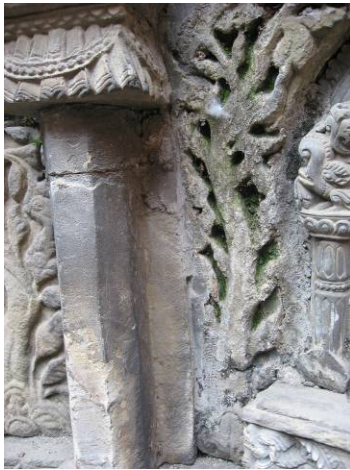
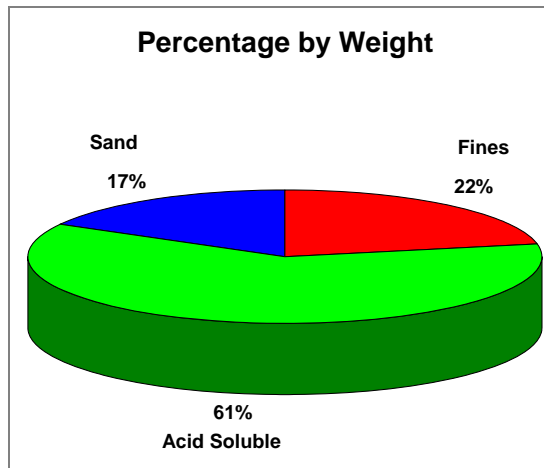
Sample M6 was extracted from repair material on carvings at the Tusha Hiti (Figure 7). The mortar had visible salts and when viewed in cross section the overall color most closely matched Munsell gray (2.5Y 6/1), with a light gray binder. The apparent joint surface of the extracted sample was soiled. Gross sample weight prior to digestion was 0.08 grams. Because this sample was extraordinarily small in size, only rough approximations can be given for the three components (sand, fines, and acid solubles).

Sand comprised roughly 15-20% of the sample by weight. Overall the sand most closely matched Munsell white (5Y 8/1) in color and was composed of grains that were white, clear, and black, with some mica fragments. Grains ranged in size from coarse (1 mm) to very fine (0.125 mm), and were sub-angular to angular in shape.

Fines comprised roughly 20-25% of the sample by weight, with an overall color most closely matching Munsell pale yellow (2.5Y 8/2).

There were no lime blebs in the sample; slight gas evolution upon addition of acid to the sample indicated a low to moderate lime content. Roughly 60-65% of the sample weight was acid soluble.

Figure 7: Location of Sample M6 (left), from repair material on carvings at the Tusha Hiti and chemical analysis data (right).

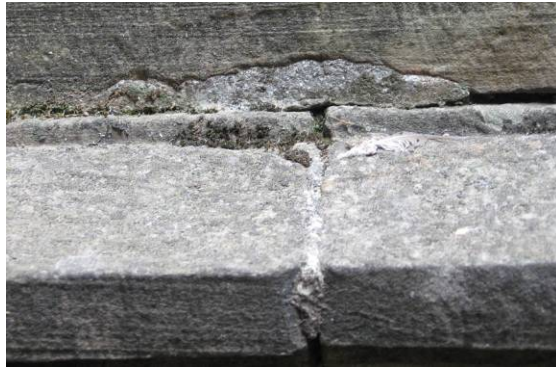
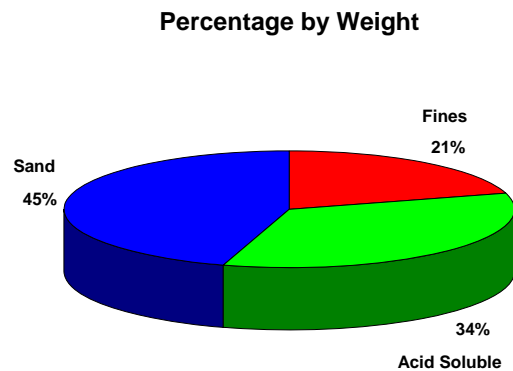
Sample M7 was extracted from a joint at the Tusha Hiti (Figure 8). The mortar when viewed in cross section most closely matched Munsell white (5Y 8/1) and had a visible white binder. The exposed joint surface of the extracted sample was heavily soiled. Gross sample weight prior to digestion was 0.54 grams.

Sand comprised approximately 45% of the sample by weight. Overall, the sand most closely matched Munsell light gray (10YR 7/1) in color and was composed of grains that were white,

clear, orange, and black, with some brick and mica fragments. Grains ranged in size from coarse (1 mm) to very fine (0.125 mm), and were sub-angular to angular in shape.

Fines comprised approximately 21% of the sample by weight, with an overall color most closely matching Munsell pale yellow (2.5Y 8/2).

There were no lime blebs in the sample; strong gas evolution upon addition of acid to the sample indicated a moderate to high lime content. Approximately 34% of the sample weight was acid soluble.

Figure 8: Location of Sample M7 (left) from joint at the Tusha Hiti and chemical analysis data (right).

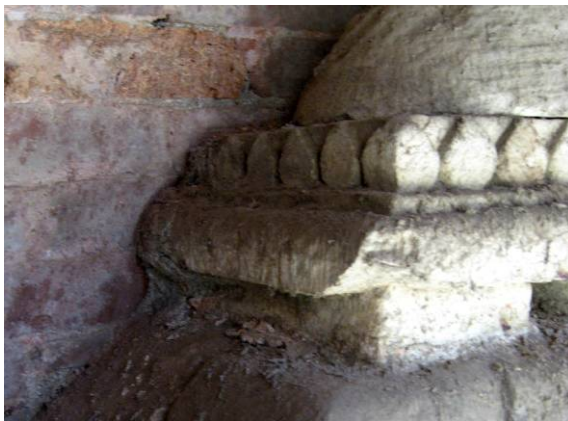
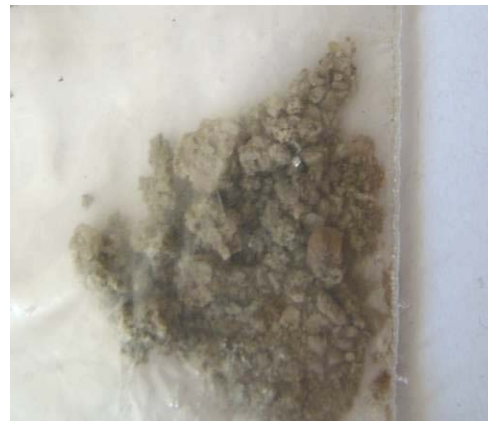
Mortar Sample M1 was extracted from the joint at the top of the shrine. This sample was found not to be highly soluble in water. The sample tested positive for carbonates, calcium and sulfates, which likely indicates the presence of calcium carbonate, likely a component of the mortar, and gypsum (calcium sulfate dihydrate). Gypsum is a common by-product of acid rain and calcium carbonate-based material. Gypsum is slightly water soluble and is therefore usually found in areas which are shielded from rainwater. Though a lack of water solubility was noted in the tested sample, this does not necessarily rule out the presence of gypsum, as gypsum requires a prolonged exposure to water in order to solubilize. The sample also tested positive for nitrates and phosphates.

Figure 9: Location of Sample M1 (left) from the top of the Dui Maju Shrine and detail of sample (right).

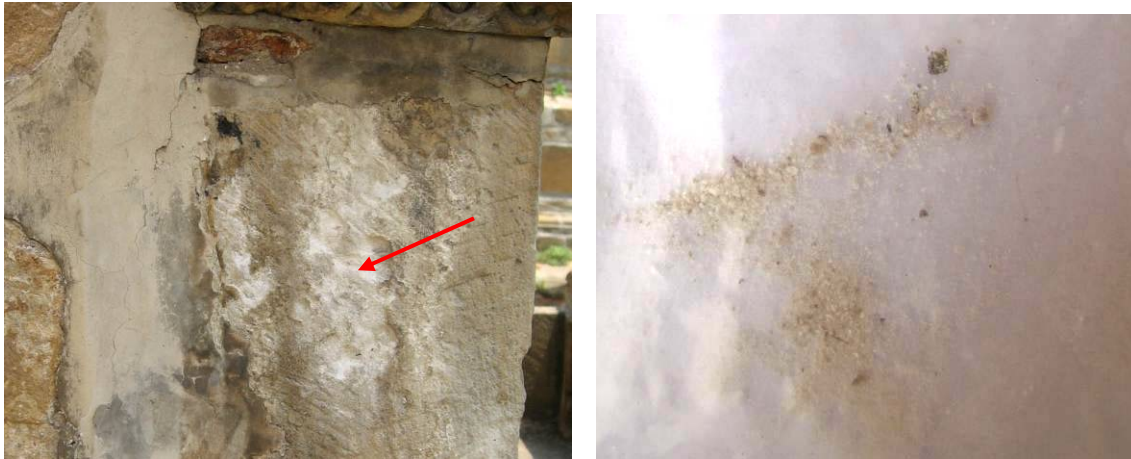
Efflorescence Sample A1 was extracted from the west corner stone of the pavilion exterior. It was found not to be highly soluble in water and tested negative for carbonates. The sample tested positive for calcium and sulfates, which may indicate the presence of gypsum. The sample also contained some nitrates and phosphates.

Figure 10: Location of Sample A1 (left) from the exterior of the Bhandarkhal Tank pavilion and detail of sample (right).

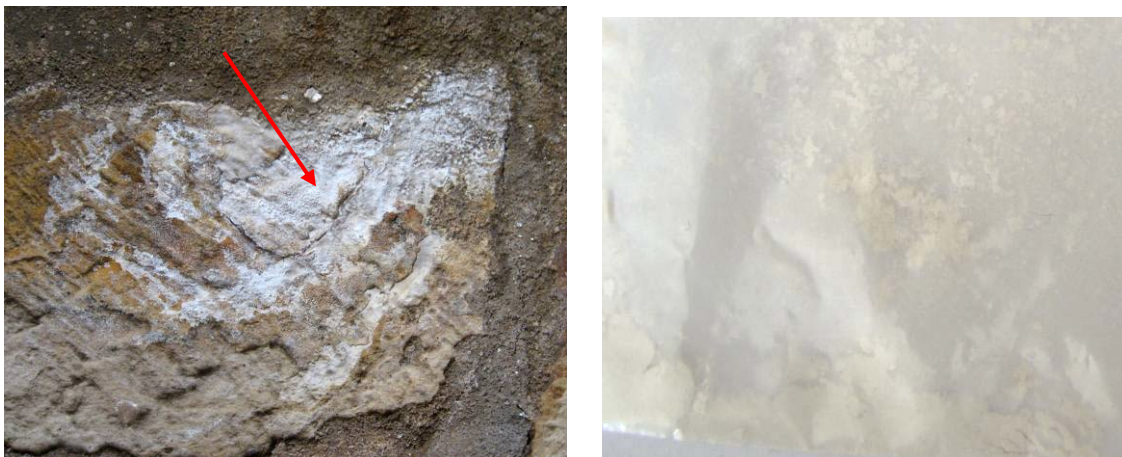
Efflorescence Sample A2 was extracted from a mortar surface on the interior of the pavilion. Sample A2 was found not to be highly soluble in water. Carbonates, calcium and only a very small amount of sulfates were found in the sample, which likely indicates the presence of calcium carbonate and possibly a very small amount of gypsum. A small amount of nitrates and some phosphates were also found in the sample.

Figure 11: Location of Sample A2 (left) from the interior of the Bhandarkhal Tank pavilion and detail of sample (right).

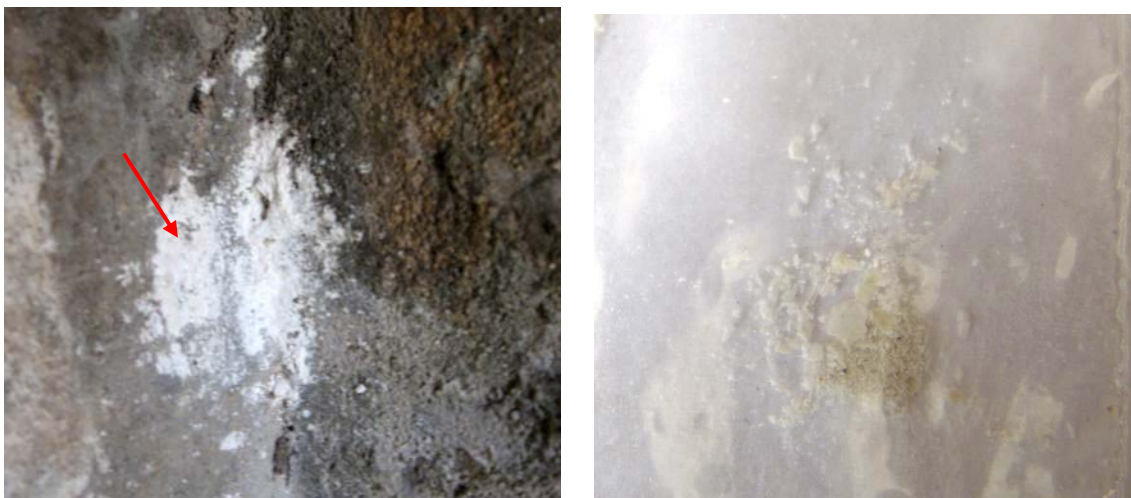
Efflorescence Samples A3 was extracted from the stone surface on the interior of the pavilion. The sample contained a mix of salt efflorescence with some crust. Sample A3 was highly water soluble, contained the highest concentration of sulfates out of all samples and did not contain carbonates. Only a very small amount of calcium was found, but a high concentration of sulfates was observed, likely indicating that the salt is not gypsum but some other sulfate compound. Some nitrates and phosphates were also found in the sample.

Figure 12: Location of Sample A3 (left) from the interior of the Bhandarkhal Tank pavilion and detail of sample (right).

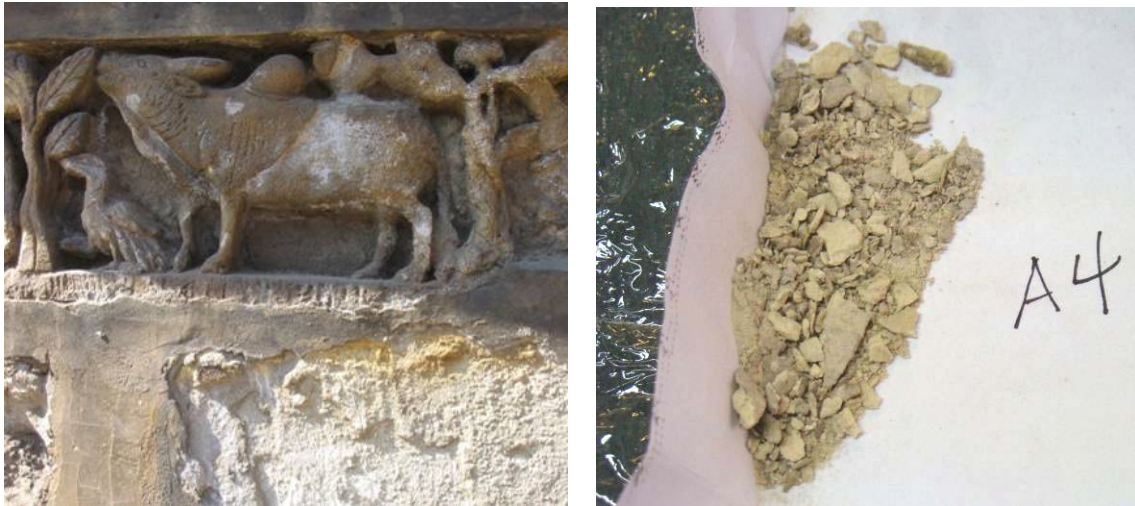
Efflorescence Sample A4 was extracted from the east wall on the exterior of the pavilion. The sample was not highly soluble in water and tested negative for carbonates. The sample tested positive for calcium and sulfates, which may indicate the presence of gypsum. The sample also contained a large amount of nitrates and some phosphates.

Figure 13: Location of Sample A4 (left) from the exterior of the Bhandarkhal Tank pavilion and detail of sample (right).

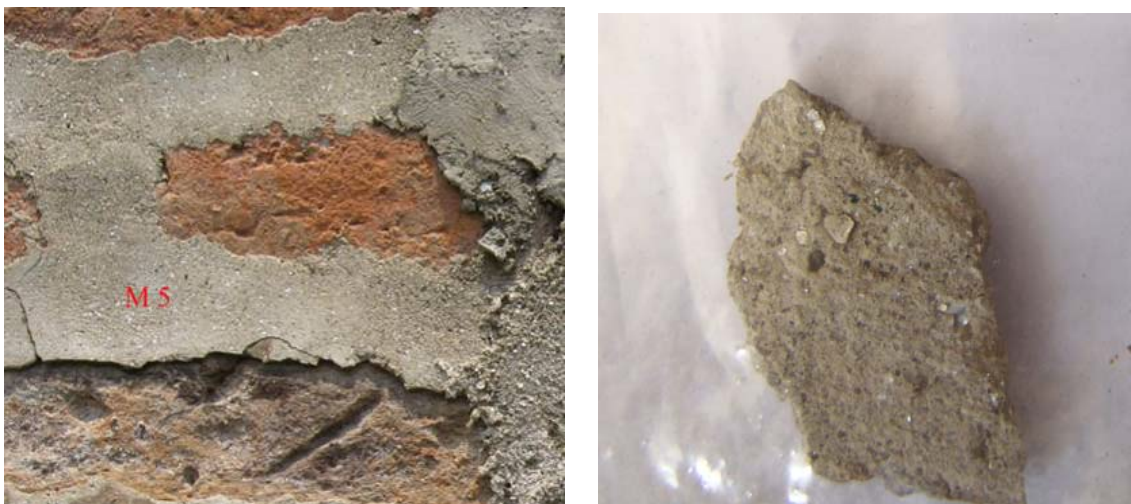
Mortar sample M5 was extracted from the north wall under the pavilion, from mortar that is said to date to 1957. This mortar was also used for repairs of carvings on the pavilion. The sample was found not to be highly soluble in water. The sample tested positive for carbonates, calcium and sulfates. Sample M5 also contained some nitrates and phosphates.

Figure 14: Location of Sample M5 (left) from the north wall of the Bhandarkhal Tank just below the pavilion and detail of sample (right).

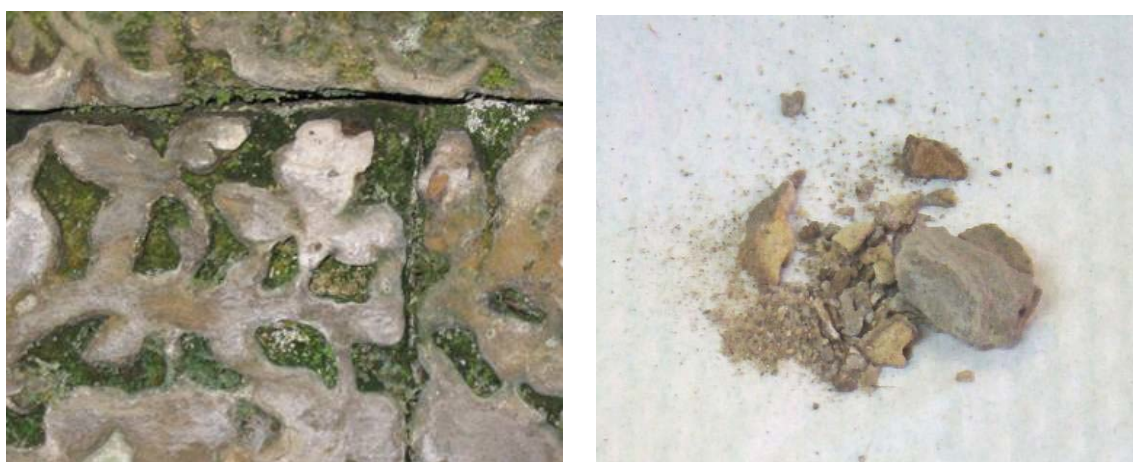
Efflorescence Sample A5 extracted from the east side of the Tusha Hiti. It was not highly soluble in water and tested negative for carbonates and calcium. Some sulfates were observed, likely indicating that the salt is not gypsum but some other sulfate compound. A small amount of nitrates and some phosphates were also identified.

Figure 15: Location of Sample A5 (left) from the east side of the Tusha Hiti and detail of sample (right).

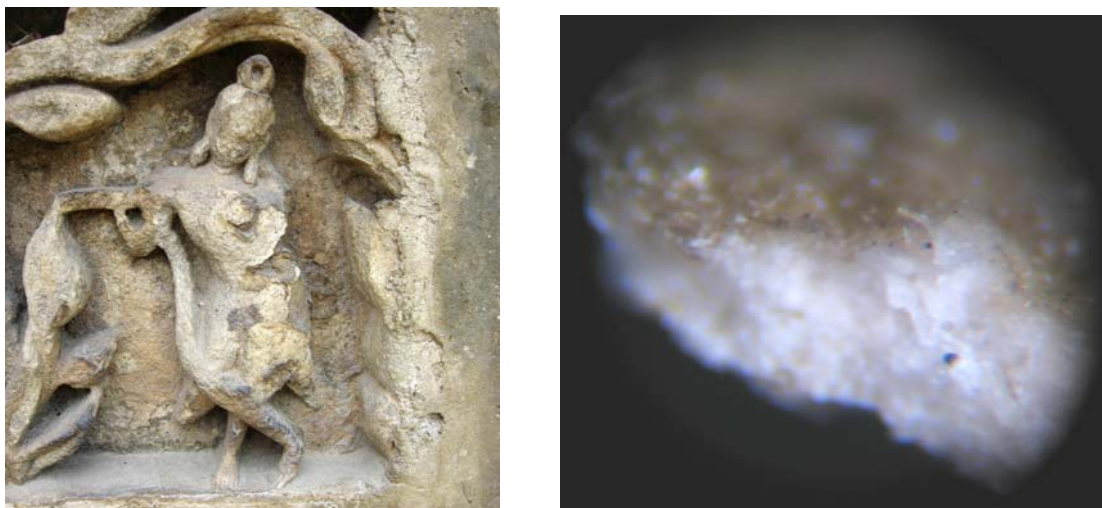
Sample C1 included a portion of stone with a visible clear coating that was extracted from the Bhandarkhal Tank. The clear coating on the surface was identified as polyvinyl acetate (possibly used here as a consolidant, which was a typical method in the 1960s to 1980s).

Figure 16: Location of Sample C1 (left) at the Bhandarkhal Tank and detail of sample with visible coating (right)

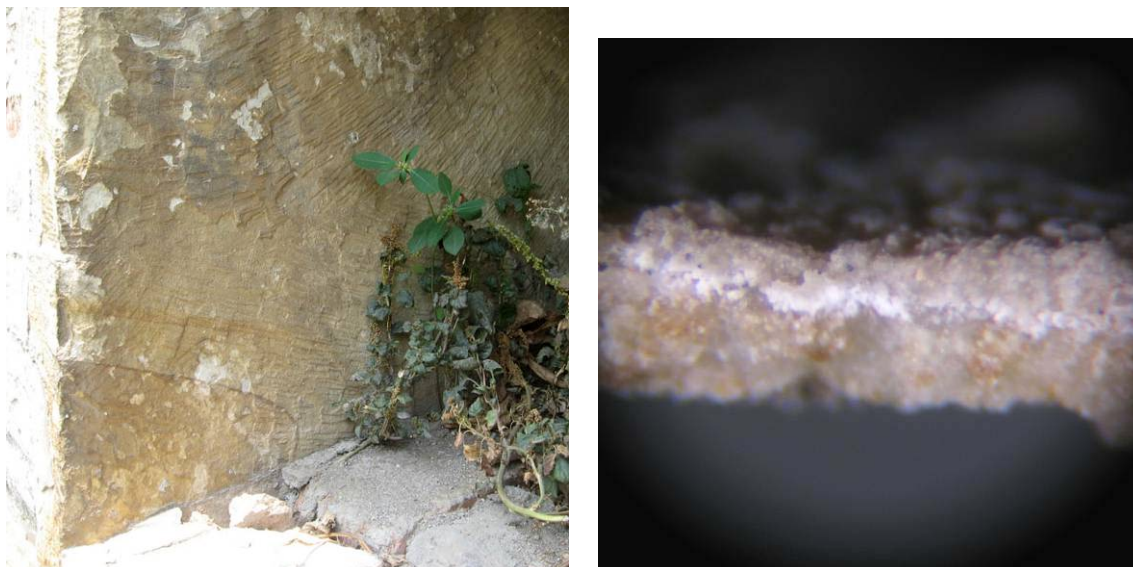
Stone Sample S2 was extracted from the niche on the north wall of the tank, under the pavilion. A surface scraping of Sample S2 revealed a mixture of materials, including gypsum and the same unidentified component detected in Sample M8. In a chloroform soluble extract from Sample S2, long-chain aliphatic hydrocarbon material(s) (which could be, for example, paraffin wax possibly used as a consolidant or water repellent treatment) were identified.

Figure 18: Location of Sample S2 (left) at the Bhandarkhal Tank and detail of sample (right).

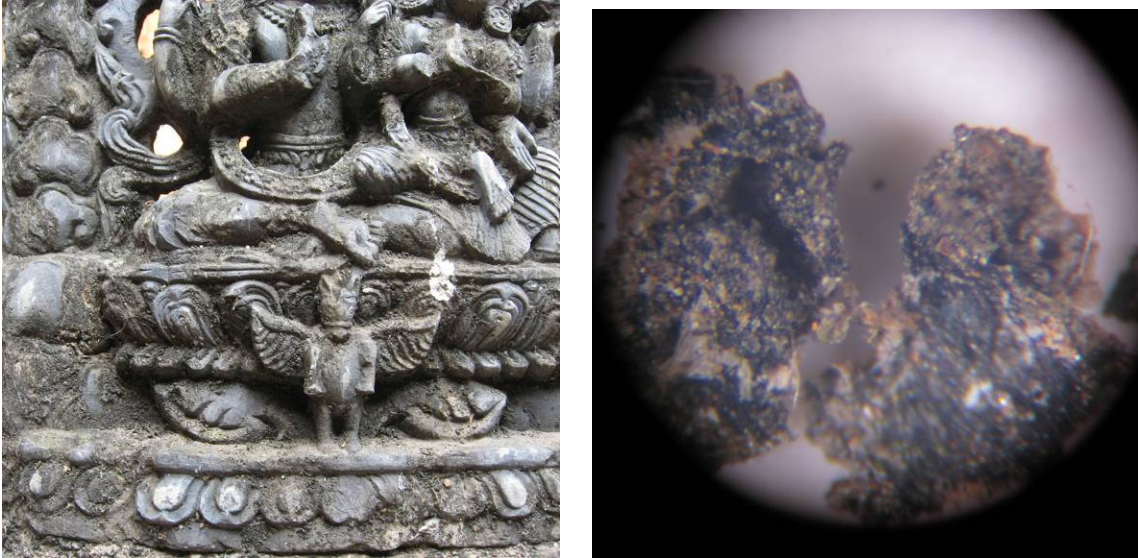
Coating Sample C2 was extracted from black deposits on the east side of the Tusha Hiti. The black coating in Sample C2 contained a mixture of materials, including unidentified protein, quartz, and additional silicate material(s).

Figure 20: Location of Sample C2 (left) at the Tusha Hiti and detail of sample (right).
