# THE PATAN ROYAL COMPLEX

## MULCOK

A Preliminary Proposal for Restoration and Adaptive Reuse  
including a Cost Estimate

May 2006

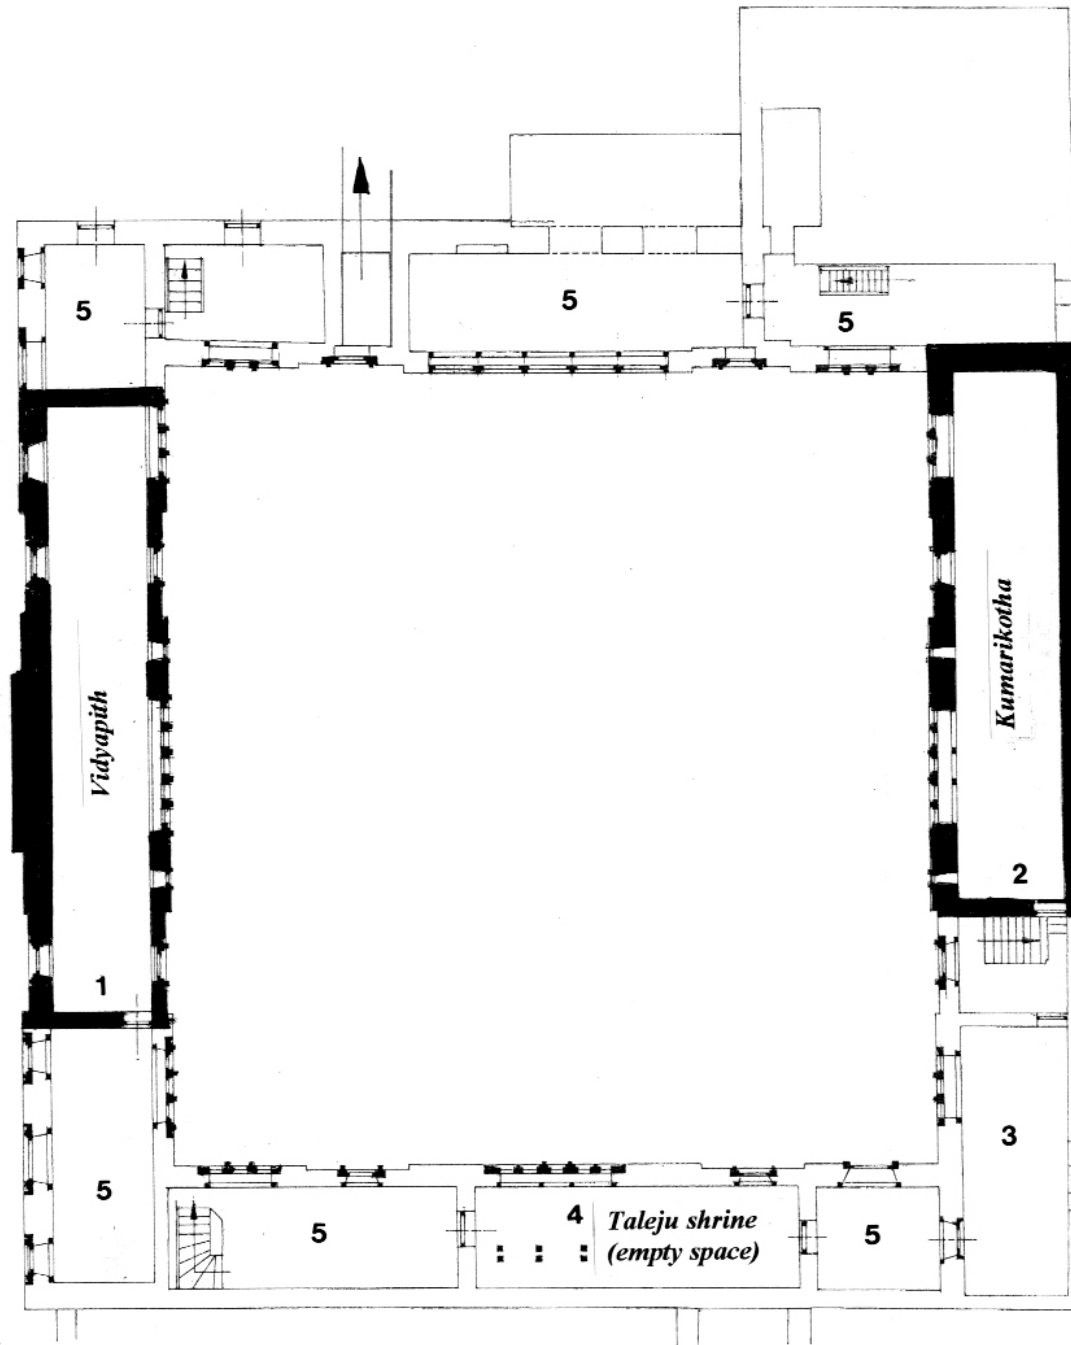
**Mulcok** – First Floor Plan, Scale 1:200  
Existing situation (November 2005)

- 1 Vidyapith of Rajupadhyaya priest, remains closed, worship discontinued.
- 2 Kumarikotha (the Kumari spends here the night of navami, the 9<sup>th</sup> day of Dasain in October).
- 3 Kitchen for the Kumarikotha (used once a year).
- 4 Empty (undefined) space above the Taleju shrine.
- 5 Storerooms (undefined)

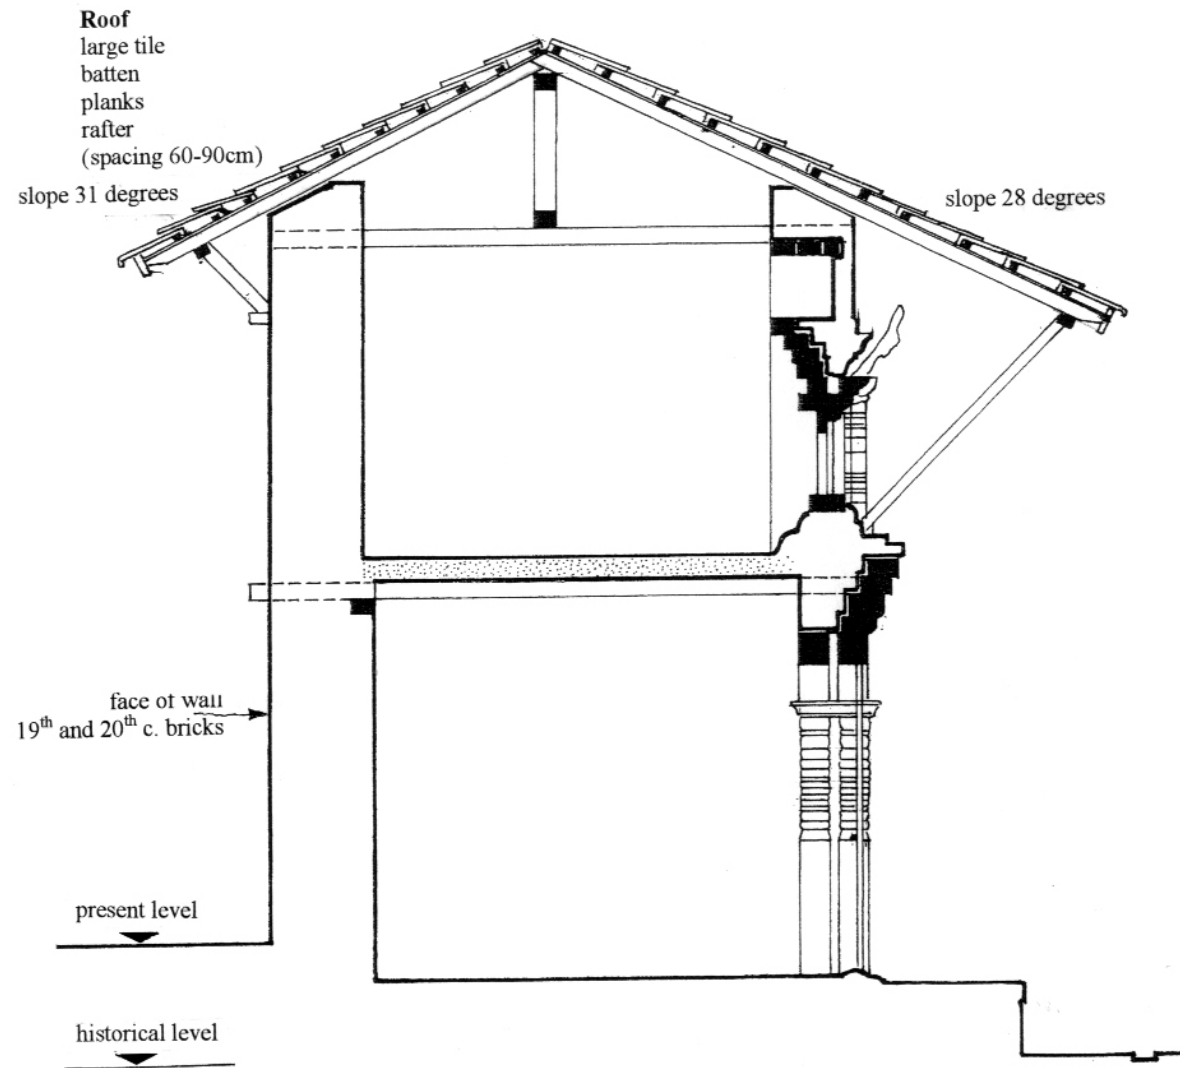
**Mulcok** – Section East Wing, Scale 1:50

Existing Situation

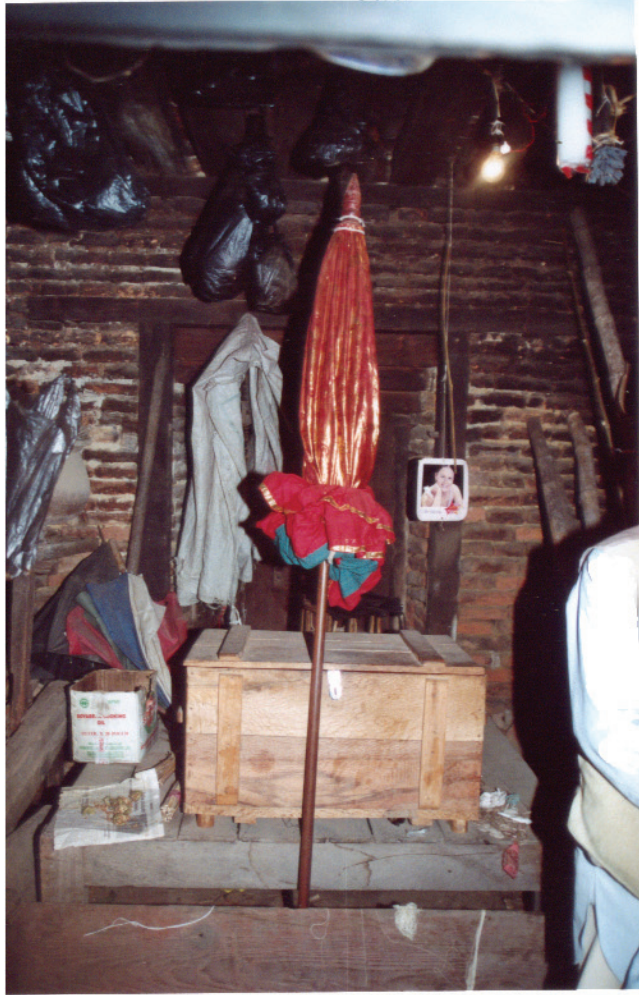
Vest wing, Khadgakothe (left) with a large wooden box for the royal sword that is paraded through the city on certain occasions.

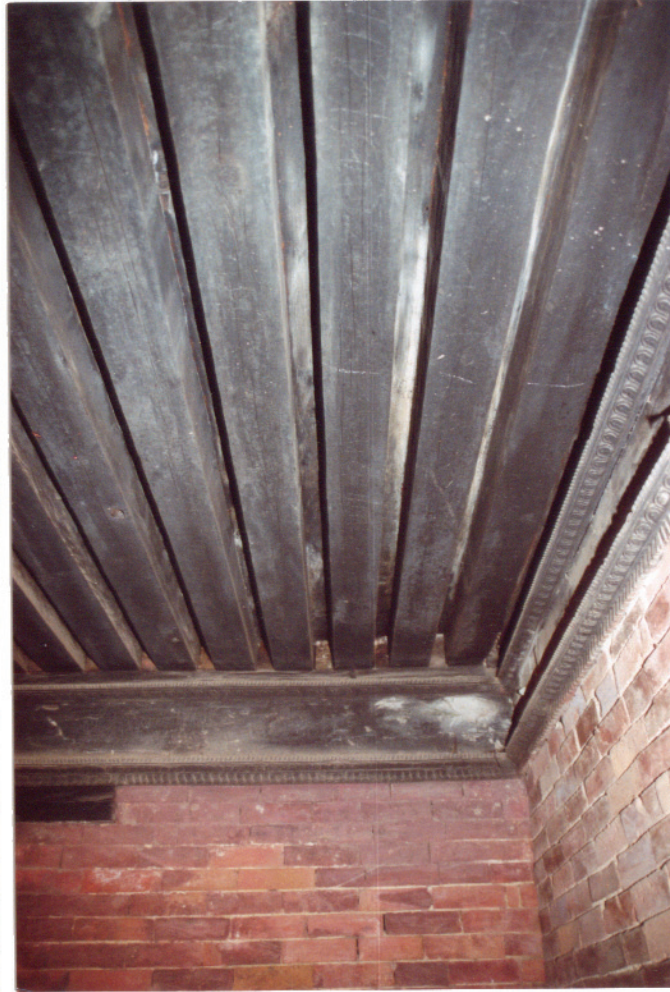
Middle intact, probably 18<sup>th</sup> century narrow spaced ceiling joists (dhalin) above the ground floor arcade (dhalan). The frieze painted on clay below the wall plate has faded away. Right, renewed ceiling joists (1999) in the guard room (the north-western corner room).  
Photo 29 November 2005

Above groundfloor, all joists except above the three arcades will be replaced following the traditional formula of size and spacing which survives above the arcades. Floors will be of 5 cm lime and brick rubble with tiles on top to allow a flow of visitors with minimum production of dust. The walls will be covered by lime and brick-dust plaster.

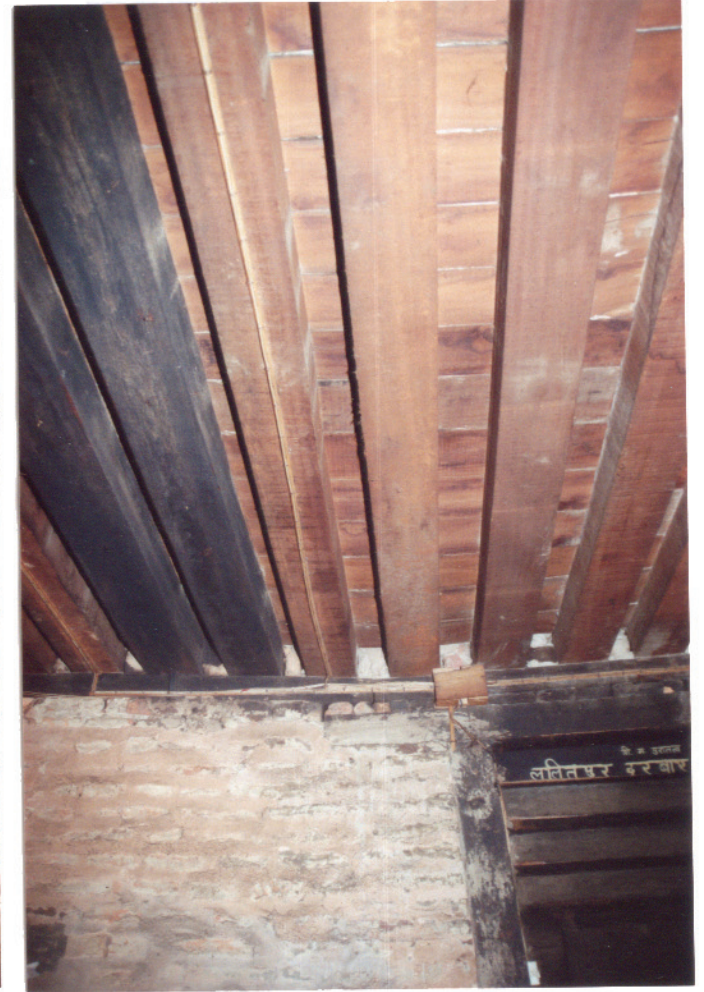
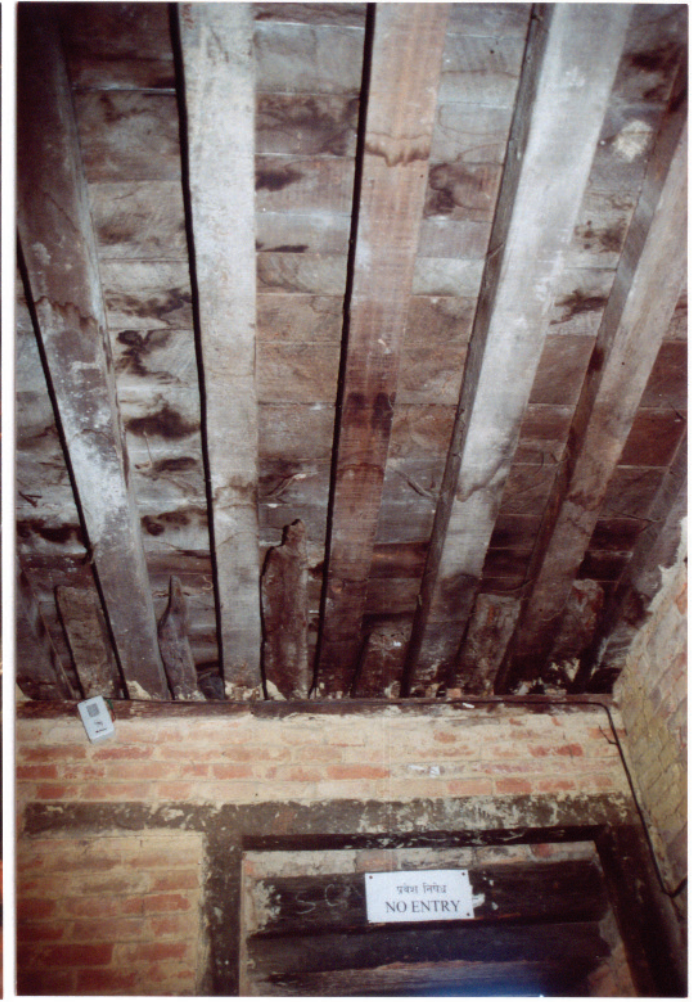
Left, west wing, renewed, ceiling joists in the room, where the Brahmin priest keeps his puja material. Middle, The original narrow spaced ceiling joists in the ground floor arcade (dhalan), the clay panel for painted scenes below the wall plate has been removed in a recent renovation. Right, renewed ceiling joists with planking above the passage to the garden area.

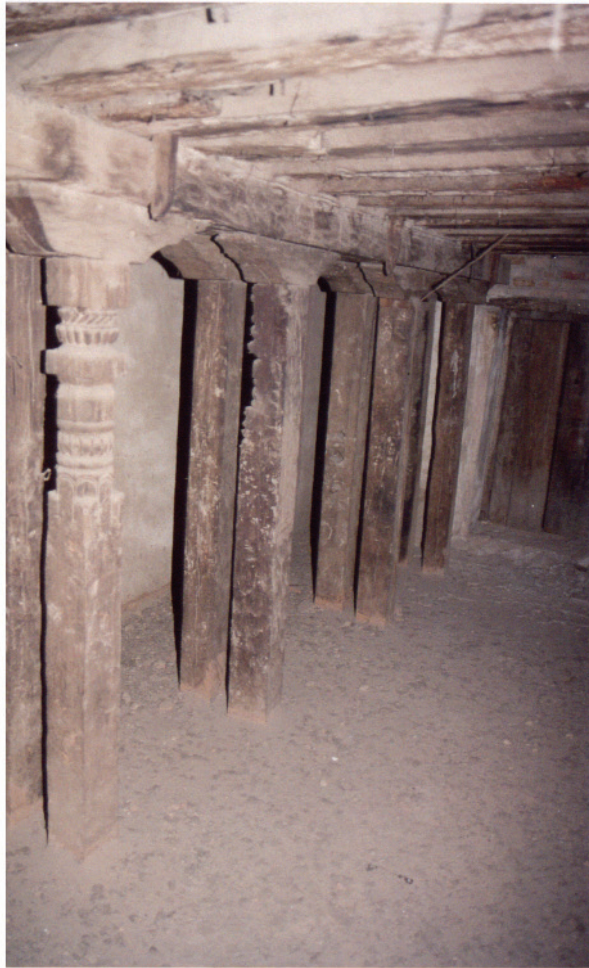
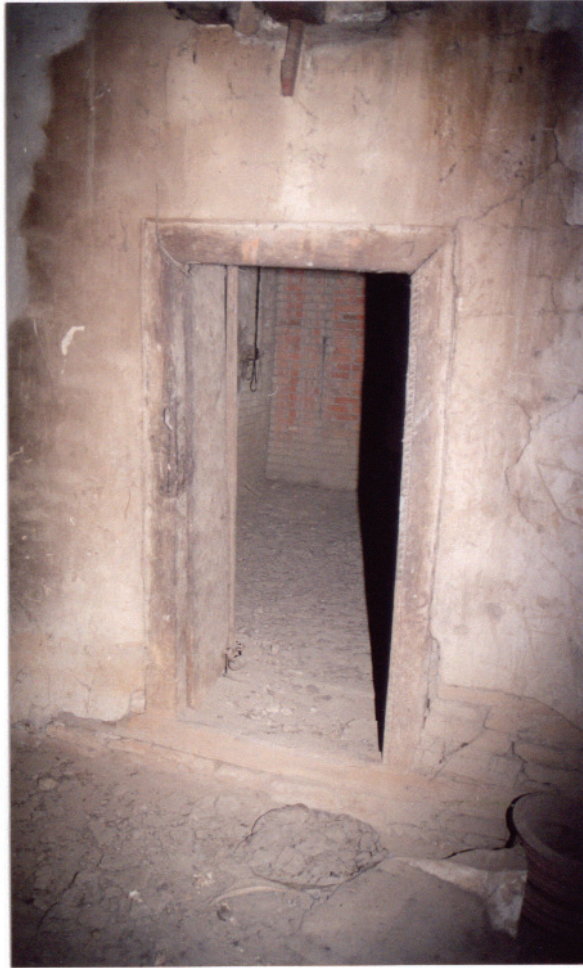
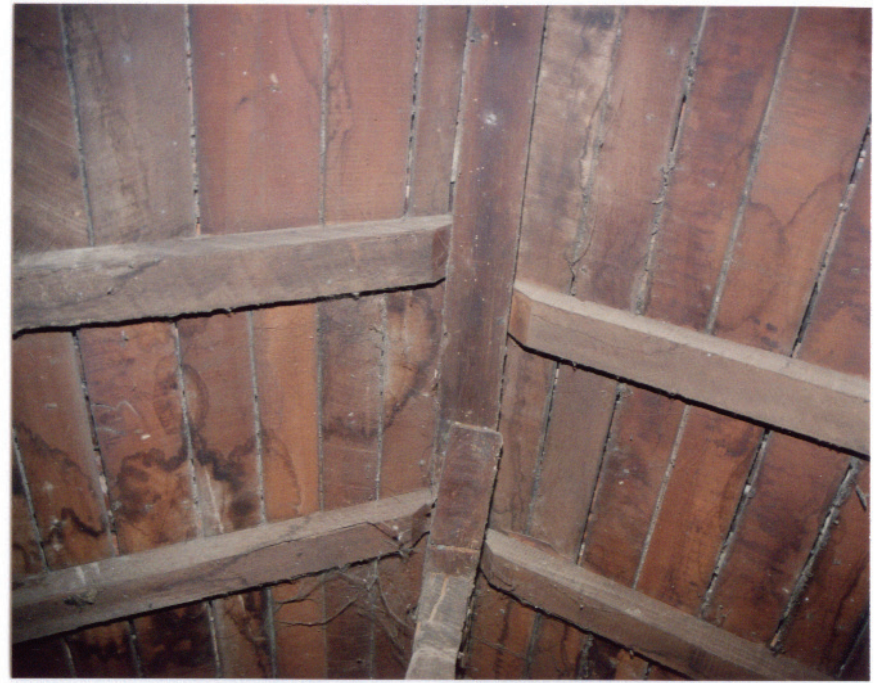
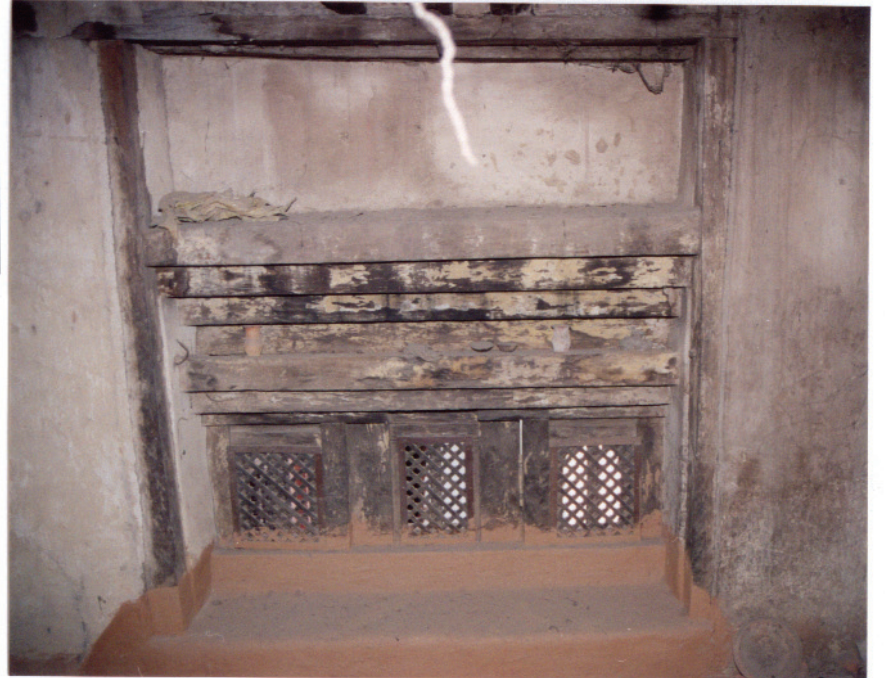
Documentation of rooms, photographs 4 April 2006

Left, row of four double posts bearing the Agam-shrine above the Talejukoṭha. The use of uncarved posts and capitals and undersized ceiling beams indicate a recent (1950s?) replacement.

Middle, door leading to the small room between the Kumārī-kitchen and the room above the Talejukoṭha.

Right, the inner frame of the triple window of the Kumārī-kitchen is largely intact. The roof displays a makeshift character with widely spaced rafters with a layer of planks. Regular shrinking makes the covering layer of tarfelt visible.

The renewal of the entire roof with historic rafter size and spacing is mandatory. In deviation from the present situation, marine plywood will have to be used as covering material, with an additional layer of multiplast. The roofing with clay and roof tiles follows the historic formula.

The relatively recent (appr. 1985) renewal of the entire roof is of a standard that makes a complete replacement mandatory. The aim is to reinstall historic standards which are based on flat proportions of the rafters (*musī*, 15 cm broad, 10 cm high) with a gap in between of 15 cm. Until the 19th century rafters were covered by long flat tiles (*cilāapā*) with a small rebate to hold the covering layer of clay. Only by the middle of the 20th century this standard was replaced by planking, topped by tarfelt to ckeck seepage. Reed or split bamboo was regularly used for residential buildings. For the replacement of the roof, the long flat tiles are reintroduced within the visible section of the projecting eaves. For the remaining section marine plywood is suggested to ensure a smooth surface for a layer of highly durable multiplast. Battens nailed on top of multiplast serves to hold the layer of clay into which the roof tiles (*āypā* or *pvalāapā*) are pressed.

Marine plywood represents an introduction of a new technique similar to the introduction of planking and tarfelt only two generations ago. Planks were never dry, the shrinking produced gaps through which the tarfelt was not only visible, but often the bitumen was leaking and finally it broke at such gaps. The nailing of marine plywood improves the stability of the structure considerably and produces an immaculate surface, fit for a museum space that has to be clean and avoid dust.

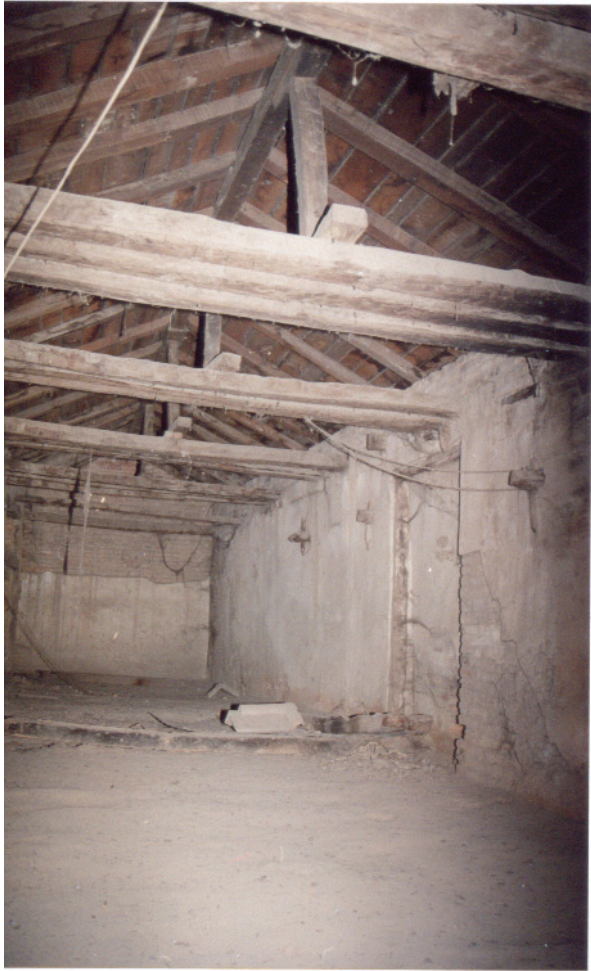
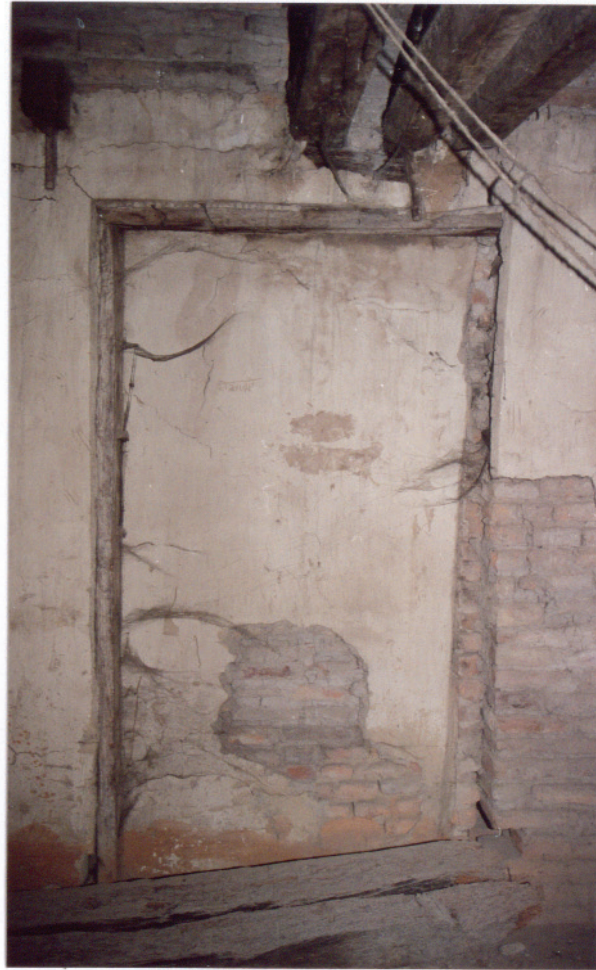
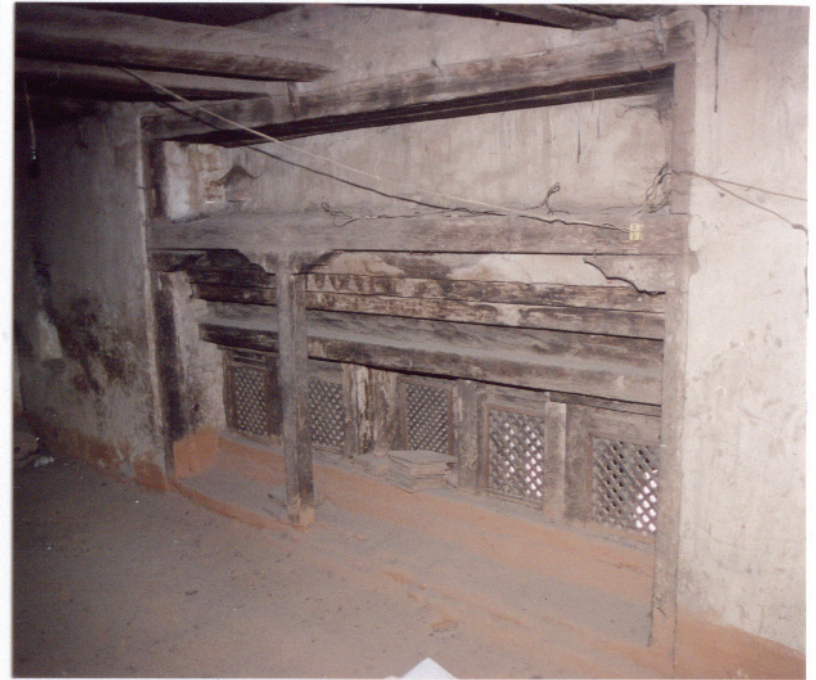
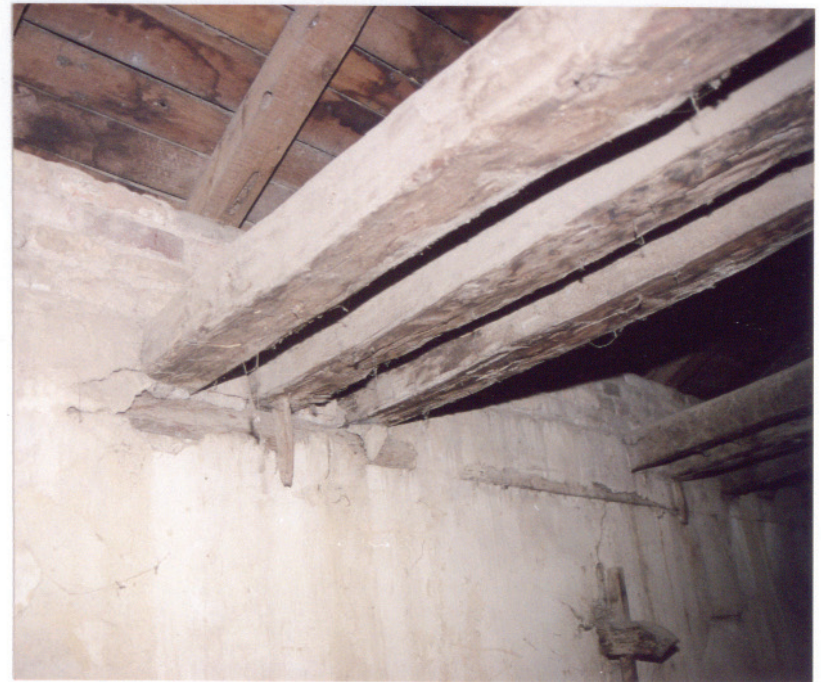
Documentation of rooms, photographs 4 April 2006

The roof had been renewed with widely spaced rafters in the 1980s, its posts and base resting on triple joists. The mud plaster probably date to the 1950s. A door frame indicates a former accessibility from a balcony, that existed until the 1950s. The inner frame of the fivefold window (*pasukājhyah*) is largely intact, one post is missing.

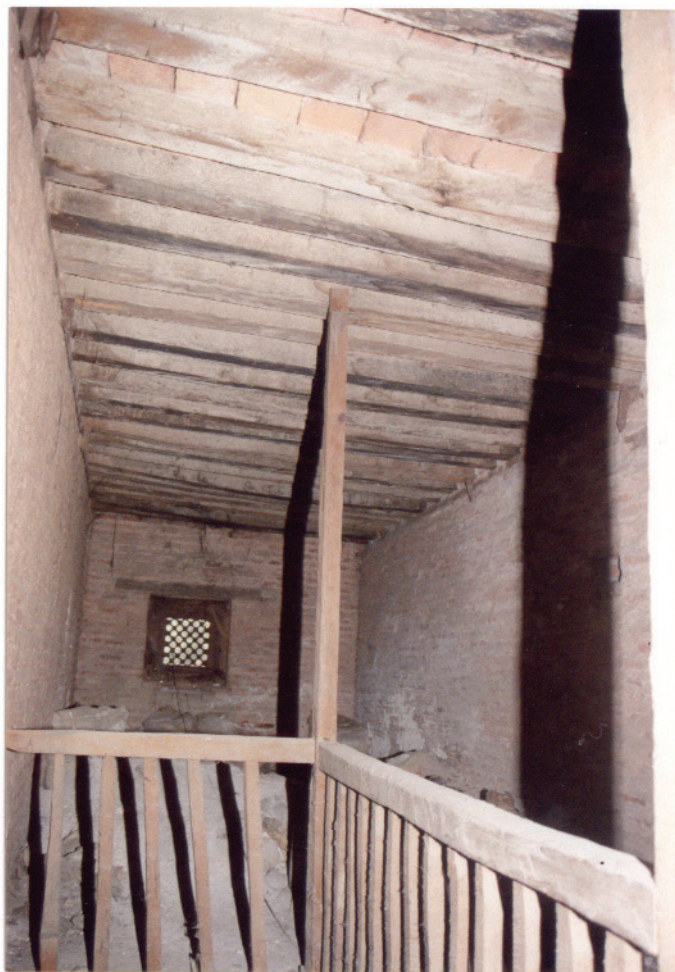
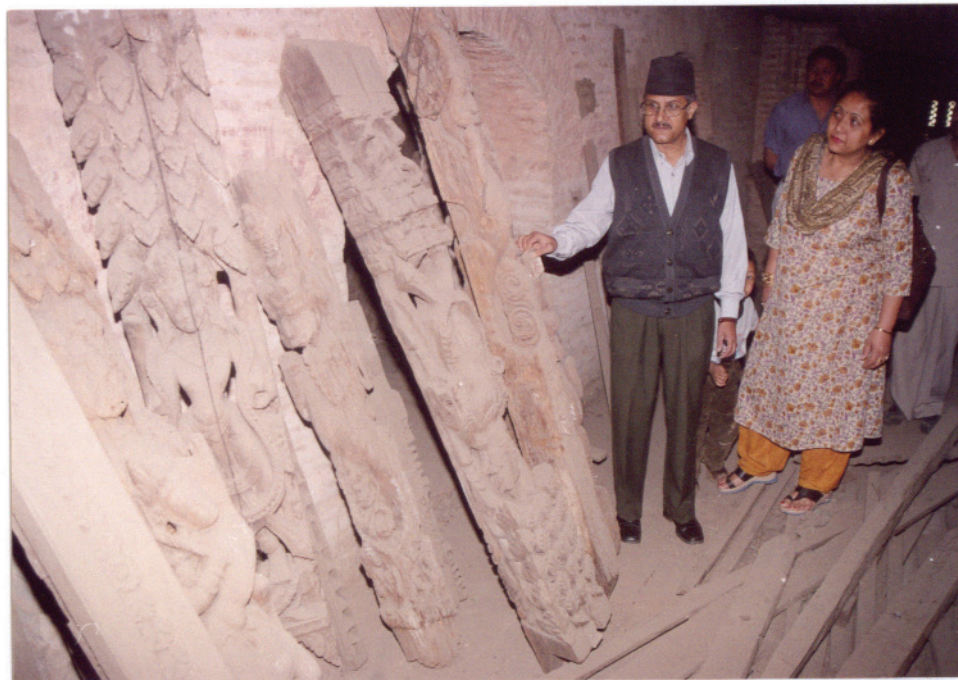
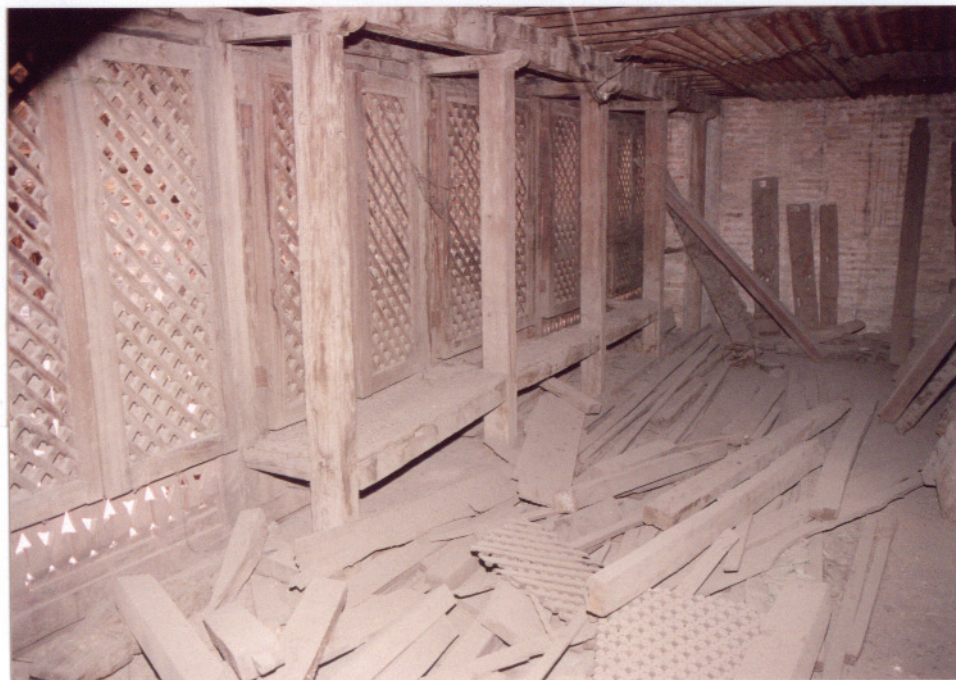
Kumārīkoṭha, the room which until 2004 had been used by the Kumārī during Dasain (in October).

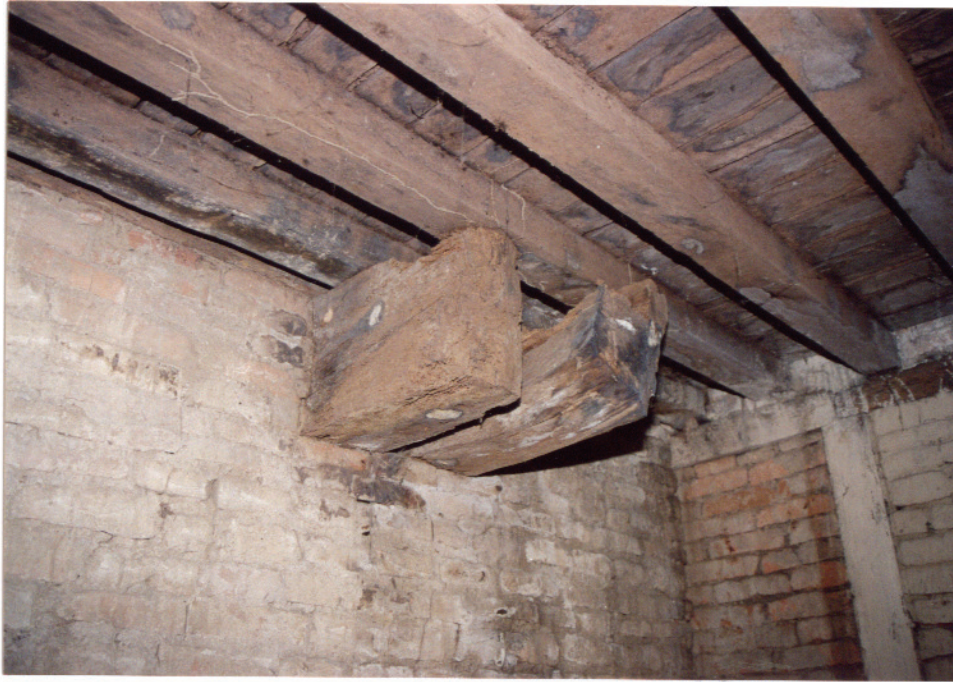
Documentation of rooms, photographs 4 April 2006

Wide-spaced, undersized ceiling joists are covered with planks.

A door-frame indicates a former access to the narrow corridor south of the courtyard. Two beams (*ninaḥ*) which bear the northern wall of the Agam-shrine project from the wall that divides the *jamarakoṭha* from the Talejukoṭha.

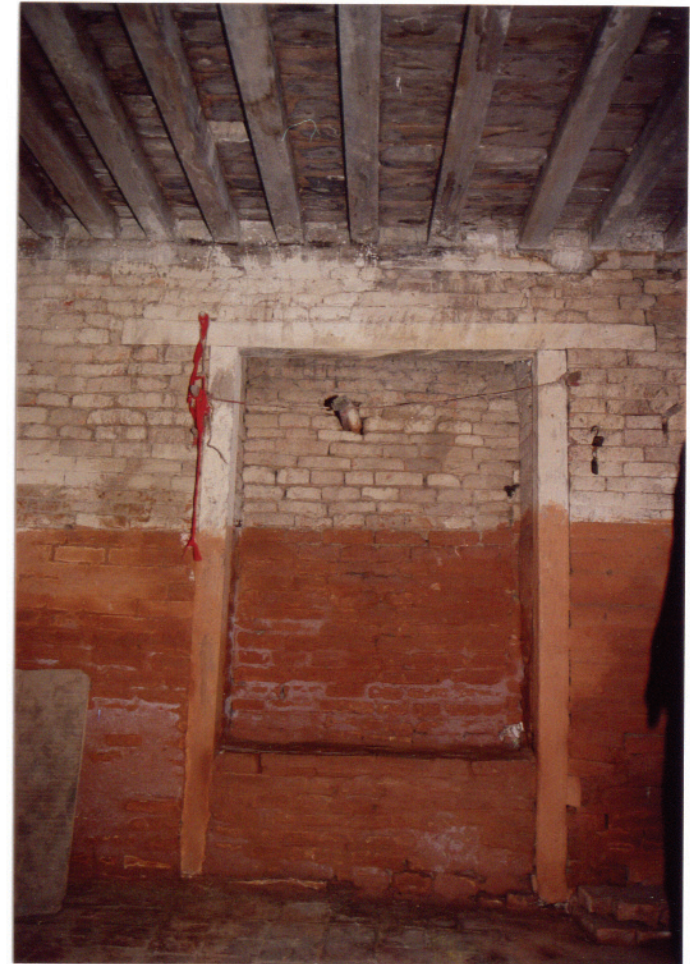
A large variety of brick types suggest that the entire wall was repaired in patches until very recently. The use of so called "Chinese bricks" from the brick factory in Harisiddhi demonstrates an ongoing process until the 1990s.

*Datiāpa*, the veneer bricks that stand out as an important contribution of Newar architecture to world art, can be found only in isolated locations. They are certainly not found in situ but were obviously reused from demolished walls. *Maāpa*, flat sized "traditional bricks" (without frog) are widely used, especially in the southeastern corner. Recent repairs with late 20<sup>th</sup> century norm bricks (*desiāpa*) in thick joints of grey clay were used to fill up larger patches.

A door on ground floor level was closed after the 1934 earthquake, its jambs got rotten as the backyard has been filled up by debris. Two door frames on first floor level represent vestiges of a former, possibly pre 1934 existence of an arcaded balcony.

- 1 at a height of 210 cm *maāpa*, size 20 x 15 cm.
- 2 below the left lintel end of the window *datiāpa*, size 21 x 6 (high)
- 3 above the right lintel of the window *maāpa*, size 20 x 15 x 4.5
- 4 Chinese brick 24 x 6 cm
- 5 left of the door lintel *maāpa* 18 x 4 and Chinese brick 24 x 6 cm.
- 6 modern norm bricks (*desiāpa*) 23 x 6.5 cm
- 7 large patch of Chinese bricks 24 x 6 cm
- 8 rotten lower end of door jamb, door opening filled with *maāpa* and *desiāpa*.
- 9 fragment of a door frame, the opening filled with *maāpa* and *desiāpa*
- 10 patches of mud plaster above the ceiling joists, above a patch of *maāpa*, 21 x 4.5 cm.
- 11 above the left lintel end *maāpa* and isolated *datiāpa*
- 12 large crack where two types of bricks meet: left *maāpa*, right *datiāpa*.

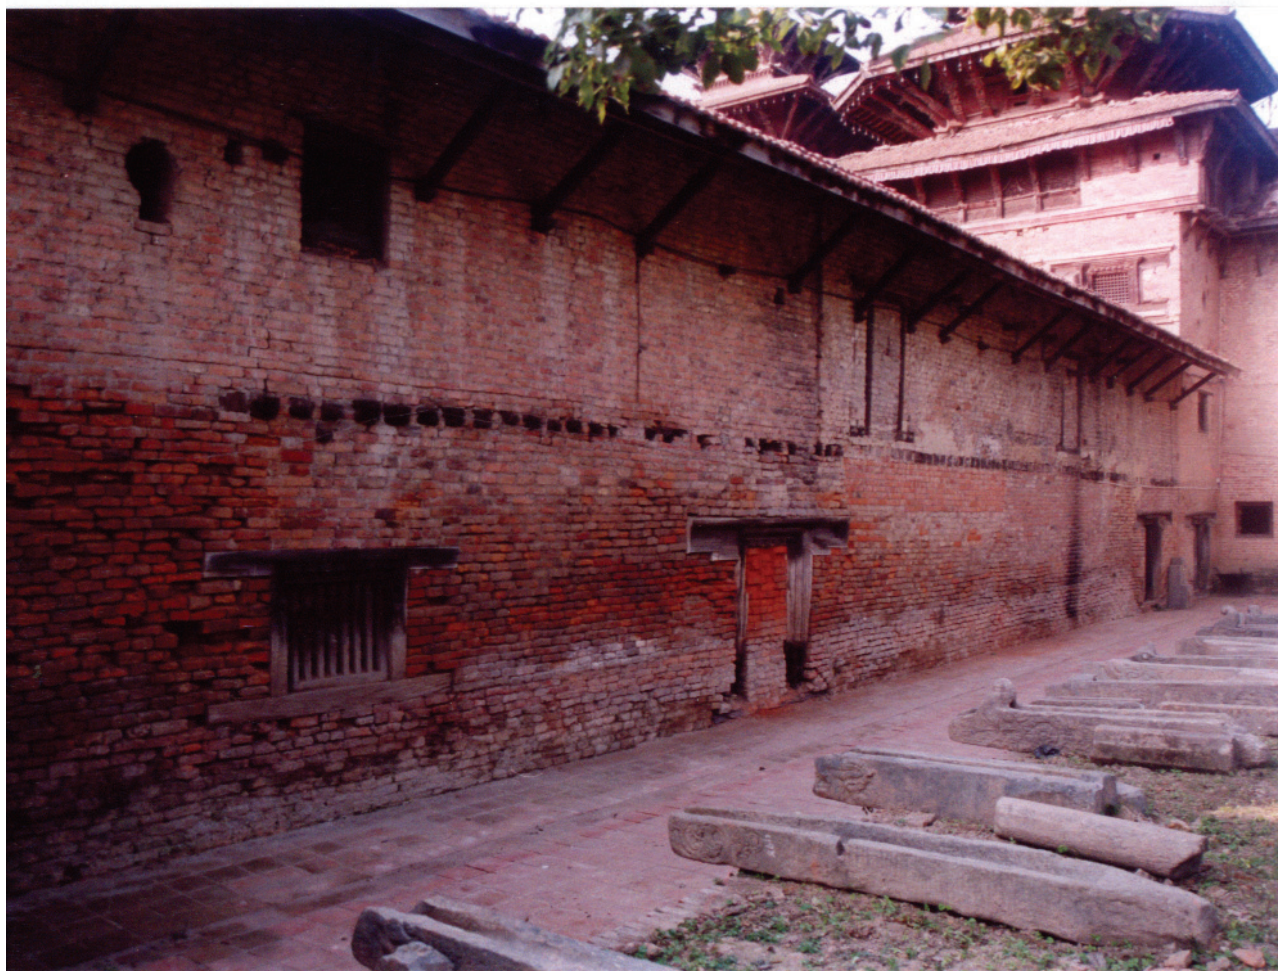
*Jamarakoṭha* - the room to grow barley during Dasain

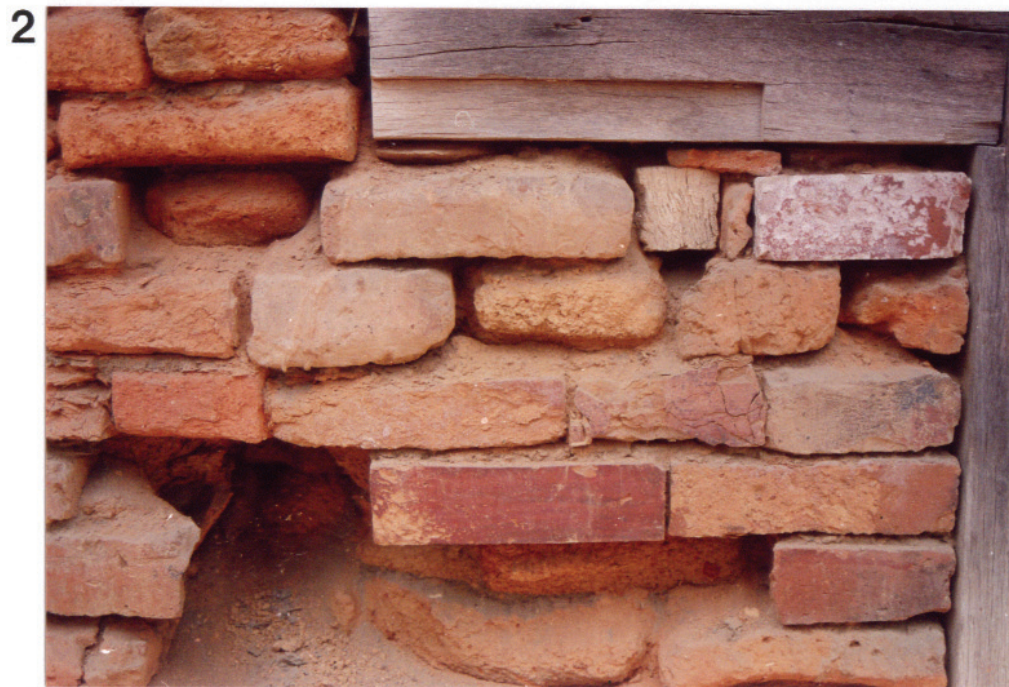
Documentation of bricks of the garden facade  
(photographs 4 April 2006).

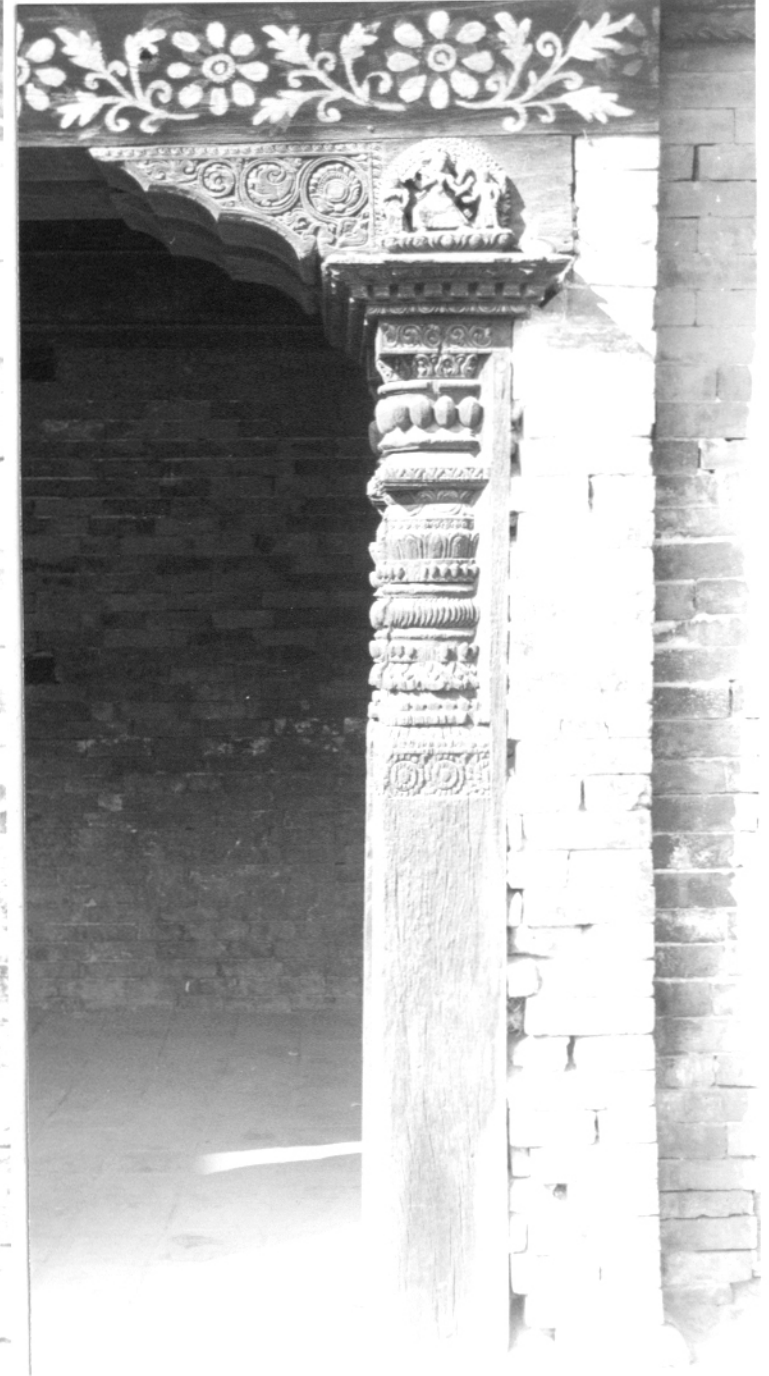
Mulcok: pillars framing the arcades. Left at the eastern arcade, middle and right at the western arcade. Photo 1<sup>st</sup> December 2005

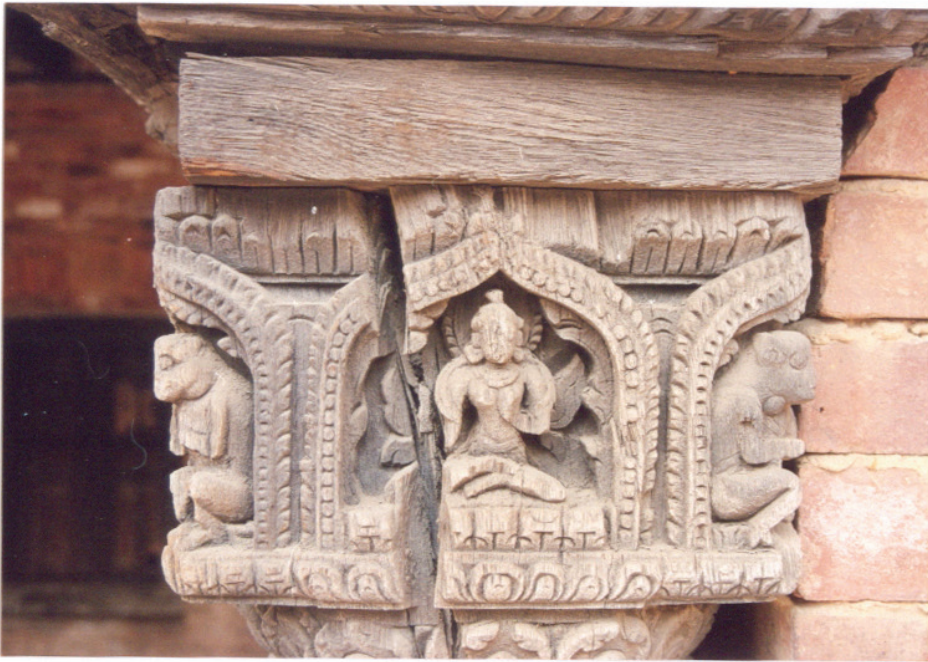
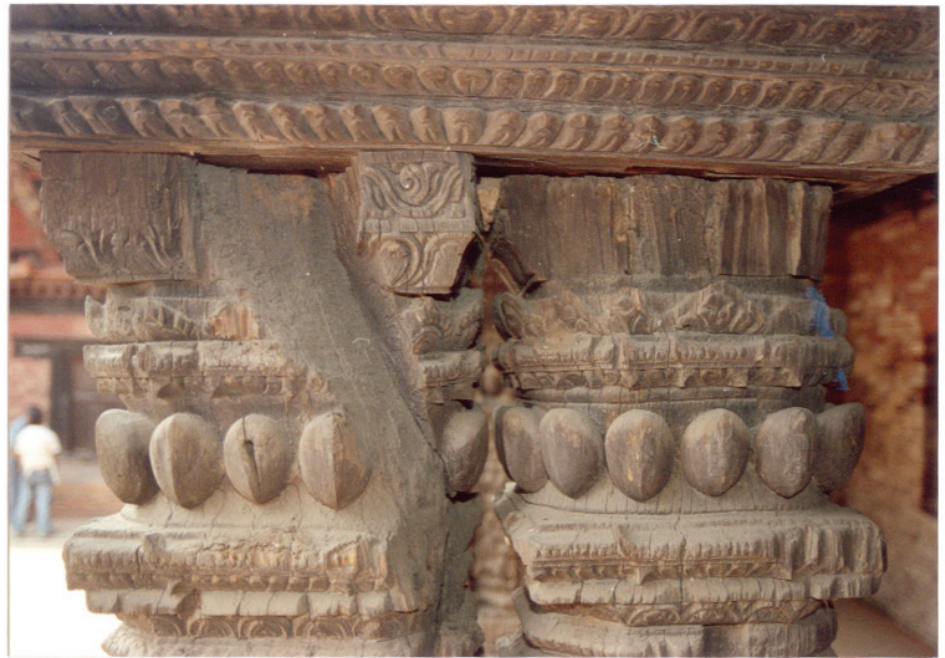
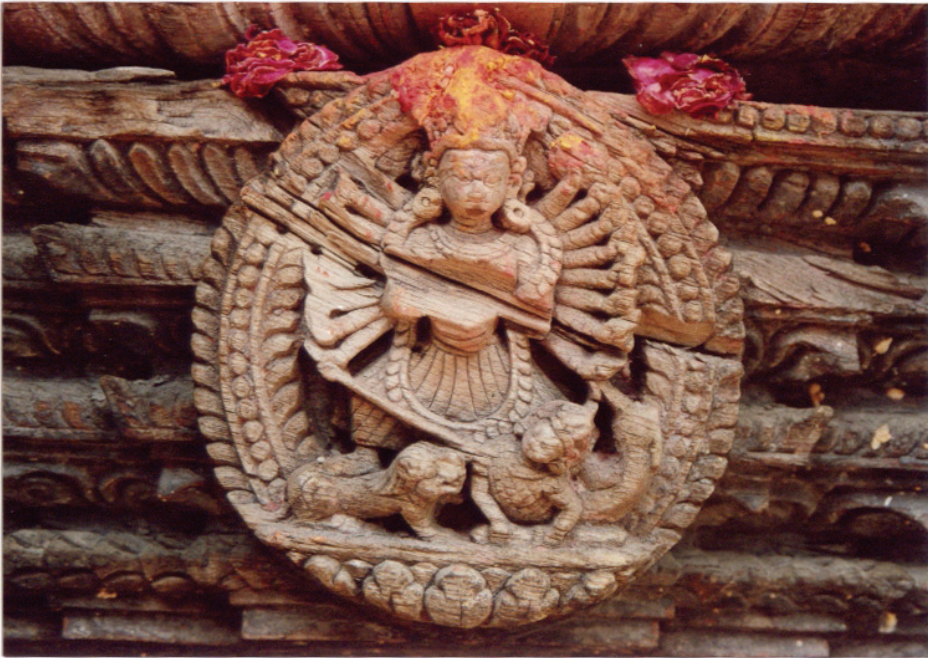
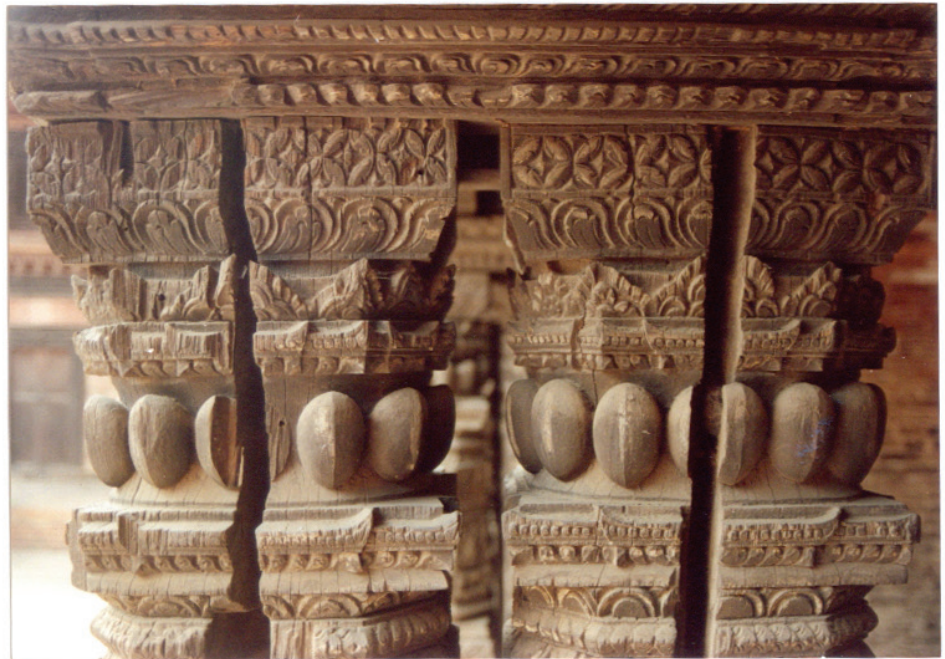
Upper ends of pillars of the northern arcade (*dalan*).  
Cracks document the fact that fresh timber was used for carvings.  
Lower left: Durgā as the slayer of the buffalo demon on the lintel  
of the door leading to the Mūchē Āgama, lost in 1934.

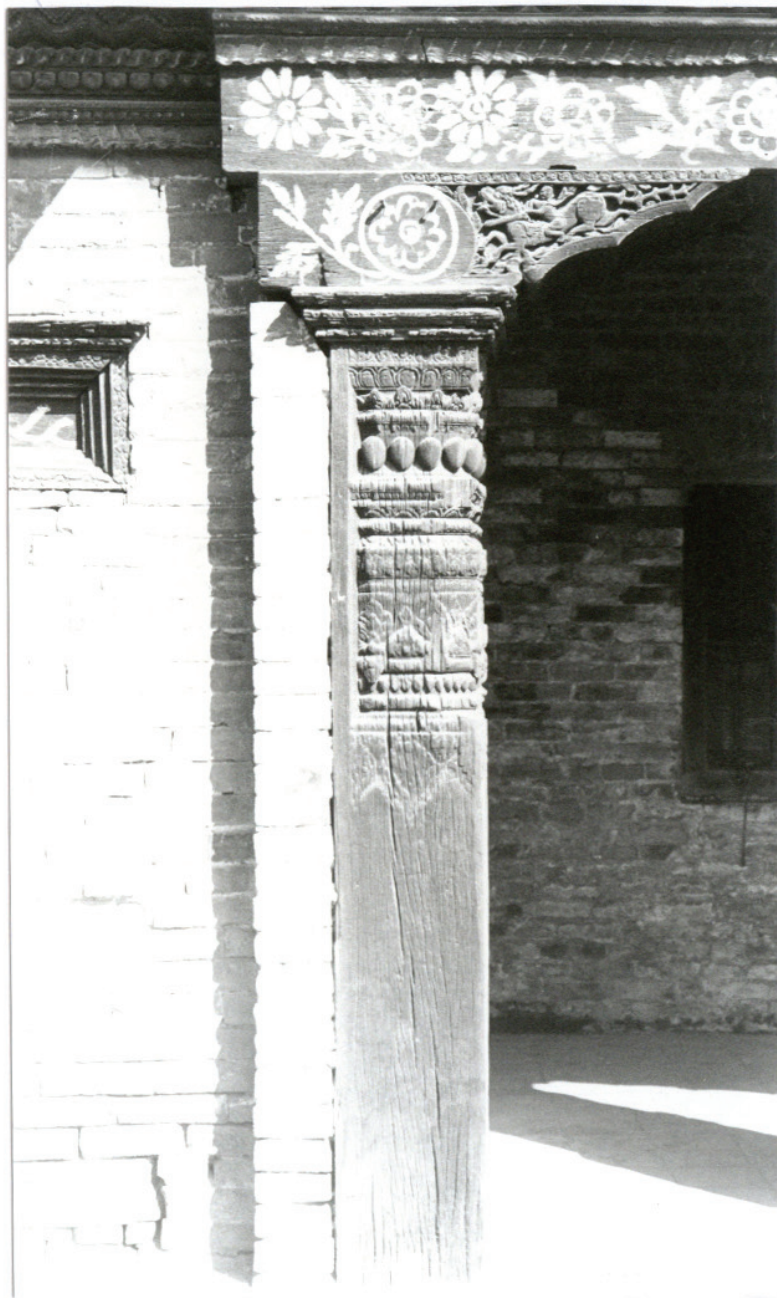
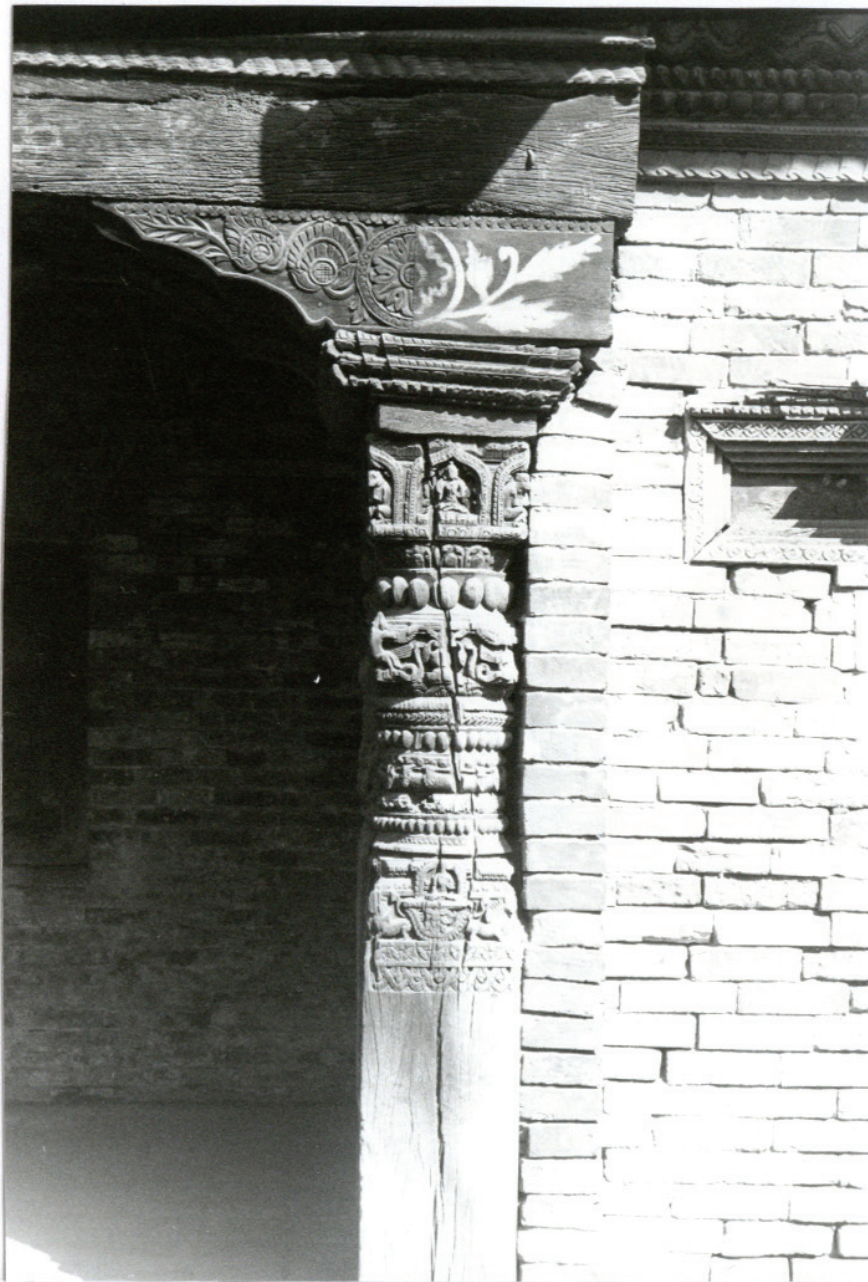
Mulcok: the framing pillars of the north wing arcade. The pillar at the eastern end is out of place as it is not designed to be placed on a wall tongue. The painted floral decoration dates to the 1980s. Photo 1<sup>st</sup> December 2005
