# THE PATAN ROYAL COMPLEX

## MULCOK

A Preliminary Proposal for Restoration and Adaptive Reuse  
including a Cost Estimate

May 2006

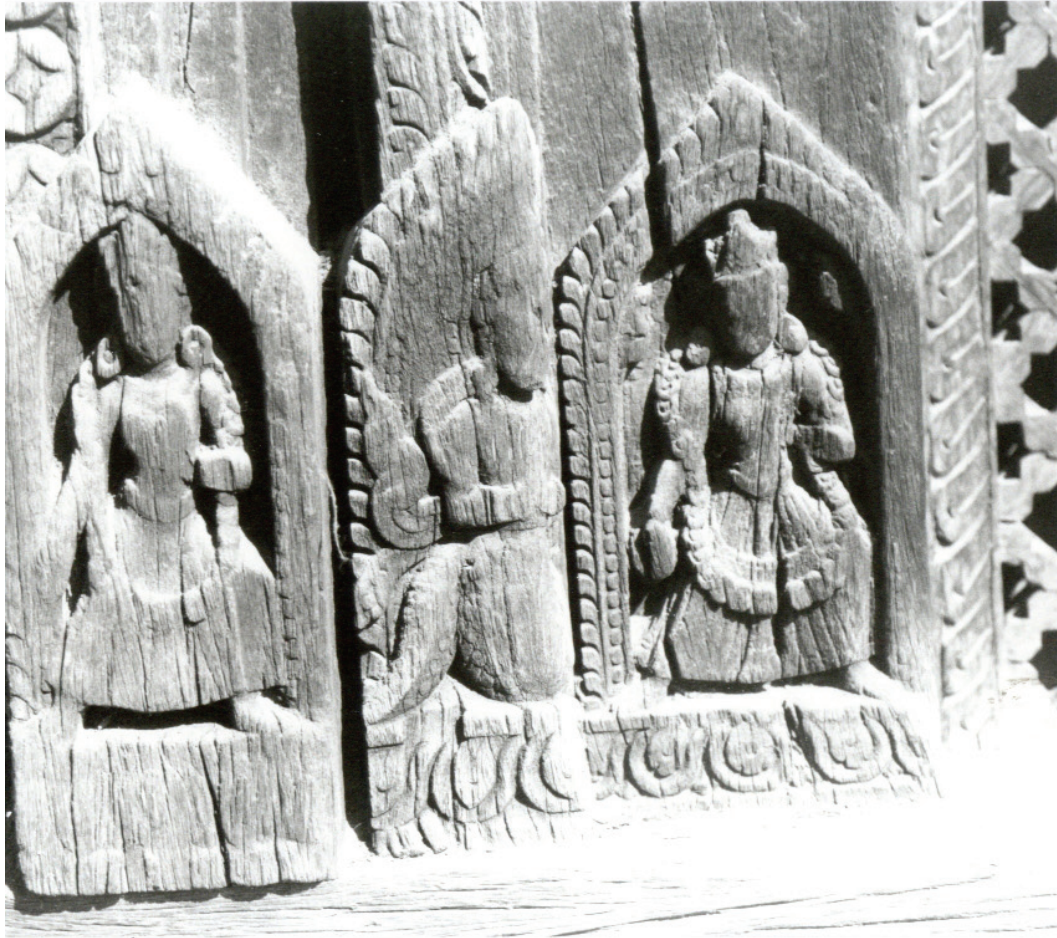
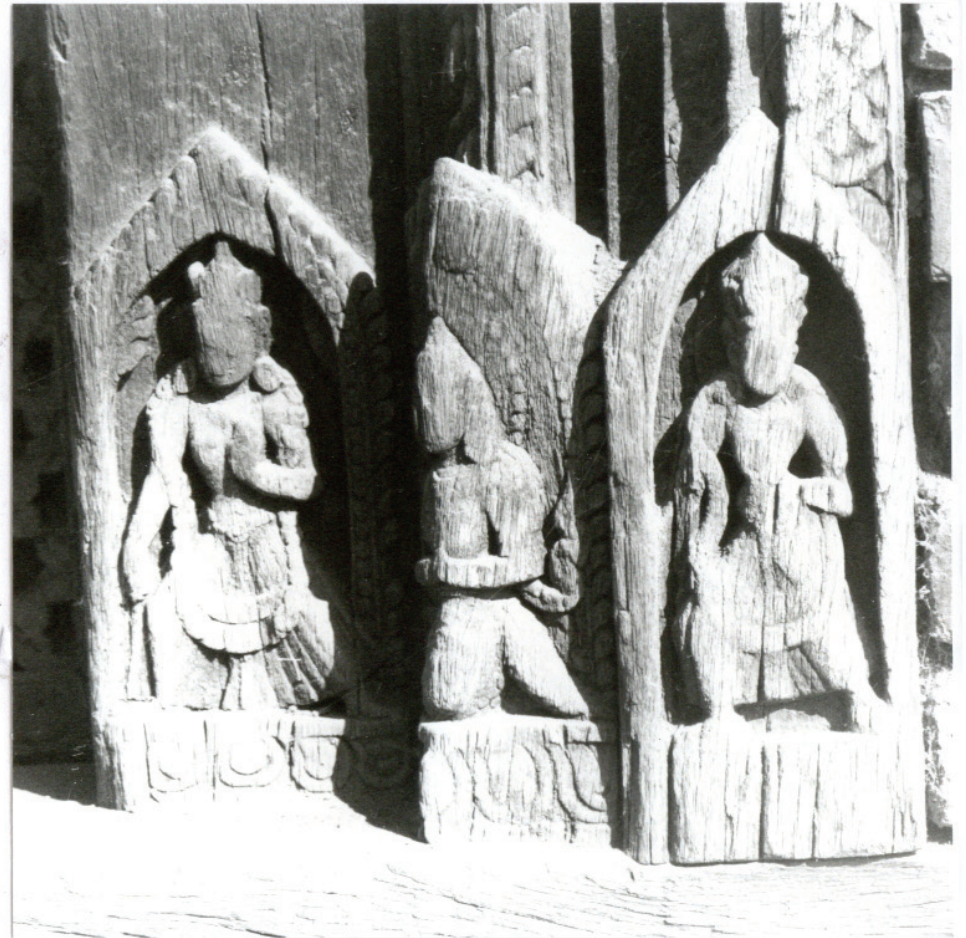
Mulcok: bottom of door jambs in the north wing. The door openings are guarded by three protective deities, in the middle a snake virgin (nāgkanya) with the gesture of adoration.  
Photo 1<sup>st</sup> December 2005

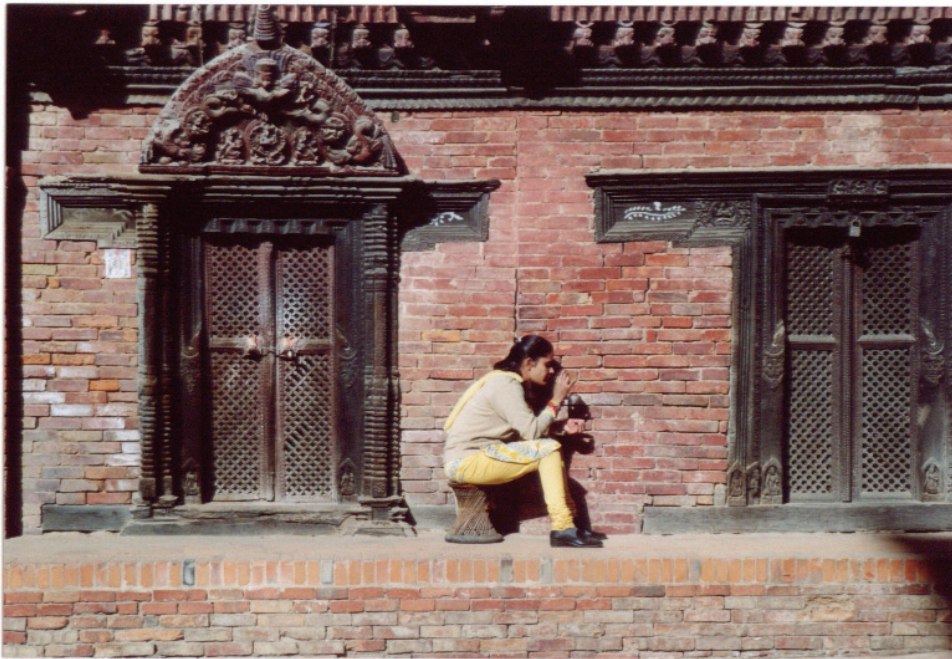
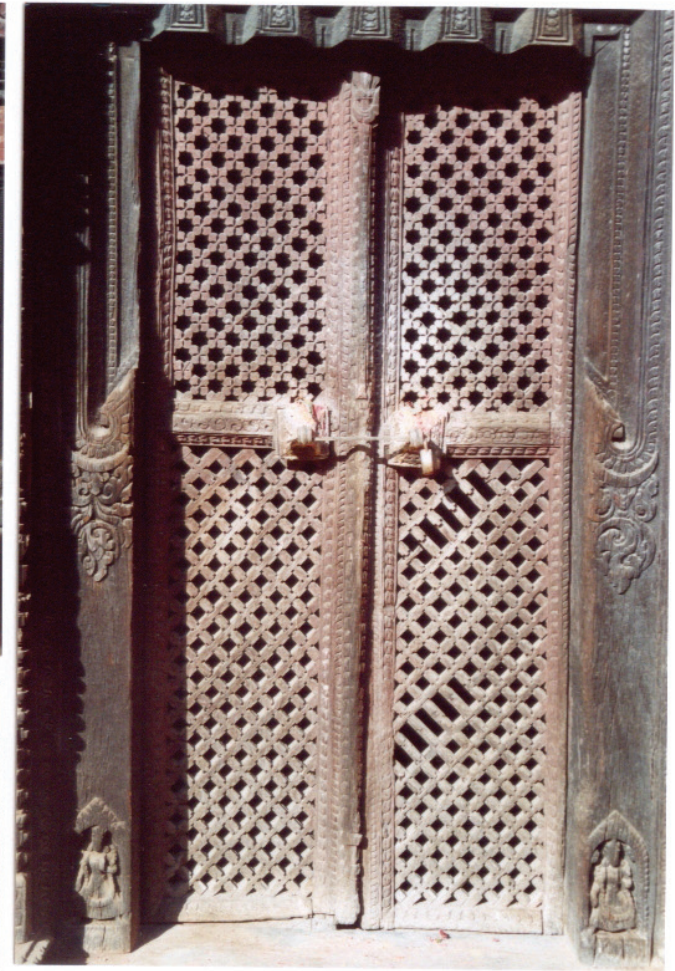
North wing with Bhagavati shrine  
(left, also detail of the door whose  
lock is worshipped. Right the latticed  
door that leads to a staircase.  
Photo 29 November 2005

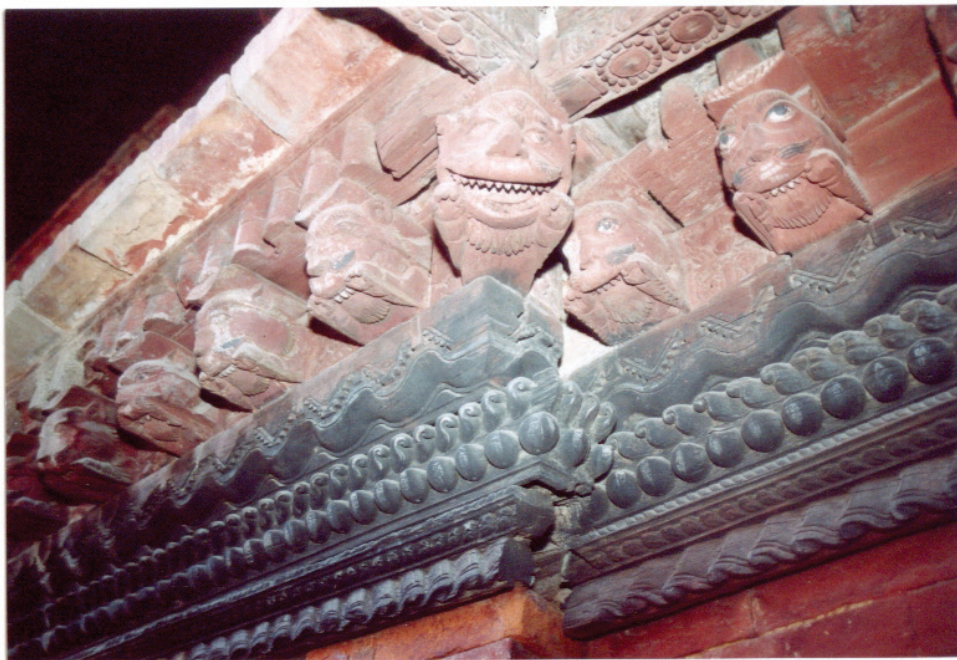
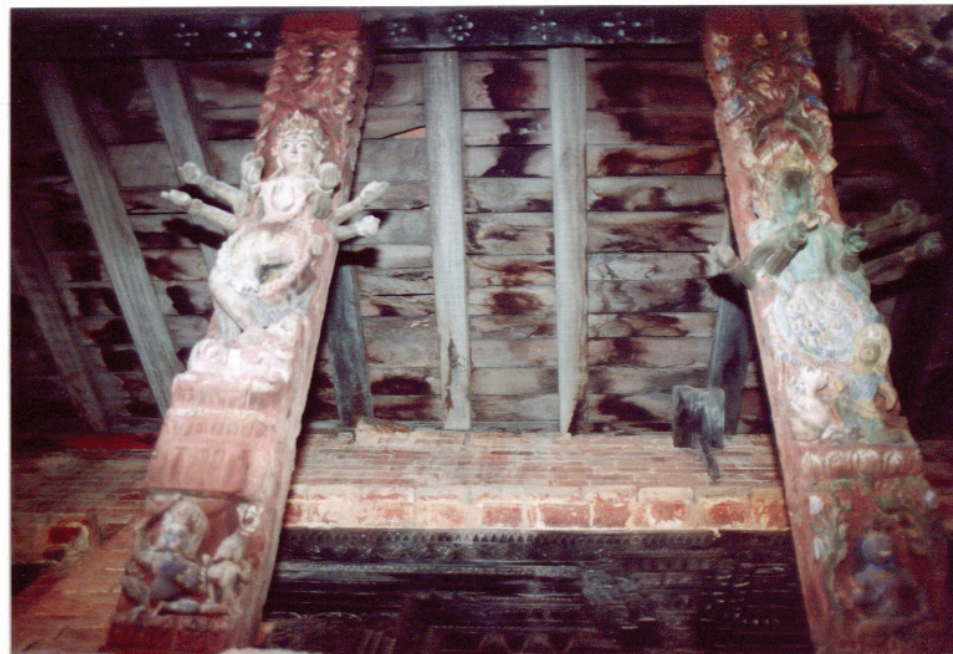
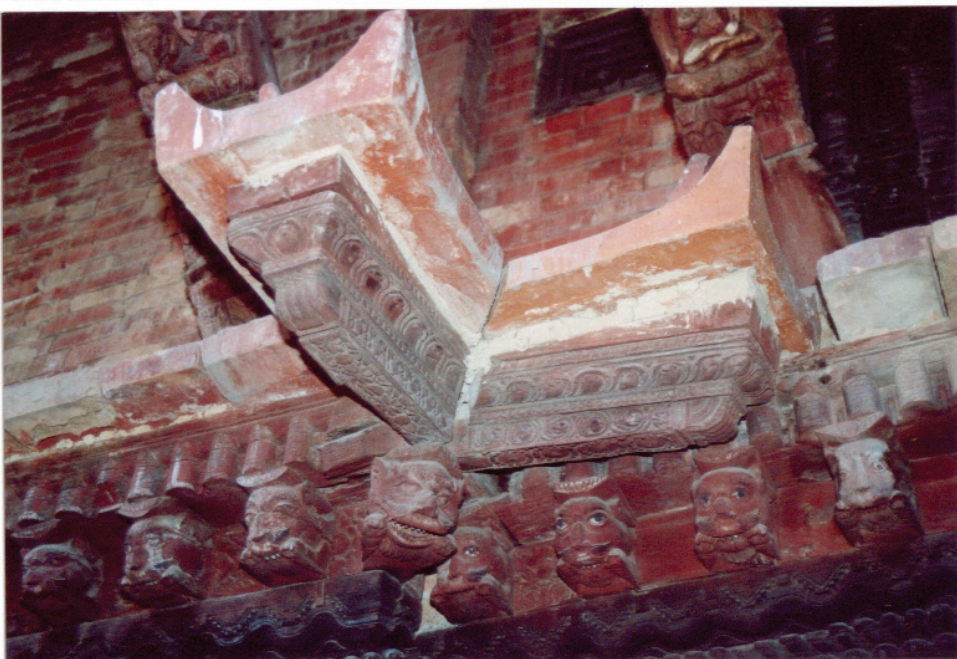
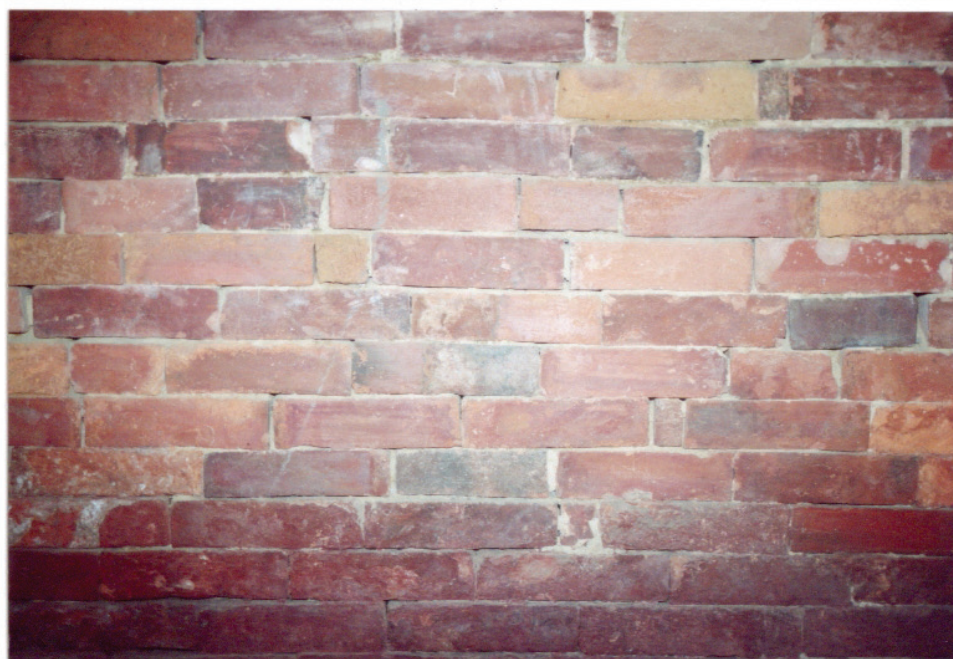
Left, south wing: the large cornice bricks have been replaced in a recent renovation (1995).  
Photos 29 November 2005

Above right: the entire roof has been renewed in 1985 with small, widely spaced rafters, planking and large size industrial roof tiles; below (west wing) repaired wall face (1995) of the open ground floor arcade.

The renewal of the entire roof with historic rafter size and spacing is mandatory. In deviation from the present situation, marine plywood will have to be used as covering material, with an additional layer of multiplast. The roofing with clay and roof tiles follows the historic formula.

The relatively recent (appr. 1985) renewal of the entire roof is of a standard that makes a complete replacement mandatory. The aim is to reinstall historic standards which are based on flat proportions of the rafters (*musī*, 15 cm broad, 10 cm high) with a gap in between of 15 cm. Until the 19th century rafters were covered by long flat tiles (*cilāapā*) with a small rebate to hold the covering layer of clay. Only by the middle of the 20th century this standard was replaced by planking, topped by tarfelt to ckeck seepage. Reed or split bamboo was regularly used for residential buildings. For the replacement of the roof, the long flat tiles are reintroduced within the visible section of the projecting eaves. For the remaining section marine plywood is suggested to ensure a smooth surface for a layer of highly durable multiplast. Battens nailed on top of multiplast serves to hold the layer of clay into which the roof tiles (*āypā* or *pvalāapā*) are pressed.

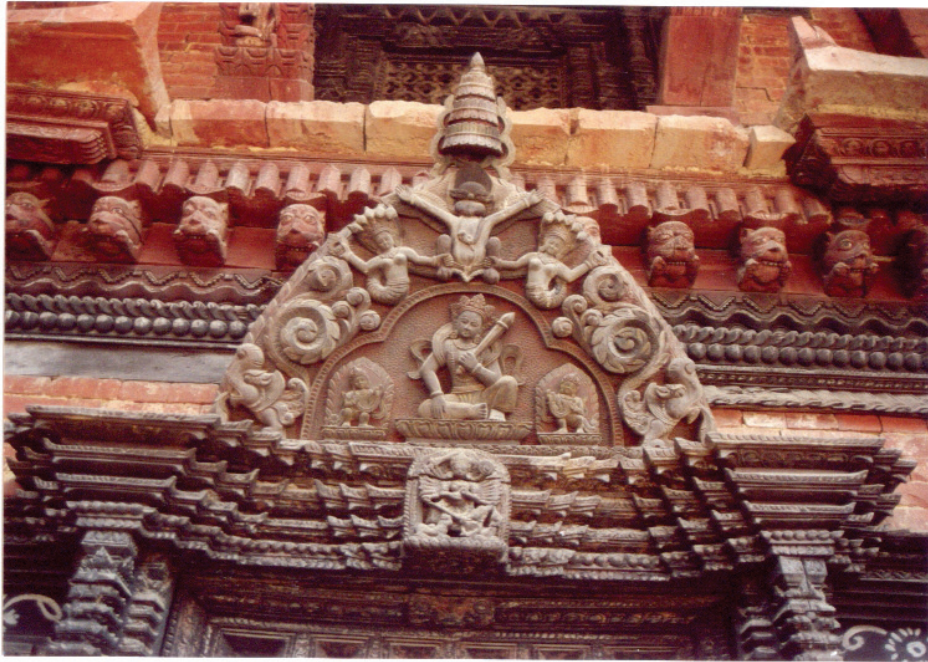
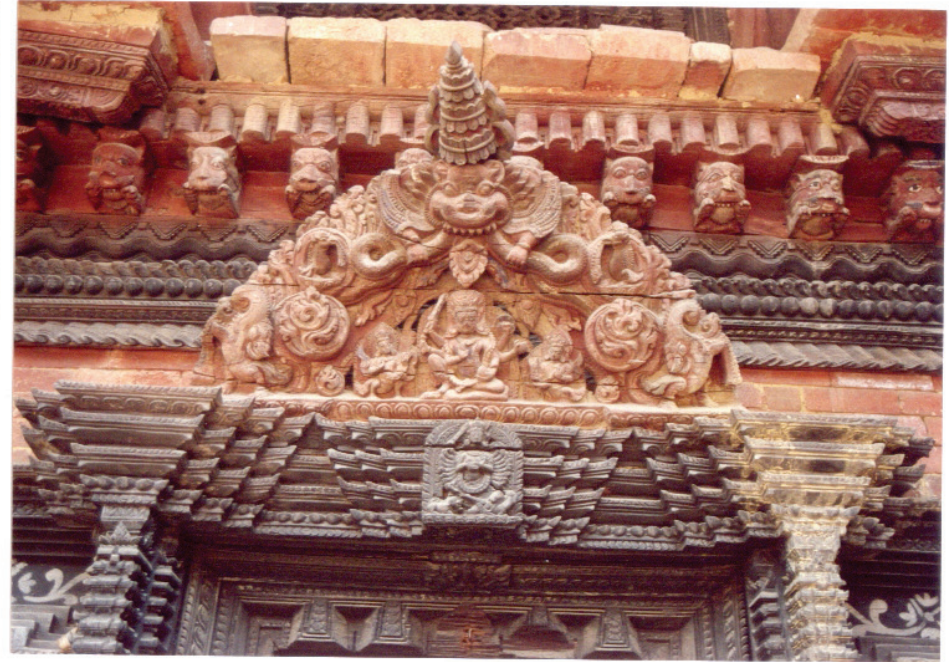
Tympana above the door flanking the main entrance to the Taleju shrine. The depiction of Durgā as the slayer of the buffalo demon on the lintel is almost identical.

Left, replacement of the lost tympanum above the eastern door. The simple carving present an unidentifiable goddess with a club, flanked by *kinnaras* under a tri-lobed arch with Garuḍa in the apex, flanked by *nāgakanyas*.

Right, the original, 17th century tympanum with Bhairava on Vetāla in the centre, flanked by two kinnaras, under a tri-lobed arch with Kīrttimukha in the apex.

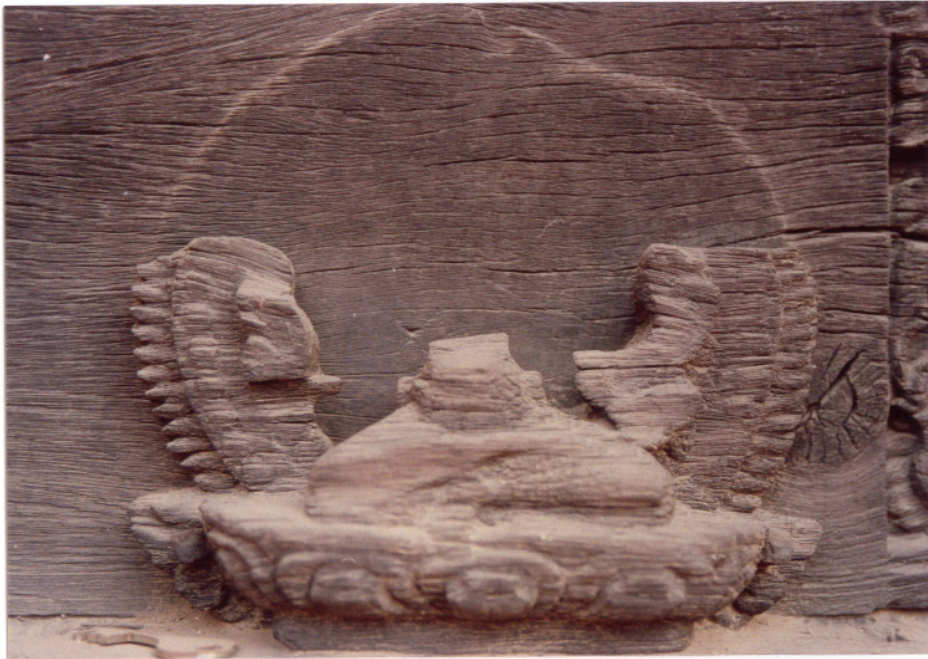
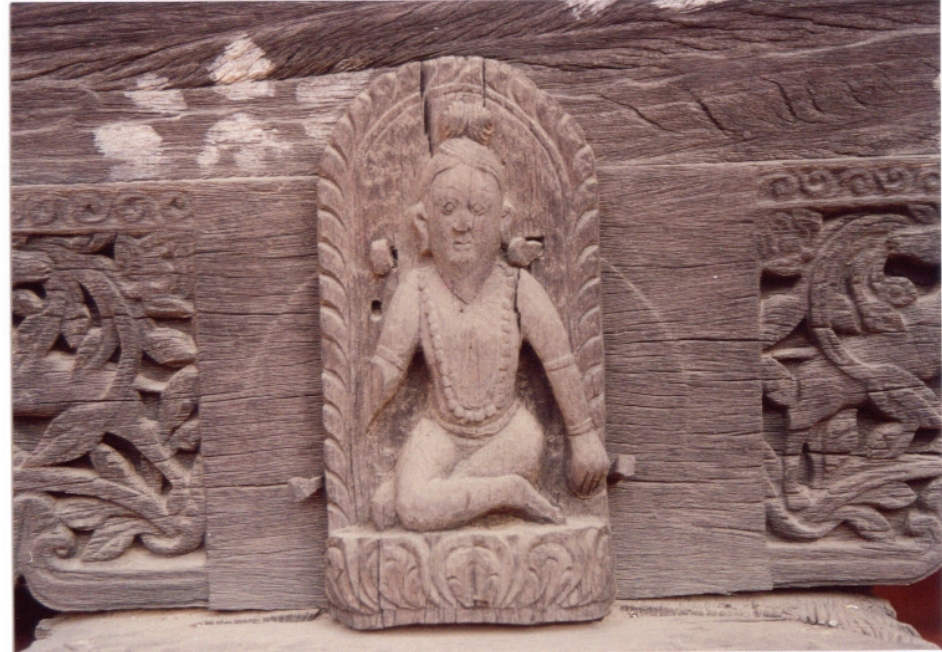
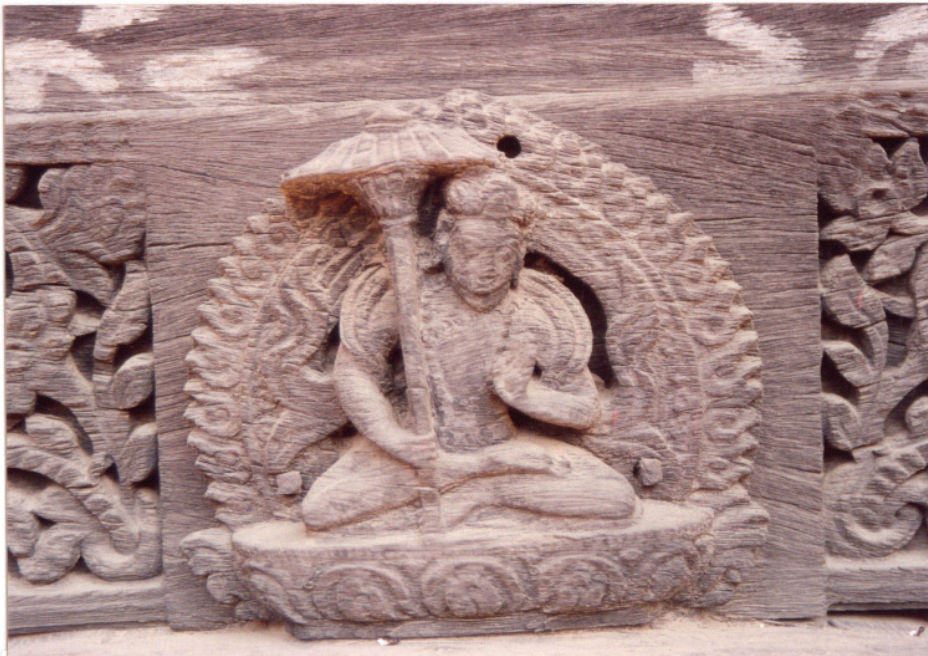
Row of six deities and two inscriptions fixed to the capitals above the pillars of the eastern arcade (*dalan*).

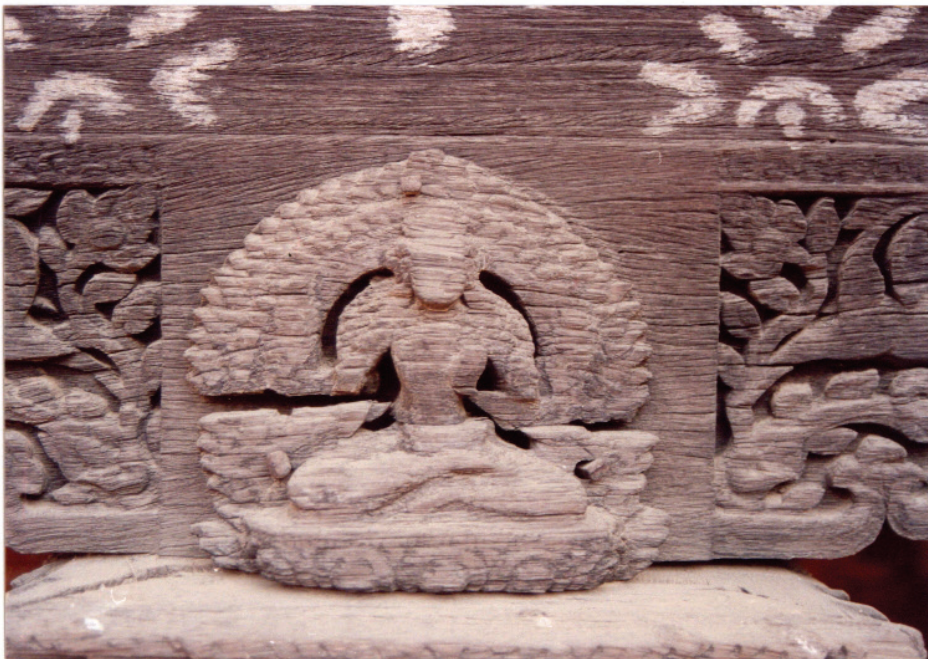
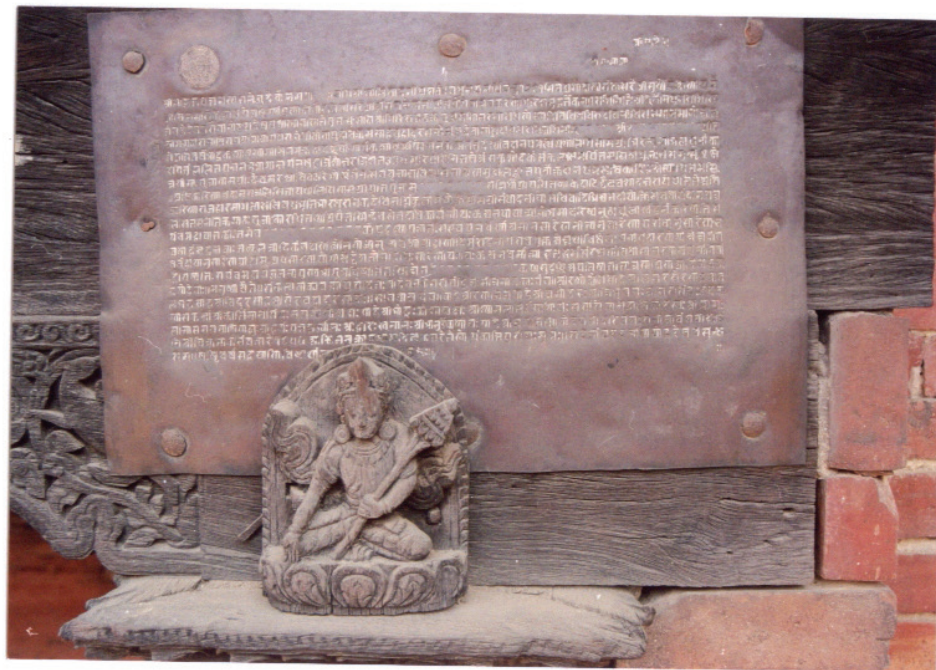
Row of six deities and two inscriptions fixed to the capitals  
above the pillars of the eastern arcade (*dalan*).  
Photographs 4 April 2006

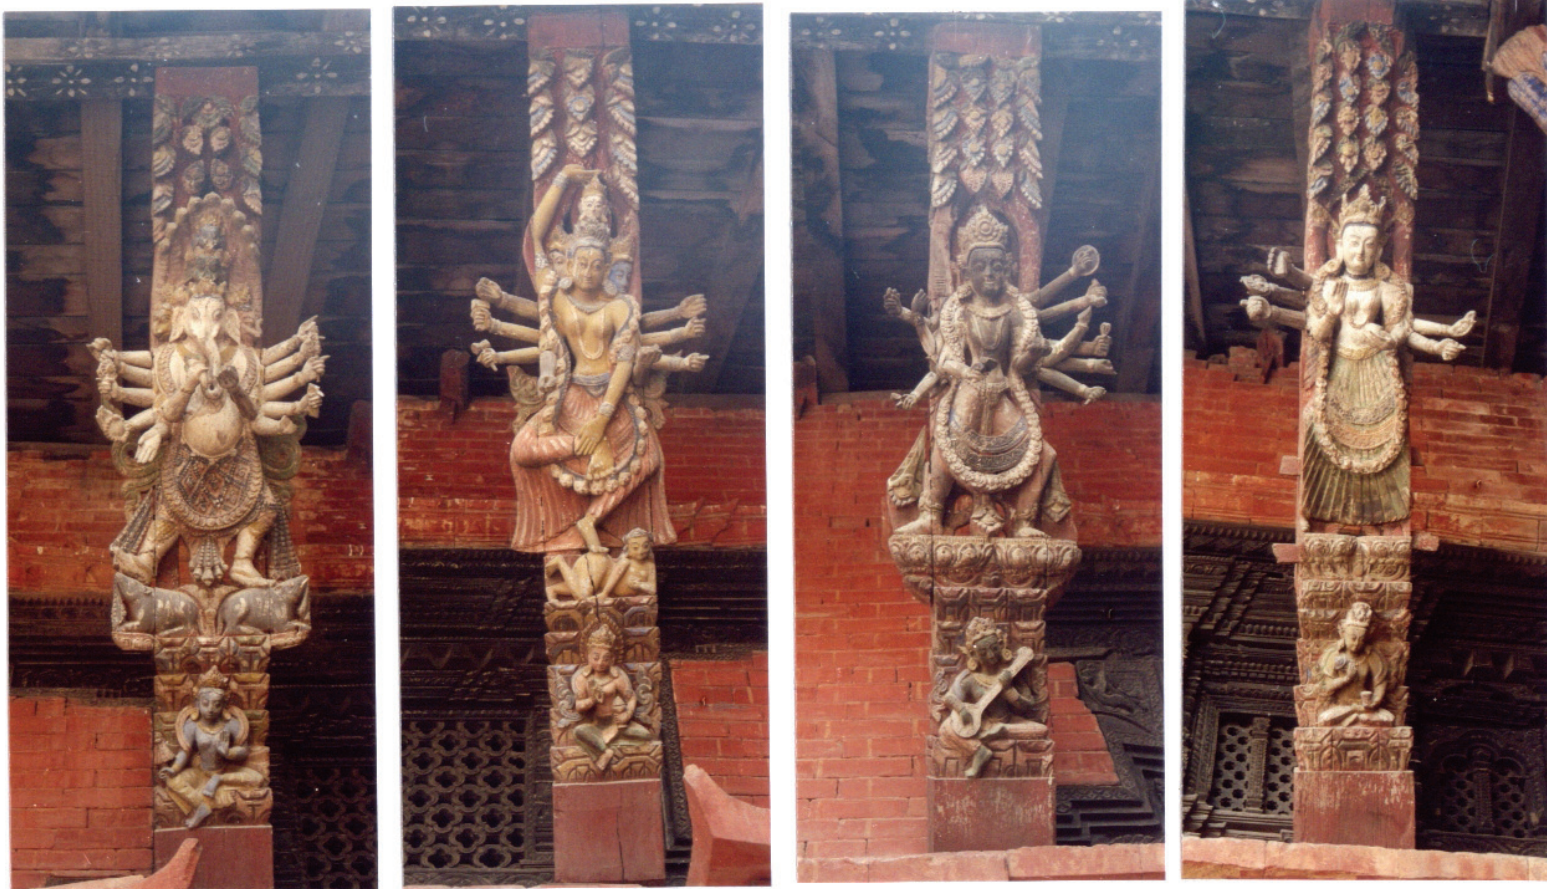
- 1 6 hands missing, 2 inferior quality, leg missing
- 2 6 hands of inferior quality
- 3 2 hands missing, 3 inferior quality, part of shawl
- 4 6 hands missing, 3 inferior quality, part of shawl
- 5 4 hands missing, part of shawl
- 6 5 hands missing, 1 inferior quality, left leg
- 7 3 hands missing, 2 inferior quality, part of shawl
- 8 4 hands inferior quality
- 9 2 hands missing, 1 inferior quality, part of lotus base
- 10 1 hand missing, 1 inferior quality
- 11 1 hand inferior quality
- 12 1 hand missing
- 13 3 hands missing, 1 inferior quality, 2 parts of shawl
- 14 3 hands missing, 3 inferior quality, 2 parts of shawl

Documentation of struts (*bilampu*), photographs 4 April 2006  
East Wing, nos. 6-10 (from left to right = north to south)

In the 1980s a number of hands were replaced in an inferior quality.  
In the meantime more hands got lost. All struts have to be cleaned in order to present them in their original surface of wood.

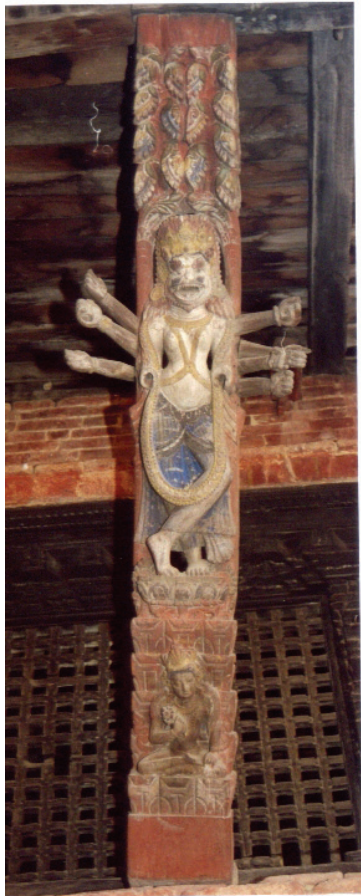
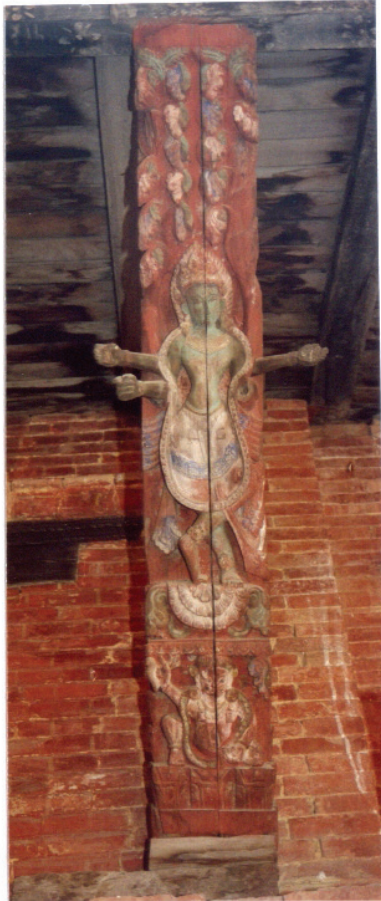
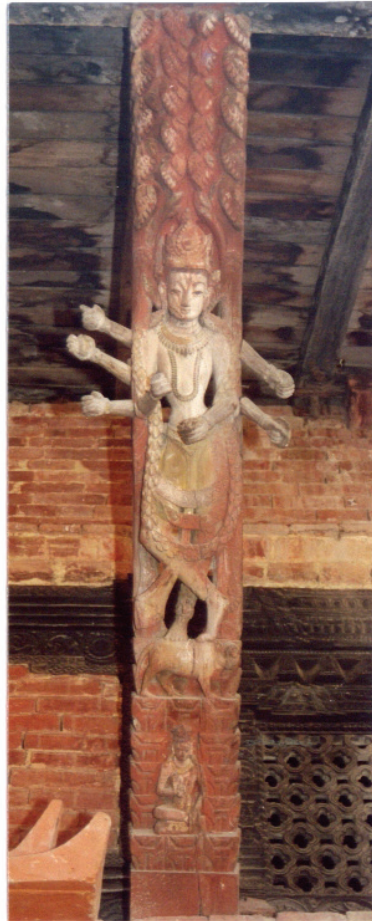
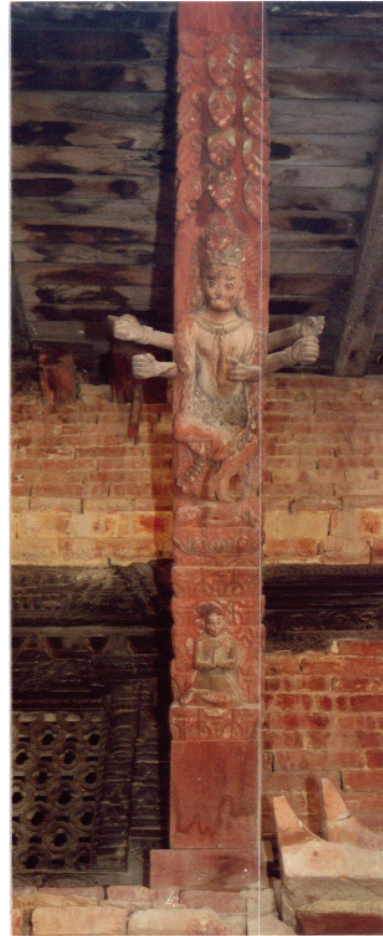
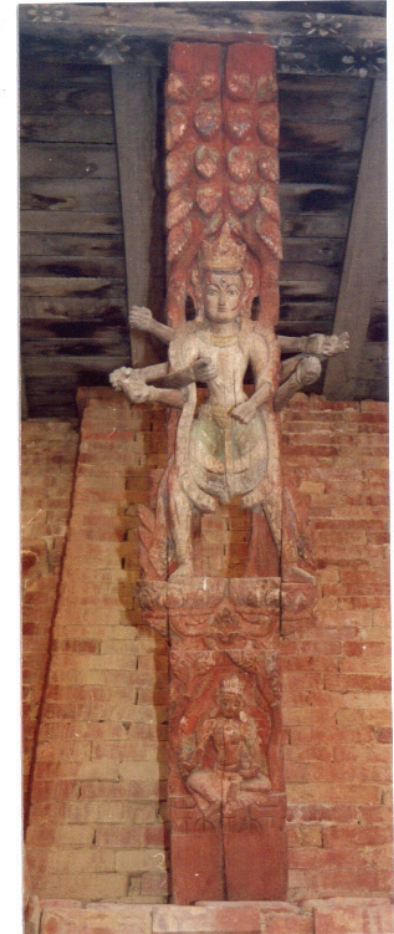
Documentation of struts (*bilampu*), photographs 4 April 2006  
South Wing, nos. 15-19 (from left to right = east to west)

- 15 3 hands missing, 7 inferior quality, part of shawl
- 16 1 hand missing, 3 inferior quality
- 17 1 hand missing, 7 inferior quality, part of shawl
- 18 1 hand missing, 5 inferior quality
- 19 6 hands missing, 8 inferior quality, part of shawl
- 20 5 hands missing, 5 inferior quality, part of shawl
- 21 1 hand missing, 5 inferior quality, part of shawl
- 22 4 hands missing, 6 inferior quality, part of shawl
- 23 1 hand missing, part of shawl
- 24 9 hands inferior quality, part of shawl
- 25 4 hands missing, 6 inferior quality
- 26 9 hands missing, 7 inferior quality
- 27 4 hands missing, 6 inferior quality
- 28 7 hands missing, 7 inferior quality, part of shawl

Replacement of missing parts and of those of inferior quality

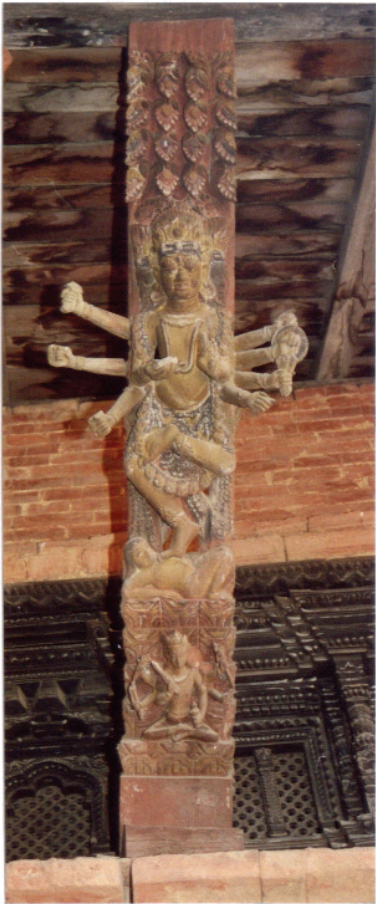
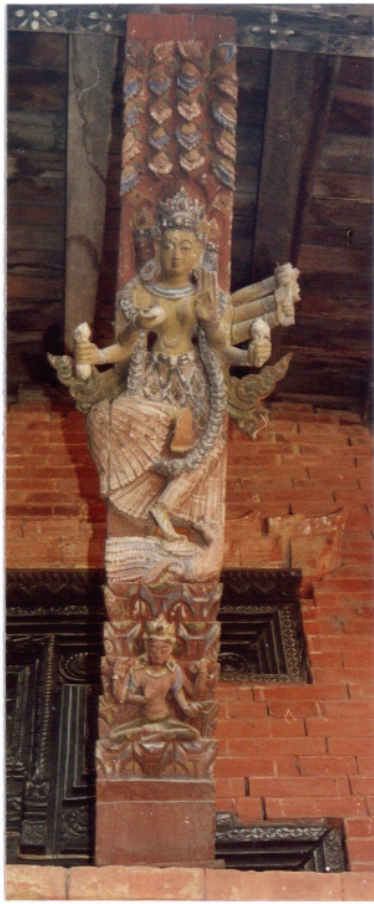
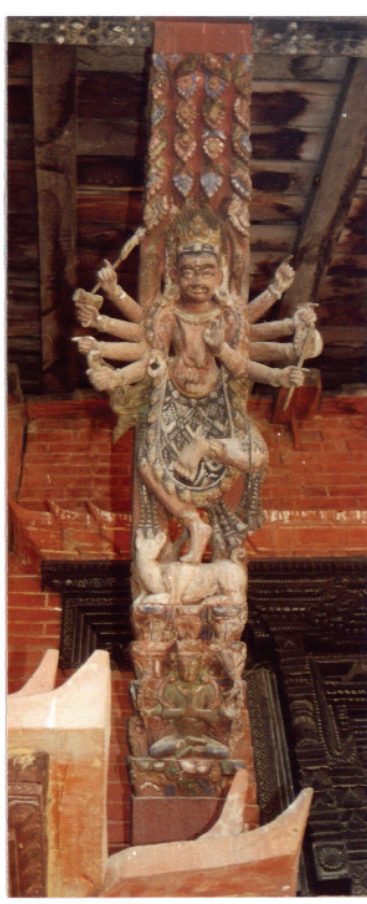
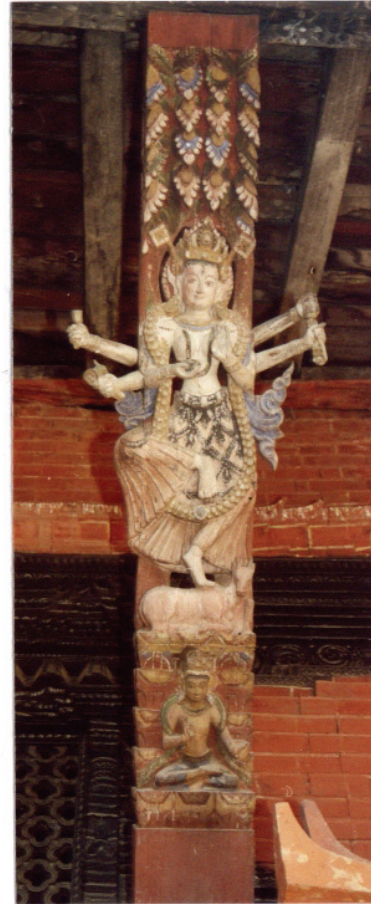
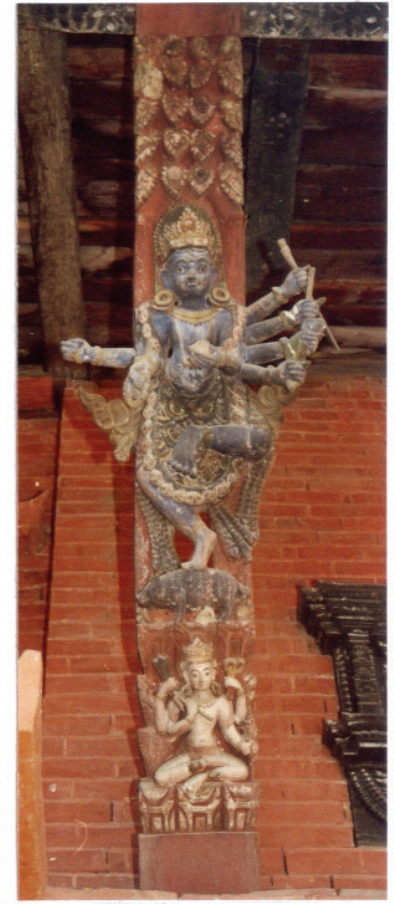
Documentation of struts (*bilampu*), photographs 4 April 2006  
West Wing, nos. 29-33 (from left to right south to north)

- 29 3 hands missing
- 30 3 hands missing
- 31 1 hand missing
- 32 2 hands missing
- 33 3 hands missing
- 34 1 hand missing, 1 inferior quality, part of shawl
- 35 ---
- 36 1 hand missing, part of shawl
- 37 3 hands missing, 3 inferior quality
- 38 1 hand inferior quality
- 39 4 hands missing, 3 inferior quality, part of shawl
- 40 2 hands missing
- 41 ---
- 42 2 hands missing, 6 inferior quality, part of shawl

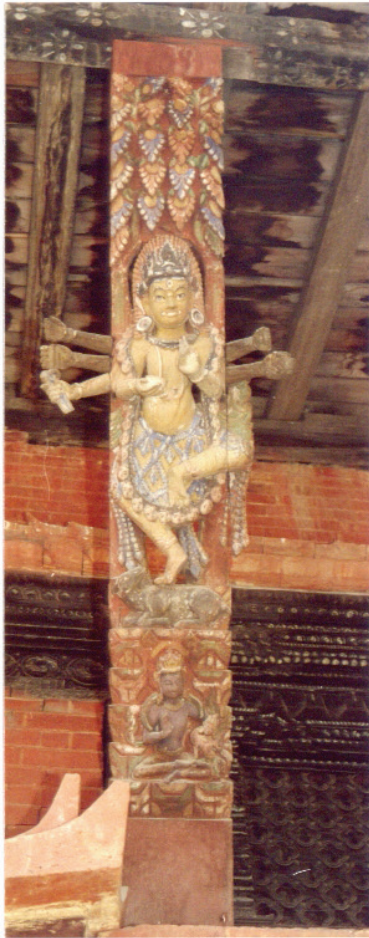
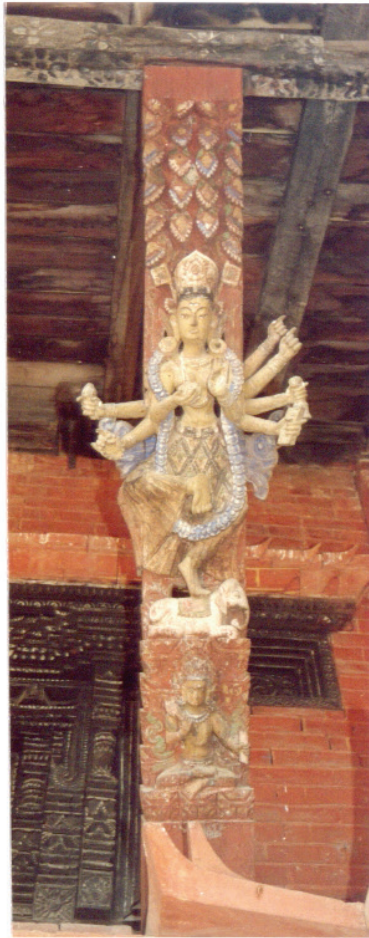
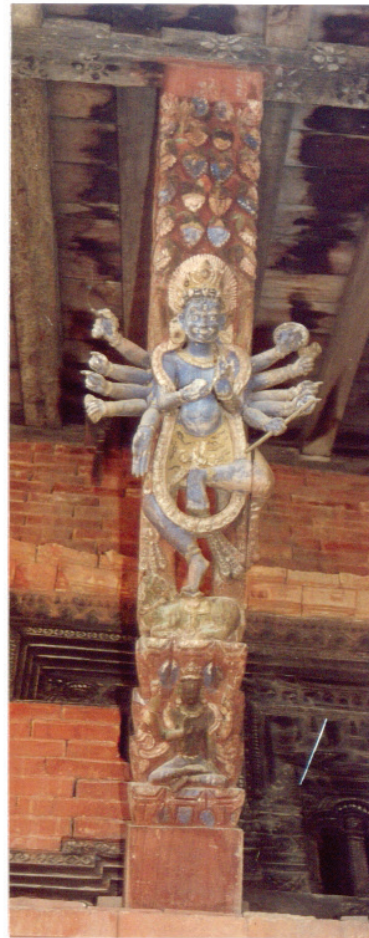
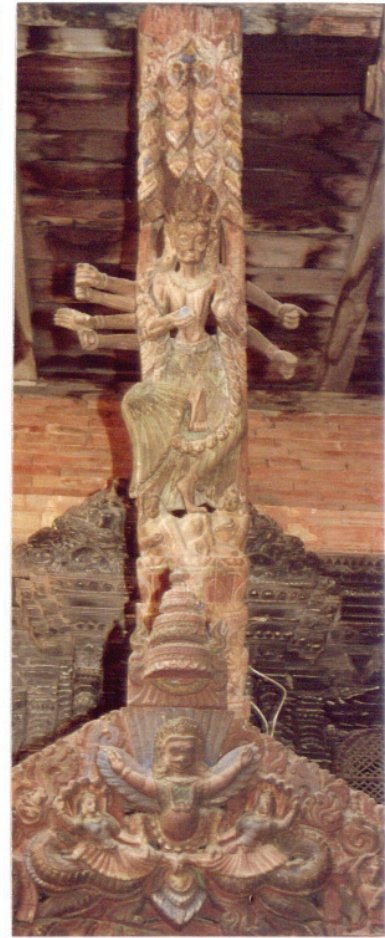
Documentation of struts (*bilampu*), photographs 4 April 2006  
East Wing, nos. 39-42 (from left to right = south to north)

- 43 2 hands missing, 8 inferior quality
- 44 2 hands missing, parts of shawl
- 45 3 hands missing, 3 inferior quality, part of shawl
- 46 4 hands missing, 4 inferior quality, part of shawl
- 47 6 hands lost, 5 inferior quality, part of shawl
- 48 3 hands missing, 4 inferior quality, part of shawl
- 49 5 hands missing, 5 inferior quality, part of shawl
- 50 6 hands missing, 6 inferior quality, part of shawl

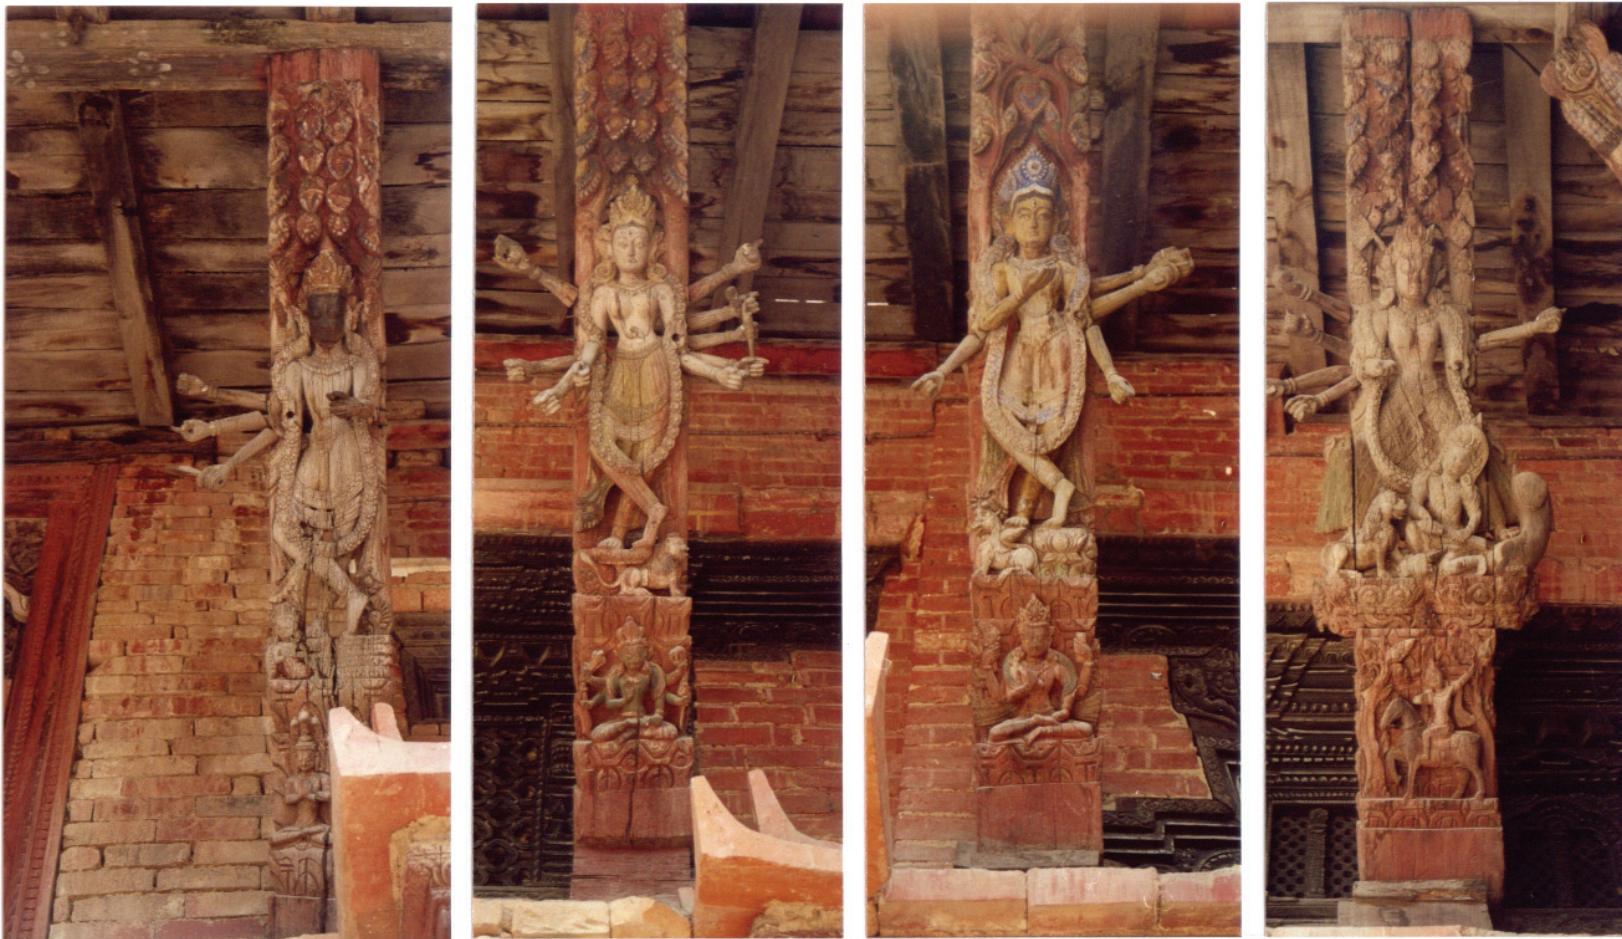
Documentation of struts (*bilampu*), photographs 4 April 2006  
North Wing, nos. 43-46 (from left to right = west to east)

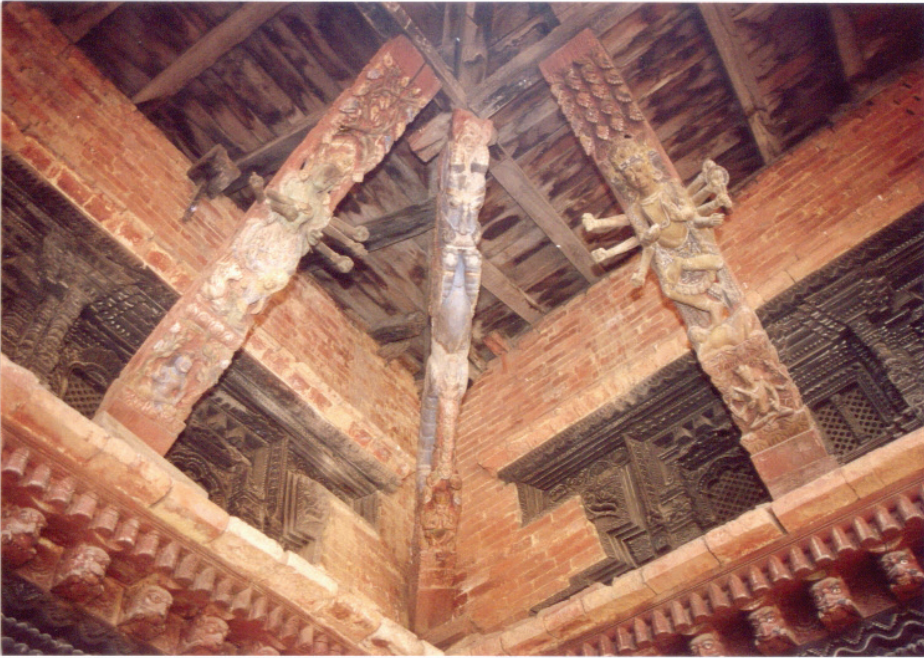
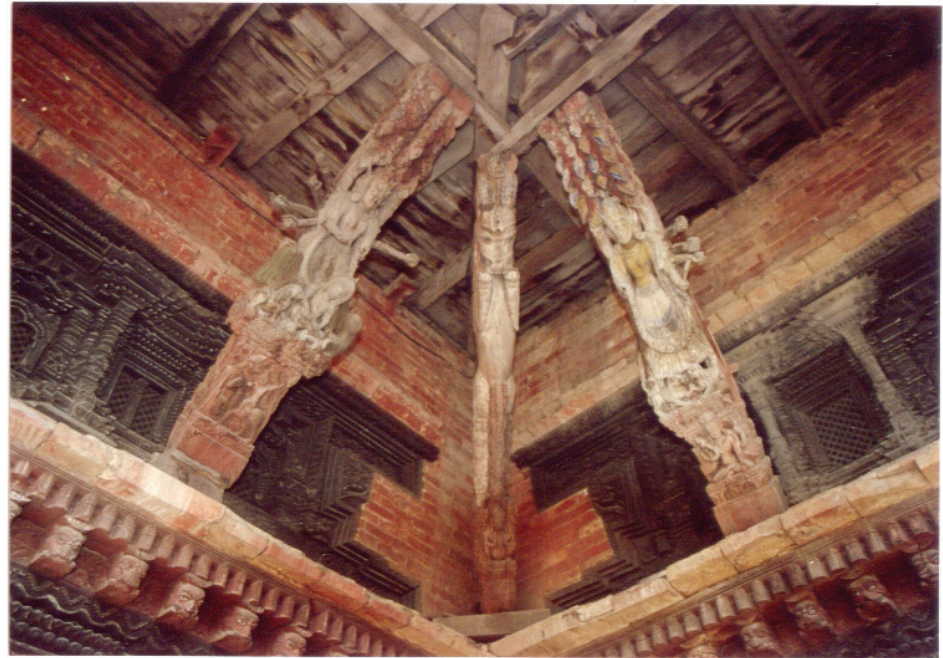
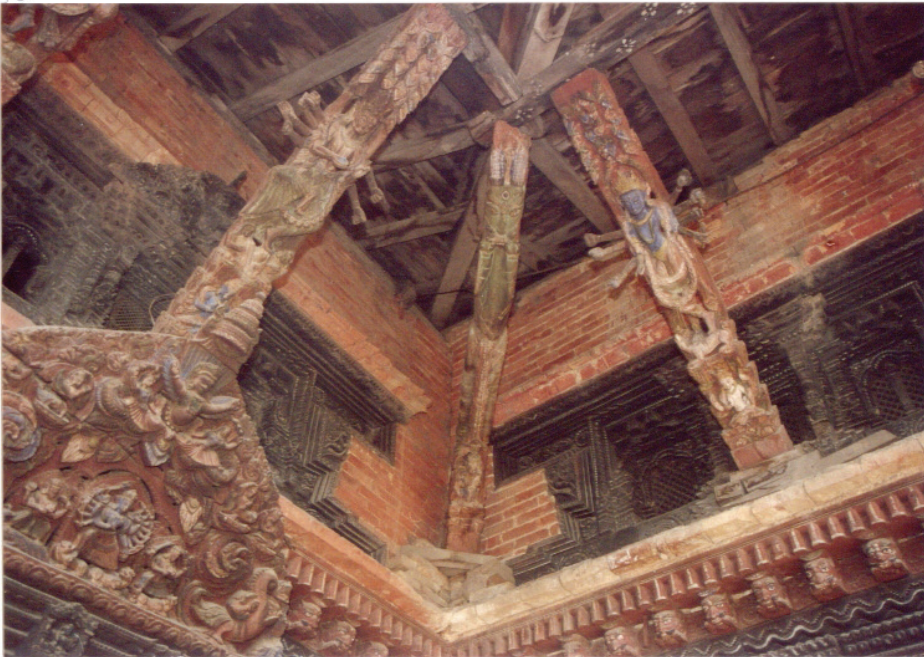
Documentation of struts (*bilampu*), photographs 4 April 2006  
 Noth Wing, nos. 47-50 (from left to right = west to east)

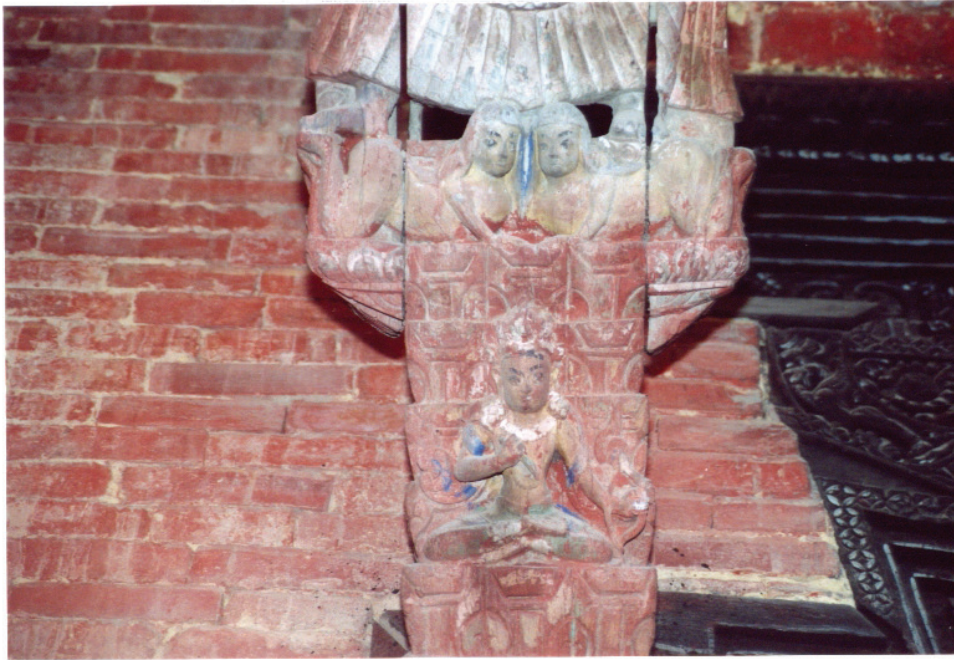
Documentation of struts (*bilampu*), photographs 4 April 2006  
 Above left southeastern corner, below left southwestern corner  
 above right northeastern corner , below right detail of no. 50,  
 depicting the twelve-armed Durga as Mahisasuramardini.

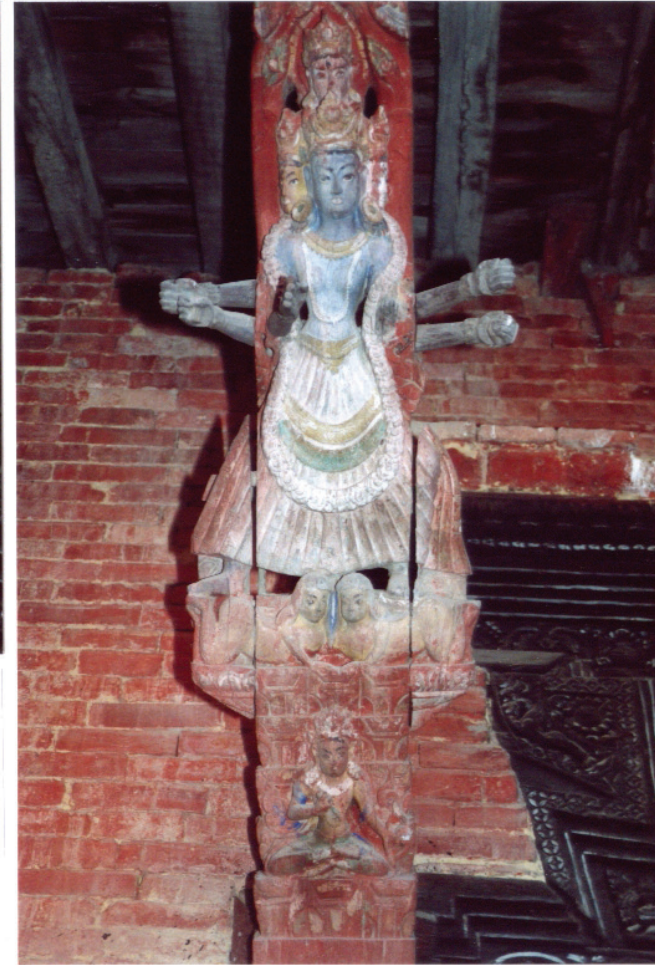
South wing, typical strut depicting a Devī on her human mount. As a late 18<sup>th</sup> century innovation, the bearing timber is flanked by additional, non-bearing elements to provide space for the deity with her legs wide apart. The colouring represents a mid-120<sup>th</sup> century innovation.
