# THE PATAN ROYAL COMPLEX

## MULCOK

A Preliminary Proposal for Restoration and Adaptive Reuse  
including a Cost Estimate

May 2006

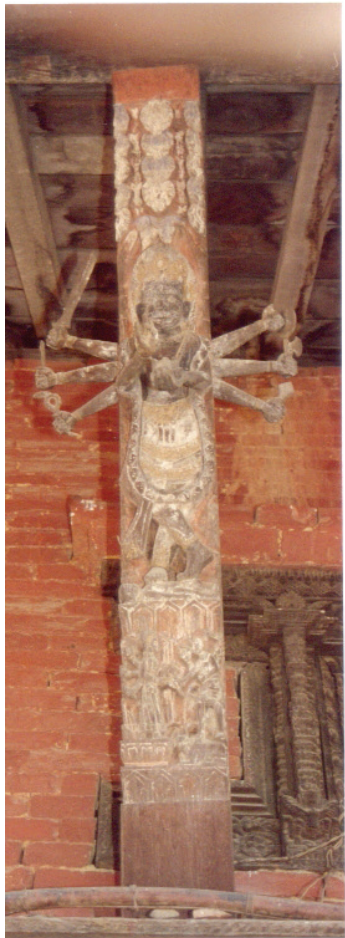
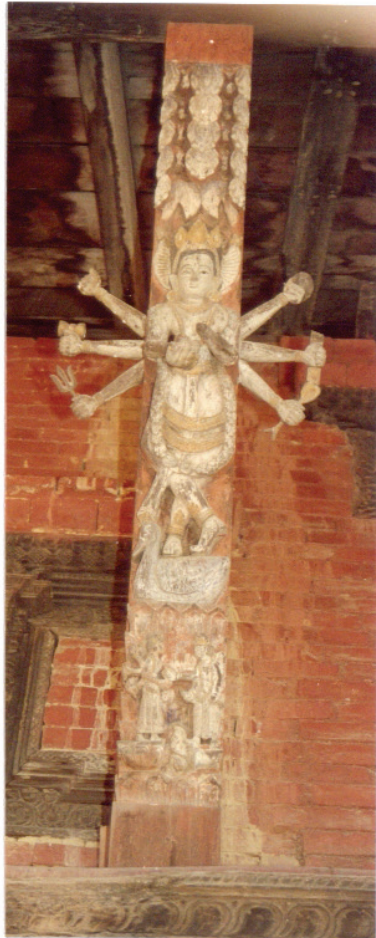
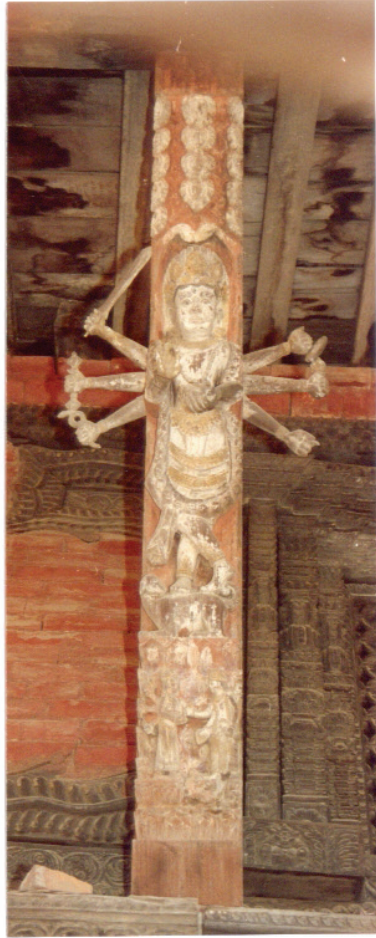
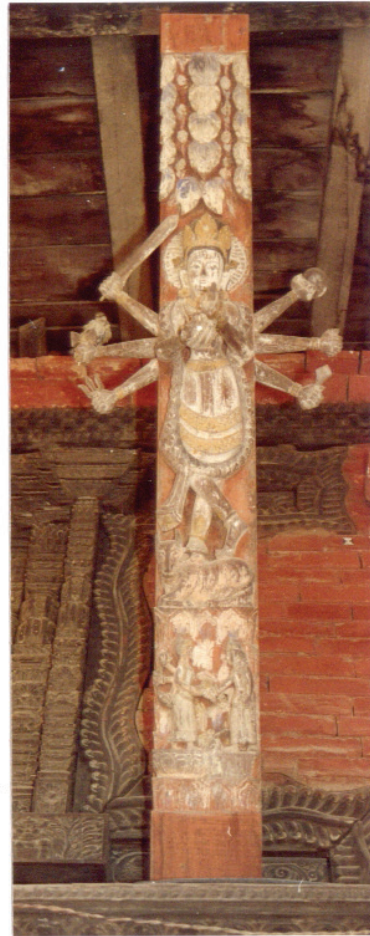
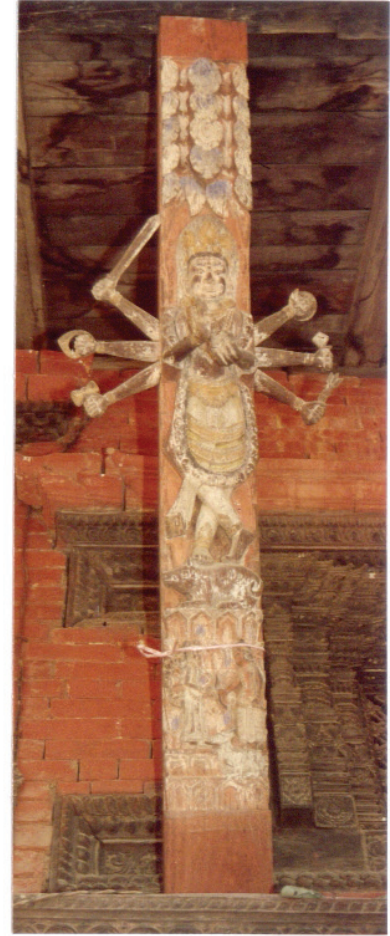
Documentation of struts (*bilampu*), photographs 4 April 2006  
Facing the Darbār Square: nos. 1-5 (left to right = north to south)

- 1 6 hands missing, 2 inferior quality, leg missing
- 2 6 hands of inferior quality
- 3 2 hands missing, 3 inferior quality, part of shawl
- 4 6 hands missing, 3 inferior quality, part of shawl
- 5 4 hands missing, part of shawl
- 6 5 hands missing, 1 inferior quality, left leg
- 7 3 hands missing, 2 inferior quality, part of shawl
- 8 4 hands inferior quality
- 9 2 hands missing, 1 inferior quality, part of lotus base
- 10 1 hand missing, 1 inferior quality
- 11 1 hand inferior quality
- 12 1 hand missing
- 13 3 hands missing, 1 inferior quality, 2 parts of shawl
- 14 3 hands missing, 3 inferior quality, 2 parts of shawl

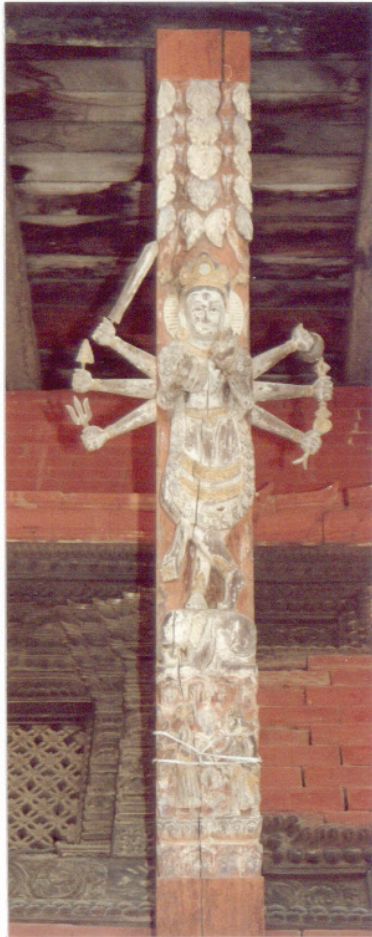
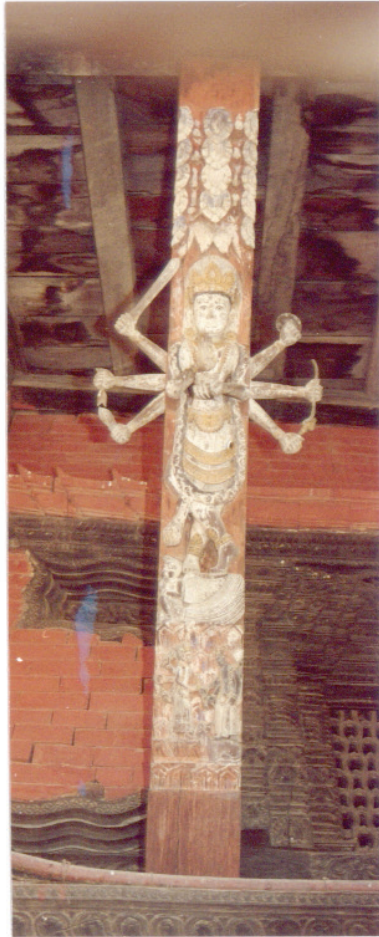
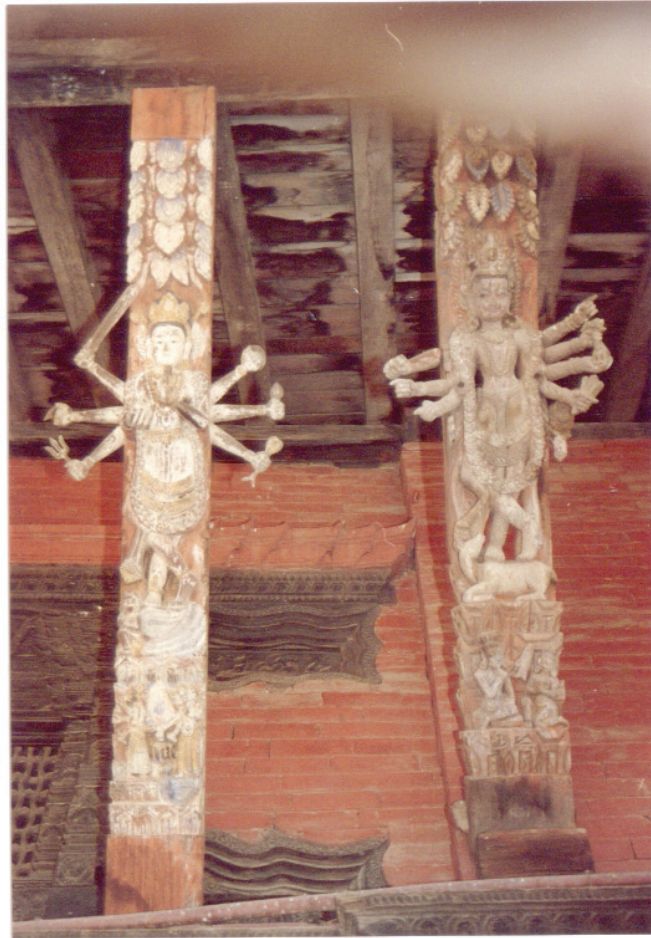
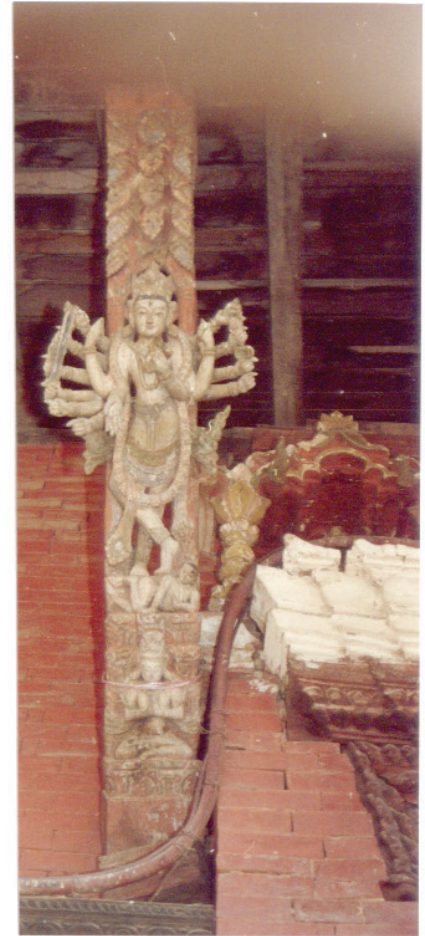
Facing the Darbār Square: nos. 6-10 (left to right = north to south)

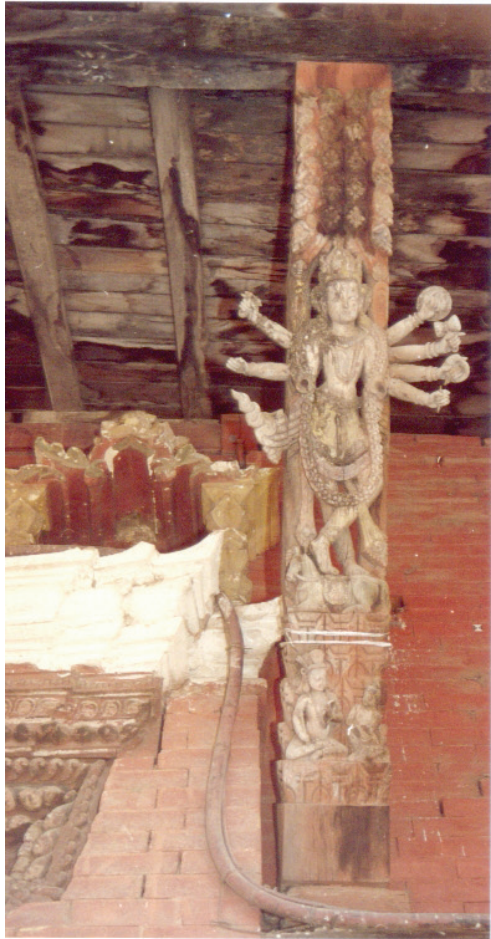
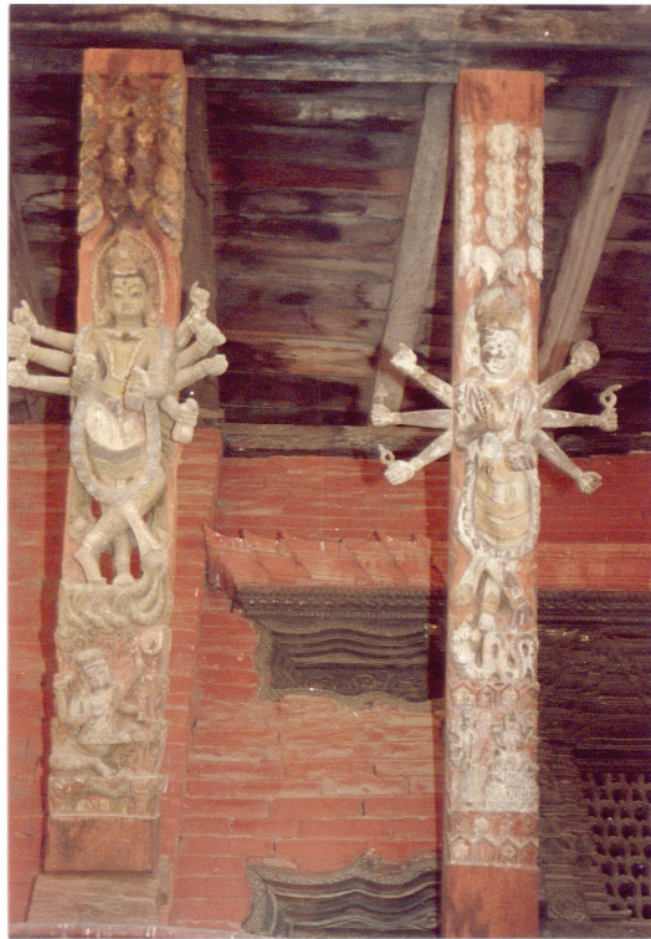
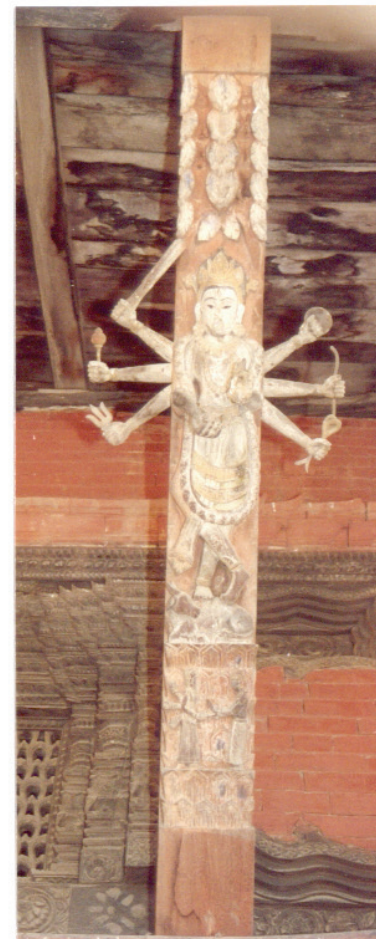
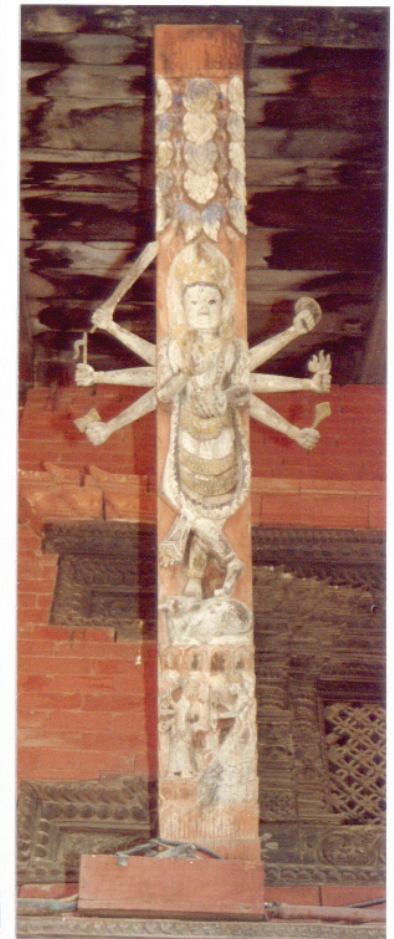
Facing the Darbār Square: nos. 11-15 (left to right = north to south)

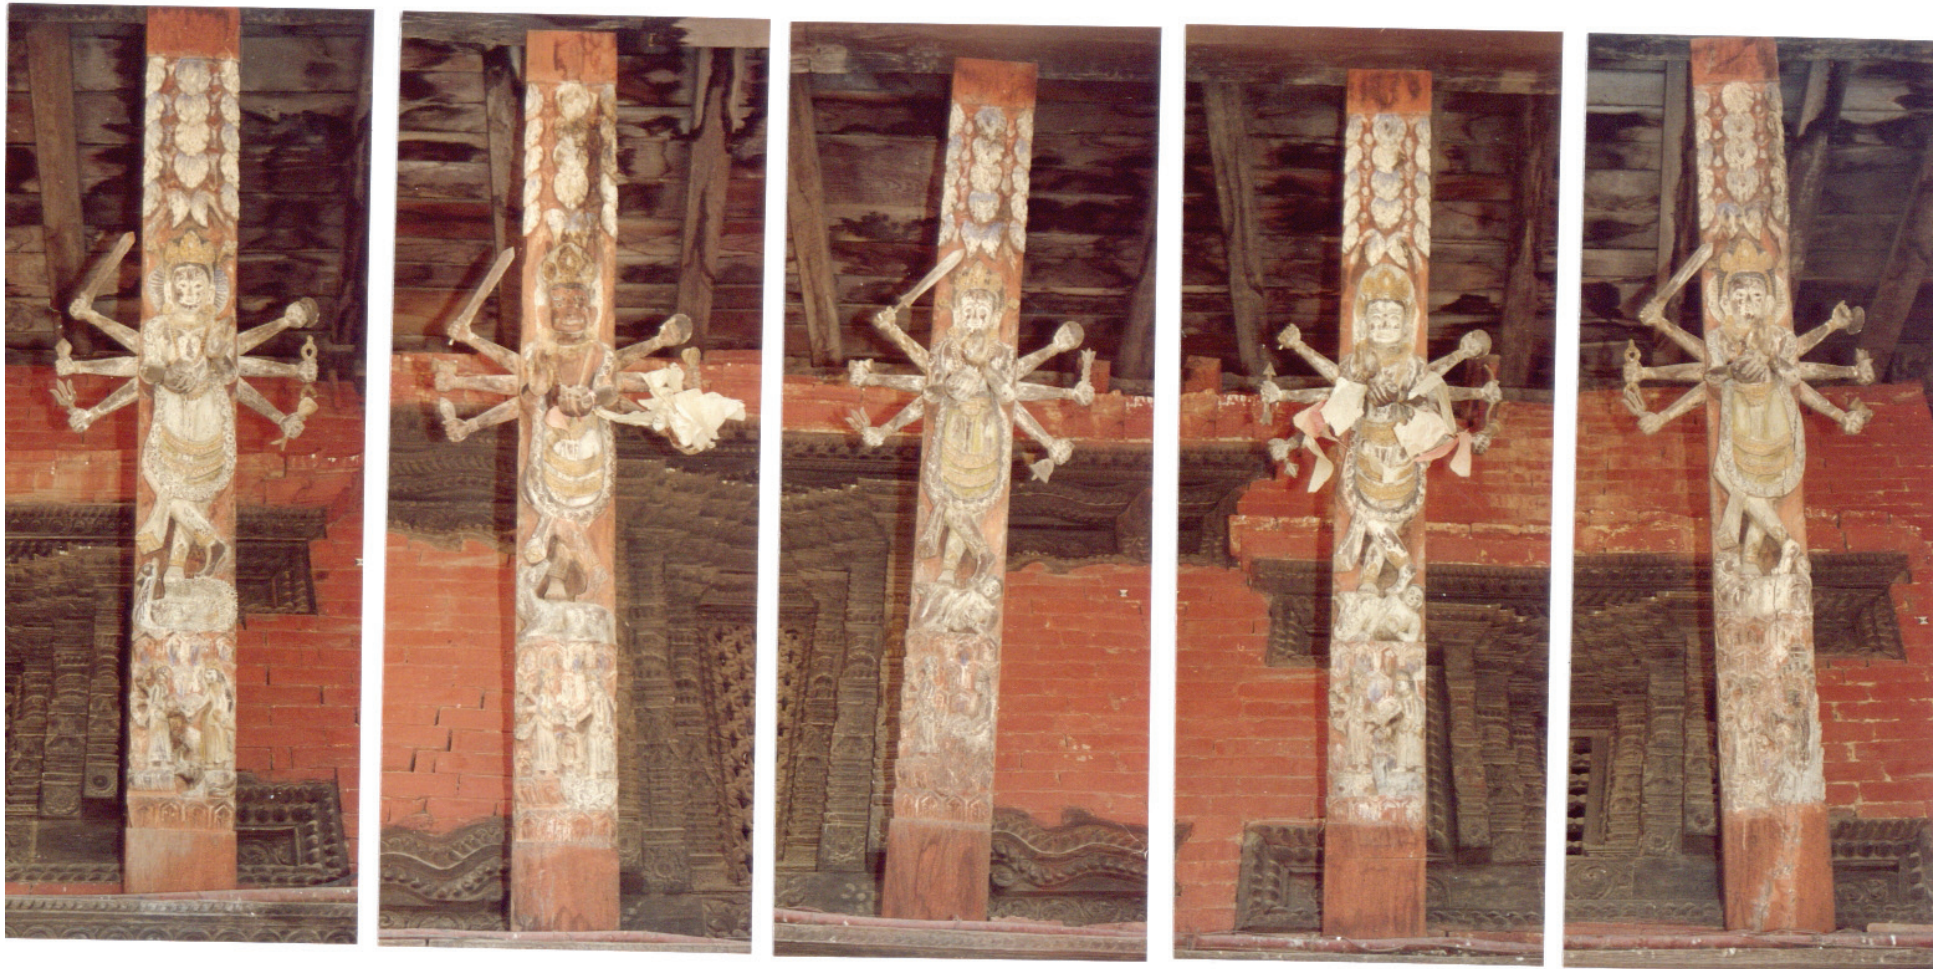
Documentation of struts (*bilampu*), photographs 4 April 2006  
Facing the Darbār Square: nos. 16-20 (left to right = north to south)

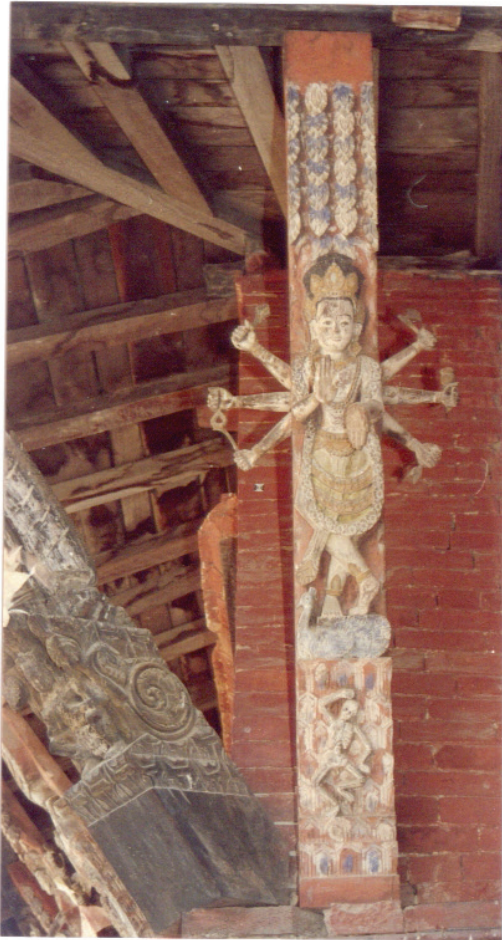
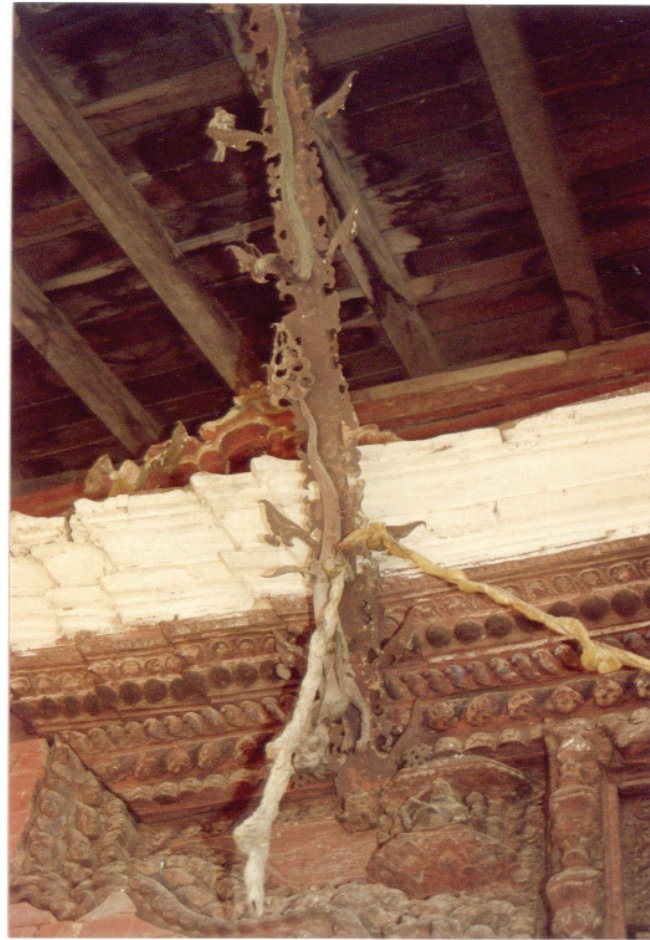
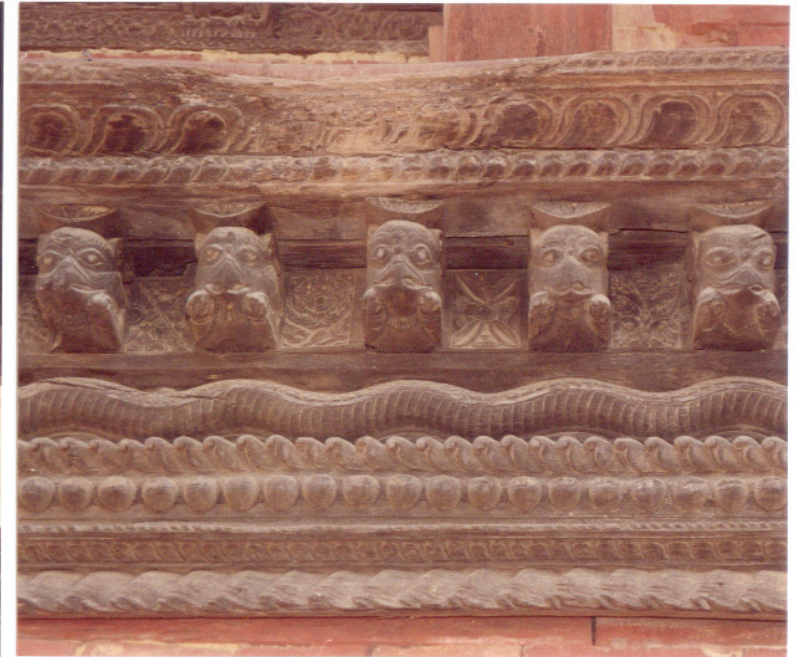
Documentation of struts (*bilampu*), photographs 4 April 2006  
 Left, facing south: nos. 21 (southwestern corner),  
 middle dragon (*malah*)-shaped strut in iron, Probably installed  
 by Jagat Shumsher Rana in c. 1855 in the context of reshaping  
 the entire entrance,  
 right detail of the cornice of the western facade with the usual  
 sequence of eight mouldings, including frill (*libin*), snake body  
 (*nagvah*), stylized beam ends in the shape of a beaked monster  
 and lotus leaves (*paleha*).

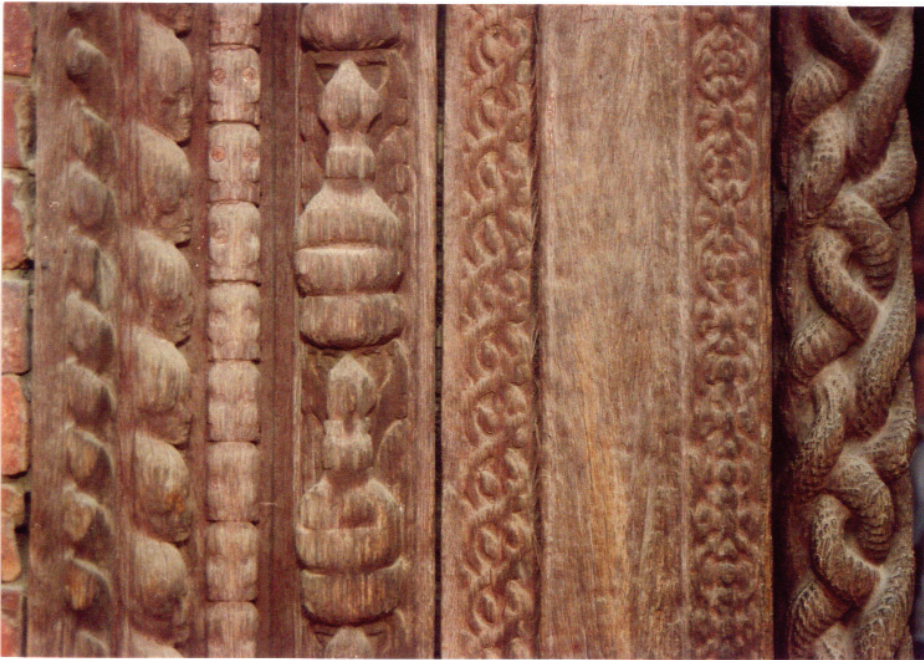
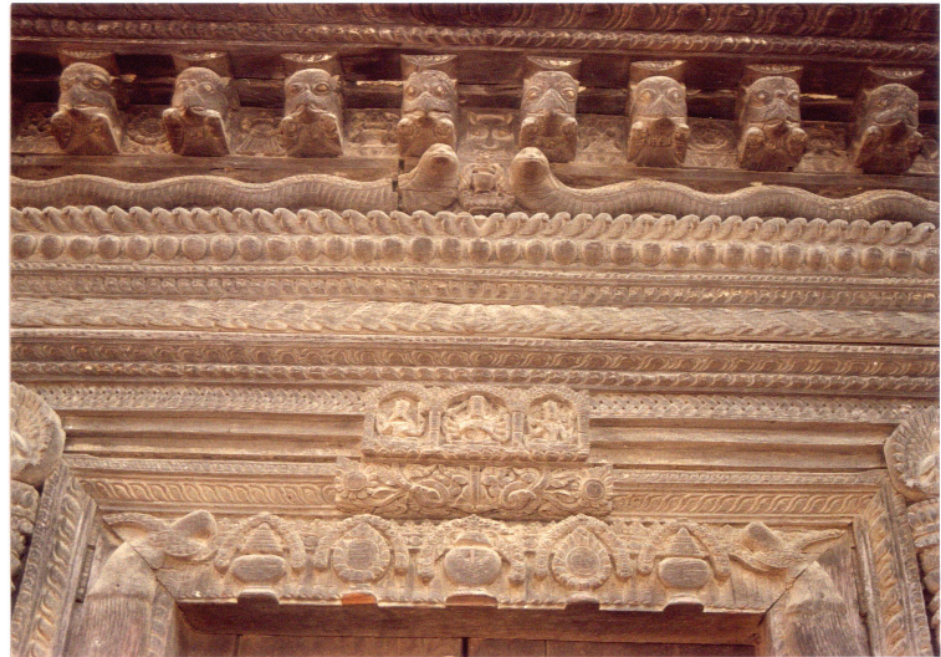
Documentation of struts (*bilampu*), photographs 4 April 2006  
 Details of the gate, which probably replaced an older one in c. 1855.  
 Left the moulded jamb, framed with skeleton faces (*kavankhvaḥ*)  
 and twisted snake bodies (*camvaḥ*), above right the lintel with pairs of yak tail  
 whisks (*camvaḥ*), vermillion container (*sinhamḥu*) and mirror  
 (*jvalanḥaykan*), framing a central vase of plenty (*kalaśa*) -  
 crowned by a female triad, probably Durgā (or Taleju) in the center,  
 framed by Lakṣmī and Sarasvatī.

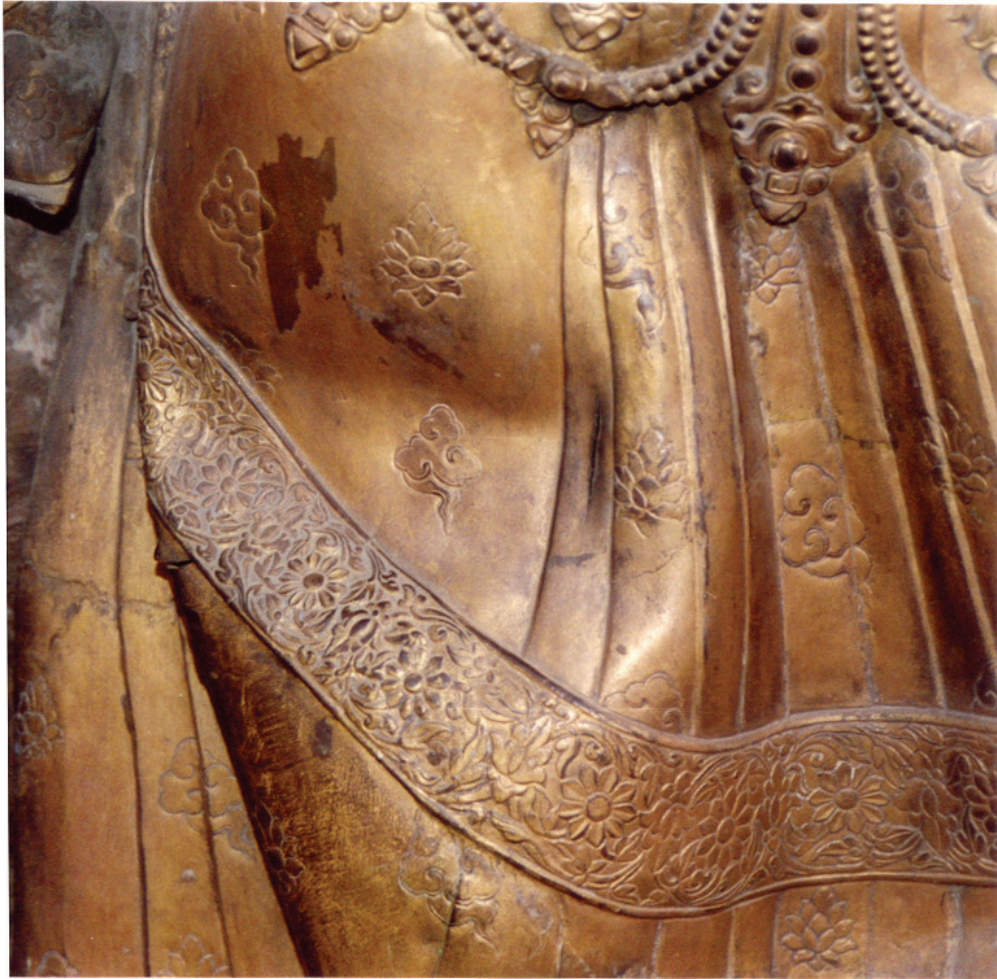
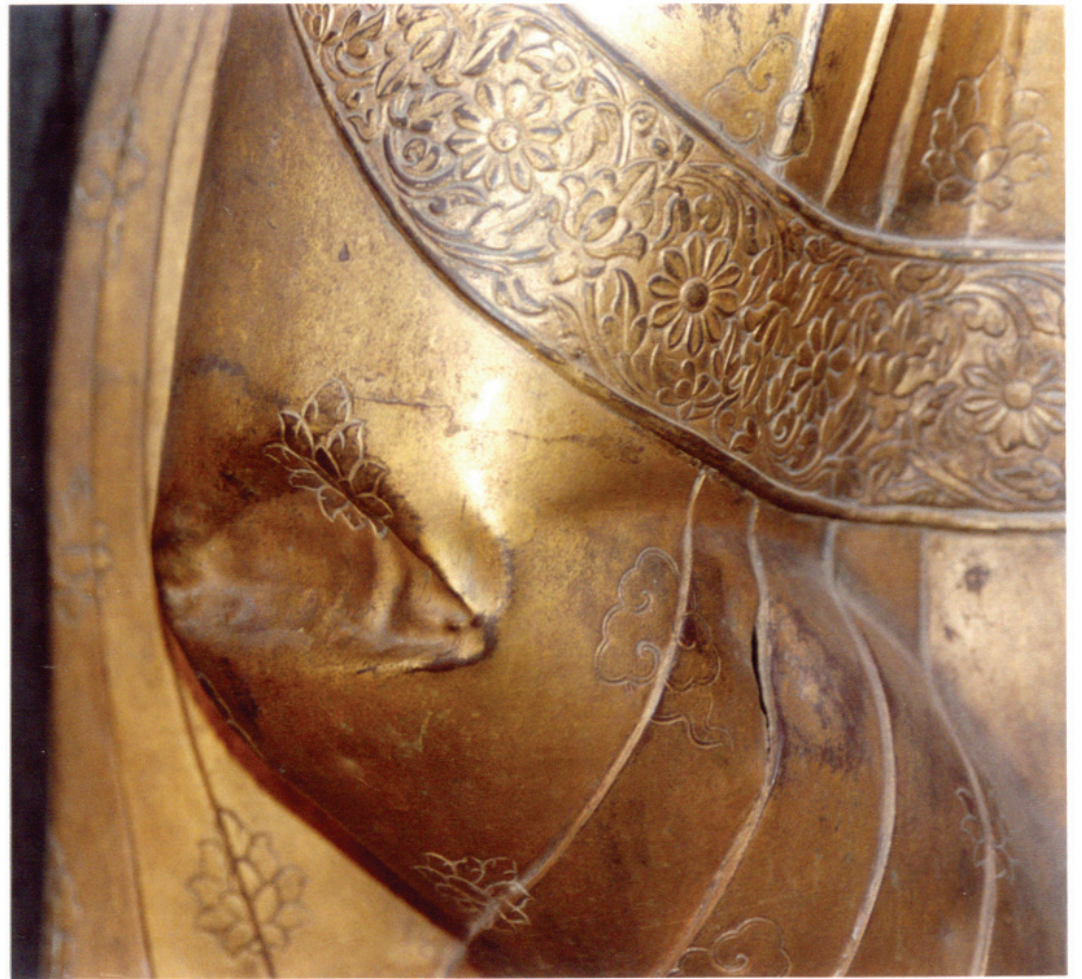
Aulcok  
 Details of battered legs and cracks  
 left Gaṅgā, right Yamunā  
 Photos Niels Gutschow, 29 November 2005

| labour: repair of Ganga, Yamuna | | 1.52.000.- |

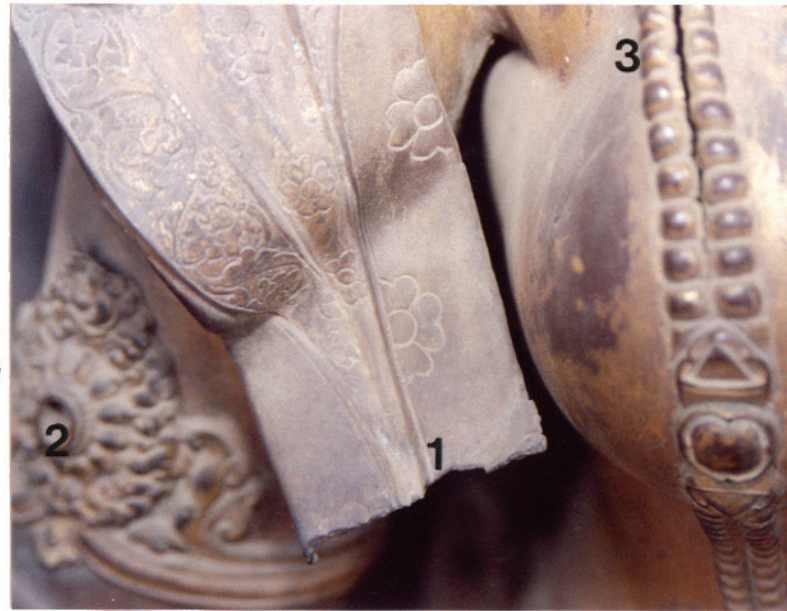
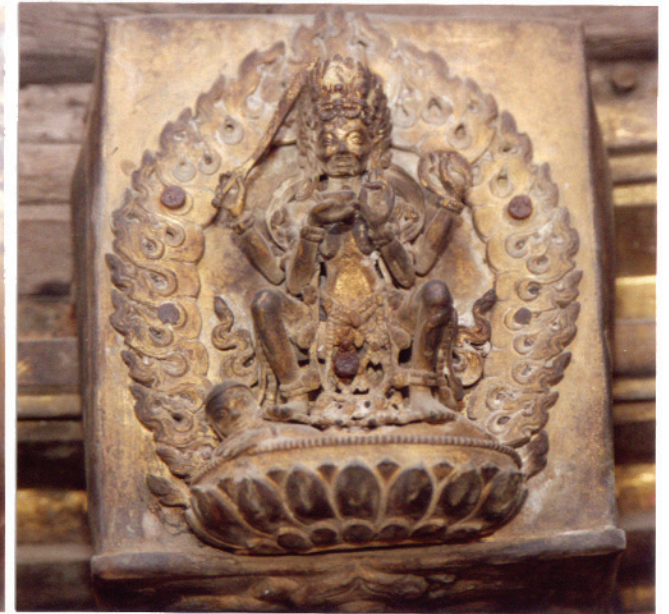
gate to the Taleju-shrine: two figures of Durgā slayer of the buffalo demon (Mahiṣāsuramardīnī) when ripped off the gilded tympanum. The lotus with her lion and the buffalo demon remains. Parvati, with her shawl broken off (1), the jewel arm lost (2) and the chain across her breast (3). the tiny figure of Kālī on the lintel survived. photos 4 April 2006

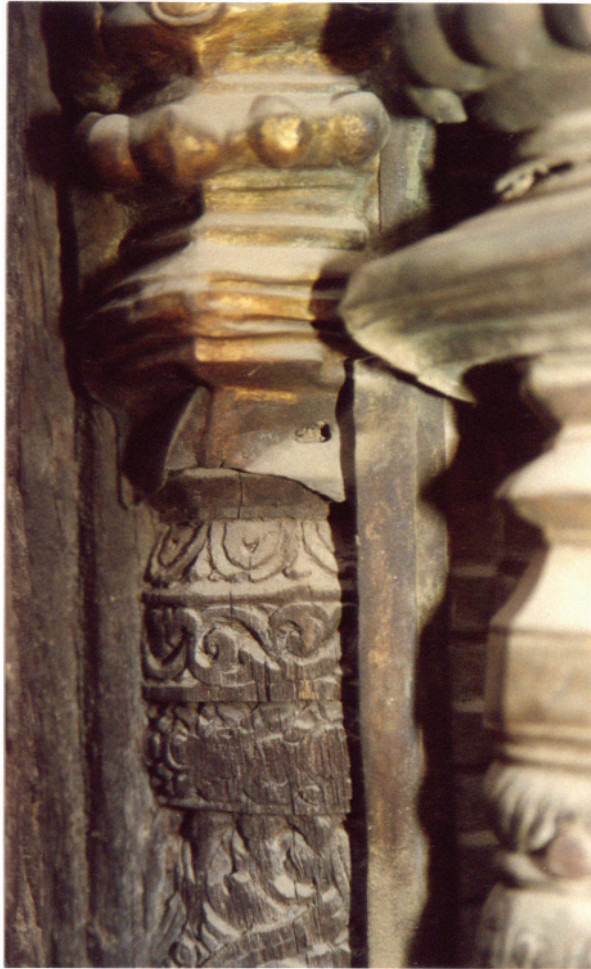
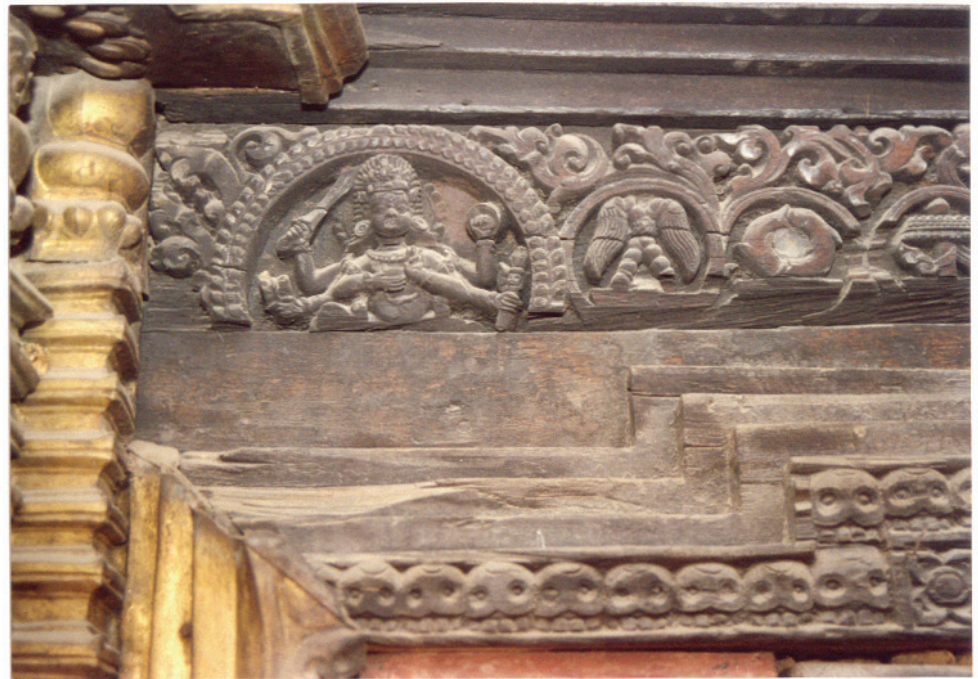
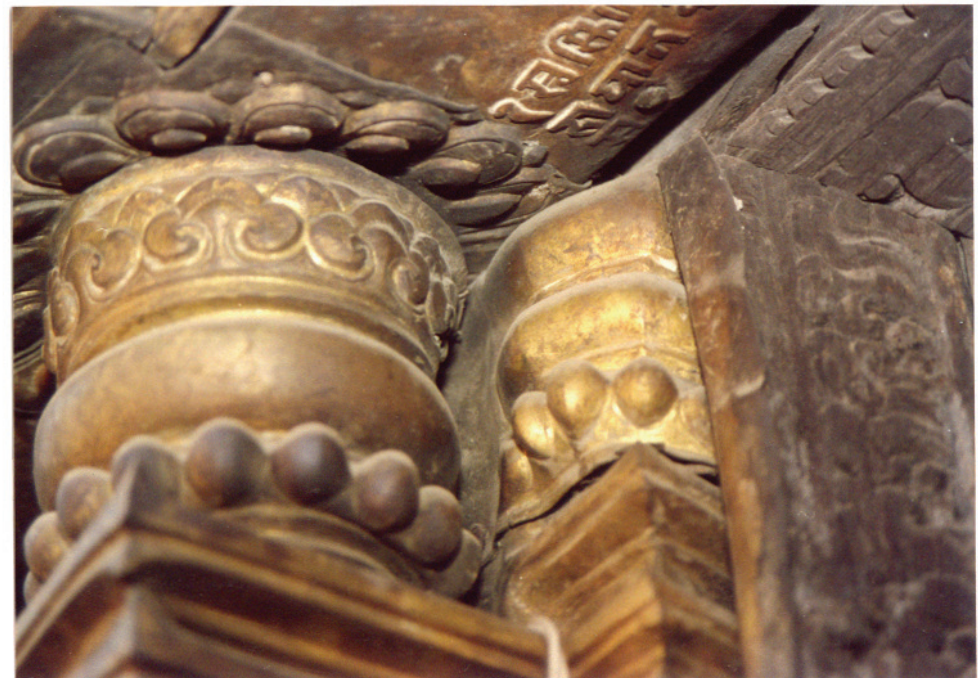
Lintel and door jambs of the entrance to the Taleju shrine.  
 Left and above, the repoussee work is incomplete.  
 Below, the inscription on the lintel documents the donation  
 of the gilded copper repoussee in AD 1707.  
 Photographs 4 April 2006

| Copper for missing parts and repair | 136 kg @ 700.- | 95.200.- |
| labour: repair of door | | 1.04.500.- |

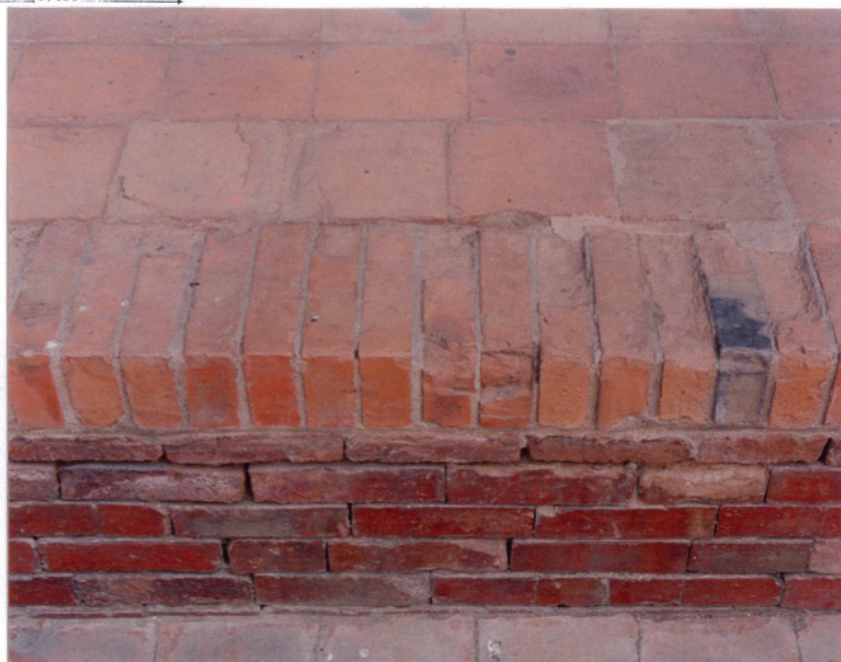
in stone 5 x 18 inches, 3 to 4 feet long @ 3.000.-/m fully dressed

The lining of the plinths in stone had been replaced by "Chinese" bricks from the Harisiddhi brick factory. The plan is to reintroduce stone in order to reinstate the historical situation.
