## EMERGENCY EARTHQUAKE REPAIRS TO THE TALEJU TEMPLE

ANNEX TO THE PROJECT PROPOSAL | NOVEMBER 2011

THE PRINCE CLAUS FUND: CULTURAL EMERGENCY RESPONSE PROGRAM

KATHMANDU VALLEY PRESERVATION TRUST

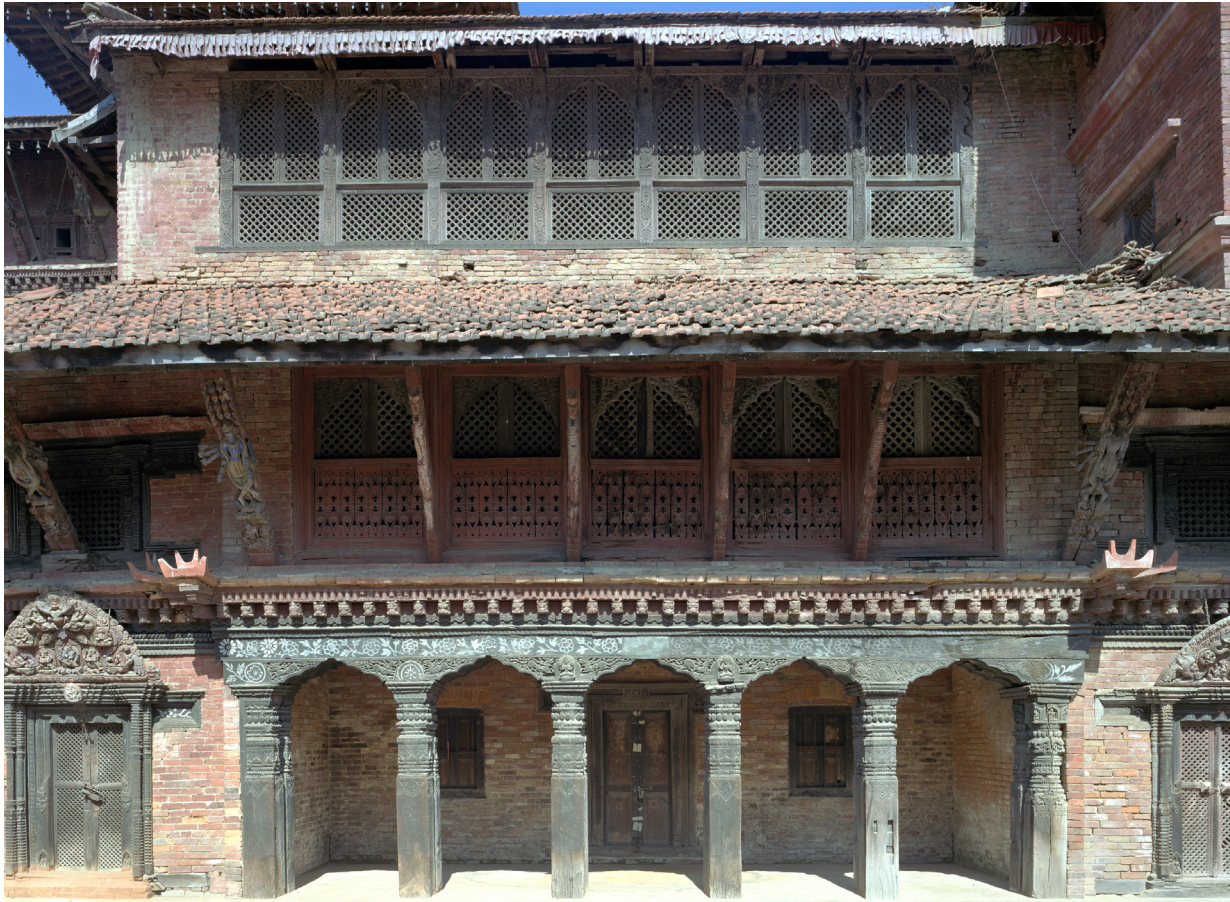
**Taleju Temple's lower level & Mul Chowk's north wing** | Sep. 2011

From this view it is seen how Taleju was built directly on top of Mul Chowk's north wing. This third level room, with its long arcade of wooden windows un-historically added after the 1934 earthquake, is the "puja" preparation room where priests prepare for the daily worship ceremony in the Taleju Temple.
