THE RESTORATION OF  
THE EAST WING OF SUNDARI COK  
AT THE PATAN PALACE COMPLEX – A UNESCO WORLD HERITAGE SITE

PROJECT APPLICATION | DECEMBER 2013

SUBMITTED TO

THE EMBASSY OF THE FEDERAL REPUBLIC OF GERMANY, KATHMANDU, NEPAL  
THE MINISTRY OF FOREIGN AFFAIRS, BERLIN, GERMANY

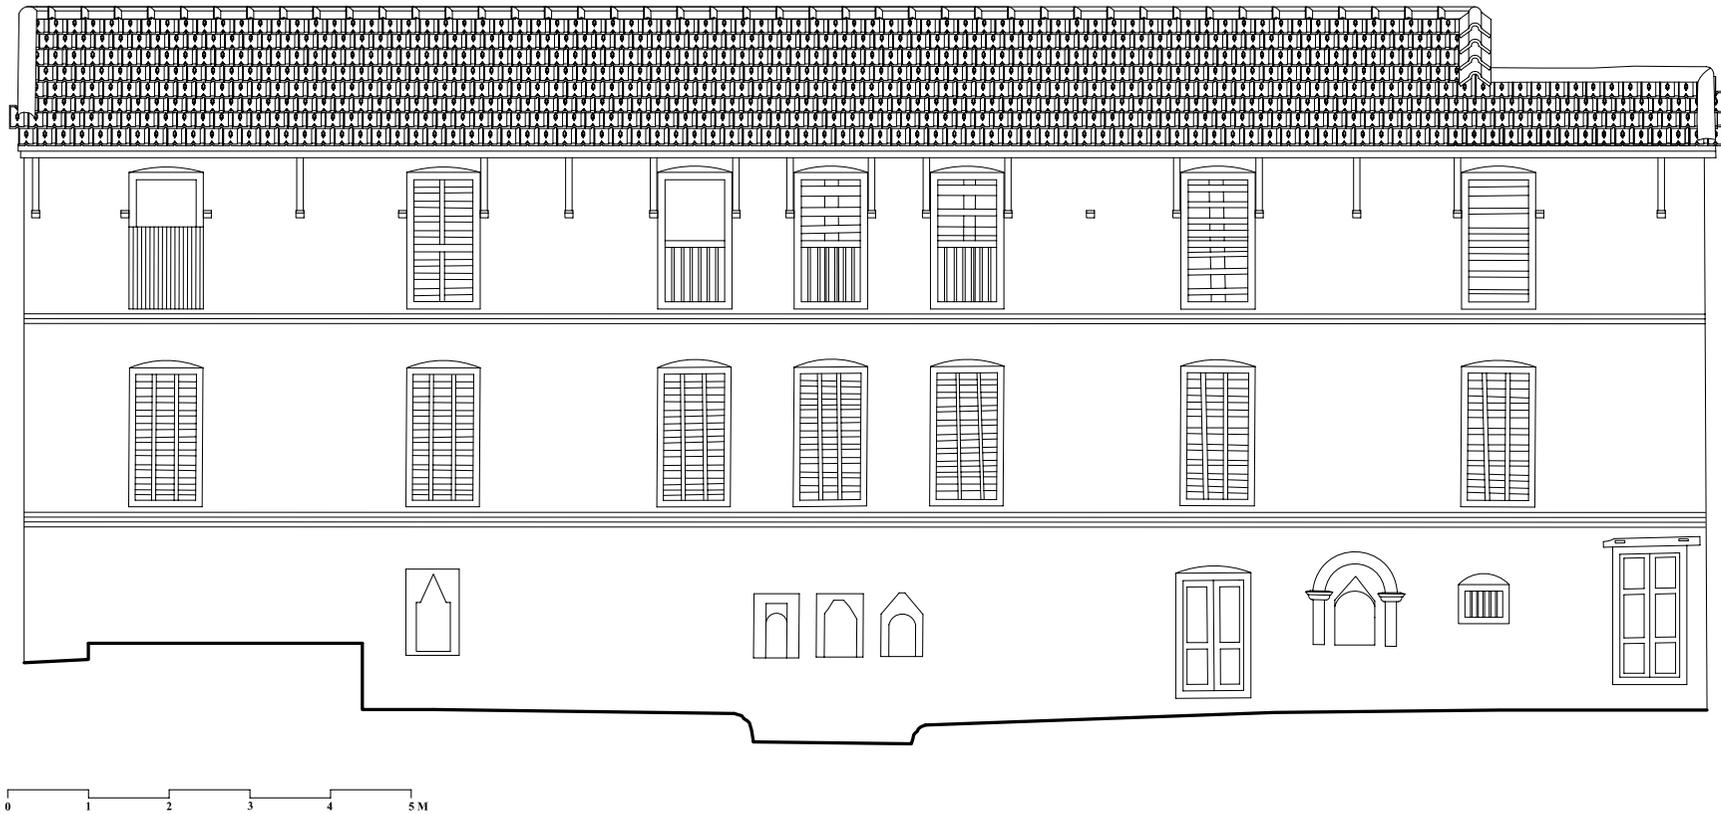
East façade of Sundari Cok, existing conditions | 2008

View of the east façade from the rear garden near Bhandarkhal Tank. Due to shortage of funds and building materials, regular bricks were used and simple windows installed. The smaller building to the left is an addition dating to the 1970s when the east wing was used as a temporary jail.

The east façade was entirely rebuilt in 1936 using low-fired mud bricks (*ma apa*). There has been no structural repair since then, but the façade has undergone minor repairs such as cement pointing of bricks on the ground floor level. This has caused severe spalling in several locations. Many brick surfaces are completely lost: in some cases, half or more of the mass of the individual bricks is gone. The upper two floors were not pointed with cement and thus retain some mud mortar.

Areas with cement mortar will be re-pointed with traditional yellow mud mortar. Severely damaged and missing bricks will be replaced with salvaged bricks matching the surrounding brick size and coursing.

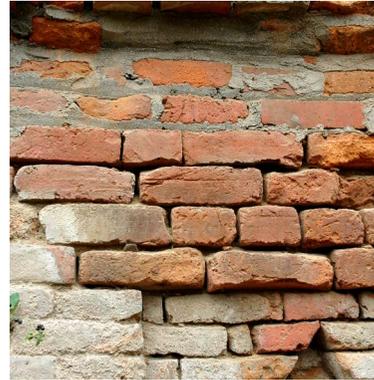
LOST POINTING

Layers of history are visible in the bricks that make up the ground floor of the east wing façade (top). The *ma apa* in the interior (bottom) are heavily damaged, largely due to the impact rising damp and careless cement pointing. There is considerable variation in the brick bonding throughout the building, with mud, lime (*surkhi*), and cement layers. The cement mortar dates from 1936 onwards.

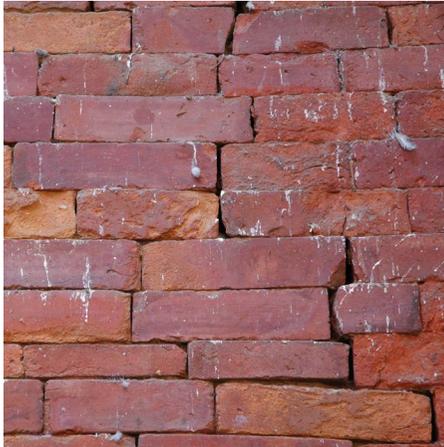
WIDE JOINTS

**Courtyard façade bricks, existing conditions** | 2009-2012

The existing *daci apa* bricks are largely intact and will be reused except when severely spalled. Loose and missing joints will be repointed with mud mortar. Historic *daci apa* bricks are constructed with a very thin joint width to minimize exposure to weather, and for aesthetic reasons. Each brick is tapered, which also improves bonding with the inner core of the wall.

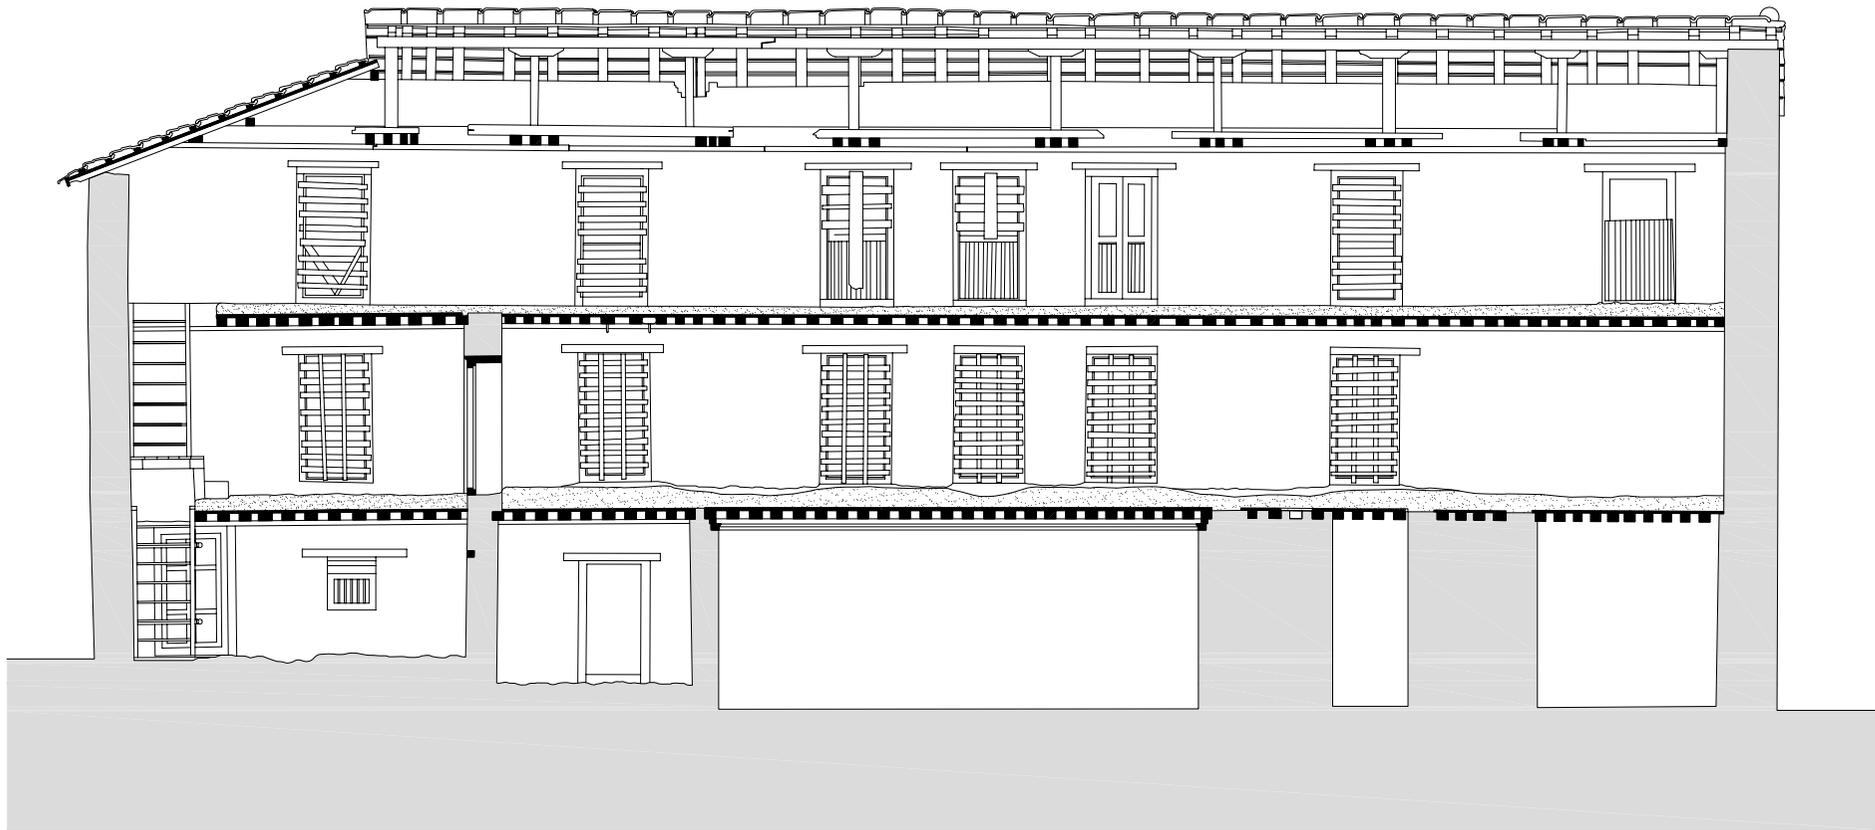
East wing of Sundari Cok, South-North section, existing conditions | 2008

Damages to the floor structure are largely responsible for the seismic instability of the building, since floor joists tie the inner and outer wall plates. The rotting of floor joists is caused by water infiltration through the poorly built roof. The loose timber joints cannot withstand lateral movement, making the building vulnerable to seismic motion.

The majority of the joists and wall plates have been affected by rising damp. There are severe cases of wet rot in the joists of the ground floor. Dry rot has affected joists on the first and second floors. In many cases, timber members affected by dry rot also show damp areas. Damp timber is more susceptible to fungal growth which in turn causes dry rot. Termite infestation is generally seen at the weak areas of the joists.

More than 75% of the floor joists on both first and second floors will be replaced. They will be chemically treated before being re-installed in a traditional configuration.

Rotten timbers will be removed and replaced. If the damp or damaged area is fairly small, it will be cut away and replaced with a new piece of timber. Removing the source of moisture will prevent further instances of rot. This will be achieved through the reconstruction of the roof, preventing leakage of water through the building (see pages 36-37).

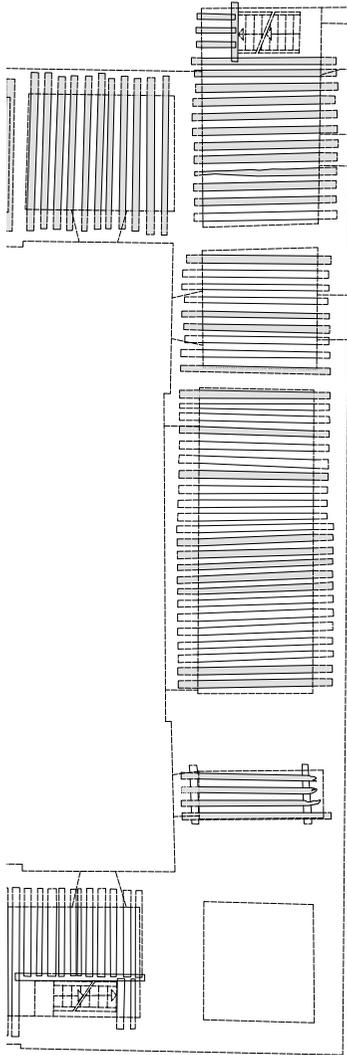
FIRST FLOOR

**East wing joist plans, existing conditions | 2008**

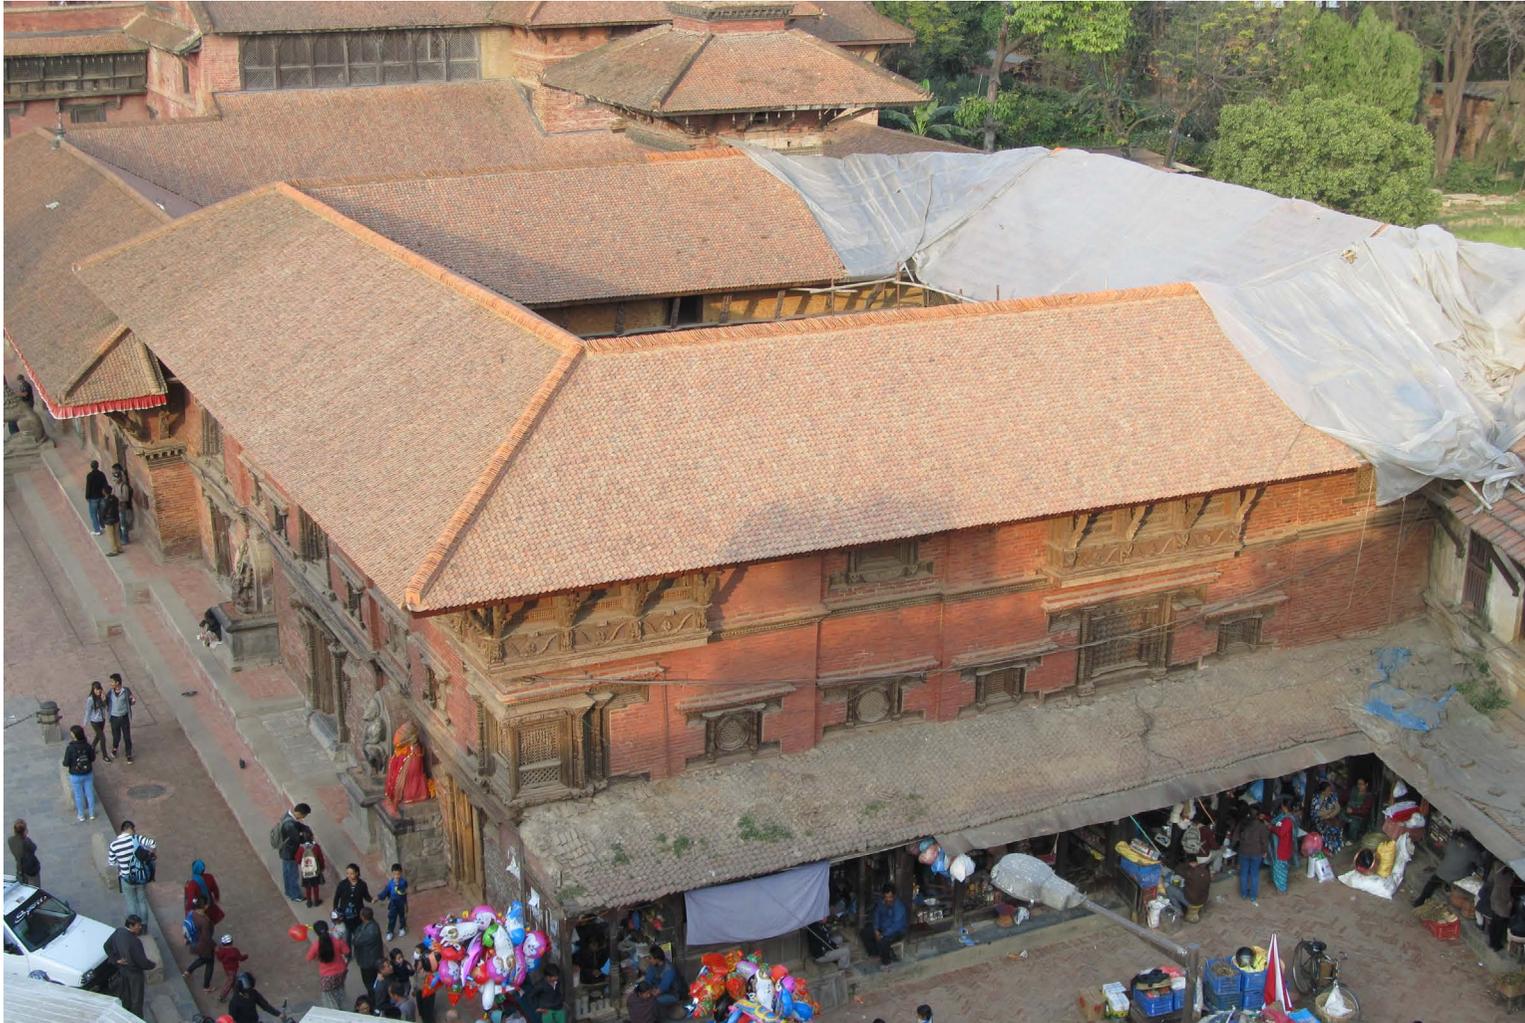
**Sundari Cok from the south** | November 2013

The roof has been reconstructed on the north, south, and west wings. The remaining east wing roof is temporarily covered with tarpaulin.

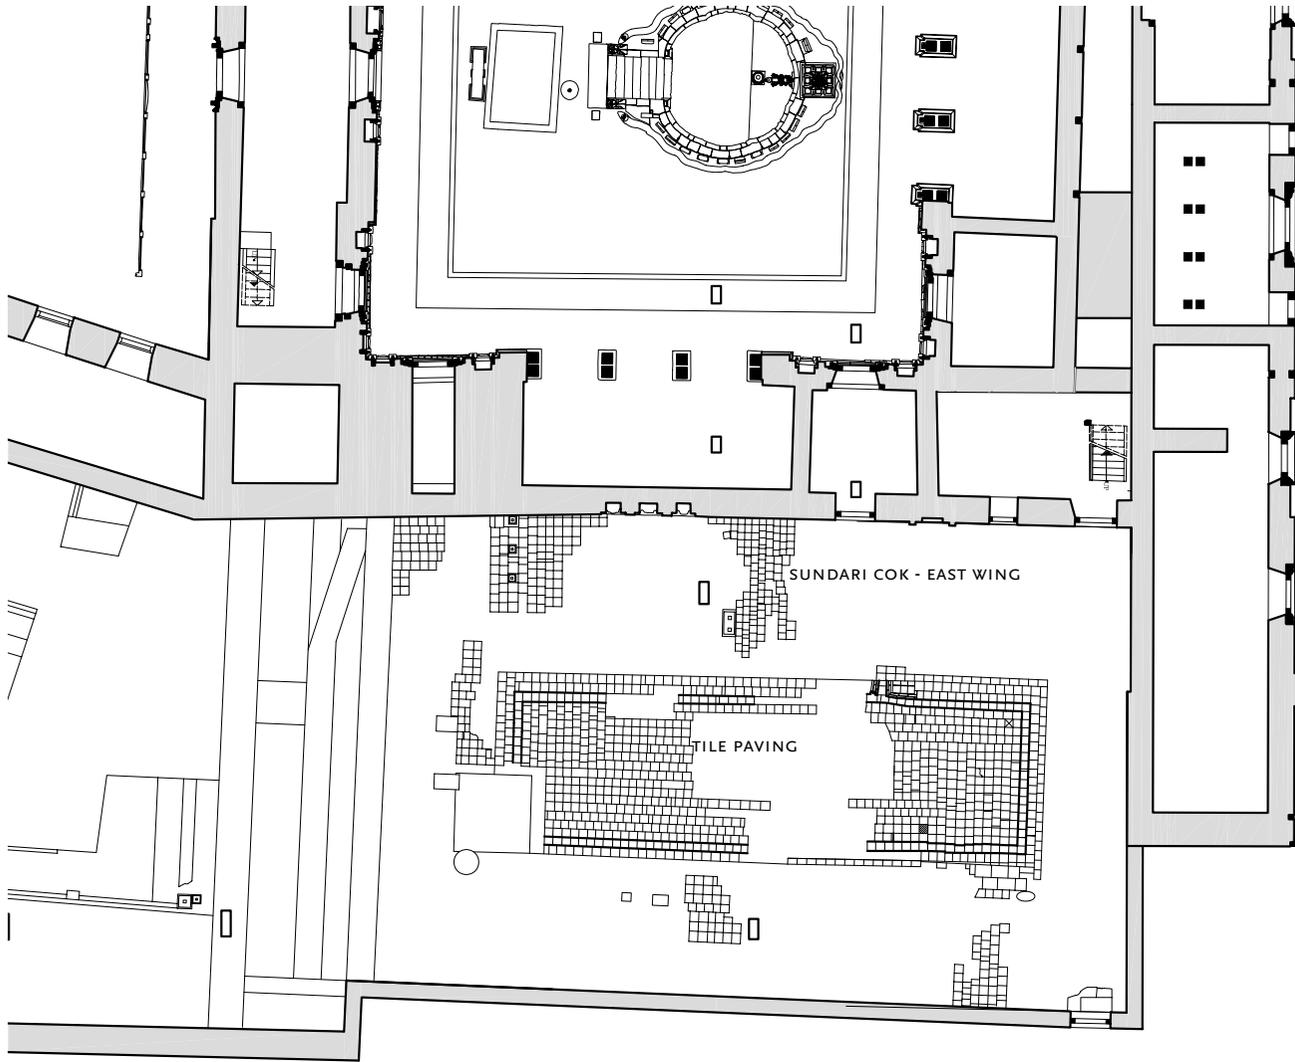
**Historic tile paving behind Sundari Cok, existing conditions | 2008**  
This drawing documents the exact location of the excavated tiles and other historical objects in the paved area between Sundari Cok and Bhandarkhal Tank.

The tiles will be laid on top of brick soling to provide a firm base upon which to grade a drainage system.

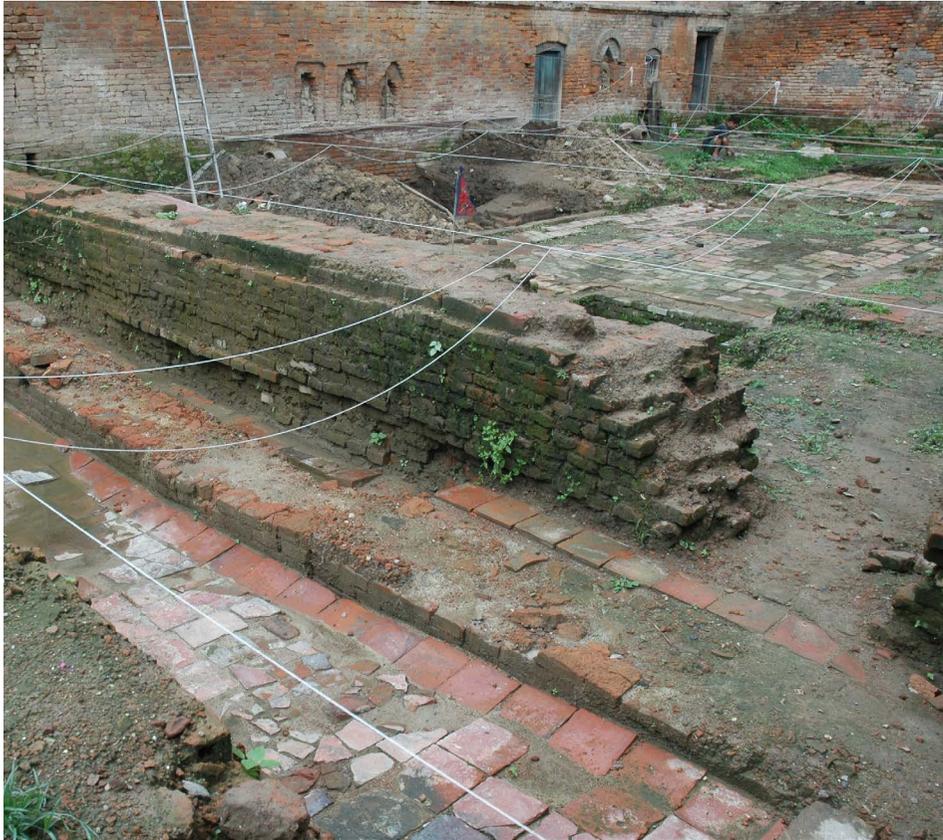
**Archaeological excavation | 2008**

An archaeological dig was conducted with care to preserve the historical *telia* tiles. The dig revealed other objects such as stone bases for timber pillars, indicating that there was once an open arcade adjacent to the east wing.
