AYUGUTHI SATTAL
PATAN DARBAR SQUARE, WARD 11

HISTORIC STRUCTURE REPORT
JANUARY, 1996

ERICH G. THEOPHILE
ROHIT K. RANJITKAR

KATHMANDU VALLEY PRESERVATION TRUST
IN COOPERATION WITH
HMG DEPARTMENT OF ARCHAEOLOGY

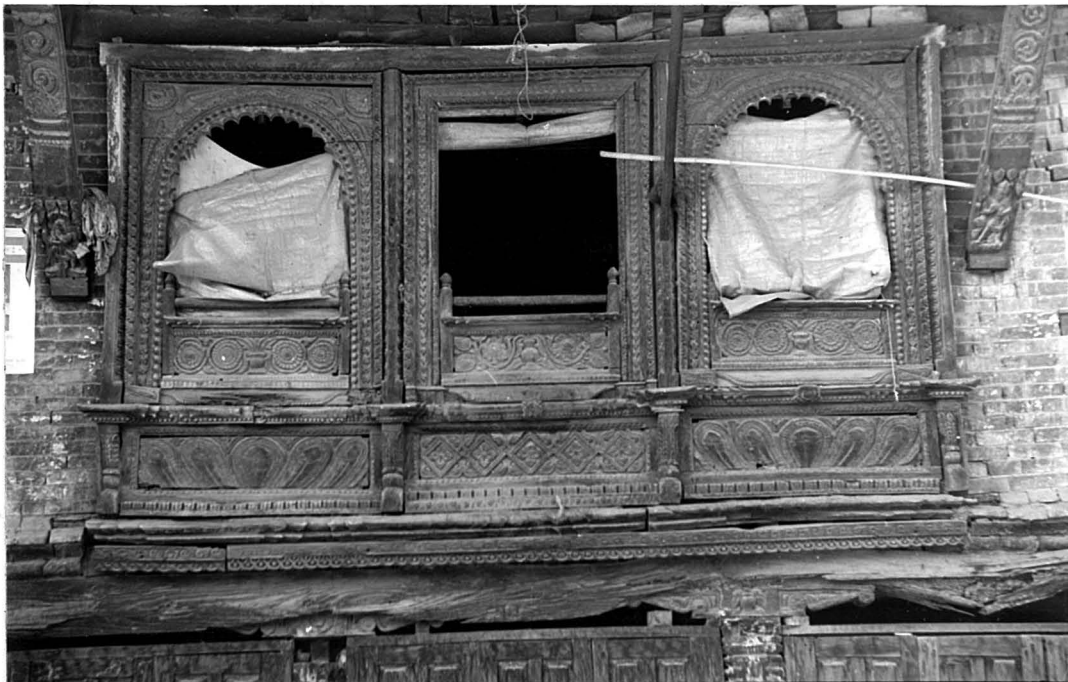
Above: multi-bay window or san jhyah of principal facade, fall, 1993. Below: principal facade spring, 1994. Notice additional wall damage at far right.

The entire facade to the right of ground floor *dalan* has deteriorated over the last seven years, in the last year the veneer brick or *daci apa* has fallen out. Photos of 1988 show a stepping crack travelling 28 courses up, just touching the right end of the *dalan's* lintel beam. The crack appears not to have been larger than one half inch, but water penetration from the damaged roof above caused the individual layers of the wall to separate, the outer veneer splaying out. This is a typical problem in the traditional buildings of the Kathmandu Valley.

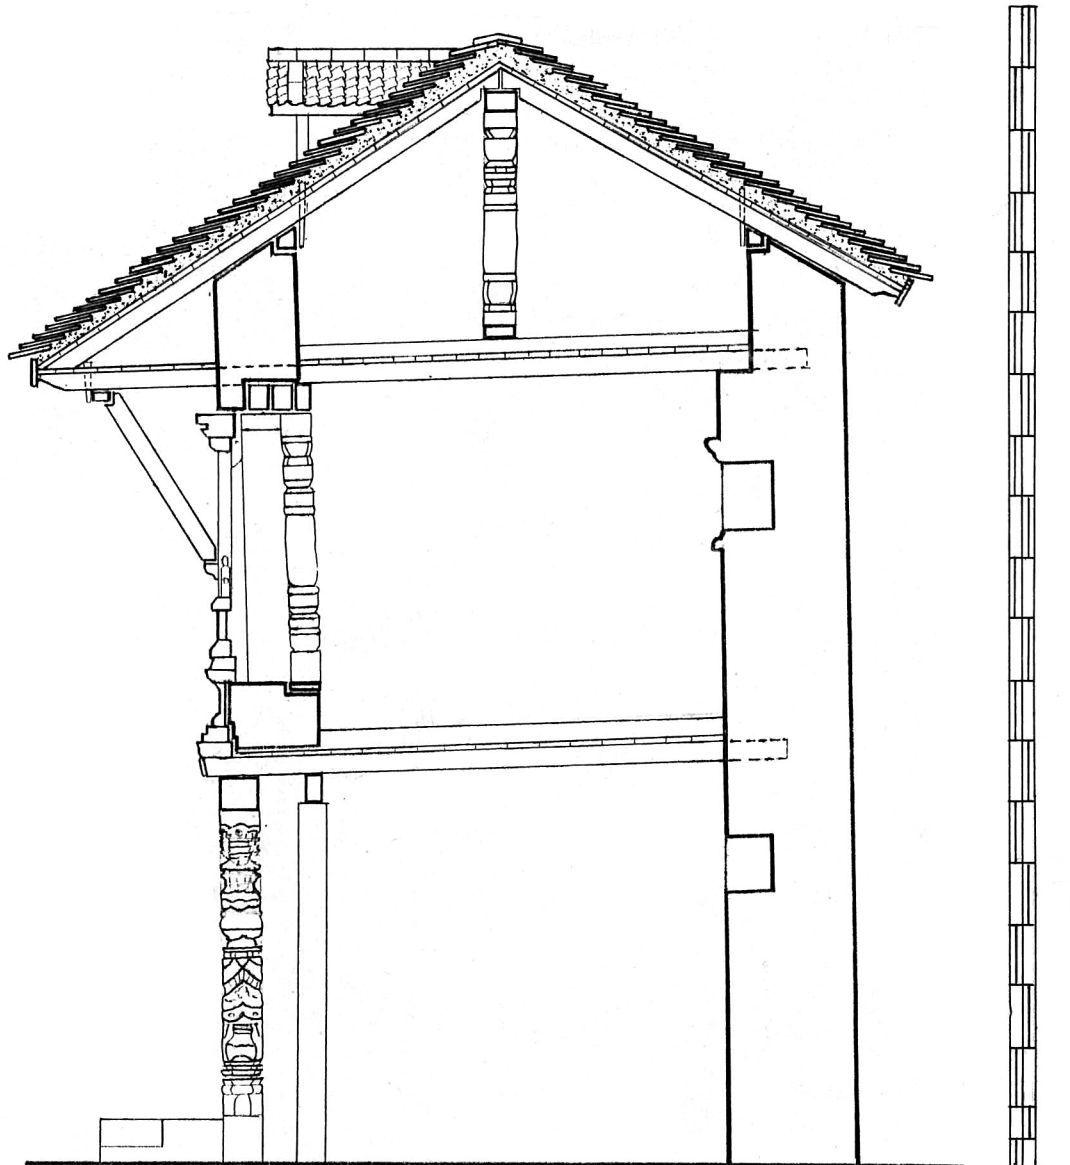
AYAGUTHI SATTAL
SOUTH-NORTH SECTION: EXISTING CONDITIONS

Mortises and carving details in all seven extant roof struts establish that they come from a leaning bay window or *san jhya*. The quality of carving suggests an age of less than 100 years. Carved timber figures in the upper story niches also appear to have come from another structure.

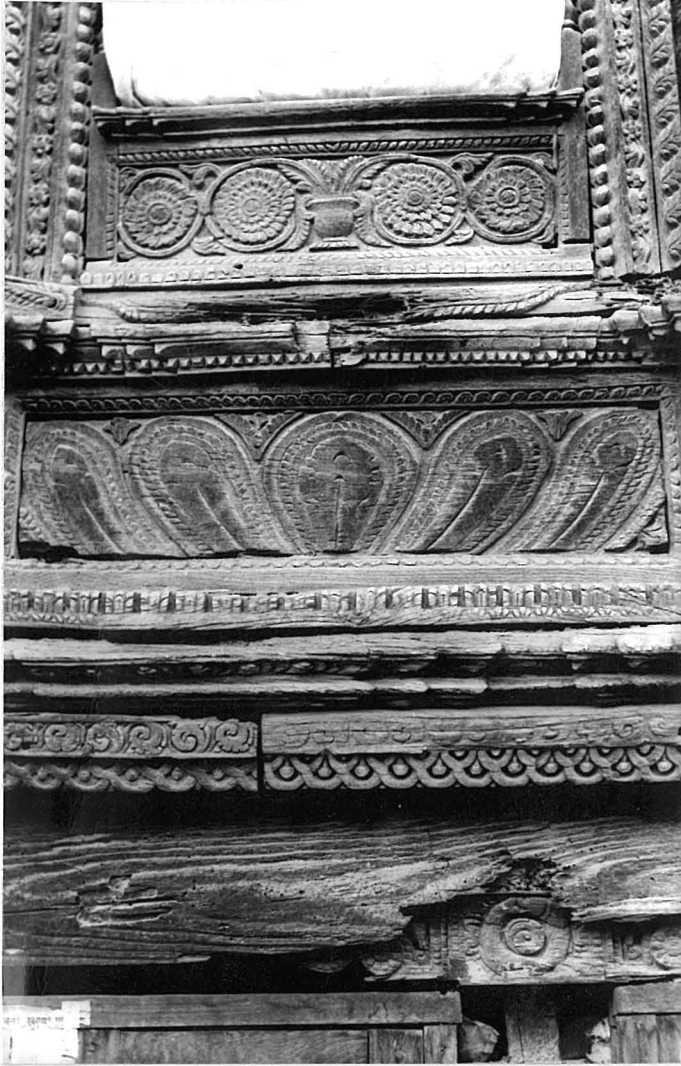
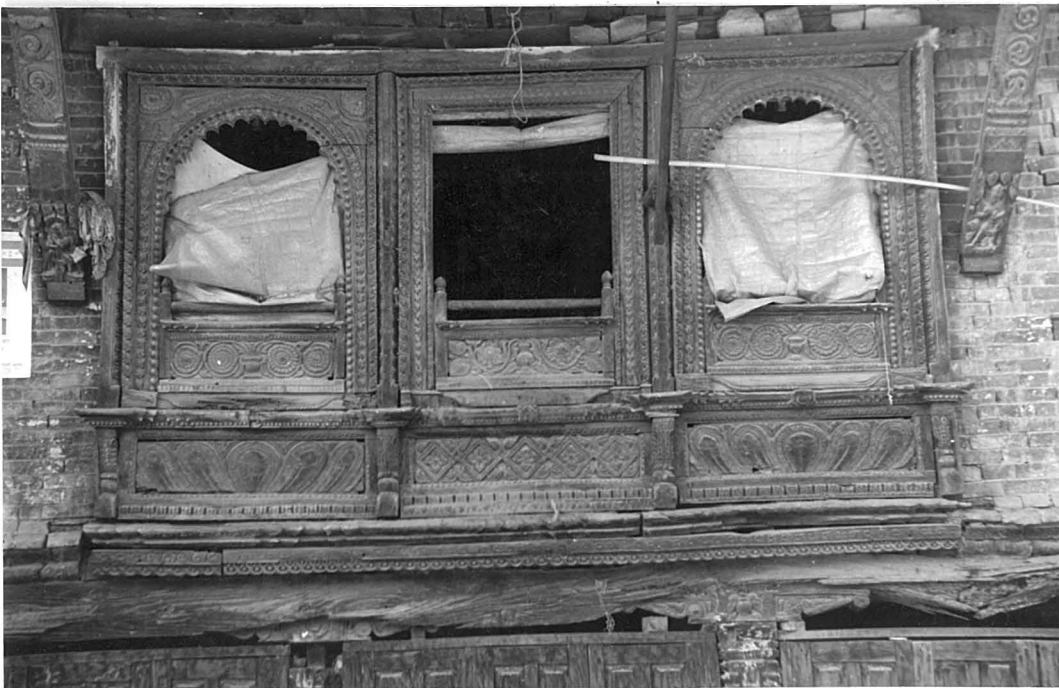
Opposite: detail of *san jhyah* central bay showing *kalash* and floral interlace. Above: detail of *san jhyah* left bay with *kalash* panel above and large scale lotus leaf pattern. in lower panel. Below: *san jhyah*, fall 1993.

Structural frames of the upper story windows including two flanking and central bay window, *san jhya* are all in fair condition except for some noticeable loosening of the joints in the *san jhya*. There are no signs of termite attack. All openings of the upper floor are missing their shutters (Newari : *kapha*) and are covered with makeshift materials. One interior door survives with shutters in fair condition. The ground floor door alone retains its historical shutters, both frame and shutters in good condition.

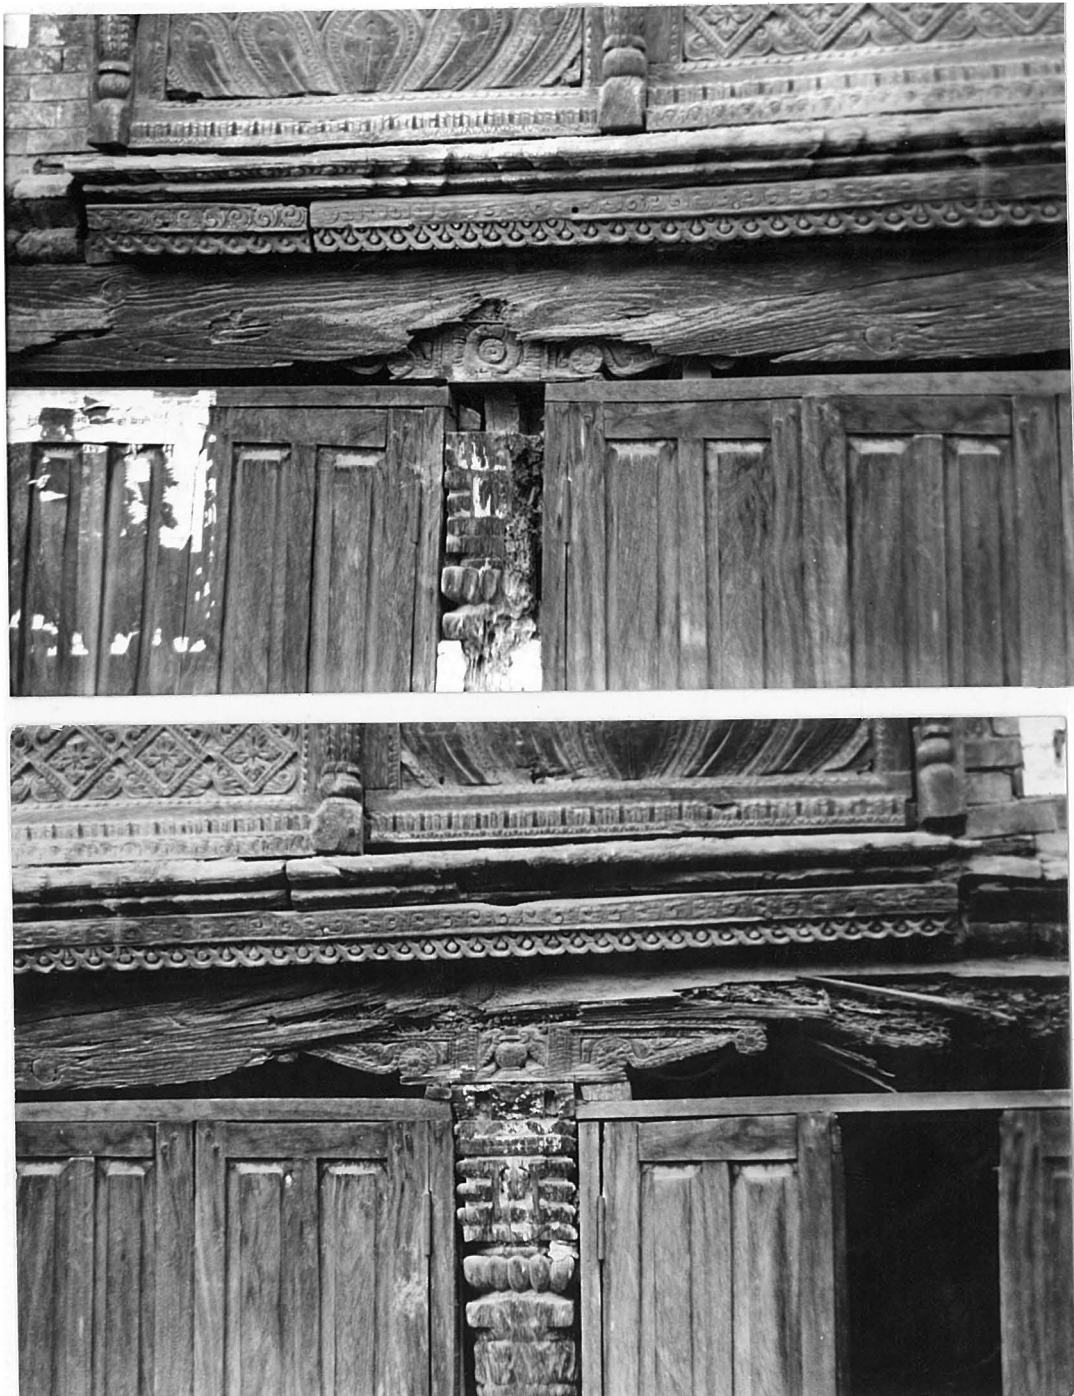
Column capitals (left central above; right central below). The details in the middle carved panel of each capital (Newari: *metli*) varies: above lotus flower, below water vessel or *kalash*. Opposite: end columns are more heavily damaged and decorative details are indeterminable.

All four historical oversized and carved timber posts in sal wood are completely structurally denatured by drywood termite infestation. This infestation was diagnosed by visiting expert Sir Bernard Feilden (based on the pest's visible mud tracks). The column capitals (Newari: *meth*) are damaged to varying degrees by the termite infestation as well, the outer of four capitals severely denatured, the central two capitals appear to have only superficial damage.

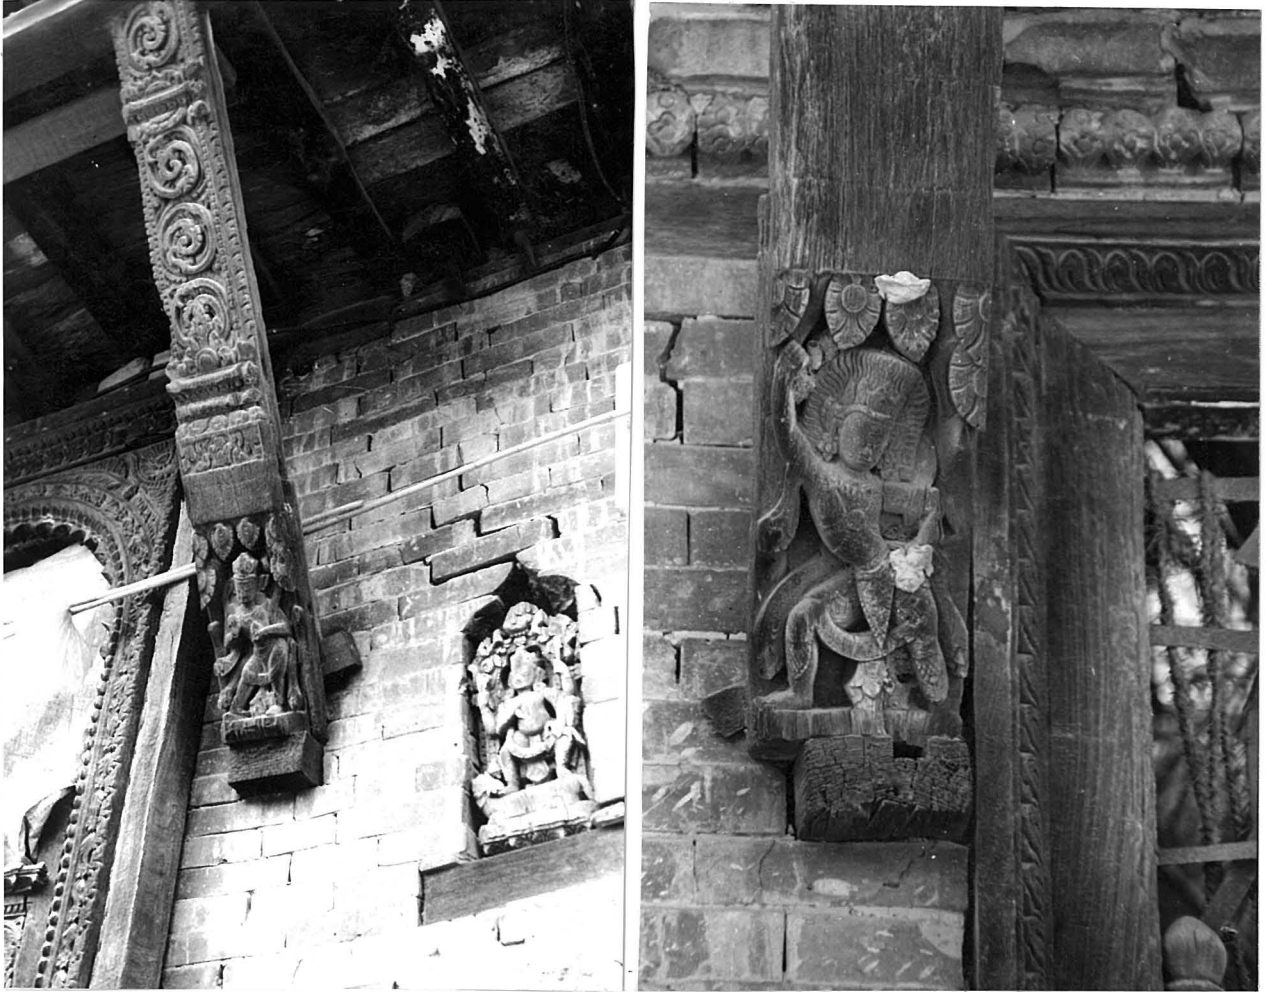
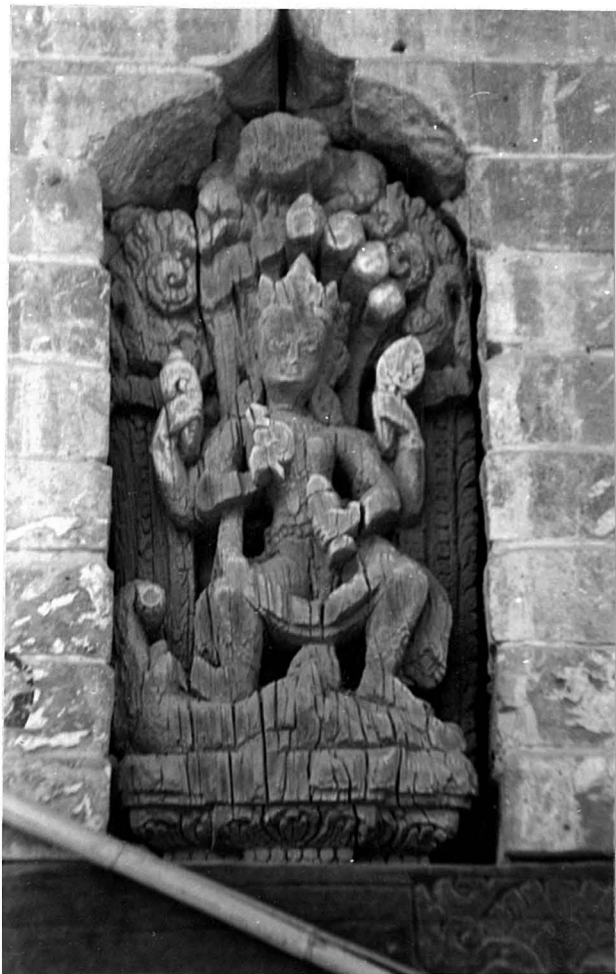
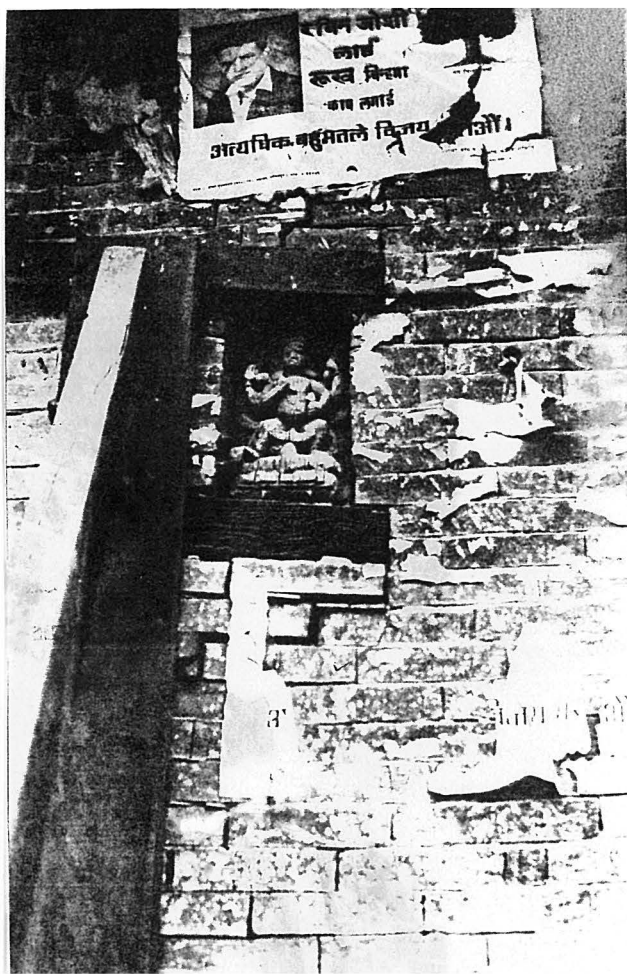
Roof struts (Newari: *tunah*). Five existing carved struts come from a leaning bay window (Newari: *san jhyah*) as demonstrated by tenons visible on the sides of each piece and the format, which would be unusual for a typical roof strut. The struts are divided into two registers with varying figures below and repetitive wave motifs above. Struts numbered left to right 1-5). Opposite upper left: strut#1 with Bhairav figure; upper right: strut #2 another pose of Bhairav; opposite lower left: strut # 3 Visnu. This page left: strut #4 Siva and right #5, Siva (?).

Seven carved struts (of nine total) are all of sal and are in good condition. There are no signs of termite attack. Two of these struts (from right end of building) are in storage. The two uncarved struts above the *san jhyah* are sal and heavily damaged by wet rot.

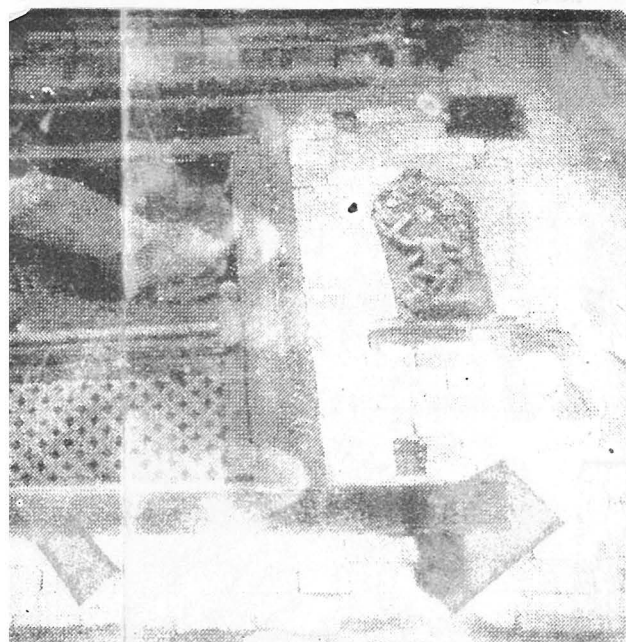
NICHE FIGURES:
 Above left: Vishnu ; above right Siva(2nd and 4th niches from left). Two additional struts depicting Bhairav are not possible to photograph because of temporary shoring. These figures do not appear to be original to the simple niches, although it is possible that they are original to the building.

Four decorative carvings in upper story niches are in good condition showing no signs of termite infestation.

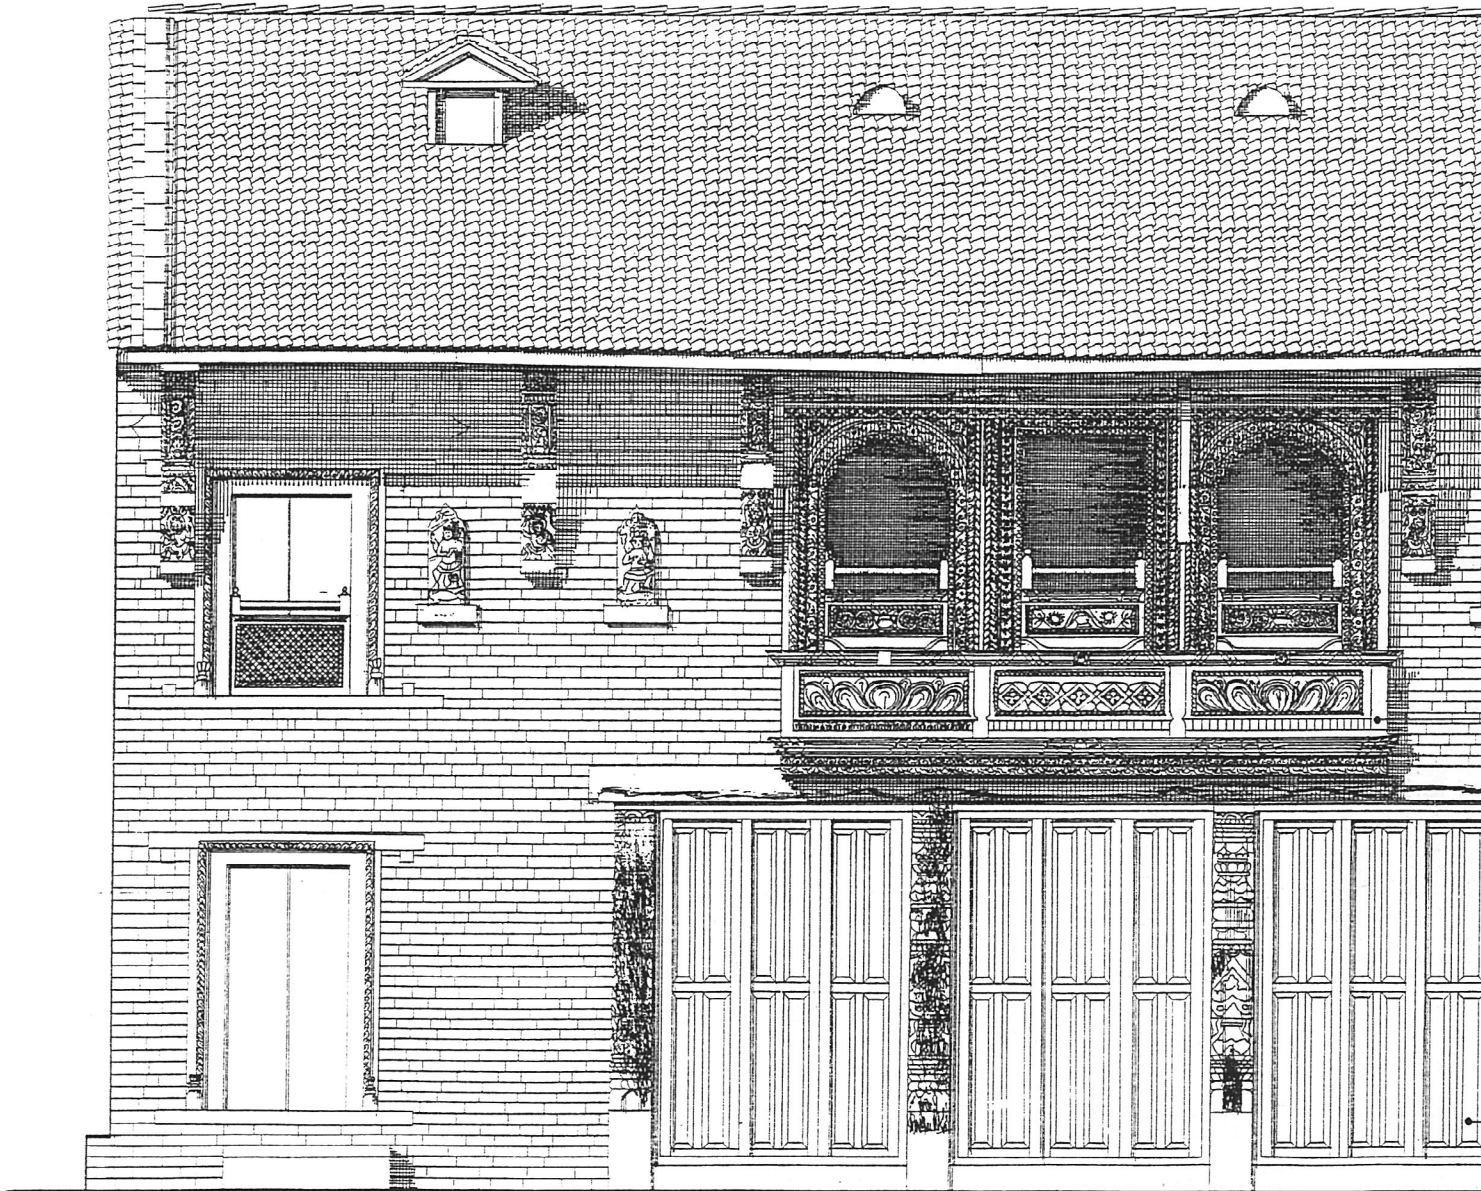
PRINCIPAL ELEVATION: EXISTING CONDITION

EXISTING CONDITIONS

ROOF TILE AND MUD COVER: DAMAGED EXTENSIVELY.

ROOF STRUCTURE: ALL RAFTERS, EAVESBOARDS, AND PURLIN ARE PINE AND SEVERELY DAMAGED BY WET ROT.

RIGHT END OF ROOF COLLAPSED 10 YEARS BACK: SUBSEQUENT WATER DAMAGE TO TWO FLOOR LEVELS BELOW.

SAL EAVESBOARD SEVERELY DAMAGED BY WET ROT.

6 CARVED STRUTS IN SAL WOOD, GOOD CONDITION. ONE CARVED STRUT IN STORAGE, CONDITION?. TWO PLAIN STRUTS OF *SANJHYA* SEVERELY DAMAGED BY WET ROT.

CARVED MINIATURES IN THE FOUR NICHEs ARE IN GOOD CONDITION.

SIDE WINDOWS IN GOOD CONDITION, LOST SHUTTERS.

SANJHYA BAY WINDOW: JOINTS ARE LOOSE. NO TERMITE DAMAGE. SHUTTERS LOST.

SHUTTERS ARE IN GOOD CONDITION.
