NARAYANA TEMPLE

KULIMA, PATAN

HISTORIC STRUCTURE REPORT

KATHMANDU VALLEY PRESERVATION TRUST
MARCH, 1998

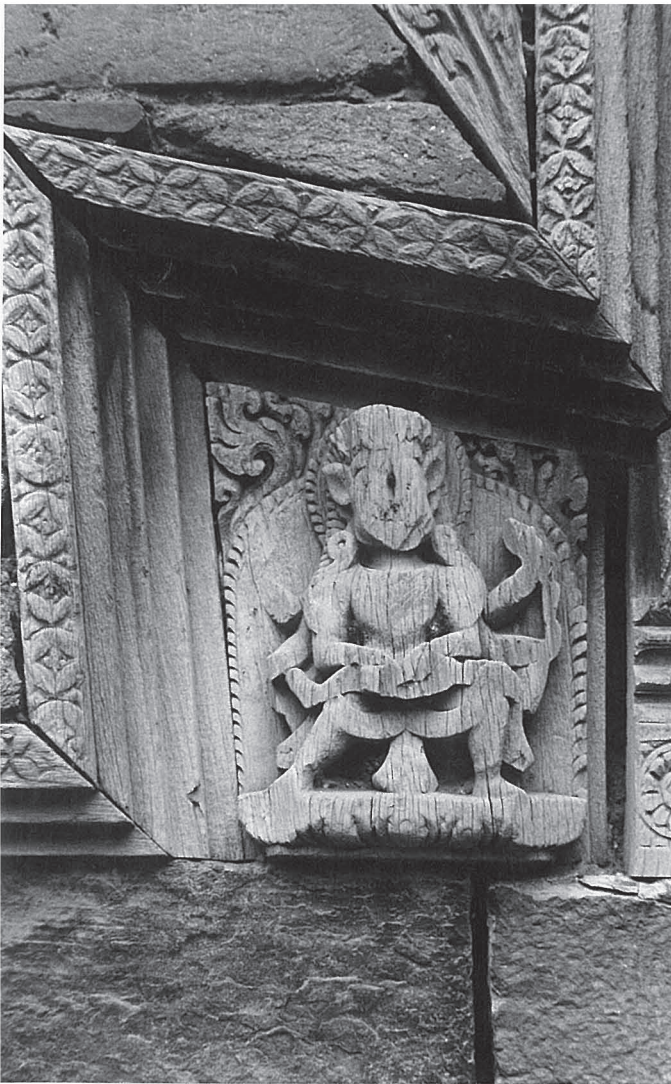
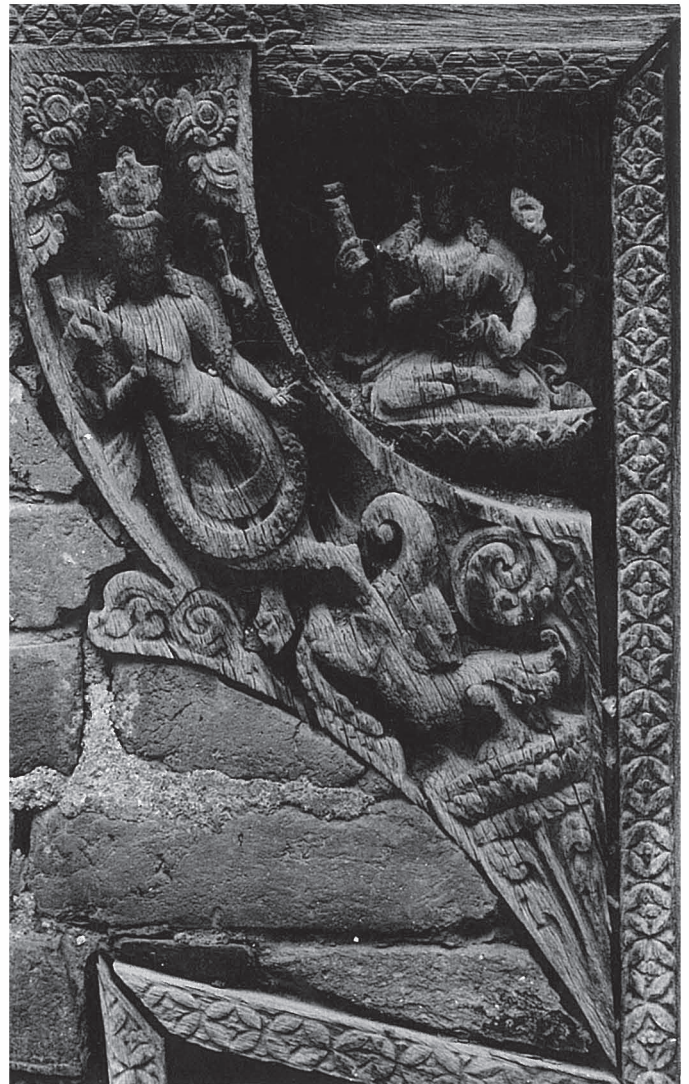
Bhairav, a protective deity, inset in the temple doorsill (left) and the curved salabhanjika (tree goddess) aboveframing the temple entrance. The fomula for placement of these protective deities is largely standardized in Nepal during the 17h-19th c.

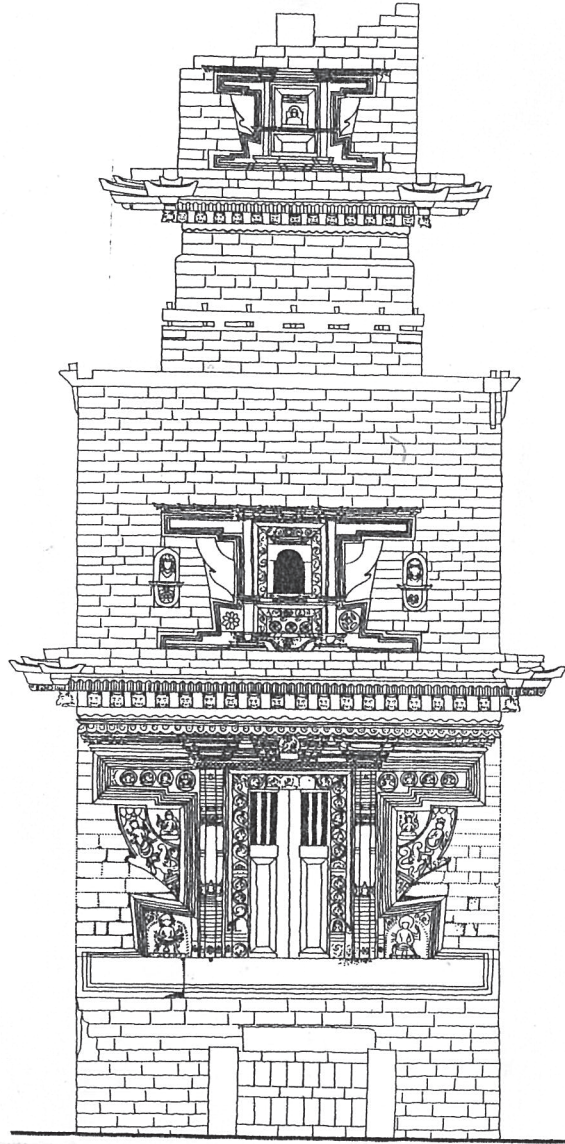
PRINCIPAL EAST ELEVATION : EXISTING CONDITION
KATHMANDU VALLEY PRESERVATION TRUST - NOVEMBER 1998

During renovation in 1958 this level was reconstructed using mixed *dachi apa* (vener brick) and *ma apa* (common brick). The top level has suffered considerable damage. The top three courses of brick masonry have collapsed as a result of water penetration. The southern face was repaired using *ma apa* in the 1958 restoration. The water has penetrated the mud mortar between the structural and veneer wall layers (inner and outer leaf layers, respectively) and has caused the wall to pull apart brick by brick. Water penetration has also caused the northern and eastern wall to bulge by 3" and the southern and western walls by 2".

Both roof levels have been completely lost without a single rafter remaining. The surviving sal wood wall plates have been completely damaged by water penetration, as have the timber posts inside the wall. Of the twenty four original struts thirteen survive (*see diagram on following page*), one *kusala* (corner strut) and four side struts have survived from the upper floor and three *kusala* and five side struts have survived in the lower.

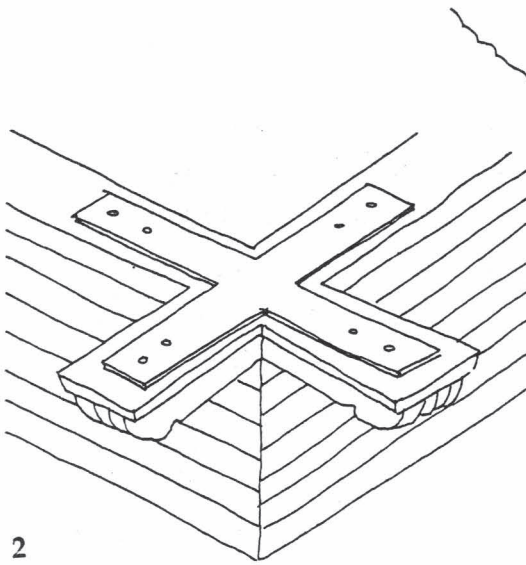
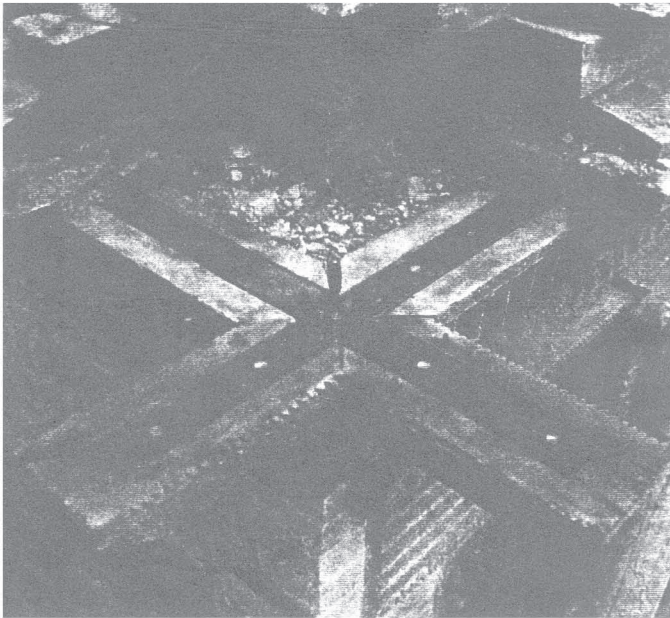
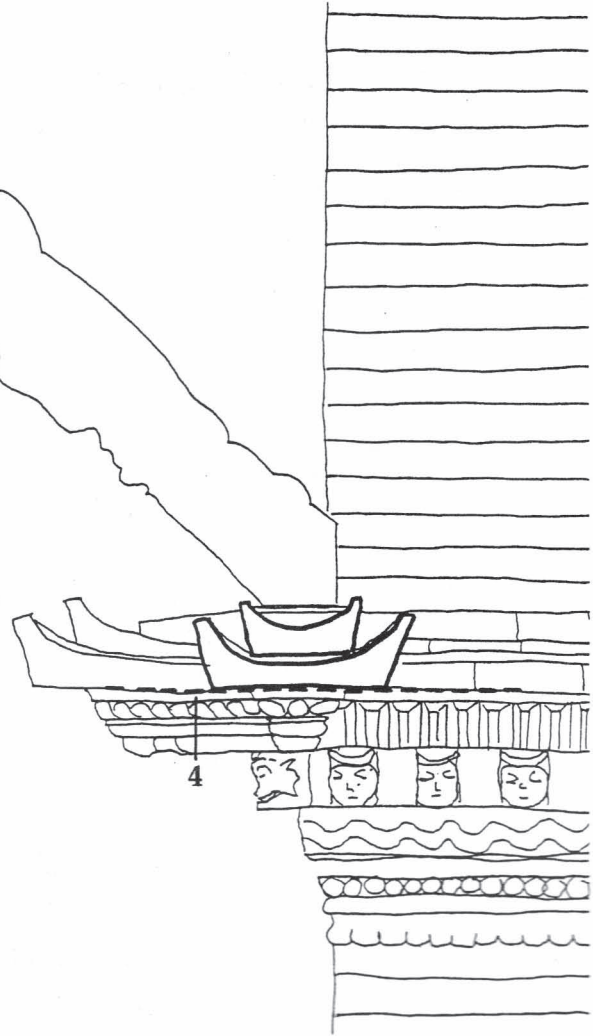
Reinforcement of *Lah-Kah*.

1. The corner lap joint timber section is not sufficient to bear the load of the corner strut. If the corner strut is off center it is highly probable that the protruding timber end will break off easily.
2. To prevent this kind of failure a metal cross piece is attached to the joint. This improves the strength and allows the even distribution of local forces.

All the wall openings and decorative elements such as timber cornice, *lah kah*, *blind* window, windows and main doorway shall be cleaned with plain water and soft toothbrushes. No structural work is required for any of the decorative elements. Two of the four timber *lah kah* (decorative corner brackets) are missing, these shall be recarved as per the remaining two. They are identical on all corners.

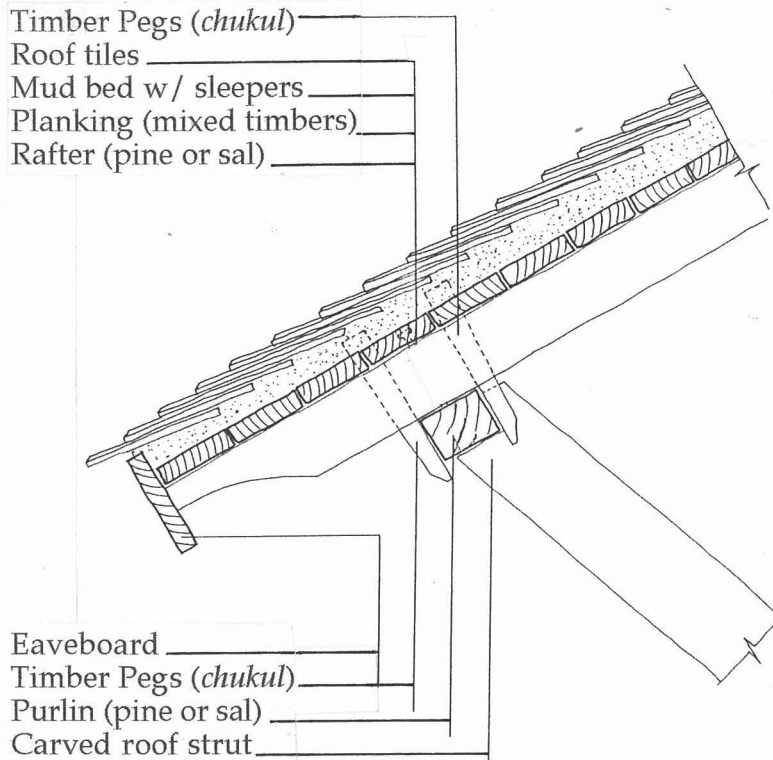
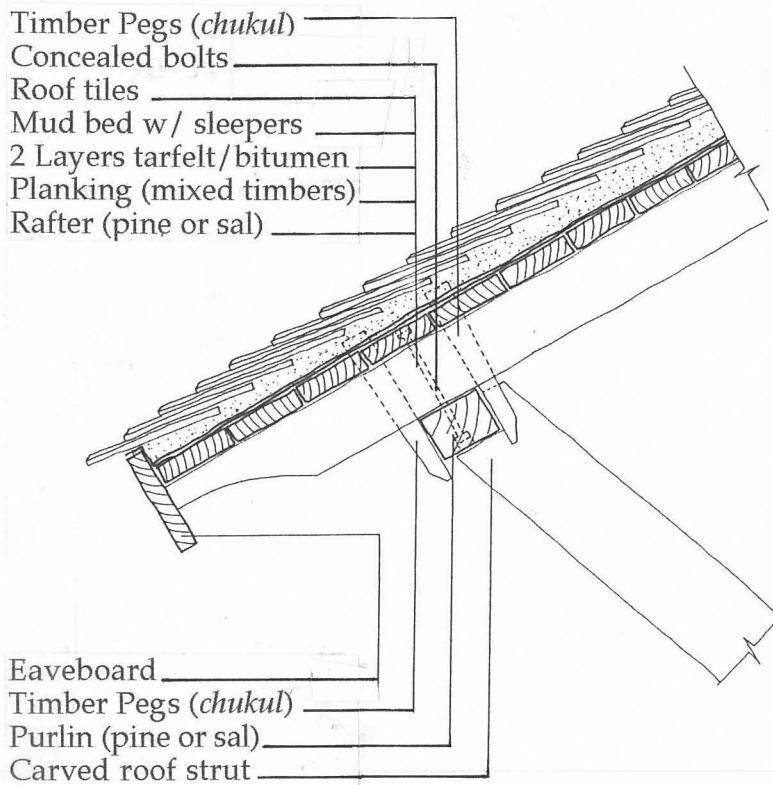
As traditionally detailed.

Improved detailing.
