**UMA MAHESWAR TEMPLE
KWALKHU TOL, PATAN**

HISTORIC STRUCTURES REPORT
MARCH, 1992

**ERICH G. THEOPHILE
ROHIT K. RANJITKAR
KATHMANDU VALLEY PRESERVATION TRUST
IN COLLABORATION WITH
HIS MAJESTY'S GOVERNMENT
DEPARTMENT OF ARCHAEOLOGY**

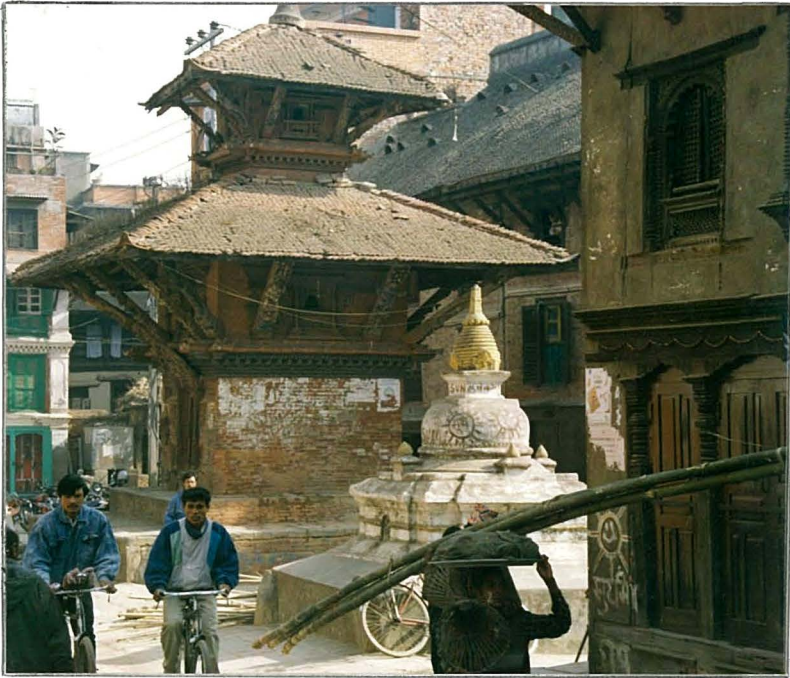
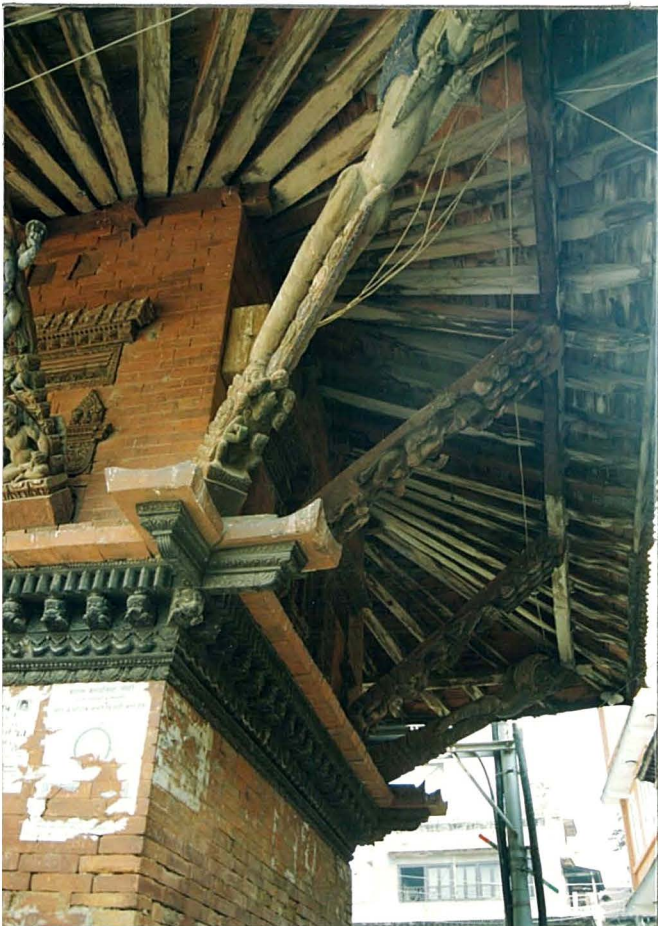
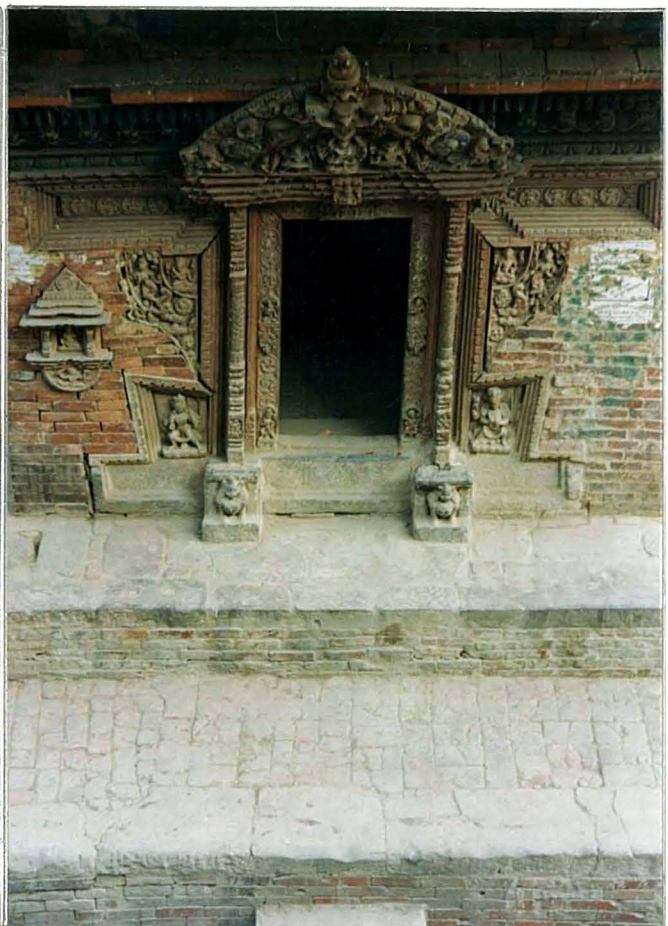
UMA MAHESWAR, JANUARY 1992. ABOVE:
VIEW FROM SOUTH BELOW LEFT:
UNDERSIDE OF LOWER ROOF AT SW
CORNER. BELOW RIGHT: BASE STORY
ENTRANCE, WEST ELEVATION, SEEN FROM
THE NEIGHBORING HOUSE.

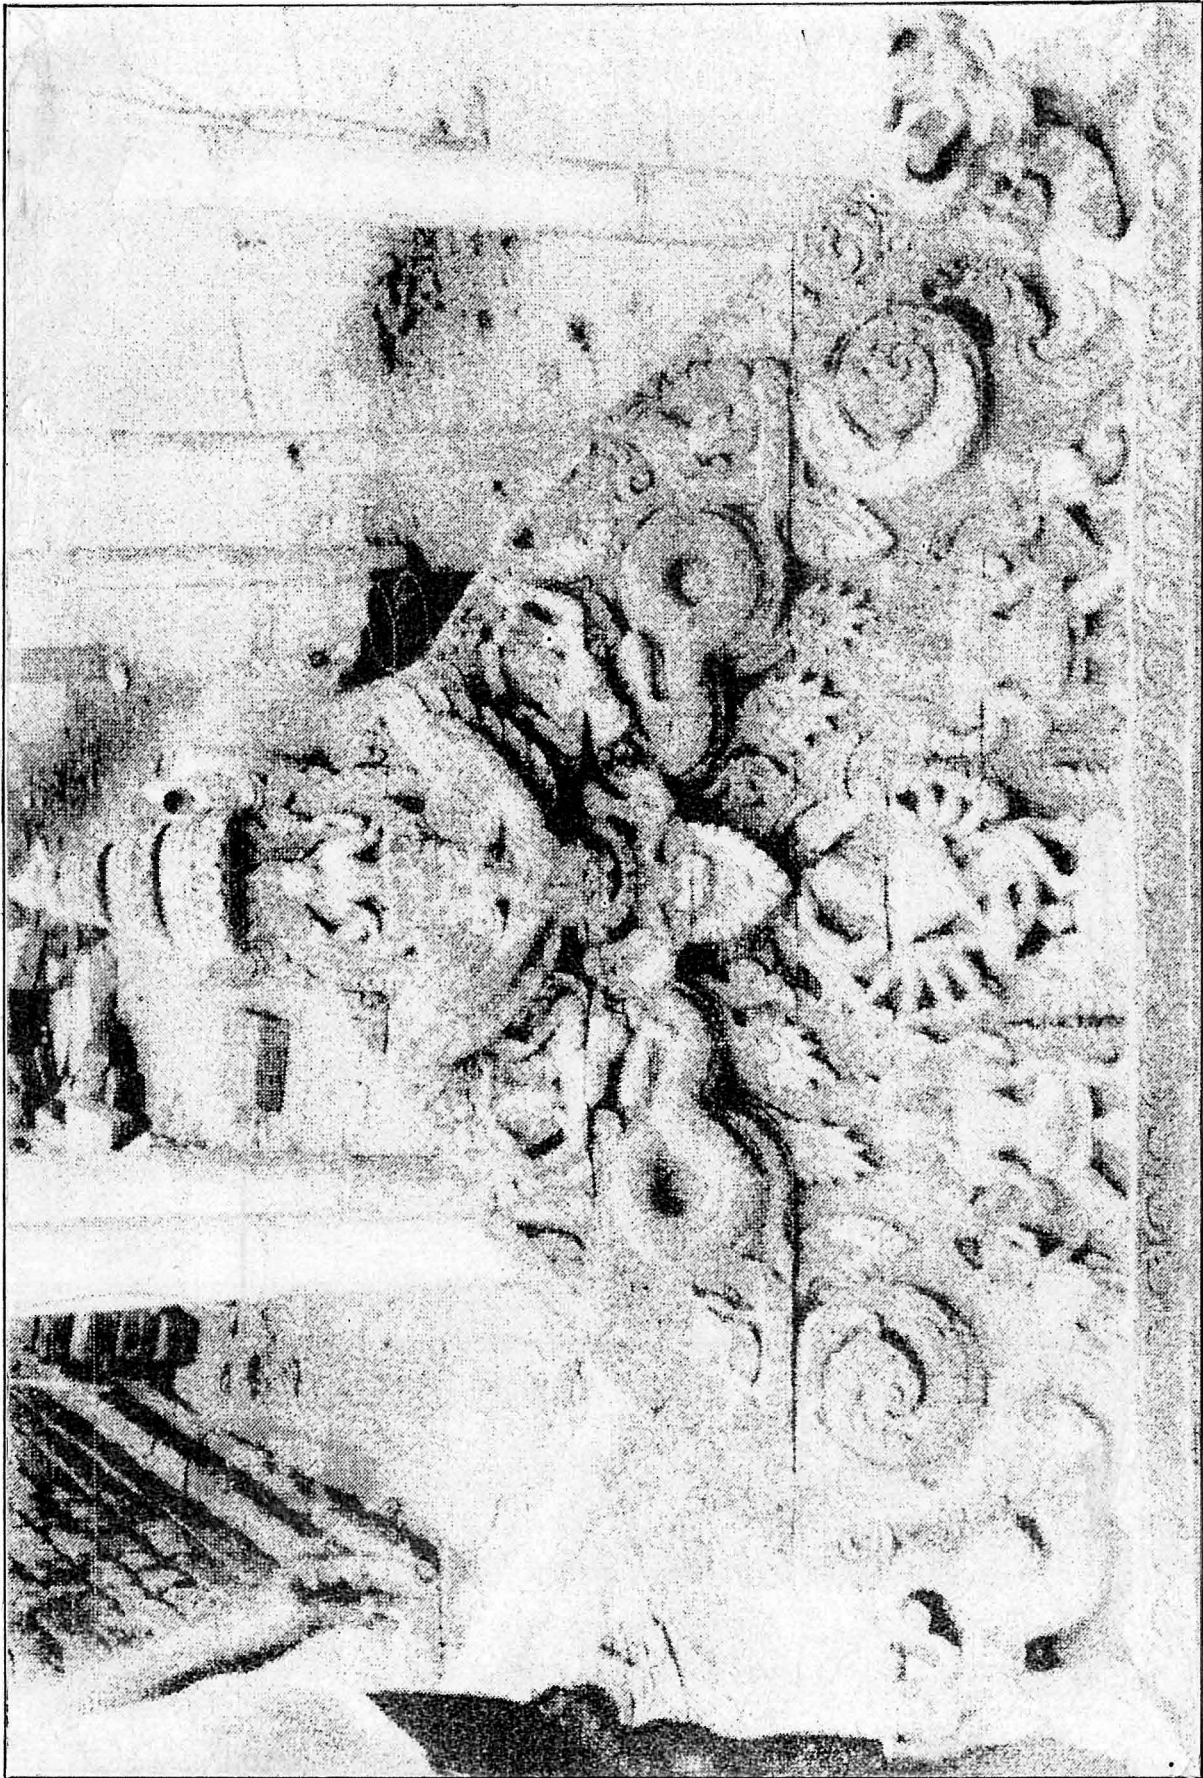
THE ENTRANCE TORANA WITH POLYCHROME PAINT CA. 1956. FEBRUARY, 1992.

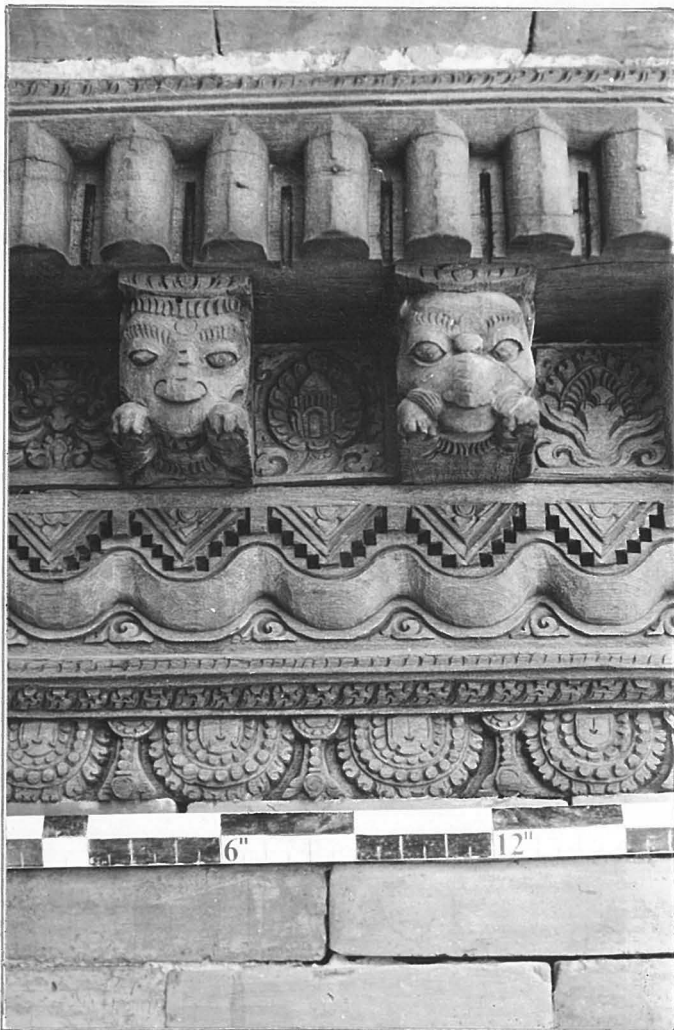
LEFT: PORTION OF BASE STORY CORNICE AFTER TEST CLEANING, MARCH 1992.
RIGHT: ENTRANCE ENSEMBLE WITH RIGHT NICHE MISSING, JANUARY, 1992.

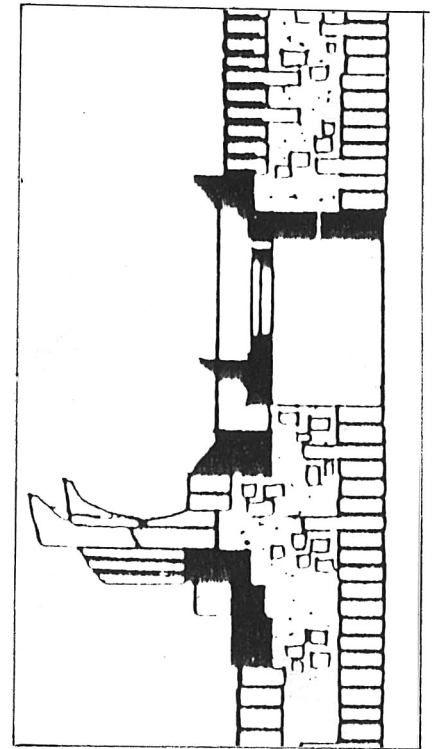
The only structural damage to the masonry wall consists of a tilt to the building's base story wall at the northwest corner. The displacement has been measured on the exterior as 5" out of plumb towards the south, 1" to the west. Maximum displacement is at the top of this 5'8" high lower story wall (measured to bottom of cornice) and tapers to the intersection of wall and plinth below. All other wall corners are within 1" of plumb. The displacement at the same northeast corner on the inside is 2-1/2", that is, less than that of the exterior corner, suggesting that the three-layered wall--especially the middle rubble fill--has taken up the difference. Extensive cracking in the north facade veneer layer appears to have resulted from this displacement. Additionally, the corner joints of the west elevation's door frame have been spread by this displacement, leaving less than one inch of structural interlock at the upper corners.

LEFT: THE RIGHT CRACK OF THE NORTH ELEVATION, BASE STORY. (REFER DRAWING OPPOSITE PAGE. RIGHT: SECTION THROUGH WALL AT UPPER BASE STORY WINDOW. THE TYPICAL CONSTRUCTION EMPLOYS INNER AND OUTER LAYERS WITH FEW HEADERS AND A RUBBLE FILL IN THE MIDDLE

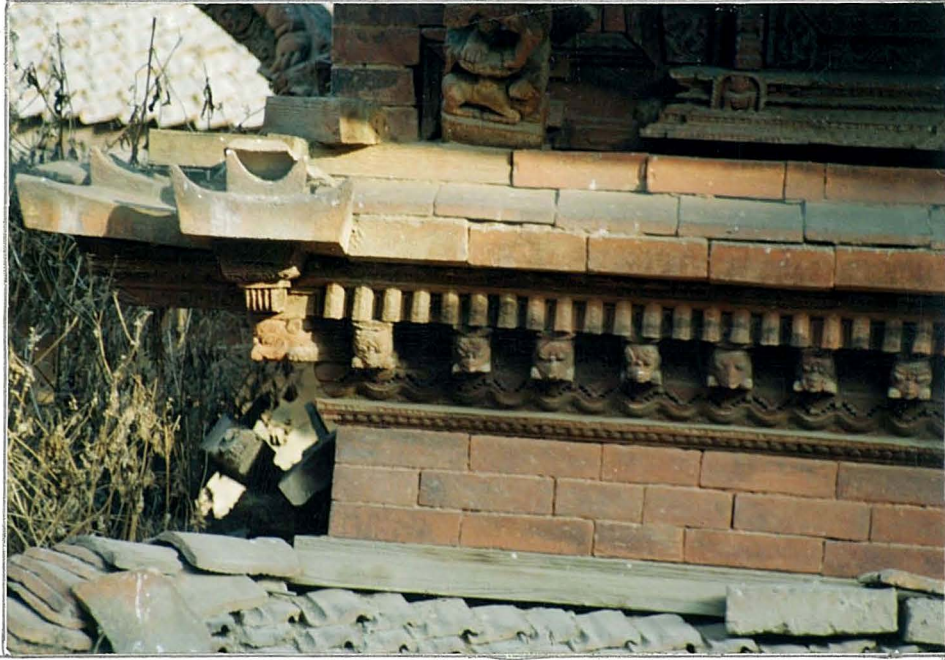
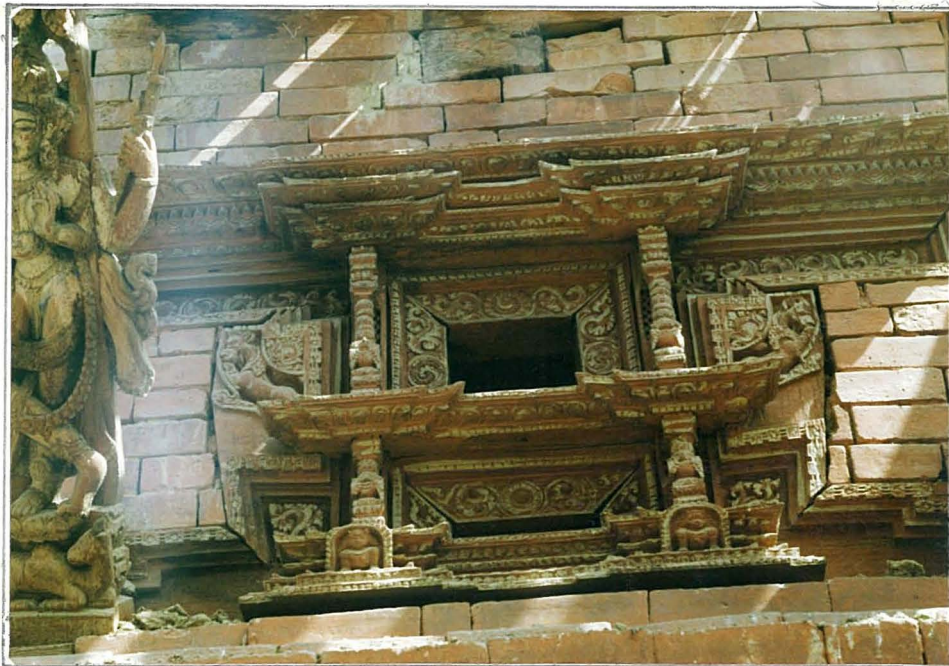
ABOVE: INTACT WALL SURFACE OF UPPER STORY AT NORTHEAST CORNER.
BELOW: UPPER BASE STORY WINDOW, SOUTH ELEVATION. JANUARY, 1992.
