**Structural Report
Itum Baha, Kathmandu**

November 2002
Dipl. Ing. Matthias Beckh

Structural Report

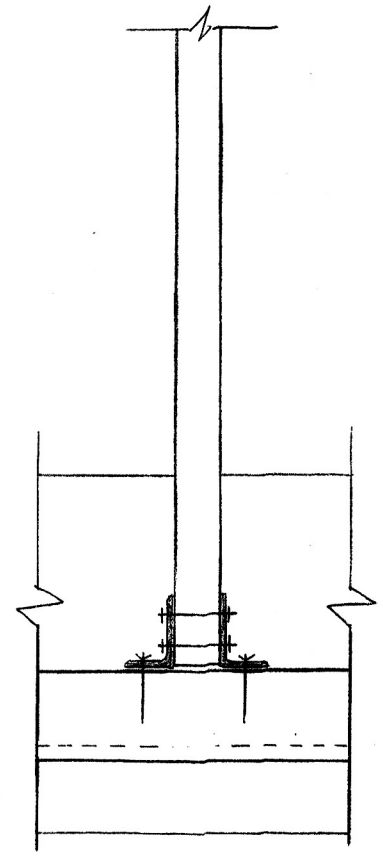
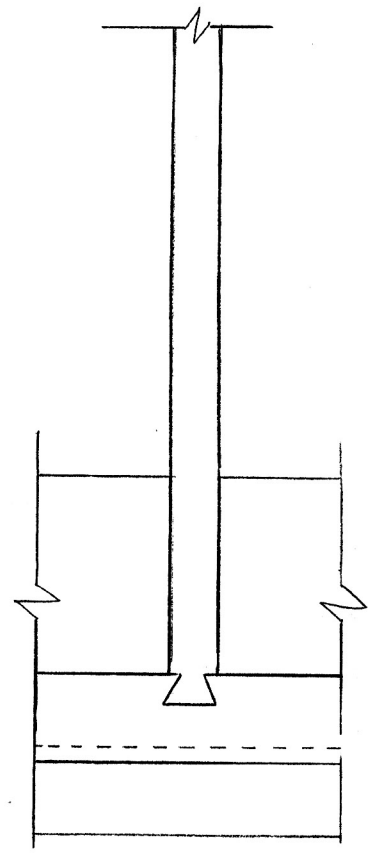
▷ Roof STRUCTURE

After the removal of the roof tiles and planking, the roof structure was inspected on 25th November. What became visible was a timber structure in its ultimate state of decay. The purlins were completely rotten and had

partially collapsed, most of the timber pegs broken off or in a state of distress. All of the top connections of the rafters had been rotten away. The lower ends of the rafters and the eave boards had been rotten and partially broken off. Similarly, the joists at the third floor were in a progressed state of decomposition, with some of them having already collapsed. Altogether, the existing roof is beyond repair and has to be completely rebuilt, using entirely new timber elements.

At the roof level, enhanced cohesiveness between the roof structure and the bearing walls will be introduced by keying the wall plates into the masonry. This will be achieved by stainless or galvanized steel pins (2 cm diameter with 30 cm embedment at every 100 cm on center). To further strengthen the loose and often weak traditional joinery (with timber peg connections), every fourth joists will be connected to the wall plate with a stainless steel bolt. Similarly, every fourth rafter will be connected to the purlin with a stainless steel bolt. Also, every fourth pair of rafters will be joined at the top purlin in addition to the timber peg connection with a galvanized steel tie. The previously described roof connections will be staggered, so that one timber element is always – at one single, but shifting position – securely fixed to another element. This will combine an enhanced cohesiveness of the roof with a reasonable degree of flexibility and ductility in the joints. A controlled amount of flexibility, as provided by the traditional timber peg joints, is

In the same manner as on the second floor level, water resistant plywood panels shall be mounted on top of the rafters and joists at the roof level. On top of the plywood panels, two layers of water-proof irrigation foil will be bonded to protect the roof structure from infiltrating water.

The roof struts will be attached to the purlin with a small stainless steel strap. This strap not only reduces the risk of dislodgement of the strut during seismic motion, but is also a precautionary measure against theft. At the bottom, the end grain of the timber strut will be protected against moisture by a thin bituminous sheet.
