KAGESWAR MAHADEV TEMPLE

KATHMANDU DARBAR INITIATIVE

FINAL REPORT

DECEMBER 2005

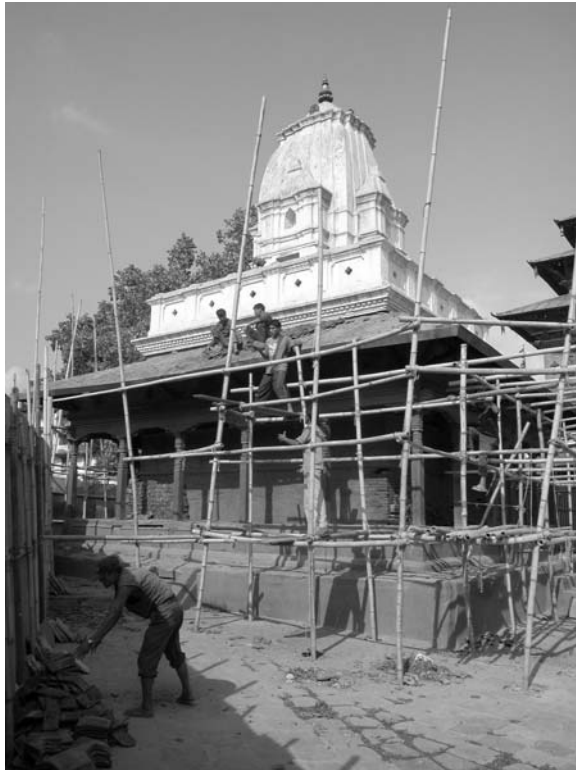
above: Kageswar Mahadev Temple under scaffolding.
Photo by: Lumanti Joshi, KVPT, April 2005.

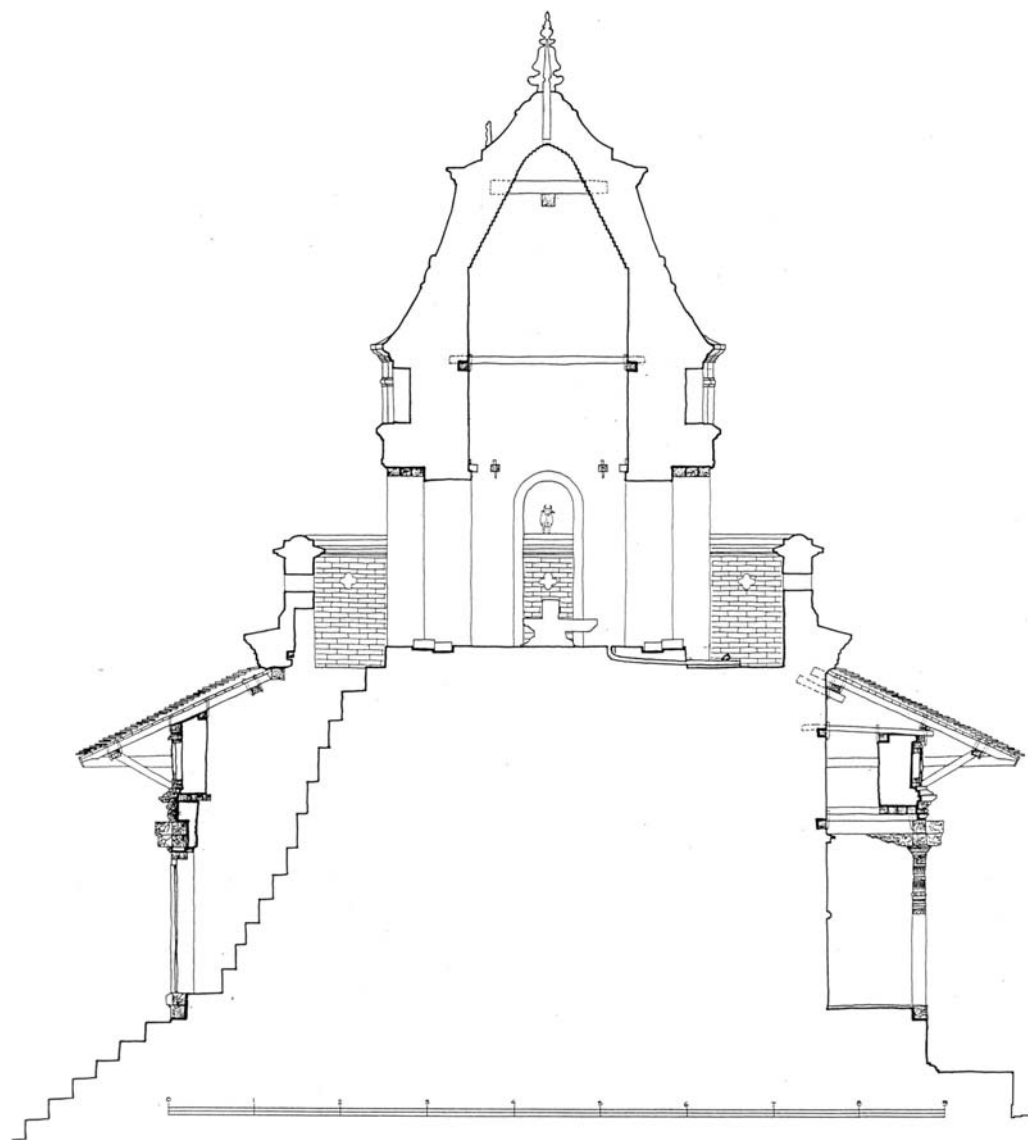
KAGESWAR MAHADEV TEMPLE
Kathmandu Darbar Initiative
SOUTH-NORTH SECTION: EXISTING CONDITIONS

- **Shikhara:** Shape of the shikhar or the dome is more slender than the pre-earthquake configuration. The plaster work is white washed and is in good condition. Similarly the details in the plaster work has also been altered.

- **Small figures:** Auxiliary deities on all four sides, which can be seen in the historic photograph, is now missing.
- **Parapet wall:** The design and pattern of the parapet wall on all sides too were altered after the earthquake. There exists a large crack on the parapet wall in the east and south facade. There is no provision of drainage of rain water from the terrace.

- **Roof cover:** Roof tiles have been displaced at some places revealing the mud bed. Ridge tiles on all corners are not properly placed (more tilt than the tradition configuration) and in north east & north west corners, some of these are missing. Corner tiles are missing on n/e, s/w and n/w corners.

- **Windows:** Intact in all sides, red washed which has faded.
- **Timber columns:** All columns are damaged at the lower ends, but intact in all sides. There are insect bore holes in all of them. Dowels, which are used for connecting the columns with *lakhashi* are different from the traditional detail. All columns in the arcade are red washed.

- **Wall fabric:** Wall is constructed with *dachi appa* laid in mud mortar, in poor condition, is red washed. Wall above the beams is in urgent need of restoration. Seepage from roof have damaged upper five layers of bricks on all sides. Large cracks have developed on the east and north facades. At many areas in the wall, as in lower 5 layers of west facade, traditional *dachi appa* has been replaced larger chinese bricks. Lower 6 layers of bricks of the principal wall and bricks around the door frame have worn out. Bricks are sprawling out, where the dampness has effected.

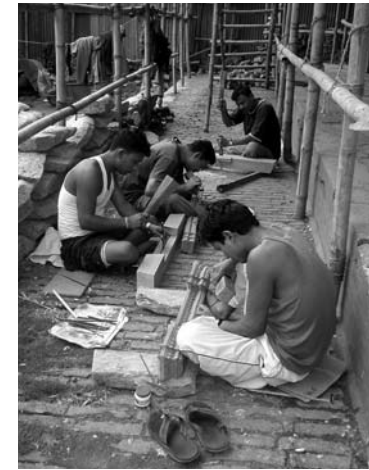
top left: Craftsmen replicated the damaged elements with reference to the existing ones. *Photo by: Raju Roka, KVPT, June, 2005.*

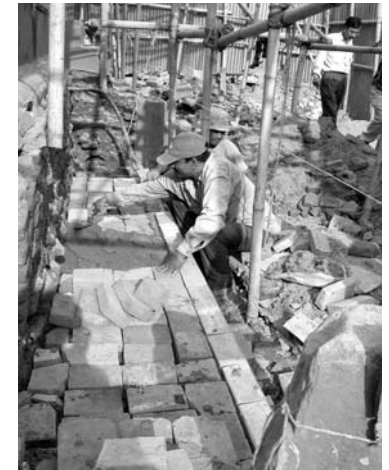
top right: Rebuilding of lower plinth. The damaged walls were dismantled and reconstructed with *dachi appa* set in mud mortar. *Photo by: Raju Roka, KVPT, May 2005.*

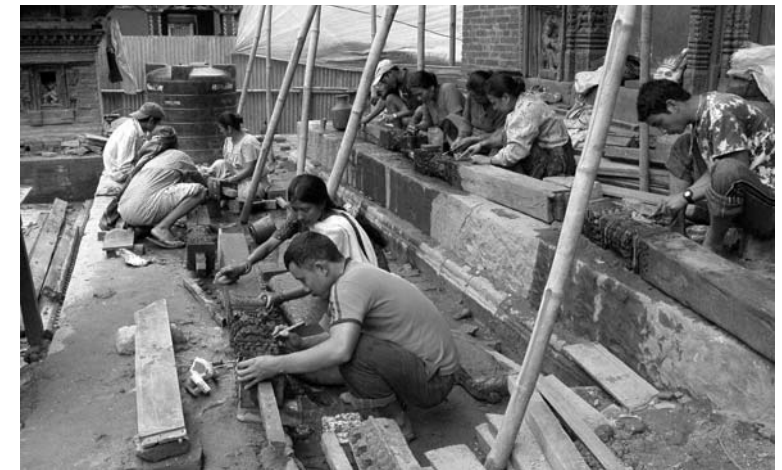
bottom: The layer of unhistoric red paint was removed from the carved elements. *Photo by: Raju Roka, KVPT, June, 2005.*

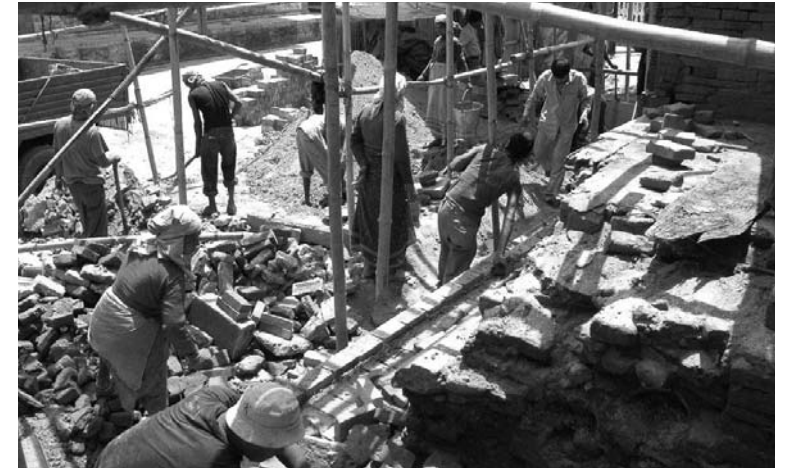
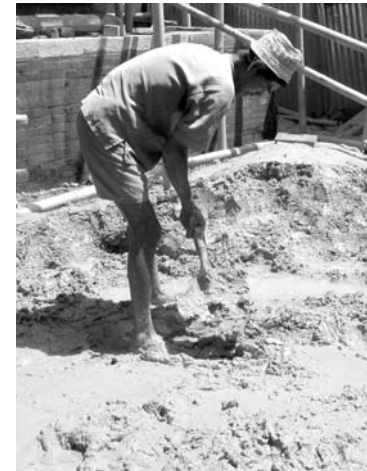
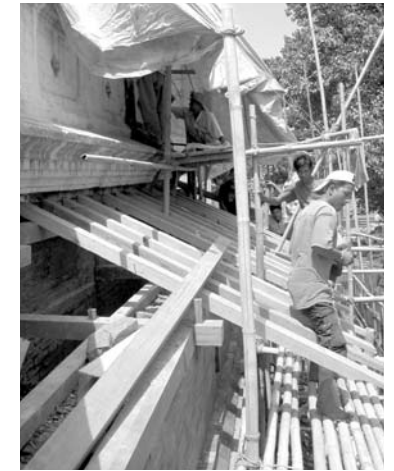
As we progressed with the restoration work, we were faced with new developments and problems. While working on the masonry wall structure, a 4" wide crack developed at the center of the east parapet wall, which must have been caused because of the settlement of the structure. With time, the crack widened and further appeared on all the other three sides as well. This was the result of the hasty reconstruction post 1934 earthquake (the joints were not properly executed), supplemented by the subsequent settlement. Sections of the parapet wall where the gaps had formed were carefully dismantled and redone with corrections of improperly executed joints.

left: Kageswar Mahadev Temple with newly prepared rafters installed. A large crack developed on the parapet walls as we progressed with work, was later repaired. *Photo by: Badri Juwal, KVPT, September 2005.*
top: Masons at work. *Photo by: Badri Juwal, KVPT, May 2005.*
bottom left: Preparation of mud for mortar. Mud mortar construction greatly enhanced seismic performance of the building. *Photo by: Raju Roka, KVPT, September 2005.*
bottom right: Carpenters installing the rafters. Every third rafter was bolted to the wall plate for stability of structure. *Photo by: Badri Juwal, September 2005.*

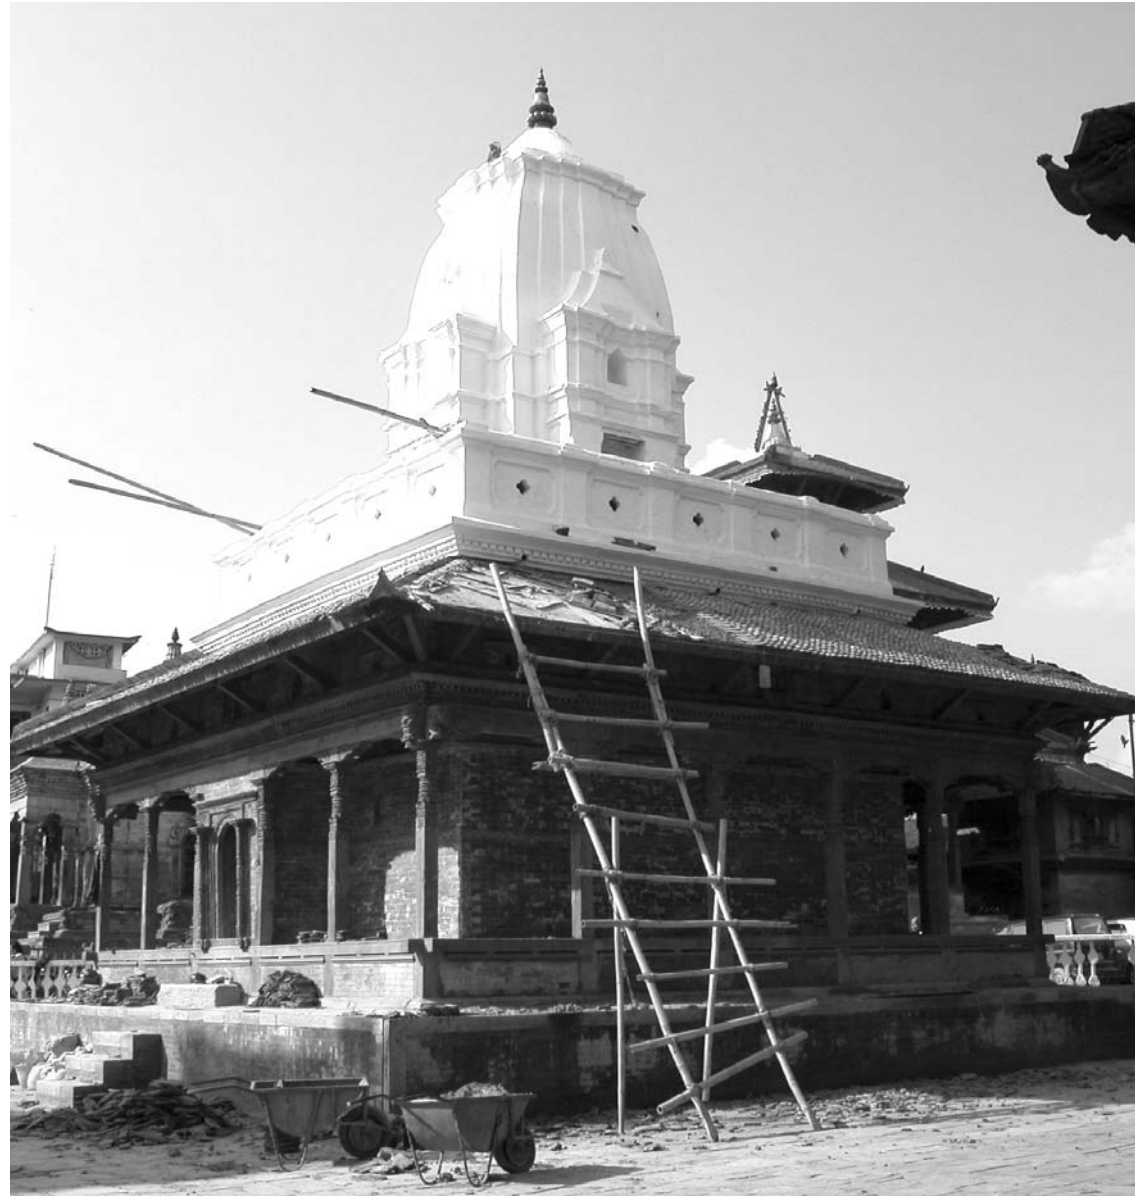
top: Battens being fixed on the roof structure to hold the mud in its position. Water proofing membrane was introduced between the planking and mud bed. Traditional roof tiles (*jhingati*) were laid on the mud bed. *Photo by: Raju Roka, KVPT, October 2005.*
right: Final stage of completion. *Photo by: Raju Roka, KVPT, October 2005.*
