MAHADEV TEMPLES

KATHMANDU DARBAR INITIATIVE

FINAL REPORT

ROHIT K. RANJITKAR * LUMANTI JOSHI
KATHMANDU VALLEY PRESERVATION TRUST
AUGUST, 2007

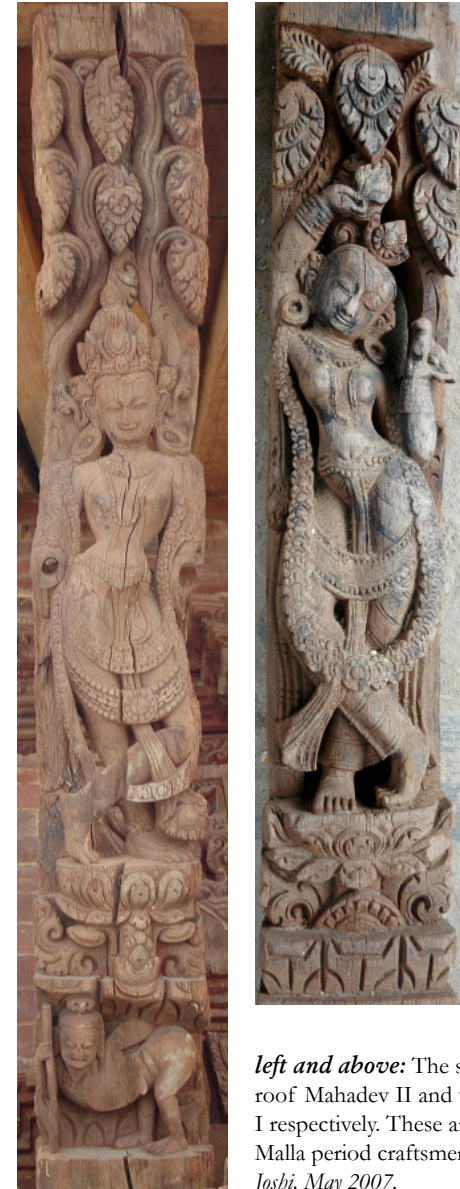
left and above: The struts are from lower roof Mahadev II and upper roof Mahadev I respectively. These are fine examples of Malla period craftsmanship. *Photo by: Lumanti Joshi, May 2007.*

Continuous settlement of the bird droppings and dust have damaged the struts, especially at the lower ends. A planking was introduced behind all the struts in both levels to prevent further decay of the struts' fabric.

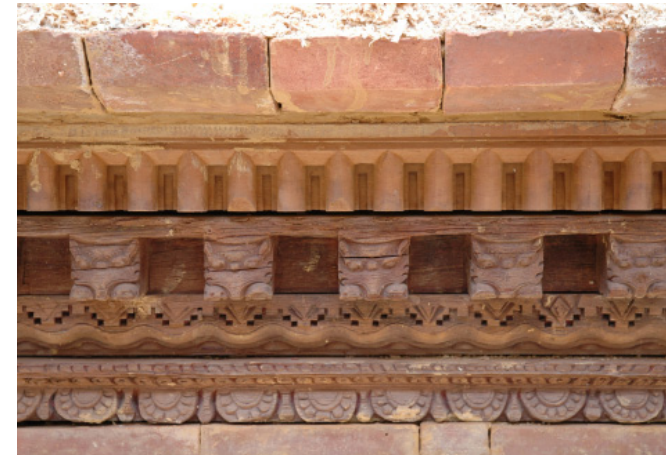
Many carved details such as the colonnettes in the windows and their bases were lost. Likewise, the cornice details, for example, the lion heads in both the temples were severely damaged by termites. In the upper level, the dental pattern in the cornice had been replaced with bricks. To complete the entire configuration of the carvings in the temples, we had to replicate them on the basis of the existing adjacent examples.

above: Replicated dental detail installed with other original cornice elements. *Photo by: Lumanti Joshi, April 2007.*

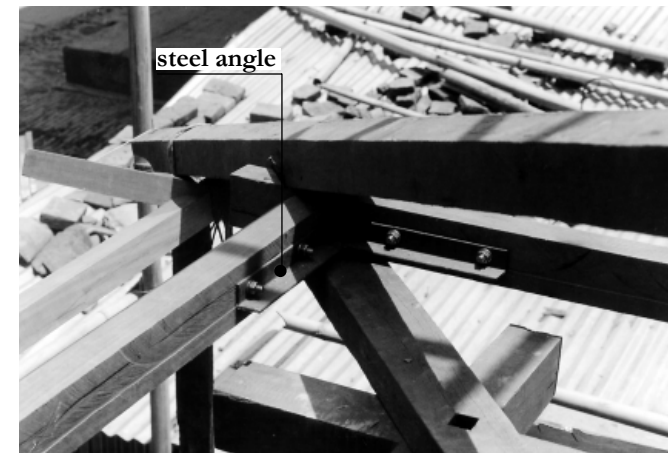
below: On the steel angle, nuts and bolts are used at the joint of the purlin, tying them together acting as one unit in the event of a seismic movement. *Photo by: Raju Roka, April 2007*

(L-sections), which were introduced at the joints between the outer and inner wall plates at all levels. This will help the existing wall plates to act as a ring beam in the event of seismic movement. Likewise, similar steel angle, screwed with steel nuts and bolts, was used at the joint of the purlins at the corner, thus, tying them together and acting as one unit in the event of a seismic movement.

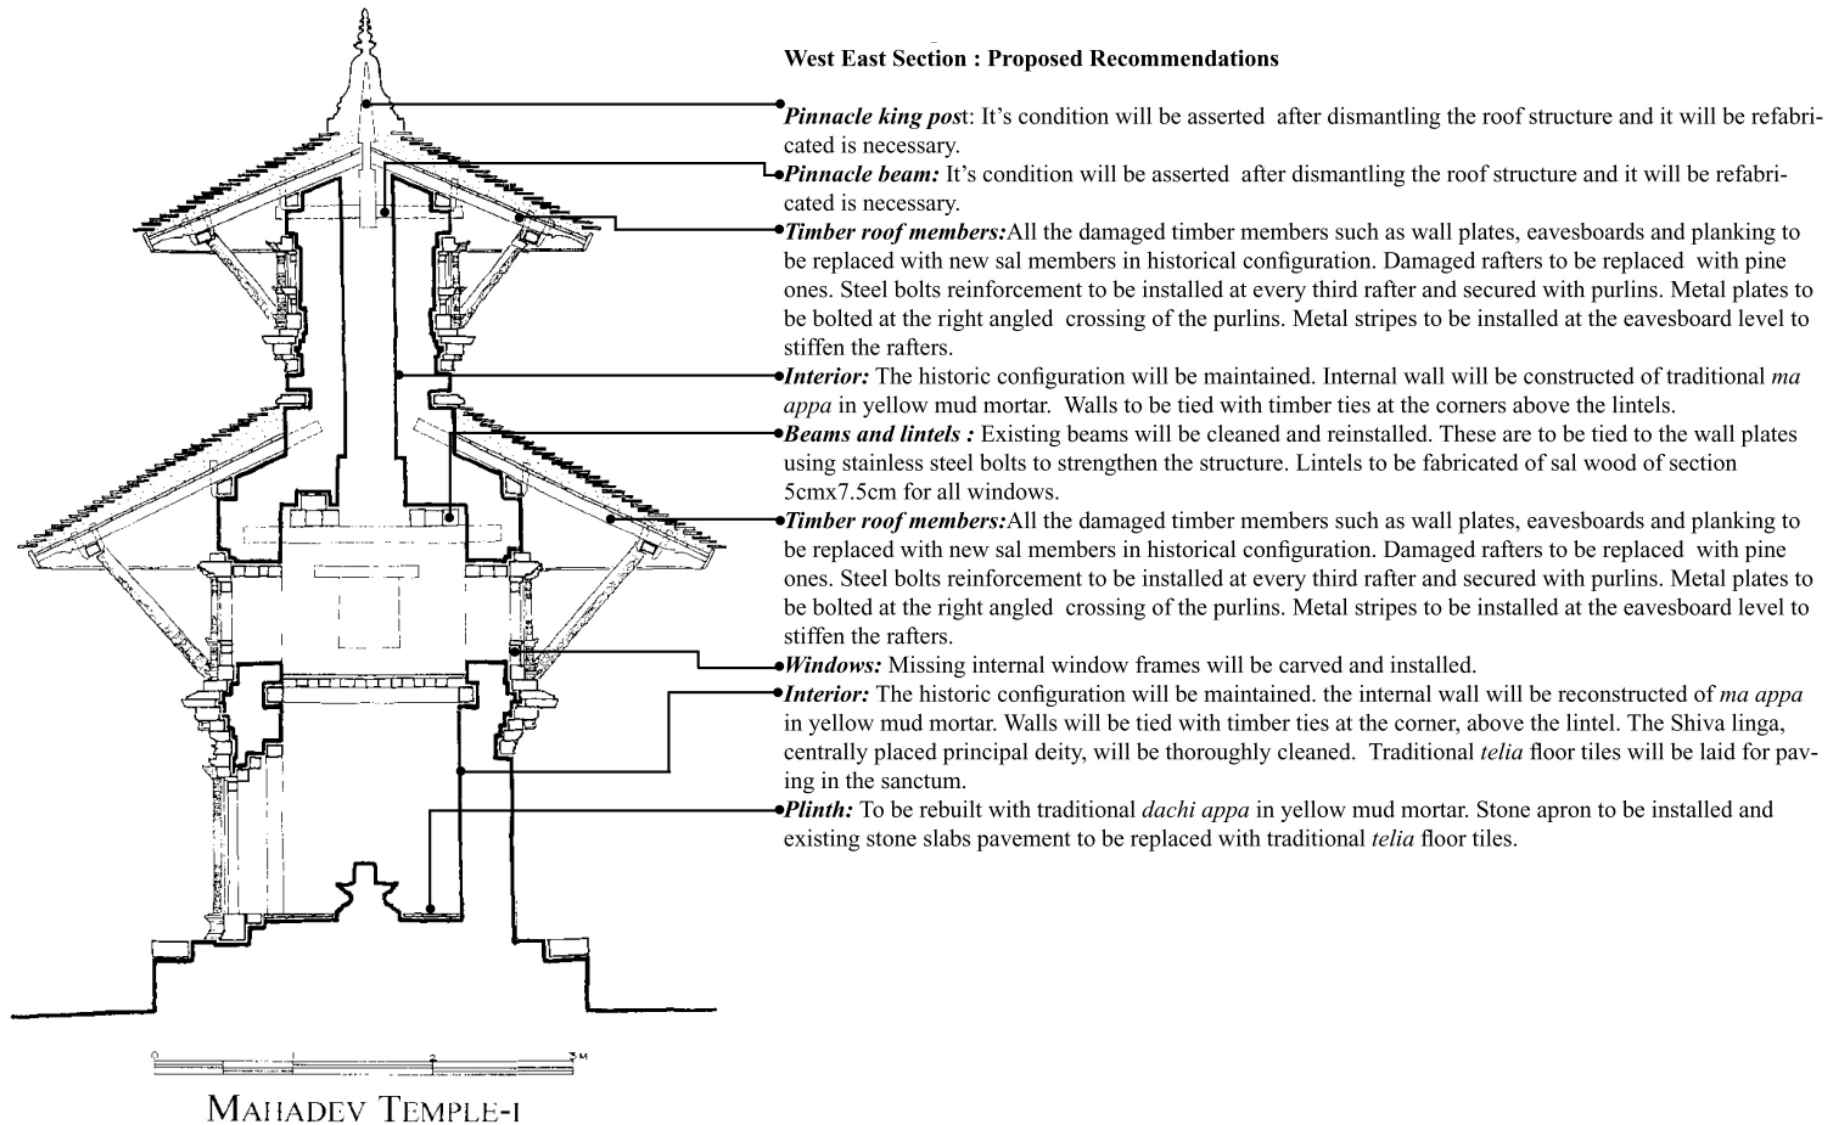
MAHADEV TEMPLE-I

- **Pinnacle:** Made with copper and the upper portion of the pinnacle is damaged. Base is constructed with bricks instead of traditional timber base.
- **Roof tiles:** Tiles are not stable and have fallen off at many places, specially at roof ends. All the corner tiles are missing. Mud bed is visible at the edges. There is excessive amount of vegetation growth on the roof. Ridge tiles are loosely stacked and about 50% of them are lost.

- **Wall Structure:** constructed with local chinese bricks in cement mortar. The upper two layers below the wall plates are loose and no mortar remains in between. Area below the cornice is plastered with lime surkhi.
Windows: All four on four sides are probably original to the structure and are redwashed with details highlighted using yellow paint. Details are not clear under the several layers of paint. However the details are not that elaborate. In all windows, *kulan* and *kulan than* are lost.

- **Cornice:** The upper layer of the cornice detail (*khichwa*) is lost and has been replaced with plain timber member. Except for this, all the other layers are painted with red color. Terracotta *lahkha* has been replaced with timber ones. Terracotta cornice details are loose at the joints.

- **Roof tiles:** Tiles are intact on all sides with vegetation growth on all sides. Corner tile at the north west corner is missing. Ridge tiles are loosely stacked and about 70% are lost. Tiles on south east, north west and south east ridges are displaced.

- **Roof struts:** All redwashed except for two plain struts on east sides. Details are highlighted with yellow color and have worn out completely. The struts can be divided into 3 distinct layers, first a layer of foliage, under this a principal figure standing on a lotus pedestal and at the lower portion depicts small figurines on the carving symbolizing mountains. Major cracks have formed at the areas where they are connected to the purlins.

- **Wall structure:** Constructed with *dachi appa* on mud mortar and has been redwashed. Joints are painted with yellow color. Walls on all sides are bulging out, is more prominent on north east corner. Upper 3 layers of bricks below the wall plates are loose. Wall below the cornice was reconstructed in 2001 using *dachi appa* in lime *surkhi* mortar. The joints have been roughly pointed with *surkhi*. Lower 6 layers on the East and South sides are severely damaged.

- **Cornice:** The timber cornice details show signs of termite attack. Details have been redwashed. Large cracks have developed on south side. 15% of the lion heads have been affected by termite attack. On east side, one of the lion heads are replaced with brick. Terracotta details are loose at the joints, some have completely worn out. Terracotta details along with the *lhakha* are all lost. The lowest cornice detail have worn out and settlement has occurred.

- **Door:** Is probably original to the structure. Details have worn out and some of the details such as the *kulan than* are missing. The tympanum is lost. Large cracks have developed on the frames. The door frame has been red-washed. The stone threshold is intact but does not belong to this door.

- **Pinnacle king post:** It has been damaged due to wet rot.
- **Pinnacle beam:** It has been damaged due to wet rot.
- **Timber roof members:** Roof structure was totally refurbished in 2001. Plankings show major damages caused by wet rot. In the east side, the lower portions of the planking have completely disintegrated exposing the roof tiles from below. Rafters are of 7.5 cm x 10 cm section. They have been affected by wet rot, the damage is more prominent at the south, east and north sides. Eavesboards are not of traditional section and have warped. They have been nailed on the rafters and at some places eavesboards are not in contact with the rafters. Wall plates are intact. Purlins are of small size and have not been properly joined. They are affected by damp.

- **Interior:** The wall fabric at this level is in fair condition and has been constructed with *dachi appa* in mud mortar. There is no opening on all sides for the windows, similar to blind windows.

- **Plinth:** The single level plinth is constructed with *dachi appa* in lime *surkhi* mortar and has been red washed. The bricks on the lower level are damaged from the rising damp. It has been paved with large stone slab, which were added to the structure during repair of the temple in 2001.

- **Pinnacle:** Existing pinnacle to be cleaned and reinstalled. Its base will be constructed of brick masonry.
- **Roof tiles:** Tiles to be salvaged and cleaned for reinstallation. Damaged ones will be replaced. Water proofing membrane (multiplast) to be introduced between the mud layer and planking.

- **Roof struts:** Unsightly redwash from the struts to be removed with mild detergent and water. The missing and damaged details to be recarved with reference to the existing ones. 15mm thick planking to be attached to all the struts to protect them from bird dropping. Stainless steel bars to be installed on the back side damaged struts for reinforcement.

- **Windows:** Layers of redwash to be removed using mild detergent and water. Missing details such as the *kulan*, *kulan than* to be recarved.
- **Wall fabric:** The external layer of brick will be replaced with traditional *dachi appa* laid on yellow mud mortar. The historic configuration will be maintained. Walls to be tied with timber ties at the corners above the lintels.

- **Cornice:** Damaged parts of the timber cornice will be refabricated based on the existing one. Terracotta cornice layers will be relaid in yellow mud mortar, replacing the damaged ones. Terracotta *lhakah* to be installed stainless steel cross reinforcement.

- **Roof tiles:** Tiles to be salvaged and cleaned for reinstallation. Damaged ones will be replaced. Water proofing membrane (multiplast) to be introduced between the mud layer and planking.

- **Windows:** Layers of redwash to be removed using mild detergent and water. Missing details such as the *kulan*, *kulan than* to be recarved.
- **Wall fabric:** The external layer of brick will be replaced with traditional *dachi appa* laid on yellow mud mortar. The historic configuration will be maintained.

- **Door:** Thorough cleaning and removal of red paint to be done. Missing details such as the door shutters, *kulan than* and *kvata* will be refabricated and installed. Stone threshold is to be maintained.

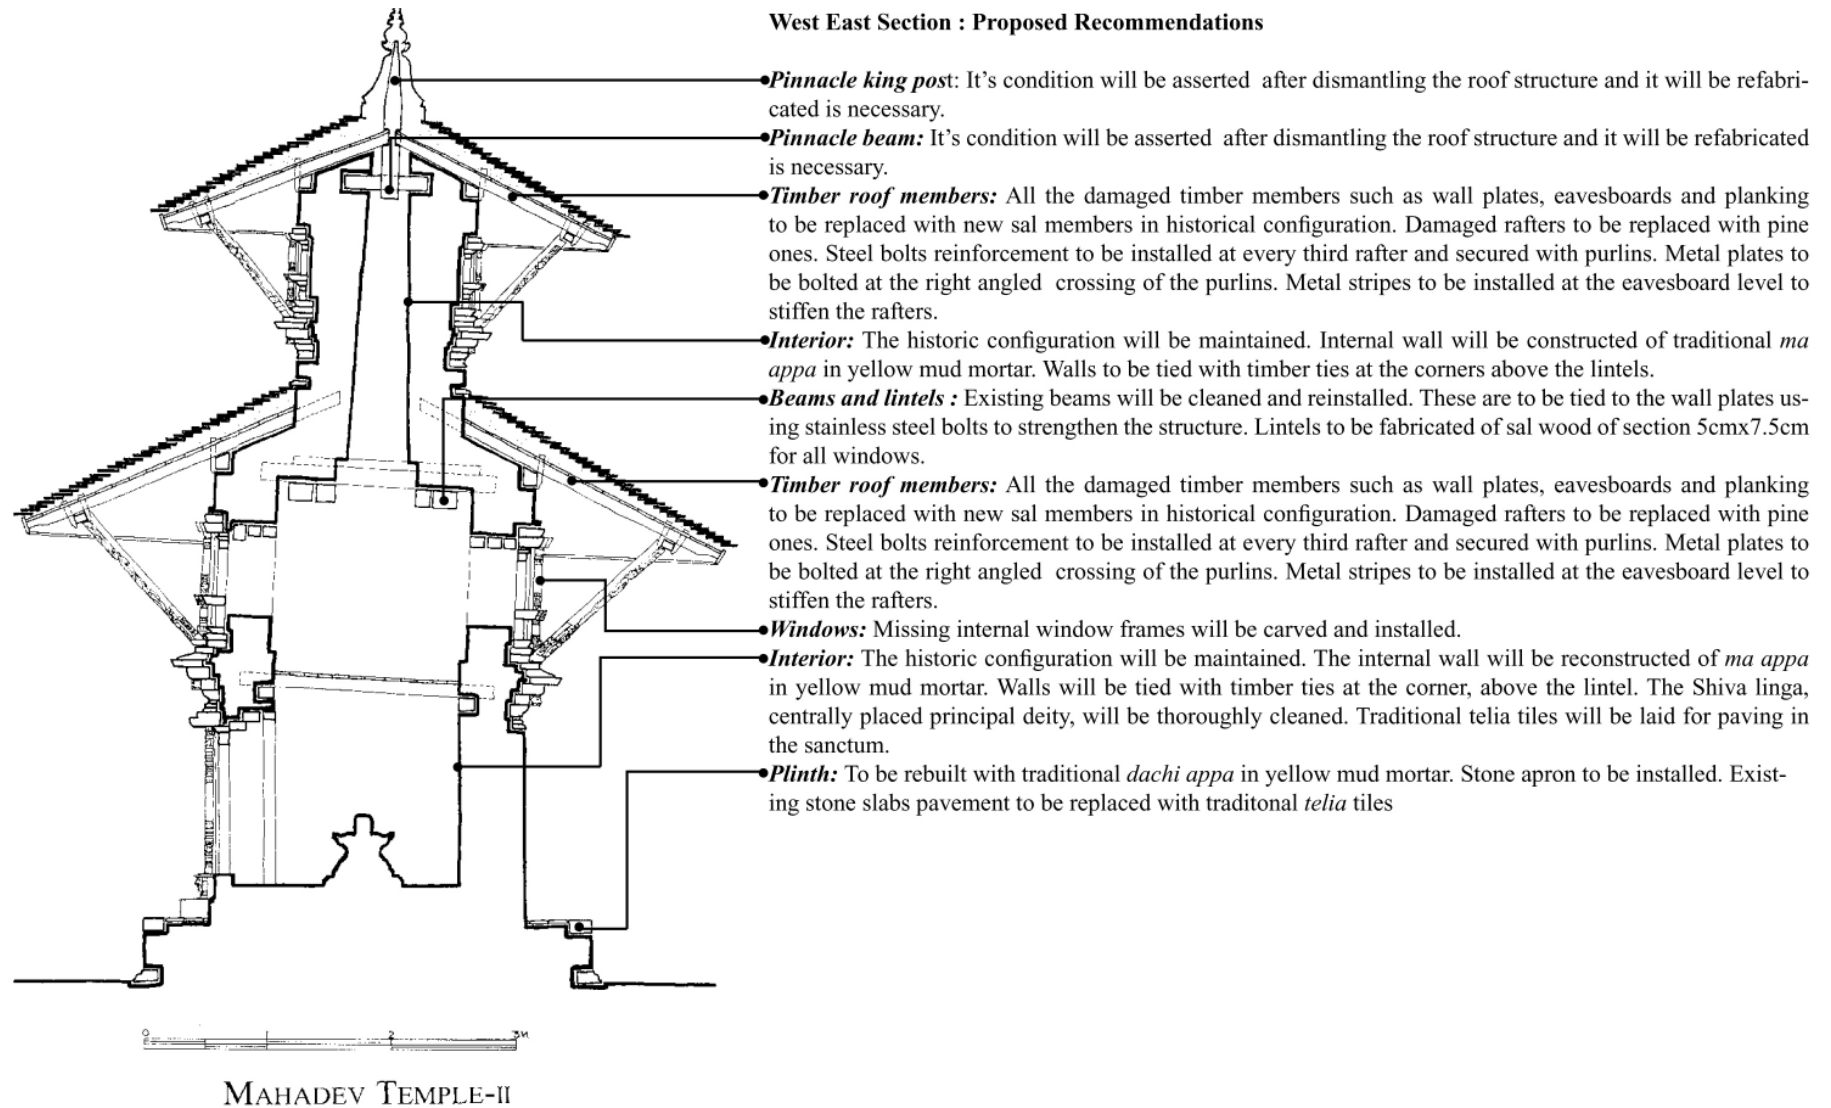
MAHADEV TEMPLE-II

• **Pinnacle:** It is a terracotta pinnacle with a gilded top, probably replaced during 1934 repair. The pinnacle is broken on the west side and does not have a proper base.

- **Plinth:** Constructed with *dachi appa* in lime *surkhi* and is in good condition. This was reconstructed in 2001 and have been redwashed. Stone threshold intact but does not have base for *kulan than* of the door way

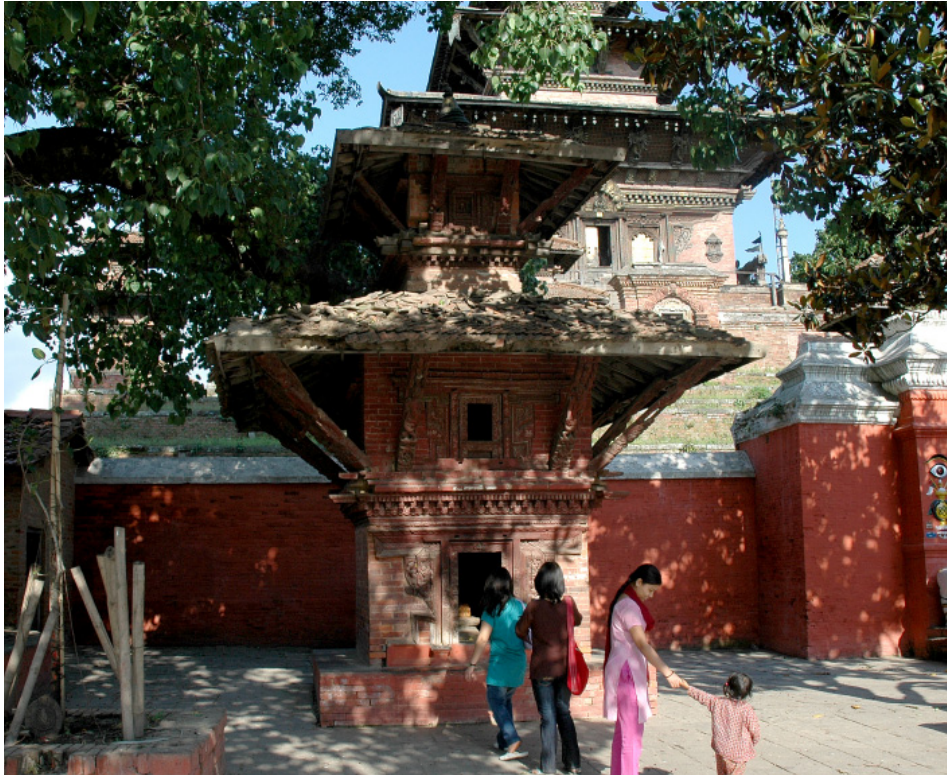
above: Mahadev Temple I, as it stood in 2006, prior to the initiation of restoration. *Photo by: Lumanti Joshi, December 2006.*

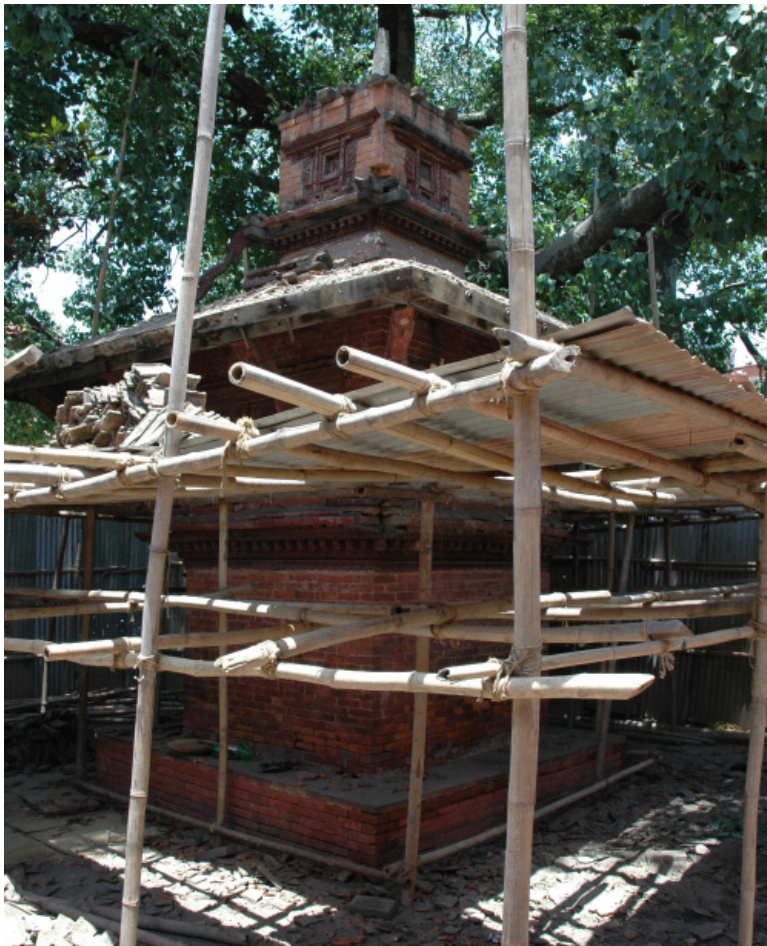
above: The upper level of the temple in the process of being dismantled. *Photo by: Lumanti Joshi, April 2007.*

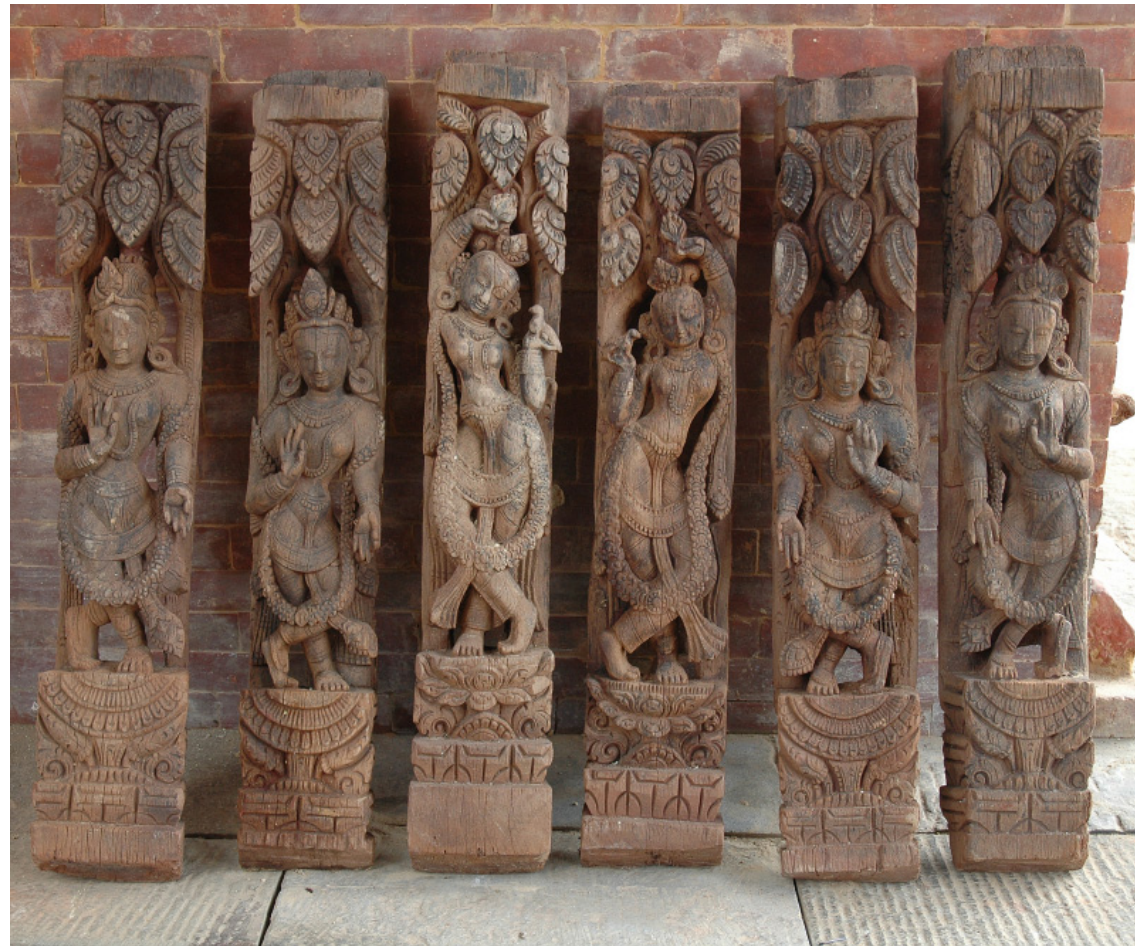
above right: The struts from both the levels were carefully brought down from their respective places, numbered and stored. The red unsightly color was removed with the help of soft brush and mild detergent, before installation. *Photo by: Lumanti Joshi, April 2007.*

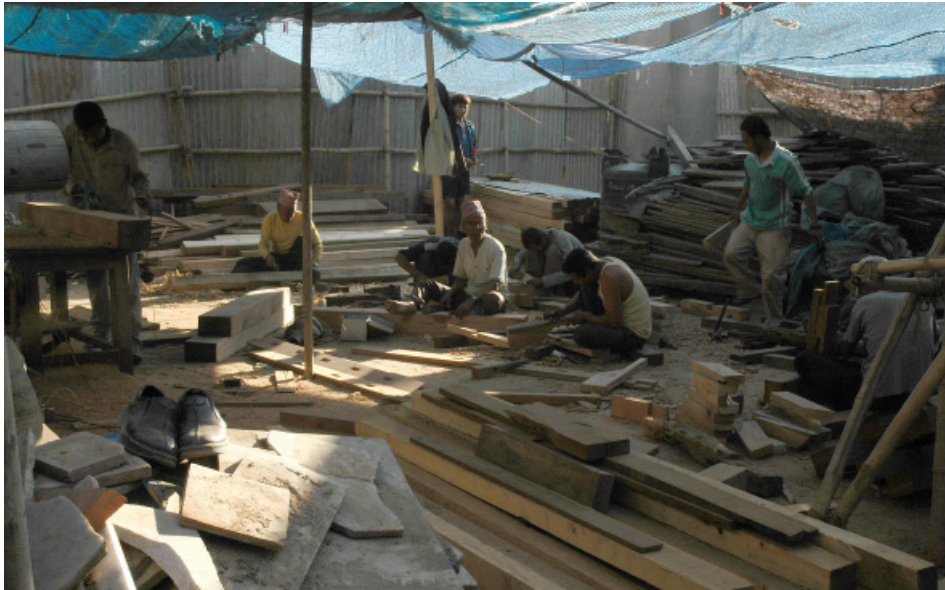
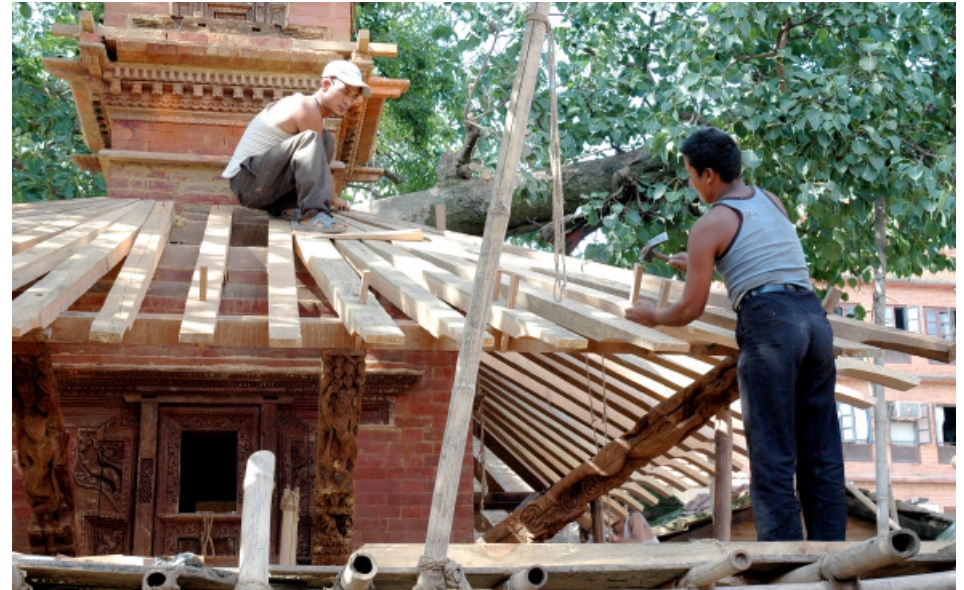
above: The carpenters installing timber roof structure in the lower level. *Photo by: Lumanti Joshi, May 2007.*

left below: The damaged and lost elements of the cornice were recarved with reference to existing ones. *Photo by: Lumanti Joshi, May, 2006.*

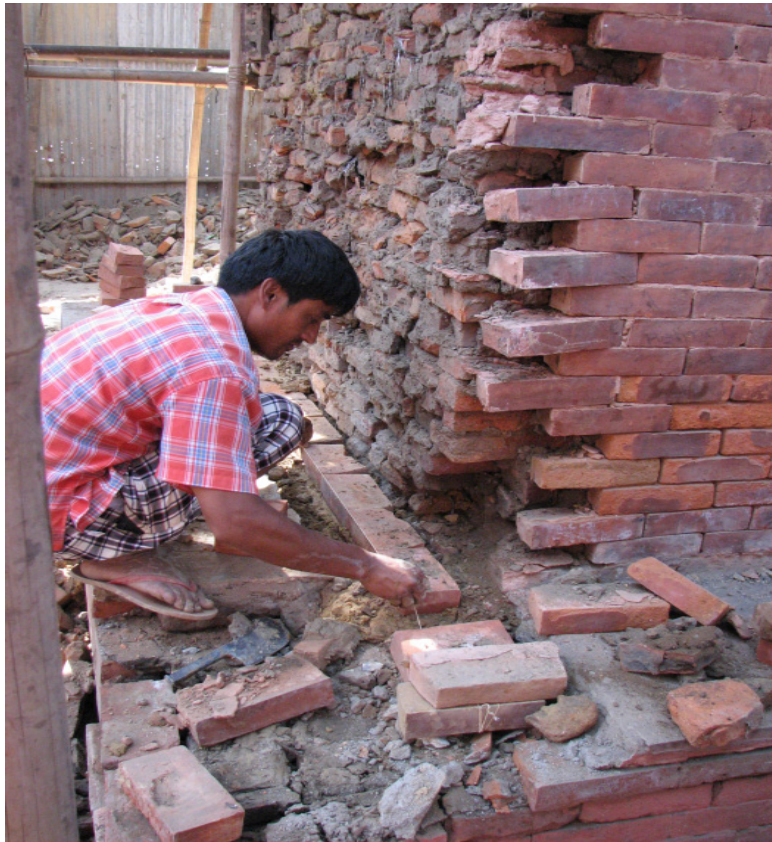
above: The lower wall being reconstructed. Damaged bricks were replaced with *dachi appa* set in yellow mud mortar. Photo by: Lumanti Joshi, April 2007.

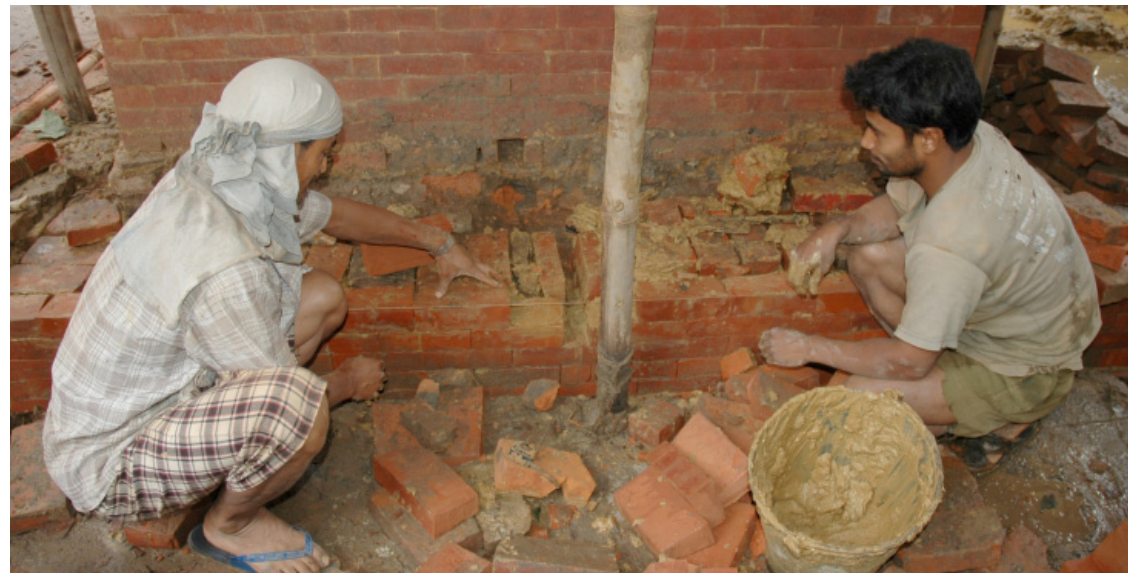
left below: Since the plinth was constructed with locally available “Chinese” brick, it was reconstructed using *dachi appa*. Photo by: Lumanti Joshi, June, 2006.

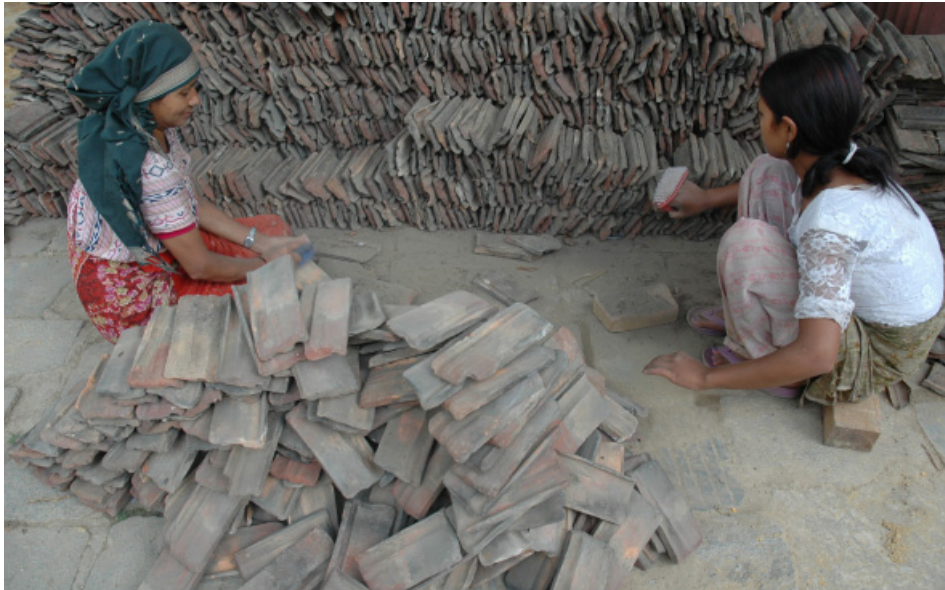
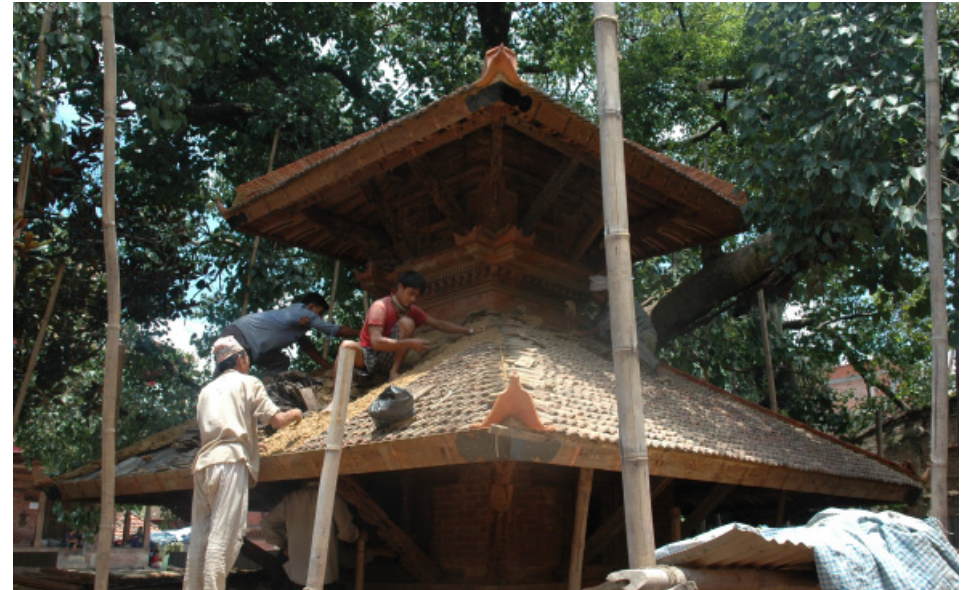
above: The masons laying traditional roof tiles on the lower roof. *Photo by: Lumanti Joshi, June 2007.*

left above: Old roof tiles were reused. They were thoroughly cleaned dry with brush before being washed with mild detergent. *Photo by: Lumanti Joshi, April, 2007.*

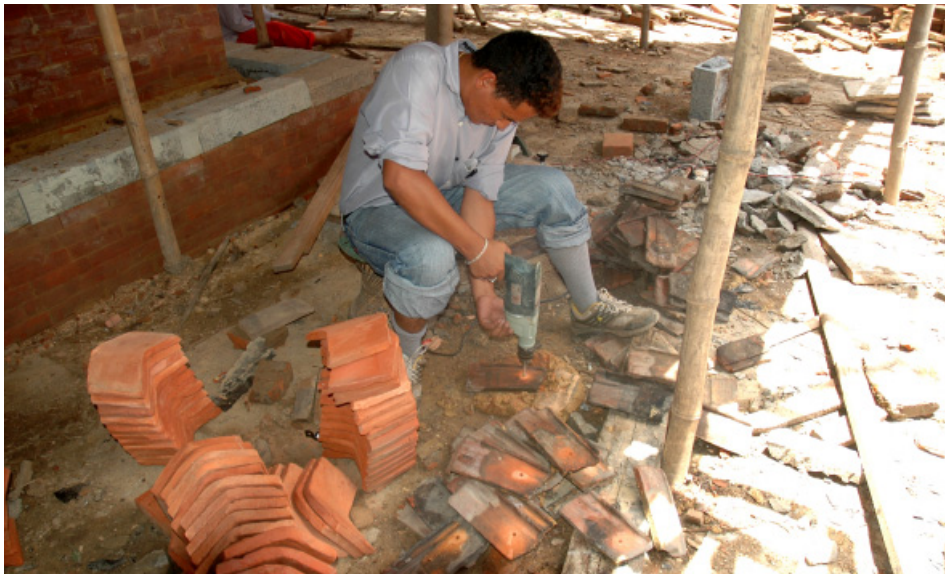
left below: The ridge tiles being drilled to be tied together with a wire prior to installation, thus, avoiding their displacement from respective positions. The first row of tiles at the eaves board are also drilled to be nailed on the plank to avoid dislodging. *Photo by: Lumanti Joshi, May, 2006.*

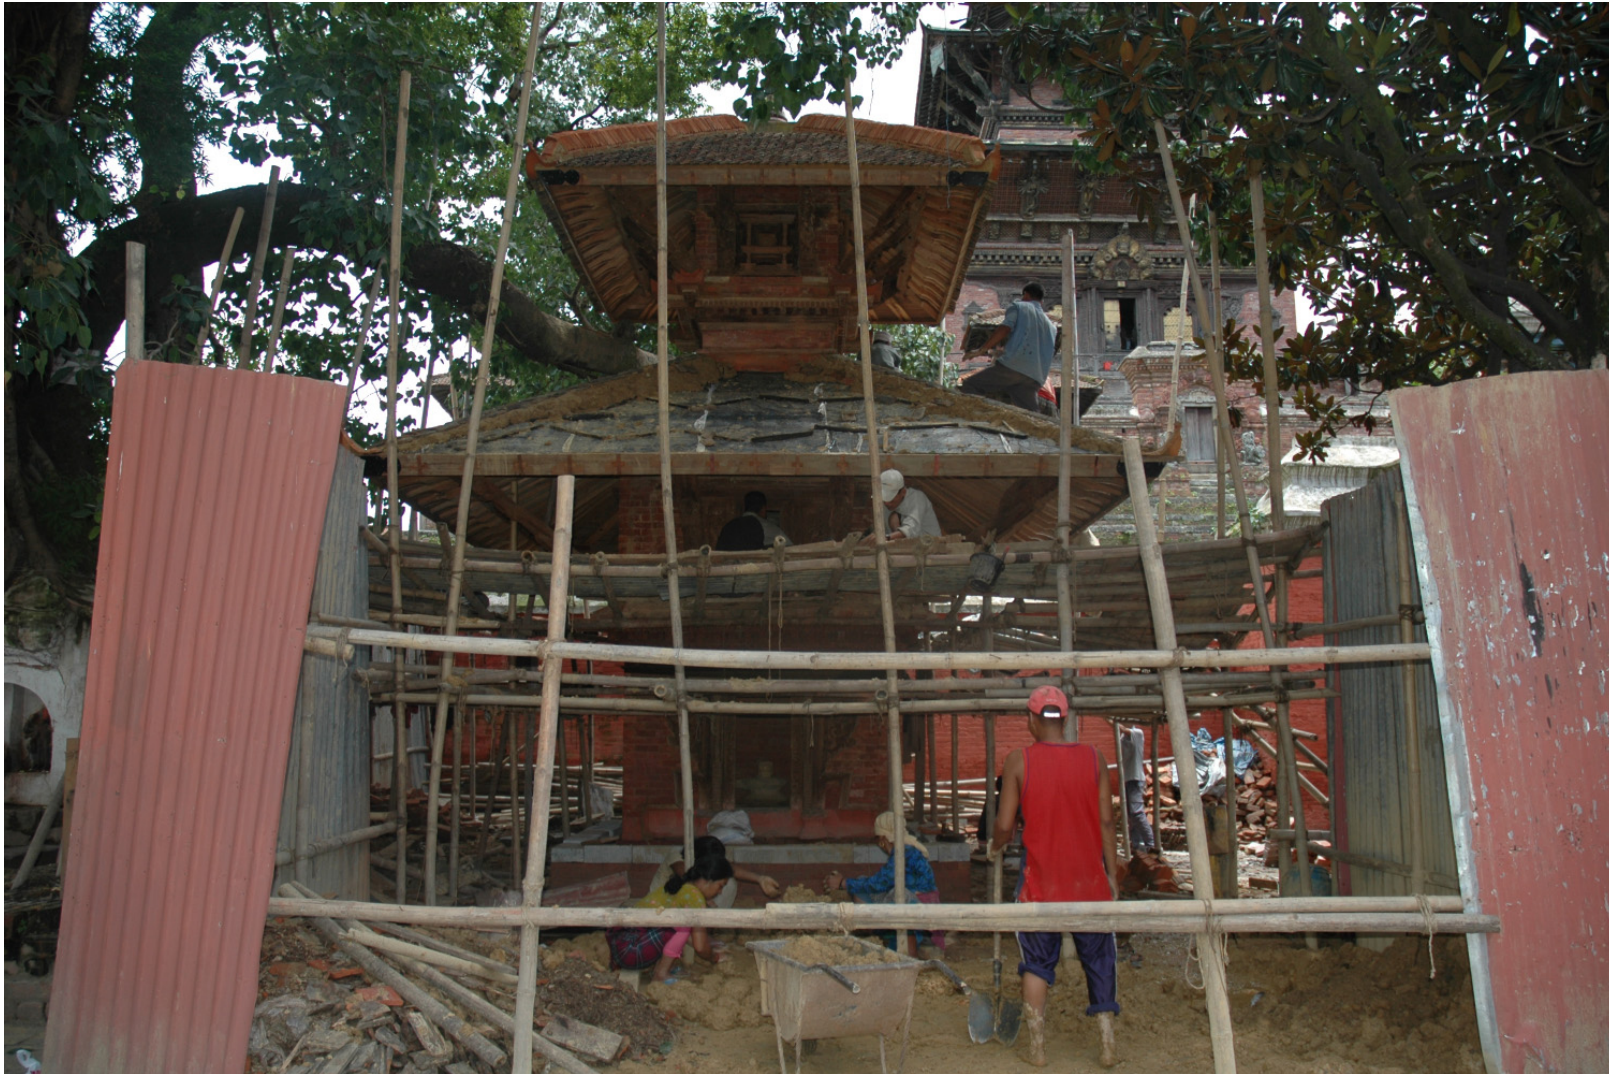
above: Battens being fixed on the roof structure to hold the mud in its position. Water proofing membrane was introduced between the planking and mud bed. Over this the traditional tiles are laid. *Photo by: Lumanti Joshi, May 2007.*

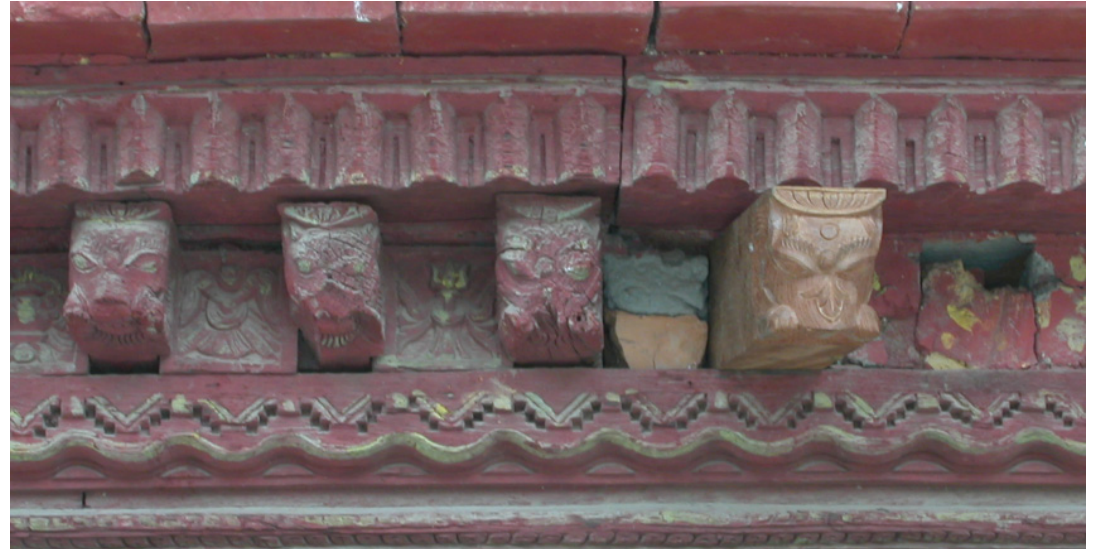
right below: The terracotta corner pieces were lost and the timber details were badly damaged. *Photo by: Lumanti Joshi, December, 2006.*

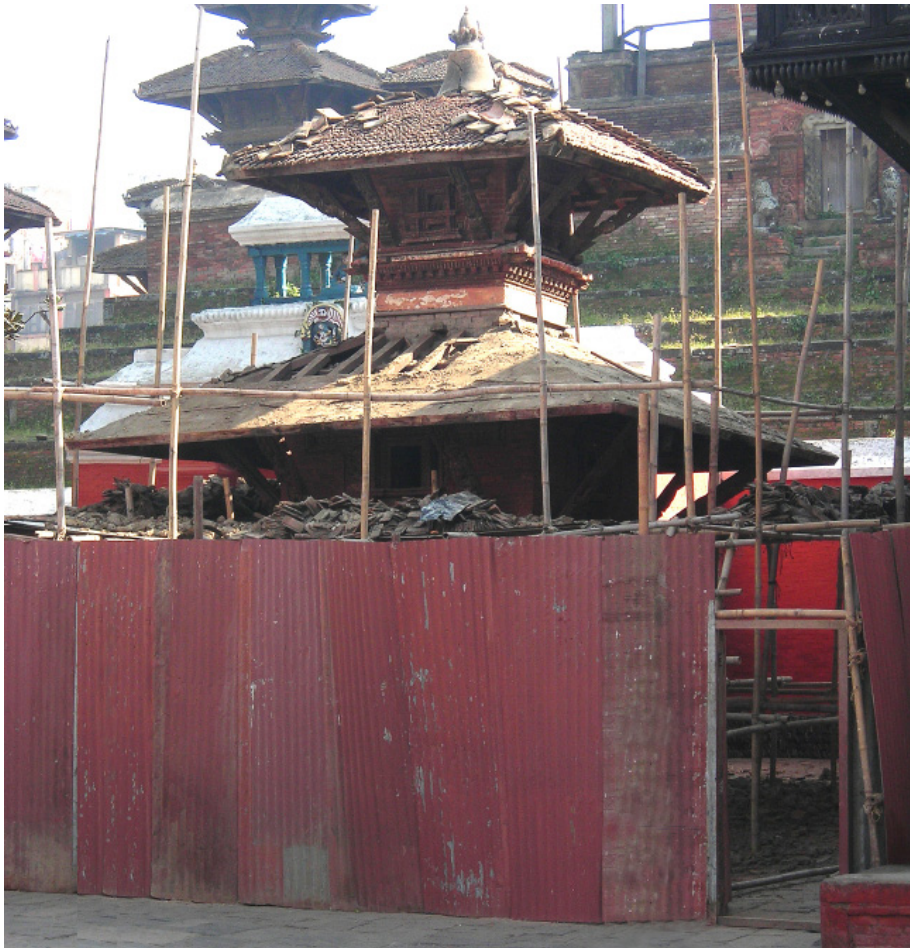
above: The roof structure being dismantled. *Photo by: Raju Roka, February 2007.*

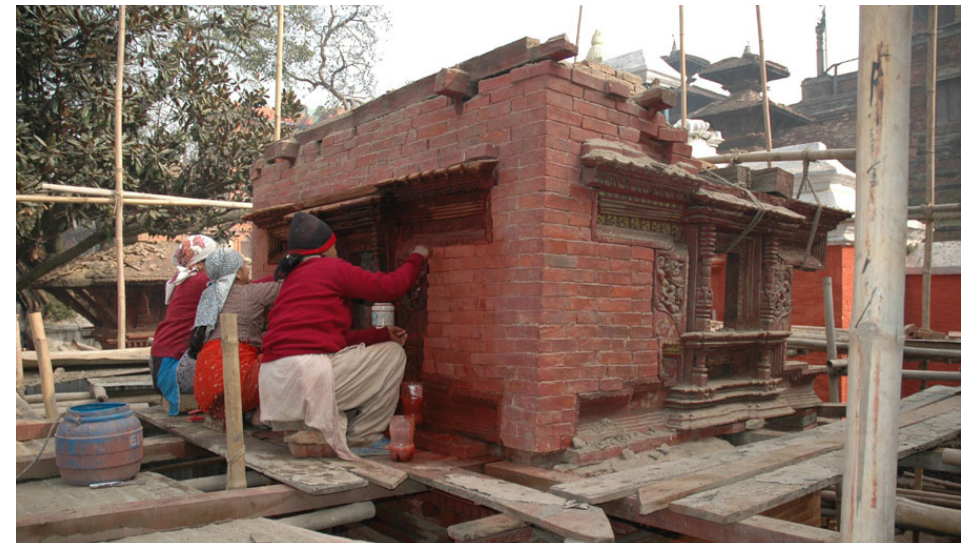
right below: The unsightly red paint from the carved elements were removed using soft brush and mild detergent. *Photo by: Lumanti Joshi, March 2007.*

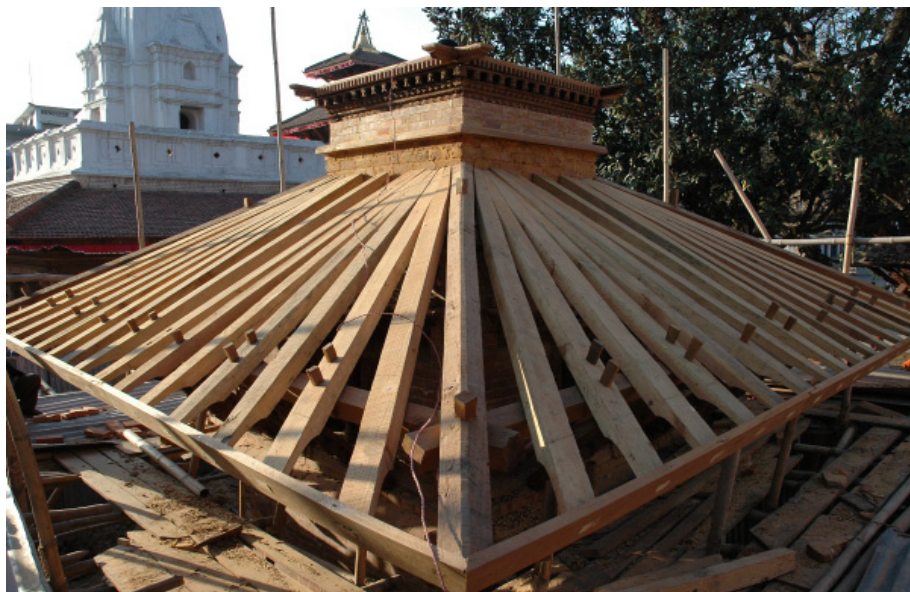
left above: Reconstruction of lower roof structure. *Photo by: Lumanti Joshi, April 2007.*

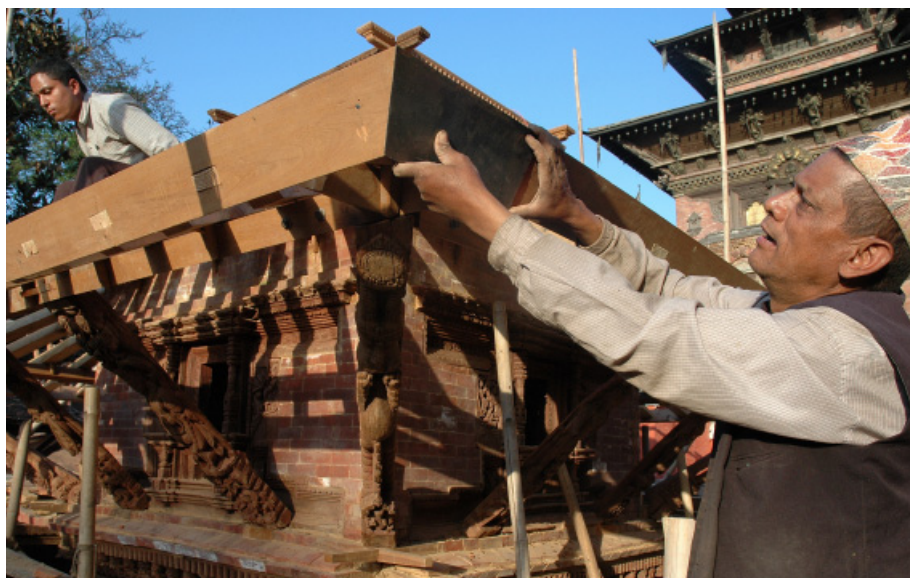
right below: Iron plates being installed at the eavesboard. *Photo by: Lumanti Joshi, April 2007.*

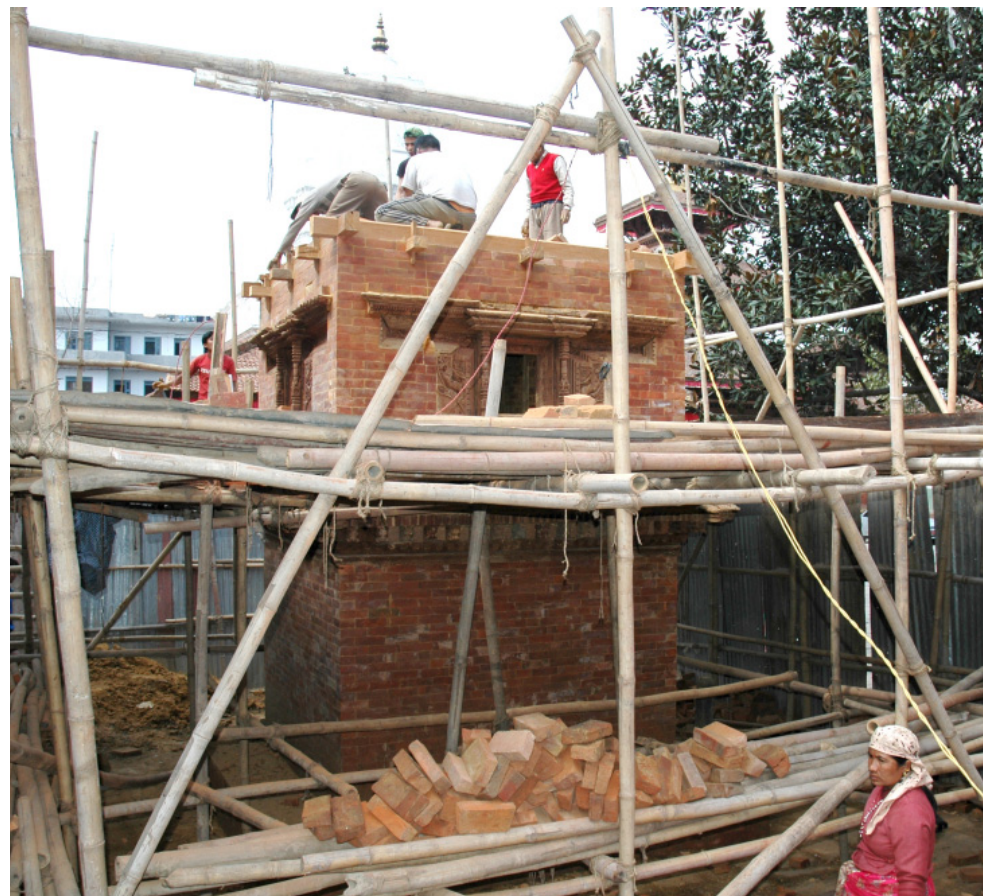
above: Construction of lower level wall being completed after correcting the settlement.
Photo by: Badri Juwal, March 2007.

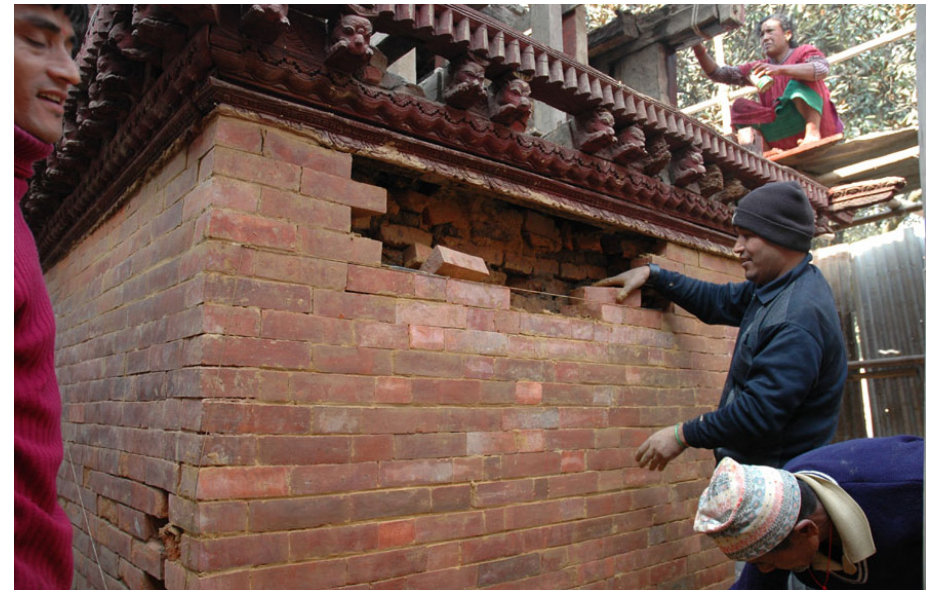
right above: The walls being reconstructed using *dachi appa* in yellow mud mortar. *Photo by: Raju Roka, February 2007.*
