NARAYAN TEMPLE

KATHMANDU DARBAR INITIATIVE

FINAL REPORT

ROHIT RANJITKAR * LUMANTI JOSHI
KATHMANDU VALLEY PRESERVATION TRUST
JUNE 2004

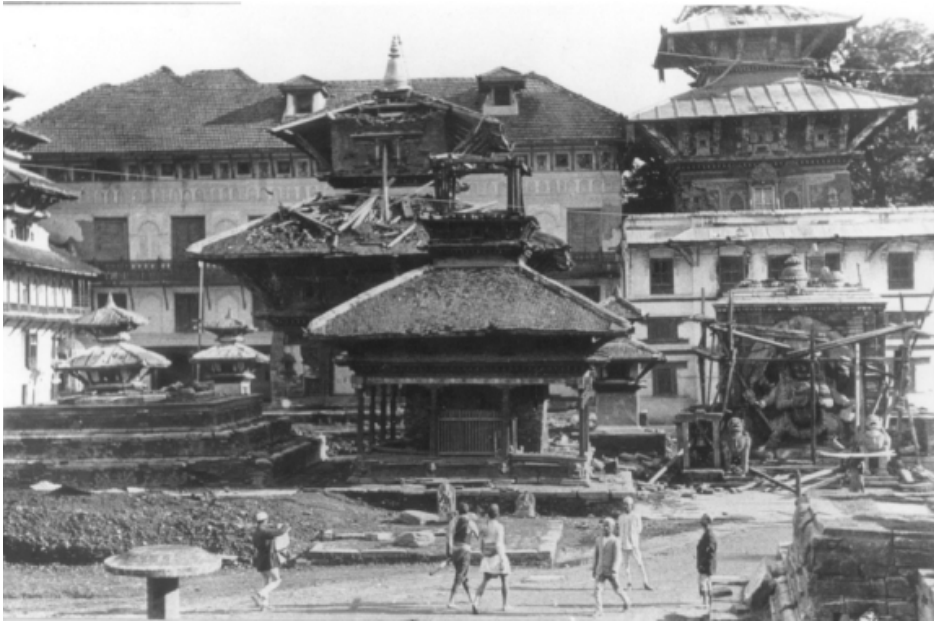
above left: Most of the temple structures in the Kathmandu Darbar Square were devastated by the major 1934 earthquake. The Narayan temple collapsed entirely up to the plinth. During the hasty reconstruction after the earthquake, many details were altered such as the lattice work in between the lower roof struts. The top roof was reduced in size as shorter struts salvaged from other temple were used. Photo courtesy: Manju Rana.

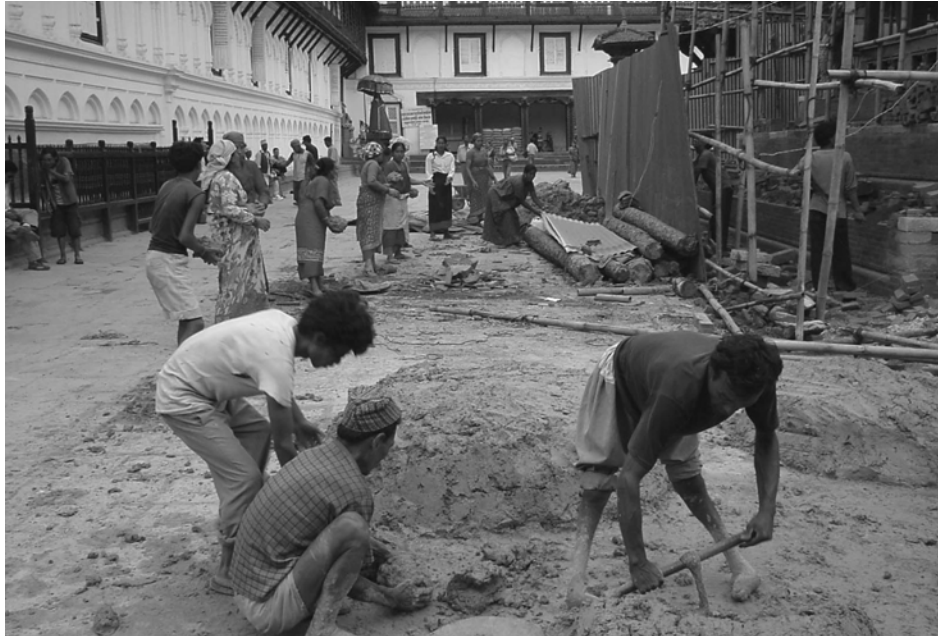
above: Preparation of mud, traditional material used for mortar for the construction. Photo: Raju Roka, September 2003

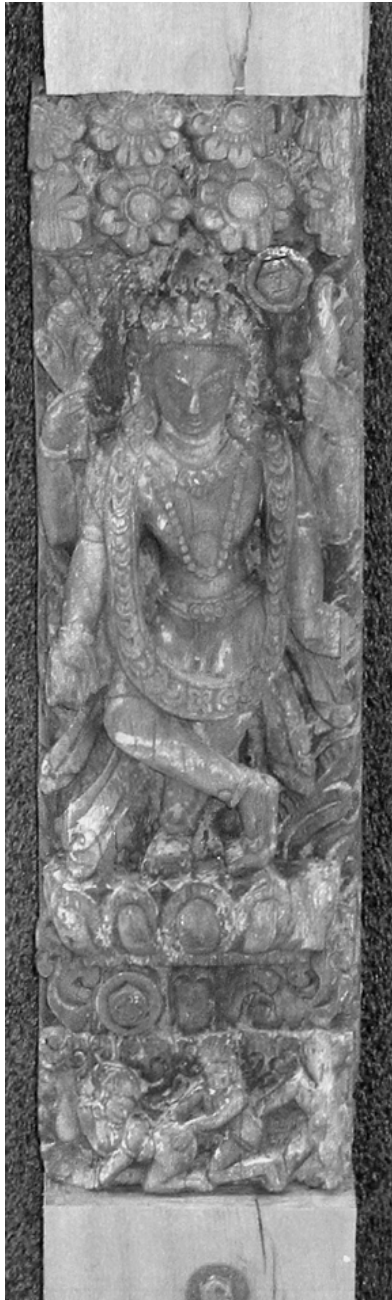
far left: Detail of one of the upper struts. Photo: Raju Roka, September 2003.

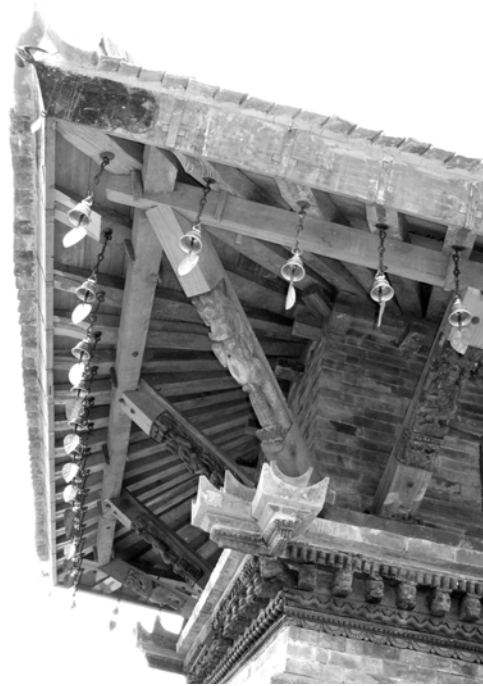
center: The struts at the upper most level. Photo: Raju Roka, September 2003.

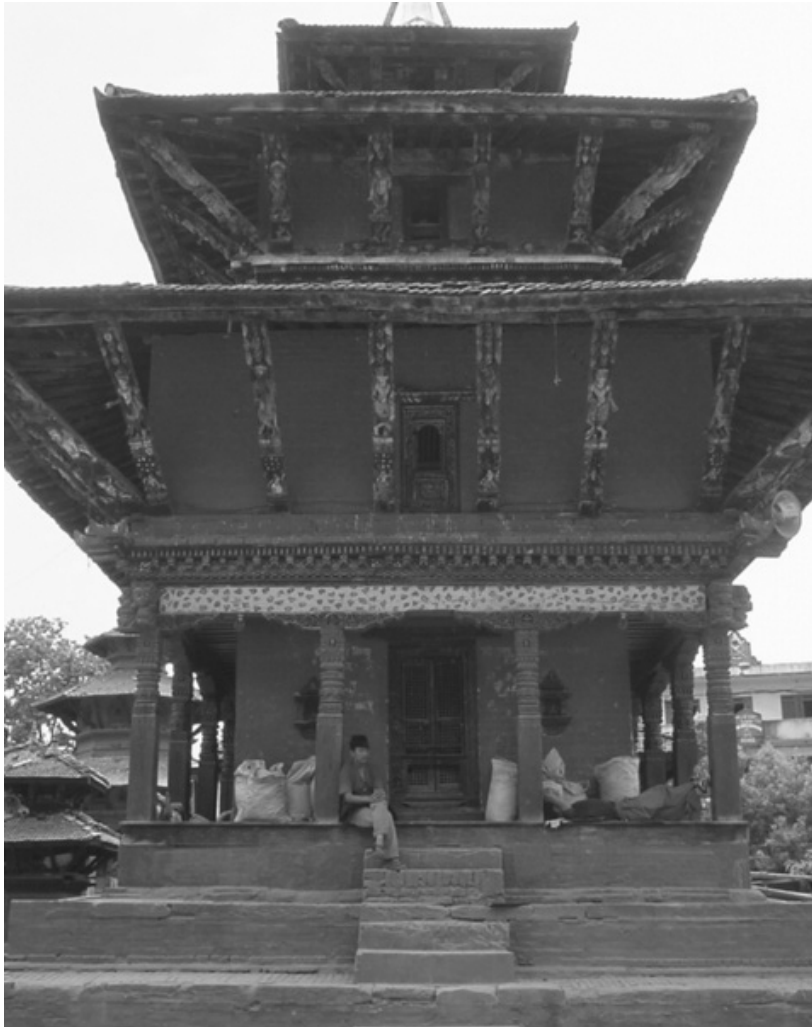
left: A view of east facade of the temple before restoration. Photo: Rohit Ranjitkar, June 1999.

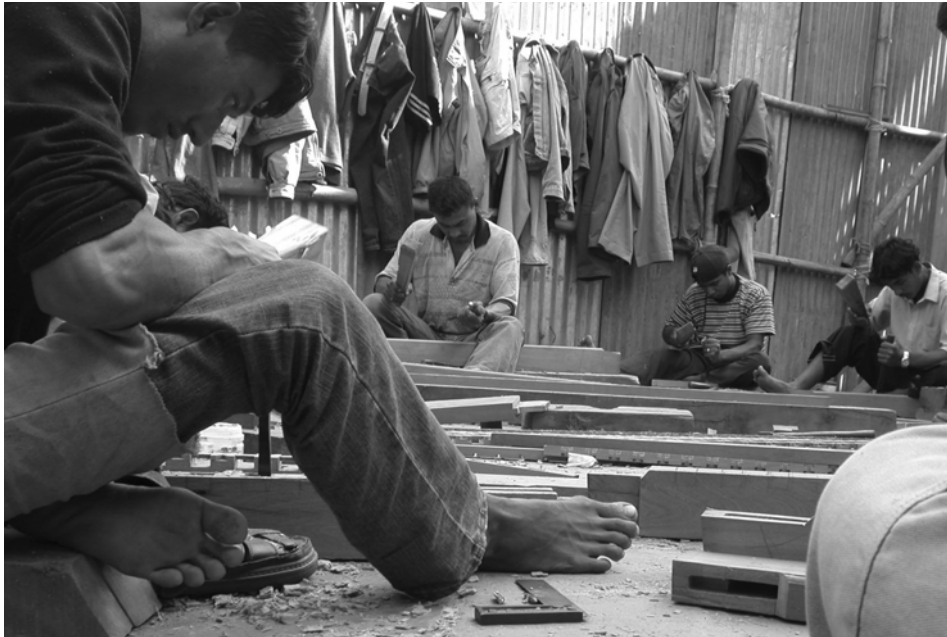
above: Carpenters work on plain timber to fabricate structural members such as wall plates, purlins, eaves boards and rafters. Photo; Raju Roka, June 2003.

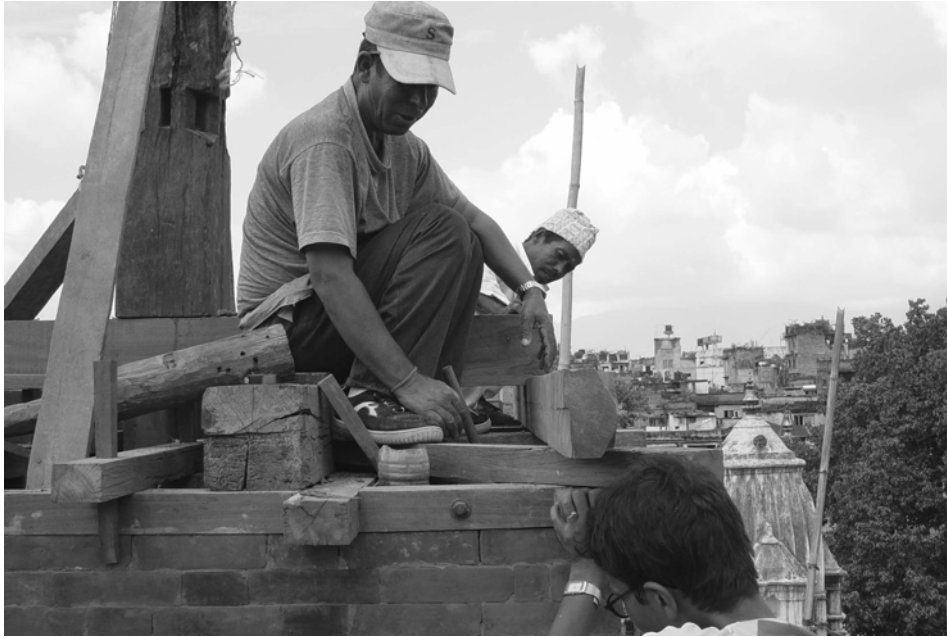
above: Carpenters fitting the wall plates incorporating the steel plates to stabilize the structure. Photo: Badri Juwal, July 2003.

The walls at both levels were rebuilt using *dachi appa* set in yellow mud mortar. The new timber structural members such as wall plates were incorporated with concealed steel plates, thus, strengthening the structure.

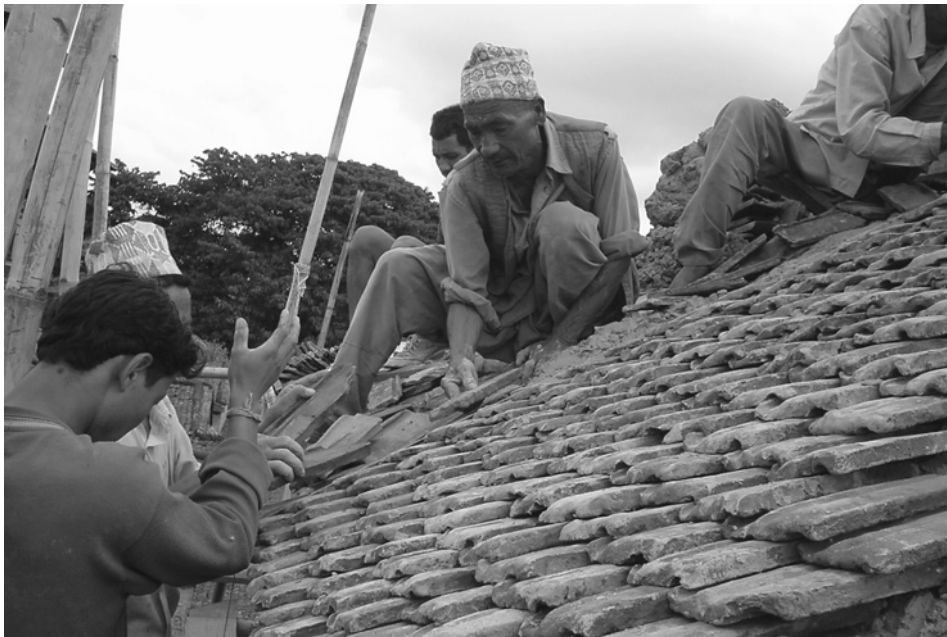
below: The traditional roof tiles or *jhingati* laid on a thick bed of mud on the upper most roof. Photo: Badri Juwal, September 2003.

The old roof structures were dismantled and new structural roof members were introduced because of the decayed condition of the existing members and to replace the lime surkhi cornice details with timber ones. Waterproofing membrane was introduced under the mud bed to extend the life of the roof. Our experience shows that careful supervision of the various work components such as mud treatment, batten installation, etc is the most critical determinant of the roof life. Above the membrane, battens were laid in diagonal sloping pattern to allow water to run off. Traditional roof tiles were then laid on thick bed of mud.

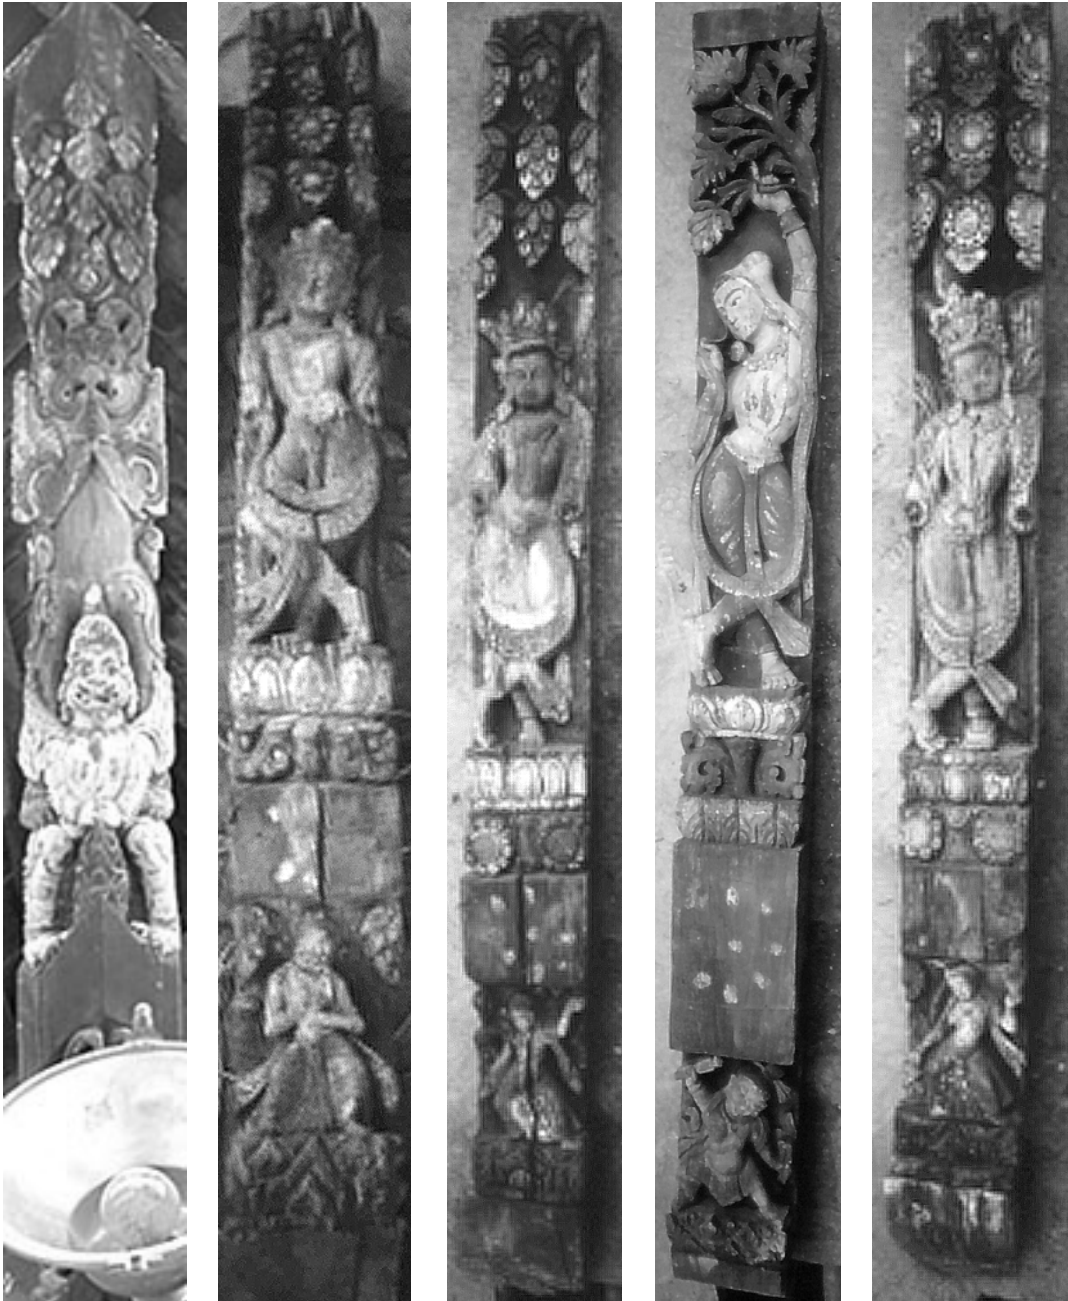
left: Some of the struts from the first floor level which were thoroughly investigated for the ongoing paint research. Photo: Heike Pfund, August 2003.

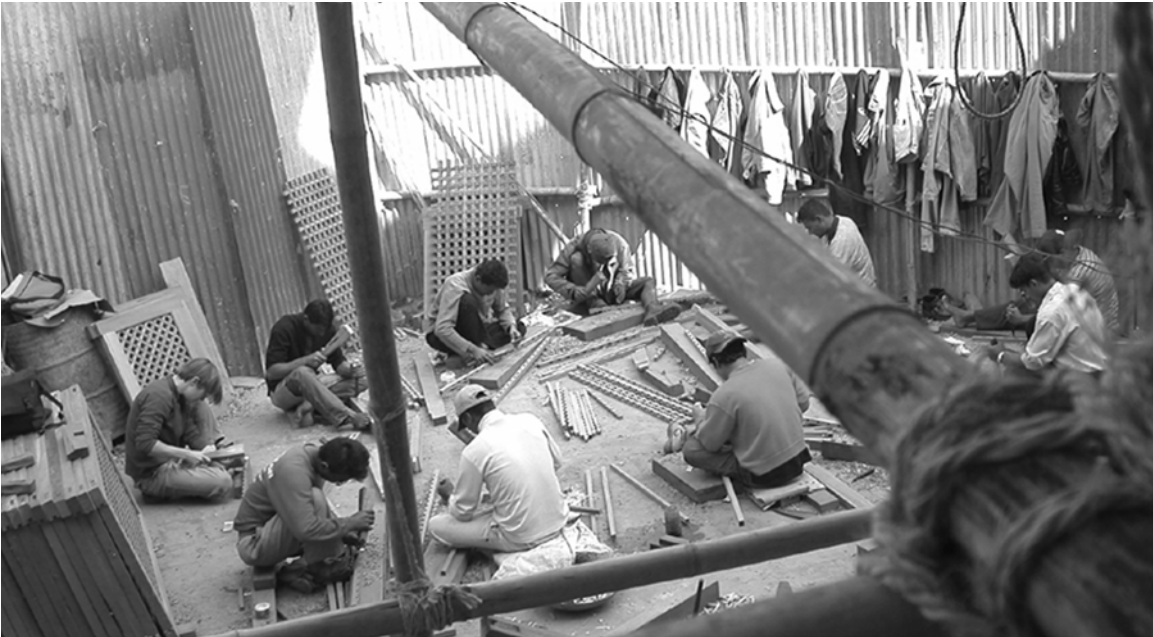
above: Carvers fabricating the details of the lattice window for the first floor level with reference to the drawings and photographs provided to them. Photo: Heike Pfund, November 2003.

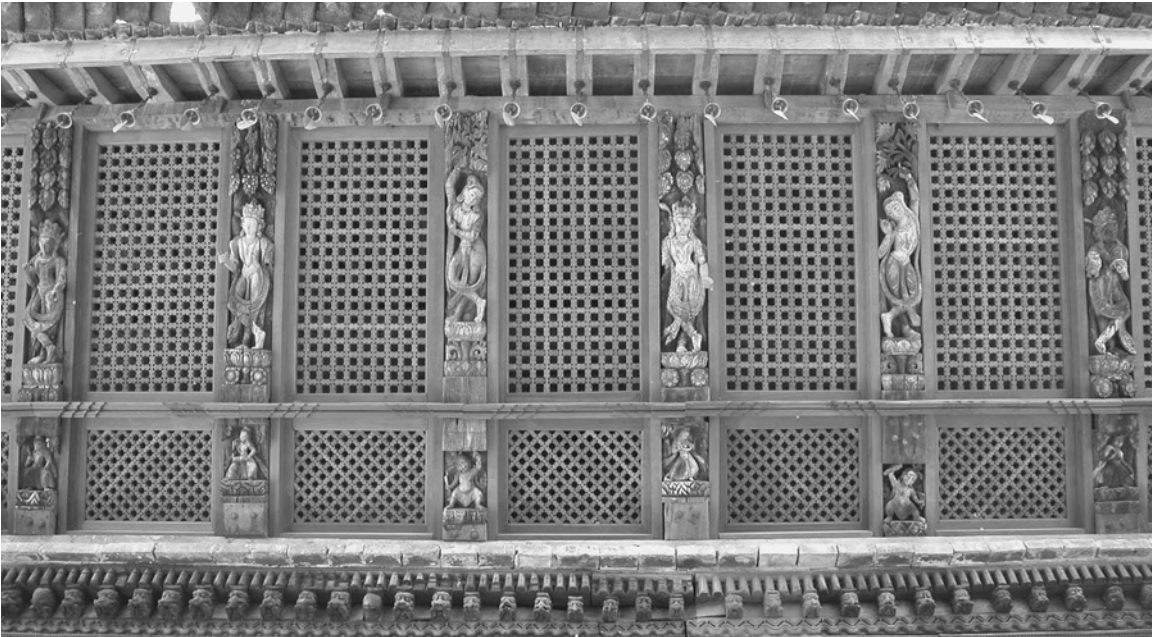
below: The lattice work after installation. Photo: Raju Roka, May 2004.

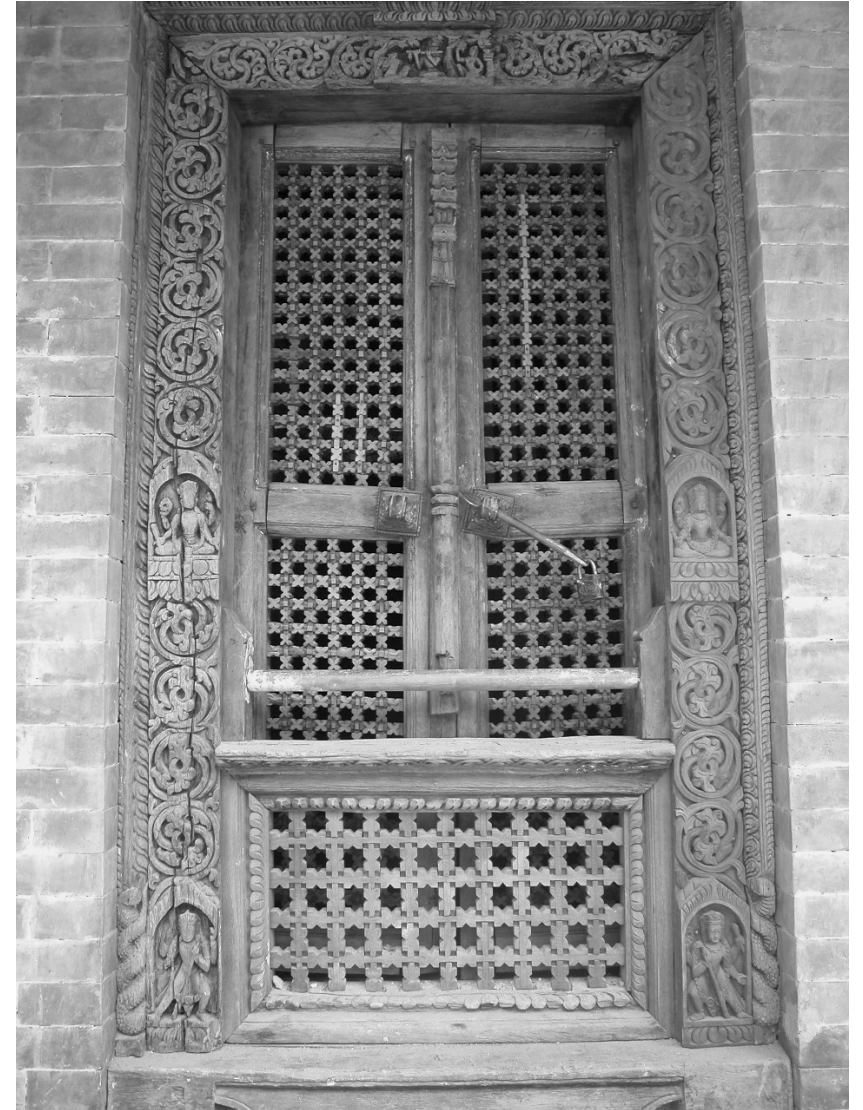
right: The detail was recarved with reference to the existing one by the German intern Irene Paetzung. The exercise was a part of her training program at KVPT. Photo: Raju Roka, June 2004.

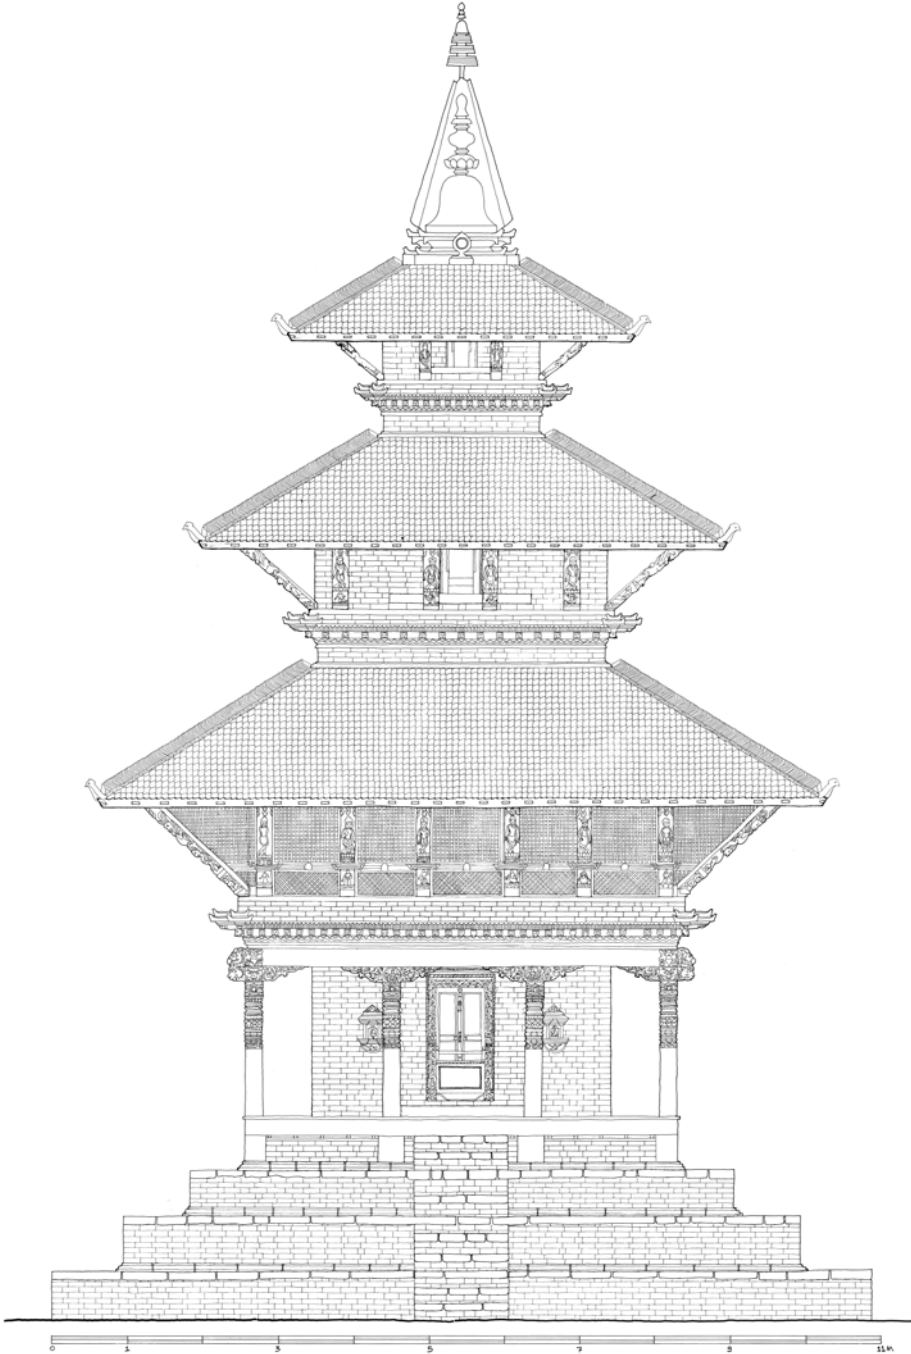
PRINCIPAL EAST ELEVATION: EXISTING CONDITION
Drawing: Lumanti Joshi, Sushil Rajbhandari, Badri Juwal and Rajan Shrestha

left: Detail of the principal entrance at the east, with missing elements in the door frame. Photo: Rohit Ranjitkar, April 2003.

left and right: Blind niches at the east facade after cleaning of the black colour. A missing column (left) from the right hand side niche was recarved. Photo: Raju Roka, June 2004.

- Carving of the missing details of the entrance doors and blind niches.
- Dry cleaning of struts at all levels.
- Installation of remaining lattice work below the lower roof.
