THE RESTORATION & SEISMIC STRENGTHENING OF
KARUNAMAYA TEMPLE | BUNGAMATI

PROJECT DOCUMENTATION/ANALYSIS
REVISED: JULY 2015

PROJECT DOCUMENTATION PREPARED
BY DAVID ANDOLFATTO AND THOMAS SCHROM
FOR UNESCO KATHMANDU

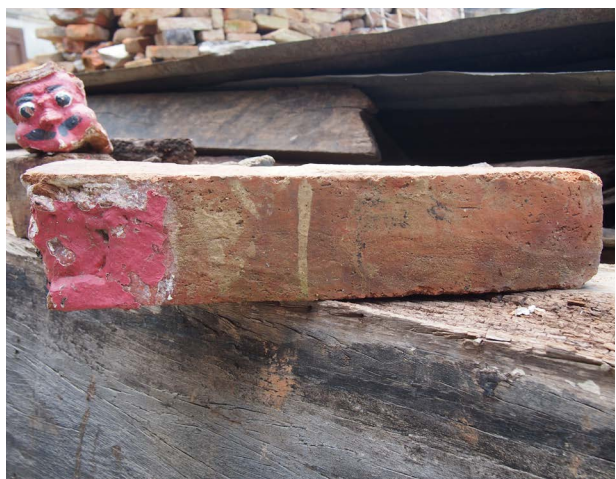
Fragments of a band of decorative terra cotta moldings
 Each side of the temple featured about 40 such heads called *dhalay khow* in Newari. According to an informant the heads represent Garuda, tigers, horses and lions.

Side view
 The individual pieces measure approximately:
 l=48 cm, w=10 cm, h=11 cm

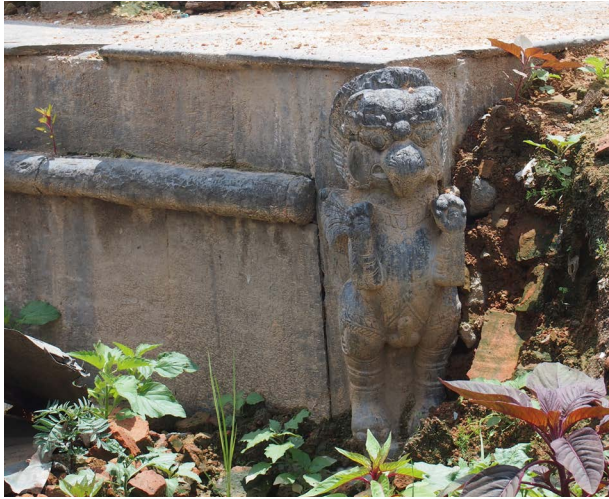
Mythical animal on the north-west corner of the lower plinth
Such representations are often called "horses" even though they are winged and feature the face of Garuda.

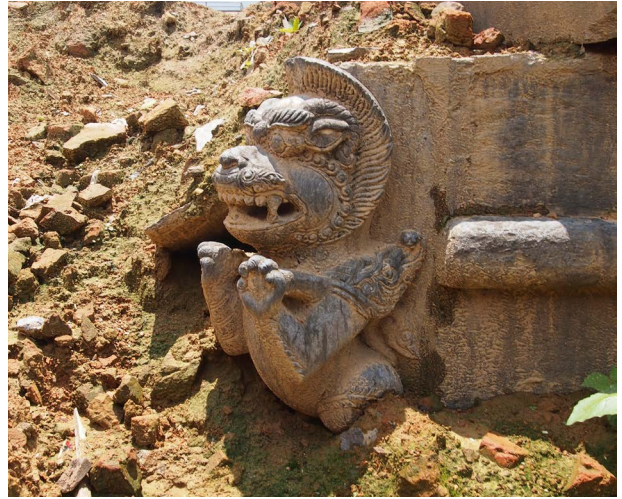
A lion on the north-east corner of the lower plinth
