LAKSHMI NARAYAN TEMPLE

KATHMANDU DARBAR INITIATIVE

FINAL REPORT

ROHIT K. RANJITKAR * LUMANTI JOSHI
KATHMANDU VALLEY PRESERVATION TRUST
AUGUST, 2007

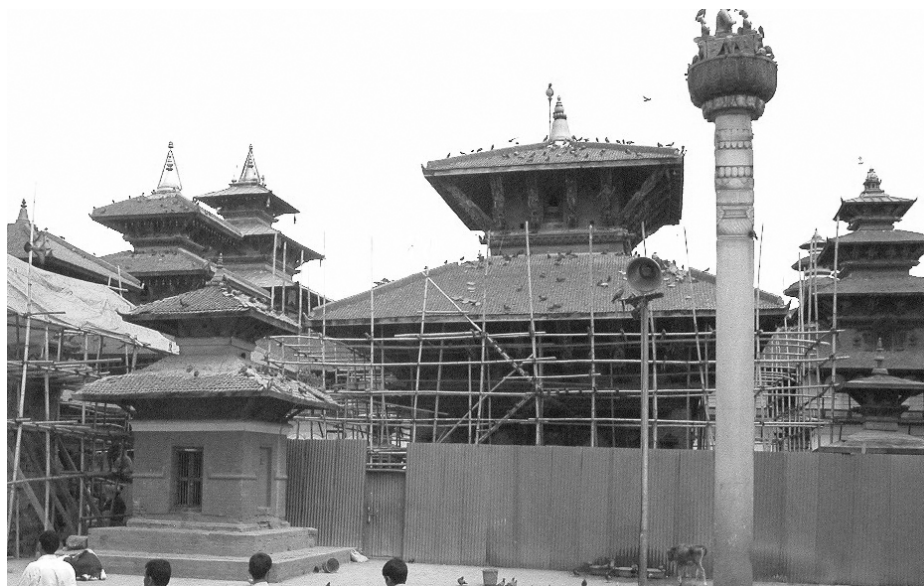
top right: The configuration was drastically changed with shorter roof line during the 1936 reconstruction. Photo taken in 1960 A.D. *Photograph courtesy: Babadur Photo Studio.*

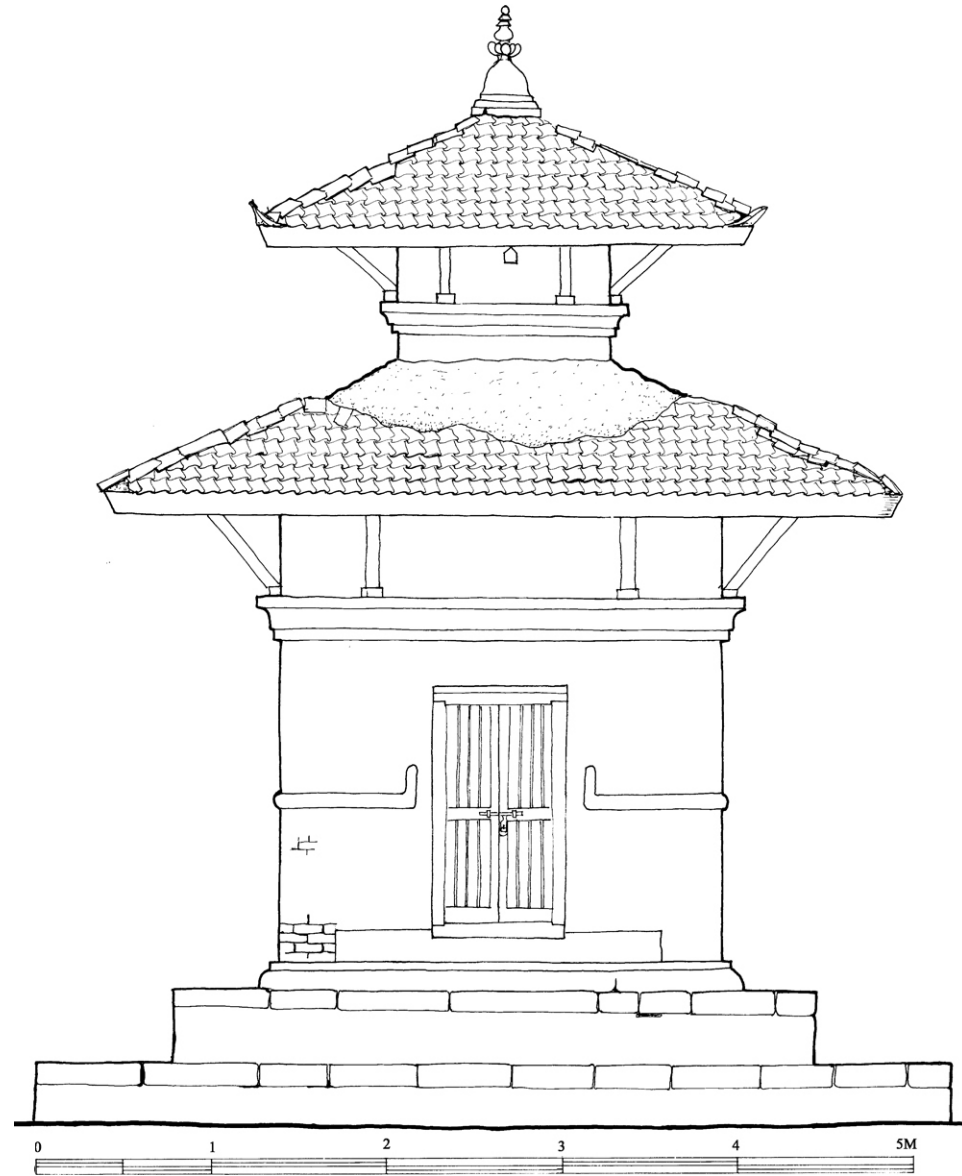
PRINCIPAL WEST ELEVATION: EXISTING CONDITIONS

- **Roof tiles:** It is in rather poor condition. Several roof tiles at the edges have fallen off on all sides, exposing the mud bed. No ridge tiles remains. Corner tiles on NE and SW are broken and NW and SE are lost.

- **Roof struts:** All corner struts and others are plain (total 12 in number) and are in fair condition. All are of smaller sections than what should be historically. However, the upper inverted portions of these are affected by bird droppings.

- **Wall structure:** Constructed with large bricks in yellow mud mortar. Has been lime plastered and red washed with small blind niches on all four sides. Though it is not in historic configuration, brick work is in fair condition and plaster work intact.

- **Cornice:** Layers of traditional timber cornice has been replaced with lime plastered detail. Constructed of lime *surkhi* and white washed, even covering the lower portion of the wall.

- **Roof tiles:** Is in very poor condition. Many of the tiles at the upper level displaced and lost from their positions, exposing the mud bed. The corners and ridge tiles are lost.

- **Roof Struts:** Struts on all side are plain (total 12 in number) which were probably change during 1936 reconstruction. Are in fair condition.
- **Wall Structure:** Constructed with 5cm thick brick on yellow mud mortar. Windows are missing and the upper wall portion (above the cornice detail) has been plastered and painted with brown enamel. Cracks have developed in the area where pegs from the wall plates meet the wall. Traditional timber cornice has been replaced with brick and *bajra* or *lime surkhi* construction and has been white washed. The *bajra* is broken at corners exposing the bricks. A plastered layer with *nagol* was added to the wall structure. Wall is plastered with lime *surkhi* and brick pattern engraved in this plaster. However the plaster is damaged at many places, like lower portions on east, north and south facades and more severely at the north west corner of the wall, exposing the bricks.

- **Doorway:** All of the four original carved doors are lost and replaced with a plain door, probably during 1936 reconstruction. The door frames do not have any carvings. Other openings are blocked with brick walls and are plastered. Each has a hole which in *Newari* is known as *Nasa Powa*.

- **Plinth:** Constructed with common bricks and the joints have been cement pointed, is in fair condition. Plinth apron stones are intact.

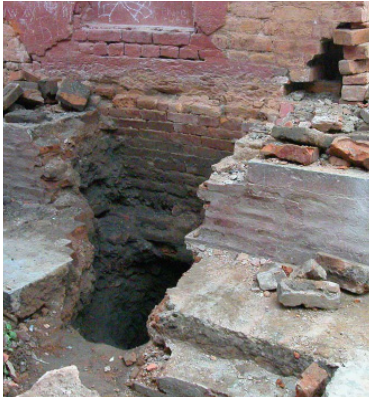
top left: The preliminary work began with excavation of a section of the foundation. *Photo by Lumanti Joshi, July 2005.*

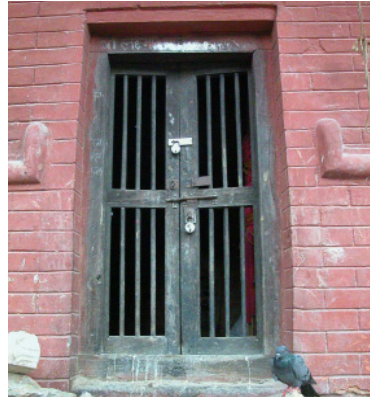
top right: During 1941 A.D. reconstruction, elaborately carved doors on all sides were replaced with this simple framed opening on west side. Openings for the doors on the other sides were blocked with brick walls *Photo by Lumanti Joshi, July 2005.*

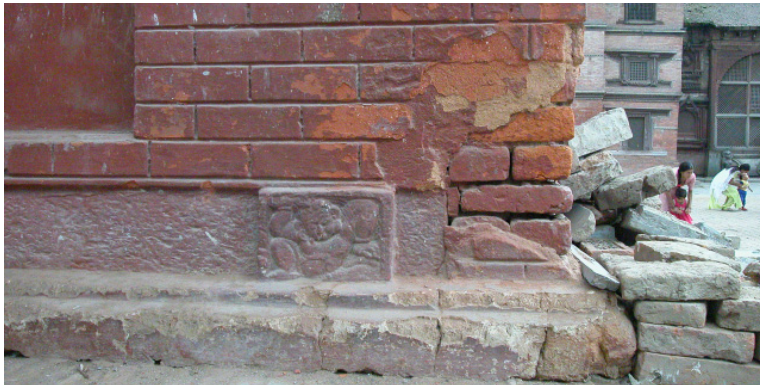
bottom: Brick work was completely damaged under the lime surkhi plaster. The bricks used after the 1934 earthquake were larger than the traditionally used dachi appa. *Photograph by: Raju Roka, July 2005.*

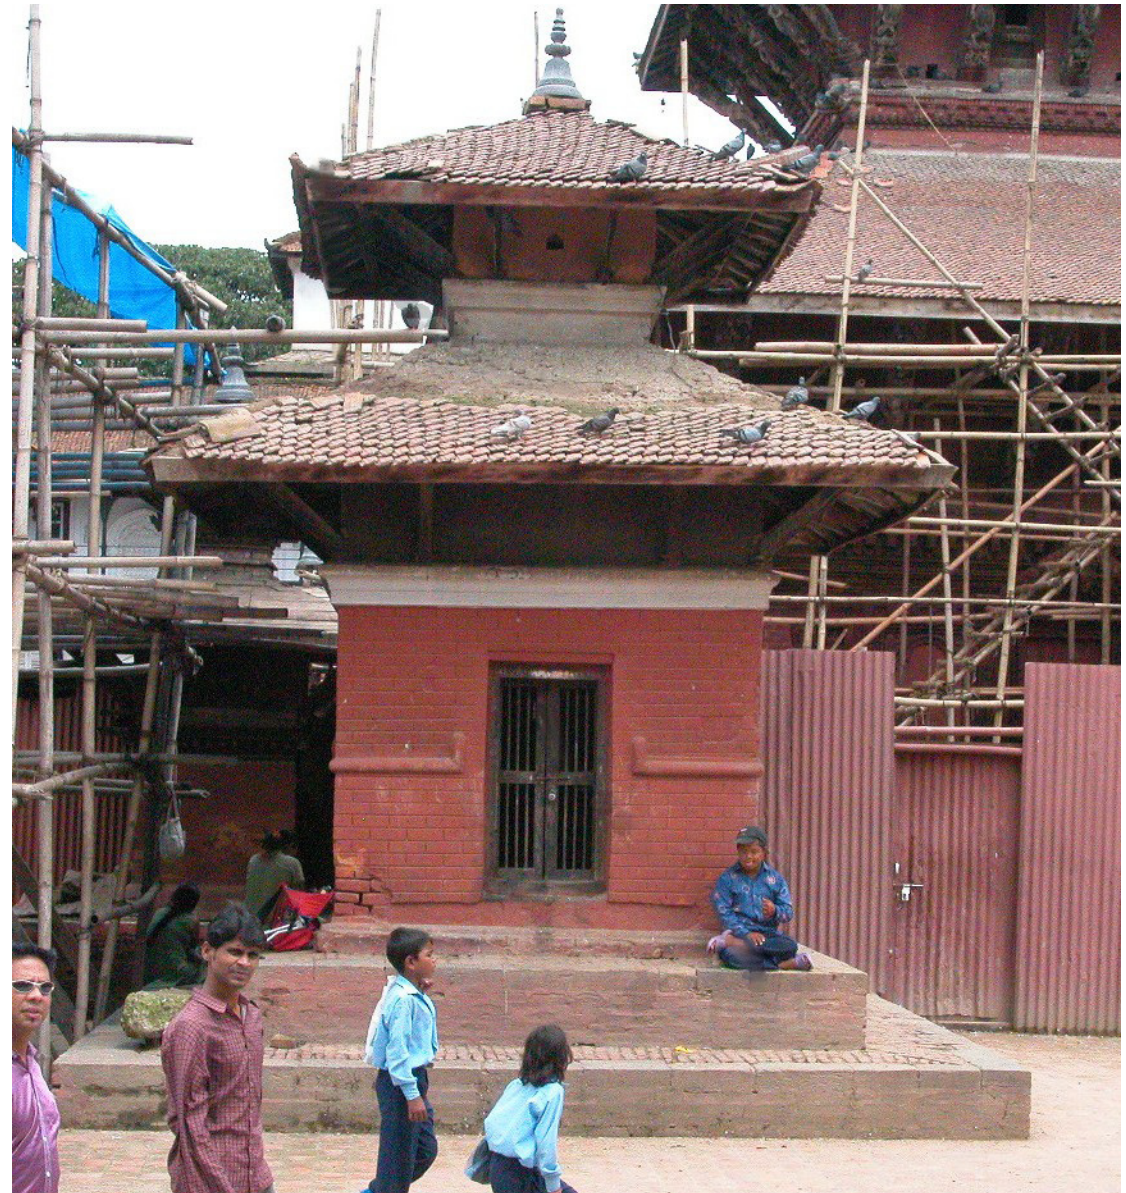
right: Lakshmi Narayan Temple, as it stood in August 2004, before the restoration work began. *Photo by: Lumanti Joshi, August 2004.*

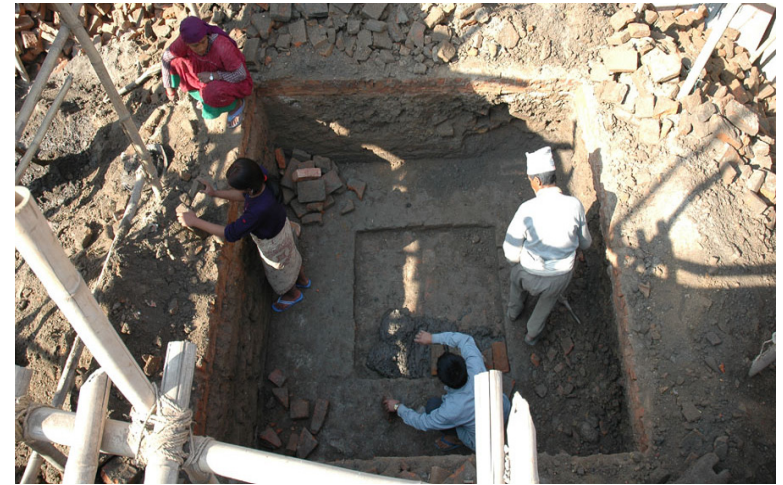
top: The base of the main structure was excavated upto 5' in depth and a solid raft like base with brick masonry was created for seismic purpose. *Photo by Lumanti Joshi, July 2005.*

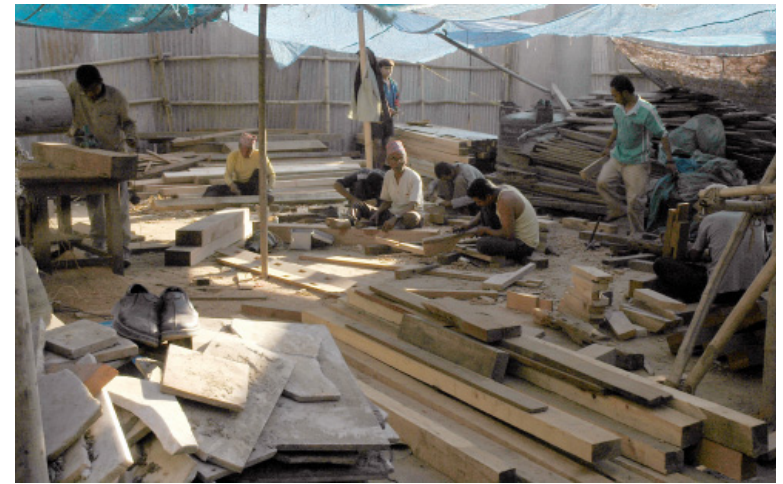
bottom: Prior to the actual construction of the superstructure, all the timber members such as the joists, wall plates, rafters and planking were prepared in situ with reference to the drawings prepared. *Photo by: Lumanti Joshi, December 2006.*

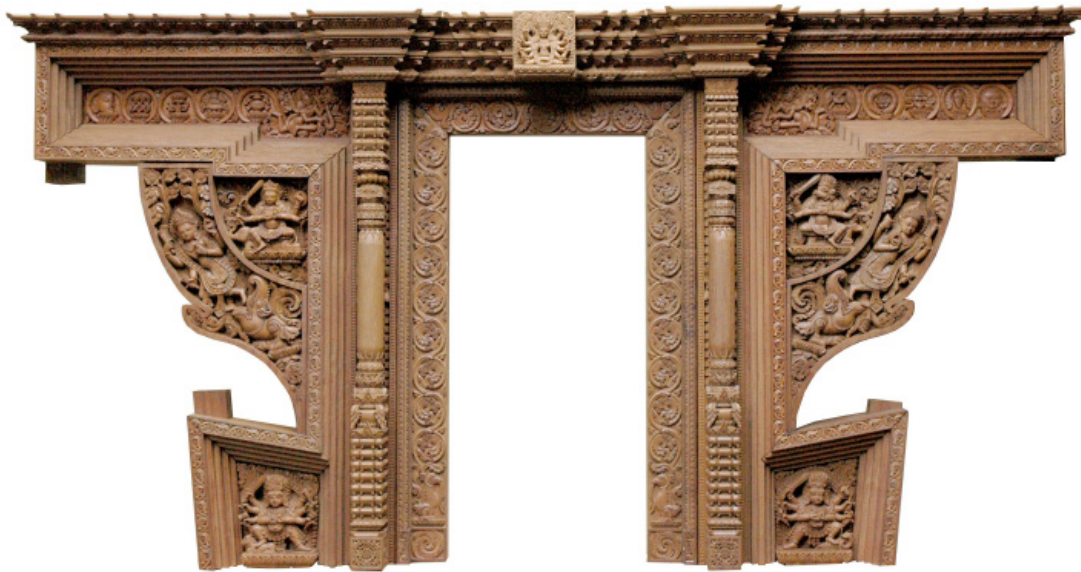
top: Door for East facade. In the left side of the door, the quarter round medallion has the images of the mother goddesses Maheswari on her vehicle the bull and the bottom door panel has her counterpart Ruru Bhairav. Similarly in the right, the quarter round medallion has Bramhayeni on her vehicle the goose and the bottom door panel has her counterpart Asitanga Bhairav. The door brackets are carved with Keshav and Vasudev, different forms of Vishnu in the left and right respectively. *Photo by: Raju Roka, September, 2006.*

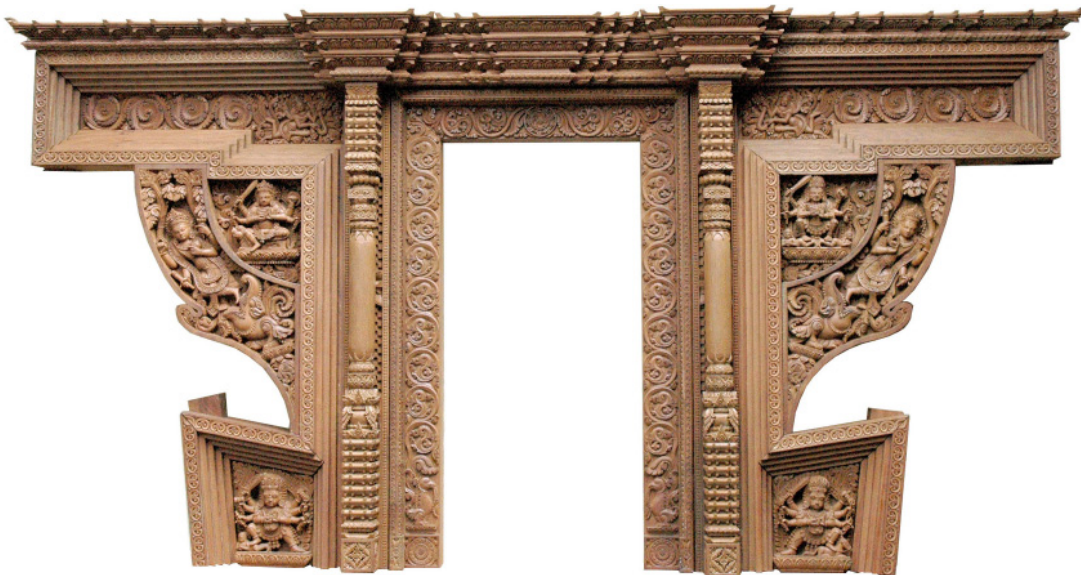
bottom: Door for South facade. In the left, the quarter round medallion is carved with Vaishnavi on her vehicle Garud and the bottom door panel has her counterpart Krodha Bhairav. In the right, the quarter round medallion is carved with Kaumari on the peacock and the bottom door panel has her counterpart Canda Bhairav. The door brackets are carved with Govinda and Sankarshan, two of the eight forms of Vishnu in the left and right respectively. *Photo by: Raju Roka, September 2006.*

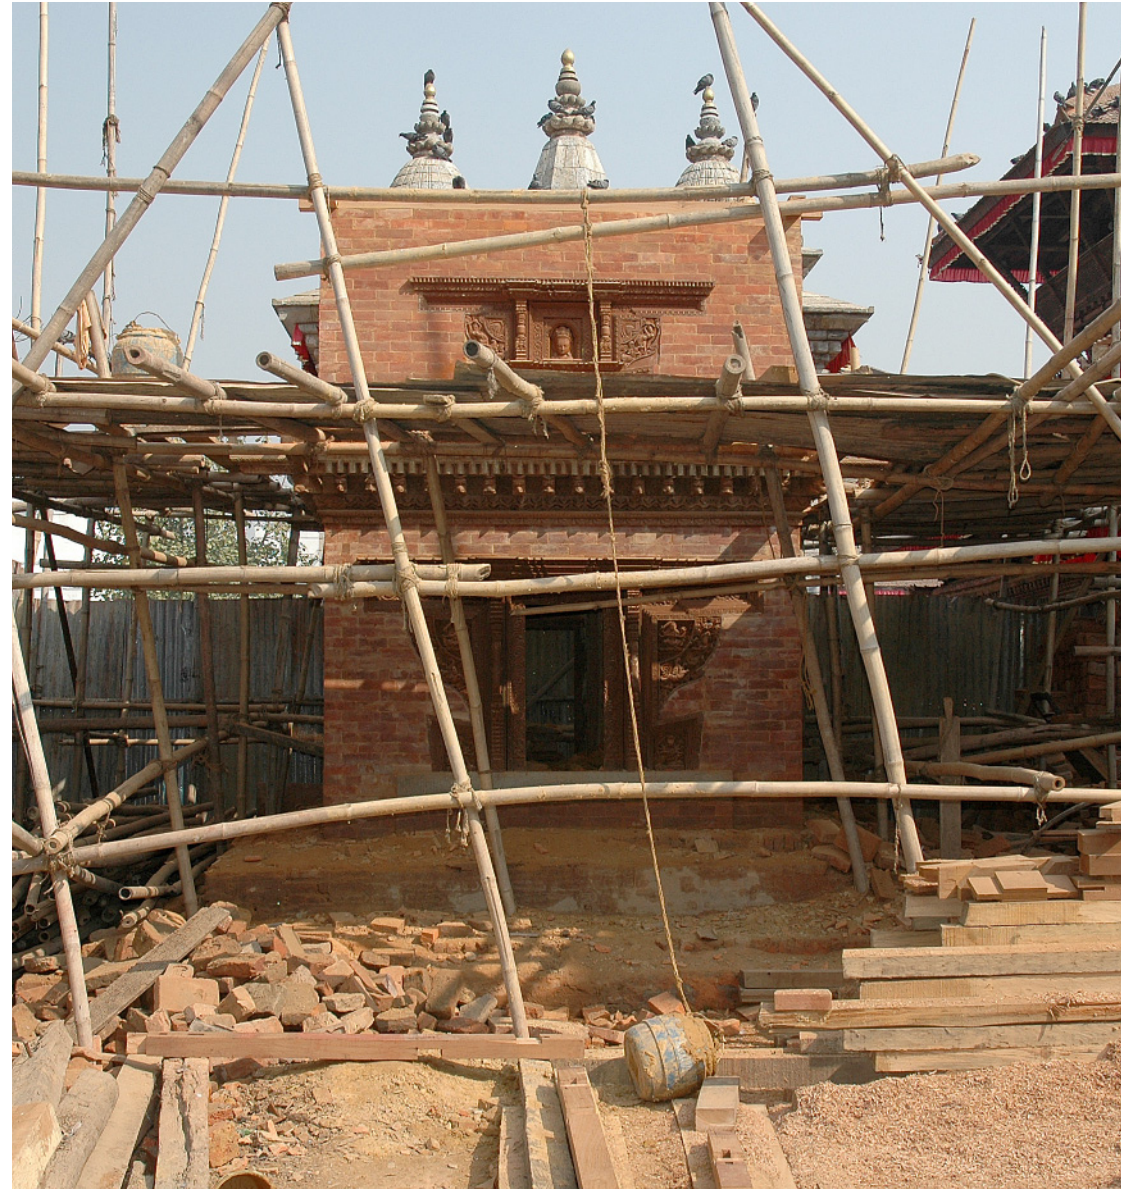
top: After the final finishing of the doors were complete in the workshop, these were installed on all four sides with their internal support frames.

bottom left: Indra Kaji and his team of craftsmen readjusting the installed door.

bottom right: Not a single example of the cornice detail remained from the original structure. Craftsmen recreated these elements like these lion heads shown in the photo on the basis of the similar pieces from the Mahadev Temples, standing outside the Taleju Temple's west entrance, KDS. Photo by: *Raju Roka, February 2007*

right: Reconstruction of lower level in the process being complete after the installation carving details and construction of brick walls. Photo by : *Lumanti Joshi, March 2007.*

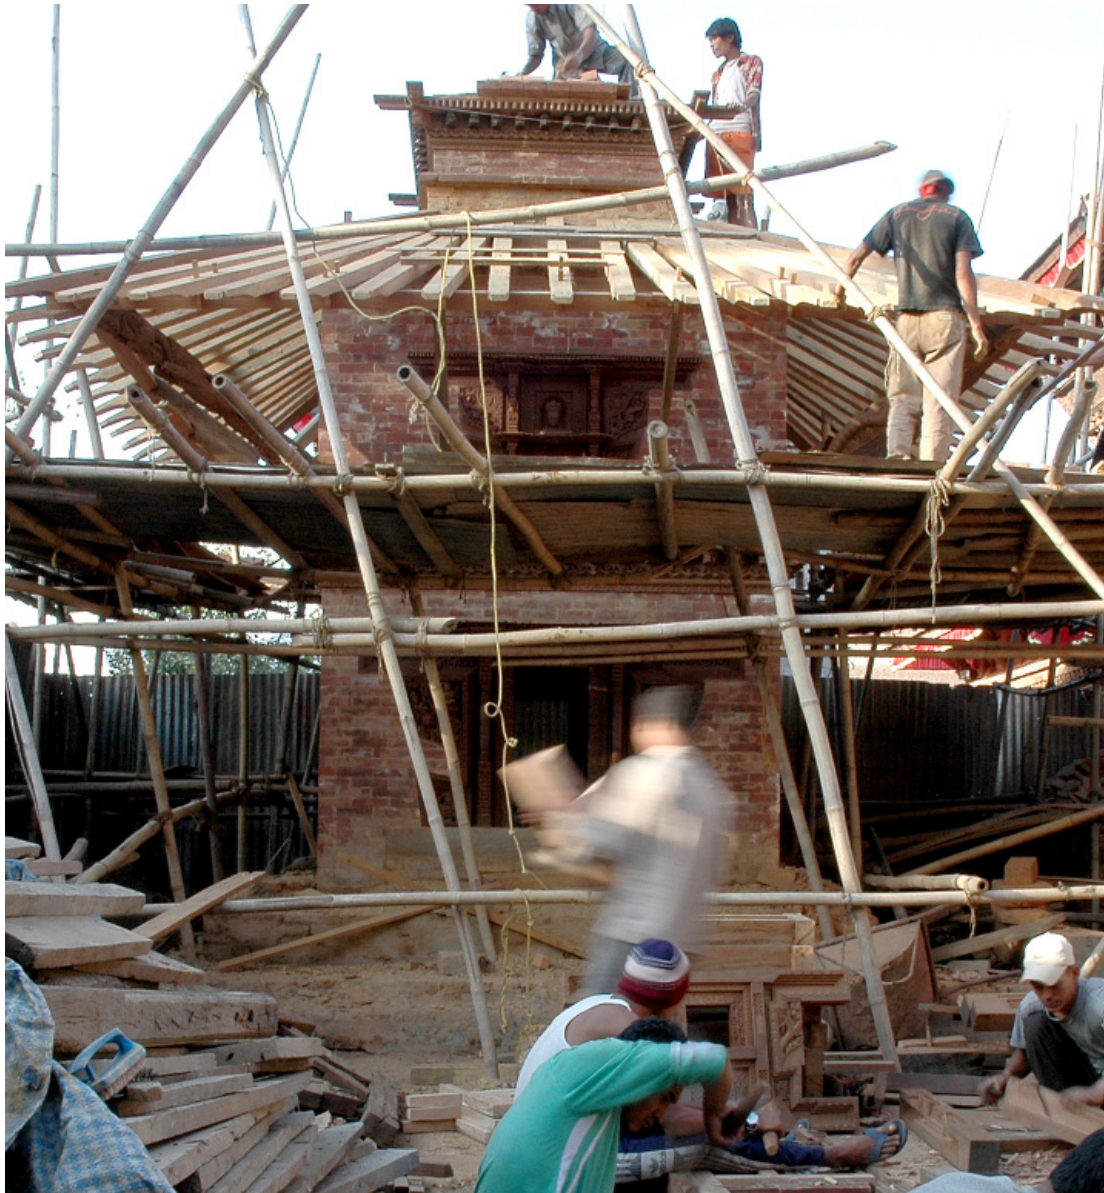
left: Work in Progress. While the craftsmen are working on the carving of window for the upper level, rafters on the lower level and the cornice on the upper level were being installed. *Photo by: Lumanti Joshi, April 2007.*

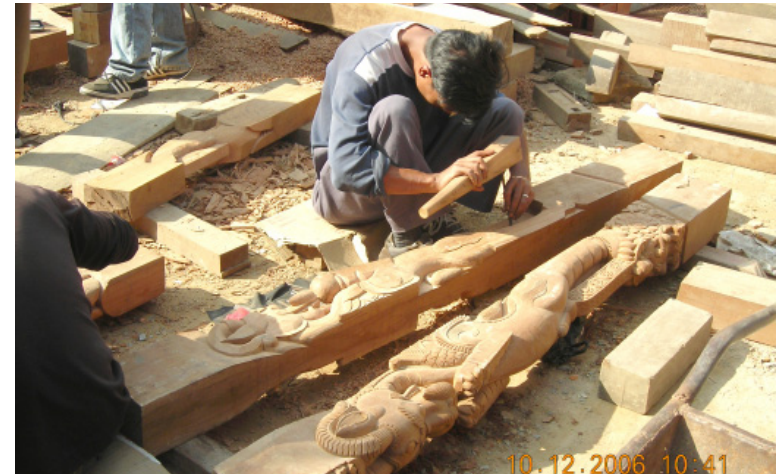
top: The corner struts from the Mahadev Temple I, where the restoration work had simultaneously begun, were used as a base for recarving the ones for this temple. *Photo by: Lumanti Joshi, November 2006.*

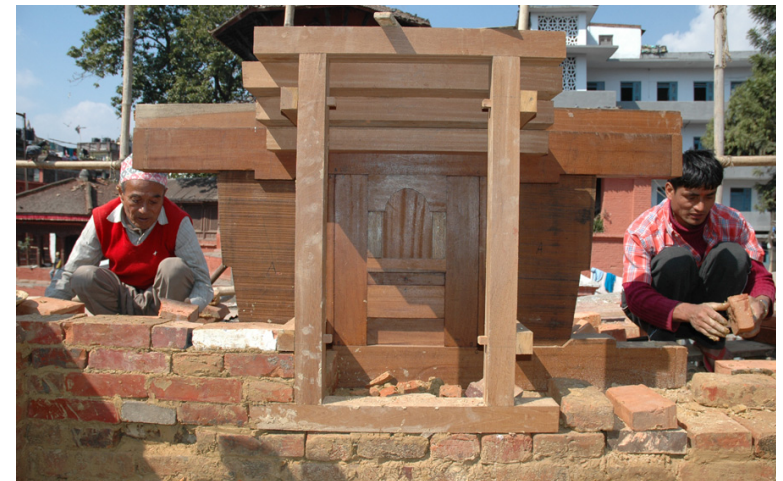
bottom: Brick wall being raised following the installation of the carved windows with their internal frames at the lower level. *Photo by: Lumanti Joshi, February 2007.*

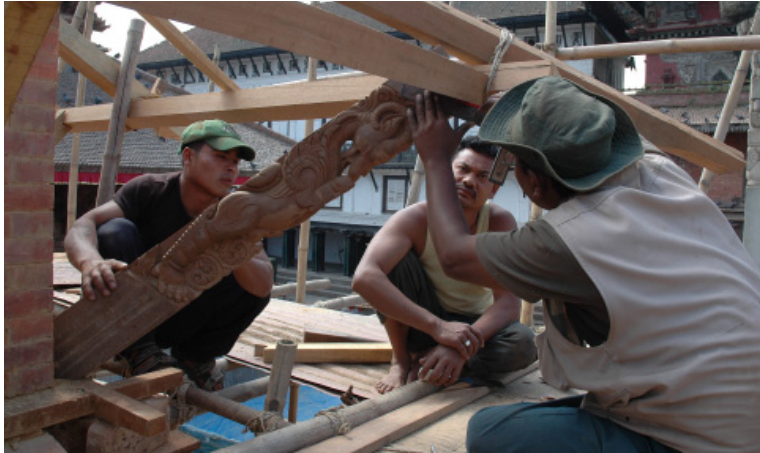
top: When the carving of the corner struts were complete, these were tried out in their respective positions for their precise size. Sometimes carpenters had to make minor correction for readjusting them. *Photo by: Lumanti Joshi, April 2007.*

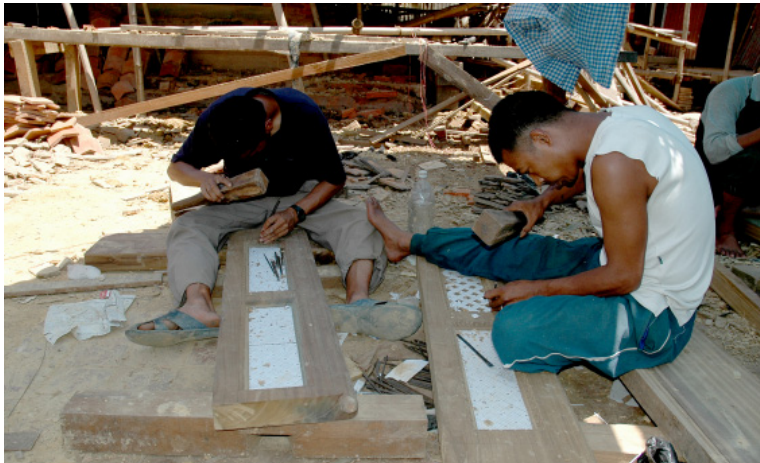
bottom: The door leaves being carved with lattice detail. The craftsmen paste 1:1 drawing of the lattice on the shutters themselves to be used as base for the carving. *Photo by: Lumanti Joshi, May 2007.*

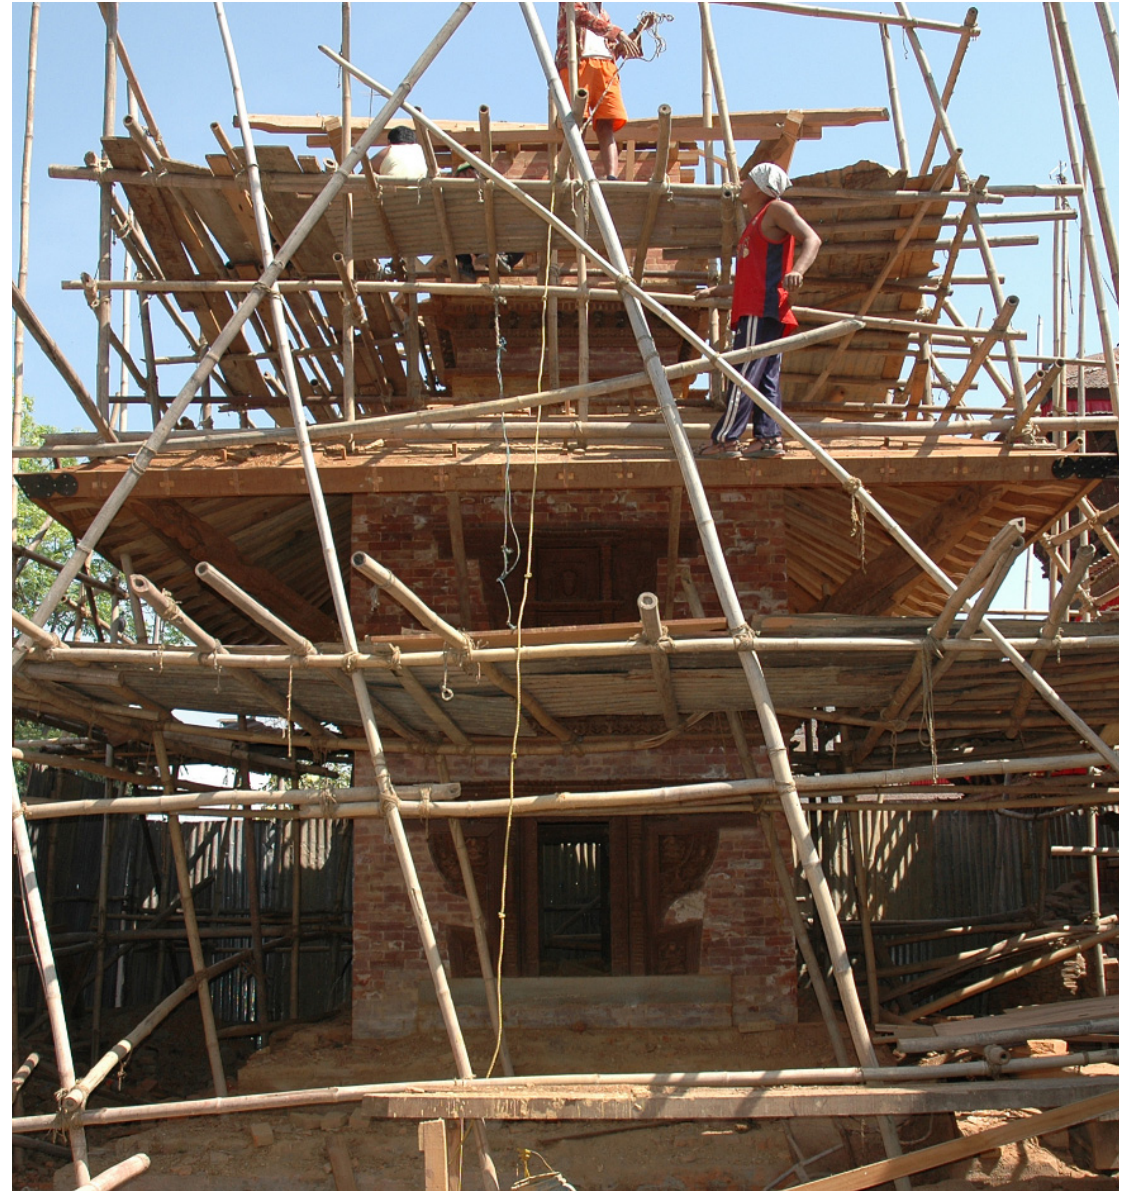
right: As the rafters were being positioned on the upper level, the work on the lower level roof was also ongoing with nailing of planking on the rafters and laying of waterproofing membrane. *Photo by: Lumanti Joshi, May 2007.*

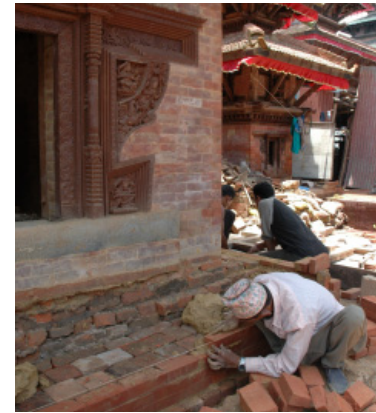
top left: The plinth was constructed with traditional dachi appa brick in mud yellow mortar. Dressed stone apron encircles the plinth on top and is paved with traditional telia tiles. *Photo by: Lumanti Joshi, June 2007.*

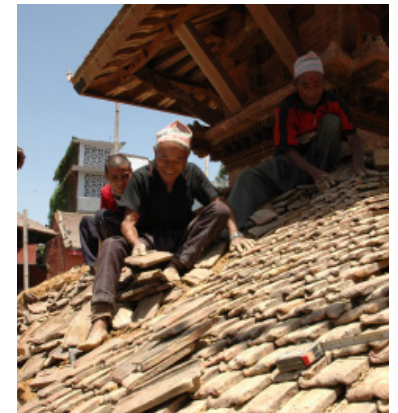
top right: Traditional roofing tile being laid on the first floor roof. For securing the tiles in their respective place, every tile at the eaves board level is nailed. *Photo by: Lumanti Joshi, May 2007.*

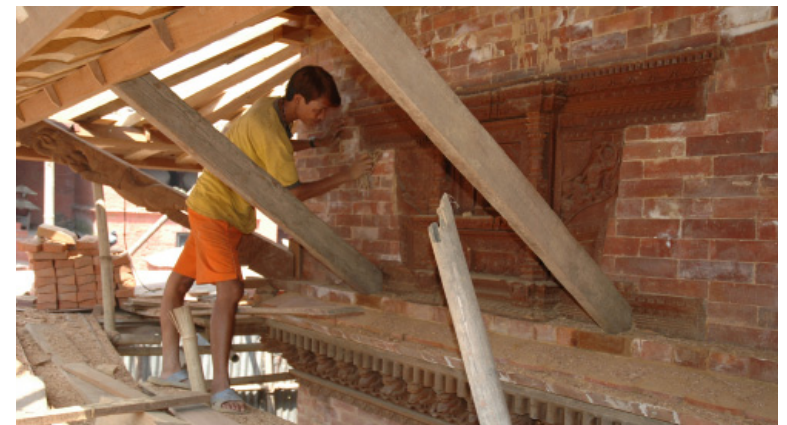
bottom: The walls after certain period of construction developed salt efflorescence on the surface. Our experience with other temples demonstrated that drying cleaning using hard brush was the most appropriate solution for this problem. *Photo by: Lumanti Joshi, June 2007.*

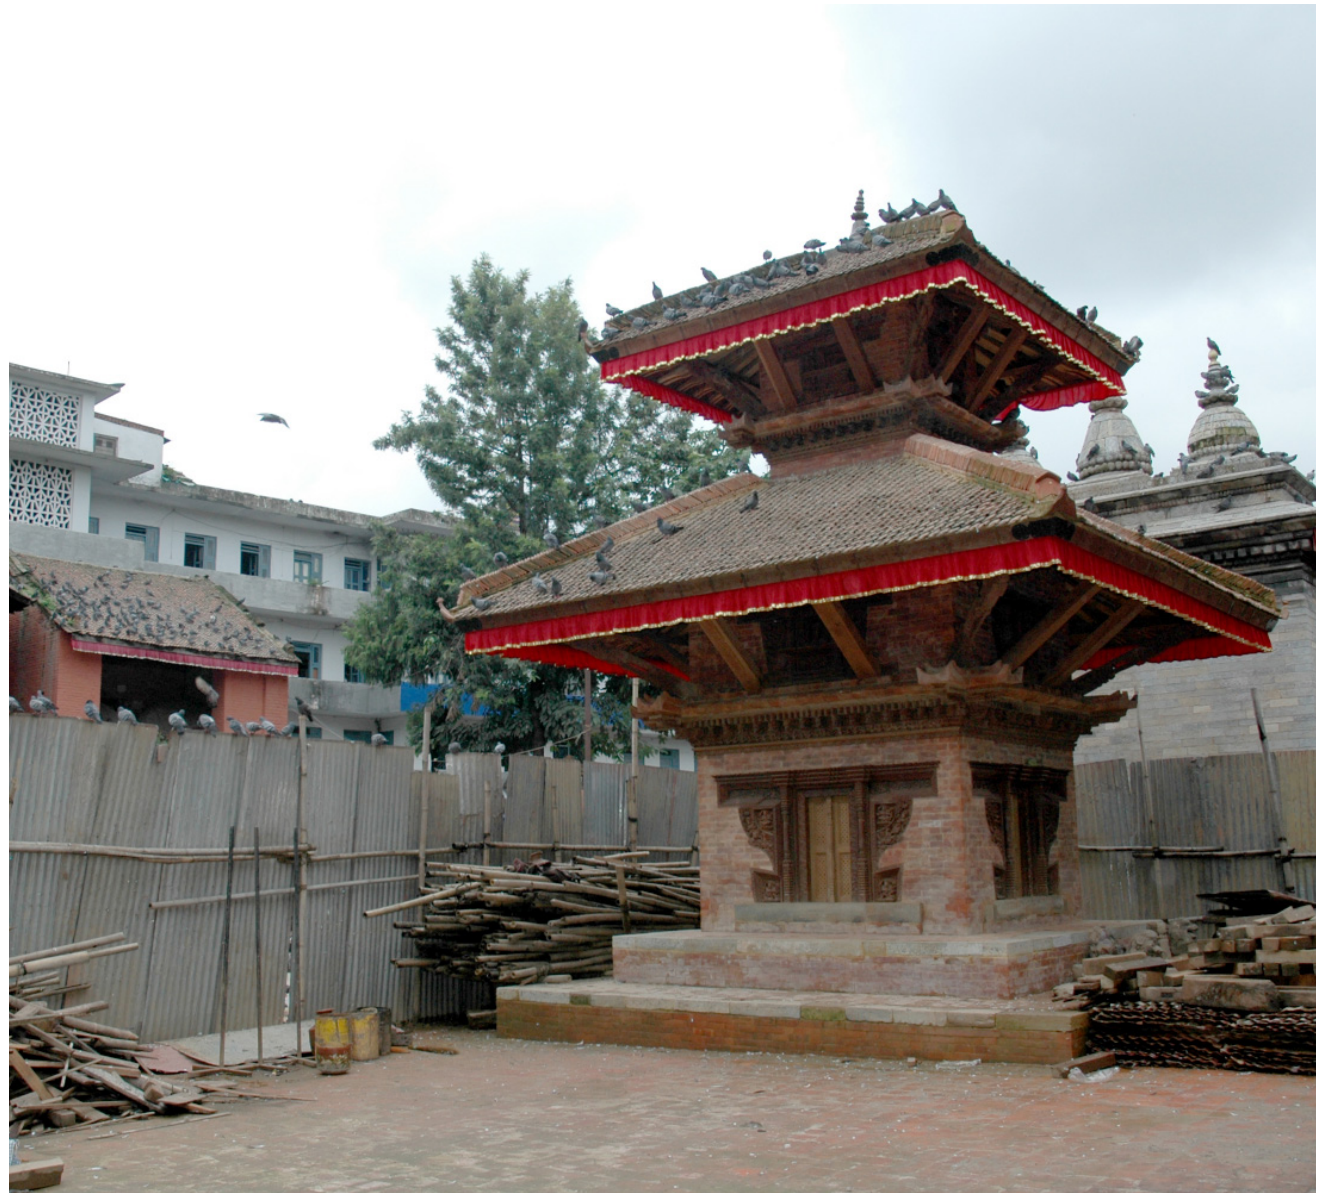
left: Lakshmi Narayan Temple after restoration in August 2007. *Photo by: Lumanti Joshi, June 2007.*
