## RESTORATION AND SEISMIC STRENGTHENING OF THE SOUTH TALEJU TEMPLE

PROGRESS REPORT | MAY 2014

THE KATHMANDU VALLEY PRESERVATION TRUST

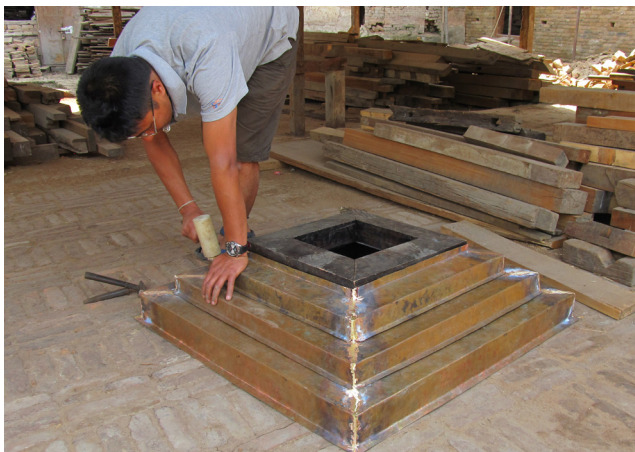
**Sealing with protective copper sheet** | April 2014

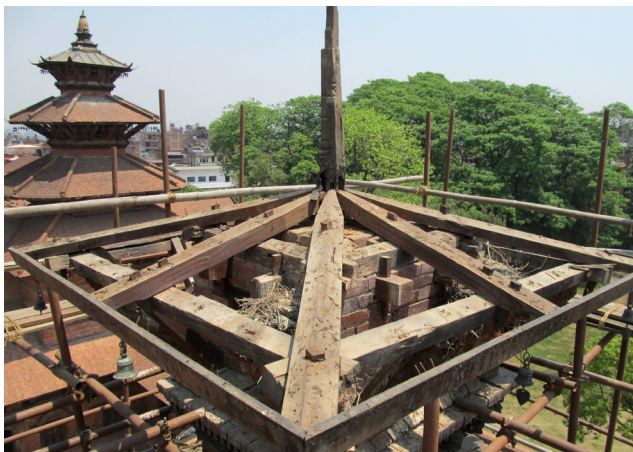
**Removal of common rafters** | April 22, 2014

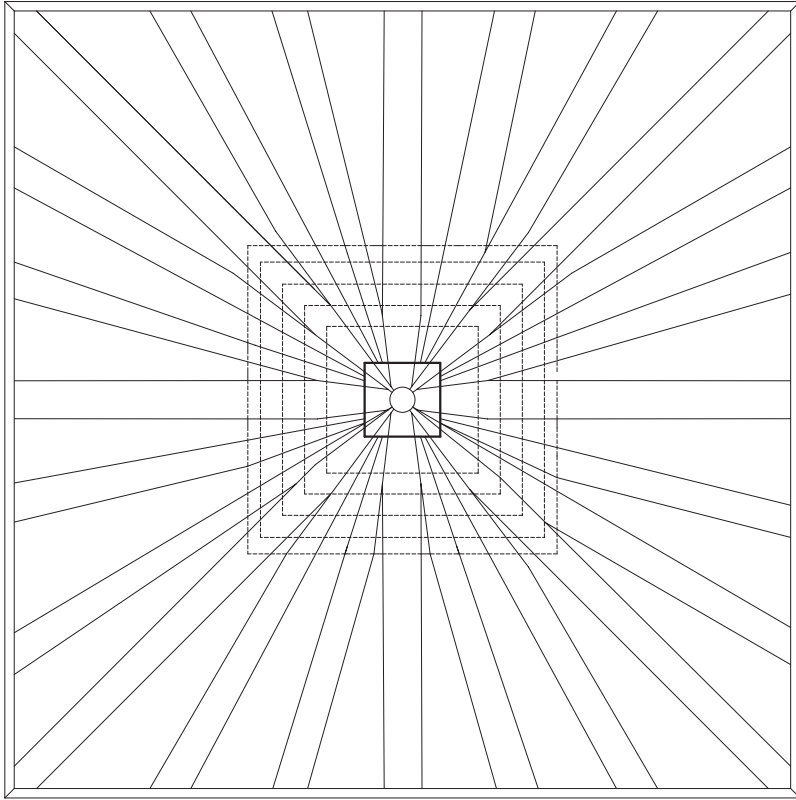
THIRD TIER | EXISTING RAFTER PLAN

The total number of rafters was increased from 24 to 32 to achieve a traditional configuration of closely spaced rafters for improved support. The drawing of the proposed rafter plan indicates the numbered sequence in which the central and corner rafters were installed. Central and corner rafters were made from Sal tree (*Shorea robusta*) wood, a locally available hardwood that is traditionally preferred for its strength and durability. Pine was used for the common rafters.

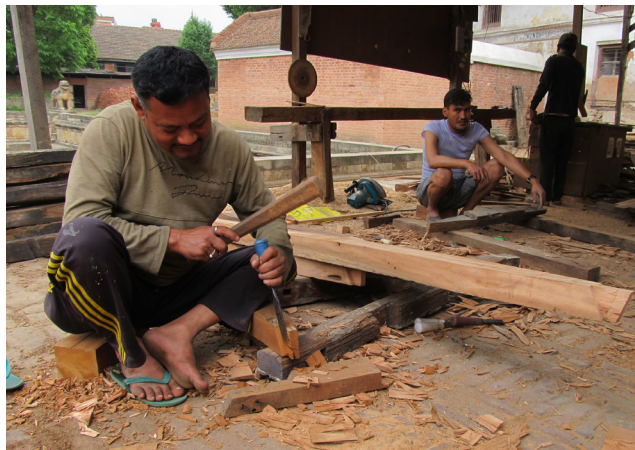
**Fabrication of new rafters** | April 28, 2014  
New rafters were fabricated by carpenters with reference to the new roof design using both sal wood and pine.

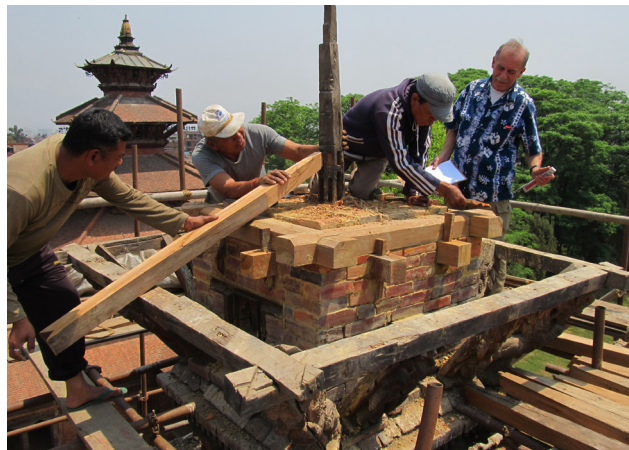
**Fixing of central rafters** | April 28, 2014  
The new rafters were joined to the existing central timber armature.

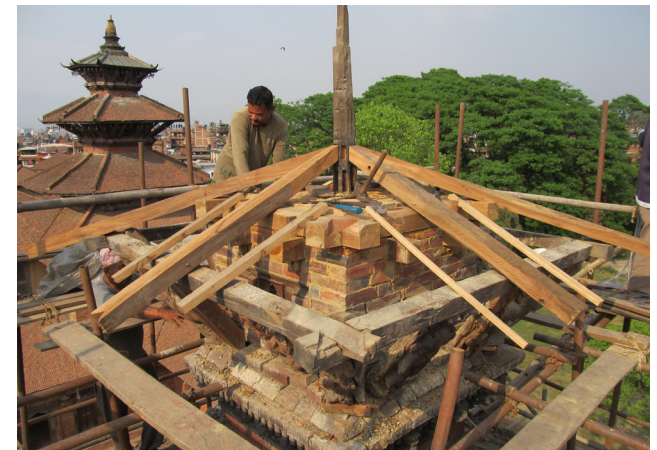
**Assembly of central and corner rafters** | April 28, 2014  
The central and corner rafters (sal wood) were placed in an alternating sequence before assembly of the common rafters (pine).

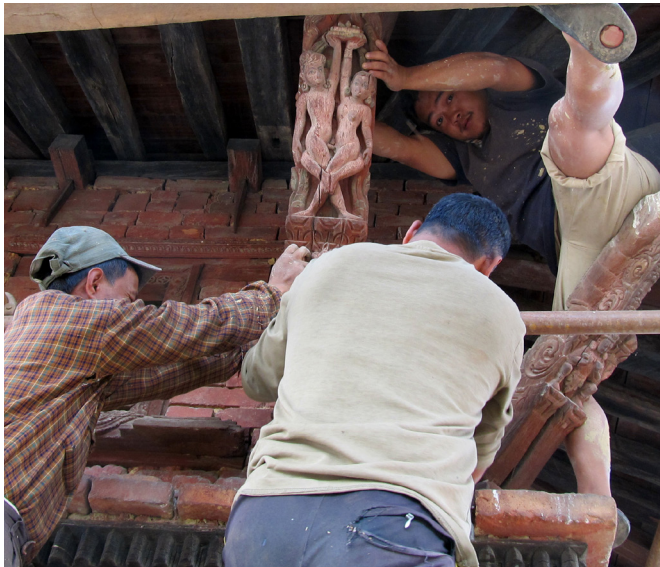
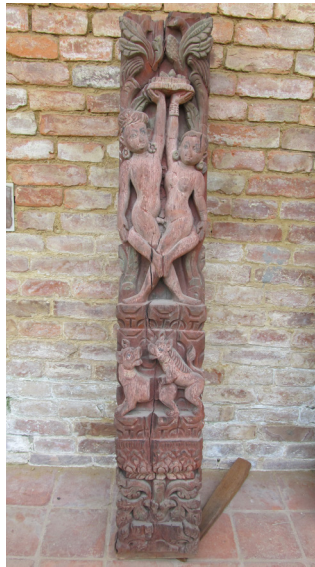
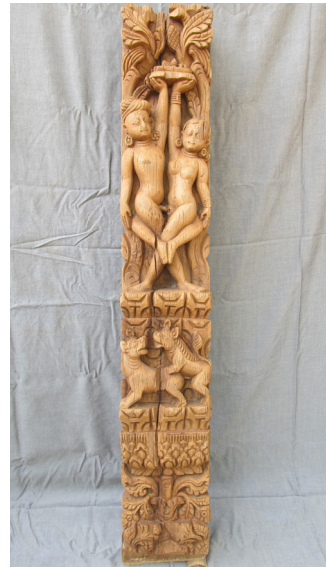
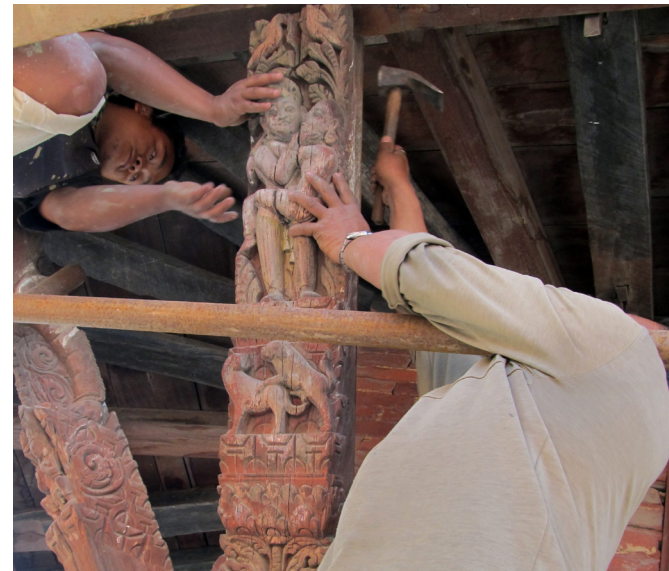
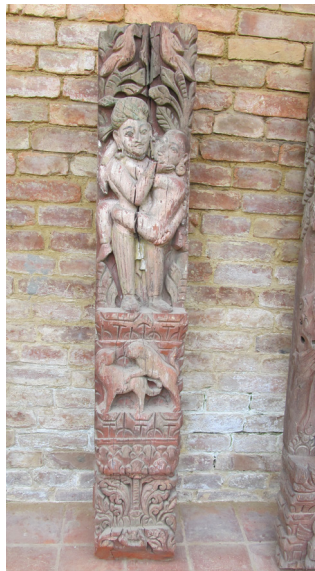
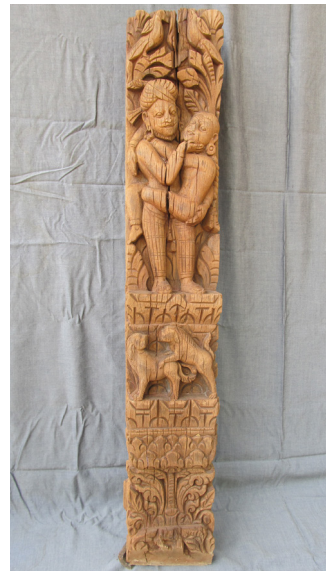
**Removal of struts from the second tier** | March 2014  
The carved struts on the second tier were carefully removed. As per the project proposal, no changes were made to the existing collection of struts except for cleaning and removal of paint.
