# THE RESTORATION OF THE PATAN DARBAR PALACE COMPLEX

A UNESCO WORLD HERITAGE SITE

PROGRESS REPORT | NOVEMBER 2012

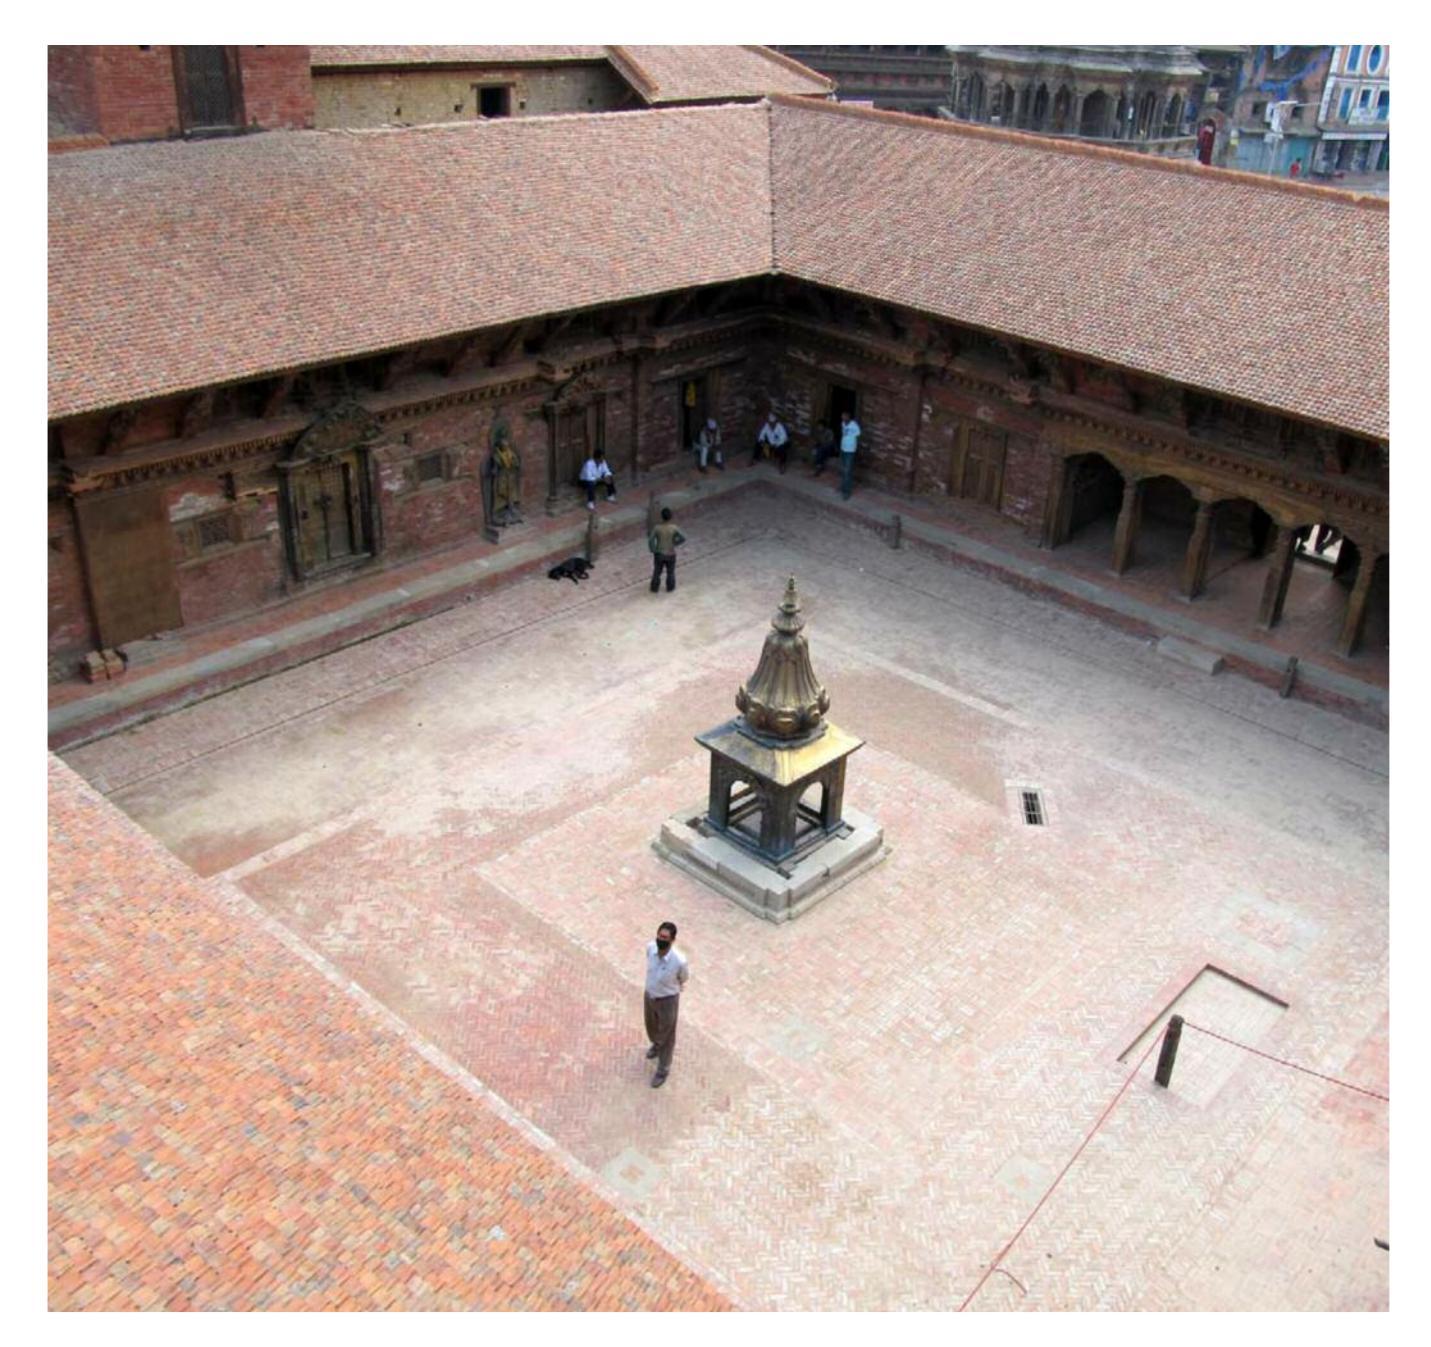
Mul Chowk courtyard | 2012 The Mul Chowk courtyard building after its restoration.The original courtyard paving has been exposed and repaired, and the roof structure has been rebuilt in the traditional style.

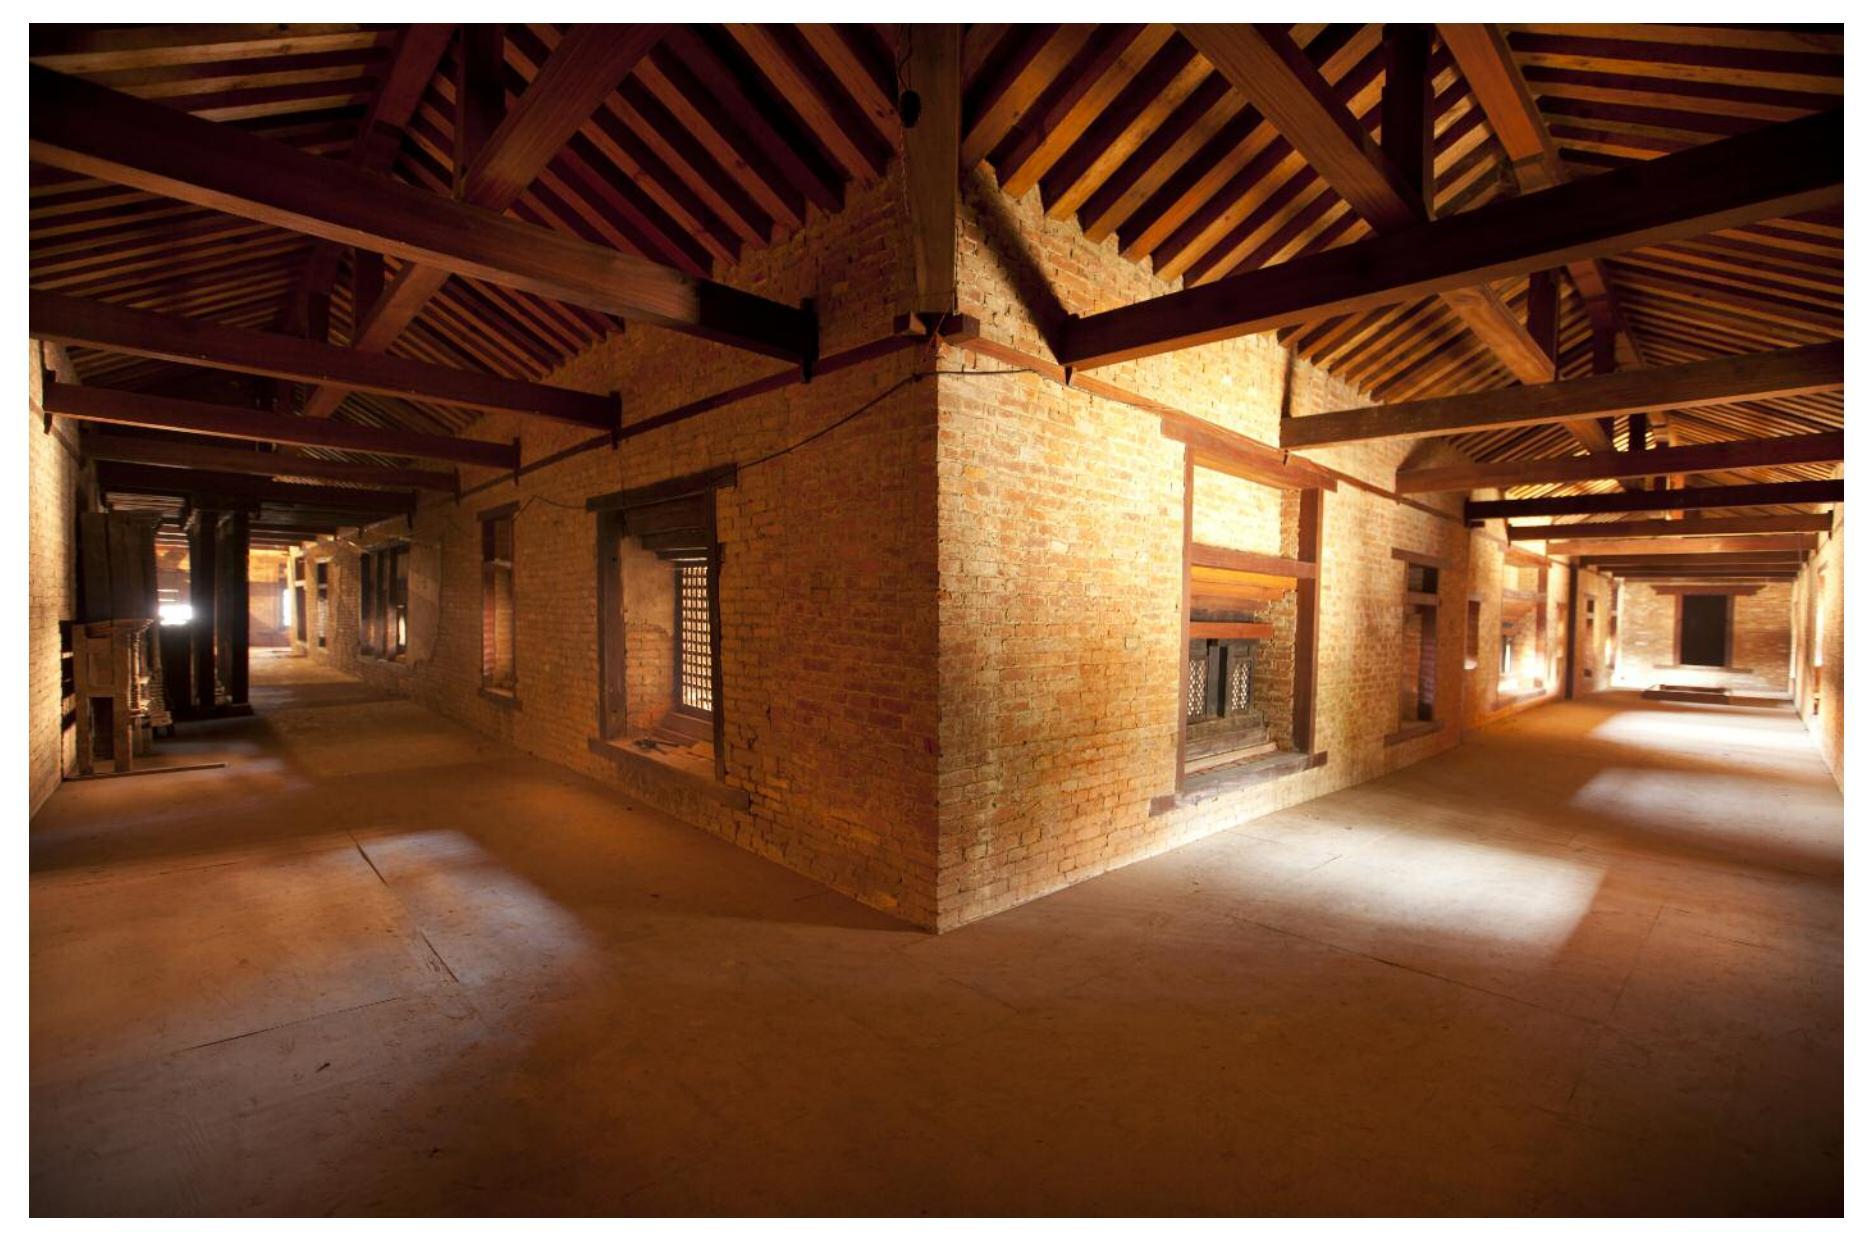
Mul Chowk interiors | December 2011 The interior of the building's south east corner after wall rebuilding and window repair. Here the floor awaits tiling.

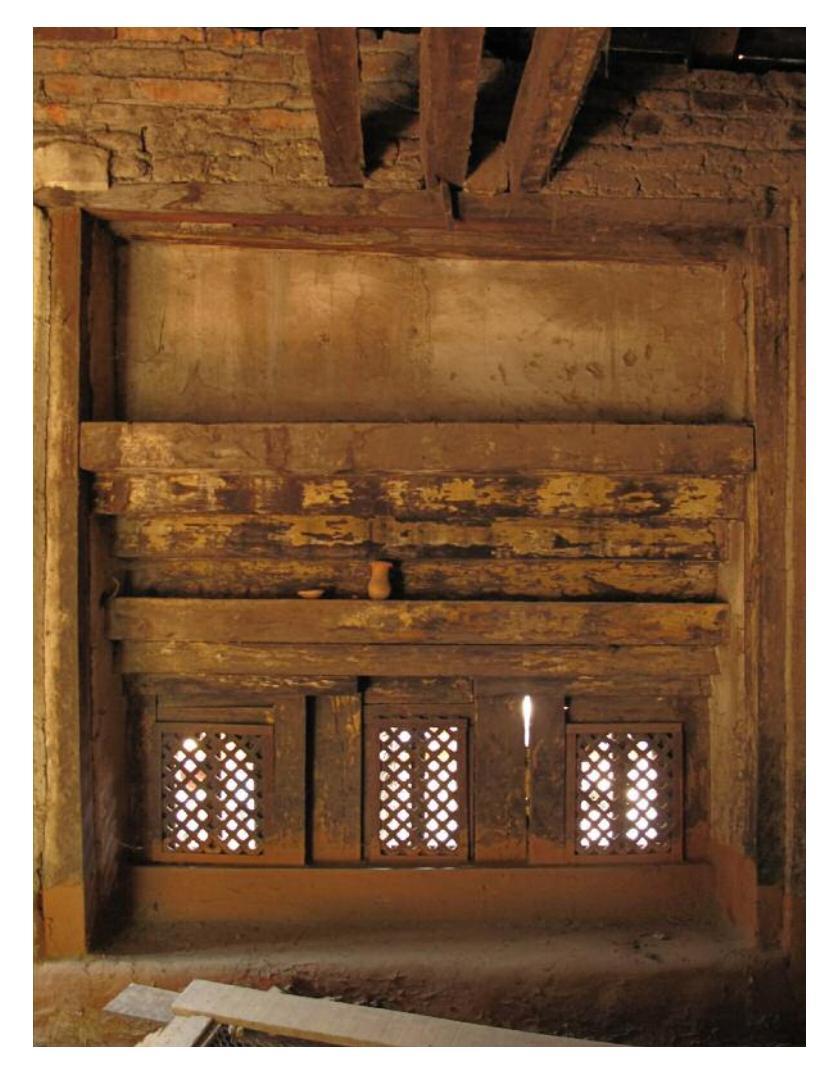
Mul Chowk window | April, 2010 A window in Mul Chowk's east wing prior to restoration.

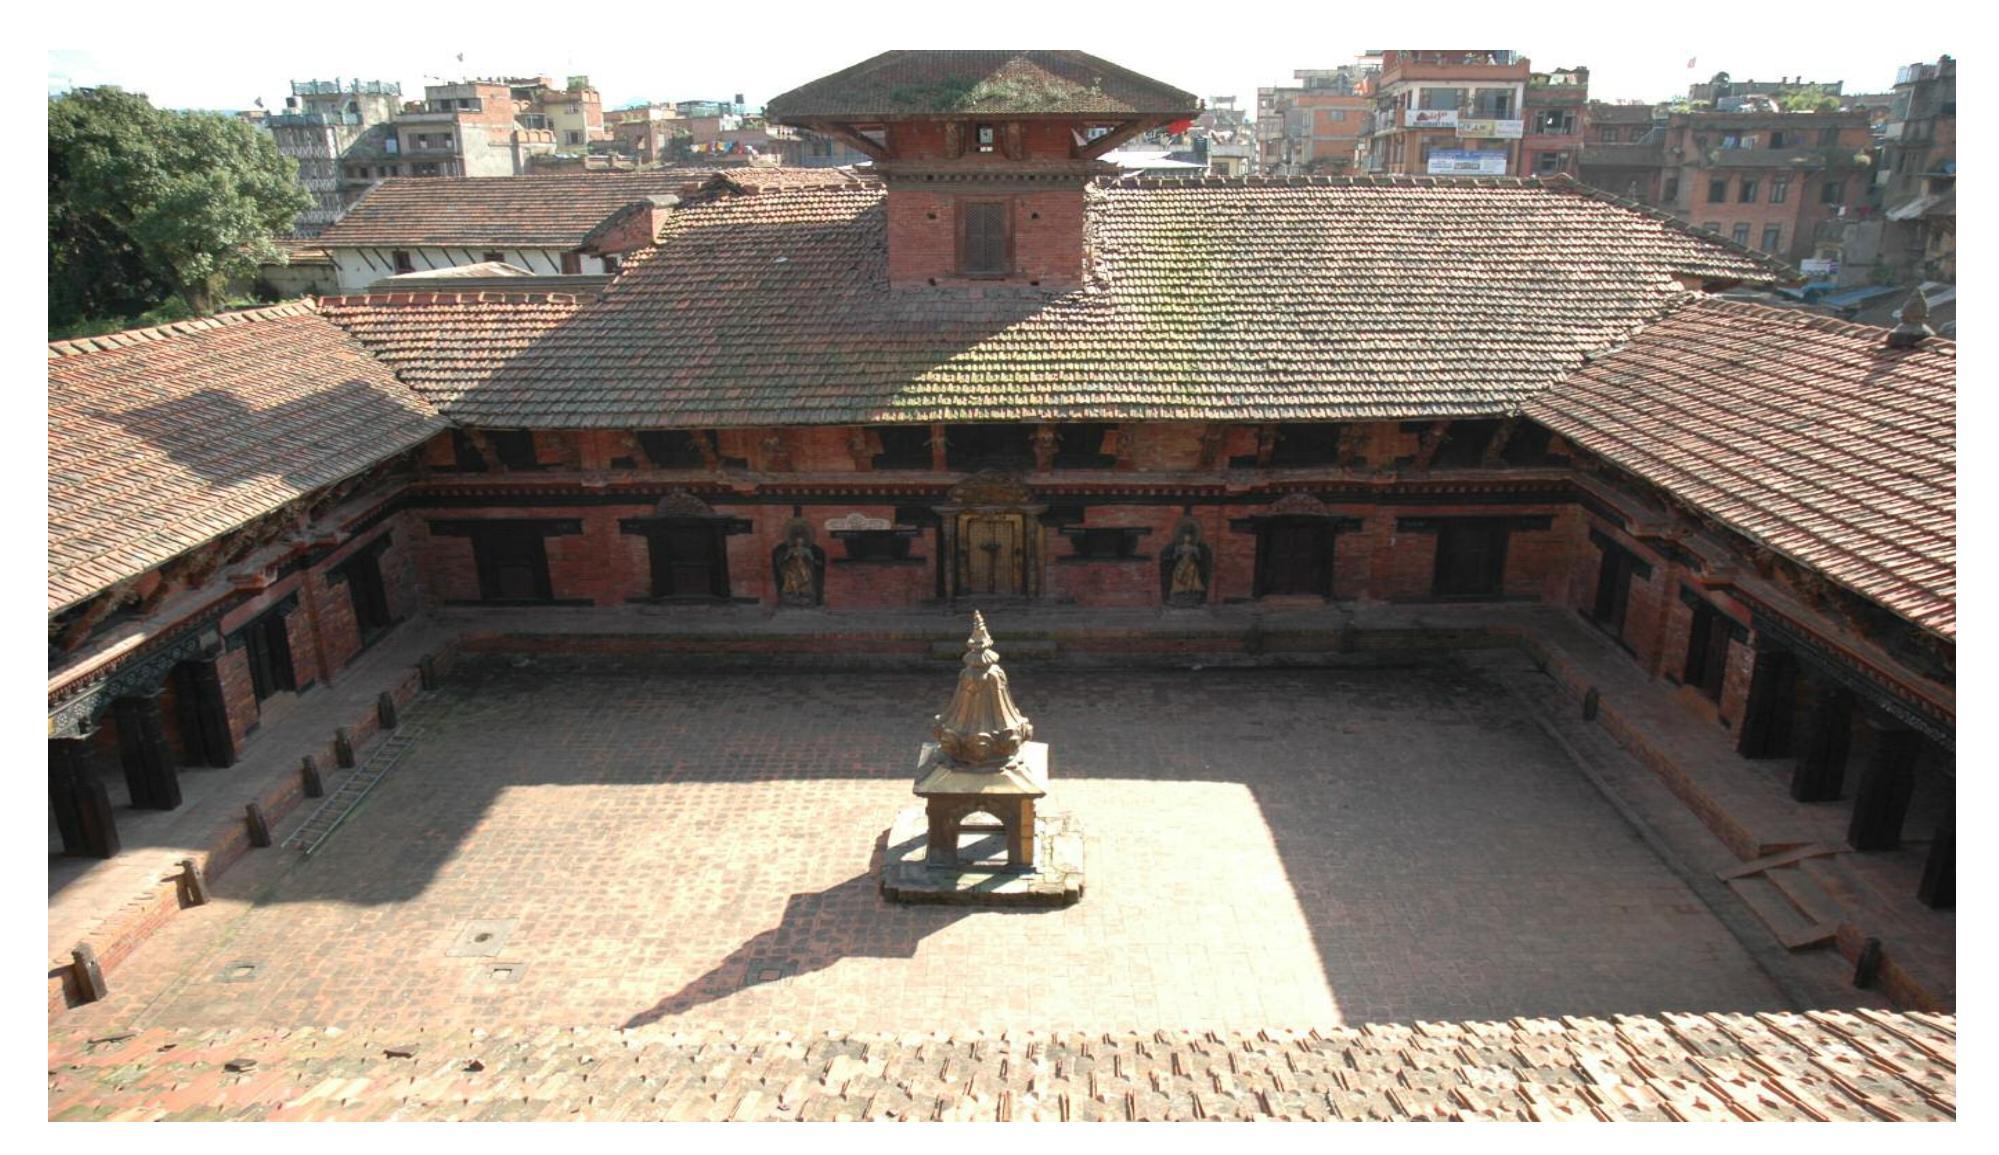
Mul Chowk roof structure | October 2007 Before restoration

**Mul Chowk roof structure** | December 2011 After restoration of the roof structure. In this photo the excavated historic courtyard can be seen. The project was able to re-use about 50% of the original brick, and the exact historic pattern was replicated when the brick was re-laid.

The existing historically inaccurate and poor-quality roof has been entirely replaced employing traditional building materials and techniques. The majority of structural roof timbers required replacement because they were damaged beyond repair by wet rot caused over many years of roof leakage. Planking and rigid plyboard were installed over newly replaced structural timbers above which a waterproofing membrane was installed to prevent from future water penetration, which was responsible for much of the building's damage. The roof was then tiled with traditional terracotta *jhingati* tiles, laid in a mud bed.

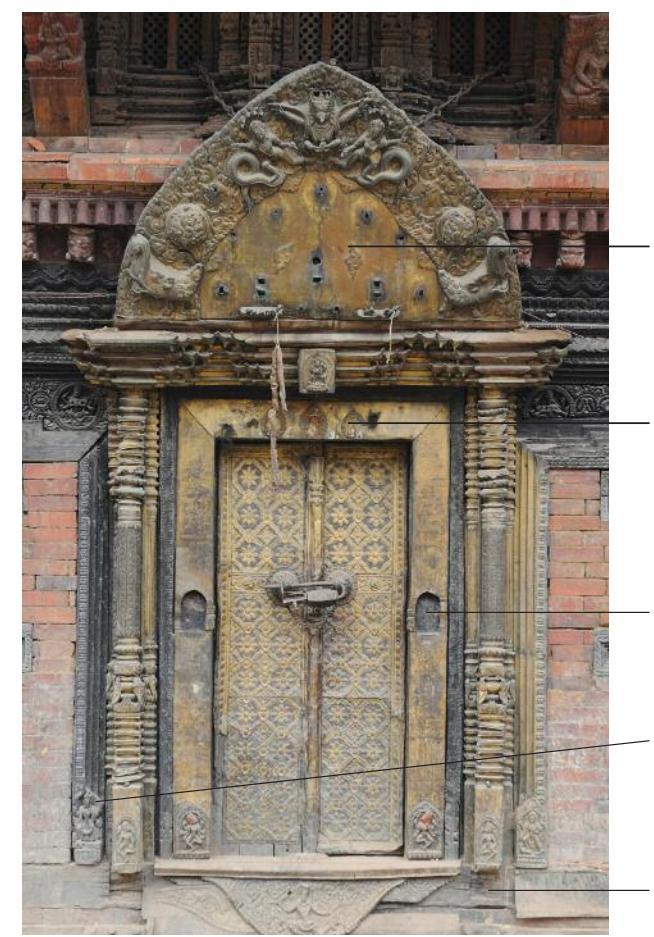
**The Golden Doorway** | Sep 19, 2011 This image illustrates how many details, particularly the small statues of the tympanum, are now missing.

#### **Missing small sculptures from the tympanum** All sculptural deities were stolen sometime after the late 1960s, as documented by Dr. Slusser's photographs.

#### Missing deities from top door frame

The three deities originally placed on the top of the door frame, and depicted in the historic photograph on the left, are now missing.

- Guardian god missing repoussé covering This guardian god on the far left outer door molding is missing its copper repoussé covering, which all four other guardian gods still retain.
- Missing pillar base | Sep, 2011 The obvious gap between the abrupt end of the pillar and the ground level indicates that the original base of the pillar is now missing. The base was likely a lion, as lions are typically used throughout the valley.

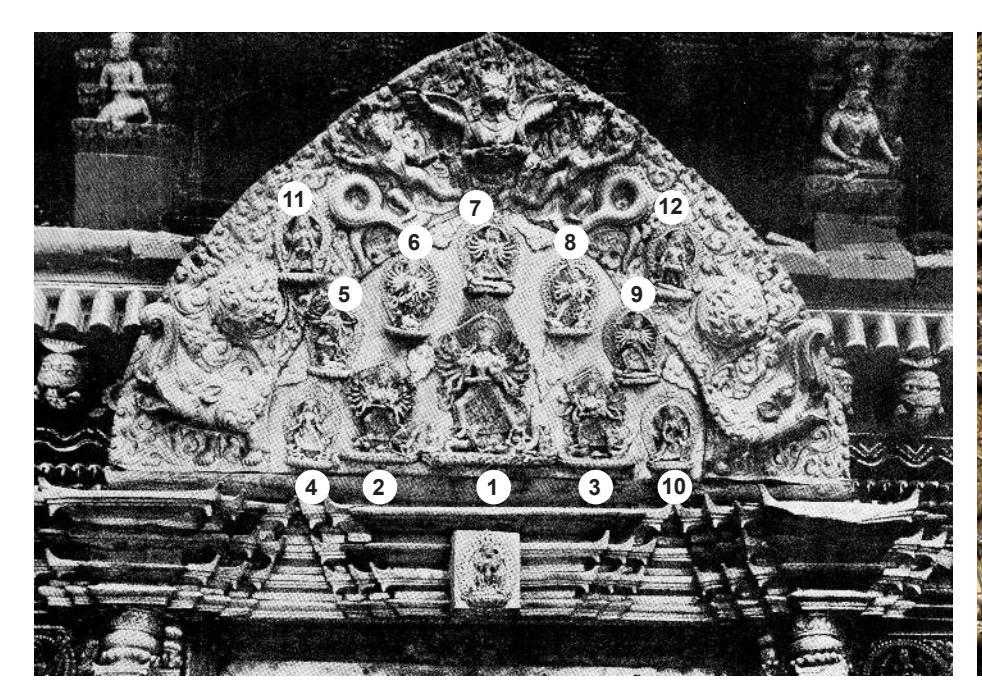
Intact tympanum | approx. 1966 – 1972 This historic photograph taken by N.R. Banerjee shows that the tympanum was still be intact in the 1960s. Here all of the sculptural elements affixed to the inner tympanum, as well as the two small deities affixed to the outer tympanum, can be seen.

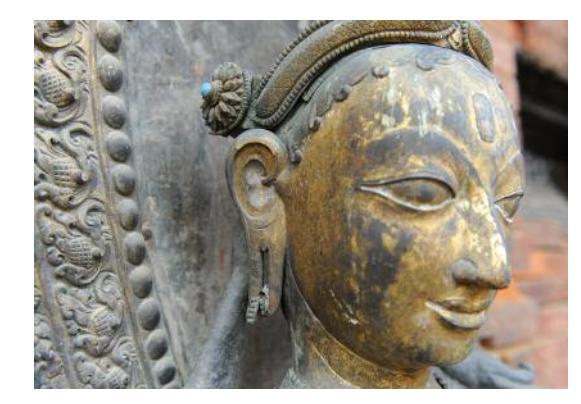
#### Yamuna's crown & jewelry | Sep 2, 2011

Yamuna's crown is pictured here, still intact, unlike Ganga's below. The turquoise stone is the only remaining crown ornament on the two statues and will serve as an example for replicating the missing three. A remnant of Yamuna's earring is also present here, and remains nowhere else.

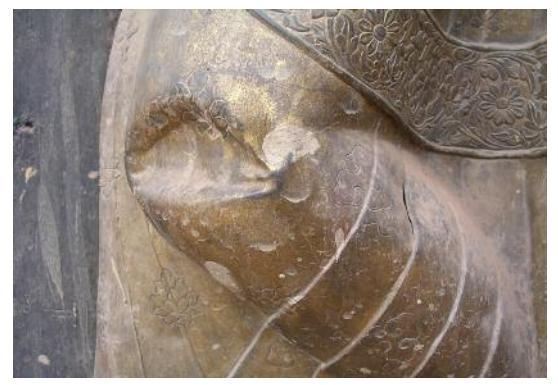
#### Detail of Yamuna's right leg | Sep 2, 2011

The severe dent pictured above cannot be repaired in-situ and mandates removal of the statue, and gently hammering the dent out from behind. A crack in Yamuna's calf, measuring four centimeters, is also seen here.

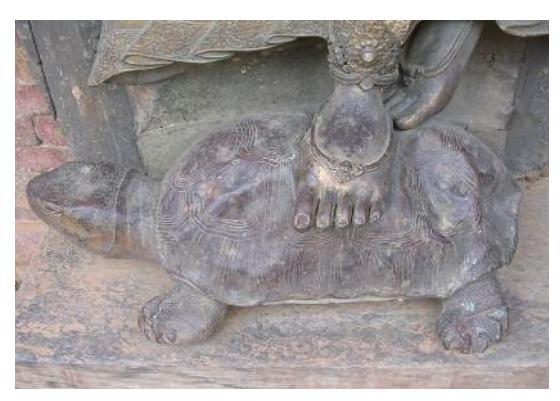
Yamuna's turtle | Sep 2, 2011 The badly deformed turtle will also require disassembly and re-shaping of the copper body. Renewed gilding will be considered for the body of the turtle.

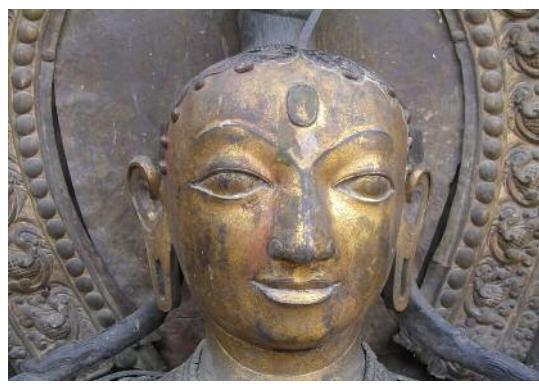
Ganga's missing crown & jewelry | Sep 2, 2011 Ganga will be restored with the same crown as Yamuna, as well as with the same jewelry, including earrings in both ears and the crown ornaments.

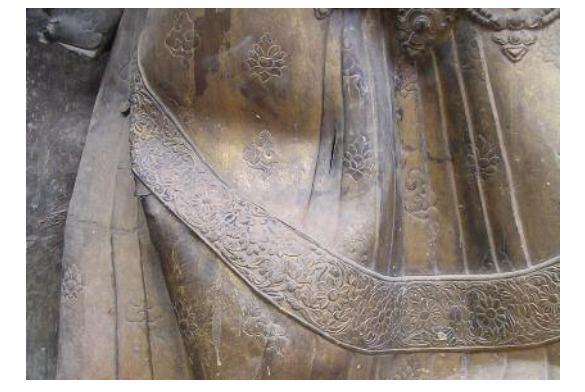
**Detail of Ganga's right leg** | Sep 2, 2011 Ganga's extensively damaged thigh is pictured above. Rectifying the severe damage, including a significant crack, will also require resurfacing and re-gilding of the affected areas.

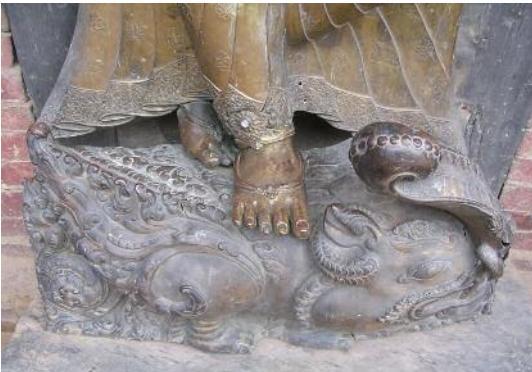
Ganga's makara | Sep 2, 2011

The trunk of the makara has been completely bent backwards. Once held up at an angle, the trunk now lies flat against the makara's body. There are also damages to the body of the makara, requiring disassembly and hammering our of deformities. Renewed gilding will also be considered for the body of the makara

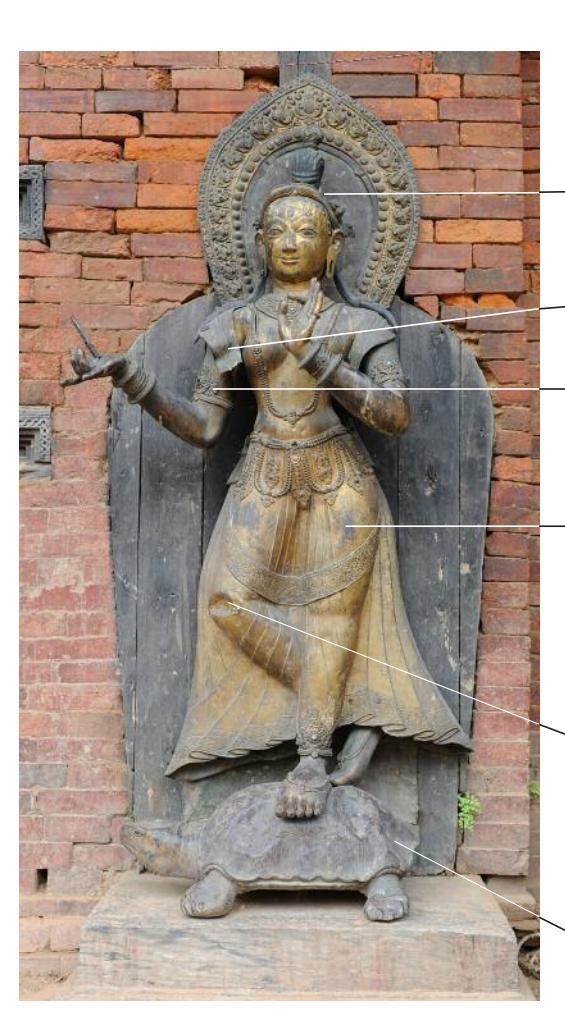
Yamuna atop of her turtle | Sep, 2011 The large dent in Yamuna's bent right leg, and her damaged shawl and crown can be easily seen here. The overall loss of gilding is also very apparent.

Damaged crown

Yamuna's crown is missing it's central component, of which there is a remnant.

Damaged shawl Pieces of Yamuna's shawl are missing.

**Missing stone** The turquoise stone on Yamuna's left arm band, is missing on her right.

Worn gilding The gilding has been entirely worn off on these rather large patches on both of Yamuna's thighs. This is a result of centuries of religious worshippers devotionally touching Yamuna in these areas.

Dents in Yamuna's right leg Yamuna's bent right leg has a severe dent, which cannot be repaired in-situ, but must be hammered out from behind after the statue is removed

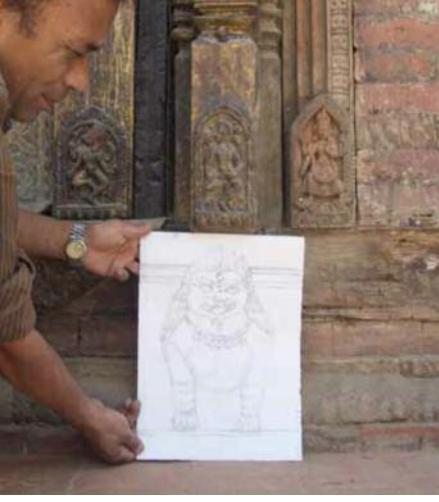
Column base depicting a lion This original lion column base is located on another doorway in Mul Chowk and provides an example of what the missing bases likely looked like. Apr 22, 2012

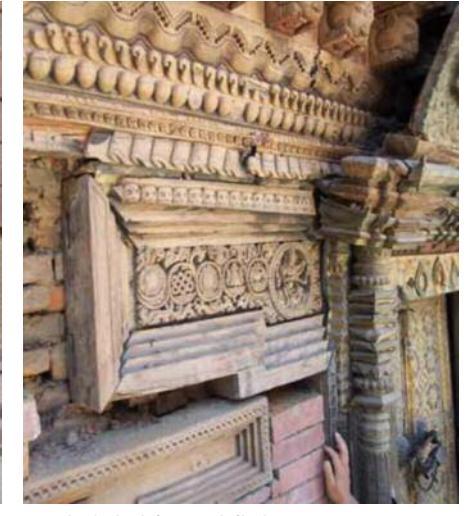
Exposed timber lintel after removal of bricks The masonry surrounding the lintel must be re-built and repaired. Here, the adjacent bricks have been removed, exposing the edges and existing conditions of the lintel edges. Apr 22, 2012

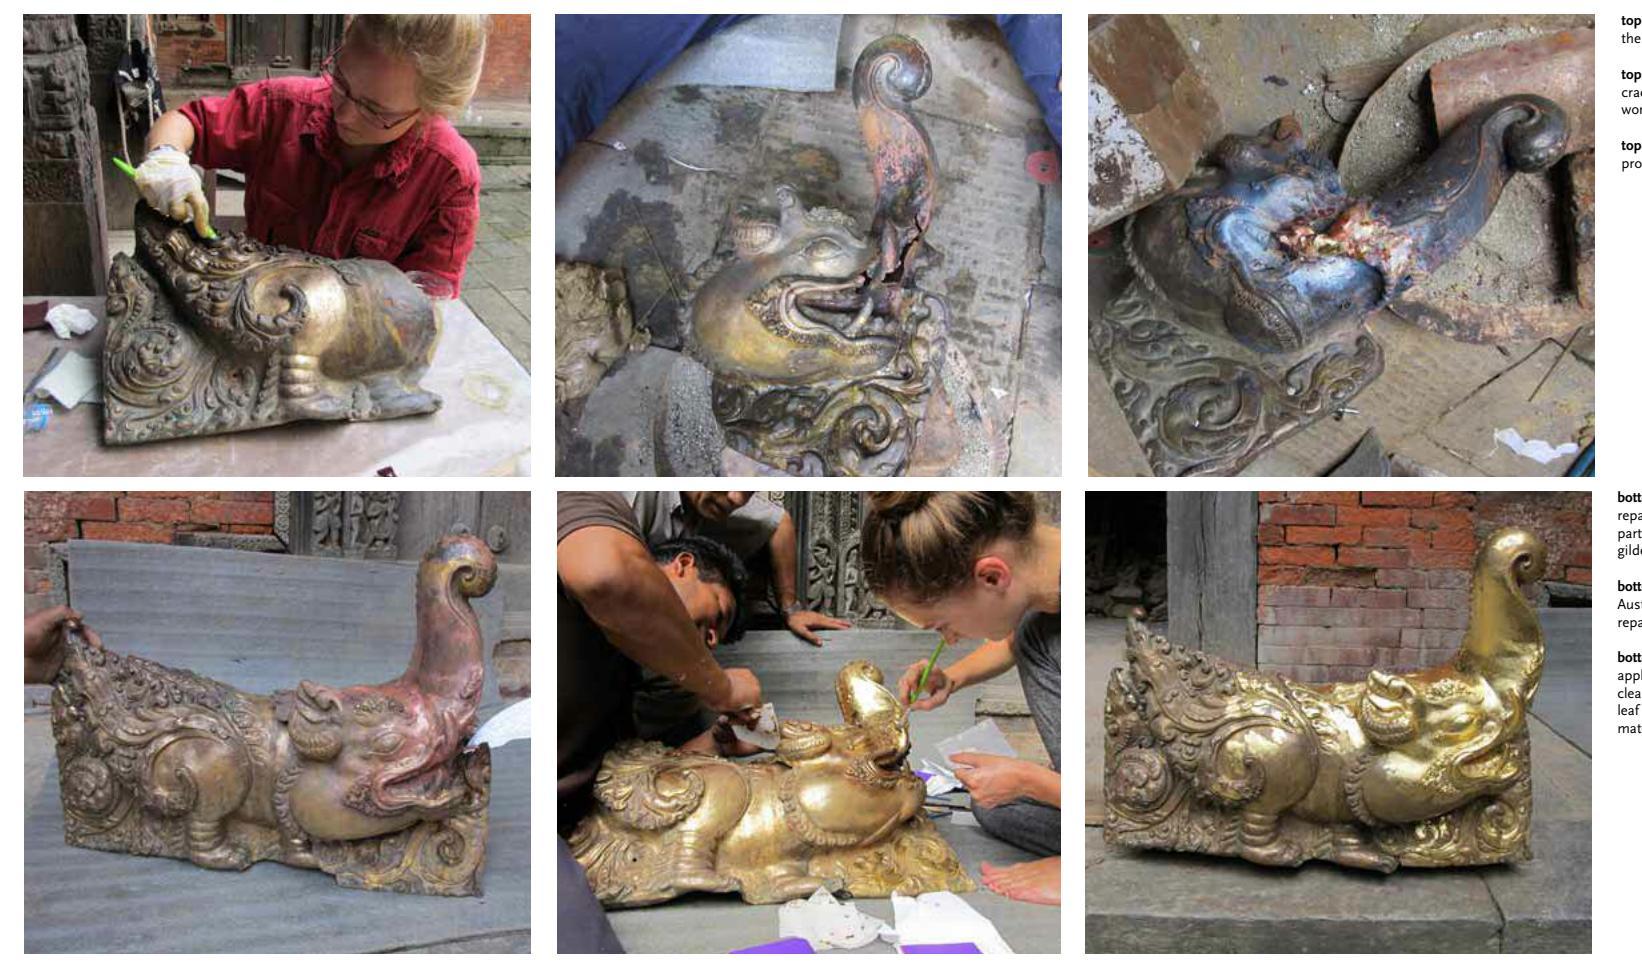
**top, left:** An Austrian student extensively cleaning the lower half of the *makara* using a toothbrush.

top, center: Detail of the *makara's* severely cracked and contorted tunk, prior to any repairwork.

top, right: The *makara's* trunk during the repair process.

**bottom, left:** The *makara* after its trunk has been repaired. Note the discoloration of the repaired part - this is because the trunk has not yet been gilded via the application of gold leaf.

**bottom, center:** KVPT repousse artist and an Austrian student applying gold leaf to the newly repaired trunk.

**bottom, right:** The *makara* after gold leaf has been applied and the lower half has been extensively cleaned. The new, and therefore more vibrant, gold leaf will be antiqued slightly to more seamlessly match the patina of the lower half.

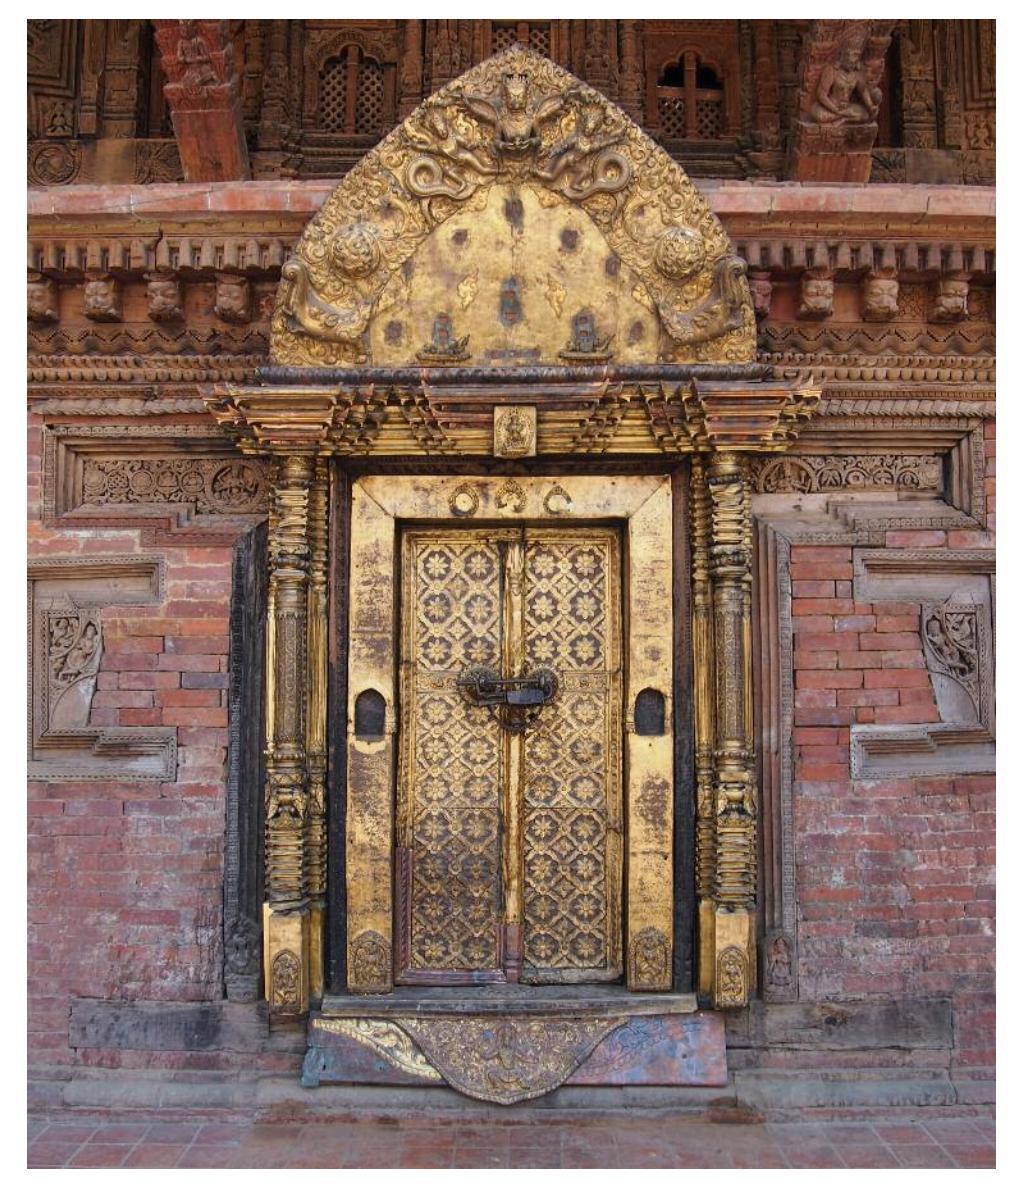
**Golden Doorway during restoration** | November 2012 The doorway after it has been extensively cleaned, partially re-gilded, and replica repousse pieces have been affixed.

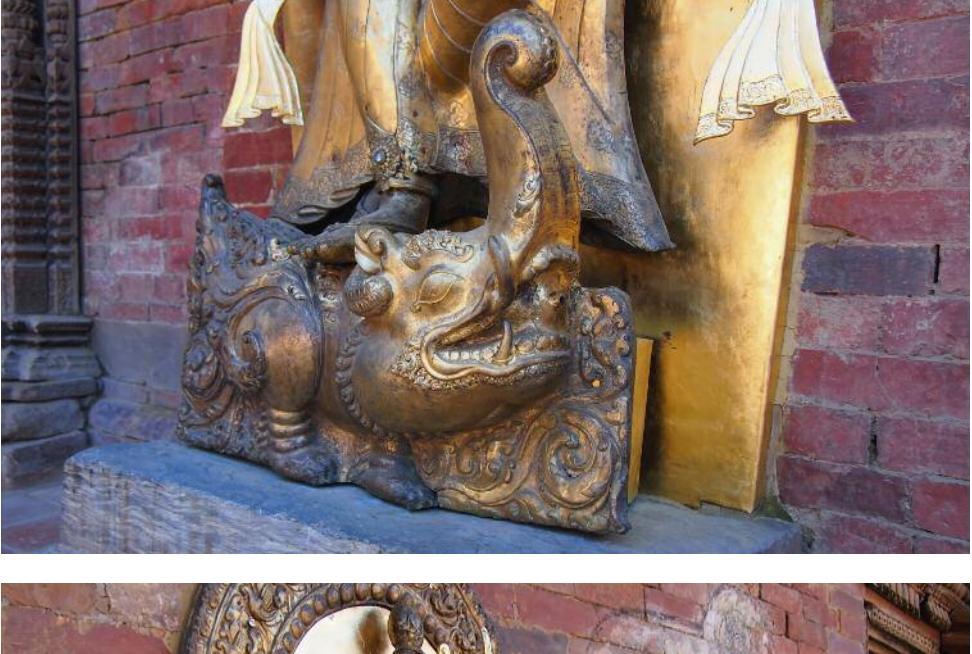
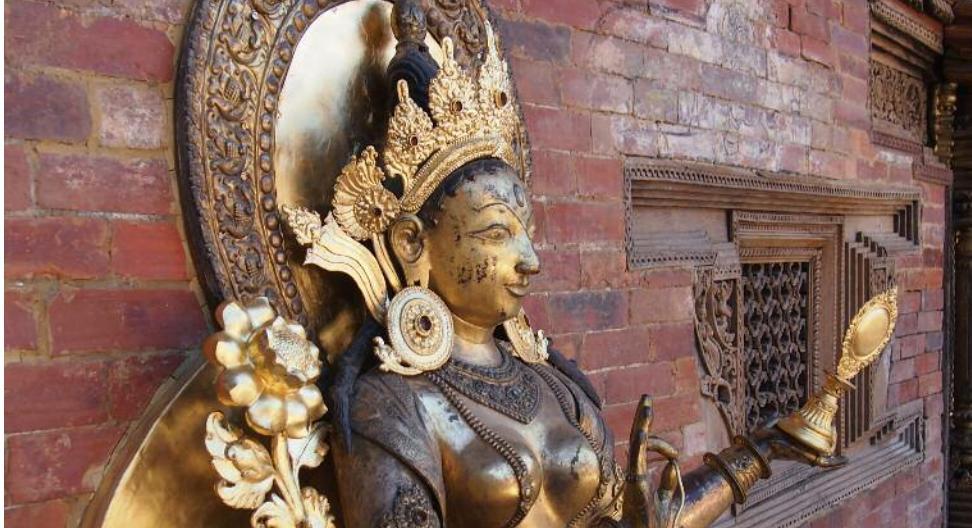
*top:* **Makara** | November 2012 The makara after the repair of its severe cracking and partial re-gilding

*above:* **Ganga** | November 2012 The Ganga status after extensive cleaning, partial re-gilding, and the replacement of her missing attributes.

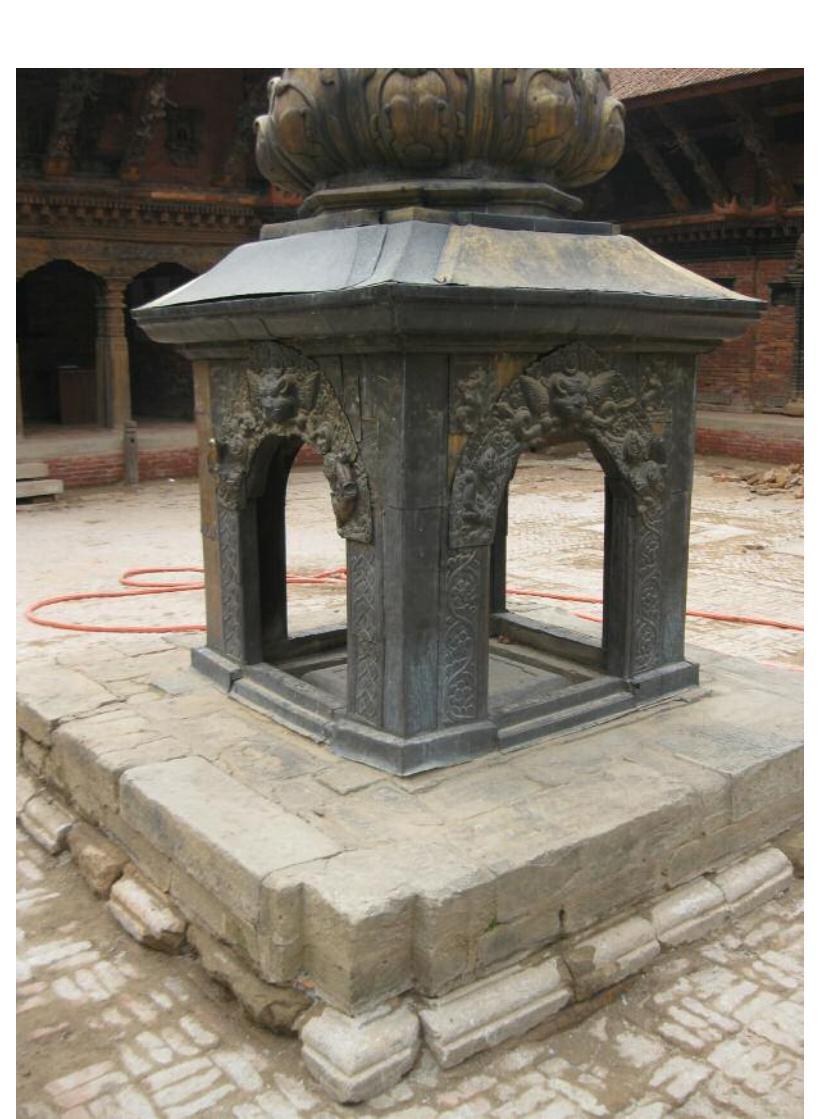
#### **Plinth prior to pavement removal** | Sep. 2011 The original quarter-round base stone is covered here by the tile pavement, which was laid in the courtyard in 1975. The tile pavement was recently removed to expose the original flooring, but because hard cement mortar was used to lay the tile, the original stone work of the shrine's plinth has been damaged.

After removing the 1975 tile pavement, the original brick flooring and quarterround base stone of the shrine were revealed. However, approximately 60% of stones are damaged due to the use of hard cement mortar, and are in need of replacement. In some places, the stone work has been poorly repaired with brick fill-ins, which need to be removed and replaced with stone.

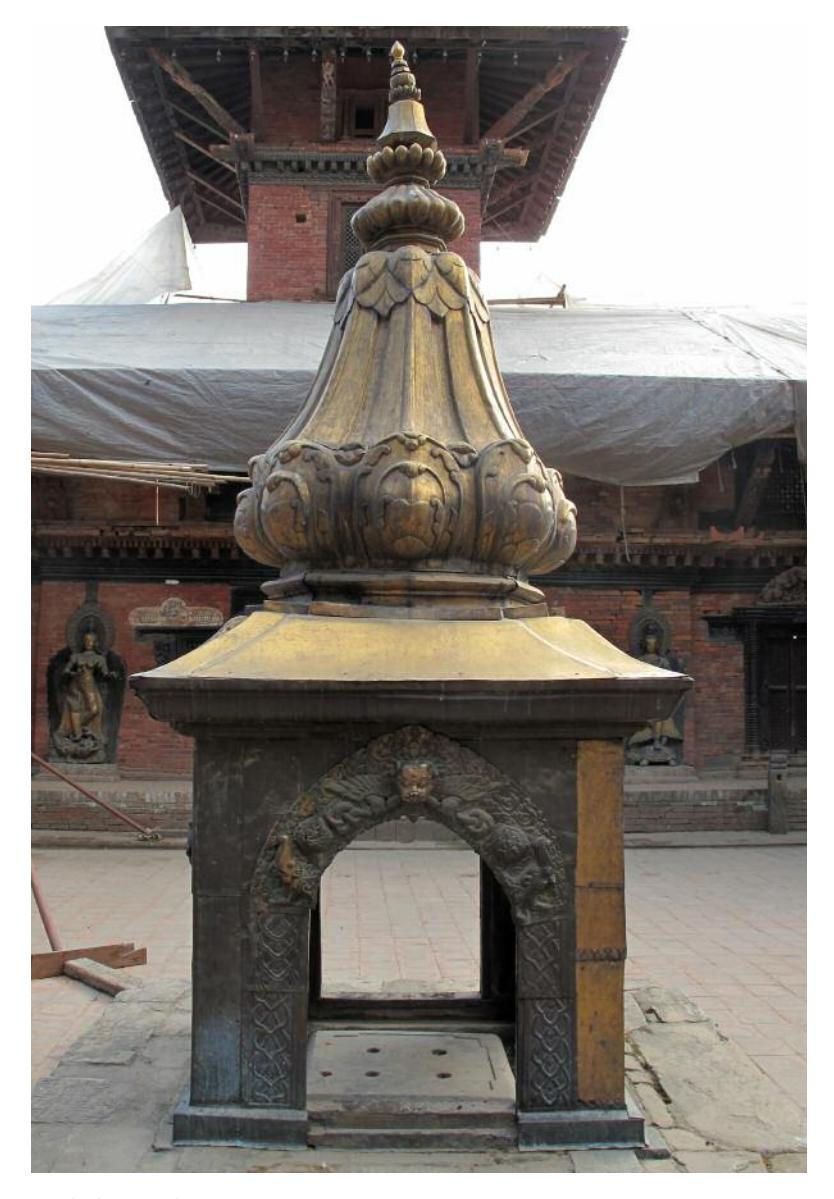
#### **North elevation** | Nov 2011 This is the only side retaining the original repoussé arch in its entirety. The gilded corner sheeting on the right is original. All other sheeting and decorative repoussé are later additions of inferior quality.

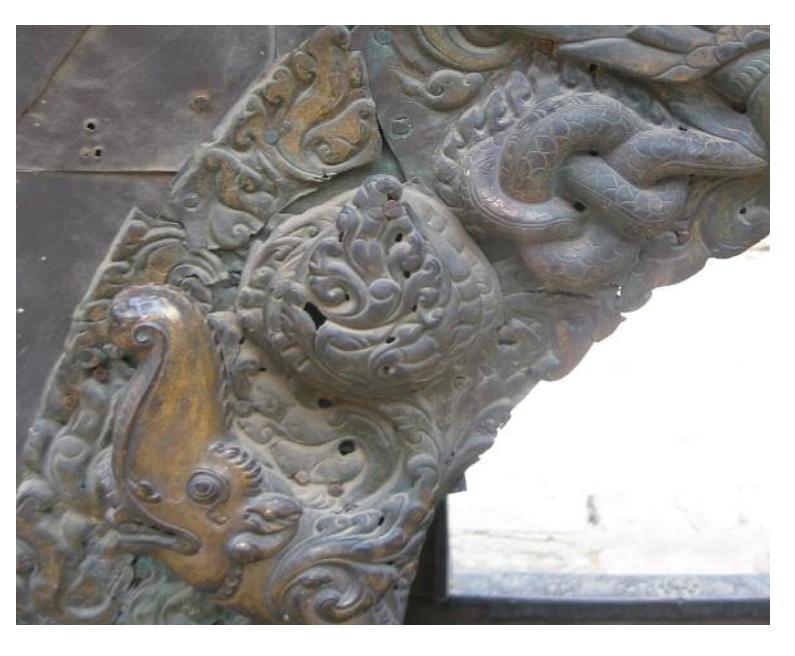
#### Detail of original chepa

head | Nov 2011 The north-facing elevation of the shrine is the only side which still retains the original arch. The repoussé work on the *chepa* head is outstanding, and the newer replacement arches on the other three sides of the shrine do not compare in craftsmanship to the original.

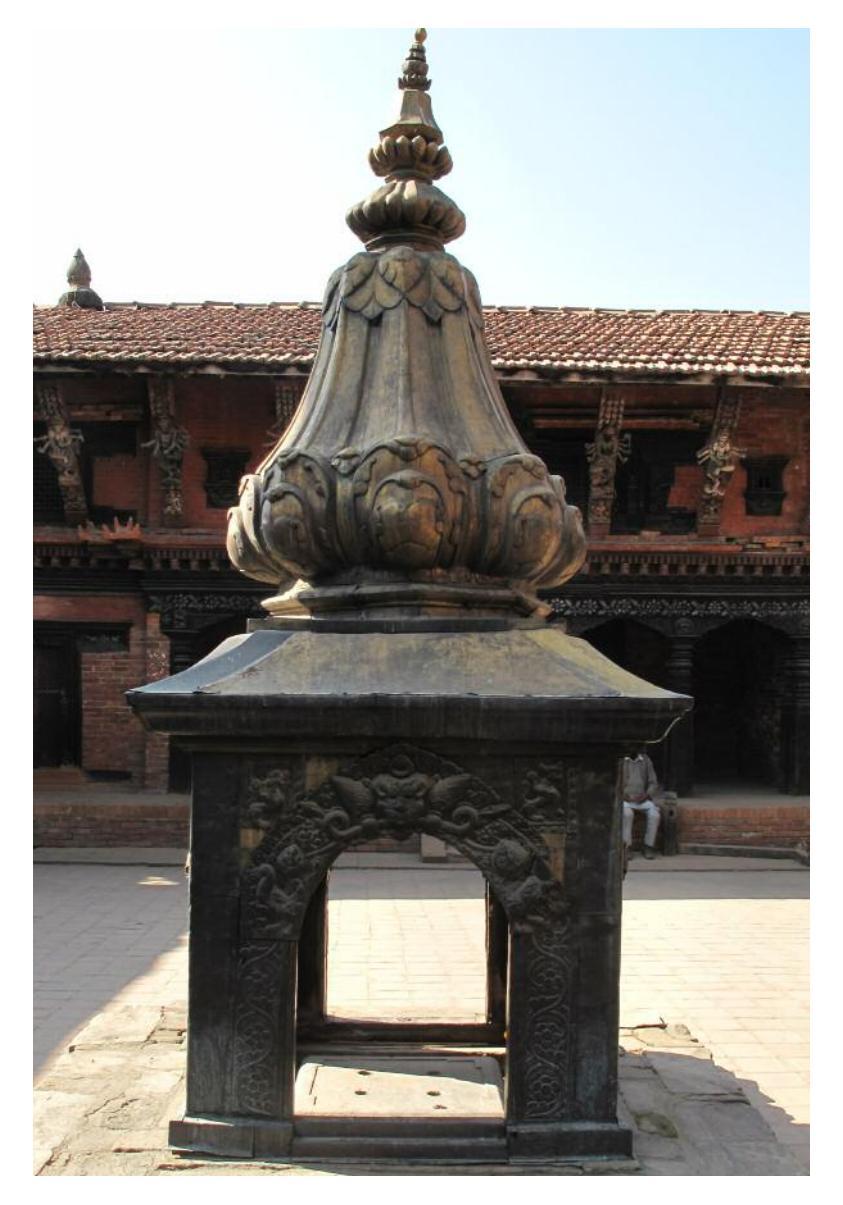
East elevation | Nov 2011 The east-facing elevation of the shrine is almost entirely new and in need of replacement. Only three small gilded pieces of original sheeting remain.

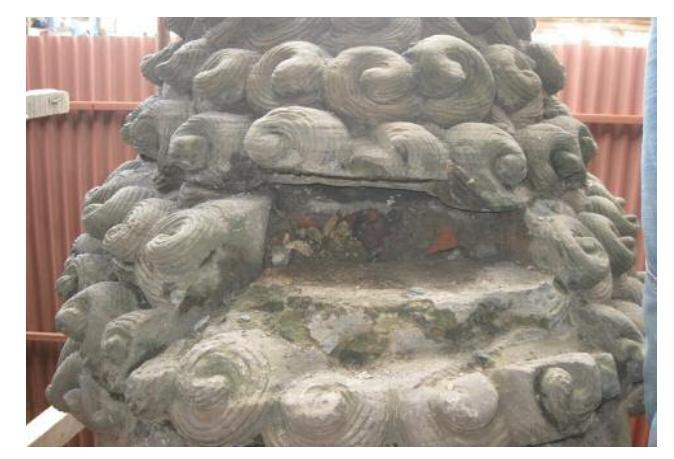
The stone lion's brick core | Sep 14, 2011 After removing this piece of the lion's mane, the inner brick core was exposed. It was decided to remove this brick filling, as it was unhistorical, and caused water retention inside the statue, leading to extensive damage.

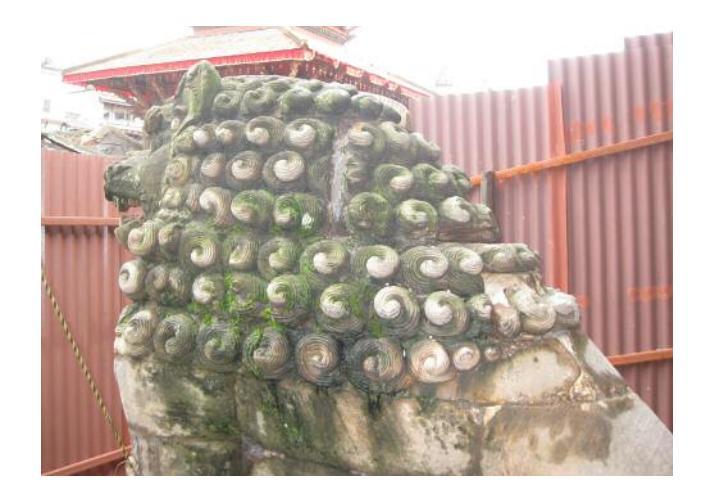
**Female lioness' mane before restoration** | Aug. 2011 The growth is at its thickest surrounding the lioness' mane and brick, where the brick fill-in was placed.

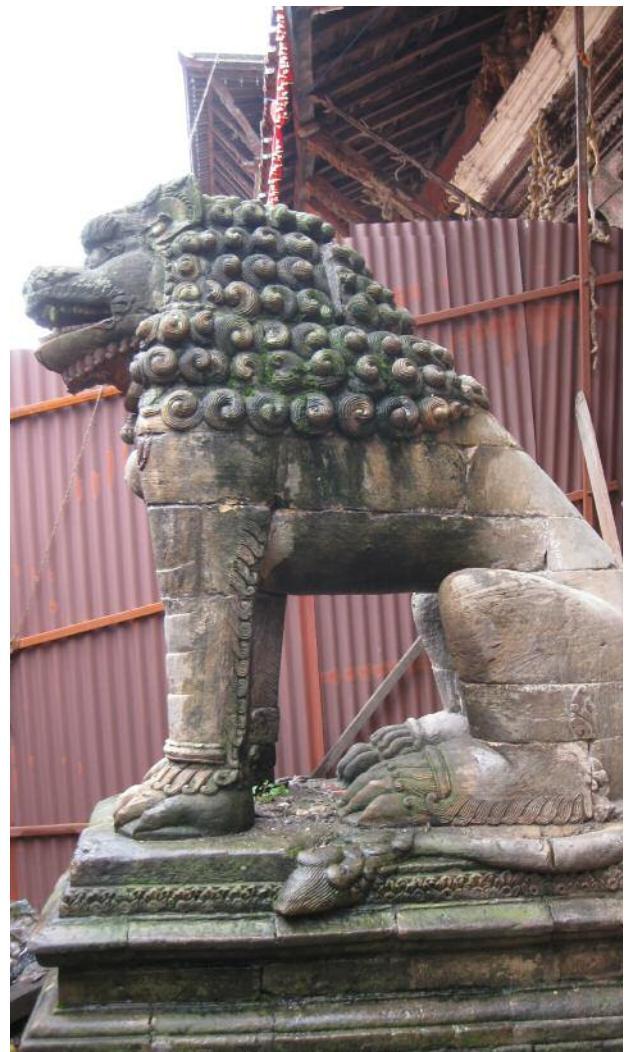
**Female lioness before complete restoration** | Aug. 2011 The female lioness statue prior to restoration was covered in dark green biological growth. The pointing between joints was also improperly and hastily done with cement, allowing water to seep into the statue. This combined with the statue's porous brick core, promoted this abundant and damaging biological growth.

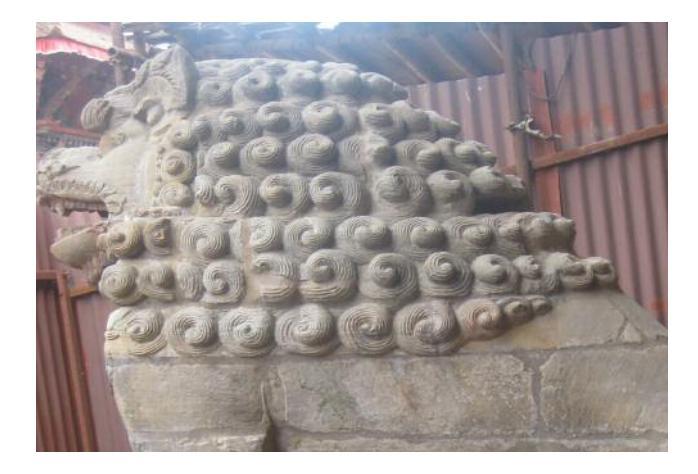
**Female lioness' mane after restoration** | Nov. 2011 The lioness' mane has been thoroughly cleaned, and after re-assembly fits together more seamlessly than it does in the corresponding photo at left.

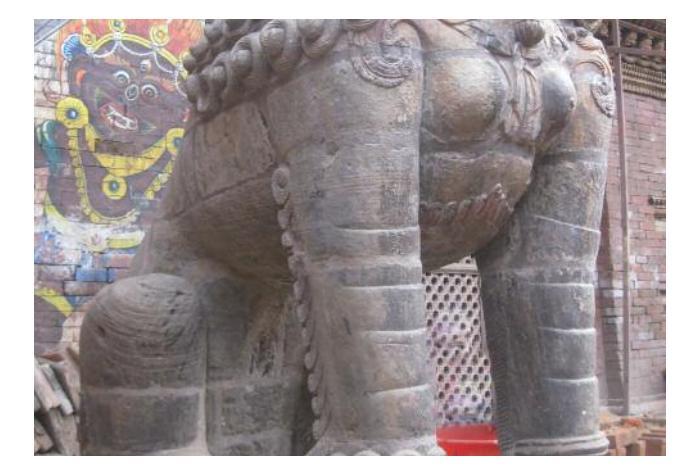
**Detail of lioness after restoration** | Oct. 2011 The details on the female lioness' chest are more easily observed after the growth has been removed. Here, he beautiful natural color of the stone is exposed.
