# THE RESTORATION OF THE PATAN DARBAR PALACE COMPLEX

A UNESCO WORLD HERITAGE SITE

PROGRESS REPORT | NOVEMBER 2012

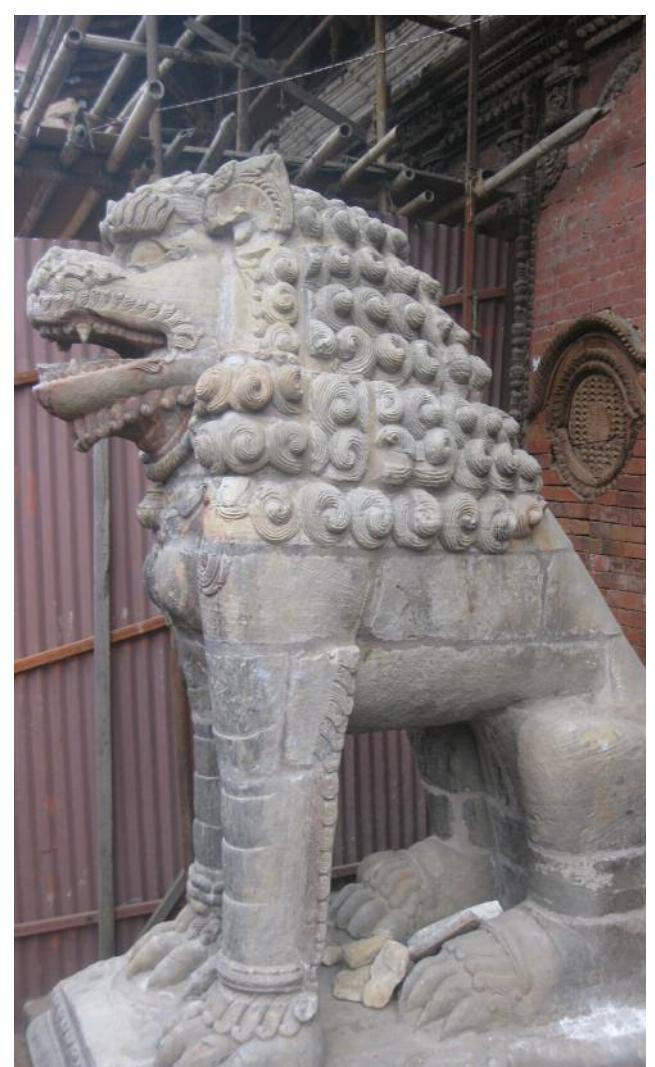
**Female lioness after complete restoration** | Oct. 2011 The stone lioness is restored to her former glory after being thoroughly cleaned and re-assembled. The stone components fit together smoothly, and the pointing is properly done, thoroughly sealing the joints.

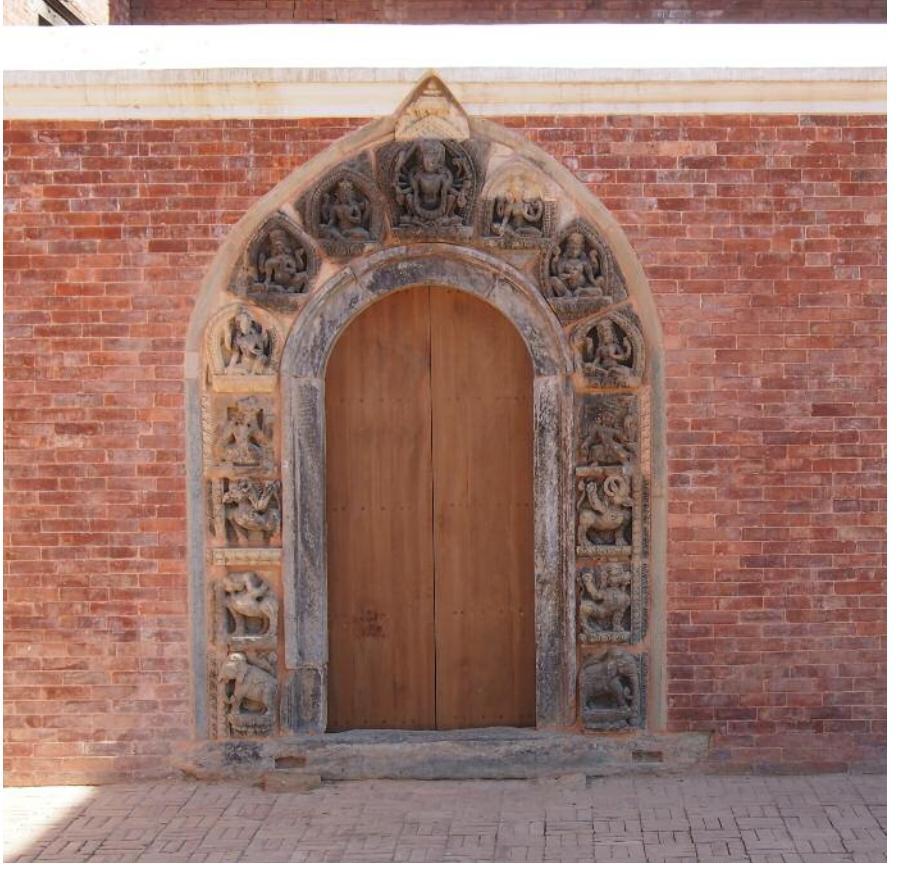
Northern Stone Gate | Nov 2012 The Northern stone gate after its restoration. The gate has been extensively cleaned, repaired, and reassembled.

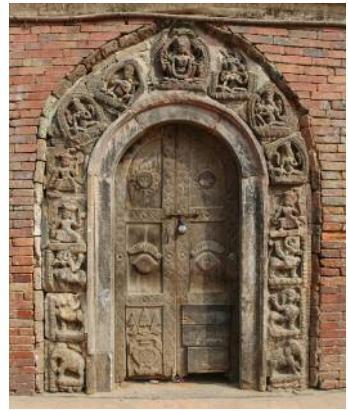
**Southern Stone Gate** | Nov 2012 The Southern stone gate after its restoration. The preexisting poorly made and inauthentic doors have been replaced with simple timber door blades.

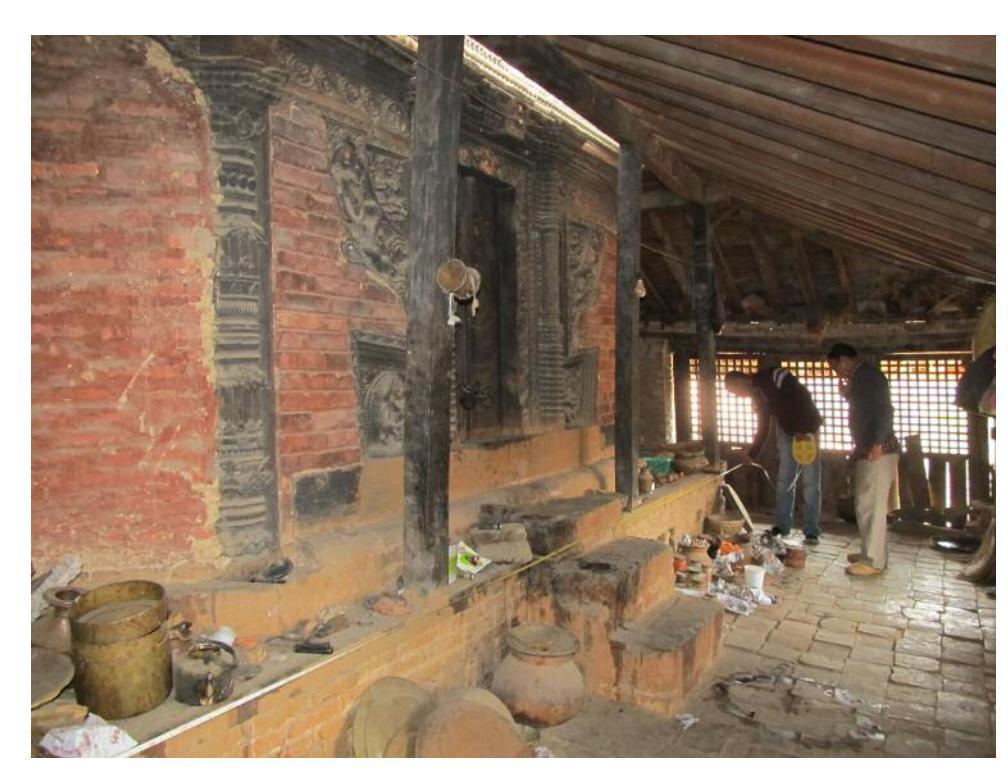
**South side of the sanctum before restoration** | April 2012 Note the sagging of the rafters and the make-shift columns and beam supporting the roof, part of an inadequate recent intervention.

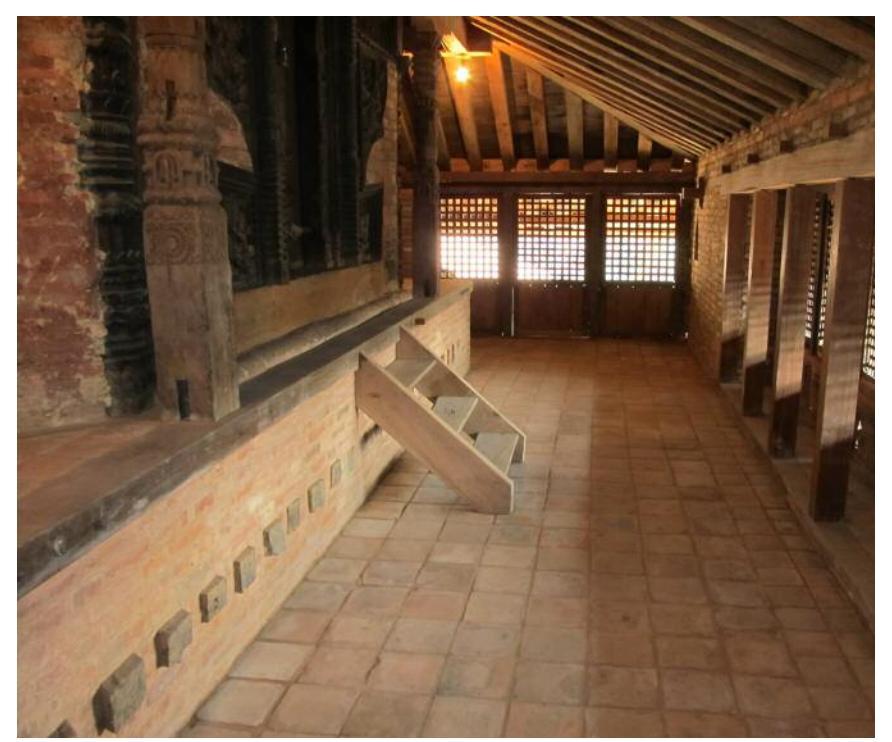
**South side of the sanctum after restoration** | October 2012 The uncarved columns (seen in the photo at left) were replaced with historic carved columns provided by the Nepal Government's Department of Archaeology. Although not original to this building, these columns date from the same period and are carved with similar motifs used on other timber elements. Also note the newly built roof with all of the bearing timbers replaced.

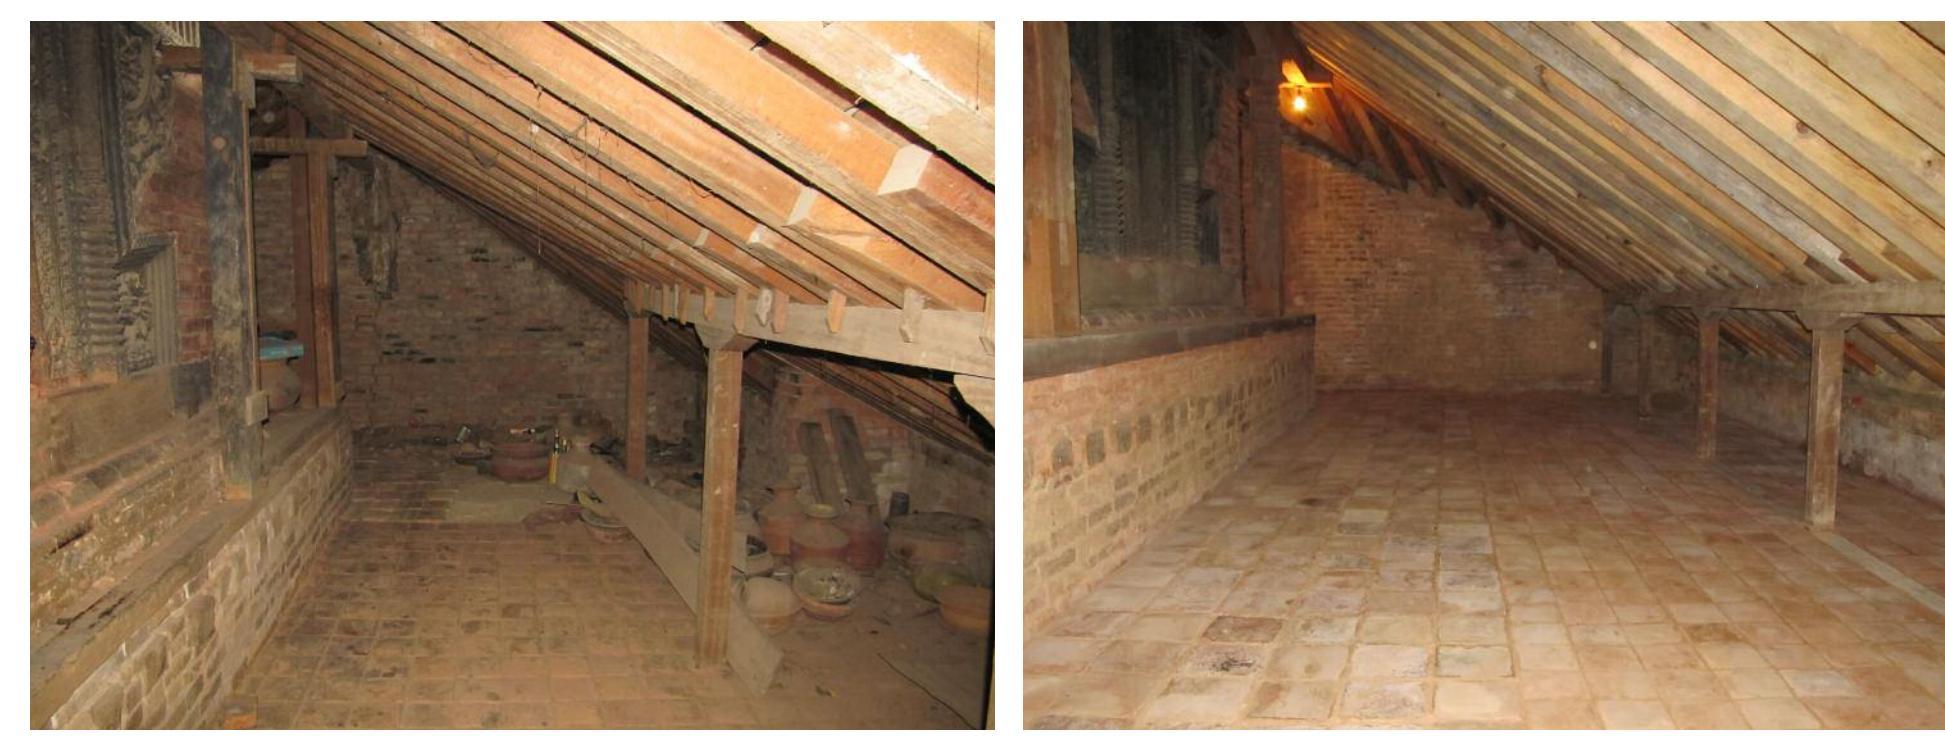
**Roof before rebuilding** | April 2012 Note the sagging of the rafters and the inadequate timber column support.

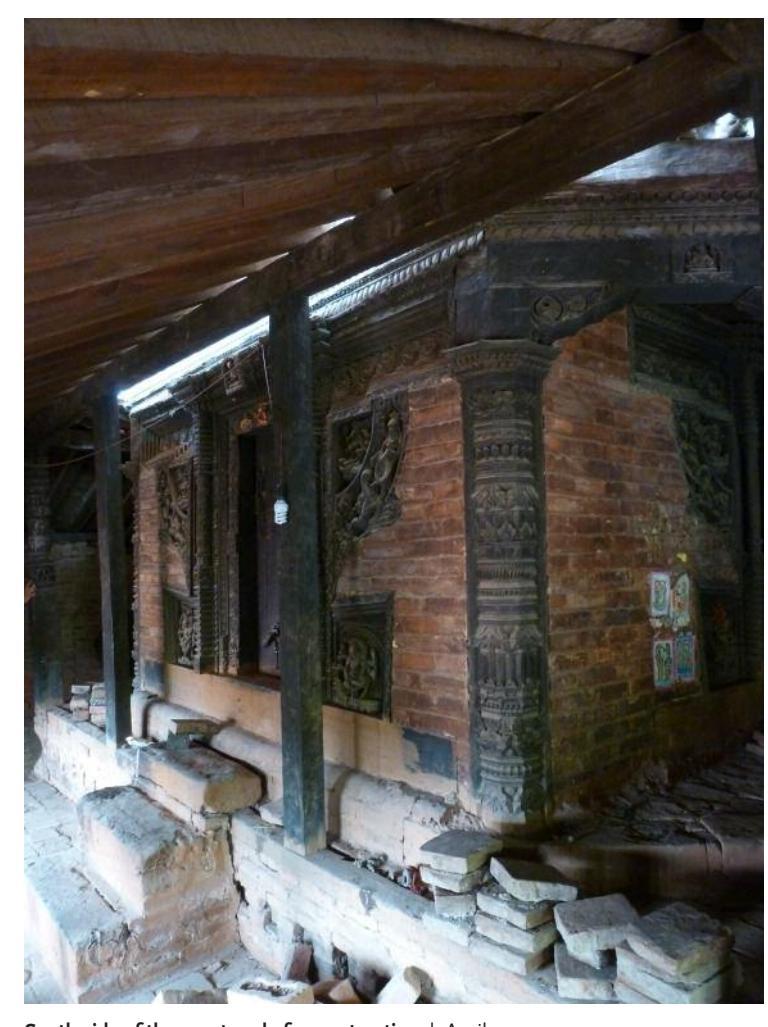
South side of the sanctum before restoration | April 2012 Note the strip of light along the top of the sanctum's cornice. This light is entering the third level via the large gap between the roof structure and the sanctum's walls. The chief focus of this seismic upgrade was to improve the structural connection between the inner sanctum's masonry structure and the surrounding roof. Also note the poor condition of the plinth. South side of the sanctum after restoration | October 2012 Note the improved condition of the masonry plinth, which was completely re-built. A new timber frame on the outer edge acts as a brace against seismic movement. The beam supporting the rafters was moved as close to the sanctum's structure as possible, and was connected to the sanctum with steel bolts and straps.

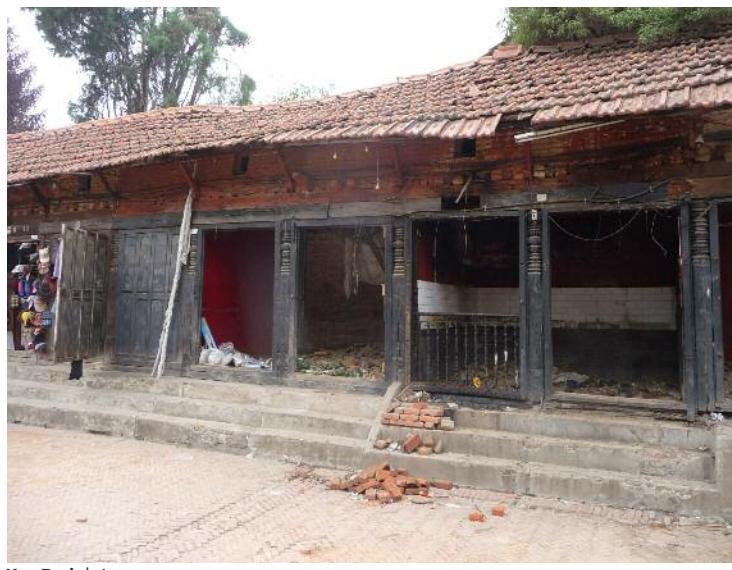
**Kot Pati** | June 2009 Kot Pati before restoration. Note the poor and damaged condition of the roof, the cement plinth and the division of the space into storefronts.

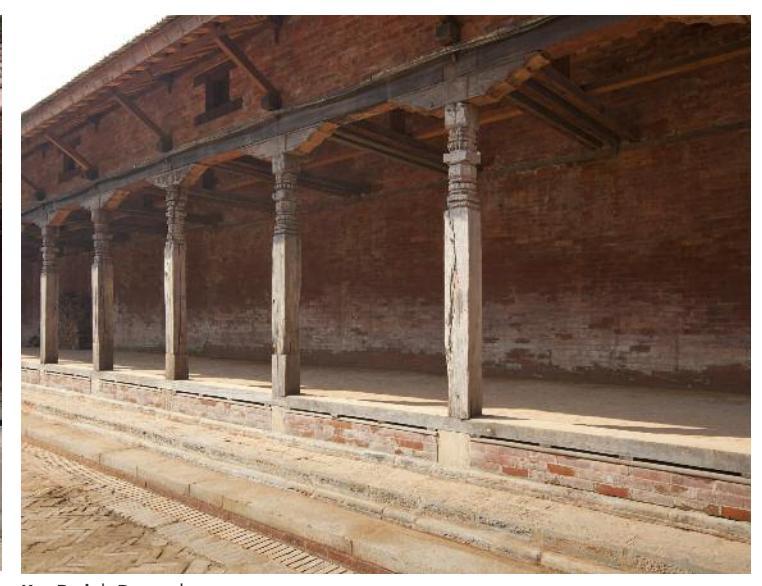
#### **Kot Pati** | December 2011 Kot Pati after restoration. Here the partition walls have been removed, the plinth rebuilt, and the roof re-built in the traditional style.
